## AIRBORNE REMOTE SENSING FOR DETECTION OF IRRIGATION CANAL LEAKAGE<sup>†,‡</sup>

YANBO HUANG<sup>1\*</sup>, GUY FIPPS<sup>2</sup>, STEPHAN J. MAAS<sup>3</sup> AND REGINALD S. FLETCHER<sup>4</sup>

### ABSTRACT

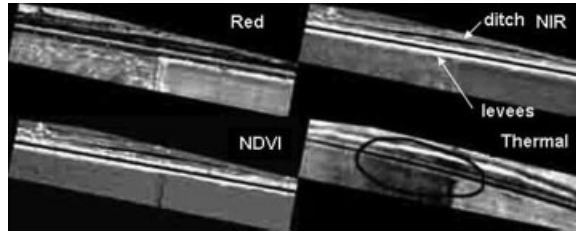
Case 1 is a concrete canal section in the Delta Lake Irrigation District (Site 3 in Table II). Red and NIR images indicated a wide drainage area along the canal (Figure 4) and a significant amount of vegetation on the canal levees. The NDVI image, which enhances the signatures of the vegetation, showed significant vegetation on the levees and in the drainage ditch (bright part on the image), and bare soil (i.e. no crops) in the adjoining fields. The thermal image presents a much cooler signature at a location on the south (bottom) side of the canal than in the adjacent area (circled in Figure 4), which is likely the location of a leak.

Figure 4. Airborne multispectral images of a concrete canal section in the Delta Lake Irrigation District (Case 1). The circled area in the thermal image showed a significantly cooler area – a large missing piece of concrete lining resulting in a major leak

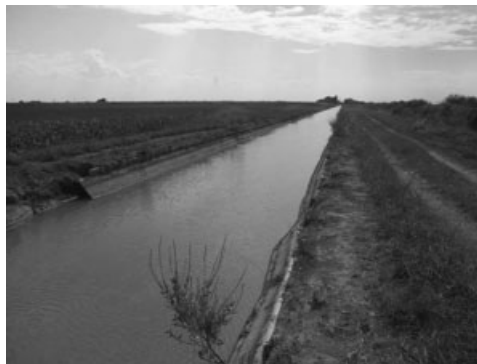
Figure 5 shows a ground-level photo of Site 3. The wide drainage area was on the north (right) side of the canal section under the thick bushes. The canal section appeared to be in fairly good condition. The grass on the levees is an indicator of seepage from the canal. The actual leak is located on the south (left) side of the canal and consisted of cracks and a large missing piece of concrete lining and corresponds to the thermal image indicator shown in Figure 4. Conclusions of the field reconnaissance were that there were both a major leak here and high levels of seepage as indicated by grass and bushes present in the area.

Figure 5. Ground-level photograph of a concrete canal section in the Delta Lake Irrigation District (Case 1)

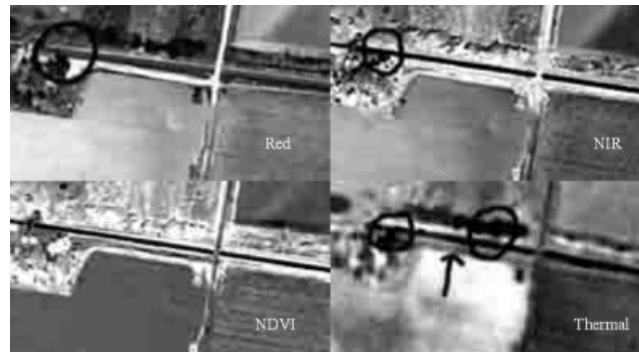
The second case study illustrates the usefulness of using multispectral images in order to filter out false positives. Site 4 (Table II) is also a concrete canal segment in the Delta Lake Irrigation District. The red, NIR, and thermal images (Figure 6) indicated that the canal section was in fairly good condition, with two areas indicating possible problems. On the red and the NIR images, the circled areas represent dense vegetation, whereas, on the thermal image, they represented areas of low temperature, which may be related to wetness. However, the corresponding NDVI image generated from the red and NIR images revealed a large tree and its shadow between the tree and the canal. Also, the NIR image indicates dense vegetation along the levee and in the adjacent area, a signature of seepage.

Figure 6. Airborne multispectral images of a concrete canal section in the Delta Lake Irrigation District (Case 2). The circled areas in the images show dense vegetation and surrounding areas, which was proven to be a tree and its shadow. NDVI with NIR and red images could differentiate the tree and shadow, but the thermal image could not

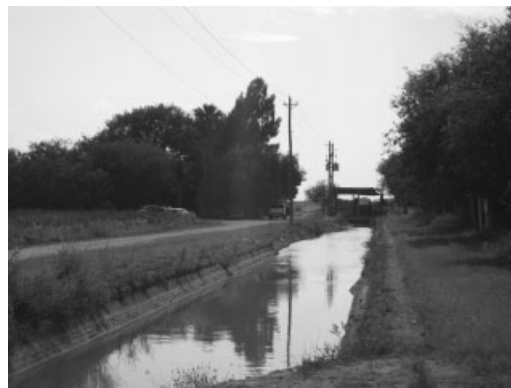
This interpretation was confirmed during field reconnaissance as shown in the ground-level photograph (Figure 7) which shows the canal segment in fairly good condition. The photograph also shows the tree and shadow which is not related to the seepage or leakage, and the vegetation which indicates seepage problems. This case explained how images obtained in other regions of the spectrum help avoid misleading information provided by the thermal image.

Figure 7. Ground-level photograph of a concrete canal section in the Delta Lake Irrigation District (Case 2)

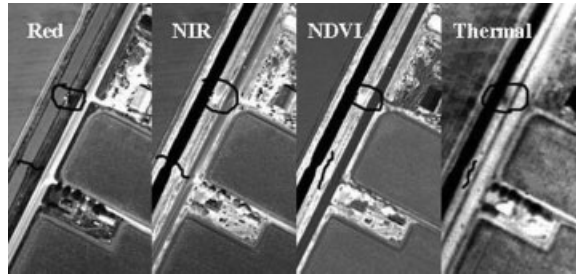
The third case illustrates a different type of problem which is easily identified through image analysis. Site 20 (Table II) is an unlined canal segment in Harlingen Irrigation District. While the canal segment appears to be in good condition (Figure 8), the red image indicates some sort of structure or artefact around the circled area, and the thermal image shows a low temperature signature here as well. The wavy line in all four images indicates dense vegetation in this area.

Figure 8. Airborne multispectral images of an earth canal section in Harlingen Irrigation District 2 (Case 3). The circled location was a standpipe structure and the marked lines showed dense vegetation

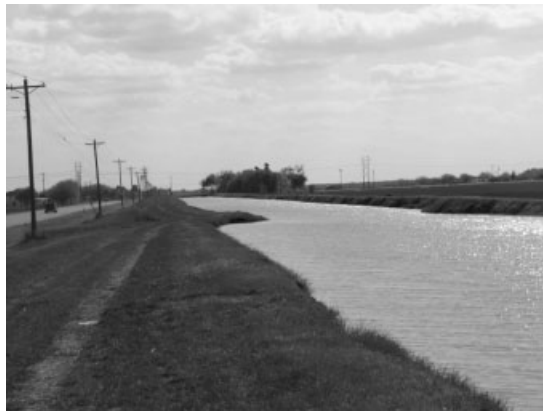
Field reconnaissance gave the site a visual rating of 6, meaning that the site may have a problem with a leak. The ground-level photograph (Figure 9) verifies that the canal segment was in fairly good condition, and grass grew uniformly along the sides of the channel (wavy lines in Figure 8). The circled area in the figure was a structure (i.e. a standpipe and valve) used to divert water into a pipeline system. Some seepage was occurring on the east side of the building as indicated by the imagery. The seepage was caused by the operation of the structure. It was concluded that a seepage problem existed at this site. It was mainly caused by the operation of the water distribution system.

Figure 9. Ground-level photograph of an earth canal section in Harlingen Irrigation District 2 (Case 3)
