# Beltsville Agricultural Research Center Hazardous Materials Assessment Part 2

**Beltsville Agricultural Research Center  
Hazardous Materials Assessment  
Project No. 103144**

**Revision 1  
April 22, 2020**

**Burns & McDonnell Engineering Company, Inc.  
Downers Grove, Illinois**

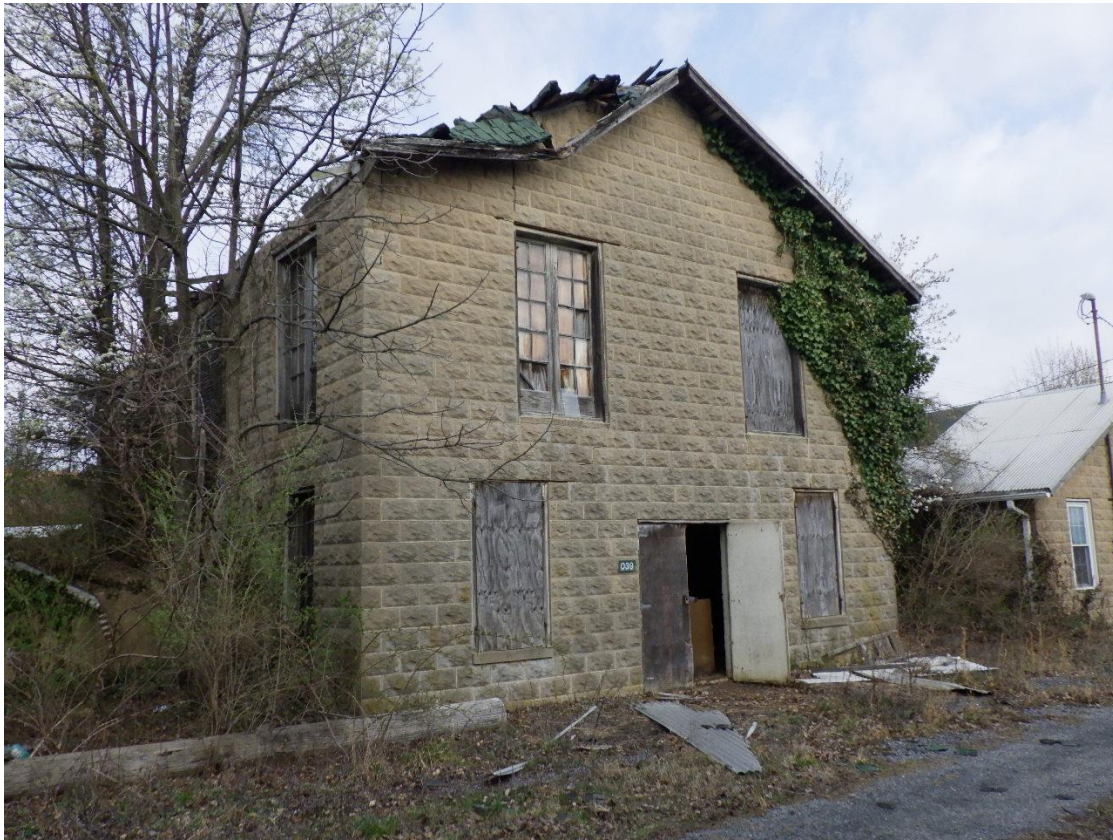
**Figure 8-2: Building 39, facing northwest, location shown on Appendix A, Figure 2**

No asbestos-containing materials were found at Building 39. Black sealant on the exterior brick was sampled and confirmed to not be ACM.

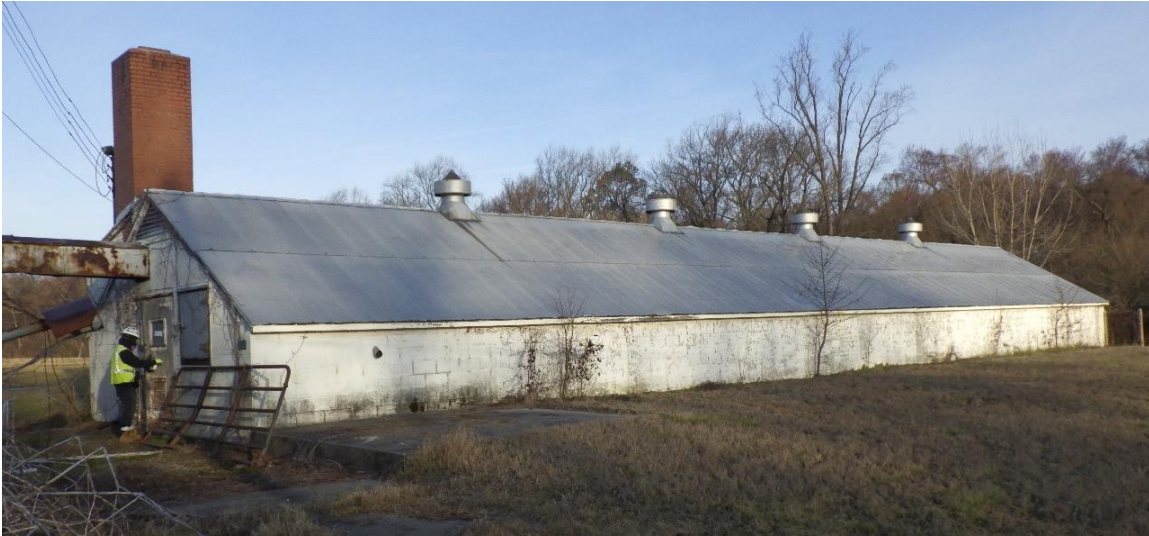
**Figure 8-48: Building 1425 – Facing northwest, location shown on Appendix A, Figure 3  
ACM**

Asbestos transite panels comprise the interior ceiling and wall panels of this swine research building.

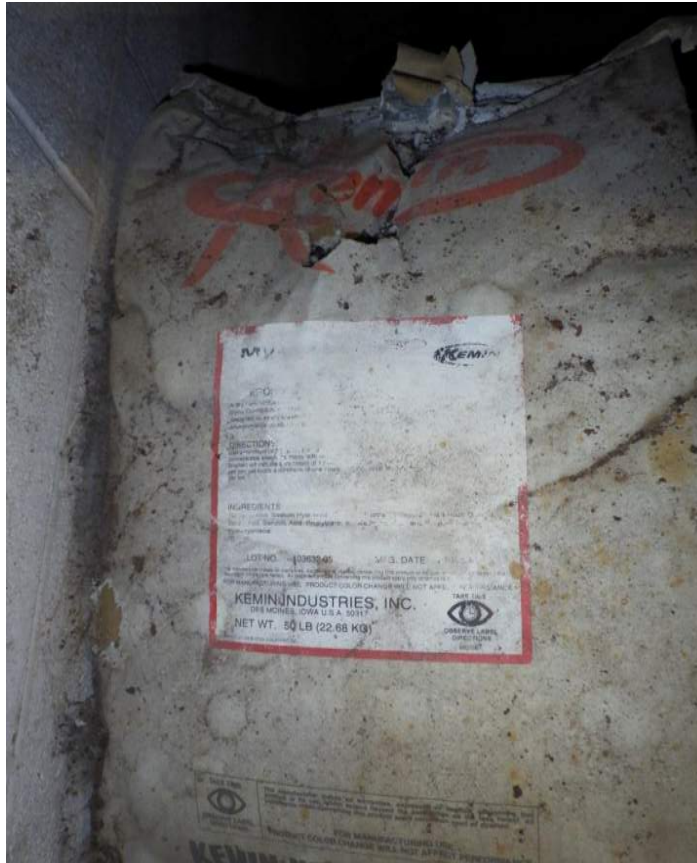
**Description:** 50lb bags of NAOH in storage, bags degraded

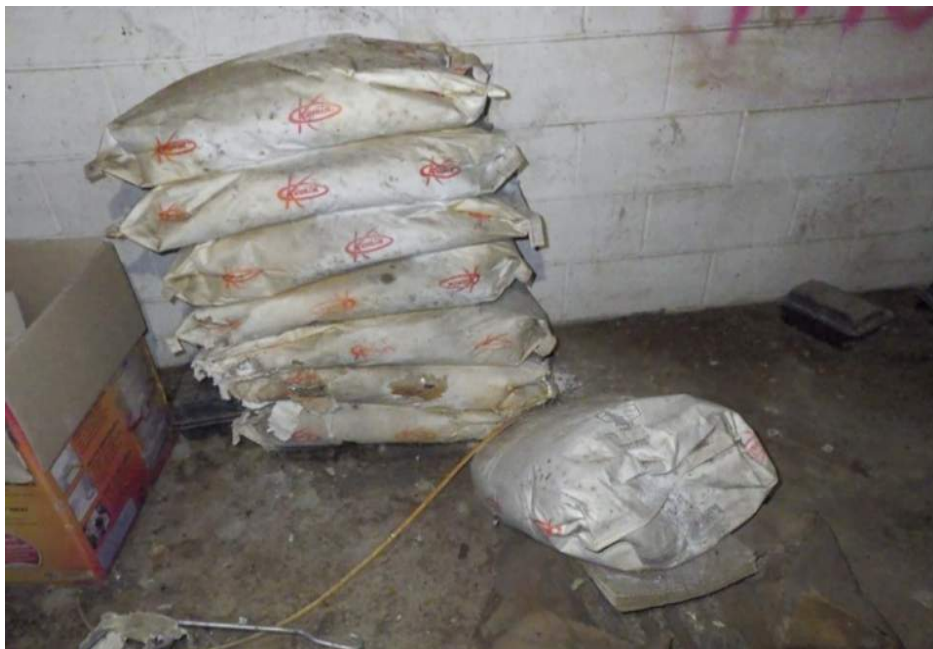
**Building/Unit:** 85

**Description:** 50lb bags of NaOH in storage, bags degraded

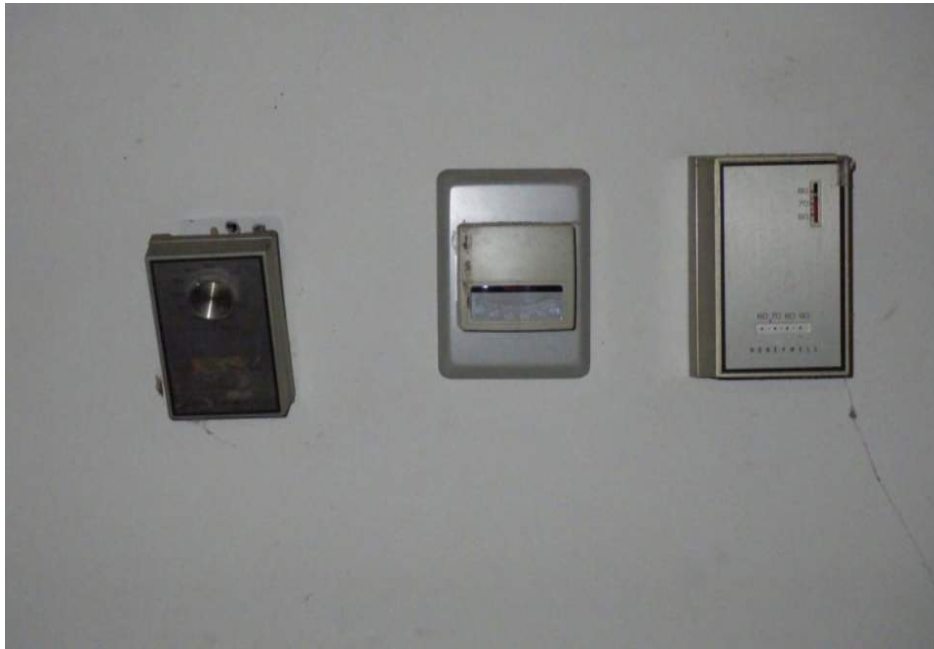
**Building/Unit:** 177B

**Description:** typical mercury containing thermostats and humidistats

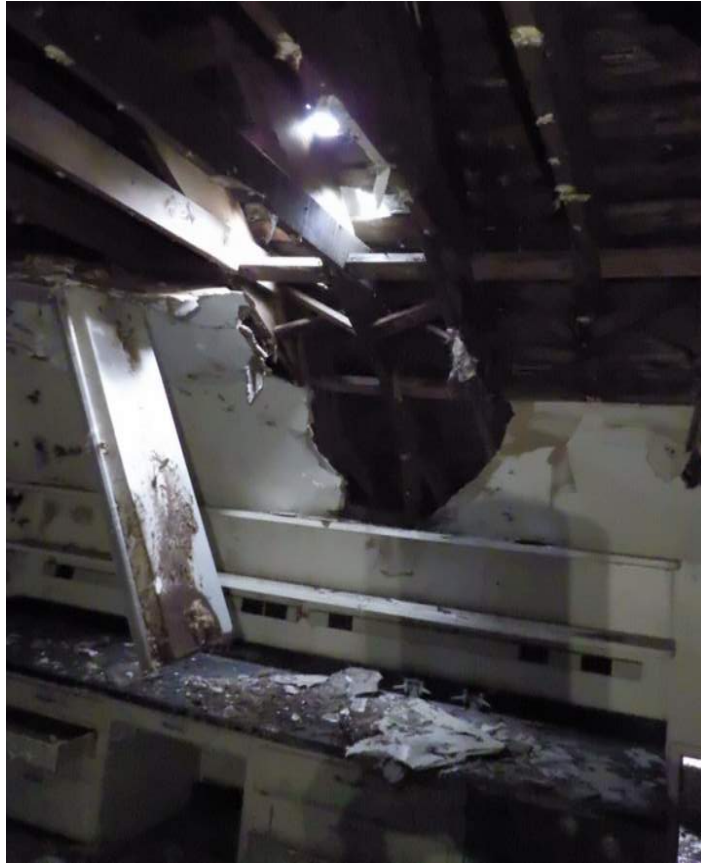
**Building/Unit:** 467

**Description:** typical 467 deteriorated roof conditions

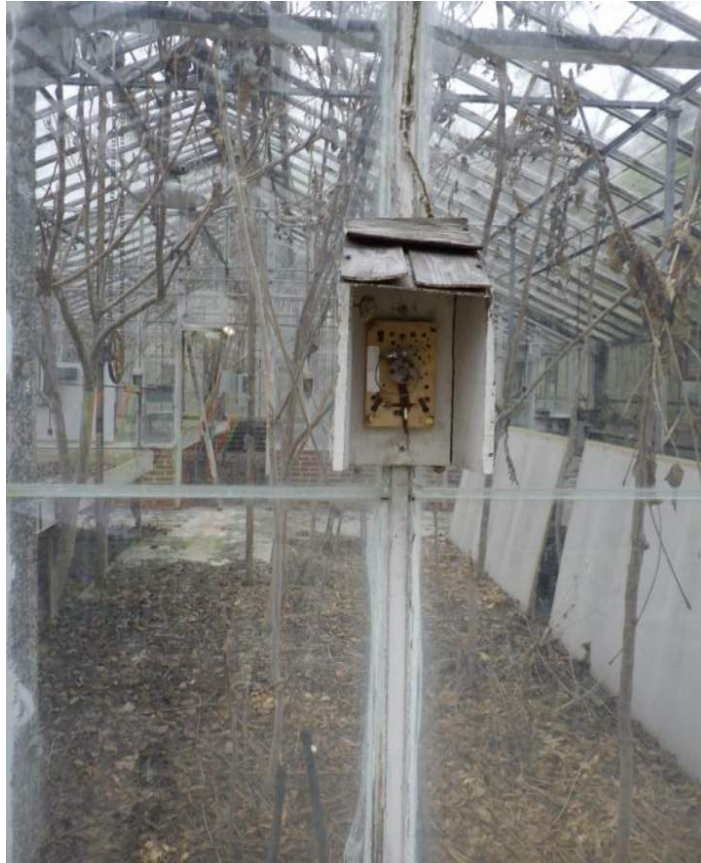
**Building/Unit:** 470

**Description:** typical degraded mercury vial thermostat in greenhouses

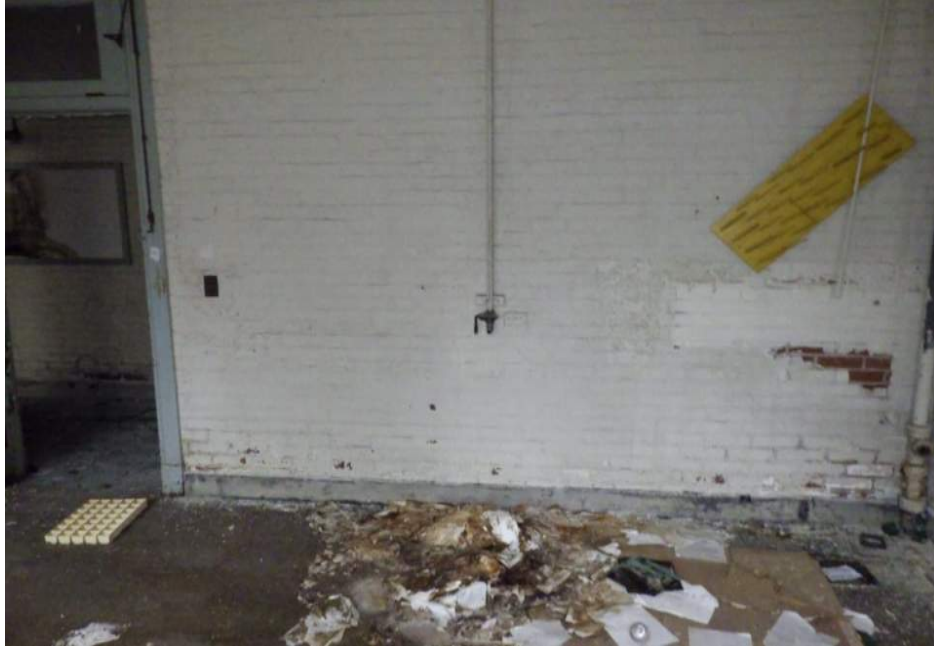
**Building/Unit:** 470

**Description:** typical deteriorated insulation piled on floor

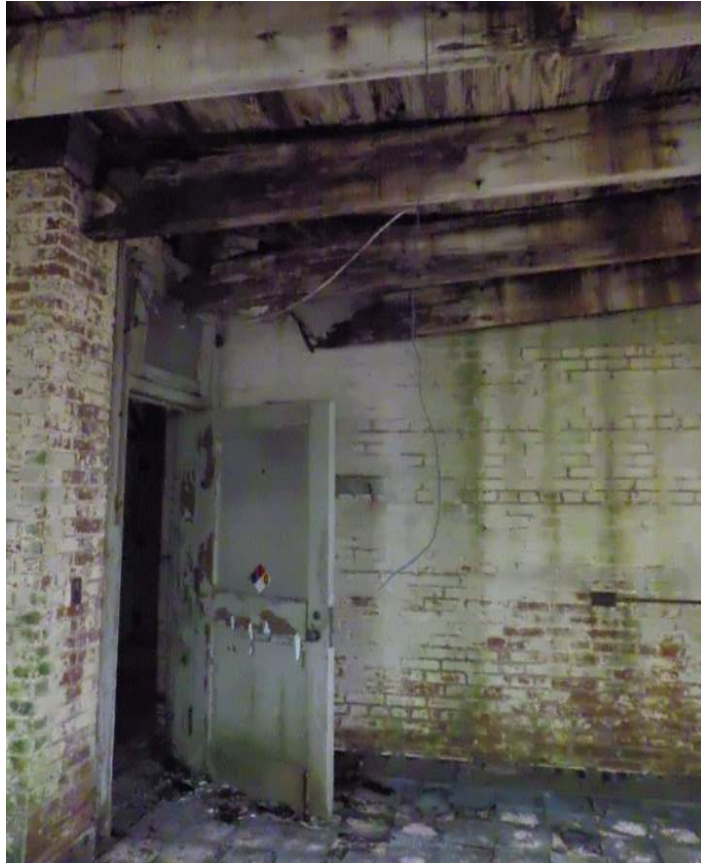
**Building/Unit:** 470

**Description:** deteriorated ceiling joists on south end of building

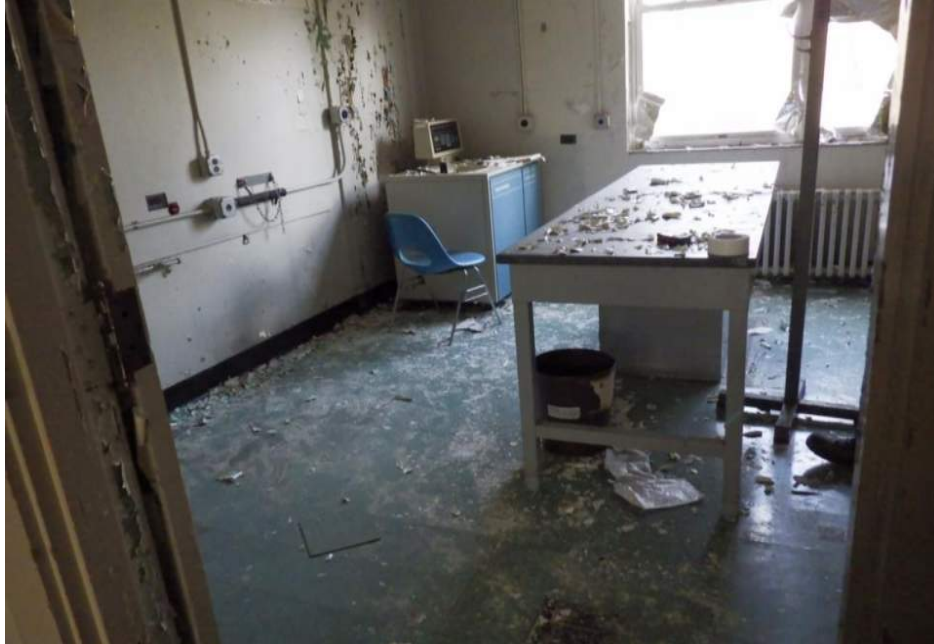
**Building/Unit:** 476

**Description:** typical floor tile and deteriorating ceiling
