# **Hydrology Report for the Agriculture Research Station, Dubois, Idaho- Revised Specialist Report for Revised Draft EIS.**

Jenny Fryxell, Hydrologist, TEAMS Enterprise

USDA Agriculture Research Station

September 15, 2015

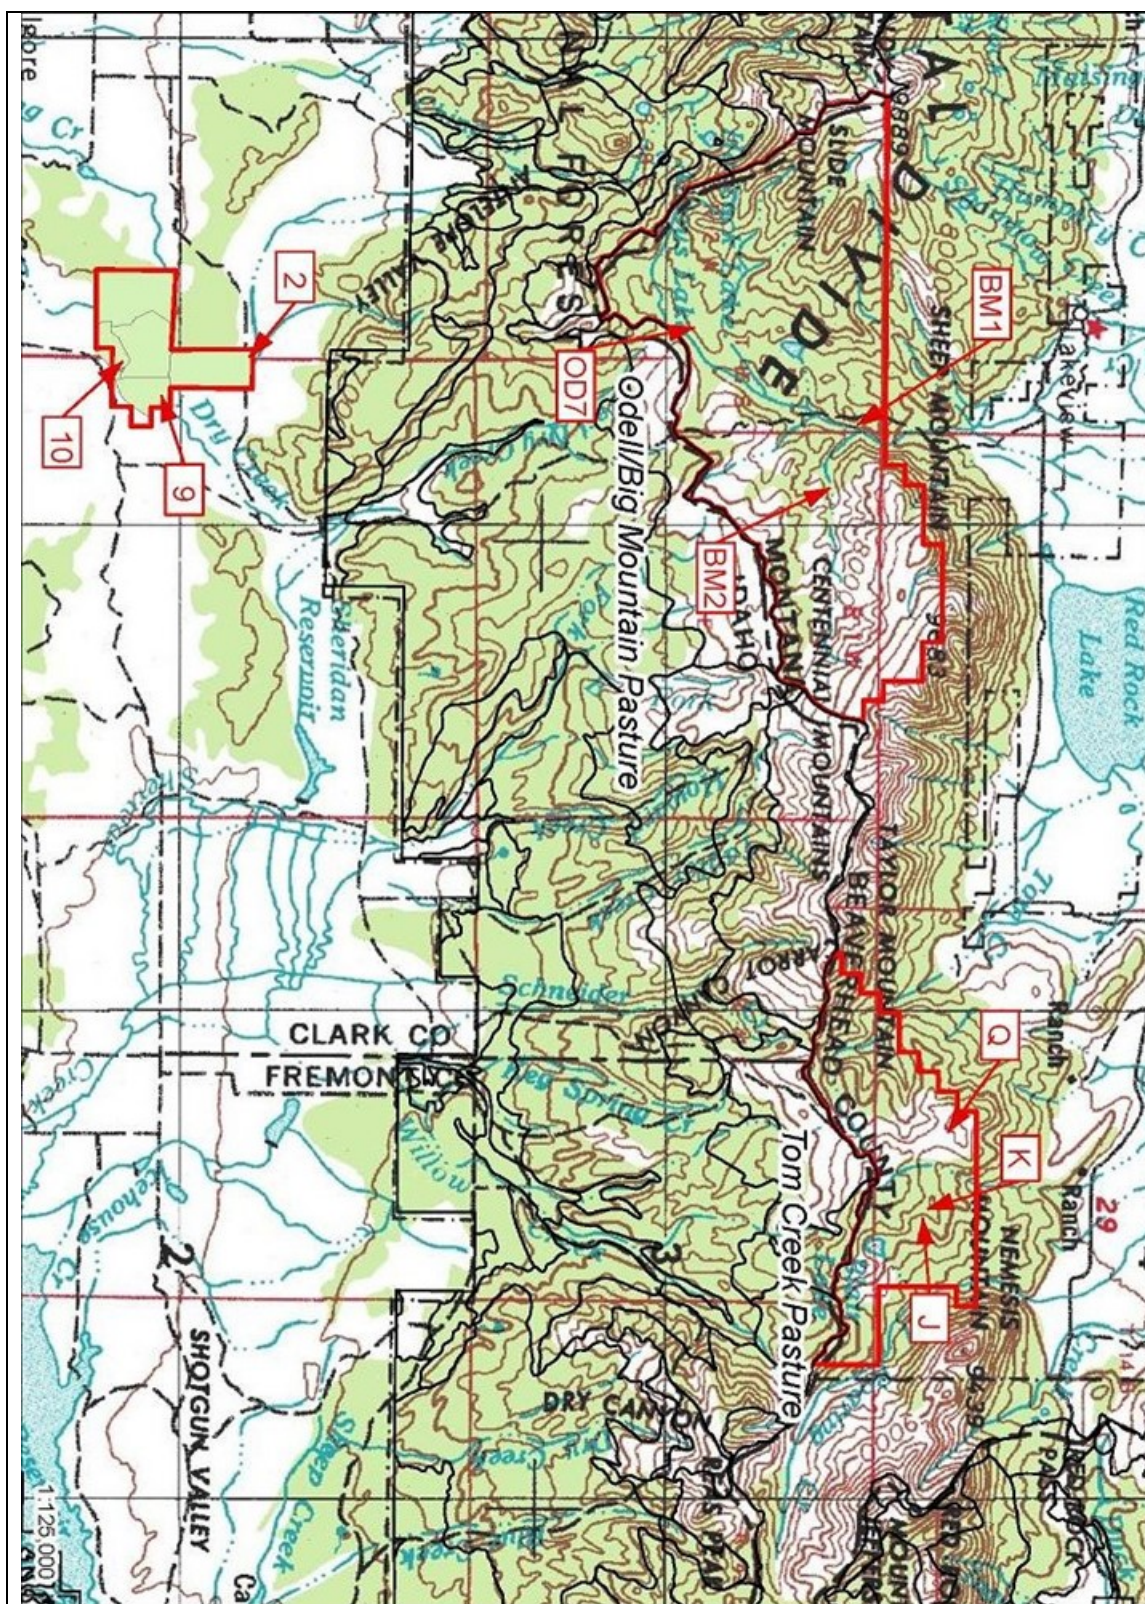
Figure 4. Overview of ARS summer grazing properties.

The eastern half of Tom's Creek grazing unit is mapped as a dark, pyroxene bearing trachyte, a volcanic rock that may be locally a trachyandesite or trachybasalt (Witikind, 1976). Underneath the trachyte and exposed on the hilltop bedding area (Point. J and K, Figure 4) is exposed Shedhorn Sandstone. The western one-half is mostly the Madison Group, a light gray cliff forming limestone. The western slopes are steep, with moderate bluffs. At the crest of the hill with bedding area (point Q, Figure 4) is an exposure of the stratigraphically lower Amsden Formations. Along the upper portion, and exposed on the hilltop, are red siltstone/shales and a limestone pebble conglomerate.

All of these points were on flat irrigated fields (points 2, 9 and 10, Figure 4).

Beaver Creek flows through the western margin of the Humphrey Ranch property. At the USGS gage site at the bridge (exit 172 from I-15) (Point Q, Figure 4), the stream at the time of the site visit was dry (July 10, 2008). The general appearance and category in the Rosgen classification are the same from this point upstream to just below the gravel pit. The stream is completely confined within a deep basalt gorge. It is a relatively straight channel, with a simple structure of riffles and glides at regular intervals. Bar development is minimal and there are few pools. There is not a readily defined floodplain, rather more of a consistent debris fan at the foot of the cliff walls that is occasionally inundated. Riparian vegetation community is sparse. An ocular assessment of Rosgen classification is an F3 (Rosgen, 1996).

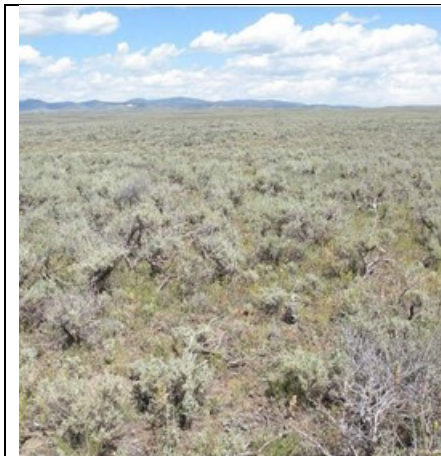
**Figure 5. Views of Typical Alluvial Flats Underlain by Basalt, Headquarters Property**

The Headquarters property is underlain by flood basalts, resulting in an uneven topography, due to multiple flow events, pressure ridges, lava tubes, “blisters” and other Surficial expressions of volcanism. In addition, there appears to be a pattern of regular jointing or fracturing. As a result, there is little water retention and the area is dominated by sagebrush (Figure 5, Moser et al, 2008).

In general, alluvial flats found on lower basin floors are dominated by sagebrush and underlying basalt flows. Areas underlain by basalt flows lack defined drainages due to the basalts high permeability and porosity. Adjacent lower elevation flatlands are very well drained and have moderate grassland productivity (Figure 5). Road densities by 6<sup>th</sup> level watershed are summarized in Table 3. These are all the watersheds involved in the Proposed Action. Table 4 summarizes the miles of road within 300 feet of streams on the Headquarters property. There are 2.7 miles of existing firebreak around the Headquarters buildings. The firebreak is roughly 20 feet wide and is comprised of mineral soil. The total area of the firebreak is 65 acres. No streams, springs, or wetlands are adjacent to the firebreak.

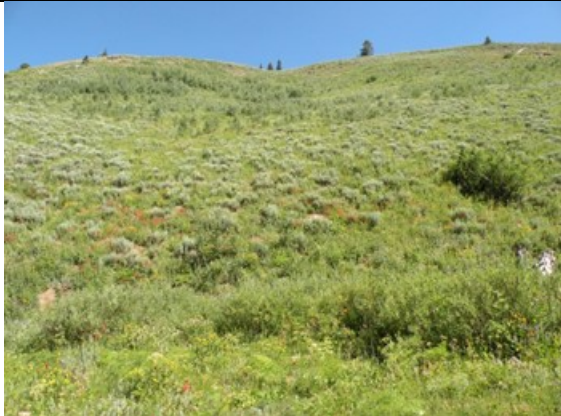
Watershed condition generally appeared consistent throughout this grazing area, based on the ride through in 2008. Three data points were taken, as the area was very consistent in appearance. Uplands were generally well vegetated with little evidence of surface runoff or erosion (Figure 6). No evidence of desertification was observed in the field. Desertification occurs when the amount of dry-land biological productivity is reduced. There are several reasons why desertification occurs, and grazing can be one of them, or there can be several factors causing this to occur (<http://www.britannica.com/EBchecked/topic/159114/desertification> ).

<b>Figure 6. Views of Uplands, Big Mountain Grazing Unit (Western Summer Range)</b>	<b>Figure 7. Views of Slumps Originating in Cretaceous Sediments, View to the North</b>

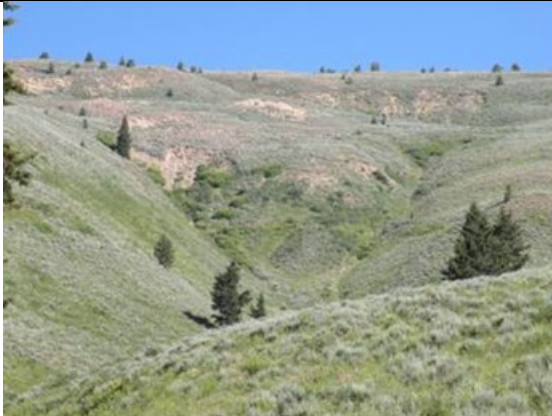
Bare soils were primarily associated with steep southwest facing ridges and were largely due to active slip faces, which are a function of the underlying Cretaceous siltstone and sandstone geology (Figure 7). These slumps start with a convex shape, and then evolve into a concave shape, where they appear to stabilize and re-vegetate. No evidence such as trailing, trampling, or bed grounds was noted in association with these slumps. As a result, these areas of disturbance are considered “natural” and not related to grazing activities.

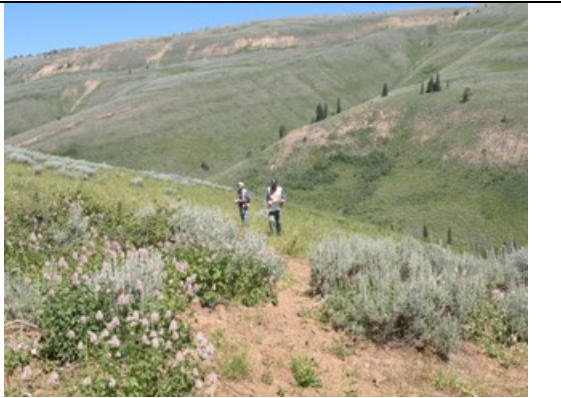
Bare ground was also noted in association with bed grounds (Figure 8). However, these areas were very limited spatially in extent. The main bedding area observed had a surface condition rating of two, with soil hydrology and nutrient cycling rated as fair.

<b>Figure 8. Edge of Bedground, Big Mountain Grazing Area, View to Northwest</b>	<b>Figure 9. Revegetated Roadbed Leading to Closed Phosphate Mine, Bottom of Spring Creek Drainage</b>

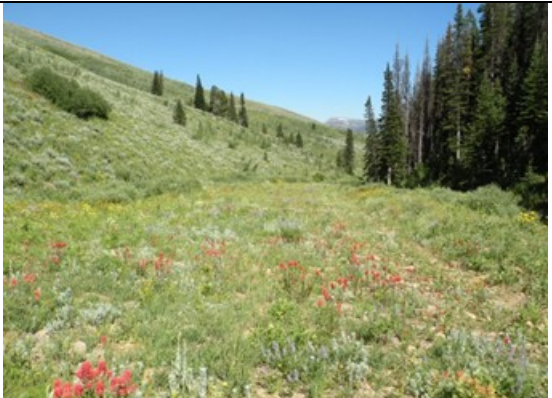
An old road leading to the J.R.Simplot mine is located in the bottom of the Spring Creek drainage. The road is confining the drainage in places, leading to increased down-cutting and increased channel confinement. Erosion of the road prism was observed in several places. However, the road surface is generally well vegetated, which acts a sediment filter.

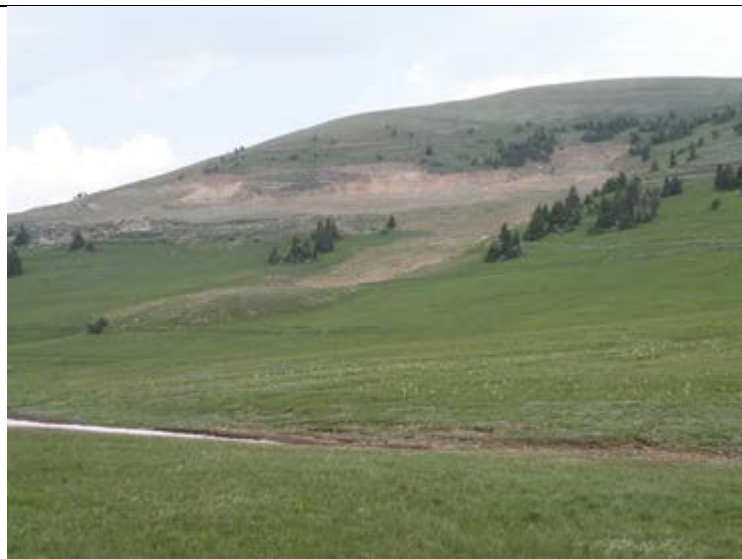
Fieldwork was also done at and near the mine site to assess existing upland watershed conditions (Fryxell, 2008). Snow patches were present and melting at the time of the visit, resulting in bare patches of ground, but green vegetation shoots were noted, indicating vegetative growth was slow in the areas, due to melting snow. Ground cover appeared to be consistent in distribution and percentage over the area, ranging from 65-80% cover; however in the area of the mine itself ground cover minimal ground cover was much less (estimated down to 25-30%). Rock fragments were abundant on the ground surface at this location and formed a type of ground cover, likely reducing soil erosion (Figure 10 ). At the mine site proper, no active areas of erosion were noted, except at where a small drainage exists from the settling pond. Some relatively minor channel widening and down-cutting has occurred for a small distance downstream. Down below the mine a small drainage runs roughly east/west, which some very

**Figure 10. View of Uplands near J.R. Simplot Phosphate Mine, Note small drainage in middle ground of photograph**

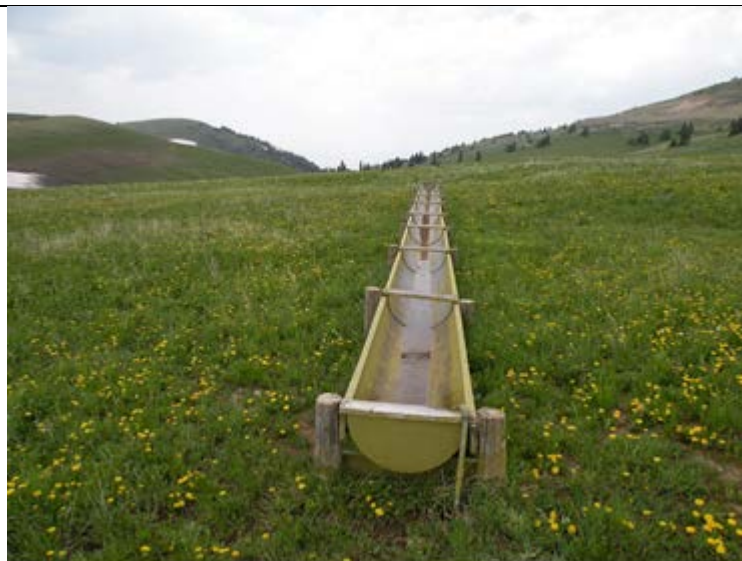
**Figure 11. View of Vegetation Growth Adjacent to Water Trough**

This portion of the grazing area had been rested in 2007, however vegetative recovery appeared to be consistent around these water developments, indicating that detrimental compaction and degradation of soil hydrology has not occurred to the extent that it impairs vegetative growth (Figure 11).

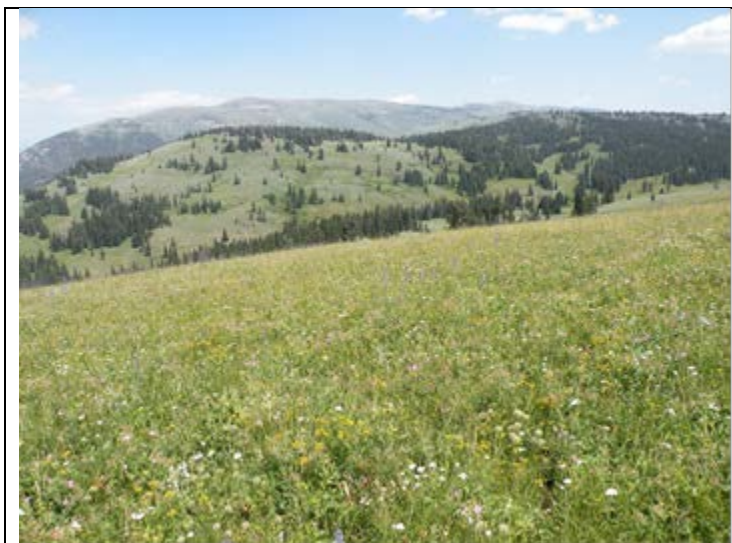
Watershed conditions appeared to be good and consistent within the West Odell grazing unit. No evidence of desertification was observed in the field. Twelve GPS points were taken throughout the Grazing Area. Although soil surface conditions varied from a “2” to a “4,” the average was 3.6 indicating fully hydrologic function and almost minimal signs of impairment (Table 5). For the points taken, the average total cover approached 64% and appeared to be consistent

**Figure 13. West Odell Grazing Unit (West Summer Range) Looking to the Northeast**

throughout the grazing unit (Figure 13). No evidence of rilling and gully, or other signs of surface overland flow were noted on uplands. Six PFC surveys were conducted and all received ratings of PFC. Please refer to the “Channel, Riparian and Floodplain Conditions” section later in this report for additional detail.

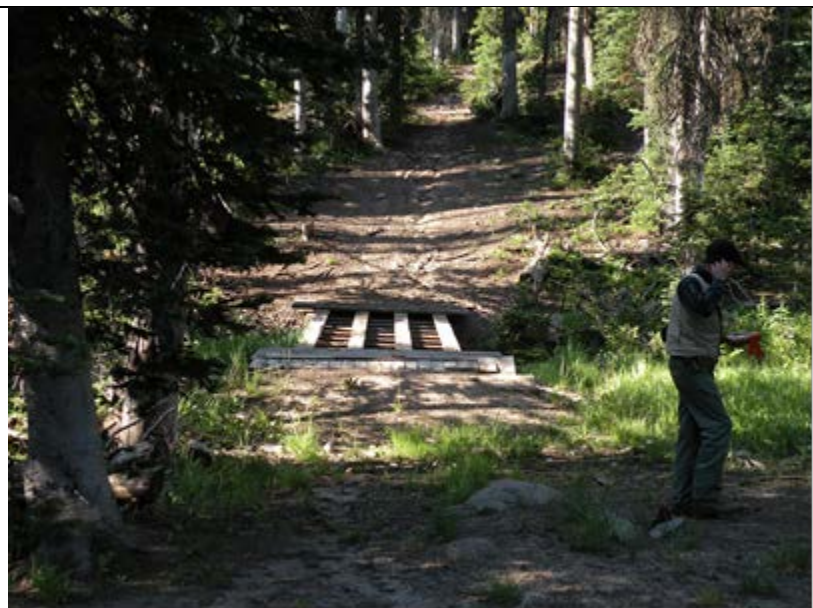
Although soil stability, hydrology, and nutrient cycling were rated as impaired in this area, active erosion features were noted only on the far side of the crossing. Rilling and incipient gully were noted and were adjacent to, and perpendicular to the stream crossing. Minor bank hardening

was also noted. Although some extra sediment was being derived from this trail, no detrimental bimodal distribution of sediment was observed in the streambed.

As a result, it did not appear that sediment contributions are exceeding natural sediment loads being carried by this stream. In addition, bank degradation was confined to where the driveway crosses Odell Creek.

**Figure 15. Sheep Driveway Crossing at Odell Creek, Upstream to Readers Right**

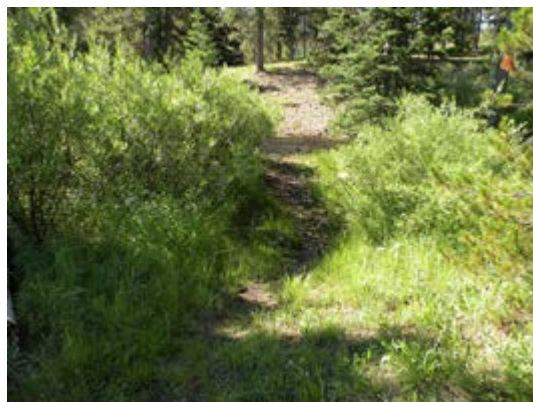
At OD5, the entry into the stream crossing is an estimated five feet wide with the exit onto a steeper sloped, which is largely bare of vegetation, and somewhat compacted. There were no well-developed rills or gullies leading down to the Creek (Figure 16 and Figure 17 ). Substrate in the stream bottom appeared not to be dominated by fines, with sub-angular siltstones to cobbles predominating. There did not appear to be a bi-modal sediment distribution.

**Figure 16. Entry to Sheep Driveway, OD 5**

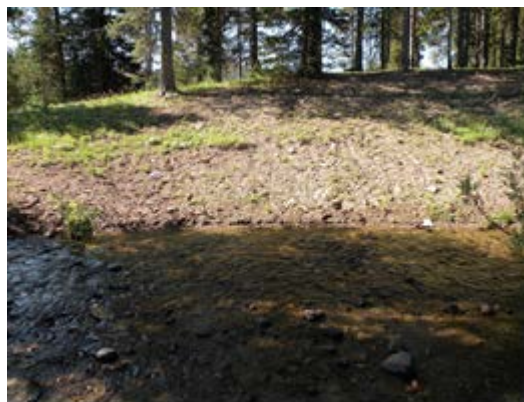
**Figure 17. Close up of Exit of Sheep Driveway, OD 5**

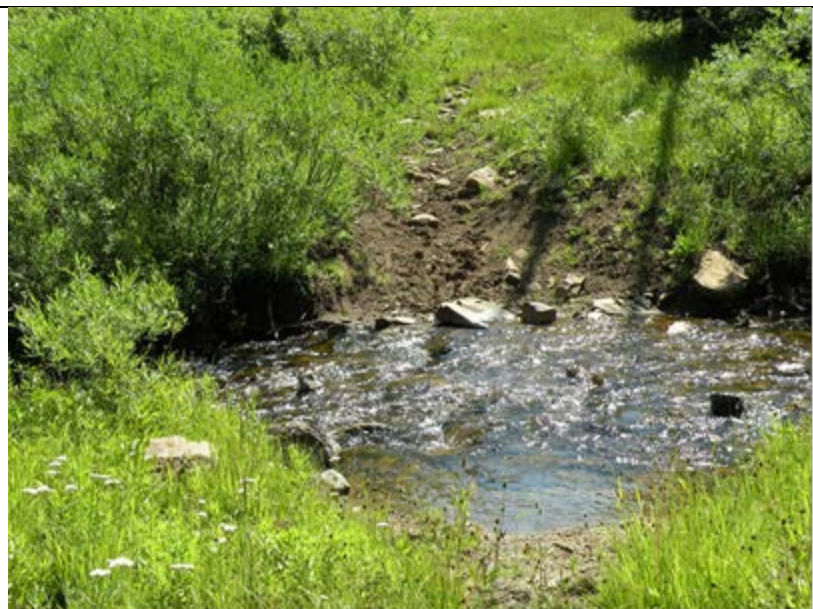
At OD 7, minor bank degradation was present at the two stream crossing areas, with one of the crossing exhibiting revegetation. Minor sediment contributions to the stream are derived from these trampled areas. However, there were no rills or gullies observed and there was no observable bimodal sediment distribution of stream substrate, which would indicate an unusually high percentage of fines for this mountain stream. Adjacent uplands were in good health with a well-distributed groundcover of broadleaf forbs and grasses (Figure 18). The driveway crossing at OD 8 was in good shape and had not been recently used and no rilling or gullies on adjacent uplands were noted. Photographs were not taken at this site.

**Figure 18. Driveway Crossing at OD 7**

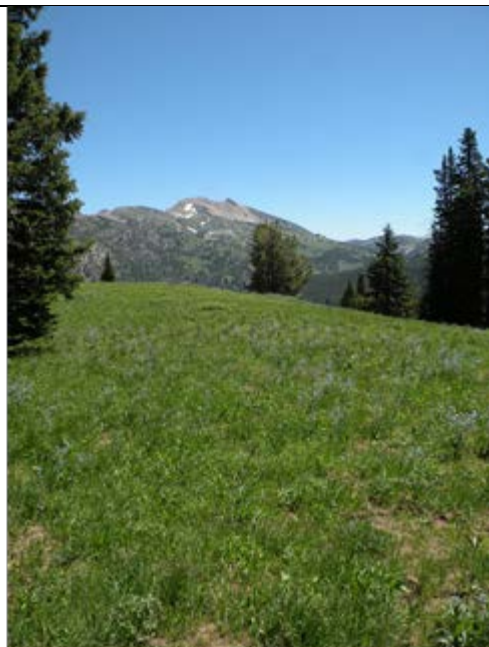
Observed surface conditions ranged between Condition Classes 1 and 4. No evidence of desertification was observed in the field. The range of total percent cover varied from 0-95, with an average cover of 64 percent. Nine total GPS points were taken. Uplands were remarkably consistent in vegetative cover. No sources of upland erosion, consisting of rills and gullies were noted. Surface Condition Class is estimated to be between Condition Class 3 and 4 for the grazing area except for the road to for the observed bedding areas and the road to Blair Lake. Some evidence of overland flow was noted in association with melting snow fields and was confined to within 50 feet of these areas, and no erosional features were noted in association with the melt

**Figure 19. Views of Uplands in Tom's Creek Grazing Area**

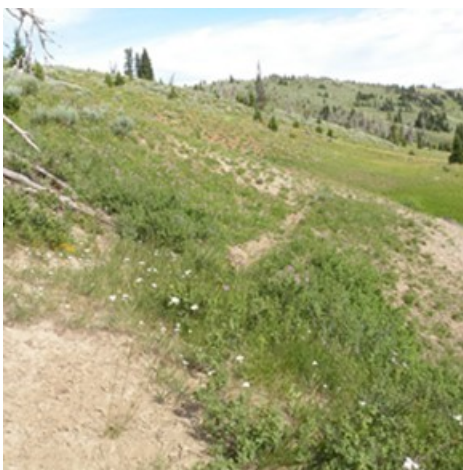
One area of uplands was of special interest, which is located at the head of the North Fork of Tom's Creek, which has been an area of past debate (Figure 20 and Figure 22). This area burned by a forest fire sometime between 1880 and 1930. Burned trees still stand and charcoal is still found in upper portions of the soil horizon. Slopes tend to be steep (over 10%) with poor site productivity (Jacobson, 2009a). Past debate has been regarding supposed over-grazing practices by ARS. This area was reviewed with ARS, Soil Conservation Service personnel and University of Idaho staff to review upland conditions. ARS notes on the meeting state: "Soil Conservation personnel believe grazing abuse by the Sheep Station had not occurred, that the site was as good as could be expected, that no current erosion was occurring, and the overall trend was up" (Jacobson, 2009a).

**Figure 20. Vegetation and Recovery of Trailing, East Portion, North Fork Tom's Creek (Bighorn Dolomite Area)**

In 2009, field work was conducted again to assess this area (Fryxell, 2009). The eastern portion of this headwater supports a consistent vegetative cover, which is being re-established after grazing by both historical and ARS grazing. Relict trailing was noted, but trails are re-vegetating throughout this portion of the headwaters (Fryxell, 2009, Figure 20). This area is designated as Unit 8 Tom's Creek grazing area (Eastern Summer Range) and has had only incidental grazing since 1994 (Jacobson, 2009a, Moffet, 2009). The 2009 field inspection revealed no evidence of rilling or gullies but evidence of naturally occurring soil creep was, as indicated by trees and snags leaning into the hillslope. Soils are stony and provide a notable measure of cover. This portion of the headwaters is underlain by the Cambrian Bighorn Dolomite.

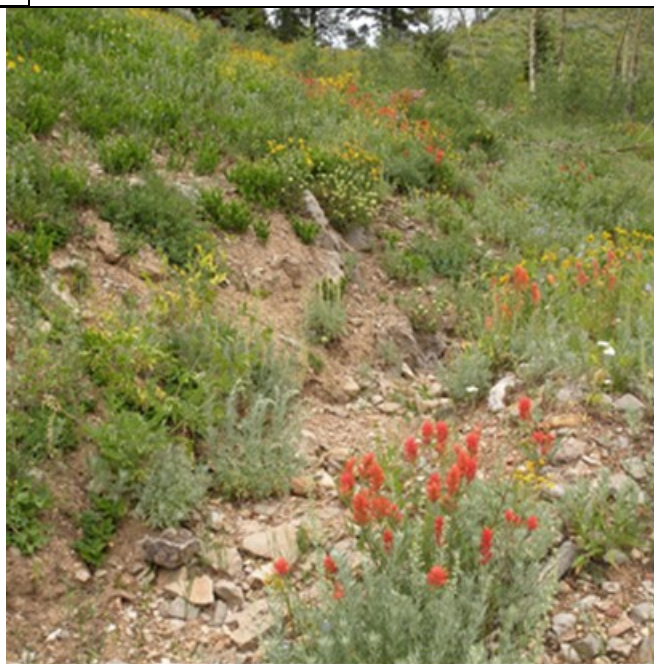
**Figure 21. Views of Intermittent Drainage, North Fork Tom's Creek, Park Shale Area**

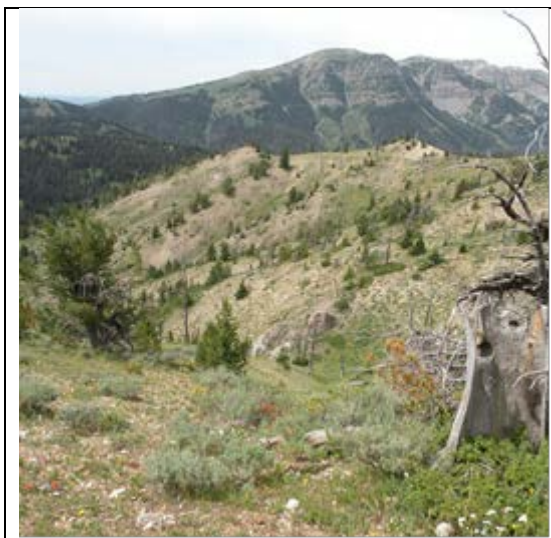
To the south, an abrupt and dramatic change in vegetative cover was observed, as vegetation becomes largely absent on the uppermost and steepest portions of the western half of these headwaters (Figure 21). On the lower portions of this area, where slope gradients are shallow vegetative cover becomes consistent and lush. Trees are sporadic in both the northern and southern portions of these headwaters due to poor site productivity. This area is underlain by the Cambrian Park Shale, which overlies the Bighorn Dolomite (Moffet, 2009, Fryxell 2009, Witkind, 1976). Even though cover is largely lacking there was no observed evidence of overland surface flow, rills, gullies or mass movement. To the north and west additional trailing was noticed, but as mentioned above these areas are now green due to revegetation. The North Fork of Tom's Creek appears to be ephemeral to intermittent. Channel definition increased in a downstream direction, reflecting increased flow volumes. The channel was classified as a Rosgen A3<sup>1</sup>, characterized as a steep, entrenched, cascading, step pool stream, in proper functioning condition. Uplands were not observed to be eroding or contributing excessive amounts of sediment (Fryxell, 2009).

**Figure 22. View Looking West to Area Underlain by Park Shale, West Half of North Fork of Tom's Creek**

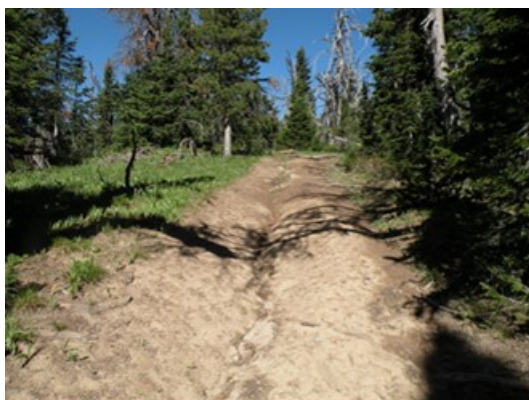
The only areas receiving a surface Condition Class rating of 1 was the road, which starts on Forest Service-administered land, which leads towards Blair Lake. The initial portion of the road has been put to bed by the Forest Service in the summer of 2008, when it was ripped and seeded. From the ARS/Forest boundary to near Blair Lake, various degrees of rilling, rutting, and gully

development were observed (Figure 23). Near the ARS/Forest Service boundary, minimal slash is in place but has not been effective in diverting water from the road. Erosion and gully development are the most severe near the end of the road where there is a 15-20 percent grade. Ruts and gullies are one to three feet in depth. An area of at least 1,000 ft x 10 feet by 3 feet is estimated to be involved (Figure 24). Areas adjacent to the road are used to drive the sheep down to the stream, where they cross on their way to Blair Lake.

**Figure 23. Road Ruts on Road to Blair Lake**

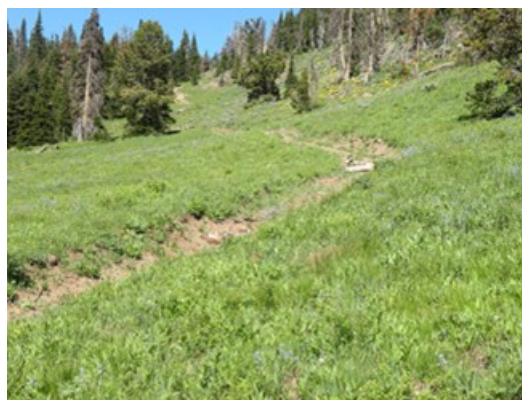
**Figure 24. Road and Erosion, Lower portion of Road to Blair Lake**

The road ends near a Rosgen A4 type stream (Rosgen, 1994). The road has functioned as a long term chronic source of sediment to this channel. Based on the proximity of the road to the channel and the contributions of sediment over time, this stream received a functional at risk rating. There are no water developments in this grazing area.

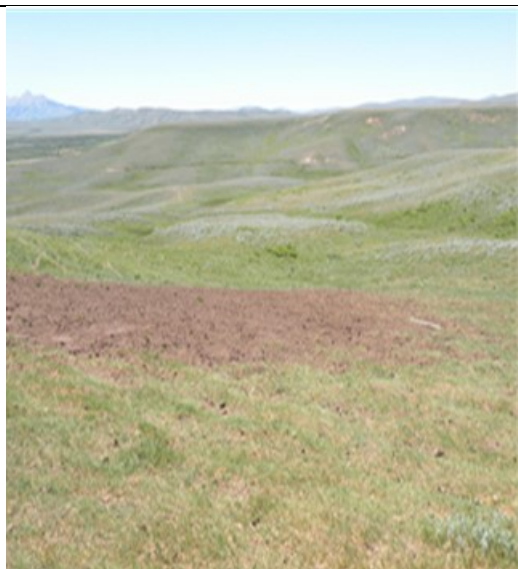
**Figure 25. View of Bedding Area, Humphrey Ranch, View to North/Northwest**

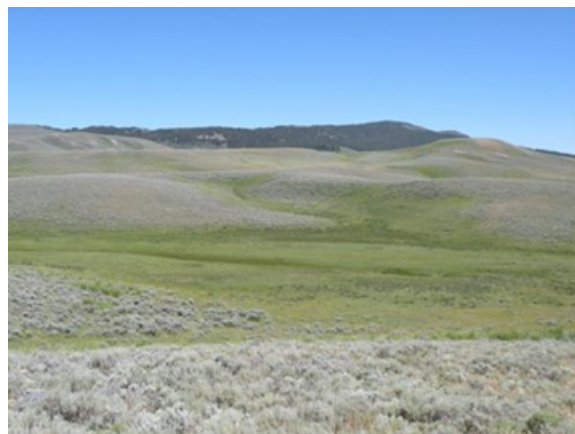
**Figure 26. View of Lowlands, Humphrey Ranch**

For all other points Condition Class ratings of 3 and 4 were given. For these 21 points, the average Condition Class rating was 3.6. Uplands tended to be well vegetated as indicated by the 89 percent cover. Lushly vegetated lowlands separate the highlands, indicating areas of increased moisture and possible subsurface flow (Figure 26).

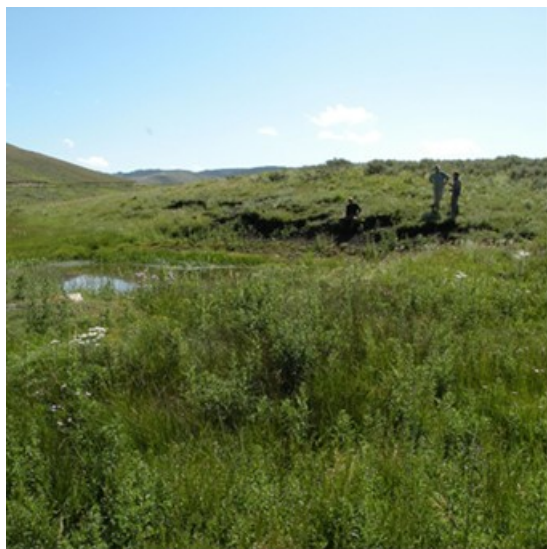
**Figure 27. Disturbance around Watering Pond**

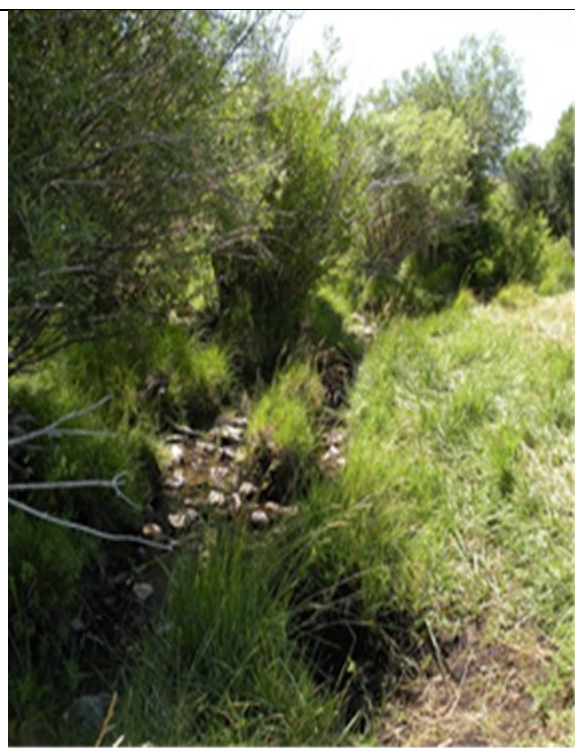
**Figure 28. Perennial Stream, Humphrey Ranch**

The second bedding area was noted immediately adjacent to the perennial stream found in the northeastern-most quarter of the grazing area, which is used for watering the sheep. Evidence of use includes bank trampling, some vertical bank development less than ten inches high, trampling in areas next to the stream and some accumulation of fines in areas where water velocity would be less during higher flow. Some channel over-widening was also observed, as were small, vegetated islands (Figure 28). Despite these indicators of use during watering, riparian vegetation was well developed with a variety of age classes, and some hedging due to browsing was noted (Figure 29). Equisetum and iris were also noted. There was no evidence of channel dewatering. Upstream from this area, the amount of use varied and channel width decreased.

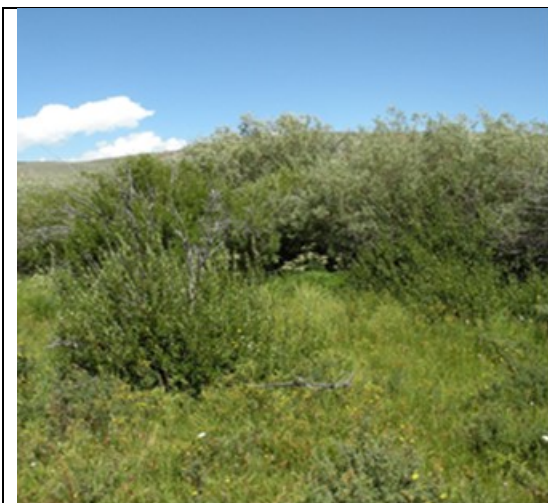
Downstream from the area of use channel width also decreased and the absence of excessive fines was observed. Bank incision also decreased both up and downstream from the area of use. The channel was observed to be in proper functioning condition below and above the area of use.

**Figure 29. Riparian Vegetation, Perennial Stream, Humphrey Ranch**

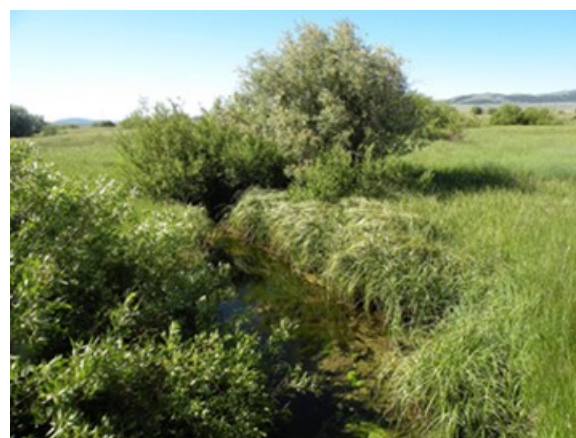
**Figure 30. Beaver Creek, Humphrey Ranch**

The second perennial drainage in this grazing area is located on Beaver Creek, which is in the far western portion of the area. Beaver Creek, where it crosses the road, is a Rosgen E3/E4 channel type, roughly five feet wide, with an anastomosing channel pattern (Figure 30). These channels are defined as low gradient and meandering, characterized by little deposition, and typically found in the bottom of broad low gradient valleys with fine alluvium or lacustrine soils.

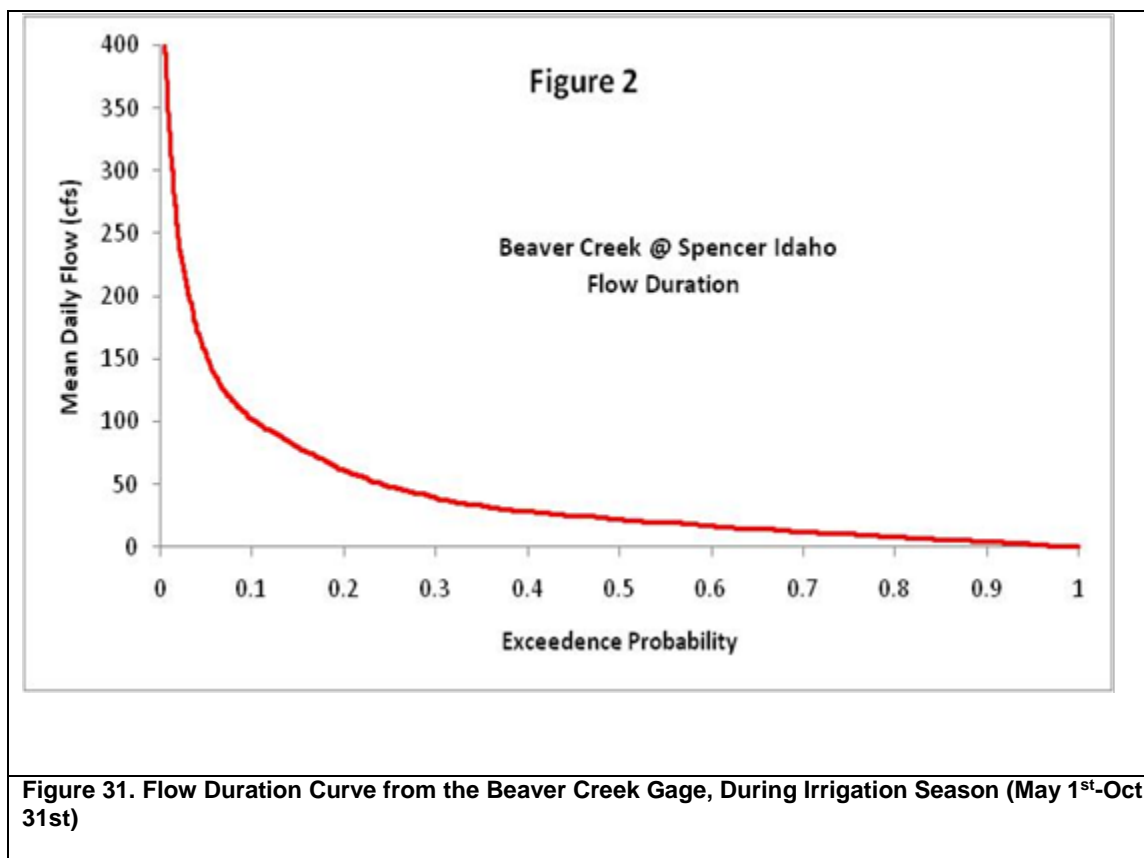
A flow duration curve for Beaver Creek is displayed below in Figure 31 .

The X-axis of the graph is the probability of exceedance of a given flow value. The high values on the steep left hand side of graph are snow melt runoff peak values; the long low tail is mid-

summer to fall values. Values from zero to 50 percent exceedance probability represent spring to early summer flows while values from 50 -100 percent exceedance probability represent late summer flows.

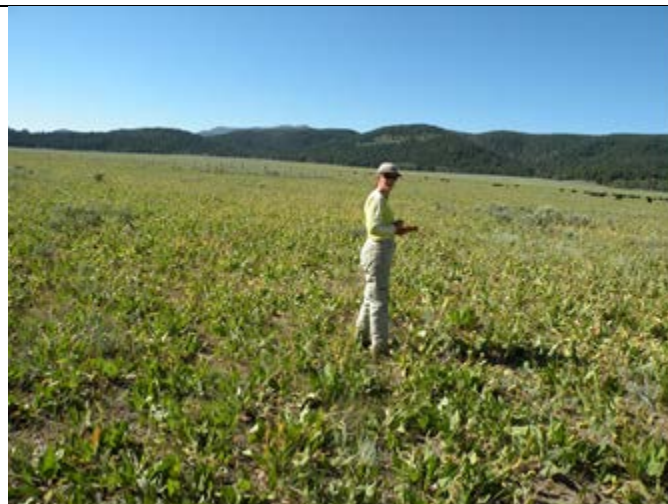
In several areas, desert-like pavement, consisting of a gravelly surface, was present. These areas lacked any vegetative diversity and consisted of only arrow leaf balsam root (Figure 32). The very low gradient surfaces may lend

**Figure 32. Arrow Leaf Balsam Root Field, Henninger Ranch**

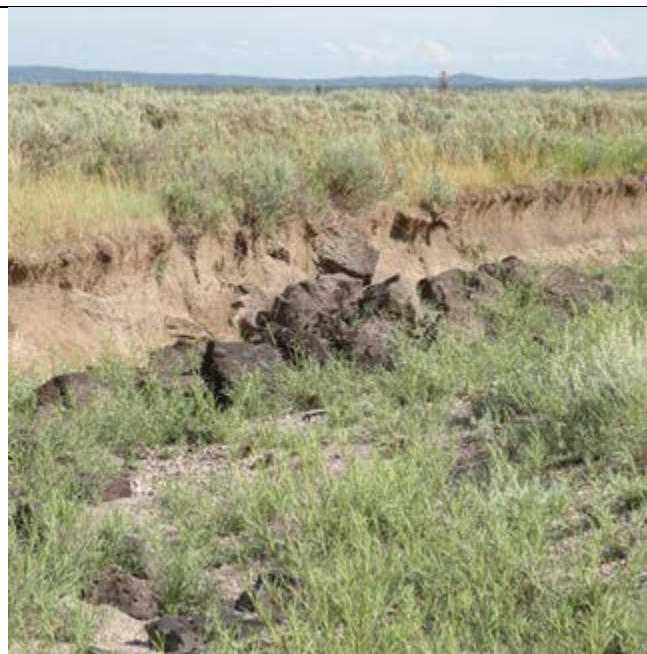
**Figure 33. Historical Rip-rapping, Dry Creek, Henninger Ranch**

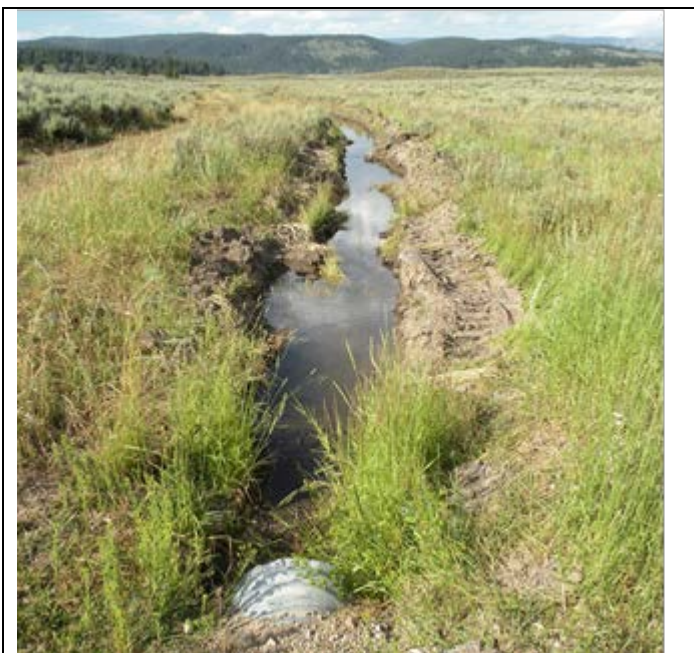
Much of the rest of the grazing area is covered by sage brush and underlain by basalts, resulting in little natural surface expression of water. The major drainage that does exist on the property is Dry Creek, which was classified as a Rosgen C4 channel type (Rosgen, 1994). A PFC survey was conducted, and a rating of Functional at Risk (FAR) with no apparent trend assigned. The FAR rating was due to alteration of channel flows due to irrigation that includes ditching, past agricultural practices, historical rip-rapping of the channel, possible influences related to the main road leading into the property.

**Figure 34. Ditching and Maintenance, Henninger Ranch**
