**National Sedimentation Laboratory  
Channel and Watershed Processes Research Unit  
Oxford, Mississippi 38655**

**Acoustic Imaging of Sediment Impounded by a  
USDA-NRCS Flood Control Dam, Oklahoma**

**By John A. Dunbar, Peter M. Allen, and Sean J. Bennett**

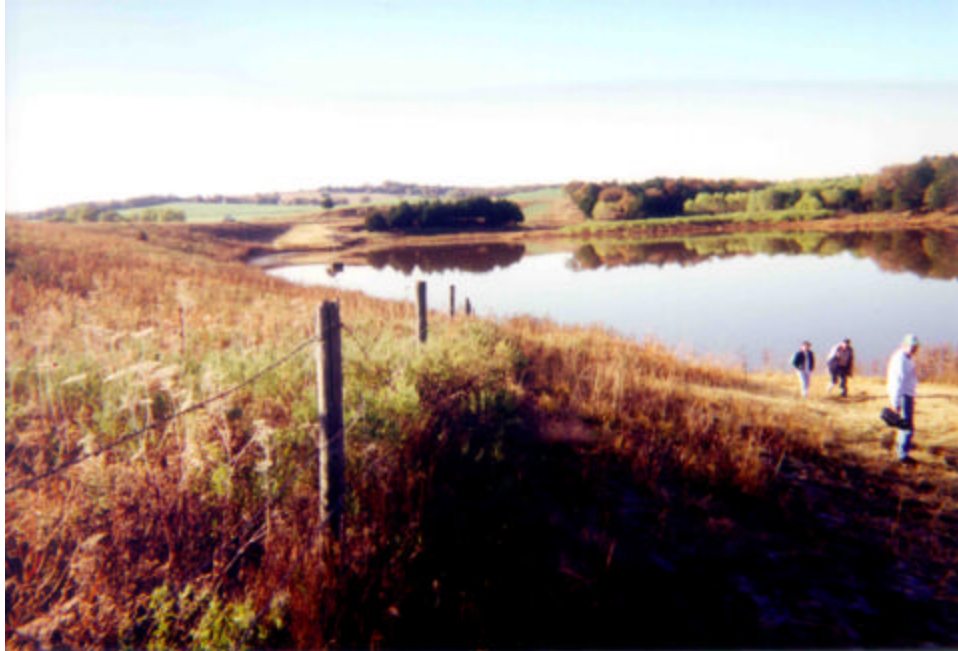
**Figure 2-1. Photograph of Sugar Creek #12 looking directly south showing earthen embankment on left, spillway channel in far distance, and reservoir (November 1999).**

Sugar Creek #12 is located near Hinton, OK, and it is a relatively small lake (19 acres) with a mud bottom and fairly shallow water depths (0.6 to 2 m; Figures 2-1, 2-2, and 2-3). Dam construction was completed on April 6, 1964. This structure has an upstream drainage area of 2,016 acres. The main stream supplying the lake is considered unstable due to the presence of actively migrating knickpoints, and excessive sedimentation rates have significantly decreased storage capacity. No boat ramp is available, and access for small vessels is difficult but tolerable.

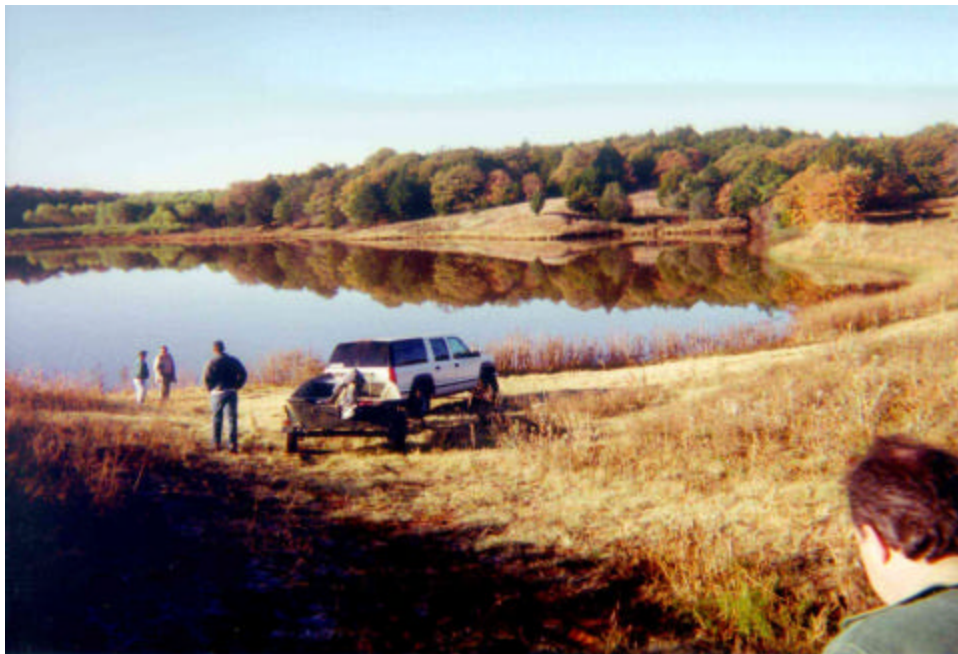
**Figure 2-2. Photograph of Sugar Creek #12 looking toward the southwest showing the reservoir and the main tributary on right (November 1999).**

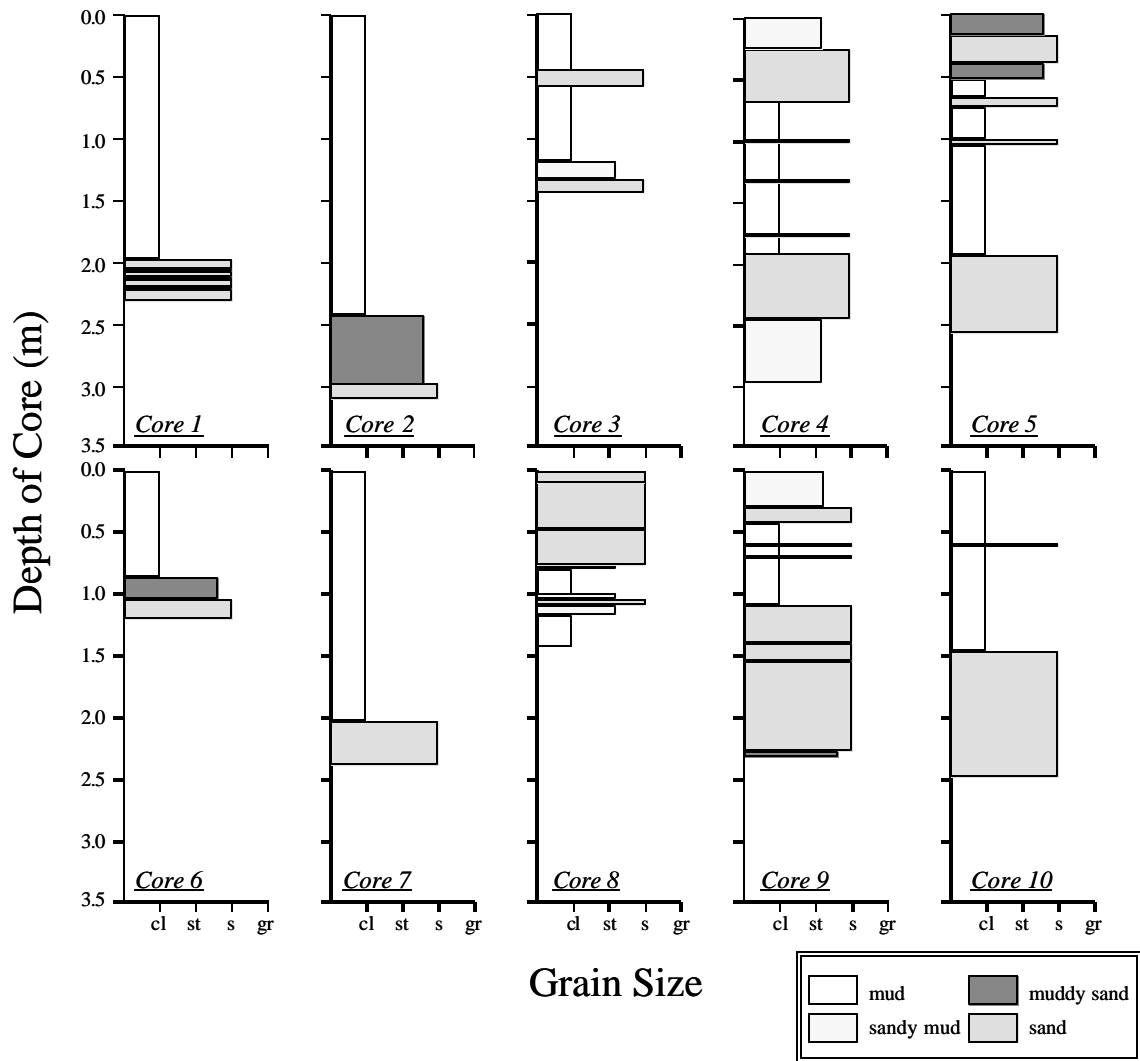
**Figure 3-2. Stratigraphic logs of cores obtained at Sugar Creek #12 (see Figure 3-1 for exact location). cl—clay, st—silt, s—sand, and gr—gravel.**

Ten continuous, undisturbed cores were obtained by Bennett and Cooper (2001) at Sugar Creek #12 and their positions are shown in Figure 3-1. These cores ranged in length from 1.3 to 3.1 m and were extracted from water depths ranging from 0.5 to 3 m. Stratigraphic columns of all cores are shown in Figure 3-2. In general, the cores are composed of sand, silt, and clay. Very thick accumulations, up to 2.4 m, of silt and clay are common (see Cores 1, 2, 7, and 10, Figure 3-2). Many of these thick silt and clay units have thin-bedded sand units (ca. 5 to 20 mm) within them (see Cores 4, 9, and 10, Figure 3-2). Layers rich in organic material such as vegetation are also common. Virtually no gravel is observed.

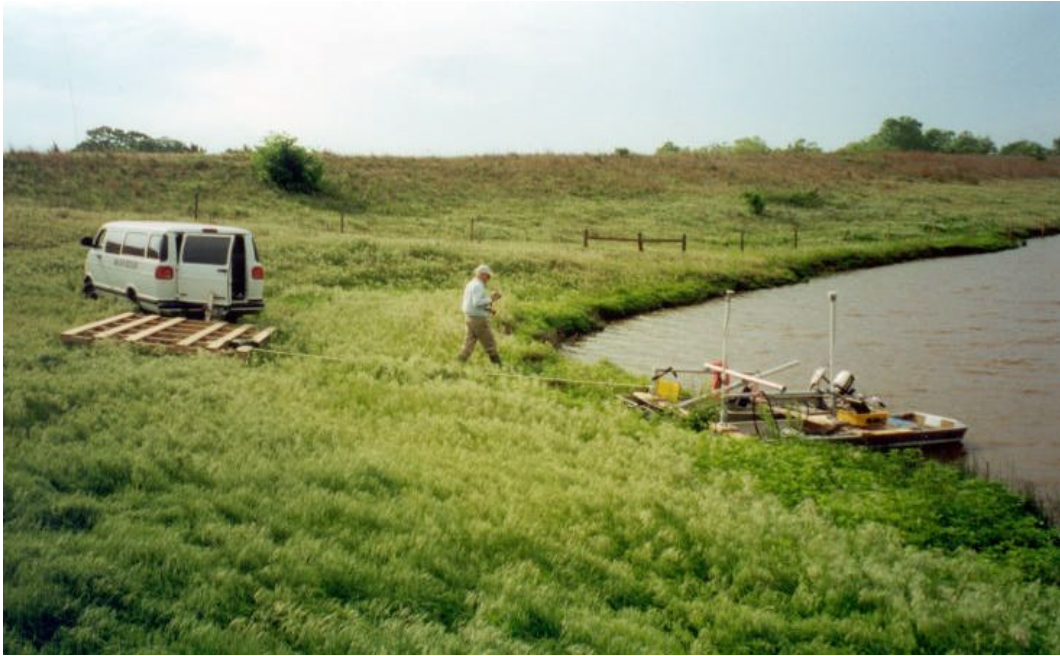
**Figure 4-1. Photograph of Sugar Creek #12 showing the survey vessels (May 2001).**

**Figure 4-2. Photograph of Sugar Creek #12 showing the survey vessels, GPS antennae, and transducer mast and transducer pod (May 2001).**

carried to the shore. A pair of 12-ft Johnboats joined together with an aluminum frame (Figures 4-1 and 4-2) provides a stable platform from which two or three people can work in water depths as little as 6 inches. The boats are powered with a 4 HP outboard motor or an electric trolling motor for low-speed profiling. The sound source is deployed on a mast between the two boats that holds the transducers at a constant depth below the surface and in a fixed position relative to the GPS antenna (Figure 4-2). Control over the transducer location in some fashion similar to this is required to achieve precision water depth information and sub-meter horizontal positioning accuracy.

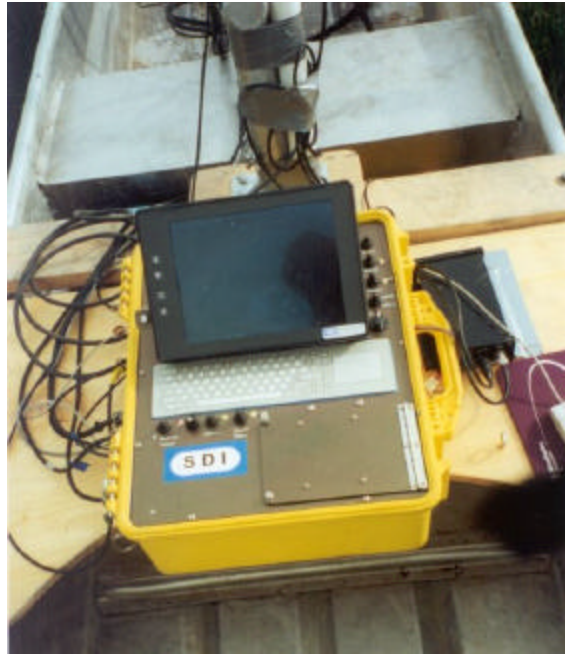
**Figure 4-3. Photograph of acoustic profiling system (May 2001).**

The acoustic profiling system used herein was developed in collaboration between Baylor University and Specialty Devices, Inc. of Plano, TX (SDI; Dunbar, et al., 1999; Figure 4-1 to 4-4). The system was originally intended to be used in sediment surveys of large water supply reservoirs, but the commercialized version has been used to survey lakes, harbors, and rivers as well. The prototype electronics module includes one computer that controls the acoustic profiling, another that controls navigation, a built-in computer monitor, and a differential GPS navigation system. All of these components are contained in one, suitcase-sized water-resistant box. The prototype module weighs 15 kg. In the commercialized version, both subsurface profiling and navigation operations are controlled by a single, faster computer, resulting in an electronics module that is smaller and lighter. Power for the electronics and acoustic source is supplied by a 12 volt marine battery. Depending on the number and type of acoustic transducers used, the sound source may weigh between 25 and 75 kg. Hence, even though the system was designed for large reservoir surveys, deployment in small floodwater retention reservoirs is logistically practical.

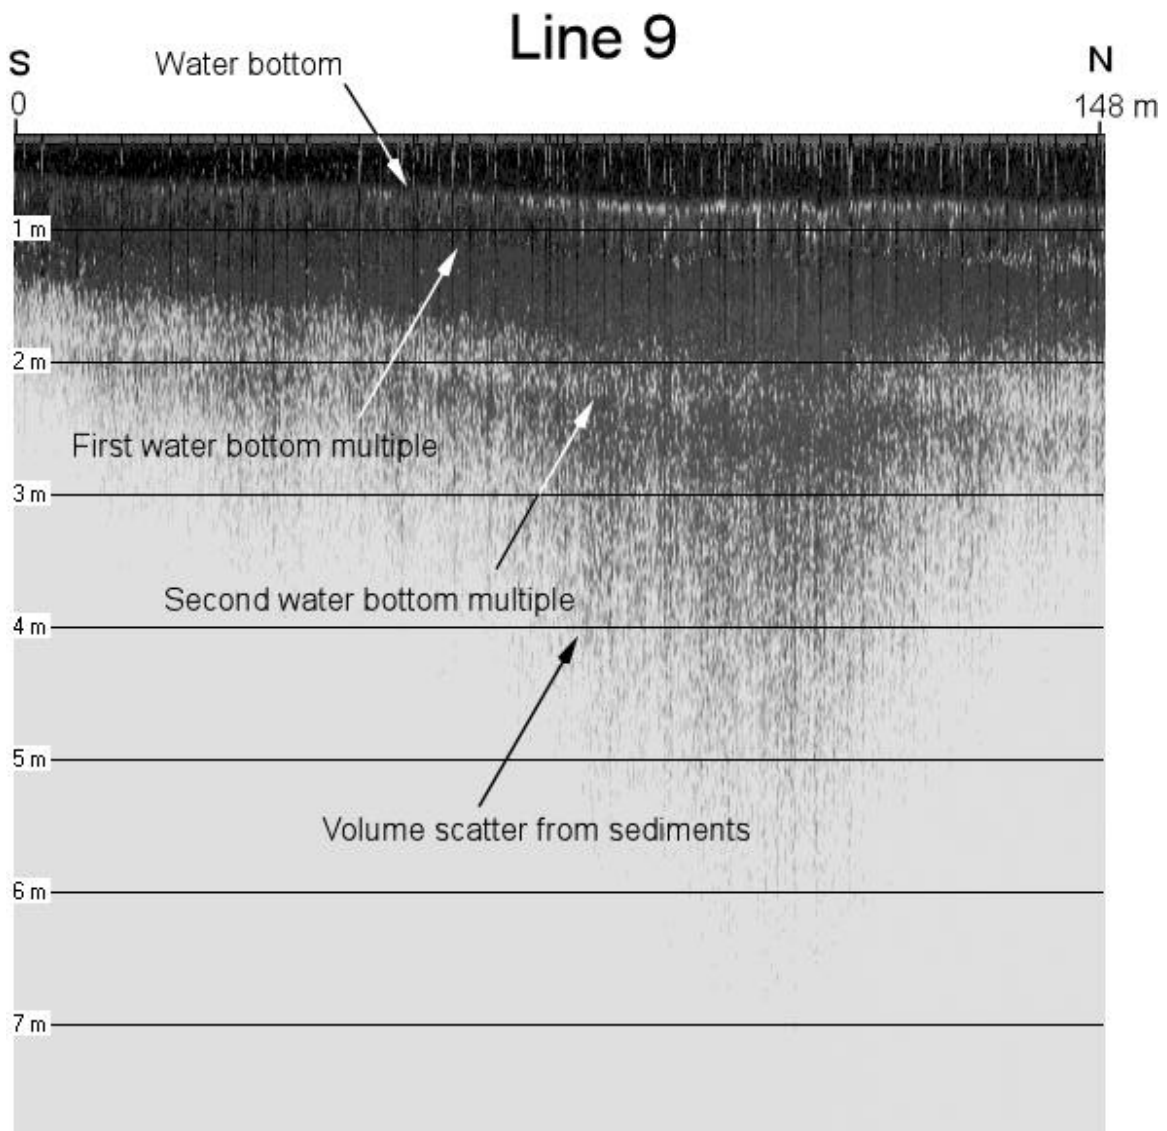
**Figure 4-6. Unprocessed field record of 200 kHz acoustic data collected along Line 9. See Figure 4-5 for line position. The water column is clear at a depth of 0.5 m on the south end of the line, increasing to 0.75 m on the north end.**

Figure 4-6 shows an unprocessed field record of the 200 kHz acoustic data collected along Line 9. Below the water bottom, the record is dominated by the first and second water bottom multiples. These events correspond to sound pulses trapped in the water layer and multiple reflected energy between the water bottom and the water surface. These reflectors are not associated with sediment layers within the subsurface. The deeper parts of the record (Figure 4-6) are dominated by scattered returns from the lake sediments from depths exceeding 5 m. The base of the sediment is not recognizable from these raw, unprocessed data.

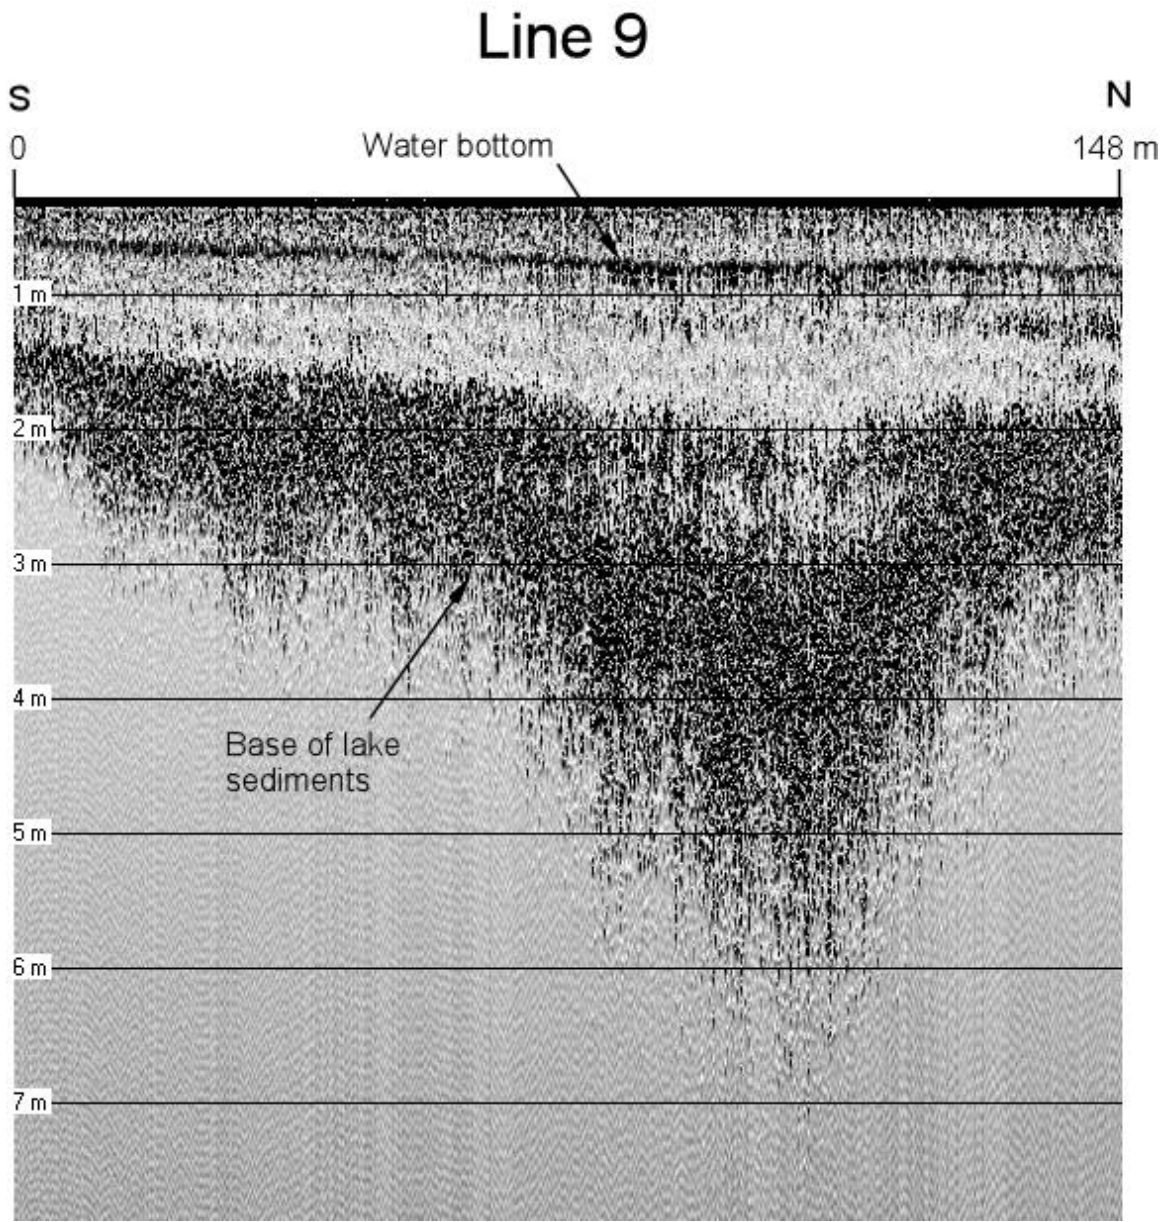
**Figure 4-7. Field record of 200 kHz acoustic data collected along Line 9 after digital processing. See Figure 4-5 for line position.**

For the example shown in Figure 4-7, predictive deconvolution with a prediction distance of 50 microseconds (10 times the dominate wave period) was applied to remove the water

bottom multiples. In the processed record, the water bottom is more distinct, the multiples are largely removed, and a gradational base of sediment is observable as compared to the unprocessed record of Figure 4-6. All data collected were processed in a similar fashion.

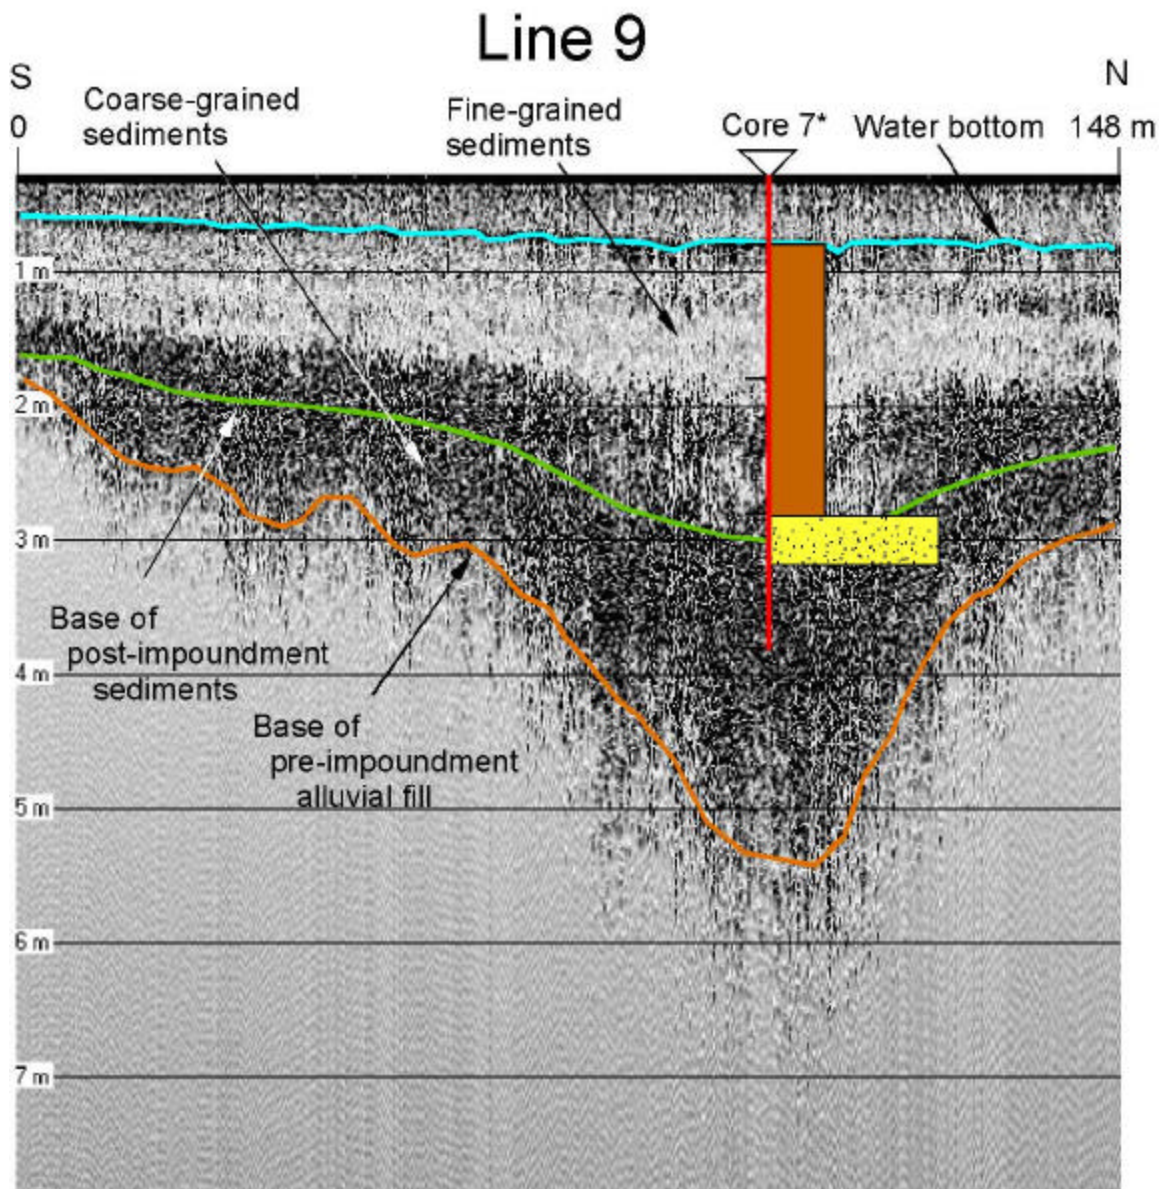
**Figure 4-8. Processed Line 9 with interpretation. See Figure 4-5 for line position. The position of Core 7 from Bennett and Cooper (2001) is projected onto the line from a distance of 19 m.**

The interpretation of the acoustic data began with Line 9, which crosses the deepest part of the sediment pool (Figure 4-8). The water bottom is clear and traceable on this and all other profiles (shown as a blue line, Figures 4-9 to 4-14). Below the bottom, three distinct acoustic facies (a package or layer of sediment) can be defined, based upon the scatter intensity level. Approximately the first meter of sediment below the bottom on all the profiles is acoustically transparent. The transparent acoustic facies is associated with shallow fine-grained sediment. In places the transparent facies contains darker streaks that thicken towards the flanks of the basin, such as near the north end of Line 9 (near the 148 m end Figure 4-8). Where one of these streaks was cored (Figure 4-9), it is associated with a coarse-grained layer within the fine-grained sediments. These darker streaks are interpreted as coarse-grained wedges shed from the flanks of the basin during prolonged low stands. However, no attempt was made to map these small packages.

At depths greater than about 1 m below the current lake bottom, all the records show a rapid increase in the scatter return level, causing the displays to turn from light gray to speckled-black. This zone is called the intermediate-scatter intensity facies. On Line 9 (between the blue and green lines, Figure 4-8), the scatter intensity within this facies decreases towards the center of the basin, as if the source of the scatter is depositionally controlled within the lake environment. However, the onset of the intensity increase does not correlate with a recognized textural change within the cores.

Below the intermediate-scatter facies is an interval of high-scatter intensity. The scatter intensity within this facies does not decrease toward the center of the basin as does the overlying intermediate-scatter intensity facies. Hence, in the center of the basin on Line 9 (between the orange and green lines, Figure 4-8) and Line 15 (Figure 4-14), the distinction between the intermediate- and high-scatter intensity facies is clear. On the flanks of the basin, the difference between these two facies is subtle. The interface between the intermediate- and high-intensity scatter facies correlates with the interface between fine-grained and coarse-grained sediments in Core 7 on Line 9 (Figure 4-8) and Line 15 (Figure 4-14) and Core 10 on Line 10 (Figure 4-9). This interface also correlates with the base of post-impoundment sediment interpreted from  $^{137}\text{Cs}$  analysis of Cores 4, 7, and 9 (Figure 4-25). Therefore, the acoustically transparent and intermediate-scatter facies correspond to the post-impoundment sediment fill.

On all lines, the high intensity scatter facies exhibits a gradational base, in which the scatter amplitude decays over an interval of about 0.5 m. The onset of the decay maps as an irregular surface that is consistent from line to line (see composite Figures 4-15 to 4-24). The surface reaches a maximum depth of 5.5 m below the water surface on Line 9 (Figure 4-8 and 4-15), at a point along the trend of the main inlet to the lake. This surface is interpreted as the base of pre-impoundment sediments, which likely takes the form of sand-rich alluvial sediments and soils.

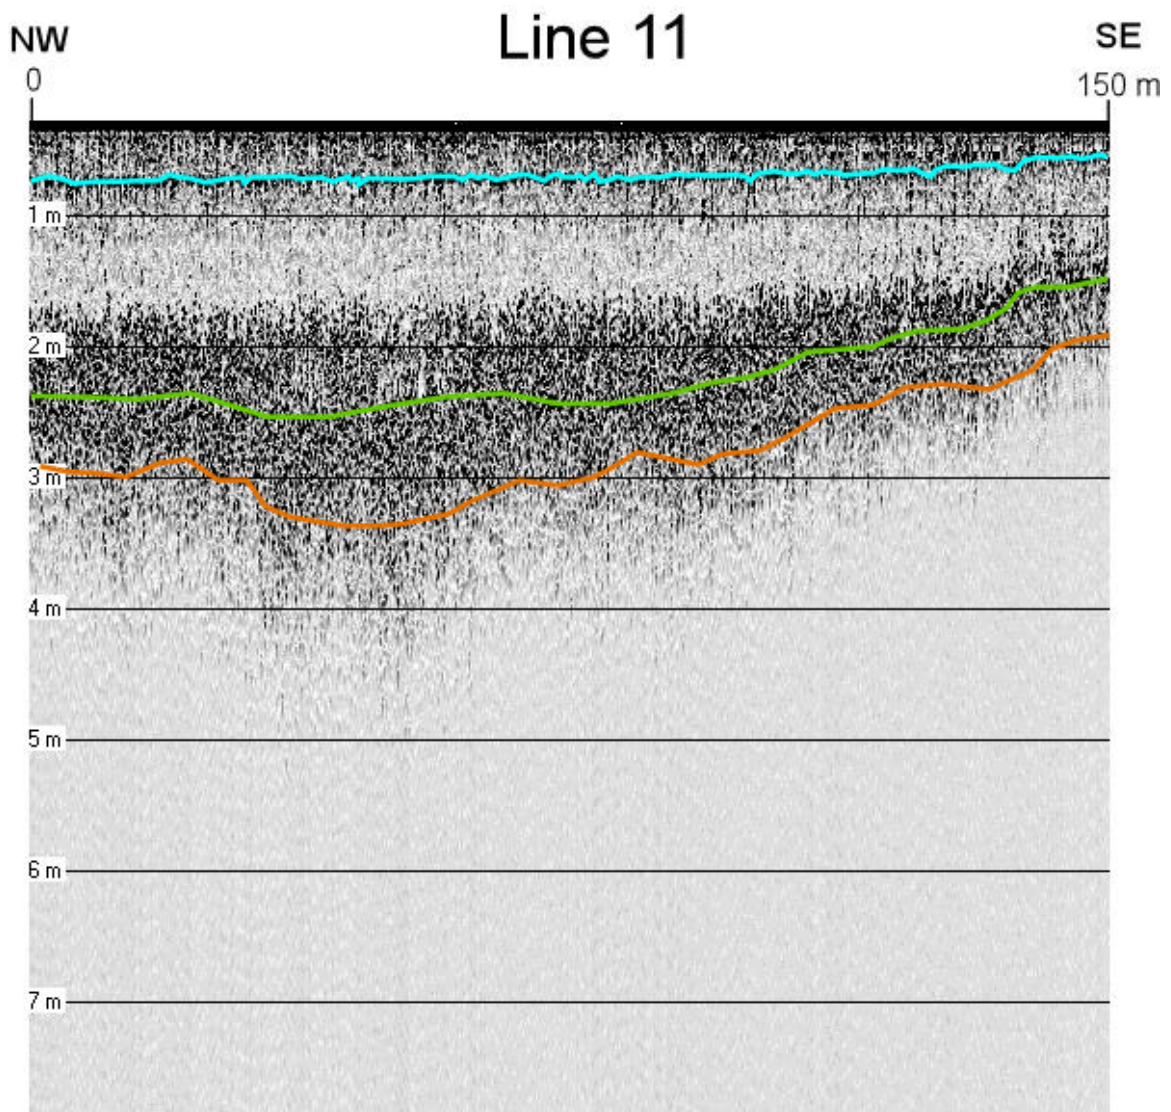
**Figure 4-10. Processed Line 11 with interpretation. See Figure 4-5 for line position.**

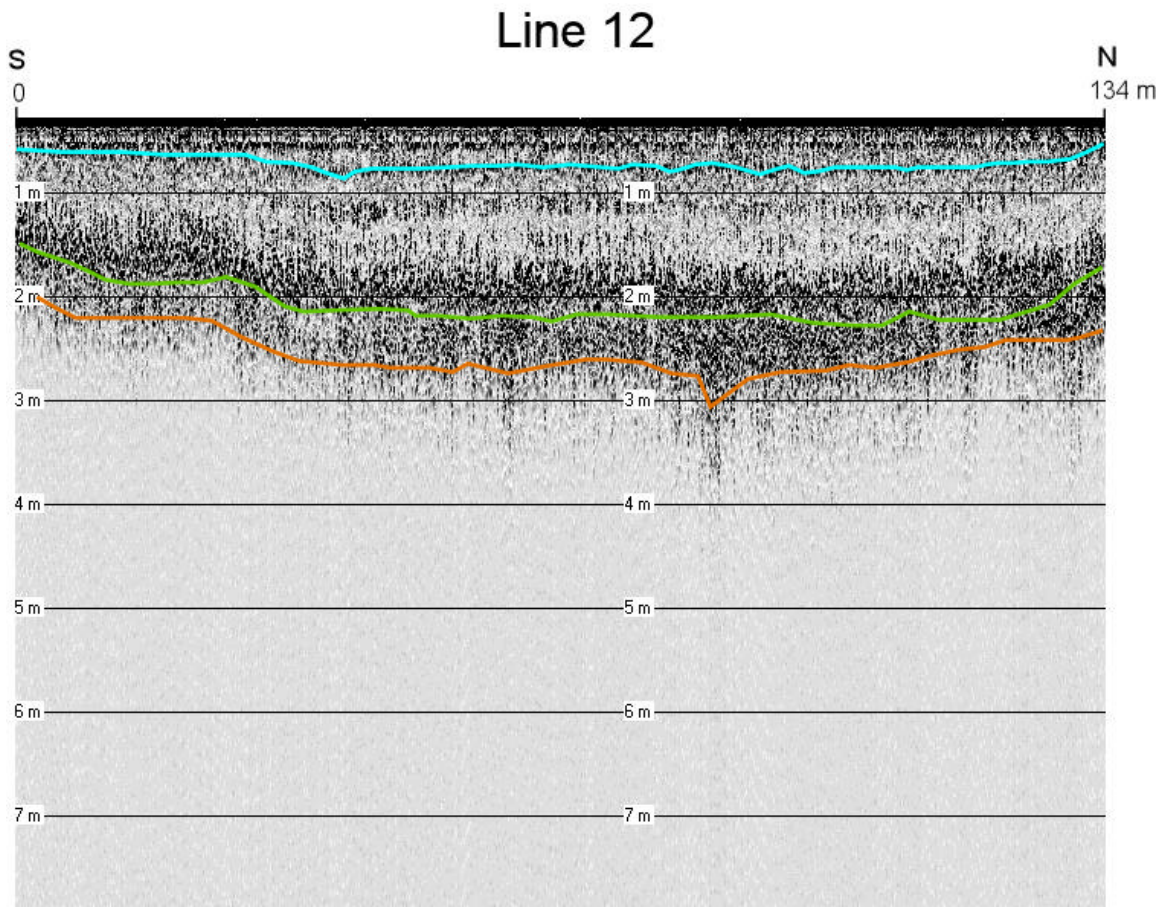
**Figure 4-11. Processed Line 12 with interpretation. See Figure 4-5 for line position.**

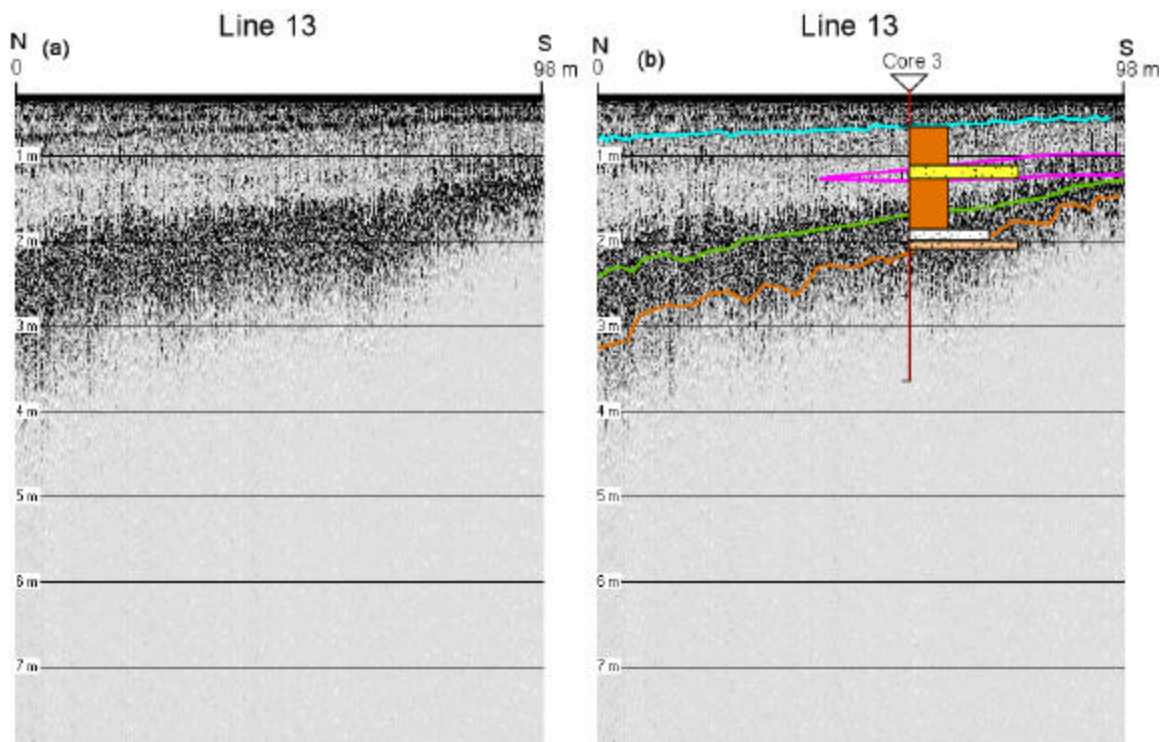
**Figure 4-12. Unprocessed (left) and processed and interpreted (on right) Line 12. See Figure 4-5 for line position.**

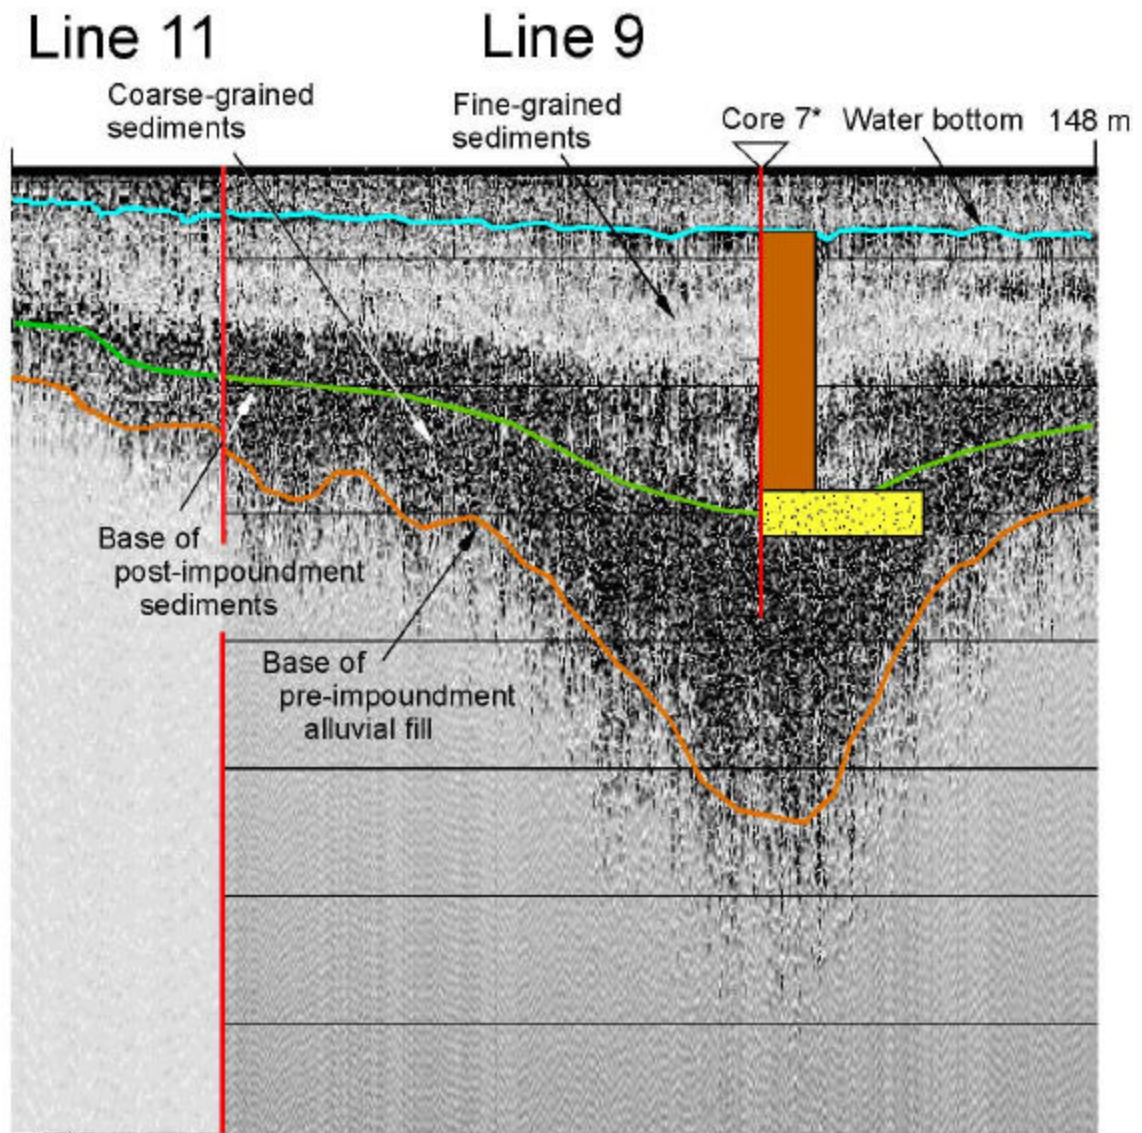
\*Location of Core 7 projected onto the line at 90 degrees from 19 m offline.

**Figure 4-15. Composite profile formed from the south end of Line 11 and the north end of Line 9. See Figure 4-5 for line positions. Location of Core 7 projected onto the line from a distance of 19 m. The intersection between the two lines is shown in red.**

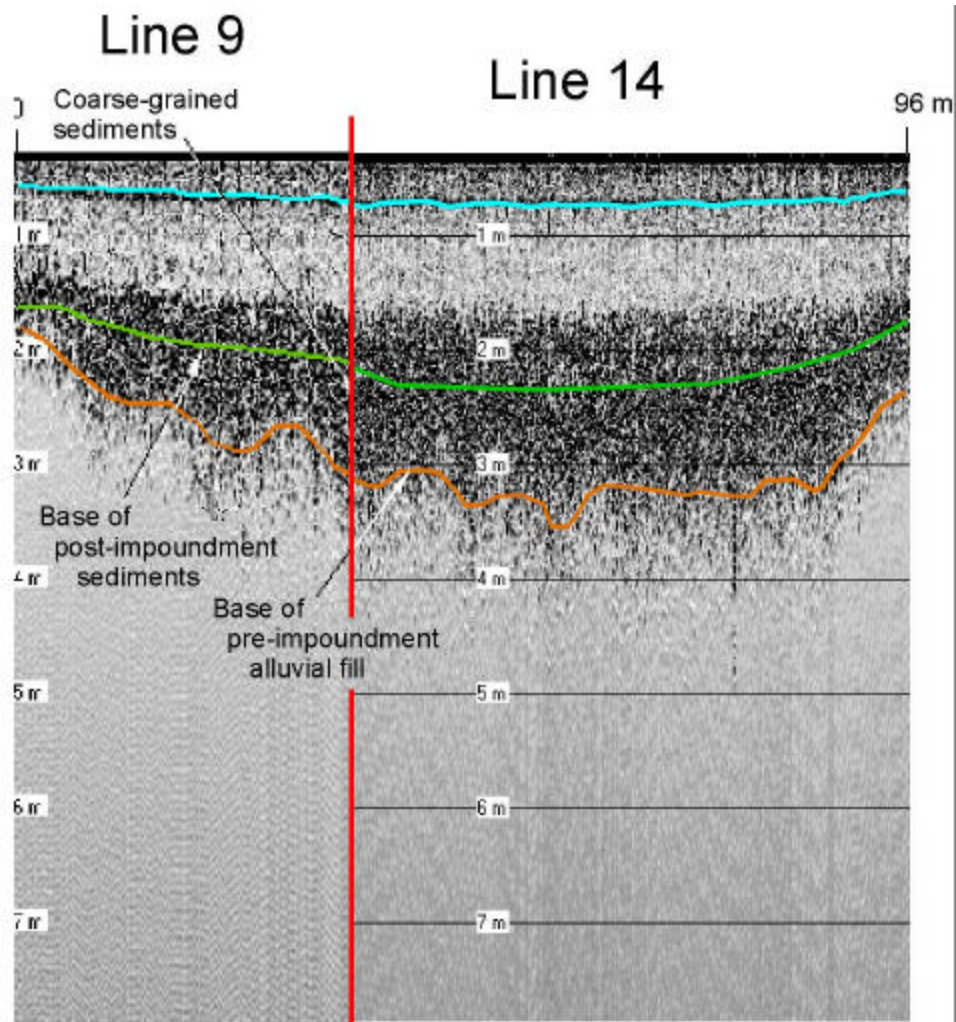
**Figure 4-16. Composite profile formed from the south end of Line 9 and the east end of Line 14. See Figure 4-5 for line positions. The intersection between the two lines is shown in red.**

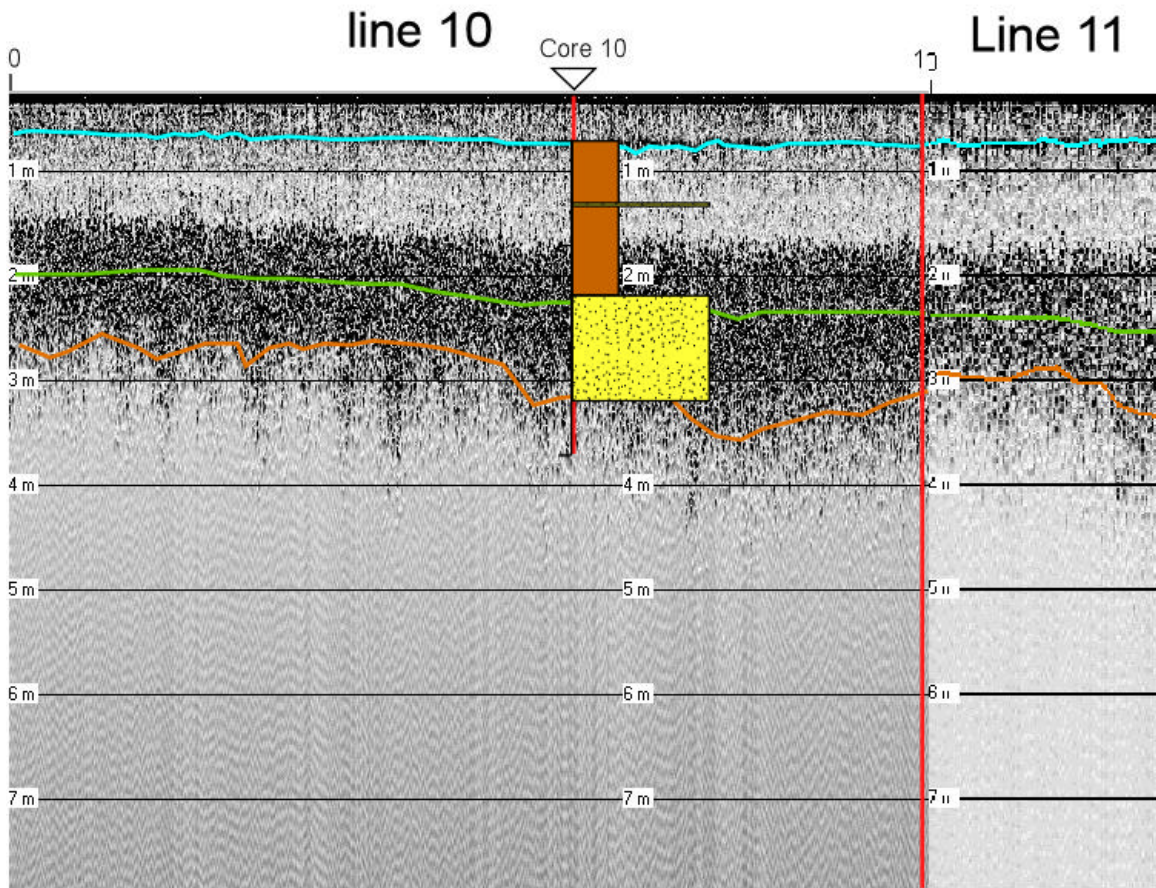
**Figure 4-18. Composite profile formed from the south end of Line 10 and the west end of Line 11. See Figure 4-5 for line positions. The intersection between the two lines is shown in red.**

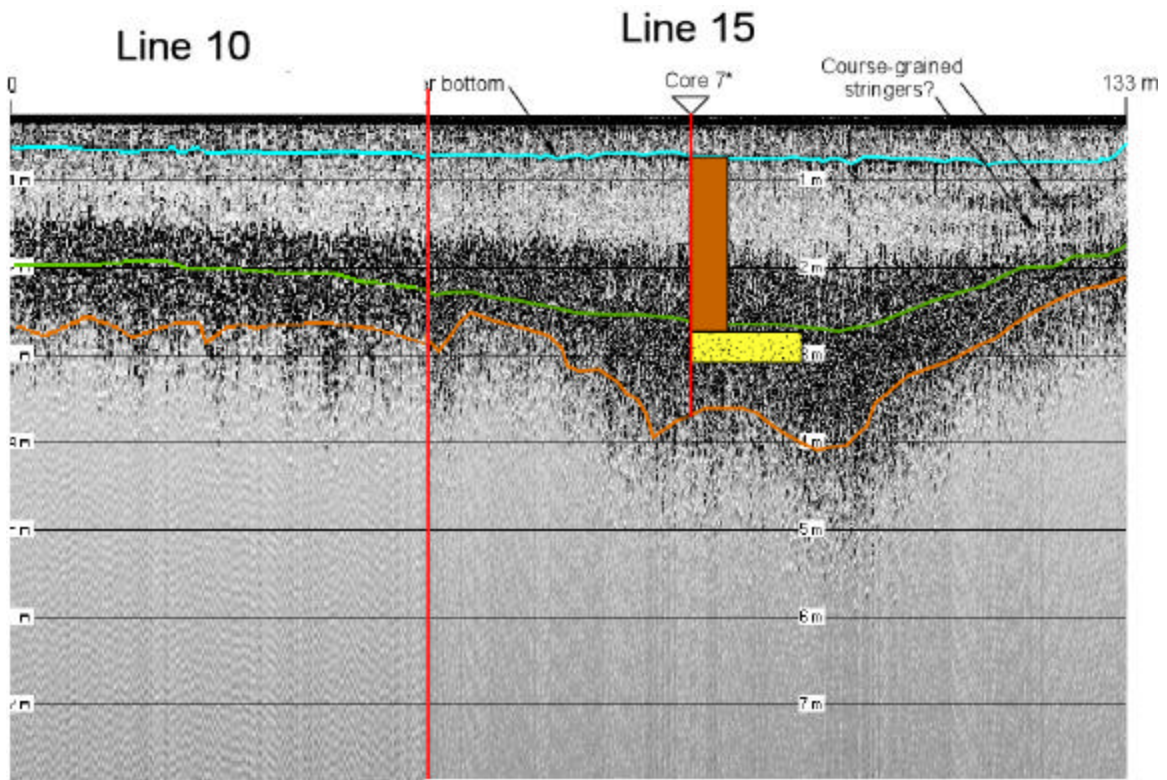
**Figure 4-20. Composite profile formed from the south end of Line 10 and the east end of Line 15. See Figure 4-5 for line positions. Location of Core 7 projected onto the line from a distance of 19 m. The intersection between the two lines is shown in red.**

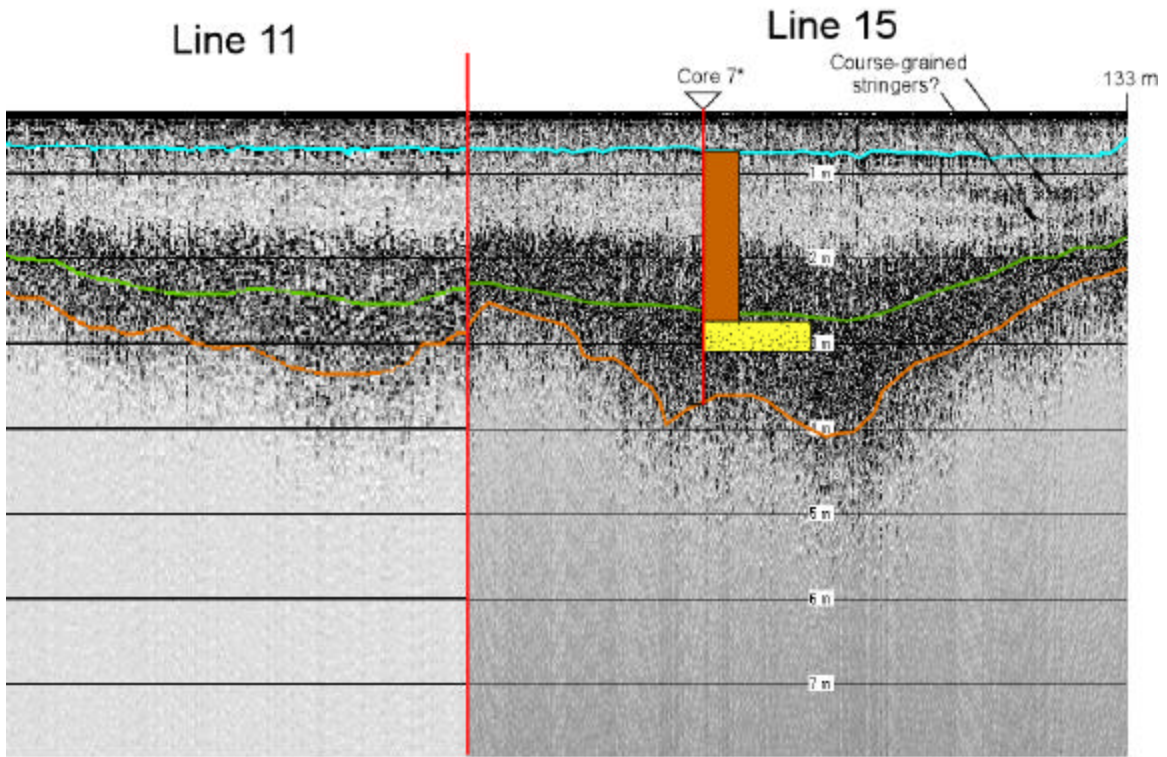
**Figure 4-24. Composite profile formed from the east end of Line 11 and the north end of Line 15. See Figure 4-5 for line positions. Location of Core 7 projected onto the line from a distance of 19 m. The intersection between the two lines is shown in red.**

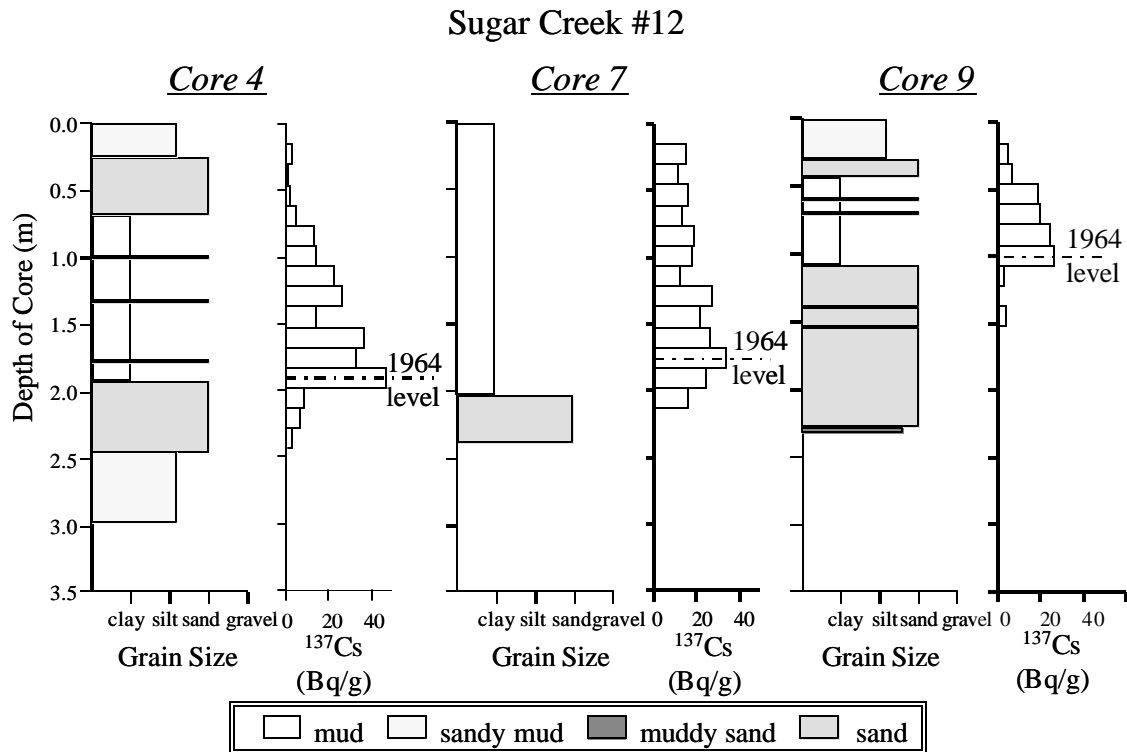
**Figure 4-25. Stratigraphic columns and radioactive  $^{137}\text{Cs}$  emissions (becquerels per gram; Bq/g) for Cores 4, 7, and 9 taken at Sugar Creek #12 (Bennett and Cooper, 2001). For the stratigraphic logs, grain size and lithologic descriptions are based on observational criteria. The peaks in the distributions of  $^{137}\text{Cs}$  coincide with the 1964 datum, and some samples near the top and bottom of each core had zero emissions.**
