Effect of Large Woody Debris Structures on Stream Hydraulics

F. Douglas Shields, Jr., Member, ASCE, N. Morin and R. A. Kuhnle, Member, ASCE

Research Hydraulic Engineer, Research Assistant, and Research Hydraulic Engineer, respectively,
USDA-ARS-National Sedimentation Laboratory, P.O. Box 1157, Oxford, MS 38655-1157
PH (662) 232 2919; FAX (662) 232 2915; email: shields@sedlab.olemiss.edu

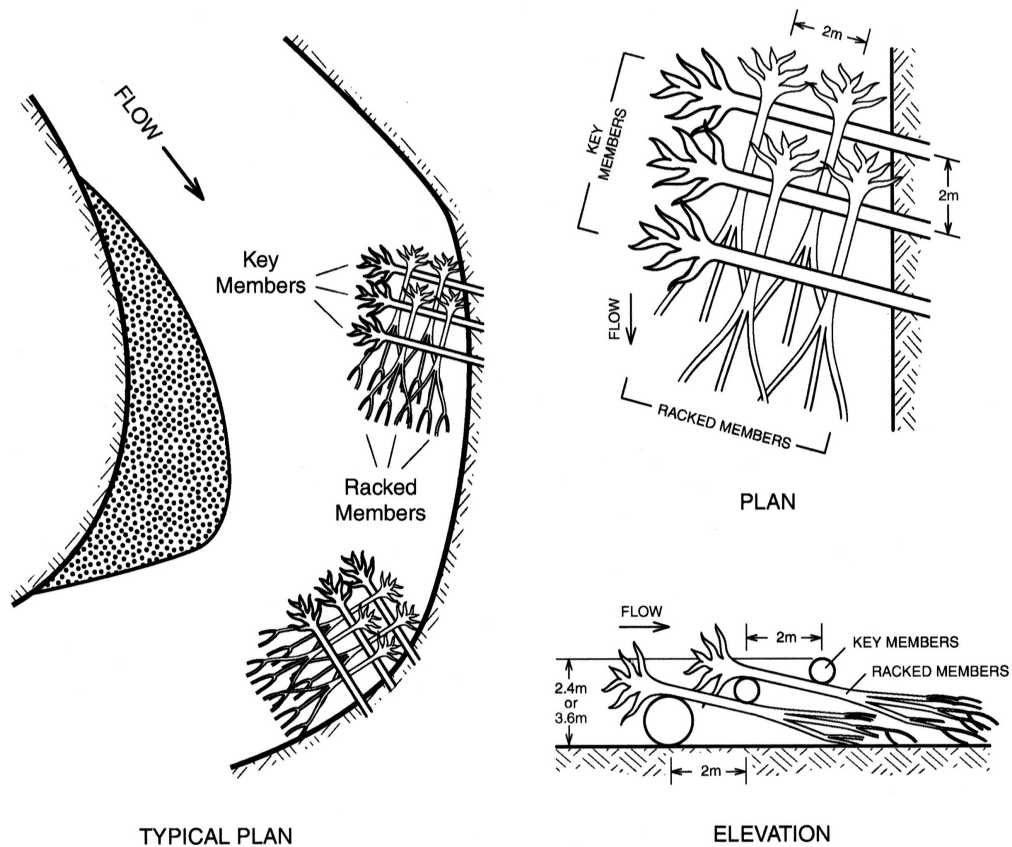
Figure 1. Typical plan and elevation for large woody debris structures.

Structures were built by stacking trees as shown in Figure 1. Members running across the flow direction were ~9 m long and were keyed into the bank toes (buried in trenches excavated in banks) when bank slopes were gradual enough to permit key trench excavation. Crest elevations were specified as either 2.4 m or 3.6 m above the adjacent streambed based on eroding bank height and channel alignment, but constructed LWDS were slightly lower, ranging from 1.1 to 3.2 m high. Structures were spaced to create nonuniformity, which is valuable for physical habitat recovery (Shields et al. 1998b), but aligned to enhance log stability and sediment deposition. Statistics for structure dimensions are presented in Table 2.

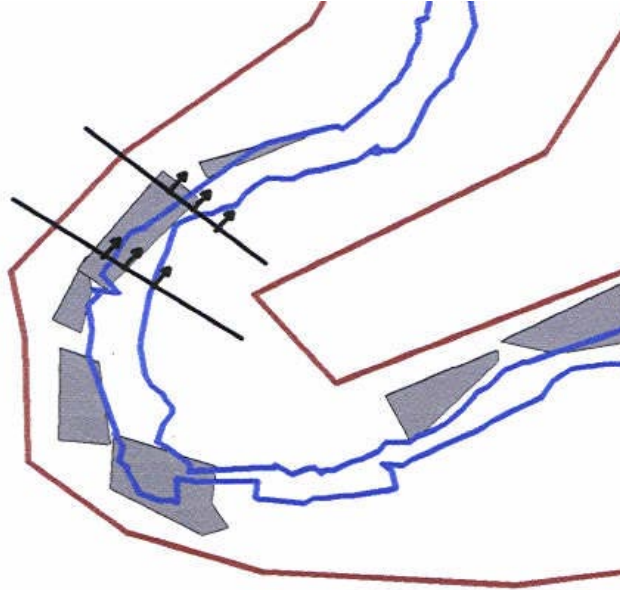
Figure 2. Location of cross sections for monitoring depth and velocity at bend apex. Arrows show approximate location of FADVs. Shaded polygons are large woody debris structures. Cross section 1 is upstream from cross section 2.

Initial impacts of the large woody debris structures on stream flow patterns were quantified using an array of FADVs installed along two cross sections about 7 m apart in the apex of a sharp bend (Figure 2). Similar records of flow depth and velocity were obtained for runoff events before and after construction. The FADVs were programmed to compute and record mean, maximum, and minimum values for each five-minute interval during preconstruction events and for intervals of one, three, or five minutes for events 8-10, 11, and 12-17, respectively, during the postconstruction period. Patterns of scour and deposition were monitored by surveying each of the two cross sections monthly. Annual surveys of the entire 2-km project reach are also underway.

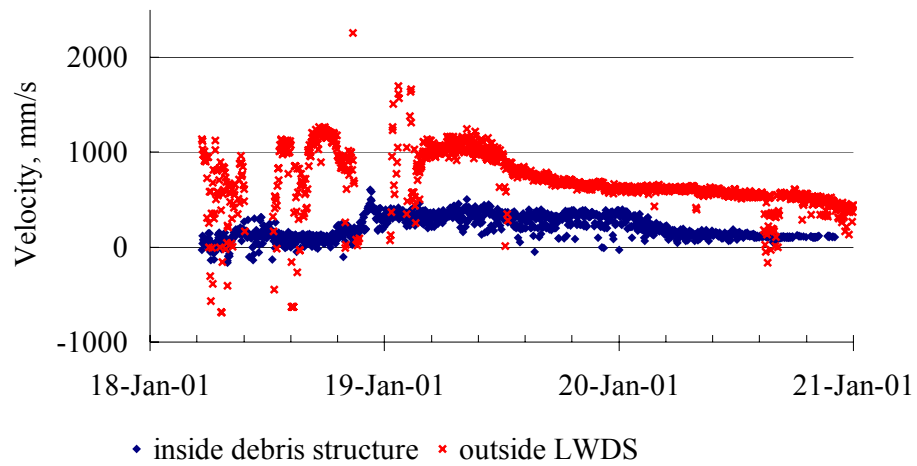
Figure 3. FADV velocity records at cross section 2 during flow event six months after construction.

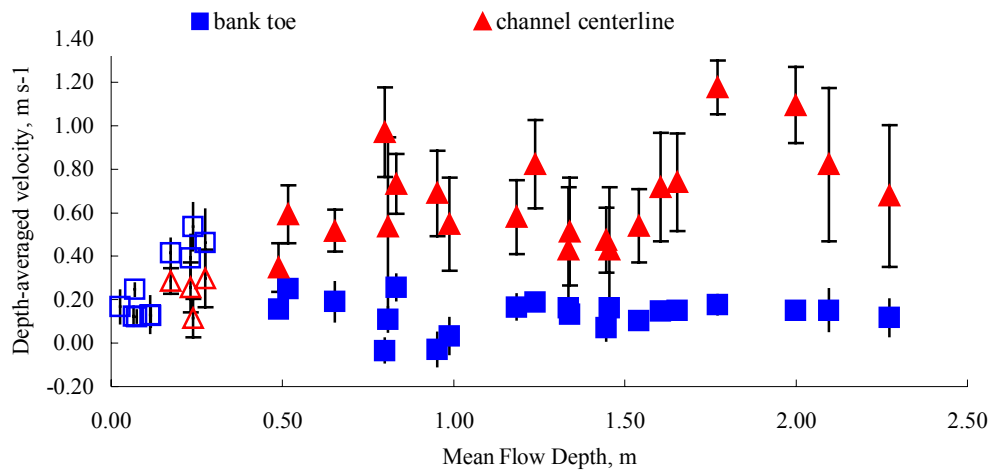
Figure 4. Means of simultaneous near-bed velocities recorded by FADVs within and adjacent to large woody debris structure. Locations for velocity sensors shown in Figure 2. Open symbols are from runoff events prior to woody debris structure construction; solid symbols are from postconstruction events; error bars are \pm one standard deviation.

FADV data indicated that woody debris structures created conditions conducive to deposition adjacent to the bank toe and within the LWD matrix. Near-bed flow velocities were reduced due to the presence of the structures. Measurements by others indicate that highest depth-averaged velocities in bends occur on the outside of the bend immediately downstream from the bend apex (e.g., USACE 1991, plate B-35). However, following placement of woody debris structures, maximum velocities were displaced away from the bank toe (Figure 3), thus preventing transport of failure blocks of cohesive soil and other sediments from the toe zone (Simon et al. 2000), and scouring deeper pool habitat at the streamward margin of the structure (Gough 1991). Simultaneous records of velocity adjacent to the concave bank toe and at the channel centerline during 10 events prior to construction and 21 events following construction showed that velocities at the bank toe prior to construction were 1.5 times as great as those at the channel centerline, but only 0.03 to 0.45 times the centerline velocity following construction (Figure 4). Mean near-bed velocities within the region covered by the LWDS were < 0.26 m s⁻¹ while means of simultaneous measurements of velocities at adjacent points outside the debris structure ranged from 0.35 to 1.18 m s⁻¹. We estimate that critical near-bed velocity for the median bed material size is ~ 0.15 m s⁻¹ (Vanoni 1975), and much higher for failure blocks (Simon et al. 2000). Average deposition for the protected regions of the instrumented cross sections (Figure 2) fluctuated during the period of observation, but totaled about 0.4 m for cross section 1, which was located under the higher, upstream portion of the woody debris structure (Figure 5). About 0.2 m of scour occurred within the protected portion of cross section 2 reflecting formation of a small pool.

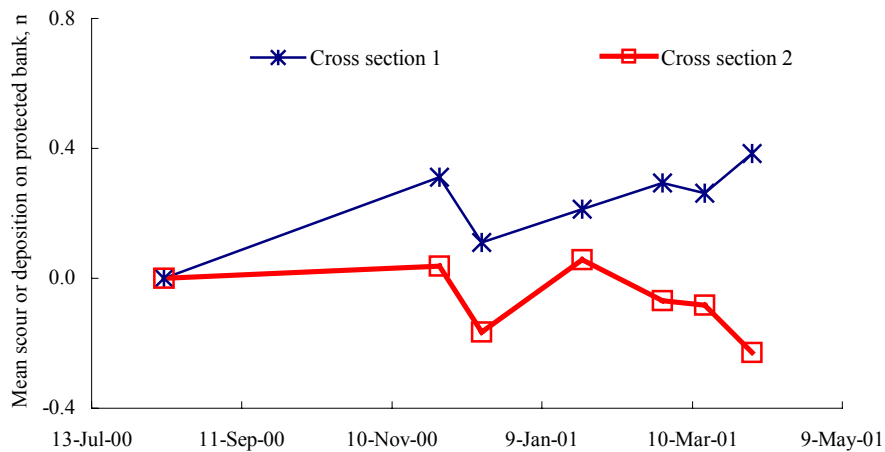
Figure 5. Average scour (-) or deposition (+) for bank protected by large woody debris along cross sections 1 and 2 shown in Figure 2. Scour and deposition were computed for segments of cross section between top bank and approximate streamward margin of large woody debris structure. Initial point (zero) represents conditions immediately following construction.
