Ten Years After: Stream Habitat Restoration Project in Retrospect

F. Douglas Shields, Jr.¹, Scott Knight²

Abstract

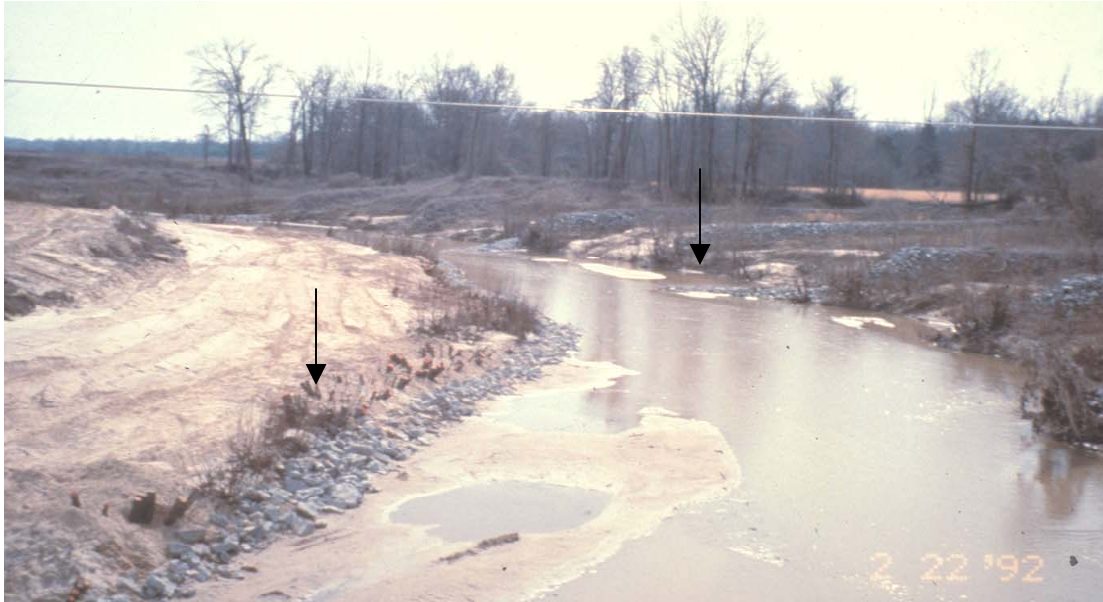
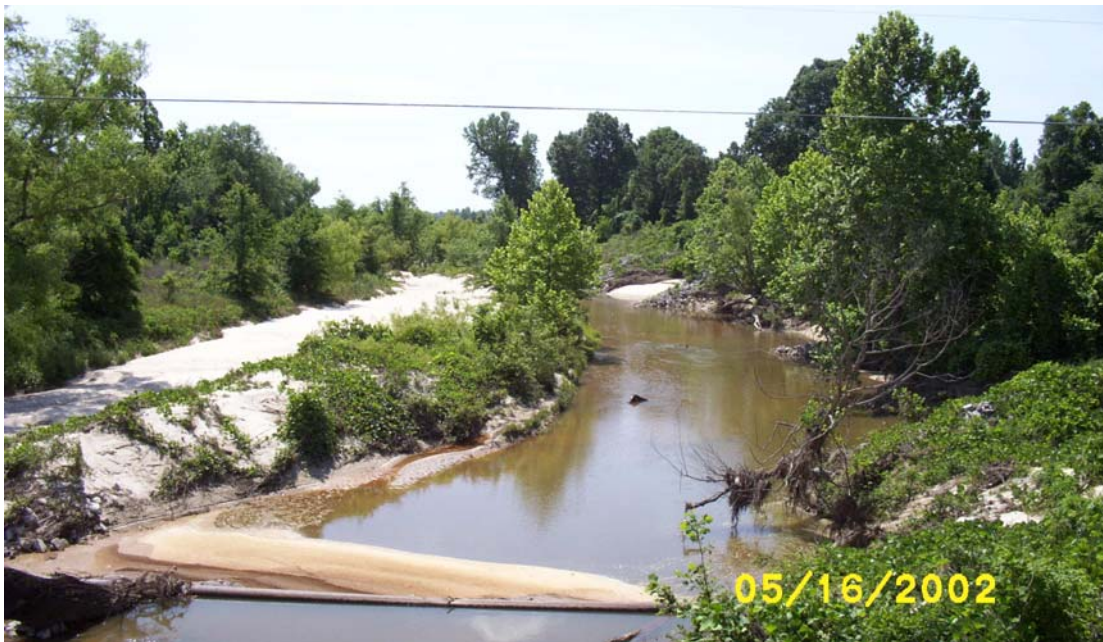
Figure 1. View of rehabilitation project reach immediately after construction (above) and in 2002 (below). Note stone toe and willow post plantings on left and spur dike extension on right side of top photo.

Rehabilitation activities were performed on Reach 1 of Hotophia Creek in January – February 1992. Prior to rehabilitation, aquatic habitat was typical of many incised channels in the region (Shields et al. 1994): base flow conditions were extremely shallow, pool habitats were rare and temporally unstable, substrate was dominated by shifting sands, and woody debris was in very short supply (Figure 1). Eroding banks were common, and riparian vegetation was sparse (Shields et al. 1998). Although stone structures had been placed for bank protection, they provided very little habitat. Rehabilitation consisted of extending existing stone spur dikes riverward to provide stony substrate and trigger formation of stable pool habitats. Willow posts were planted in the sandbar opposite the stone spurs, and a minimal stone toe was placed along the planted bars. The primary objective of the project was to increase the availability of stable pool habitat at base flow.

Although 70% of the willow posts planted in the treated reach died during the first two years after planting due to poor soil conditions or competition from exotic species (Shields et al. 1995b) by 2002 woody debris density increased by an order of magnitude in both streams (Figure 1 and Table 5). Vegetation invaded stone revetments and sandy berms, consistent with the conceptual incised channel evolution model (Simon 1989), roughly doubling woody cover on banks in both treated and untreated reaches.

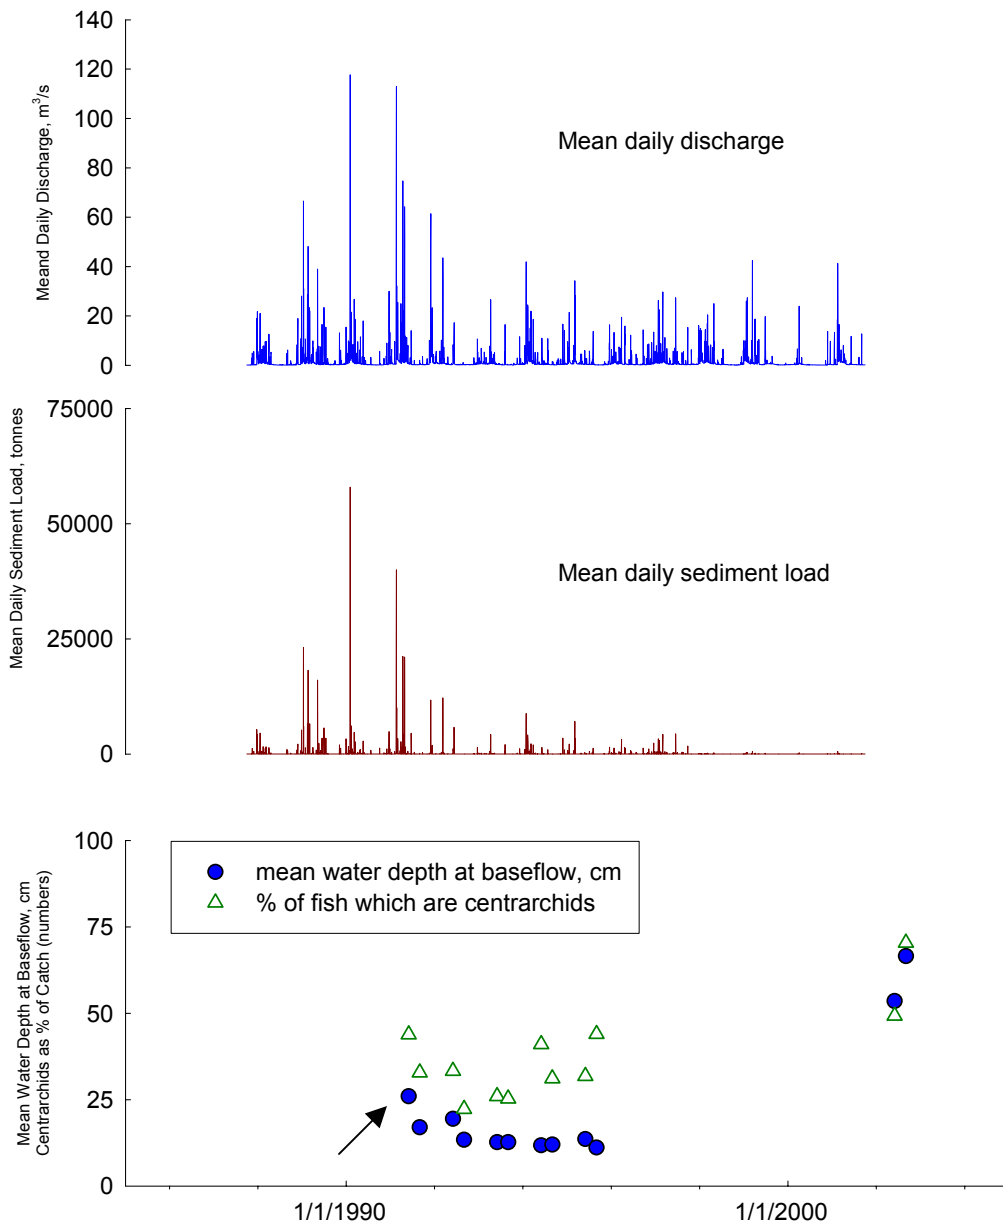
Figure 2. Mean-daily discharge, mean-daily suspended-sediment load, and mean water depth and percent of fish catch comprised by centrarchids (sunfishes) for treated reach of Hotophia Creek, Mississippi, 1987-2001. Rehabilitation works were constructed in 1992. Mean water depth for Spring 1991 (arrow) elevated by higher than normal discharge.

Suspended-sediment discharge fell sharply following rehabilitation in both streams, due at least in part to drier conditions (Figure 2 and Table 3). Hotophia Creek suspended sediment load dropped by a factor of six. Significant morphologic changes occurred within the rehabilitated reach of Hotophia Creek (Table 4). During the four years immediately following restoration, mean flow depth increased only slightly, although the depth and size of scour holes associated with the stone spurs more than doubled (Shields et al. 1995b). However, by 2002, the mean depth in the rehabilitated reach was 2.5 to 3 times greater than the same reach before rehabilitation, the untreated reach upstream, and Peters Creek (Tables 4 and 5). Both streams became narrower, and bed material became more heterogeneous.

Baseflow channels of both the treated (Hotophia) and untreated (Peters) streams became narrower and deeper during the decade of observation, consistent with changes expected for systems with declining sediment load (Werrity 1997) and increasing bank vegetation (Hey and Thorne 1986). Rehabilitation works placed along Hotophia Creek in 1992 have been more effective in producing habitats more similar to nonincised streams than orthodox erosion controls placed upstream on Hotophia Creek or along Peters Creek. Fish populations have responded to habitat improvements in a fashion consistent with a conceptual framework proposed earlier (Shields et al. 1998). However, fish species and population density were much lower when sampled in 2002 than for 1992-1995. This may be indicative of the sharp reduction in sampling efficiency occurring for water depths greater than about 40 cm
