**HISTORIC SITE SURVEY
BELTSVILLE AGRICULTURAL RESEARCH CENTER**

**U.S. DEPARTMENT OF AGRICULTURE
AGRICULTURAL RESEARCH SERVICE
CONTRACT NO. 53-3K15-5-9071
TASK ORDER NUMBER 14**

**VOLUME III
BUILDING FORMS**

STRUCTURE FORMS (001-085B)
VOLUME 3

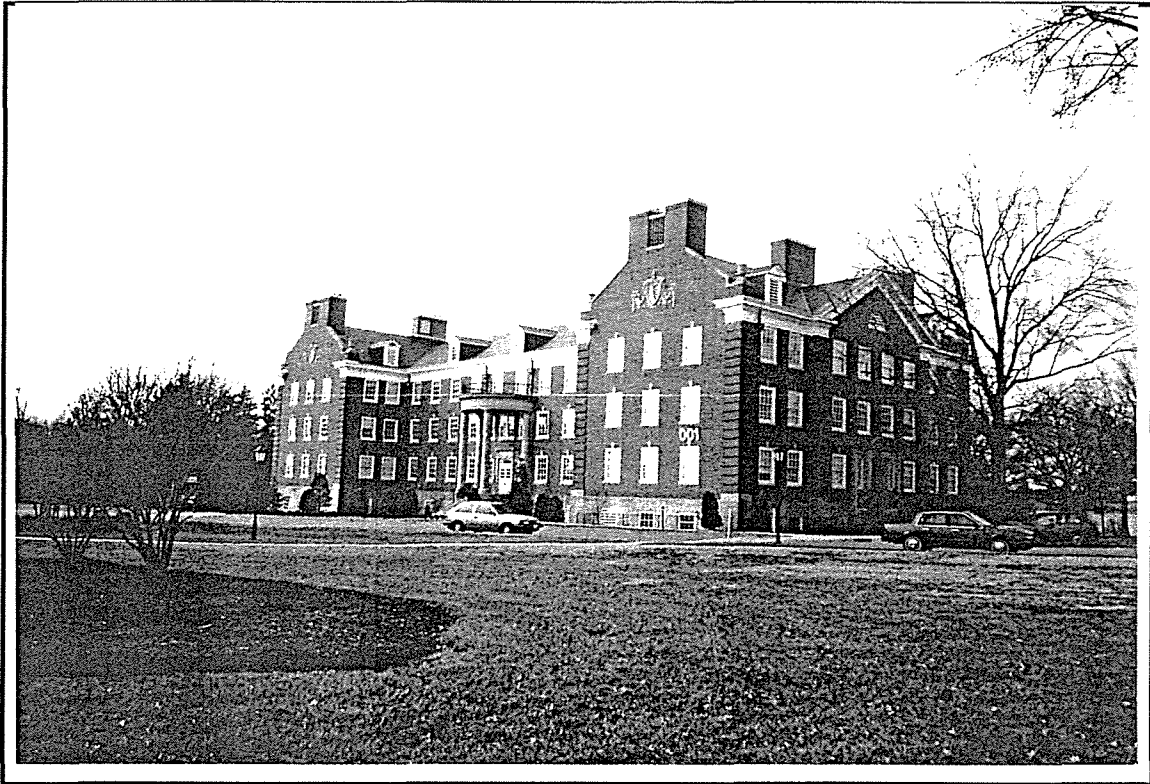
Photo ID: Building 001, East and North Facades, 2/97

The front (east) elevation is a symmetrical composition. It is 16 bays long and is divided into projecting three-bay end sections and a long recessed central ten-bay section in the center of the building. The major focus of the front facade is the central half-round projecting portico capped with a decorative metal rail. Windows throughout the building are replacement six-over-six, double-hung sash. All windows have stone sills.

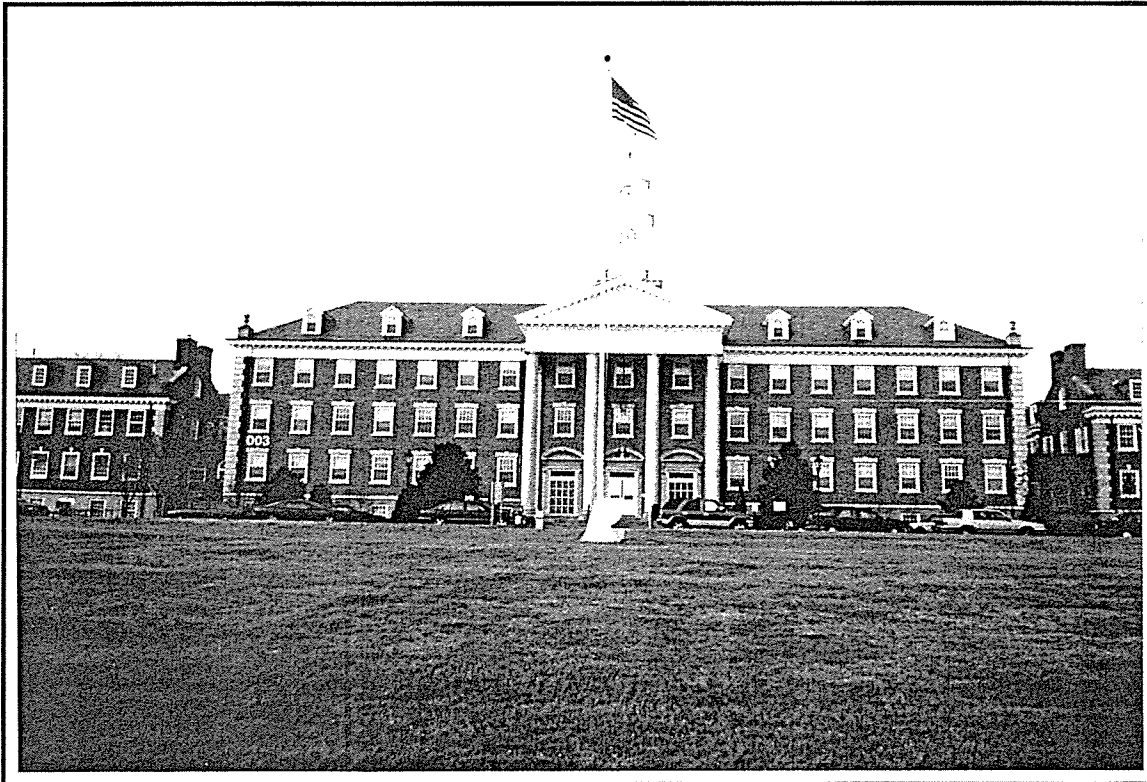
Photo ID: Building 003, East Facades, 2/97

The front (southeast) elevation is symmetrical in design. It is 17 bays long, with seven bays on either side of the dramatic three-bay-wide three-story Corinthian portico. A clock tower, which rises above the portico, is a central focus of attention for the building. Windows throughout the building are replacement six-over-six, double-hung sash. All windows have stone sills.

At the first floor level, a flight of stone steps (divided into thirds by metal rails) leads to what were originally three separate entrances. (The two side bays have been converted to windows and only the central bay now has an operational door.) The main entrance doors are double three-panel wood doors, topped with a decorative glass transom. At the side entrances the openings have been filled with fixed, multi-pane windows. Around the openings are stone surrounds surmounted by rounded pediments. On the central bay the pediment is broken, with a decorative element centered between the openings. The pediments are supported by brackets at the sides. The windows at the first floor level have stone flat arches with stone keystones. At the second floor level, the fenestration is uninterrupted by the portico and the windows have stone flat arches with stone keystones. At the third floor level also, the fenestration and detailing is consistent with the other floors. Above the third floor is a denticulated wood cornice and the slate roof of the attic story. Six gabled dormers, located on either side of the central clock tower, pierce the roof. The dormers have round-headed windows. The clock tower is of brick and wood construction. The first level of the tower is a square brick structure with brick quoining and a single round window which is centered on the structure. This section is topped with a wood balustrade with trophies located on the four corners. Above the first level, the tower is of wood construction. The second level features a single round-headed window centered on each facade. The third and final level of the tower is the site of the clock, which is centered on the front facade. The other facades of the tower are unornamented. The metal roof cap of the clock tower is bell shaped and is crowned with a weather vane.

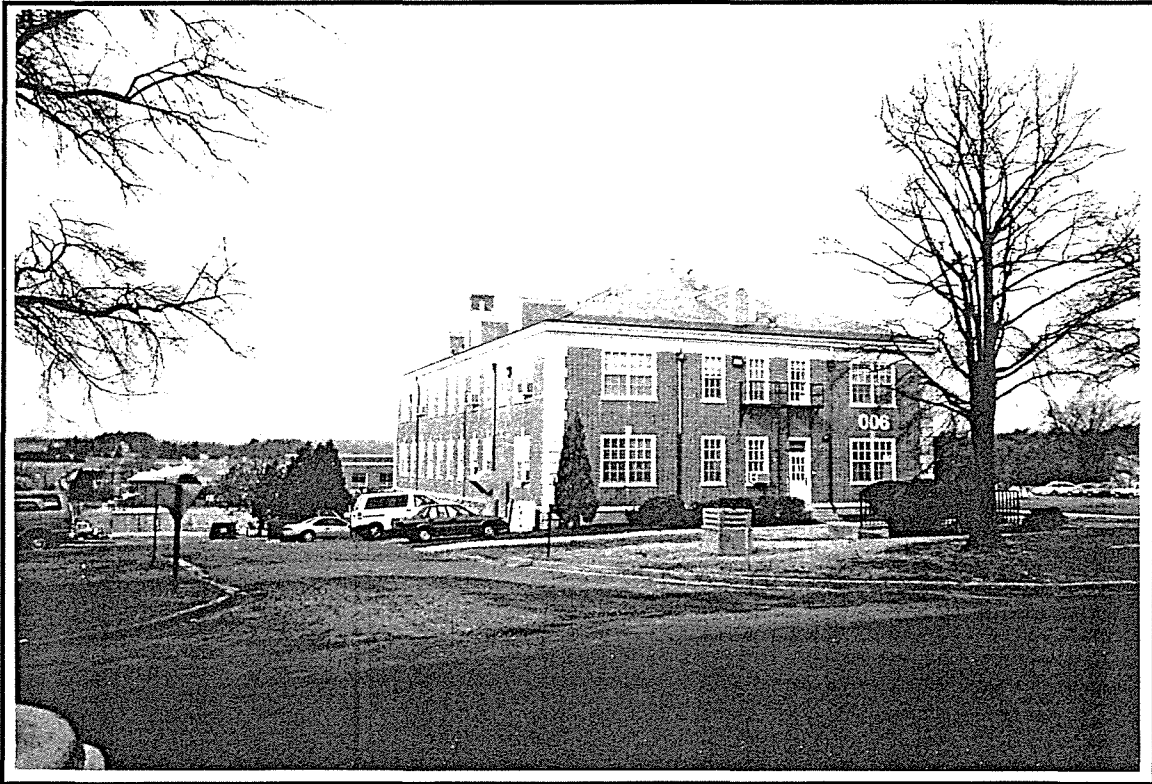
Photo ID: Building 006, South and East Facades, 2/97

The front (northeast) facade has a three-part composition and is nine bays wide. Stone quoining separates the two end bays from the central seven bays. With the exception of the single large window above the entrance on the second floor, windows throughout are replacement six-over-six, double-hung sash. Windows on the end bays are paired. Flat arches, that top the first floor windows, include stone keystones at the centers and, on the windows on the ends, also at the sides of the arch.

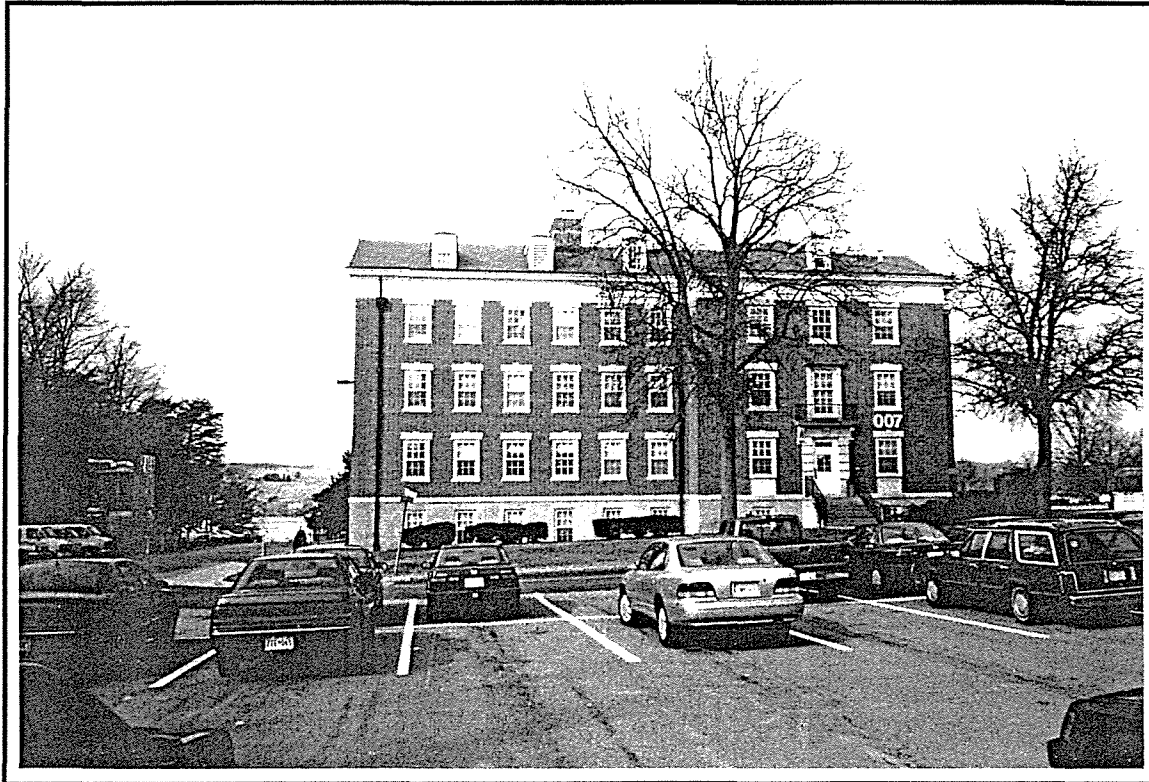
Photo ID: Building 007, East Facades, 2/97

The 15 bay-wide front facade has a three-part composition consisting of three-bay wide pedimented end sections which bracket the long central section. Windows throughout are replacement six-over-six, double-hung sash with flat arches and keystones.

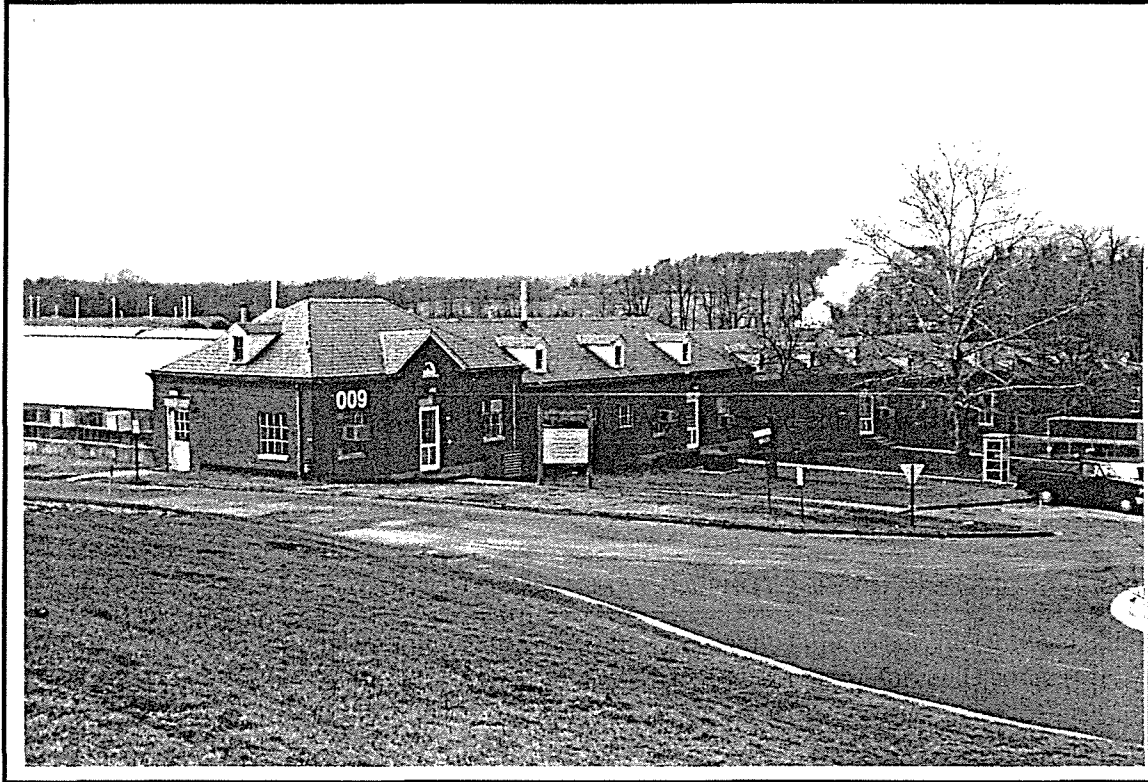
Photo ID: Building 009, East and North Facades, 2/97

Range 3 consists of a long horizontal headhouse and six greenhouses attached at right angles to the headhouse. The front of the building faces northeast onto Range 3 Drive. Because of its sloped site, and to prevent shading of the greenhouses, the building is stepped to follow the contours of the topography. The one-and-one-half story Georgian Revival headhouse is of concrete block construction with brick veneer walls and concrete foundations. All downspouts and gutters are copper, and the roof throughout is of slate. Decorative detailing is of limestone, with the exception of windowsills and interior door lintels, which are of cast stone.

Alterations to the headhouse have been minor and appear to be reversible. They consist in general of the insertion of a number of window-unit air conditioners, security lights at the entrances, and assorted vents which penetrate the roof. On the interior, greenhouses have been altered by the introduction of various modern mechanical systems including air-conditioning units and various revamped heating systems. Certain portions of the interior of the headhouses, such as those that house laboratory facilities, have been significantly altered over time.

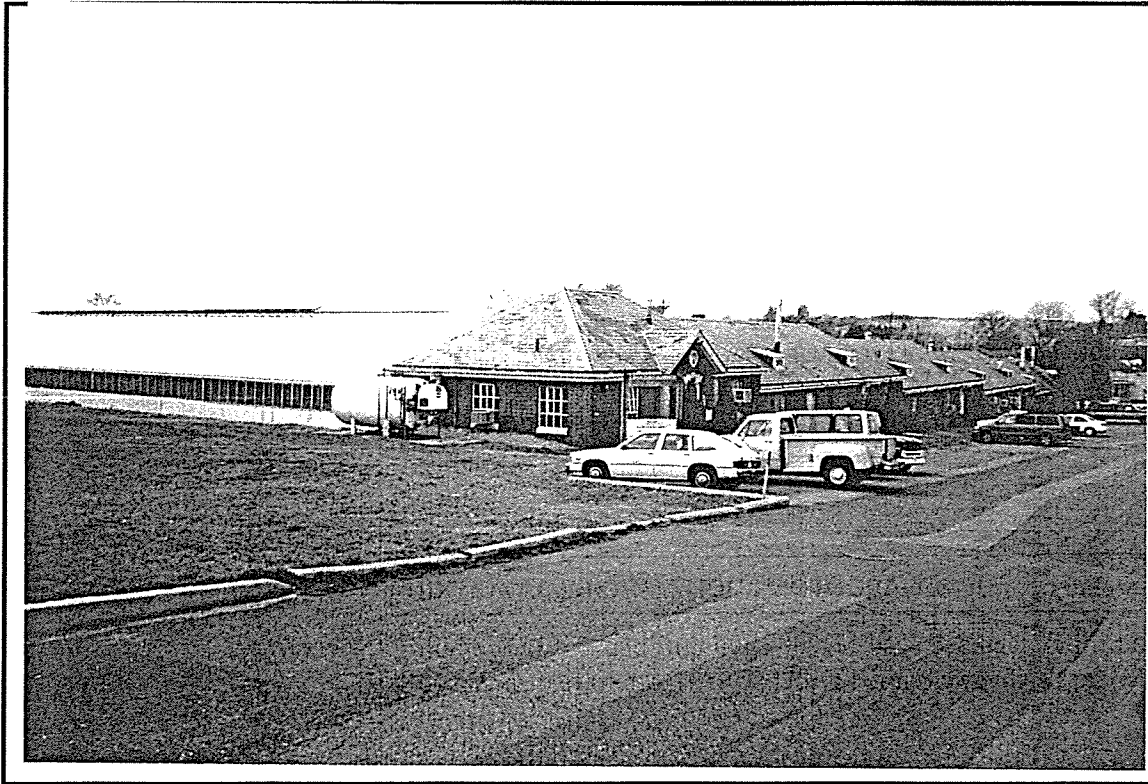
Photo ID: Building 010, East and North Facades, 2/97

Range 2 consists of a long horizontal headhouse with associated greenhouses. Originally, five greenhouses were attached at right angles to the rear of the headhouse, and a palmhouse and a large free-standing greenhouse of a more decorative design was linked to its east side. The five greenhouse structures were demolished in 1994 and new greenhouses were built on their site. The Palmhouse was demolished at the same time but was not replaced.

The front of Range 2 faces northeast onto Range 2 Drive. Because of its sloped site, and to avoid shading the greenhouses, the headhouse is stepped to follow the contours of the topography. The one-and-one-half story, Georgian Revival building is of concrete block construction with brick veneer walls and concrete foundations. All downspouts and gutters are copper, and the roof throughout is of slate. Decorative detailing is limestone, with the exception of windowsills and interior door lintels, which are of cast stone.

The major alteration to the building was the demolition of the greenhouses and of the Palm House. The greenhouses were gable-roofed with eaves of the "angle iron" type. Roughly 40 feet by 308 feet, they were of galvanized steel construction with wood moldings, sash, and doors. The greenhouses' glass panels were 16 inches by 24 inches. Each had vent sash at the ridge (gable) and on the sides at the eave line of the building. The greenhouses have been replaced.

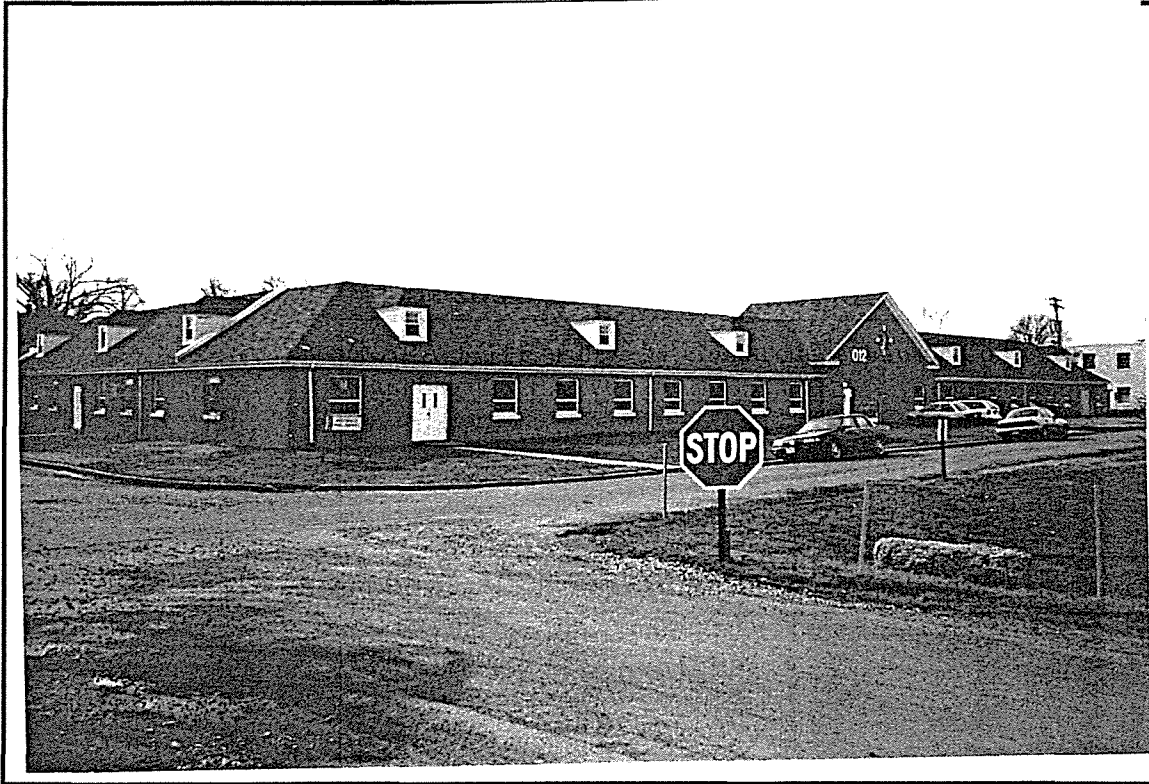
Photo ID: Building 012, East and North Facades, 2/97

Building 012 is a large one-and-one-half story brick storage/service building constructed in an open-air courtyard arrangement. Building 012 faces northeast onto Range 2 Drive and has vehicular access to the interior courtyard from the southeast. The rectangular building has a long (20-bay) front (northeast) facade that features a central gabled pavilion with a central bullseye window. The building's hipped roof has shingle roofing and hipped dormers. The building has recently been stuccoed, painted, and given metal replacement windows. (They consist of a fixed upper section and a lower pane that pivots.) The central courtyard provides parking and additional service entrances for the building. The building is in good condition. The building was constructed in two pieces. Farm Service Building C, a small section of the building was completed in 1938. Farm Service Building A, the rest of the building, was constructed in 1941.

One section of the building faces north. Its four-bay-wide front facade has brick facing and a flat roof with a stepped parapet. Window openings have flat arches and the metal windows themselves consist of four horizontal panes, the two center panes of which pivot. The rear and side facades of the building are of painted concrete block. There is a one-story concrete block addition to the west. The rear features a roll-type garage door at the second-story level. Both buildings are in fair condition.

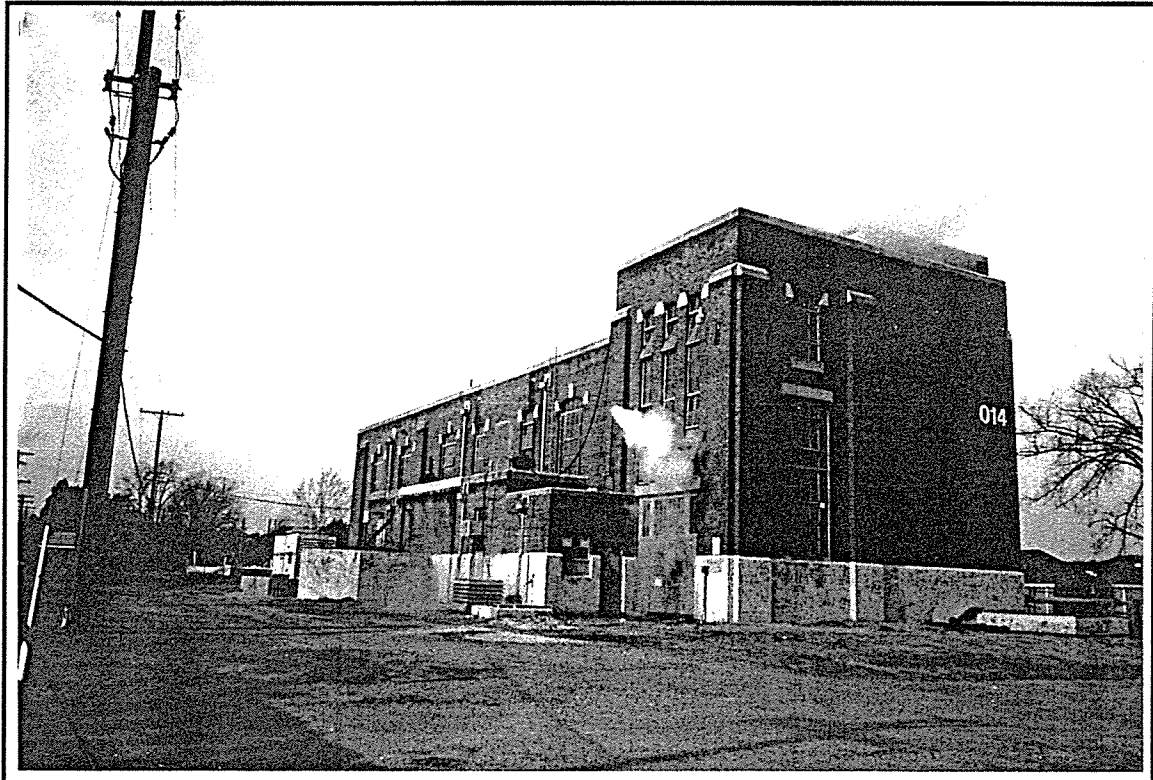
Photo ID: Building 014, East and South Facades, 2/97

The original section of the Central Heating Plant was completed in 1939. Funding for the building, which cost \$146,980, came from PWA and WPA sources. Within a few years, an addition to the building and replacement of some of the equipment inside the building became necessary as a result of the relocation of the Arlington facilities.

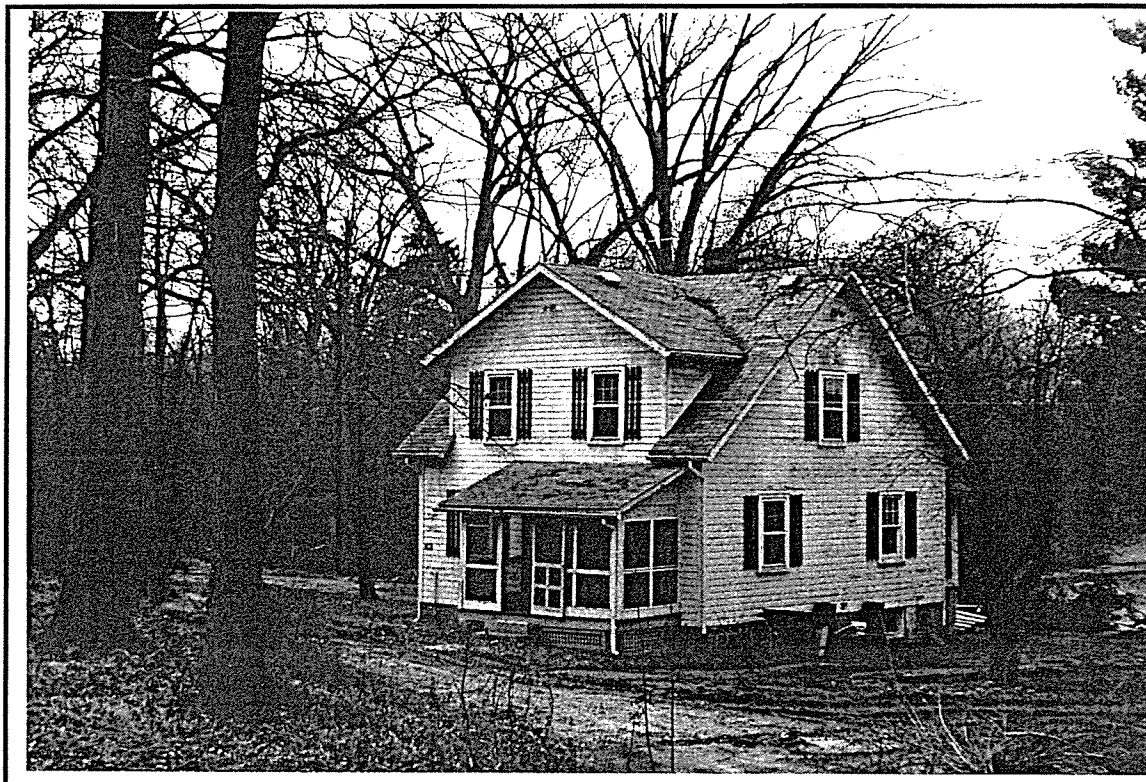
Photo ID: Building 016, North and East Facades, 2/97

The Ramsburg House is a two-story, wood-frame house with clapboard siding and a raised concrete-block foundation. The asphalt shingle roof is cross gabled. Storm windows have been added to the original six-over-one, double-hung windows. All windows have distinctive vertical board shutters.

The south elevation contains the primary gable. There is a small, frame, entrance porch with a flight of six concrete stairs leading up to it. Three one-over-one double-hung windows are evenly spaced on the first story, and a single one-over-one, double-hung window is centered on the second story. A centered stair in the concrete block foundation leads to the basement ; it is flanked on each side by a small square window.

The north elevation contains the primary gable. There are two, six-over-six, double-hung windows on the first level and one on the second level. The concrete block foundation forms a raised basement which contains several small rectangular windows.

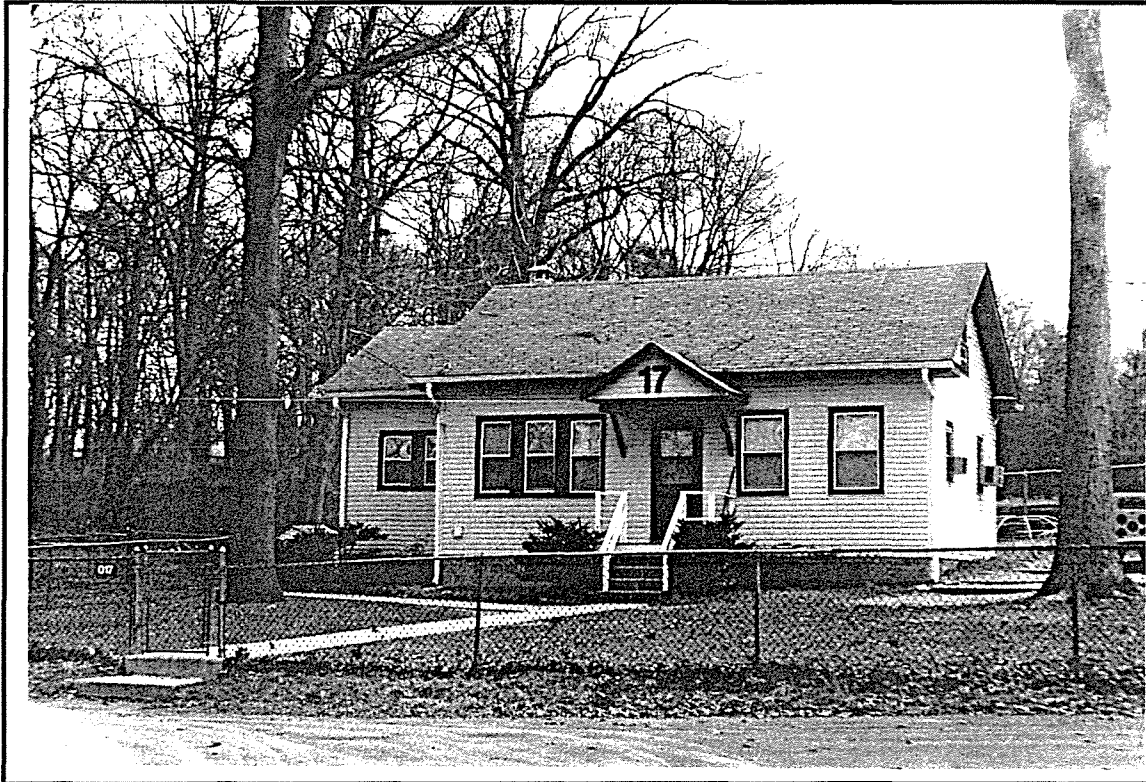
Photo ID: Building 017, West Facade

Building 017 is a modest, one-and-a-half story wood bungalow with horizontal wood siding and a concrete block foundation. The building has a gabled roof covered with asphalt shingles. Windows throughout are one-over-one double-hung replacement windows. The massing of the building consists of a main block to the south and a smaller recessed section -- possibly an addition -- on the north end of the building. The front (west) facade of the building has a central entrance located under a small stoop. The entrance is flanked on the north by a grouping of three windows and on the south by two windows. This facade of the smaller recessed section has a single paired grouping of windows. The south facade features two windows at the first floor level and an attic window and vent. The north facade has a single window. The east (rear) facade has a door on the north end and four windows of various sizes distributed along the rest of the building.

The North Farm parcels expanded the site to the south and west and roughly doubled the Bureau's holdings along Route 1. Two houses came along with the new North Farm purchases. One, Building 017, was on the 19.494-acre Brown property, about 100 feet south of Building 001. Soon after its purchase, the building was moved on skids by two tractors to its present location near Canary Road. It was placed on a new foundation and extensively renovated. A contemporary document describes it as "a very comfortable one story, five room house with small basement, hot water heat, plumbing, electricity, etc." (RG 54, Entry 151A, Box 1) The building was home to a long line of Bureau employees, most of whom were associated with shop or field operations. The building is currently used for a day-care facility.

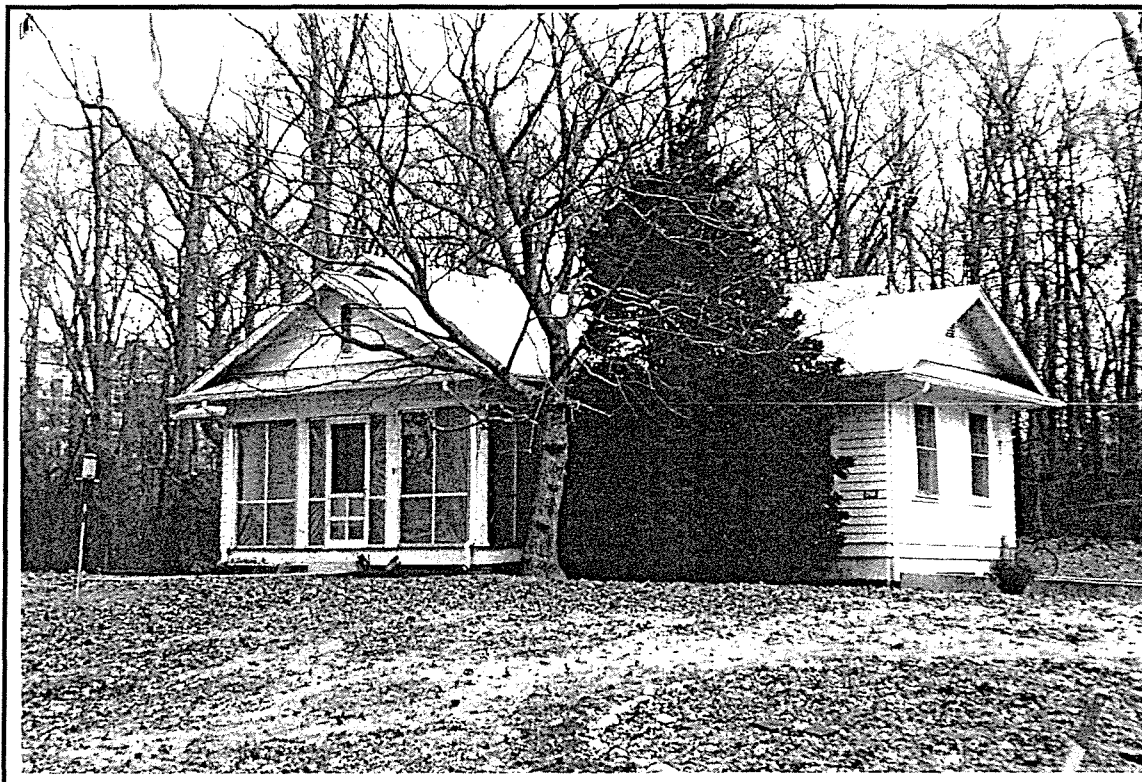
Photo ID: Building 018, South and West Facades, 2/97

The Smallwood House is a one-story, wood-frame bungalow with clapboard siding and a concrete-block foundation. In some details it resembles the catalog houses popularized by Sears, Roebuck and Co. in the 1920s and 1930s. The overhanging roof consists of a main gable which runs west to east. A smaller porch gable on west facade also runs west to east, off-center from the main gable. A secondary gable is perpendicular to the main gable and protrudes to the south. This secondary gable is split into two sections, with the smaller section continuing south from the larger section. At the middle point of the main gable is a chimney.

The north elevation has a small, central, one-over-one, double-hung window flanked on each side by a larger, one-over-one, double-hung window. There are also two smaller rectangular basement windows in the concrete-block foundation.

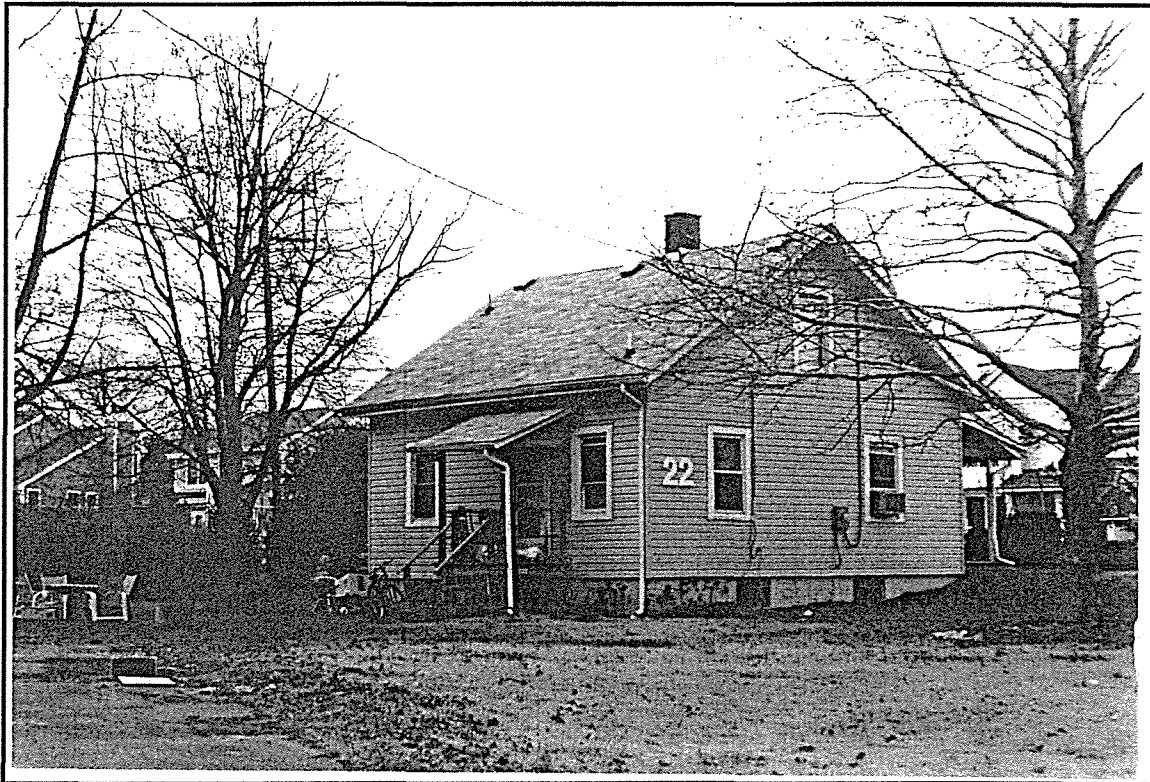
Photo ID: Building 022, South and East Facades, 2/97

Building 022 is a small, one and one-half story, side-gable house. The house, which sits on a raised concrete-block foundation, is a simple square box. The gabled roof overhangs substantially, especially on the end-gable elevations. Centered along the ridge of the roof is an interior chimney. There are entrances on both the north and south elevations, each characterized by an overhanging shed-roof porch. The north and south elevations are three bays wide, and the side elevations are two bays across; each elevation has two windows. The principal (or north) facade features a large shed-roof porch that extends along almost the entire facade. The porch, supported by four simple posts, shelters the central entrance door and two flanking one-over-one windows. Both the windows and the door have simple wooden surrounds. The south facade is now used as the primary access to the house. The entrance that is located in the central bay is slightly off center. Flanked by two one-over-one windows, the door is sheltered by a projecting shed roof supported by two simple posts, and accessed by a flight of stairs. The east and west (or end-gable) facades are each punctuated by two windows. Set in the concrete foundation are two small windows, opening into the basement. In the apex of the gables are small vents. The house has recently been entirely renovated; new windows, a new roof, vinyl siding, and a new porch were included in the renovation.

Building 022 was constructed in the early 1930s by the U.S. Department of Agriculture for use as a laborer's cottage. Named the Yowell House for its first government occupant, Albert Yowell and his family, the residence was used to house government farm laborers. It was one of two houses erected by the government for use as employee housing. Neither house was equipped with water, a furnace, or electricity. By the mid 1930s, the Yowell House was considered in poor condition and valued at approximately \$1,200. A description of it in the inventory of residences listed it as "a cheap 5-room frame house built principally from second-hand lumber, no furnace." Albert H. Yowell, a farm laborer who earned \$70 a month, occupied the house with his wife and two children. House rent of five dollars a month was deducted from his pay. Because there were no amenities, there were no extra charges deducted for heat, light, or power. In 1938, the Yowell house was one of a number of residences that was painted, using Public Works Administration monies. It was listed third in order of importance, among six houses named. Another item on the list of improvements to be undertaken was the installation in the Yowell House of kitchen plumbing, bathroom fixtures, a septic tank, tile field, shallow well pump and tank, and a pipeless furnace. Since its construction, the house has continued in its use as an employee residence. It seems likely that initially the house was intended for laborers' responsible for work in the North Farm area.
