**HISTORIC SITE SURVEY  
BELTSVILLE AGRICULTURAL RESEARCH CENTER**

**BELTSVILLE, MARYLAND**

**VOLUME IV  
BUILDING FORMS**

STRUCTURE FORMS (156-288)  
VOLUME 4

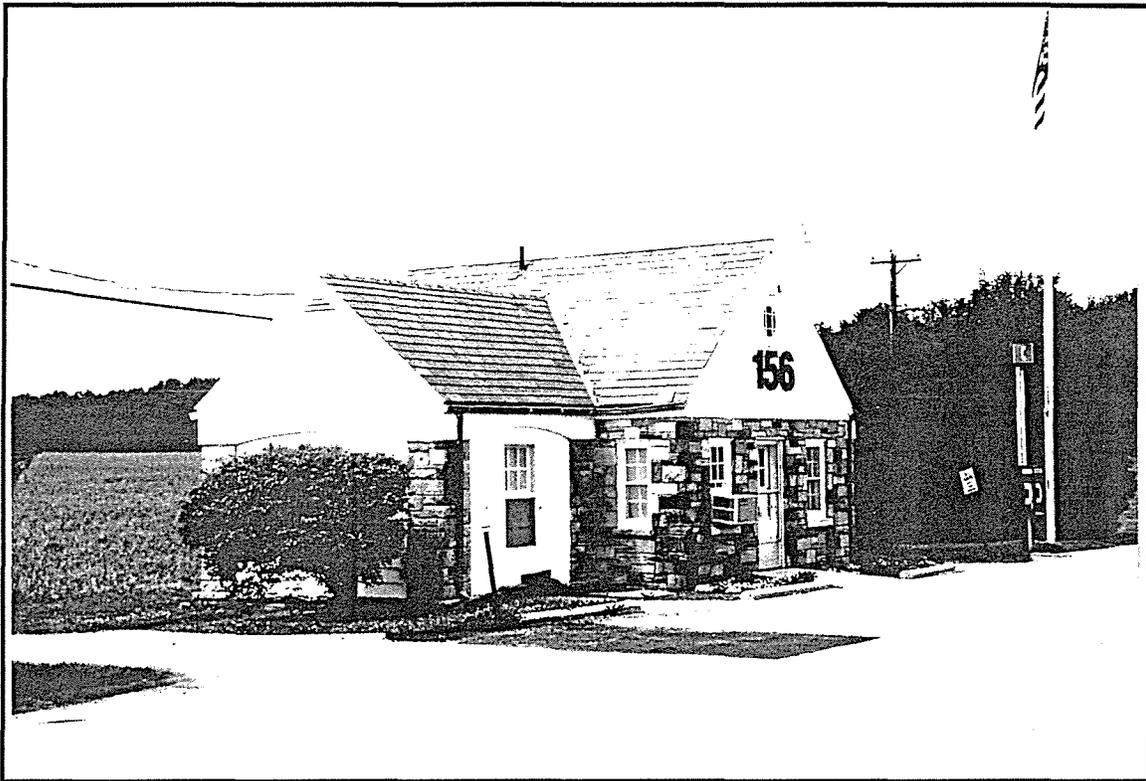
Photo ID: Building 156, North and East Facades, 6/97

This is a small front-gable building with a side gable wing on either side. The north facade center portion of the building is stone masonry backed with four-inch cinder blocks. The central entryway contains a storm door. To the left of the door is a small six-pane window, and a larger six-over-six window is to the right of the door. The gable area is clapboard and a small multi-pane circular window is located at the apex. The wings have stone corners, with the center portions containing filled in clapboard sections. Double-hung multi-pane windows are featured on both wings, and there are vents in both gables. The roof is covered with slate.

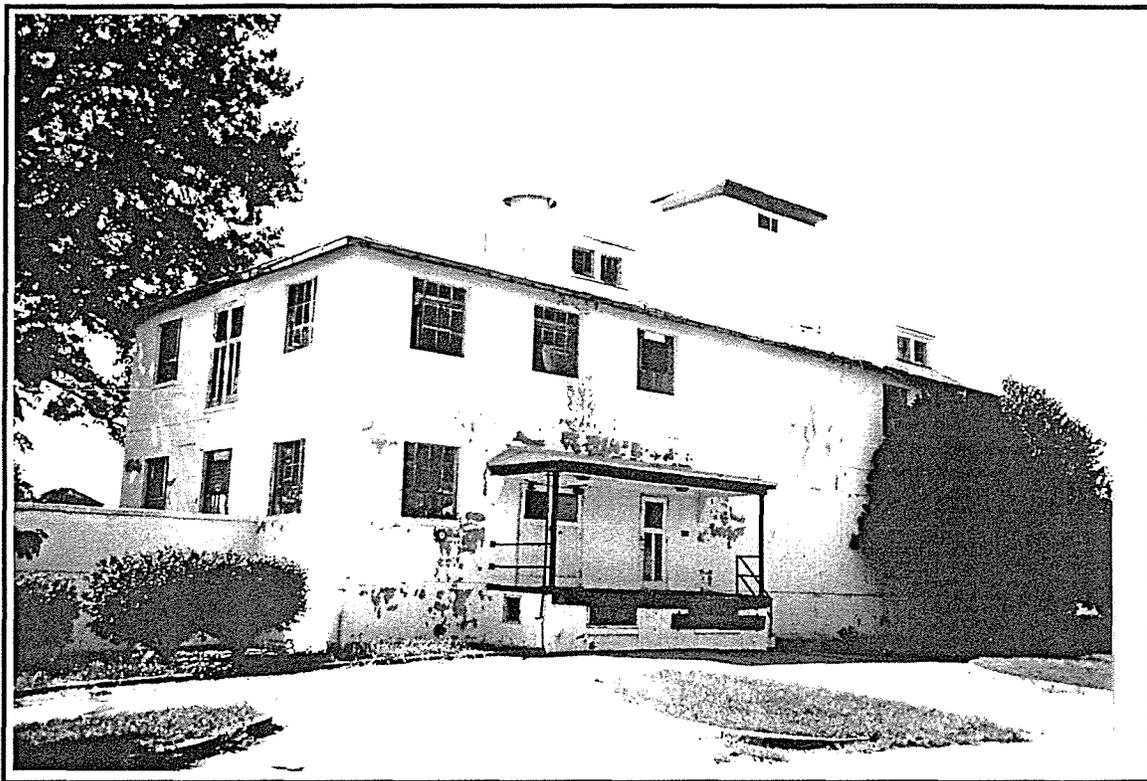
Photo ID: Building 157, East and South Facades, 4/97

This is a two-story, poured concrete, rectangular laboratory building with a concrete foundation and raised basement. There are three bays on the north facade. Original twelve-pane windows with four central panes that pivot outward are on the first and second levels. There are metal replacement doors on the east elevation that open to a loading dock area on a raised platform. An elevator on the interior of the east elevation rises beyond the roofline and is capped by a hipped roof. Original wood double doors are located on the second level of the south elevation and have no exterior stairs or porch. Two hipped roof ventilator dormers are on both the east and west elevations. The hipped roof is covered foam insulation over the original asbestos shingles, and metal aerators are located on the ridge line. There are exposed wooden rafters which are in poor condition. No gutter system is present. The building appears to have been added onto at the south end, although an attempt was made to remain true to the overall form of the building core. Although currently unoccupied, the building is in fair condition, although the roof is in poor condition. The building is located adjacent to Well #1, and there is evidence of planned foundation plantings.

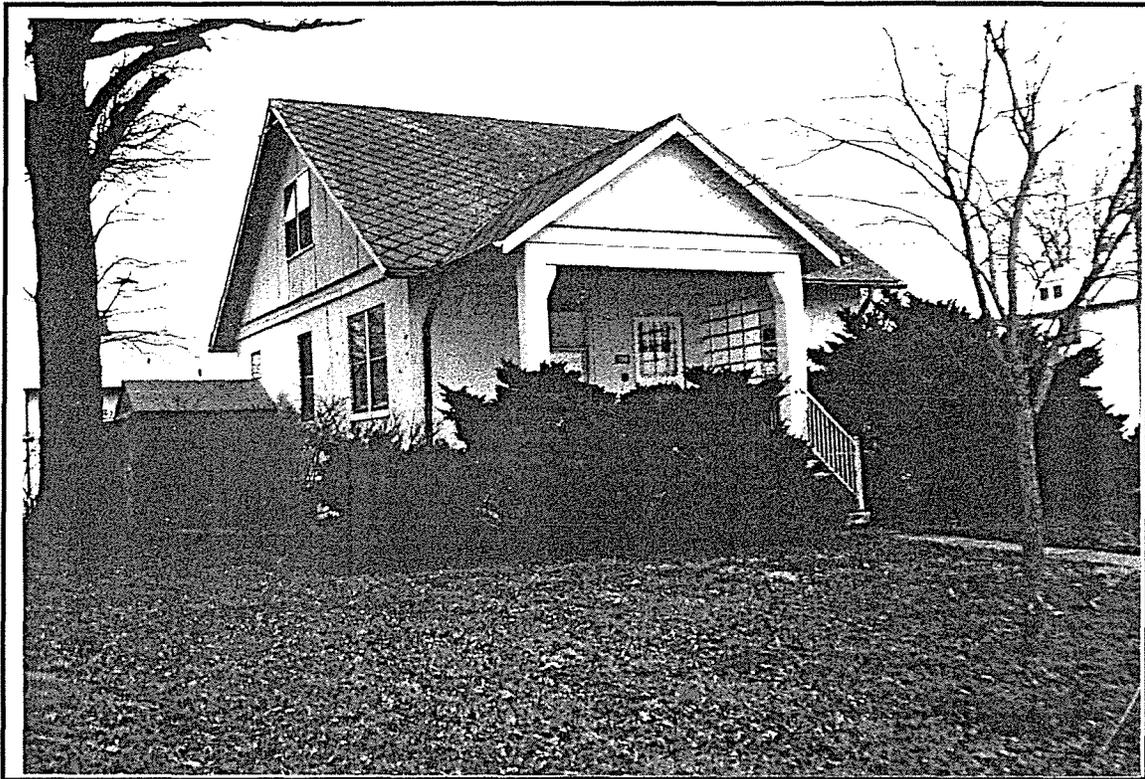
Photo ID: Building 159, North and East Facades, 4/97

Building No.: 159	Master Plan Page: P-5	Grid: D-4
Building Name/Historic Name: Dairy Residence		
Farm Area/Street Address: Central Farm/Bureau of Dairy Industry		
Date of Construction/Source: 1928/NARA		
Historic Use/Current Use: Residence / <i>Vacant</i>

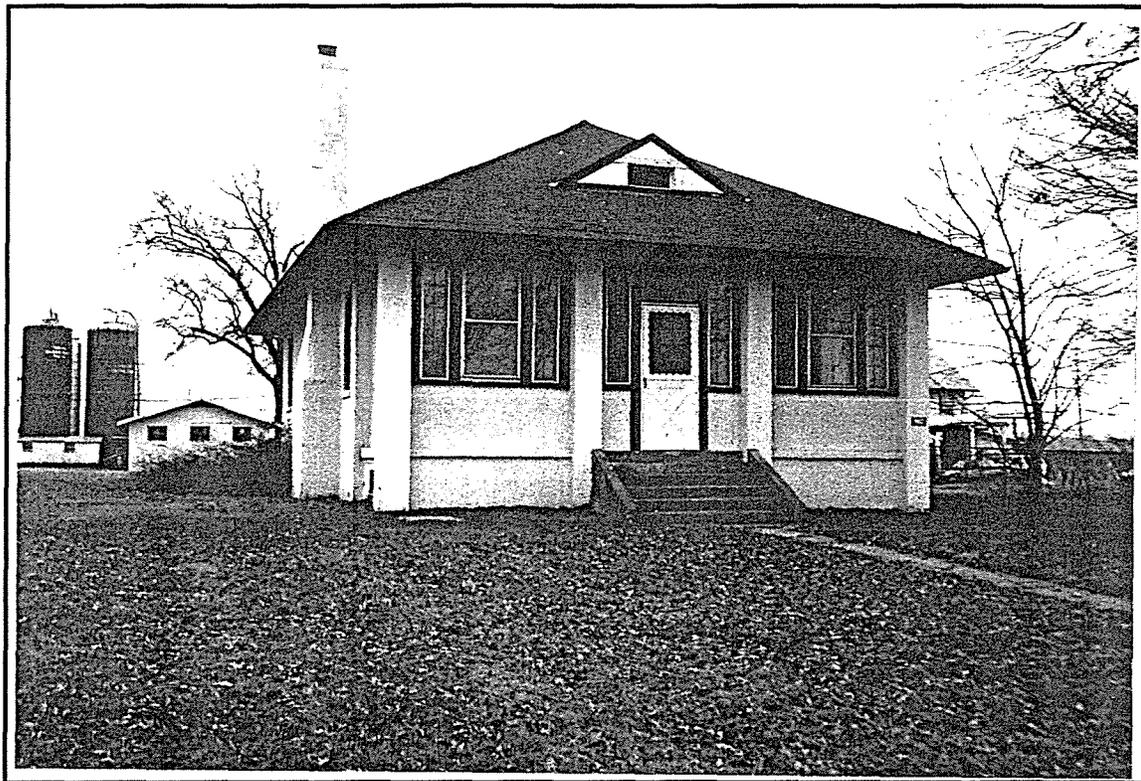
Photo ID: Building 160, North Facade, 2/97

This is a one story poured concrete storage building with a stucco finish. The hipped roof is covered with diamond-pane shingles. Overhanging wood eaves with exposed rafters are present. The north facade contains double wooden doors at the west end with four-light windows at the upper half of the door. Two six-light, three-over-three, wooden sash windows are present. The west facade has a square wooden opening with a concrete sill. Above the opening is a two-light transom. The south facade has a single six-light window on the east side. There are serious cracks on both the south and north elevations. The east facade has a central wooden window with six lights and a concrete sill, above which is a two-light transom also with a concrete sill.

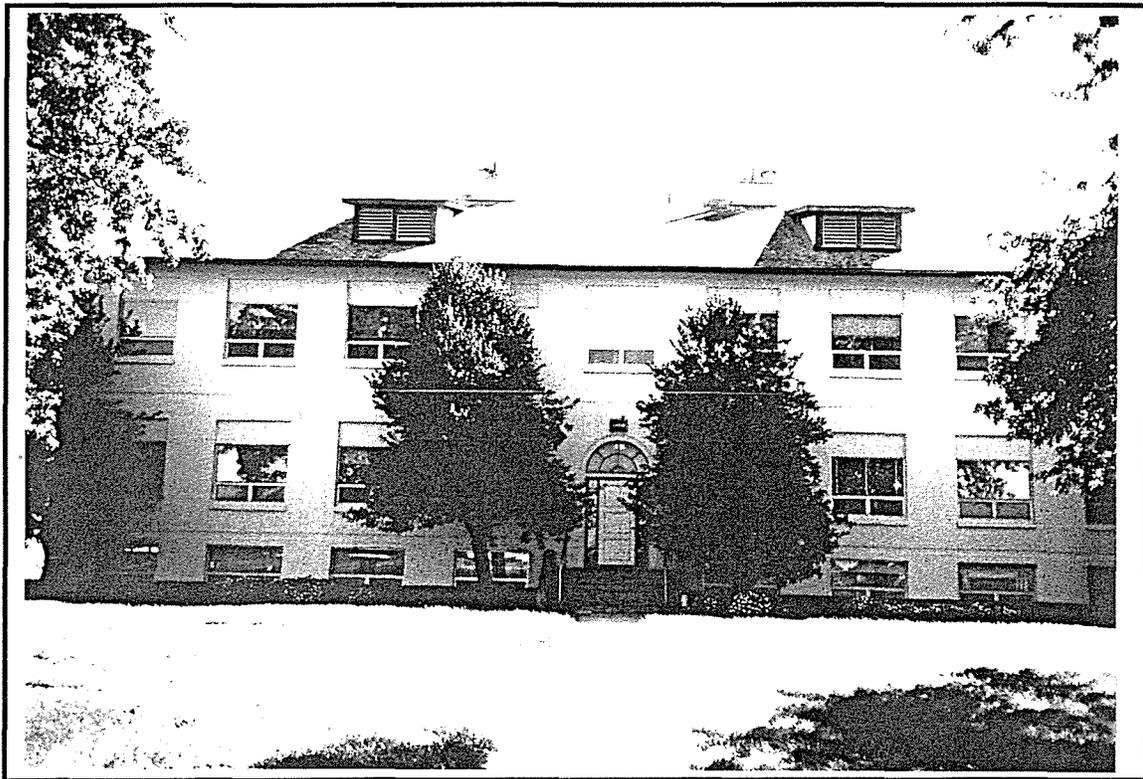
Photo ID: Building 161, North Facade, 1/97

This large, three-story building faces north on Powder Mill Road. It is of poured-concrete construction atop a concrete foundation. The hipped roof is covered with asphalt shingles, and there are two ventilators along the ridge line. The principal (north) facade is nine bays across, punctuated by large windows that have been filled in. There is a central entrance door with a fanlight and sidelights (later addition). Other facades feature smaller windows (on later portions of building). There are metal replacement doors throughout, and metal gutters are present. The adjacent laboratory (Building 161A) is located partially underground. Large ventilation tubing extrudes from west facade.

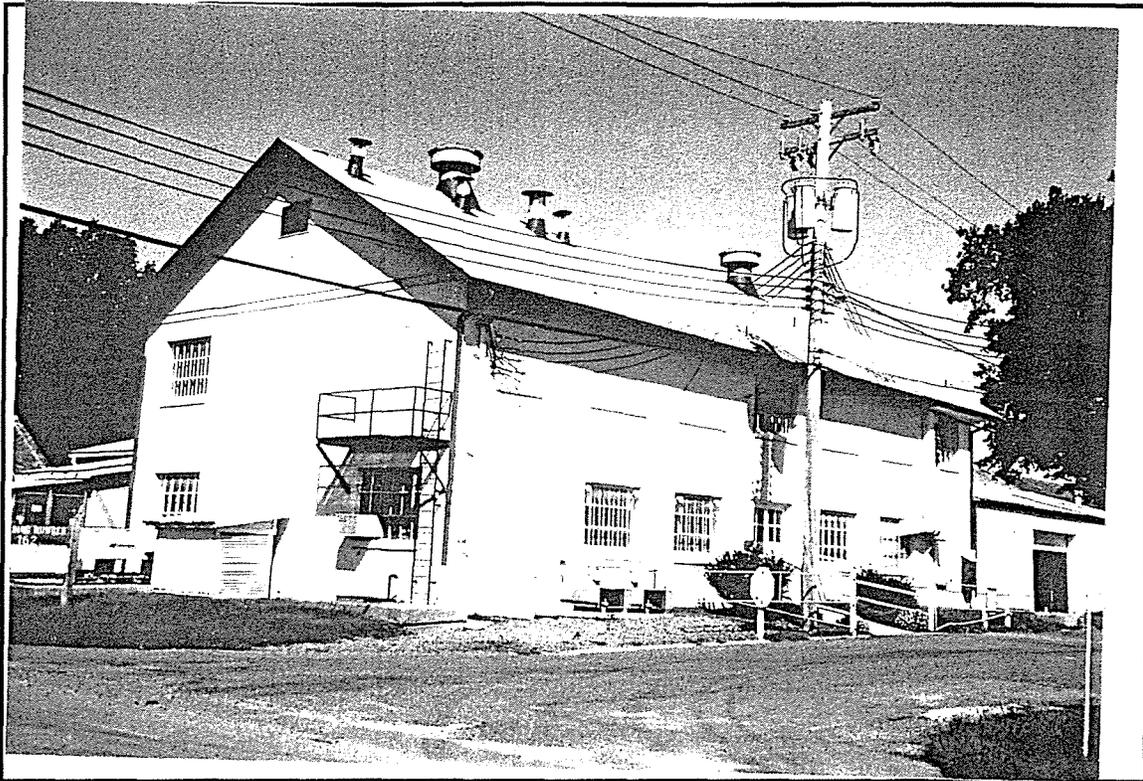
Photo ID: Building 162, West and South Facades, 1/97

This rectangular two-story building has a side-gable roof covered with asphalt shingles and numerous galvanized iron ventilation pipes along the ridge line. The building is of concrete construction, finished with a smooth yellow plaster stucco. There are copper gutters. The windows of the building are all fixed, metal, casement windows, with 16 lights and an upper movable ventilating section. The north facade, which is six bays wide, features a first-floor, wood-frame addition with a corrugated steel roof and a concrete-block foundation (Building 162A). An exterior flight of stairs leads down to double metal doors at a basement level. At the rear, extending to the east is a large, one-story addition of cement block with a metal gable roof. The west gable-end elevation of the original main block reveals central double doors in the second story that have been closed up, as well as diamond-shaped shingles that have been stuccoed over. The south facade retains a single, central, upper-story window, with virtually all other windows blocked in. The first story has two casement windows on either side of central double doors. There are windows in the end bay at west end, blocked in. The addition is a one story with garage door on the south side with a metal strips roof. There are double doors at east end of the south facade. The east facade has three bays across casement windows. The first floor is obscured by an addition at the east end, which has four metal recessed casement windows. A ventilation panel is located in the apex of gable.

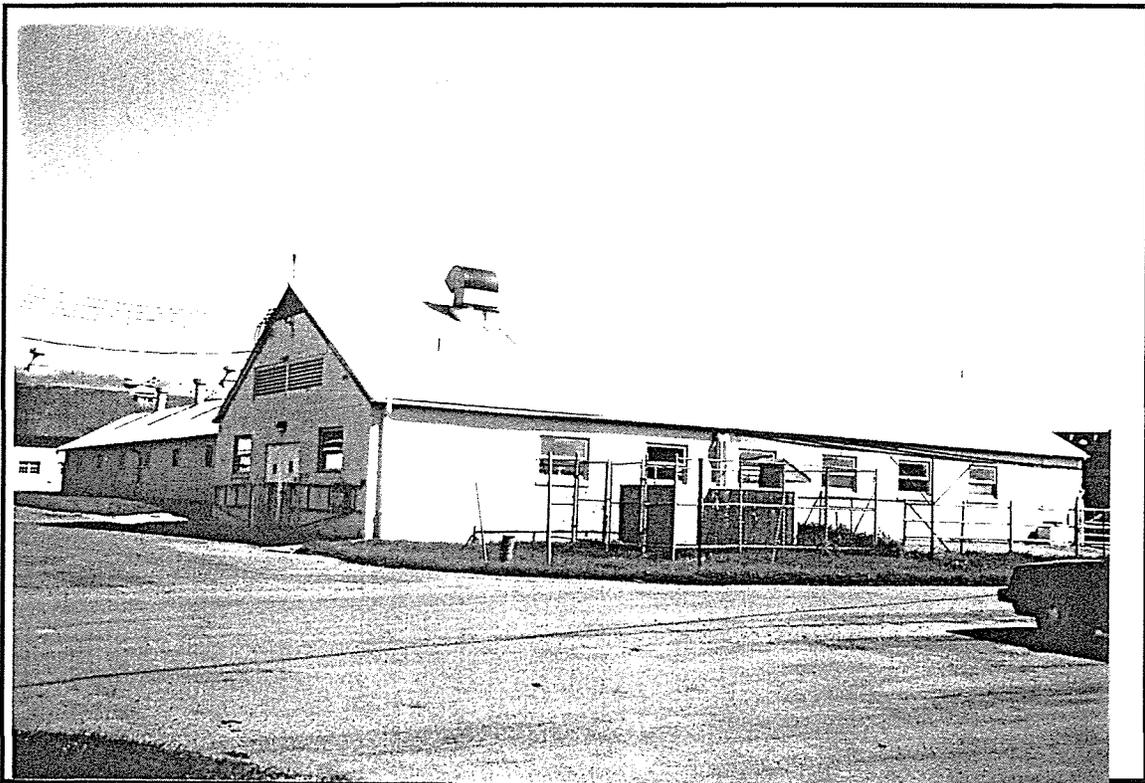
Photo ID: Building 163, Looking East, 1/97

The maternity and calf barns are adjoining buildings which form an L-shape. Both are single-story frame barns with flushboard coverings, and both have gable roofs. The maternity barn (Building 163) lies on a north-south axis. The north facade features double metal replacement doors flanked by replacement one-over-one windows. A large metal gate covers the entire width of the facade. A louvered double vent is located in the gable area. The east facade contains the calf barn. The south facade has two off-center replacement doors, and a small, shed-roof entryway is also located off-center. Small vents are located in the gable. The west facade contains one-over-one replacement windows. The roof is covered with sheets of corrugated metal. The calf barn and the maternity barn connect at the northern end of the east facade. The calf barn (Building 163A) is situated on an east-west axis. The north facade is punctuated by a series of small, square windows, some of which are original, fixed, four-pane windows, while others have been replaced with single panes of glass. The east facade contains an off-center wood door with six panes of glass, and a small square window that has been filled. The south facade contains a series of windows and doorways which lead from the barn out to an enclosed pen. All openings contain screens. The west elevation is connected to Building 163. The gable roof is covered with sheets of corrugated metal, and ventilator shafts are present on the roof.

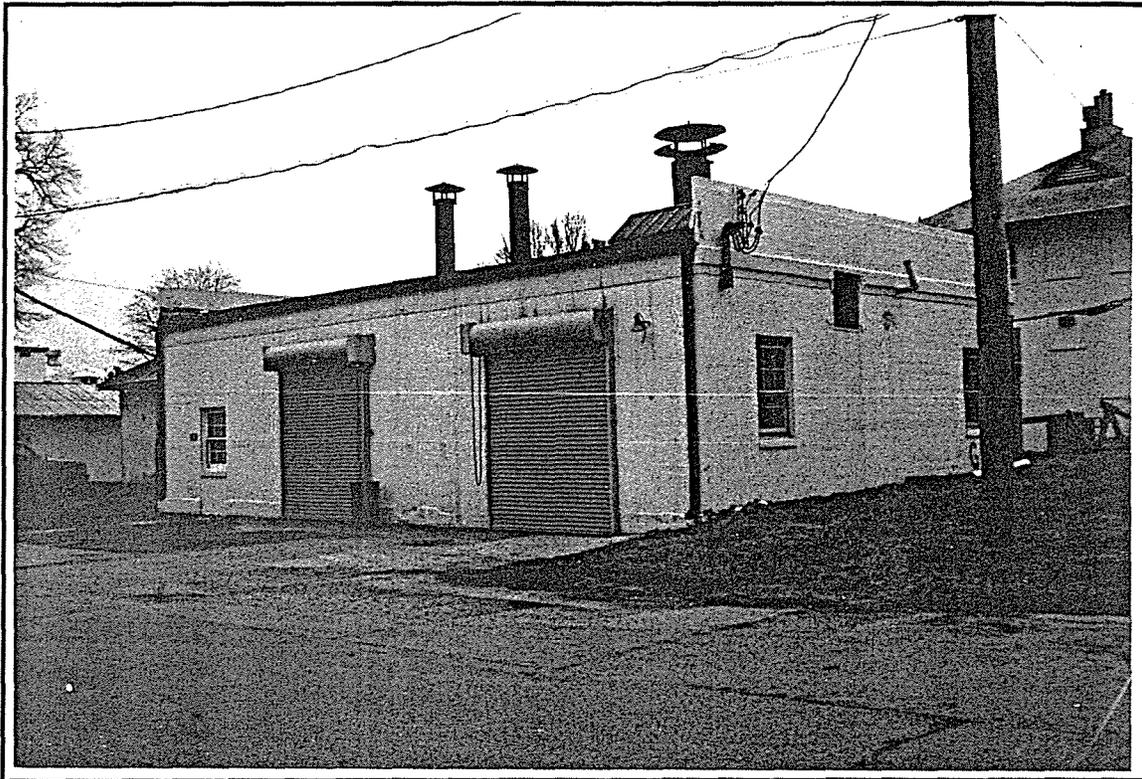
Photo ID: Building 165, South and East Facades, 1/97

This one-story building is located in the center of the Dairy Area, oriented on an east-west axis south of the administration cluster along Powder Mill Road. It is of poured concrete construction atop a concrete foundation, with a flat roof. Three bays across, the building is characterized by double-hung, wood-sash windows, and copper gutters. A number of the doors have been replaced with metal roll doors.

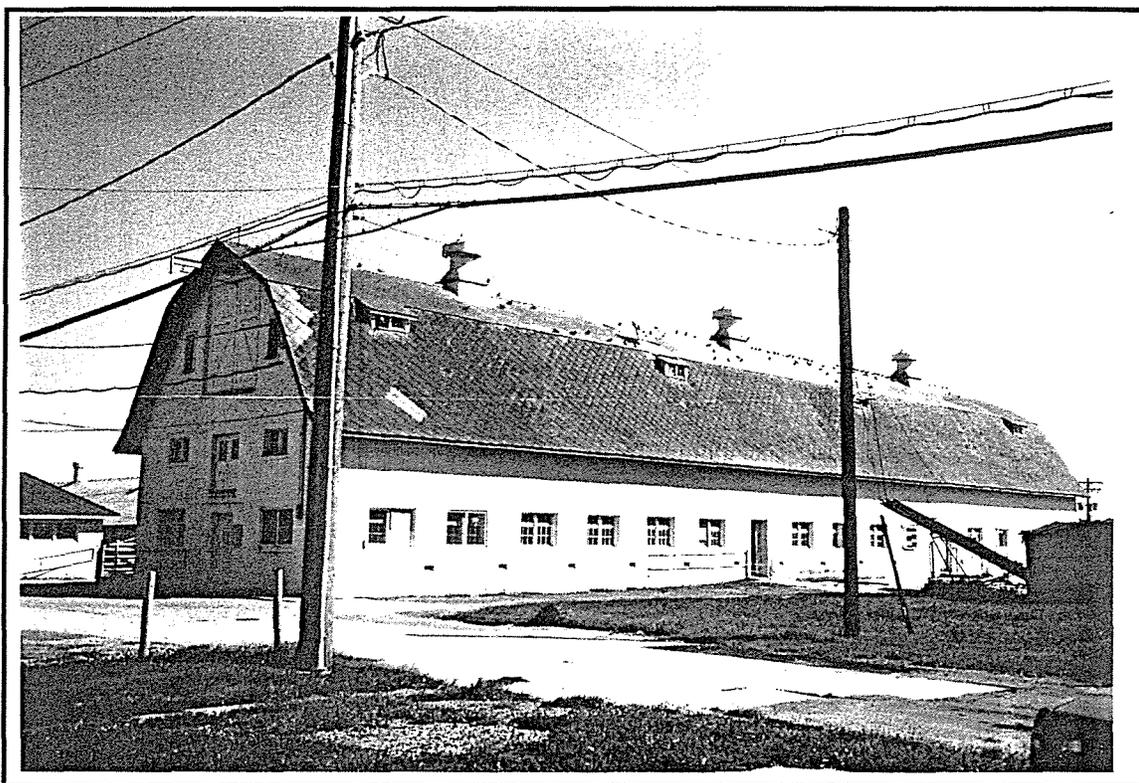
Photo ID: Building 166, North and West Facades, 1/97

This rectangular barn has a gambrel roof and a raised concrete foundation. The roof has four shed-roof dormers spread along the ridge of the roof on both sides and three aluminum metal ventilation towers. The upper story of the north facade is covered with painted diamond shingles. There are also large wooden loading doors in the upper story, flanked by small narrow sidelight windows. A metal pulley system extends over the wooden doors. Below the shingled area is a smaller set of loading doors that are wooden with four lights in each door. They are flanked by a pair of square, double, four-light windows. The first floor has a central recessed door, flanked by double windows. There is a gabled projecting entrance, with a ramp for cows. The gambrel roof is covered with diamond-shaped, asbestos shingles. There is a concrete staircase to a wooden door with a three-light transom. The ground level recedes and at the basement level there is a similar wooden door. The south facade is identical to the north facade. The west facade has many windows, and two doors are located in center section of building.

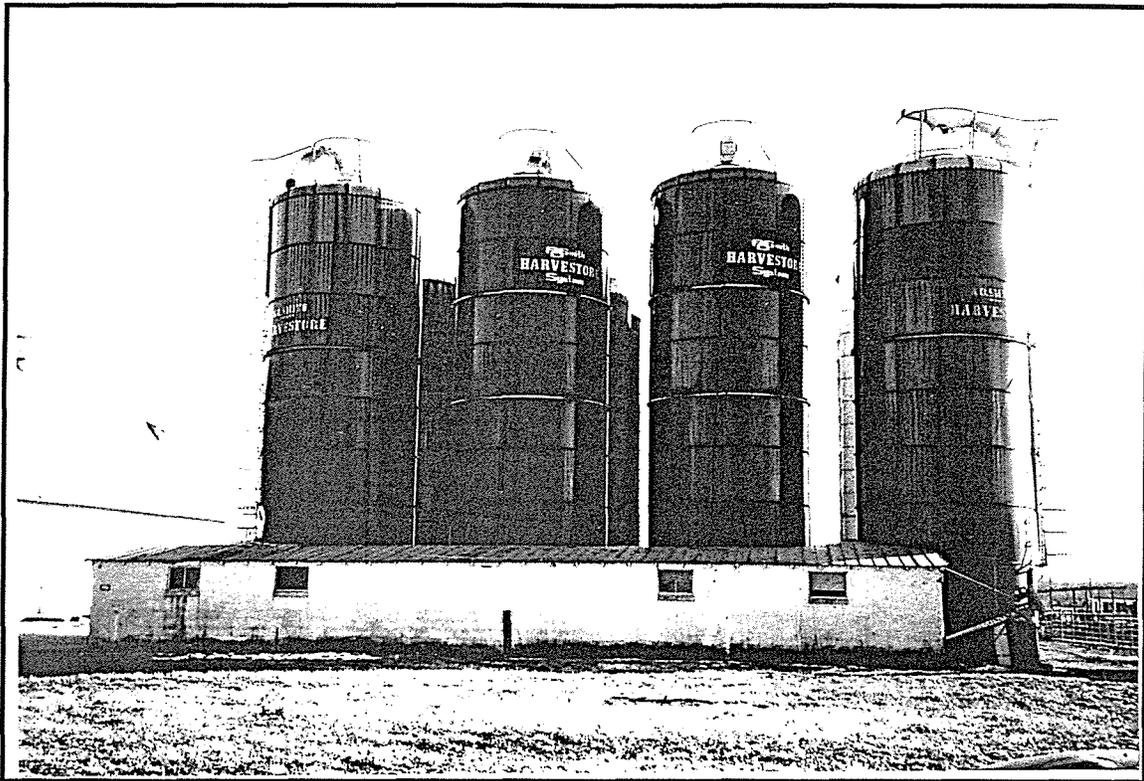
Photo ID: Building 166A, North Facade, 1/97

This one-story shed is located in the middle of the dairy area south of Powder Mill Road. The building is of concrete-block construction, atop a concrete foundation. It has a shed roof with exposed rafters, covered with aluminum. The north facade has four double-paned windows. The west elevation features a track sliding door. On the east facade, there is plywood covering the door area. The south elevation is connected directly to several silos.

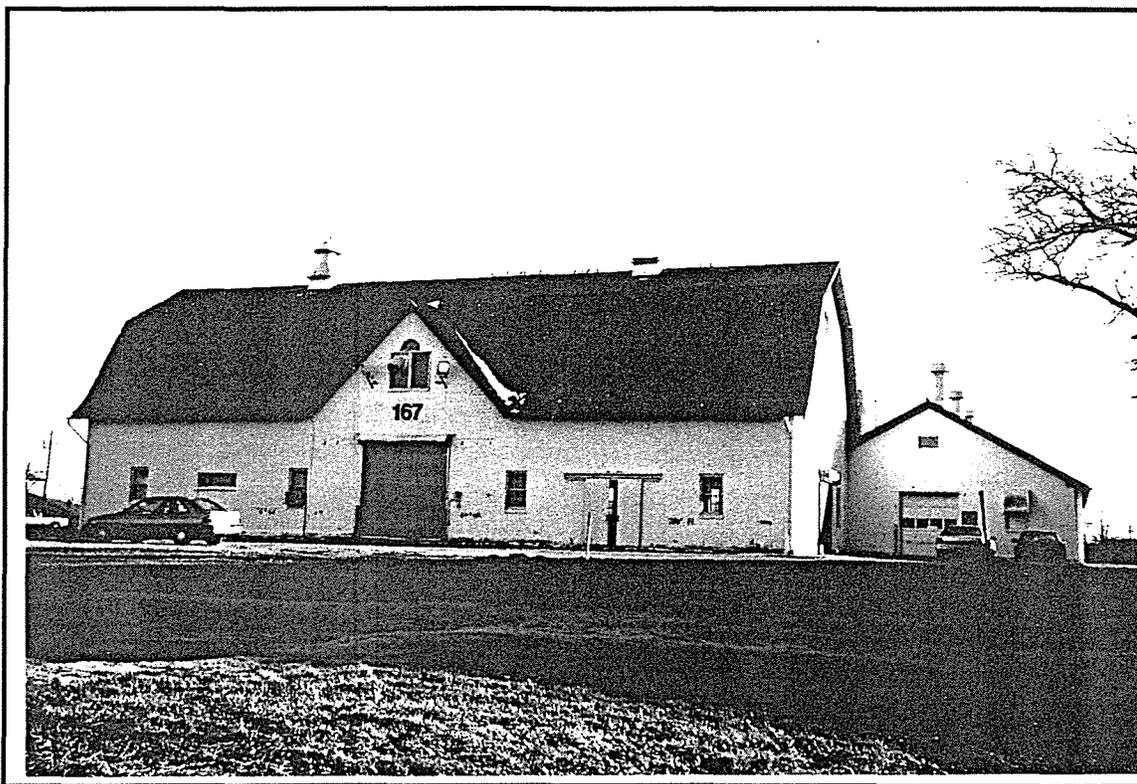
Photo ID: Building 167, North Facade, 1/97

This is a two-story, poured-concrete, rectangular barn with east and west rectangular wings. Concrete foundations are found in the core building and the wings. The core building has seven bays on the north elevation (main facade) and three bays on the west (side) elevation. There are six-over-six, metal sash windows, and a metal roll door has replaced the original sliding door. The loft area on the second level has a loading door. The gambrel roof has a frontal cross gable and a vent located in the gable area. The roofing material, which was installed in 1997, is red tile with a diamond pattern, which imitates the red asbestos tile roofing found throughout BARC. There is a galvanized gutter and exposed wooden rafters. Aerators are located on the ridgeline. The interior is still used as a barn. The wings contain six-over-six, wood-sash windows. The south elevation of the east wing contains the original wood door. Metal hood awnings are located over some windows on the west wing. Aerators are also present on the ridgelines. No gutters are present on the west wing, but there are galvanized gutters on the east wing. While the core barn is in good condition, the exterior walls and the roofs of the wings are deteriorated. The building is located adjacent to poured-concrete silos with hemispherical domes.

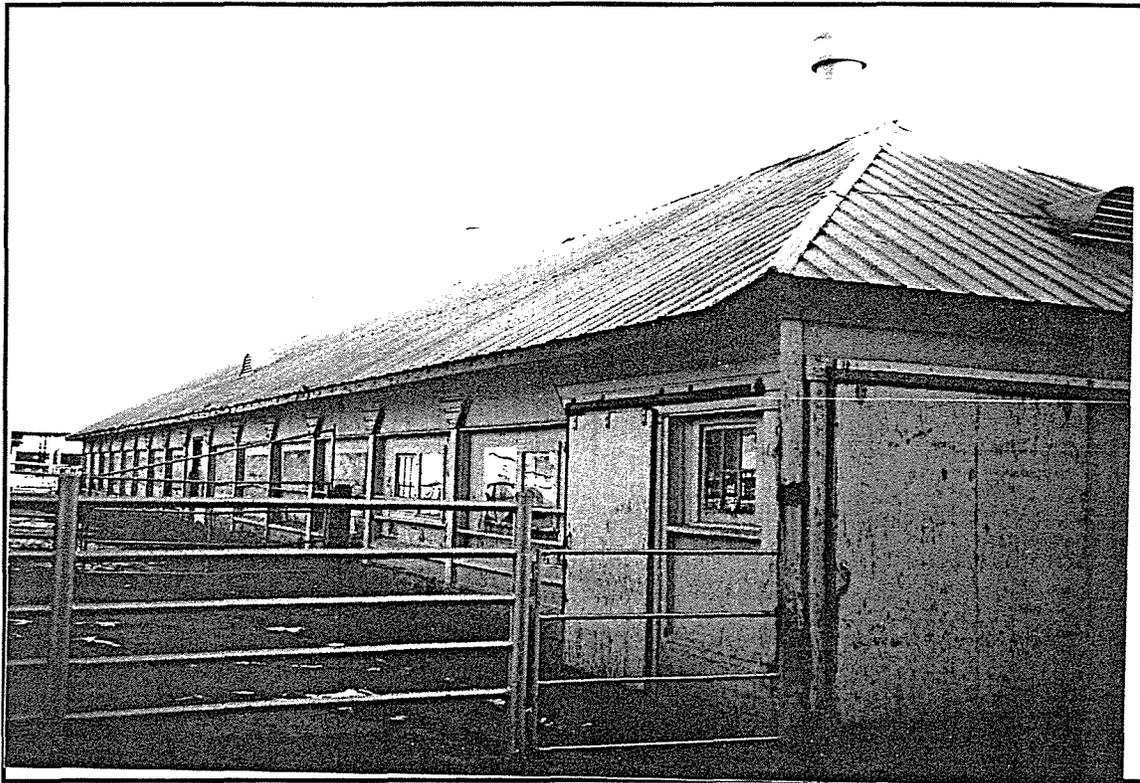
Photo ID: Building 170, North Facade, 1/97

Building No.: 170	Master Plan Page: P-5	Grid: D-, E-4
Building Name/Historic Name: Test Barn/Milk House		
Farm Area/Street Address: Central Farm/Bureau of Dairy Industry		
Date of Construction/Source: 1914;1921;1930-34;1937-38/Drawings		
Historic Use/Current Use: Open Cow Shed/Milk House

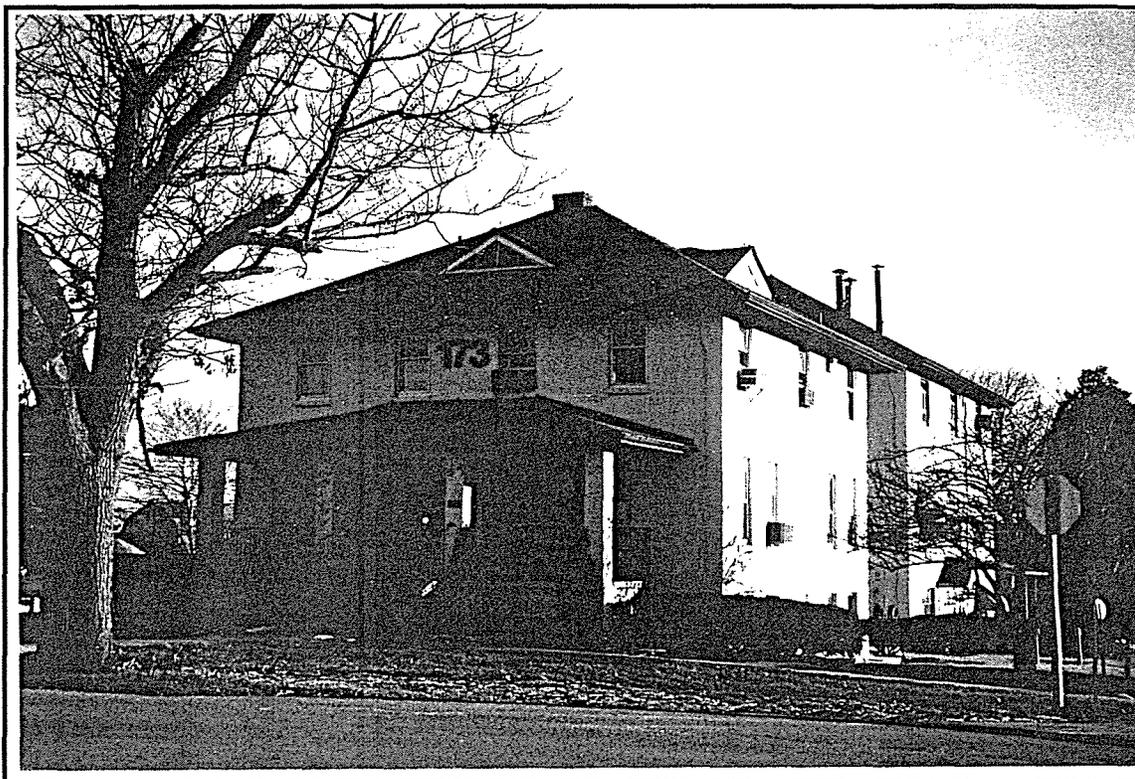
Photo ID: Building 173, North and West Facades, 1/97

This is a tripart, two-story, multipurpose, poured-concrete building with hipped roofs, concrete foundation, and a raised basement. The building contains an original block, hyphen, and a later rear (south) addition. The original core building is two stories with three bays on the first level and four bays on the second level of the north facade. A hipped roof porch covers the first level of the north elevation. There is a wood door and one-over-one aluminum replacement windows on the north elevation. The core building features a hipped roof with asphalt shingles and gable eyebrow dormers, each with four lights, on the north, east, and west elevations. The east elevation is three bays deep. The hyphen is one bay deep. The rear addition is three bays deep and contains multiple bays on the south elevation. Windows on the addition have 18 panes, each with central pivoting panes, and some windows have awnings. There is a fire escape located on the east elevation of rear addition. The south elevation of the addition contains a hipped roof with a shed-roof dormer. Multiple ventilators are located on the roof and replacement gutters are found on all three parts of the building. The building is currently occupied and is in good condition.

Building 173 is part of the initial 1910s wave of construction, and has served several purposes since its construction. Built as a dining facility for employees of the Bureau of Dairy Industry, the building uses materials that are found in other large buildings in the Dairy Area. In 1949, the building was adapted for use as a breeding and genetics laboratory, with the goal of breeding research being how to breed high milk producers. Later, milk secretion and mastitis became the focus of the research conducted in Building 173. The ultimate goal of the research of the Bureau of Dairy Industry was to increase milk production of the experimental herd. Findings were then passed on to farmers in the United States. Work conducted in this building during its years as a laboratory have greatly contributed to the body of knowledge which allows farmers to increase production and profits.

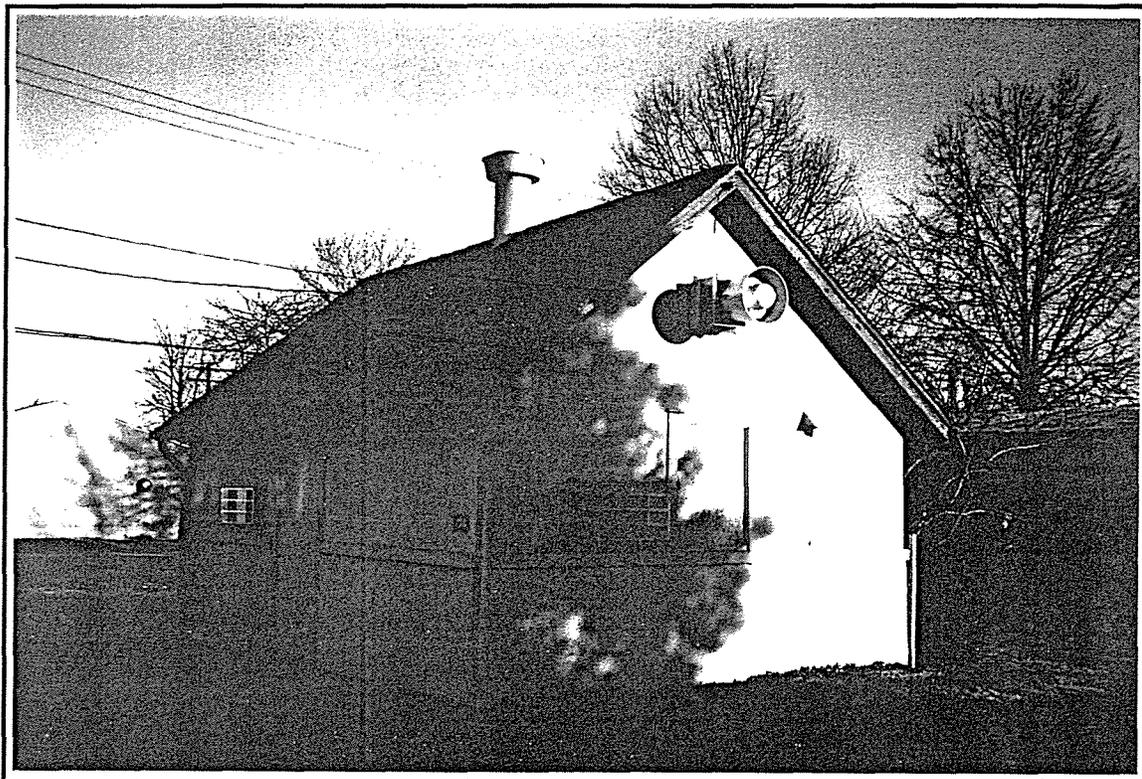
Photo ID: Building 174, North and East Facades, 1/97

This is a small, rectangular, side-gable building. It is poured concrete construction with a stucco finish. A concrete foundation is present. Window openings on the north, east, and west elevations are boarded up. Twelve-pane windows are located on the south (main) elevation, as is a paneled door with six panes of glass. The roof is covered with red asbestos tile material with exposed rafters. There are galvanized gutters. The building is in fair condition.

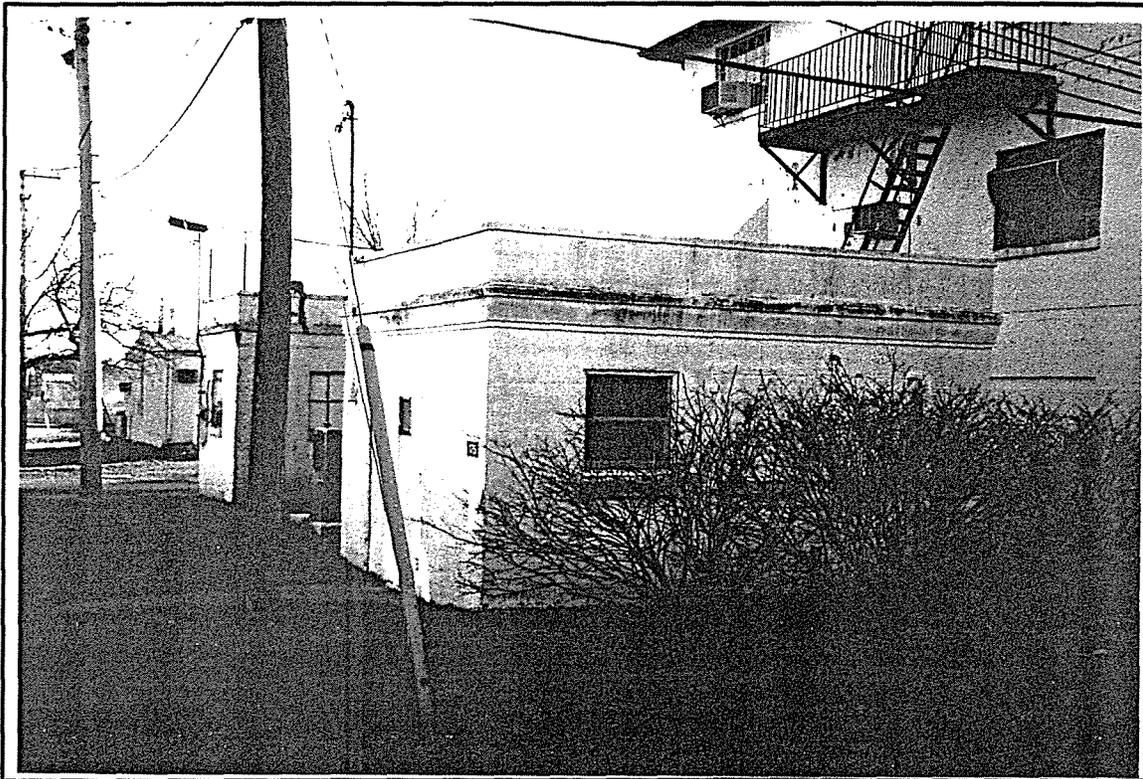
Photo ID: Building 175, North and East facades, 1/97

This is a small, rectangular, poured-concrete building with a concrete foundation. There are three bays on the north facade, where a metal replacement door is located. The south elevation has remnants of a pedimented entryway and small single-pane windows located high on the exterior walls. The building features a parapet-like flat roof and there is no gutter system. The building is currently unoccupied and is in fair condition.

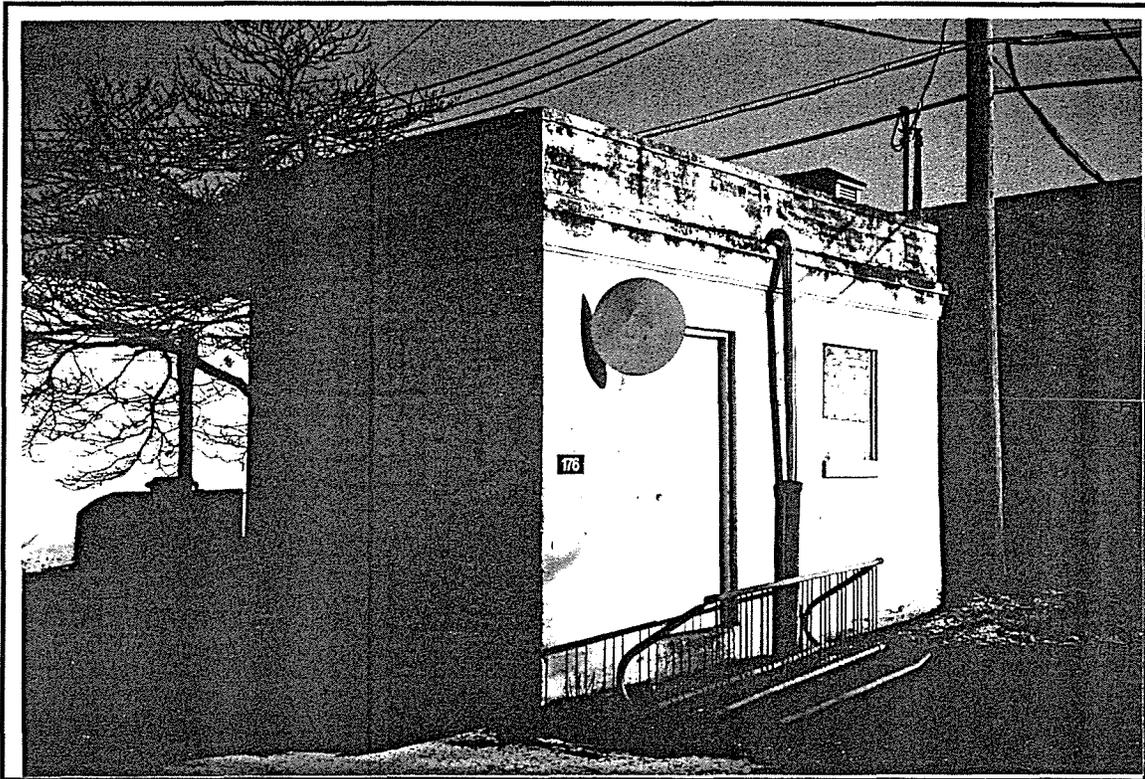
Photo ID: Building 176, South and West Facades, 12/97

This building is a small, rectangular, one-story, poured-concrete storage building with a concrete foundation. The north elevation features an off-center metal screen door over a boarded-up doorway, and a window which has been obscured by an air-conditioning unit. The east elevation features a central, three-over-three, metal window. The south facade has no openings, and the west facade is identical to the east facade. There is a flat roof and no visible gutter system, although downspouts from the roof are present. No significant alterations are apparent. The building is currently vacant and is in good condition.

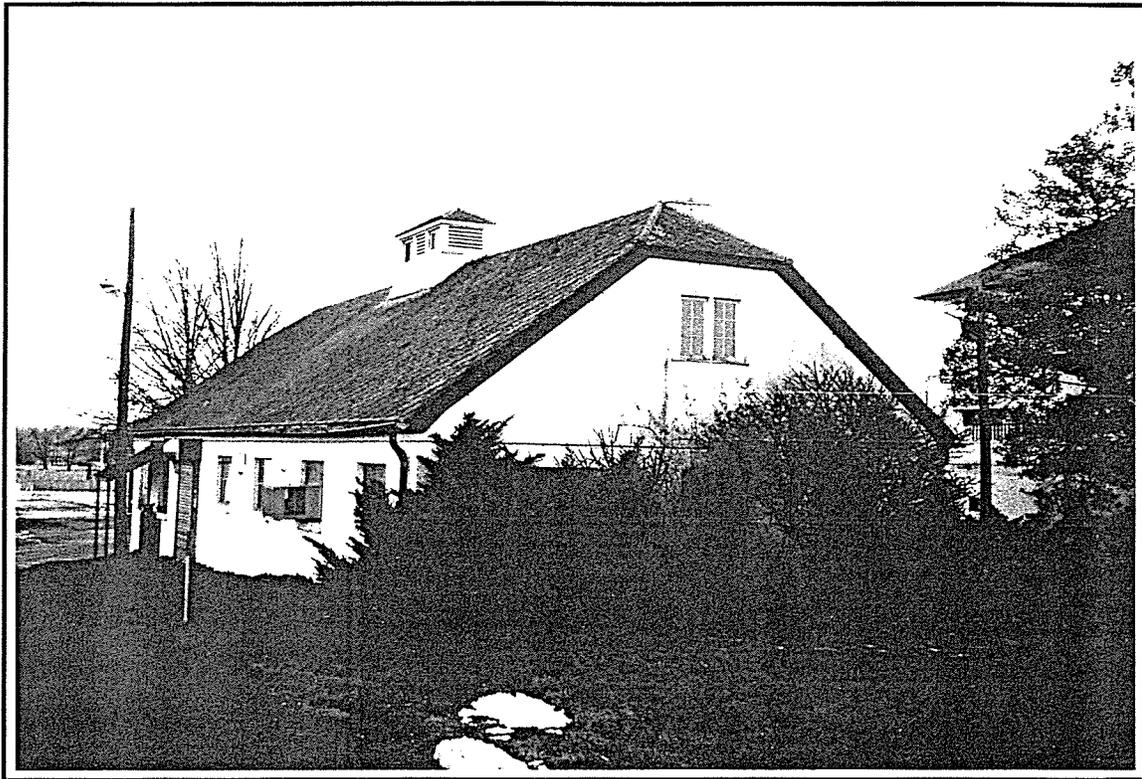
Photo ID: Building 177, North and East Facades, 1/97

This is a rectangular building constructed of poured concrete with a stucco covering. There is a concrete foundation. Casement windows with upper central portion that pivots open are located on the north and east elevations. A replacement door is centrally located on the south elevation, which is the main entry facade. The south elevation also has a second-story door that indicates use as a loading point for hay. The north elevation is obscured by shrubs, but a set of six-pane casement windows is present on the second story. There is a shed roof extension on the east elevation. The west elevation has a central door with two small fixed windows with large concrete sills. The gable roof is covered with diamond-pattern, red, asbestos tiles. There is an Edwardian-style cupola with vents on the ridgeline and clipped gables on the north elevation. Original copper gutters are present.

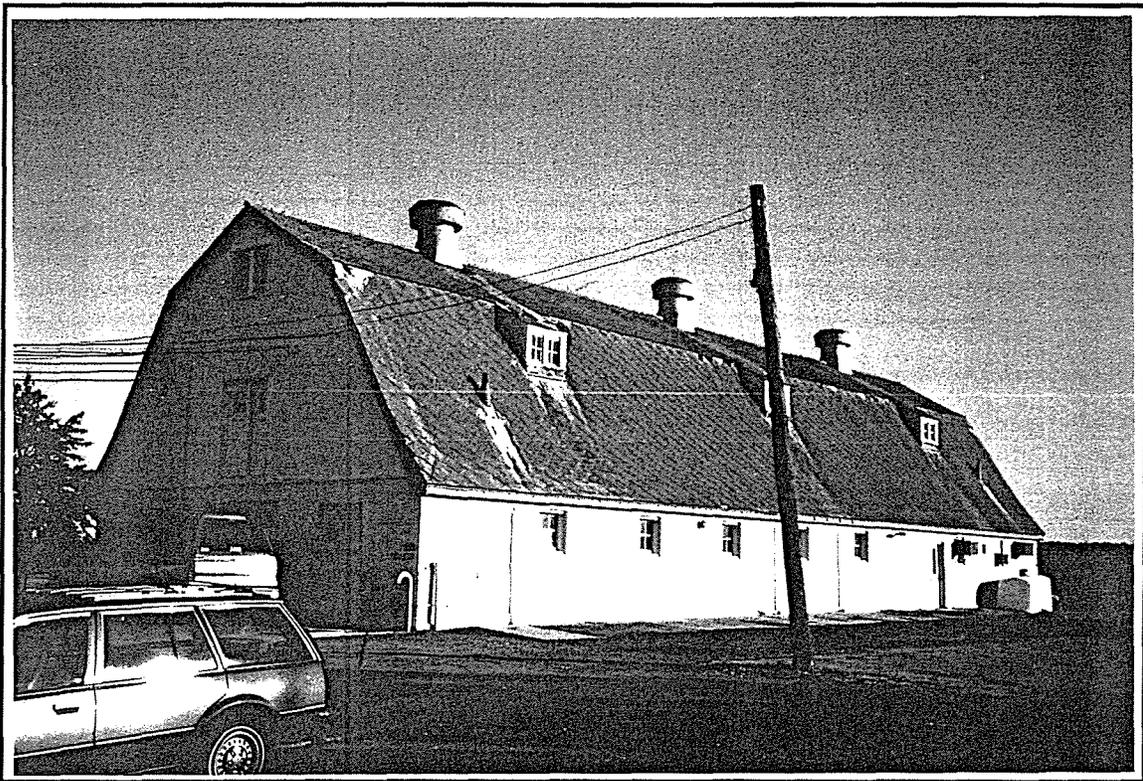
Photo ID: Building 179, North and West Facades, 1/97

This building was constructed to house bulls used for breeding purposes. Designed in late 1934 by the Dairy Engineers of the Bureau of Dairy Industry, it was constructed in early 1935 as part of FP 11 and was funded by New Deal monies. The building employs materials typically found in other New Deal-era buildings in the Dairy Area. Located in an adjacent yard was a steel bull exerciser, which was constructed c. 1936. Bulls were tethered to a large, circular apparatus, and were exercised for several hours each day, following each other in a large circle. Researchers believed that this exercise benefitted the health and temperament of the bulls.

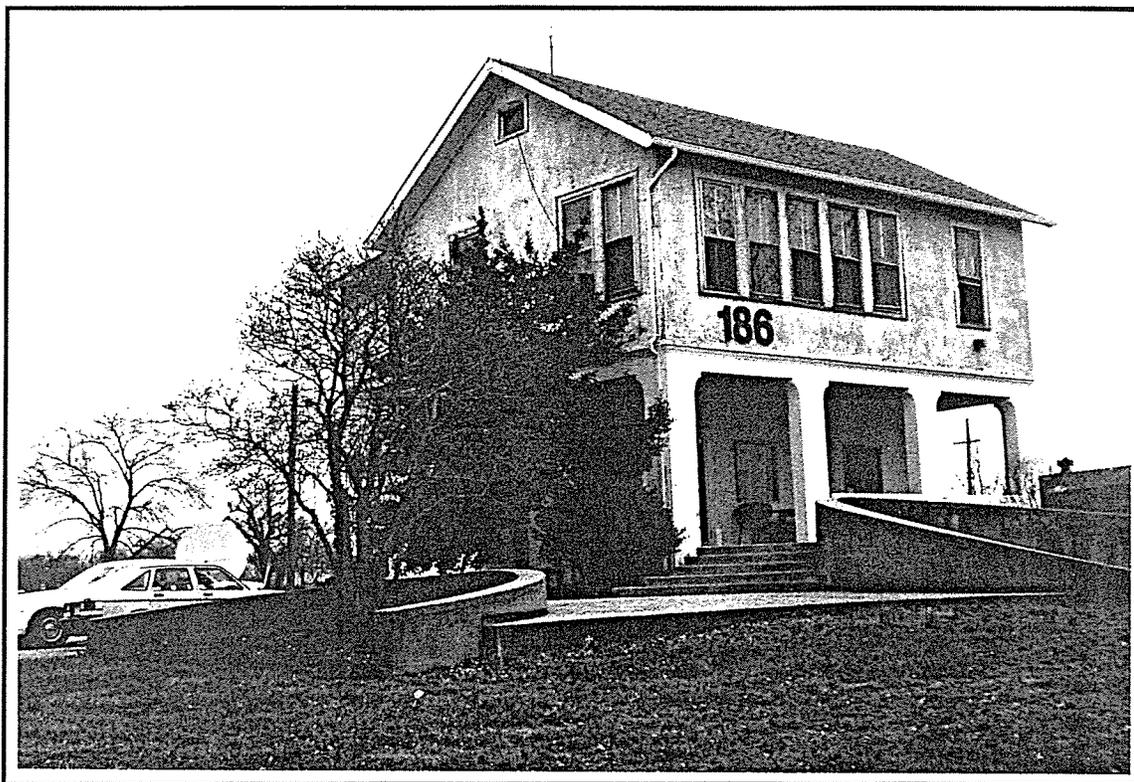
Photo ID: Building 186, South and West Facades, 2/97

This is a two-story wood, concrete, and stucco former residence which has been adapted for use as BARC security headquarters, although security vacated the building in February 1997. The building has undergone many alterations and additions since its construction in 1925. The original roof form was cross-gabled; however, alterations have obscured this form to a certain degree. The building has a brick foundation. The south elevation faces Powder Mill Road. The porch on this facade has been drastically altered, and an accessibility ramp has been added. The first story is recessed behind a porch. The porch has replacement posts. An off-center metal and glass replacement door and single-pane replacement windows are present. The east facade contains both original wood-sash replacement windows that are irregularly placed. A half-glazed wood door with a screen door is also located on this facade. There is also a small, shed-roof addition. The north facade features a gable addition. There are also original and replacement windows on this elevation. The west elevation contains wood sash, two-over,-two windows, and a vent is located in the gable area. The cross gable roof is covered with shingles, and two interior brick chimneys are present.
