**HISTORIC SITE SURVEY  
BELTSVILLE AGRICULTURAL RESEARCH CENTER**

**BELTSVILLE, MARYLAND**

**VOLUME IV  
BUILDING FORMS**

STRUCTURE FORMS (156-288)  
VOLUME 4

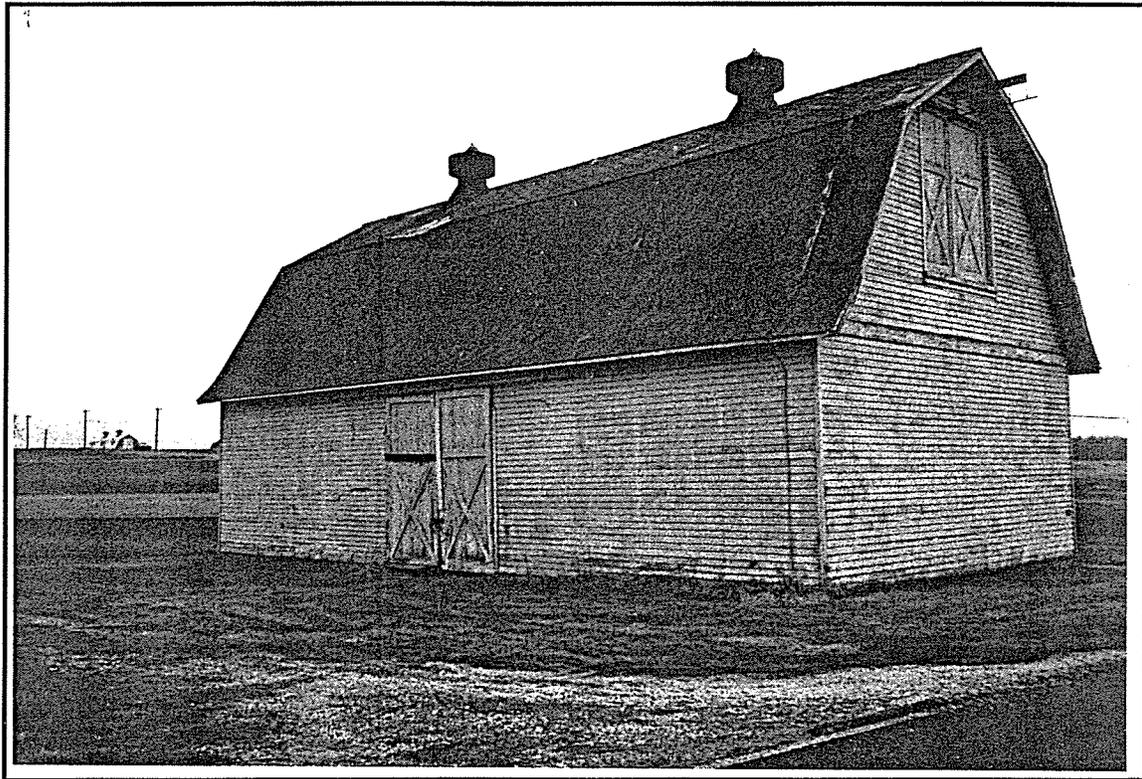
Photo ID: Building 188, West and South Facades, 2/97

This building was constructed in 1933 and served as a storage facility for hay used to feed the experimental dairy herd. Its size and design mirror other barns located in the dairy area, although it is of frame construction, instead of the more preferred concrete. The building was most likely located away from the central Dairy Area because of the associated risk of fire hazard. The double door design allowed wagons to be driven through the barn, and hay from the overhead loft could be easily dropped down into the wagons' beds. A hay barracks, dating from the same time period was located near the barn, and served as additional storage space for hay. The barracks burned in 1965.

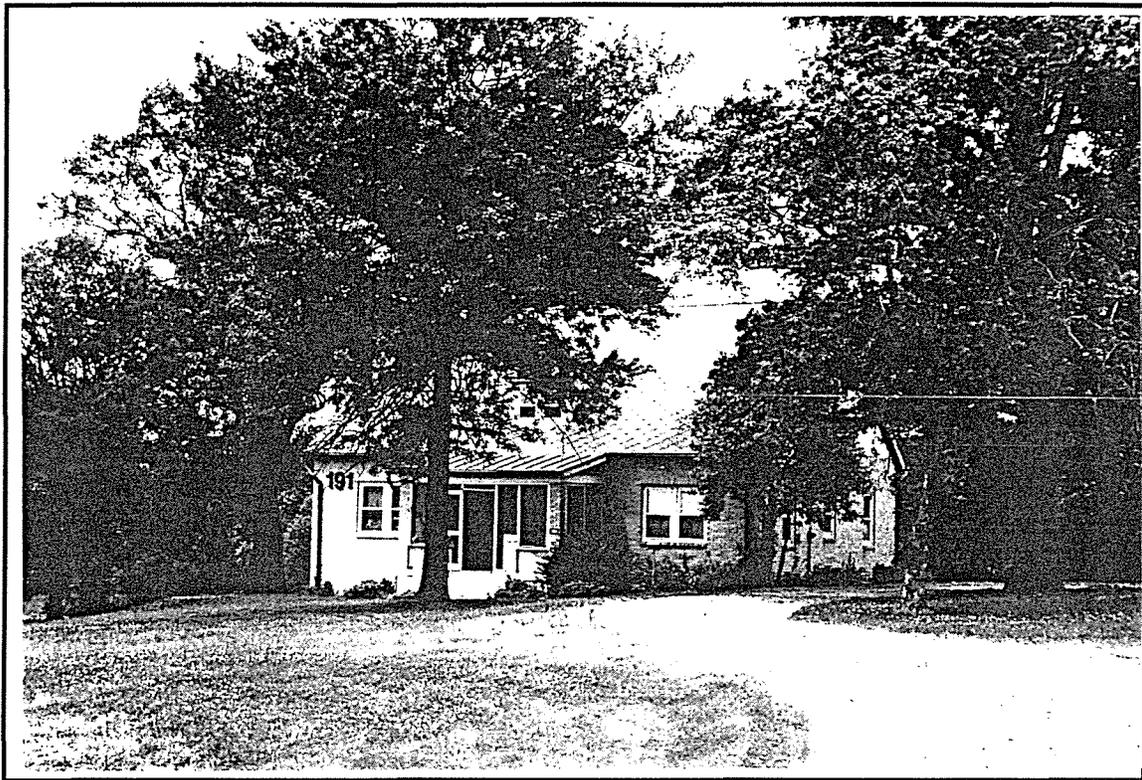
Photo ID: Building 191, West and South Facades, 2/97

The principal (or south) facade is three bays across, with a projecting, shed-roof porch enclosing the entrance door in the center bay. In an early BARC photograph dated circa 1939, the porch has not yet been screened in. The entrance door visible in the 1939 photograph, a wooden door with sidelights, is still extant today. In the photograph, the porch's shed roof was covered in the same composition shingles as the main roof; these shed-roof shingles have since been replaced. On either side of the porch are paired one-over-one windows. These windows, like all those of the building, have brick flat-arch, vertical-joint lintels and slipsills of brick headers.

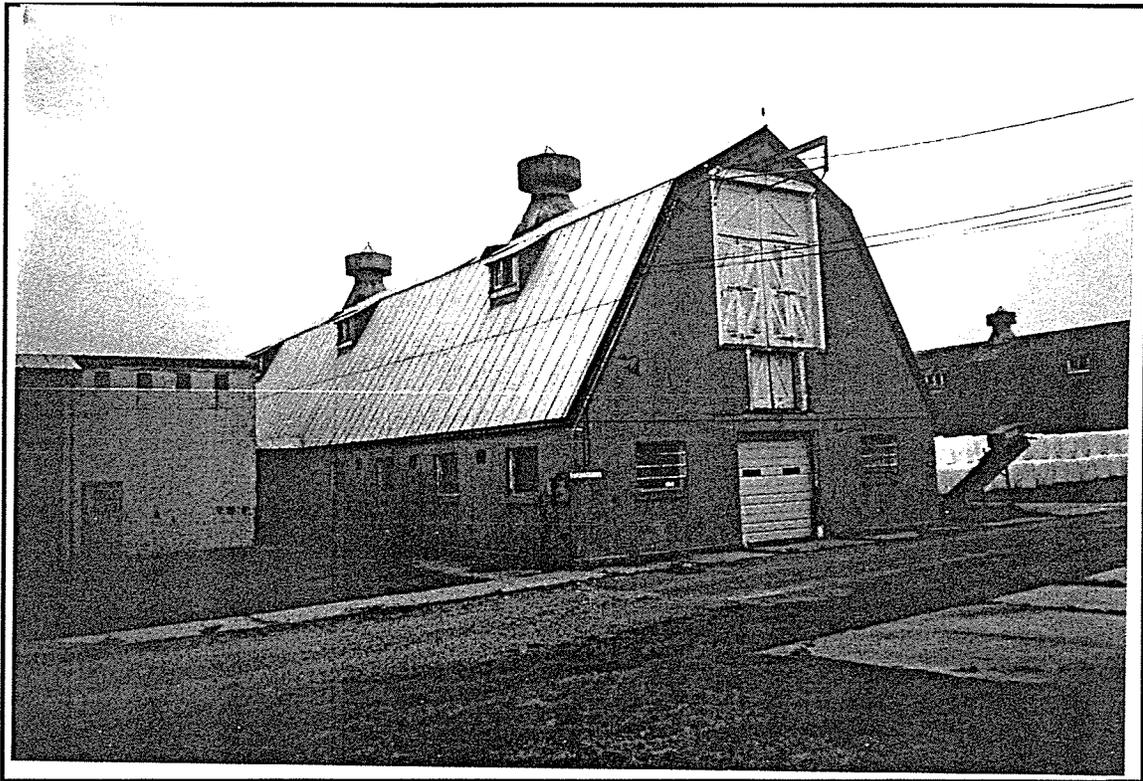
Photo ID: Building 192C, South and West Facades, 2/97

This is a two-story, poured concrete barn with stucco covering the second level. The building has a concrete foundation and a low gambrel roof. An overhung, metal, roll door is centrally located on the south facade; it is flanked by large, single-pane, metal windows. There is a double wood door in the loft area on the second level. The west facade features evenly spaced, single-pane windows. A concrete-block wagon shed is attached to Building 192C by a cross hyphen. The north facade is identical to the south facade. The east facade is punctuated by evenly-spaced, single-pane windows. A small concrete addition with brick chimney and four- and six-pane metal windows extends from the east facade. The gambrel roof is covered with metal panels. Shed-roof dormers are present on the east and west sides of the building, and two-over-two, wood-sash windows are located in the dormers. Large aerators are located on the ridgeline. No gutter system is present.

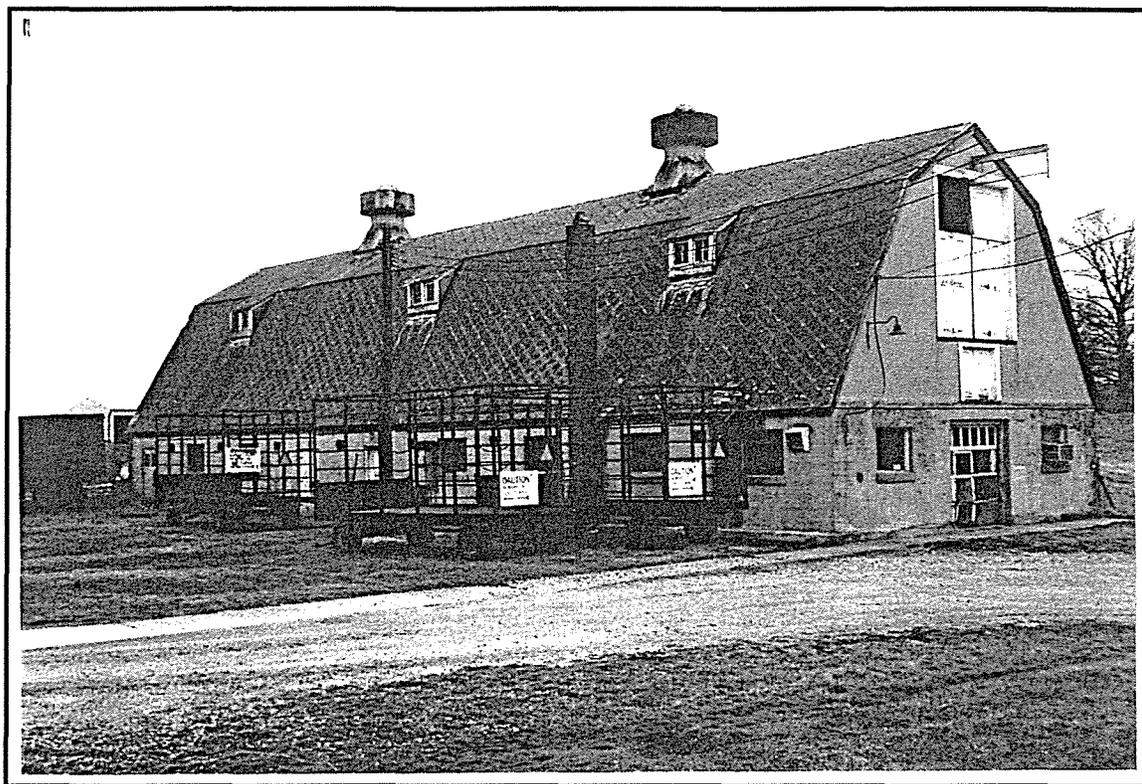
Photo ID: Building 192E, West and South Facades, 2/97

This is a two-story, poured-concrete, rectangular, gambrel-roof barn with a concrete foundation. Large, single-pane, metal windows flank the door. There is a double wood door in the loft area on the second level. The north facade is identical to the south facade. The east and west facades are identical; each is punctuated by a series of evenly-spaced, single-pane windows. The gambrel roof is covered with red, asbestos, diamond-pattern shingles. Shed roof dormers are present on the east and west sides of the building, and two-over-two, wood-sash windows are located in the dormers. Aerators are on the ridgeline. There is no evidence of a gutter system.

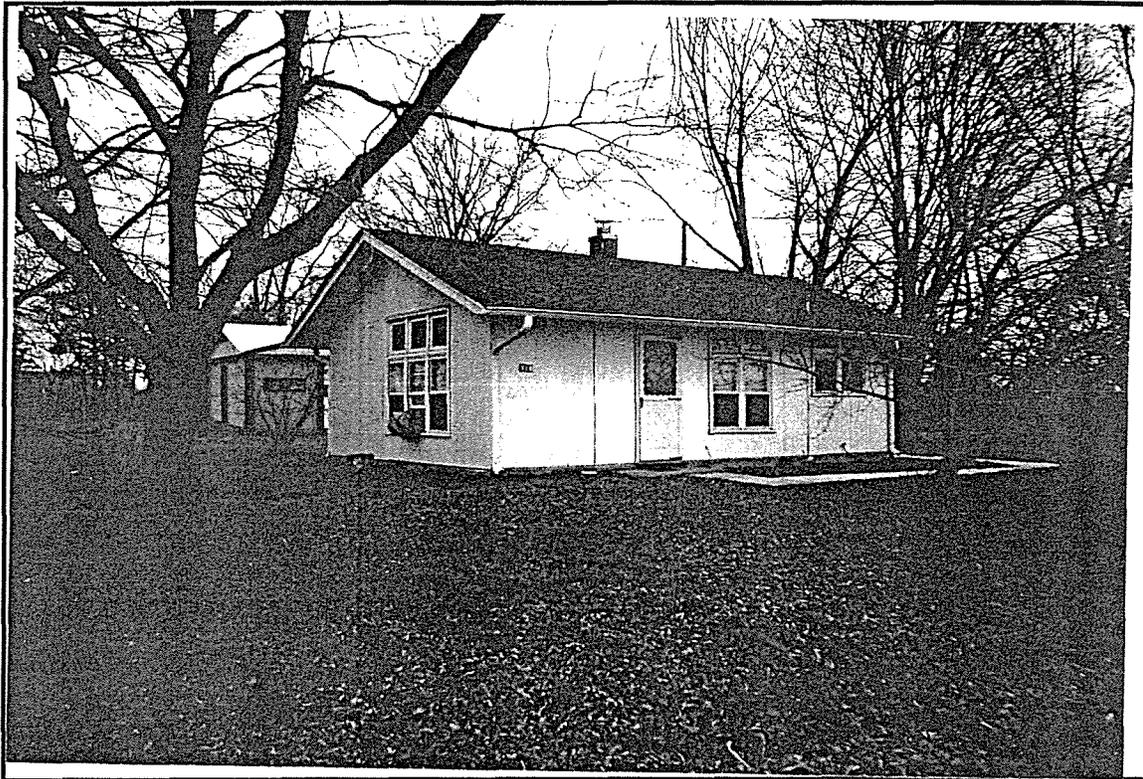
Photo ID: Building 193B, South and East Facades, 2/97

Completed in the summer of 1952, Building 193B was one of two buildings with identical plans built on the site. (The other, Building 193C, was demolished.) The building's foundations consist of a six-inch reinforced-concrete beam laid on concrete posts set two feet below grade. It has a concrete slab-on-grade floor underlaid with roll roofing. The exterior walls of the building are composed of four-feet-by-eight-feet-wide vertical asbestos cement panels. The roof is covered with asphalt shingles. Windows are frameless (the wood studs are used as jambs). They consist of both fixed glass and double-hung sash.

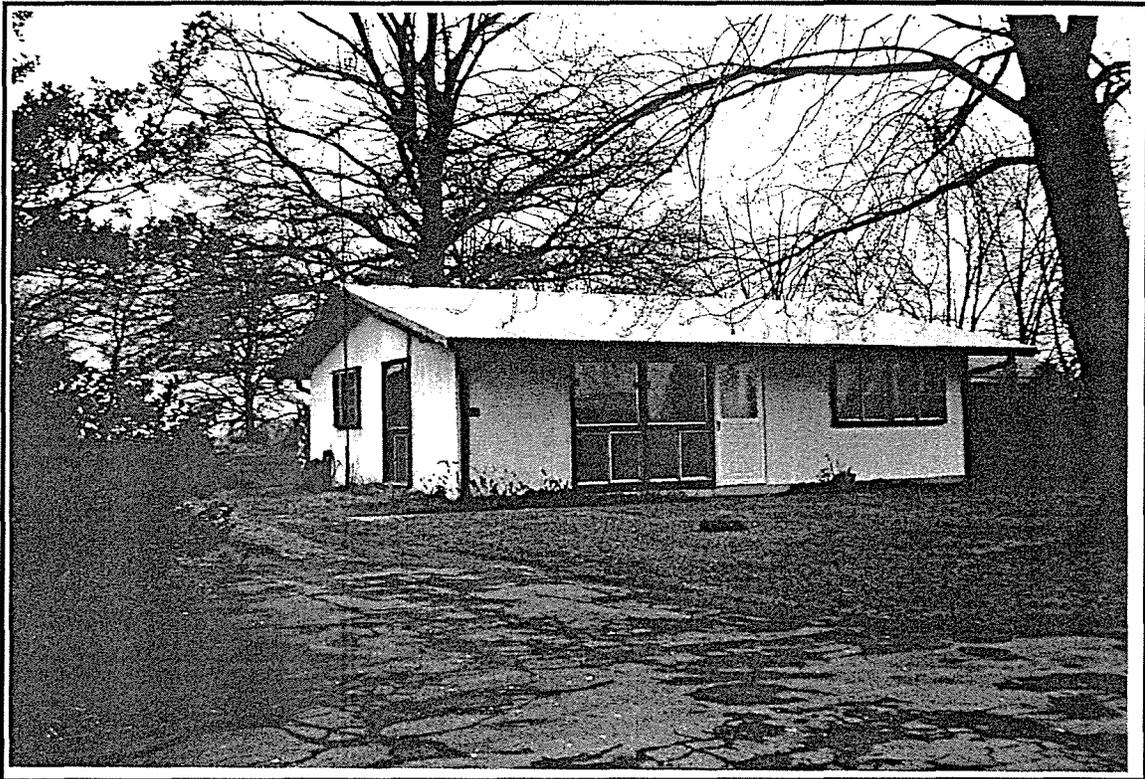
Photo ID: Building 193D, North and East Facades, 2/97

The most recent of the expansible farmhouses, Building 193D, was completed in the fall of 1954 and first occupied in November 1955. The foundations of the building are of six-inch-thick, reinforced concrete set ten inches below grade. The floor is a concrete slab laid over twelve beds of alternating gravel and earth (one-half of the slab was underlaid with a vapor barrier). The exterior walls of the building are of 1 1/4-inch corrugated aluminum. Some windows in the building are fixed sash and others are horizontal sliding aluminum sash.

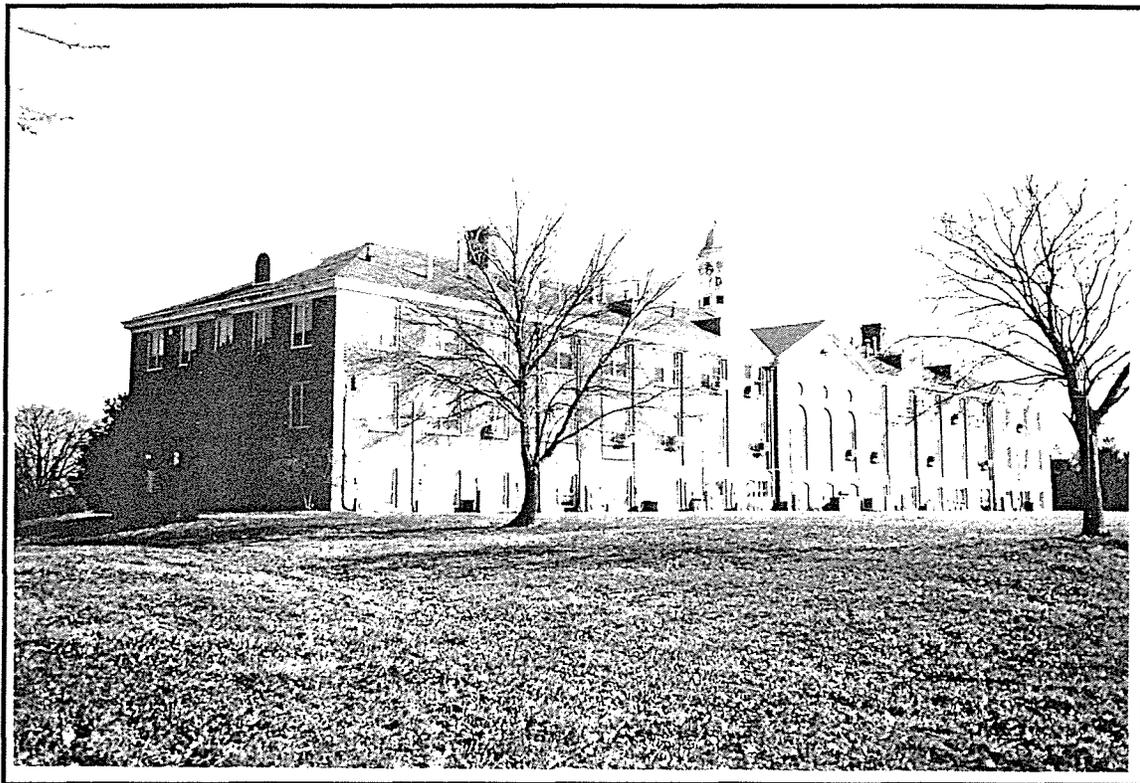
Photo ID: Building 200, West and South Facades, 1/97

The north facade is nineteen bays long. There is no central compositional element such as seen on the south facade. Each bay features a window, most are replacement windows, though on the lower levels some original windows are evident. The strongest features of this facade are the second, third, and fourth bays at either end: highlighted with light-brick detailing, these bays project slightly and feature large Palladian-style, metal-frame windows. At the basement level in these projecting wings are double metal doors with stone arched headers. At the roof level, like on the south facade, there are eight rounded copper dormers. There is mechanical equipment on the ground.

The east and west facades, which contain the principal entrances to the laboratory, are very similar. Five bays wide, each features a central flight of stone and slate stairs leading to the raised first-floor entrance (a replacement metal door which has a single-light transom). The entrance has a projecting brick pedimented surround and is flanked by two windows on either side, on both the basement and first floor levels. There is a single round-headed, copper-roofed dormer on the roof.

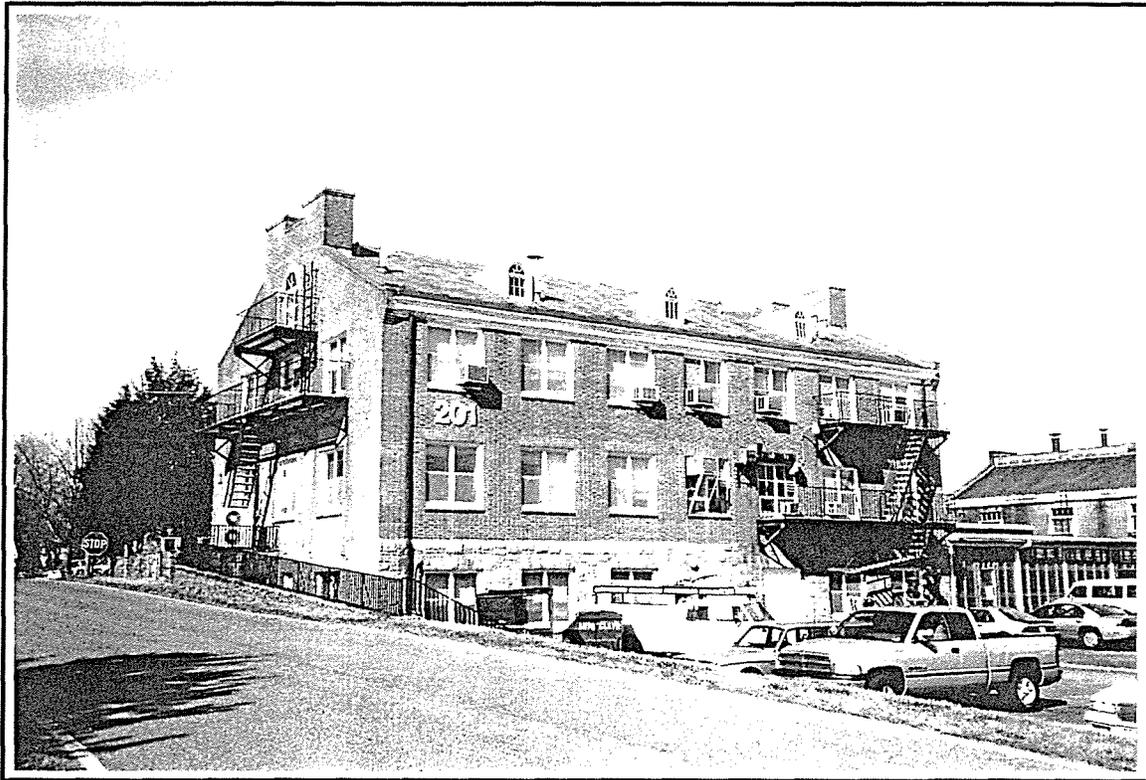
Photo ID: Building 201, South and East Facades, 2/26/97

Building 201 is a two-and-one-half-story, side-gabled building, which follows in its architectural style and form the precedent established by Building 200, the Main Laboratory. The building is brick, with a stone facing on the raised basement level. Oriented along a north-south axis, the building faces west onto a grassy quadrangle which is bounded by the principal buildings of the Animal Husbandry area. The building has replacement gutters and a boxed cornice on the east and west facades. Seven bays long, the building features on the main (west) facade a central entrance, double doors with eight lights each, set in a pedimented brick architectural surround with projecting piers. The windows are double, one-over-one aluminum frame, with those of the first story having brick jack headers. The east facade features seven windows across the first and second stories, three rounded, copper-roofed dormers, and an exterior fire escape at the northern end of the facade; the stone-faced exposed basement level features a central double door, with a stone segmental arch surround, flanked on either side by three windows. The three-bay, end-gable (north and south) facades are characterized by chimney-end projections at the roof line and fenestration patterns identical to the main facades on the two principal stories. The attic story of the south gable end features a large rounded-arch window; the north gable end features an oculus. There is an exterior fire escape on the south facade. There is a small, shed-like, wood-frame addition on the north facade.

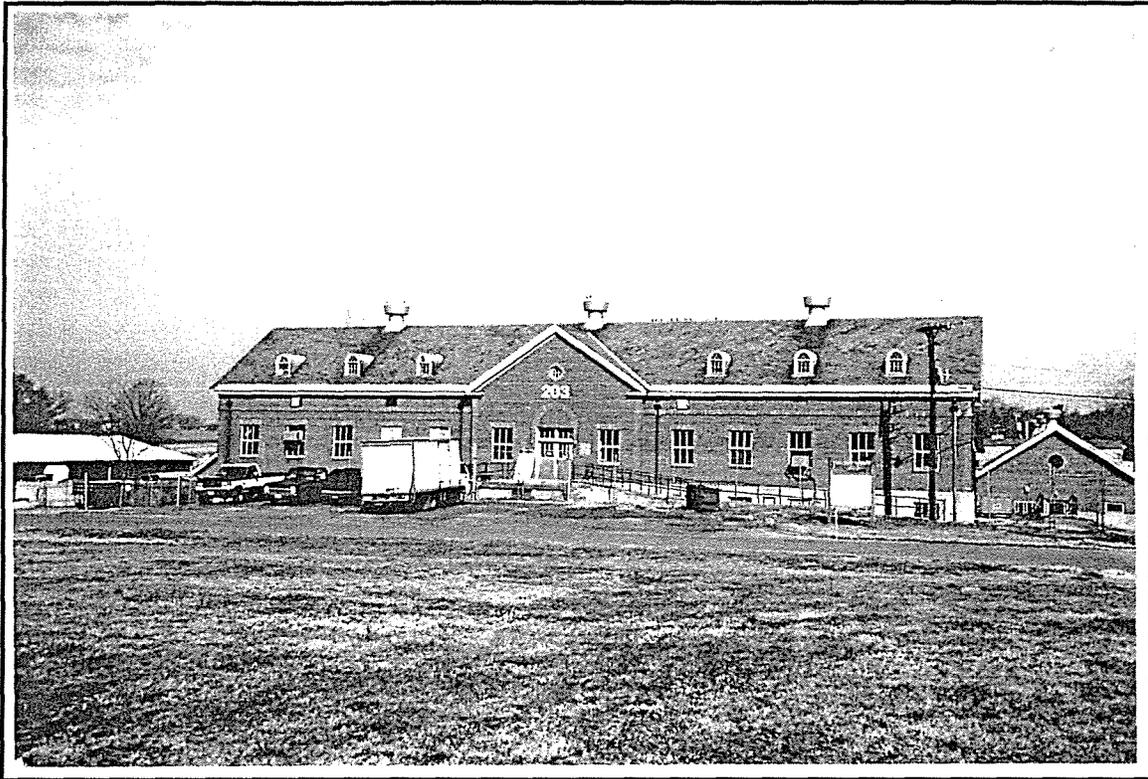
Photo ID: Building 203, South Facade, 2/26/97

Building No.: 203	Master Plan Page: P-5	Grid: G-3
Building Name/Historic Name: Large Animal Building		
Farm Area/Street Address: LPSI/Animal Husbandry Road		
Date of Construction/Source: 1938/Drawings		
Historic Use/Current Use: Animal Building/Quarantine Area

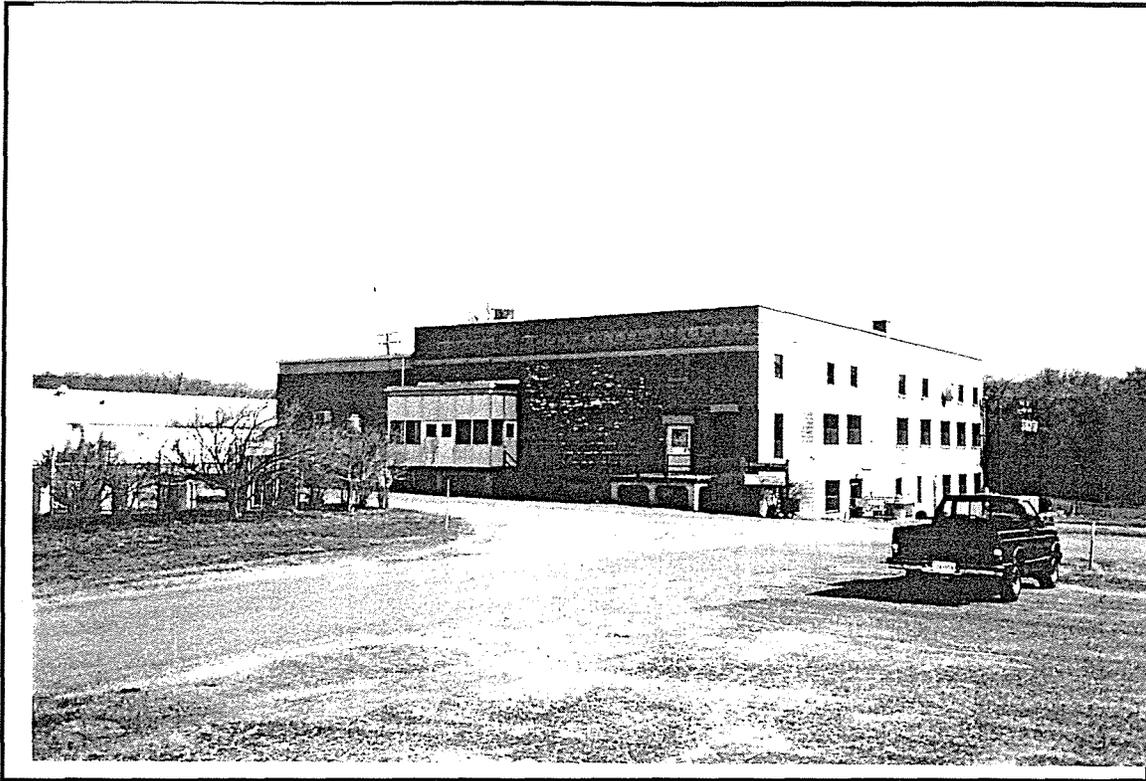
Photo ID: Building 204, West and South Facades, 2/26/97

Building No.: 204	Master Plan Page: P-5	Grid: G-2
Building Name/Historic Name: Abattoir		
Farm Area/Street Address: LPSI		
Date of Construction/Source: c. 1924/NARA		
Historic Use/Current Use: Abattoir

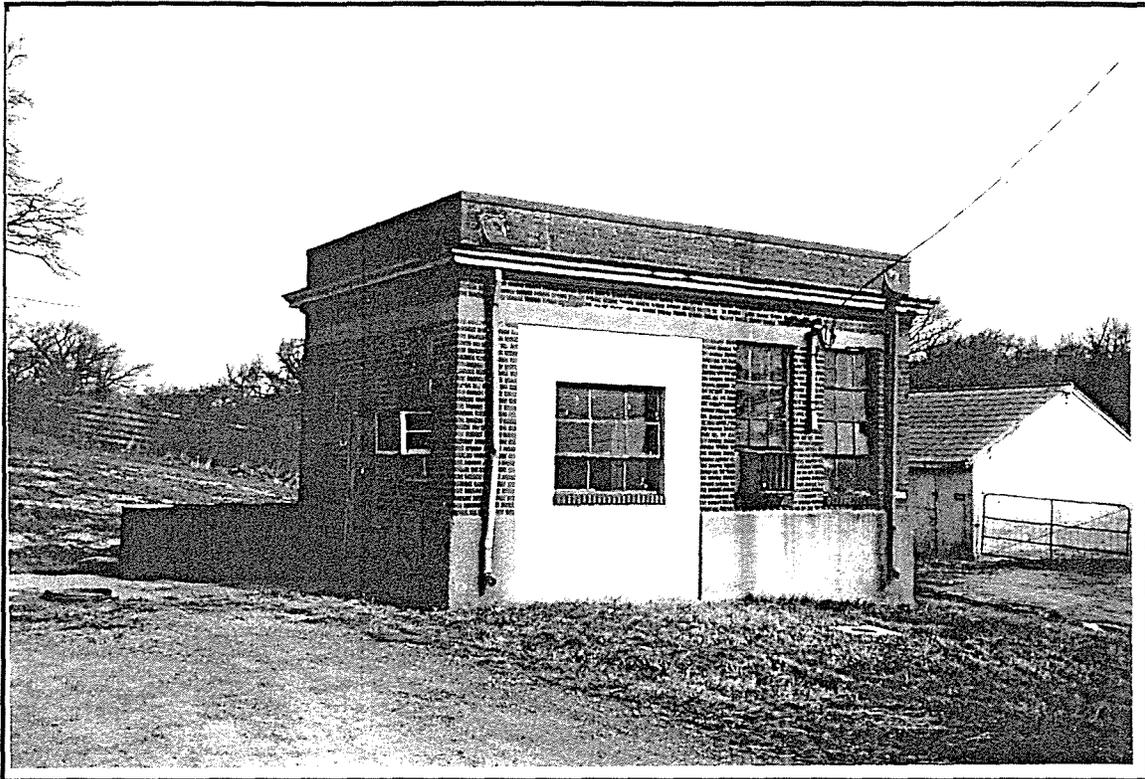
Photo ID: Building 204A, West and South Facades, 2/26/97

Building No.: 204A	Master Plan Page: P-5	Grid: G-2
Building Name/Historic Name: Post Mortem Building		
Farm Area/Street Address: LPSI/Animal Husbandry Road		
Date of Construction/Source: 1933/Drawings		
Historic Use/Current Use: Support Building

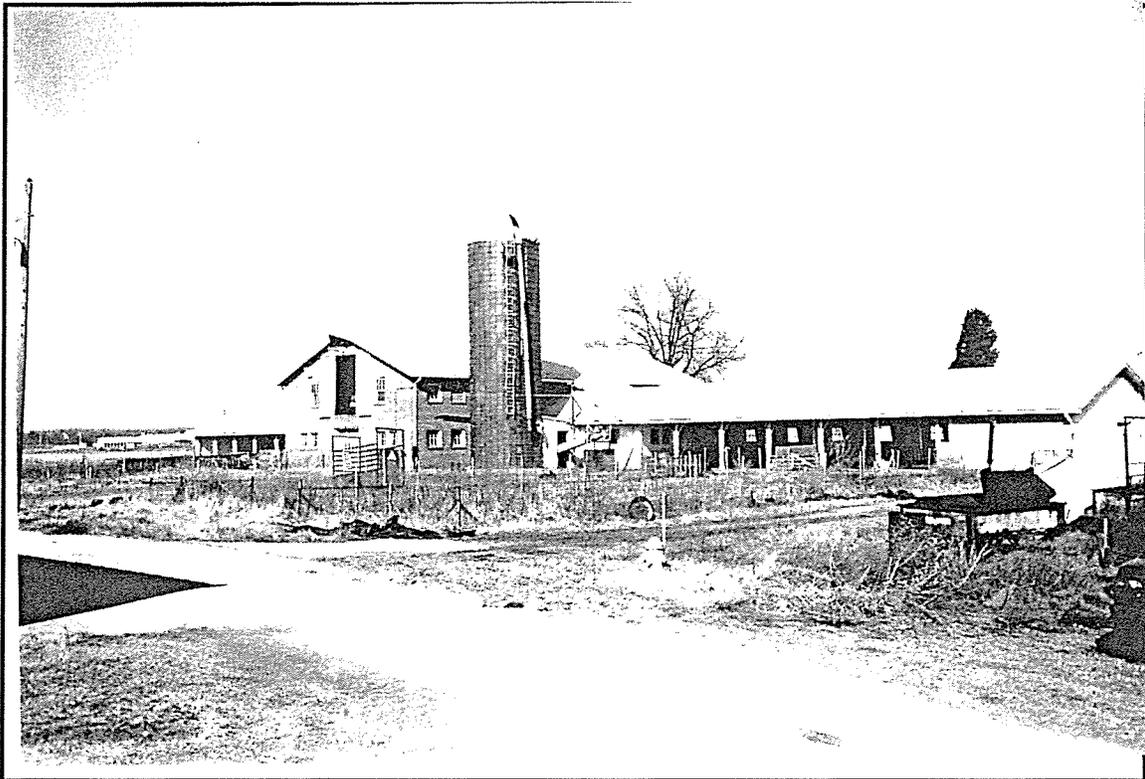
Photo ID: Building 215, South Facade, 2/20/97

Building No.: 215	Master Plan Page: P-5	Grid: F, G-6
Building Name/Historic Name: Sheep Barn		
Farm Area/Street Address: Sheep Area - Beaver Dam Road		
Date of Construction/Source: 1934/NARA		
Historic Use/Current Use: Sheep Barn/Vacant

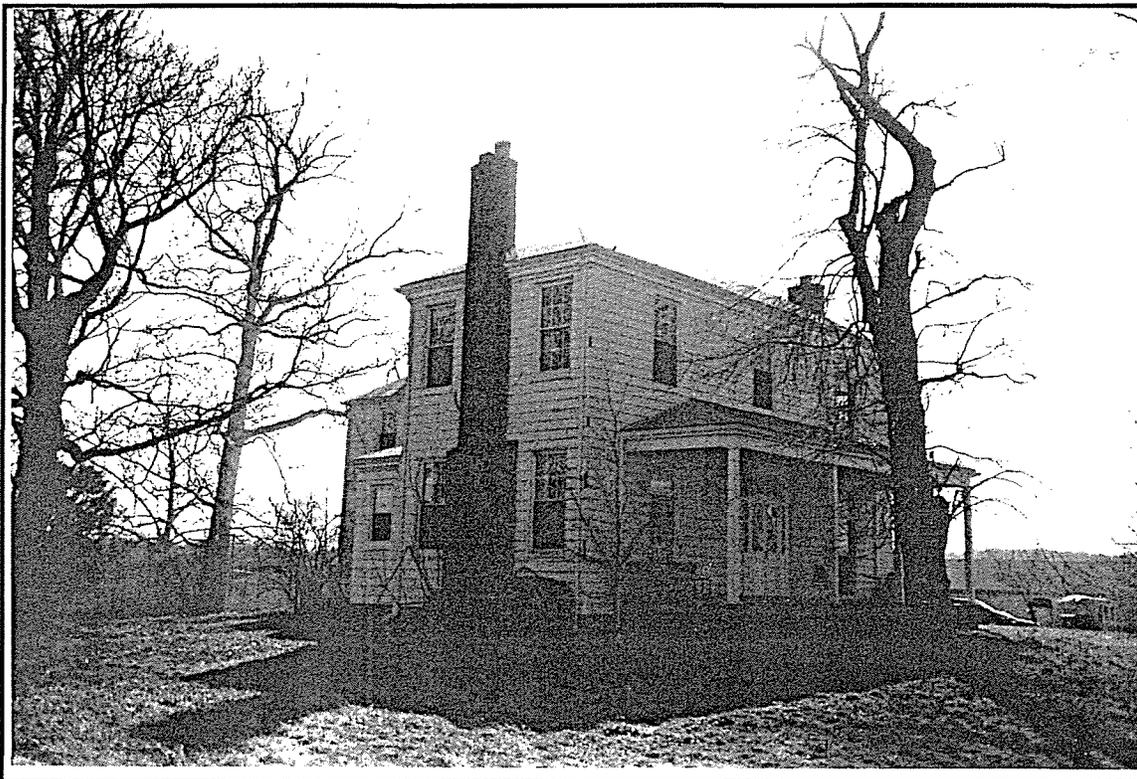
Photo ID: Building 216, North and West Facades, 2/20/97

Building No.: 216	Master Plan Page: P-5	Grid: G-6
Building Name/Historic Name: William Shea House		
Farm Area/Street Address: Sheep Area - Beaver Dam Road		
Date of Construction/Source: ca. 1857/Tax Records		
Historic Use/Current Use: Residence

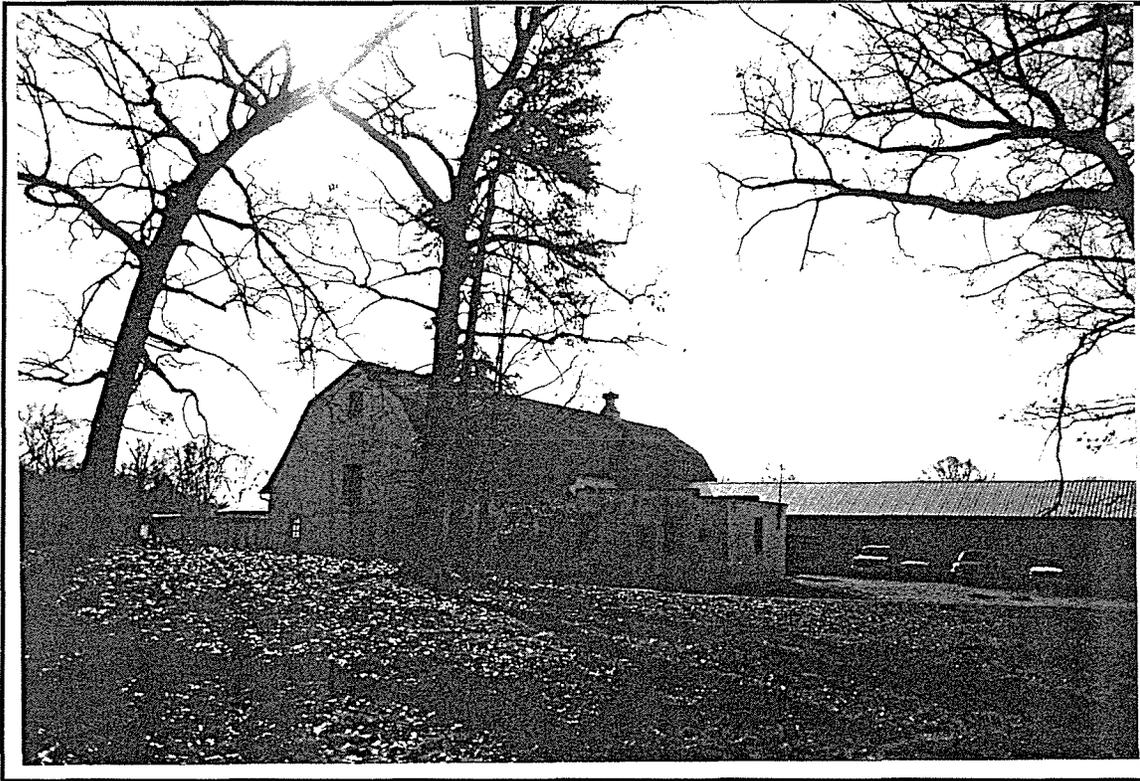
Photo ID: Building 224 (and Building 223), North Facade, 2/20/97

Building No.: 224	Master Plan Page: P-6	Grid: A-3
Building Name/Historic Name: Beef Cattle Barn		
Farm Area/Street Address: Powder Mill Road		
Date of Construction/Source: 1928, 1935/Drawings		
Historic Use/Current Use: Beef Cattle

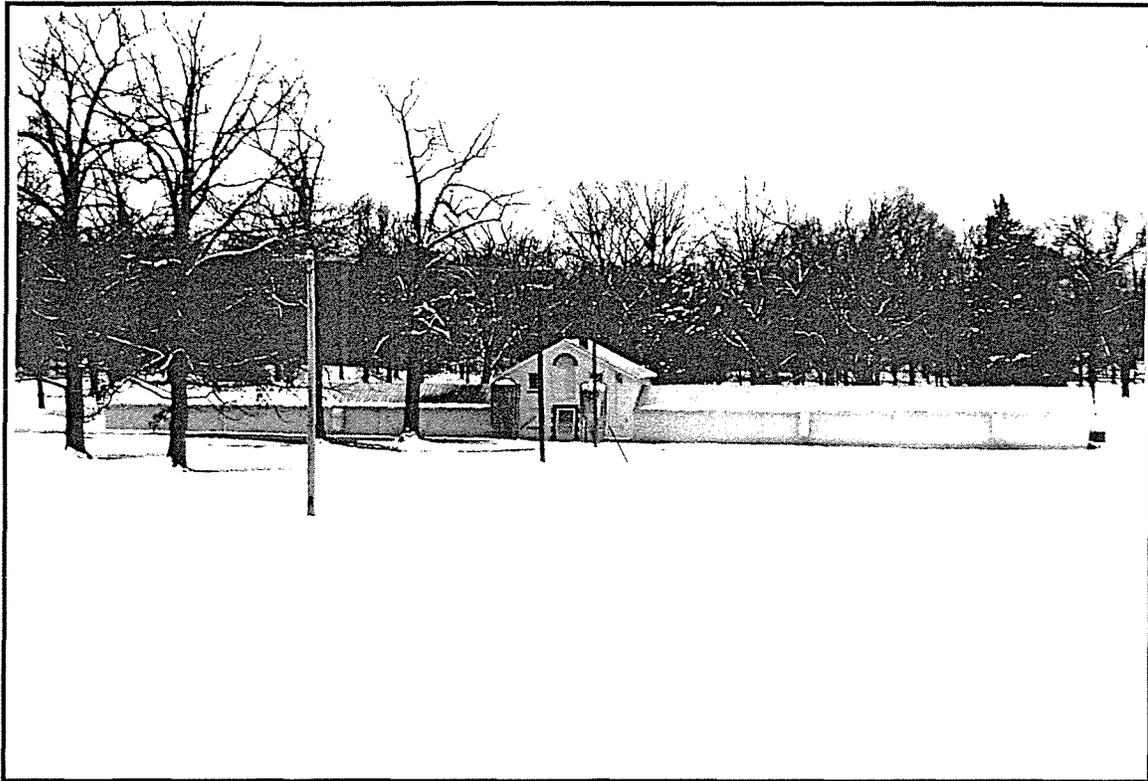
Photo ID: Building 236, North Facade, 2/97

Building No.: 236	Master Plan Page: P-1	Grid: G-7
Building Name/Historic Name: PROP Brooder House		
Farm Area/Street Address: Poultry Area		
Date of Construction/Source: 1934/Drawings		
Historic Use/Current Use: PROP Brooder House/ ½ vacant, ½ Laying House

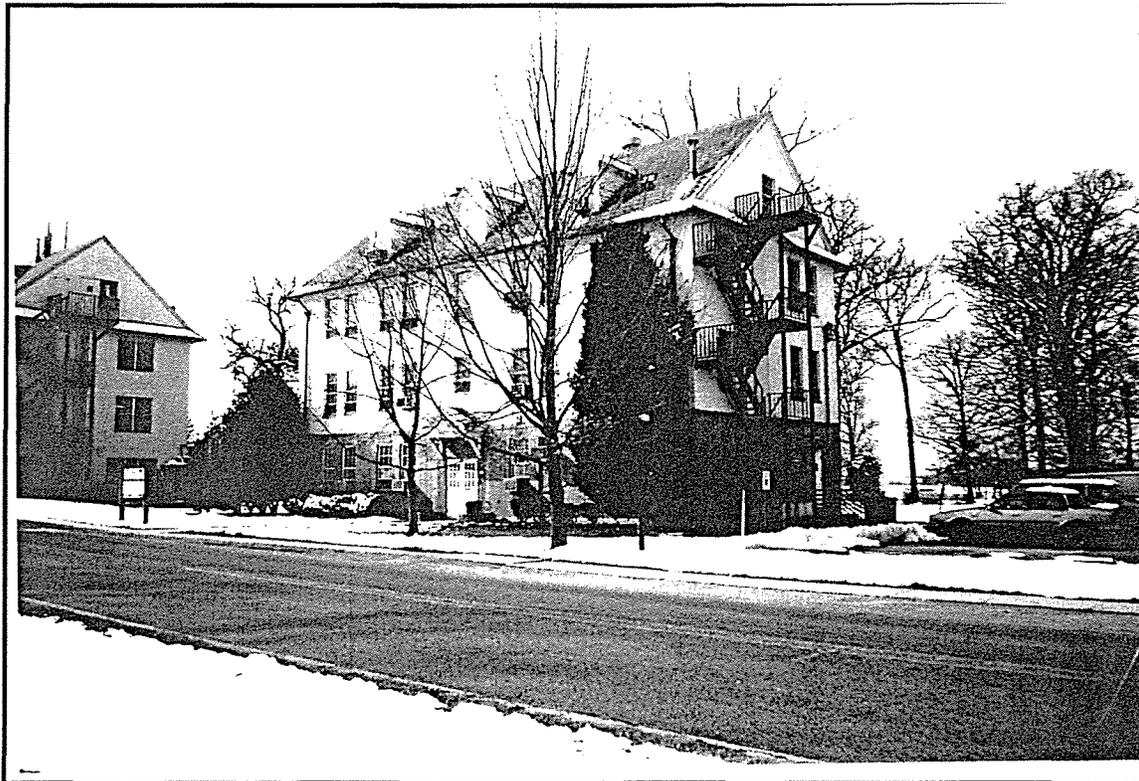
Photo ID: Building 263, North and East Facades, 2/11/97

Building No.: 263	Master Plan Page: P-1	Grid: G-6
Building Name/Historic Name: Fundamental Research Laboratory Building		
Farm Area/Street Address: Poultry Area - Poultry Road		
Date of Construction/Source: 1934/Drawings		
Historic Use/Current Use: Laboratories and Offices

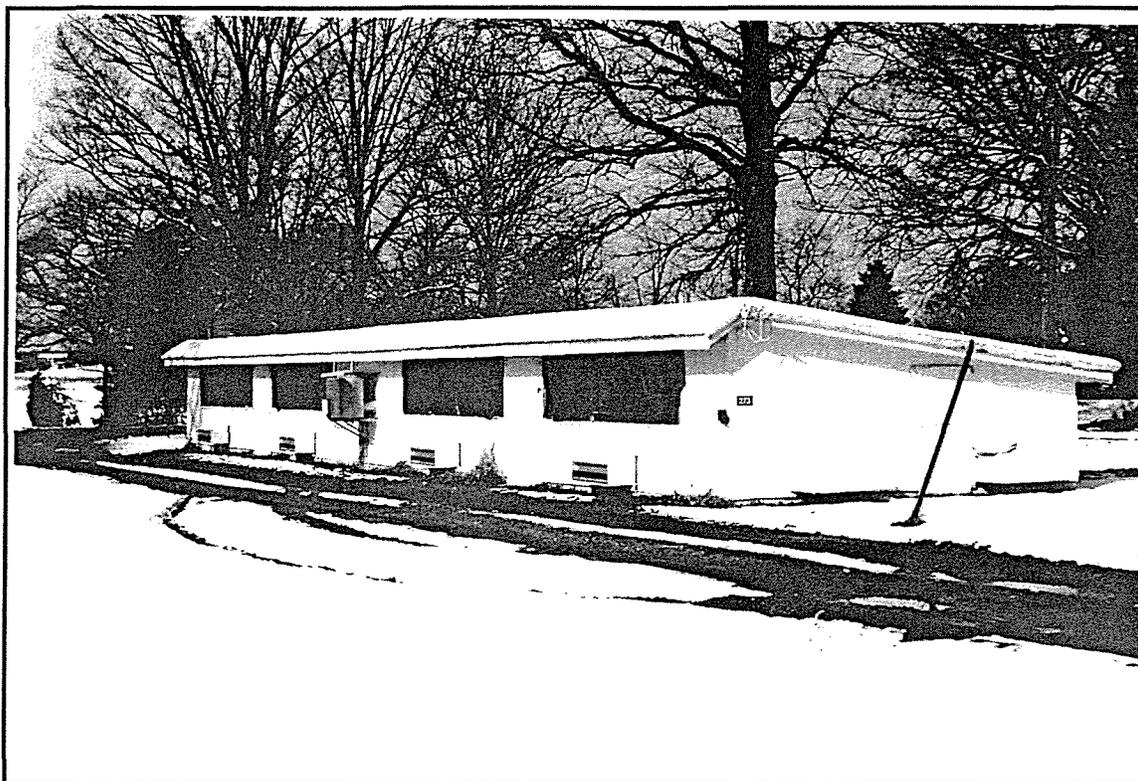
Photo ID: Building 273, South and West Facades, 2/97

Building No.: 273-275,277-278	Master Plan Page: P-1	Grid: G-6
Building Name/Historic Name: Poultry Laying Houses		
Farm Area/Street Address: Poultry Area		
Date of Construction/Source: c. 1935/NARA		
Historic Use/Current Use: Laying House/Turkey House

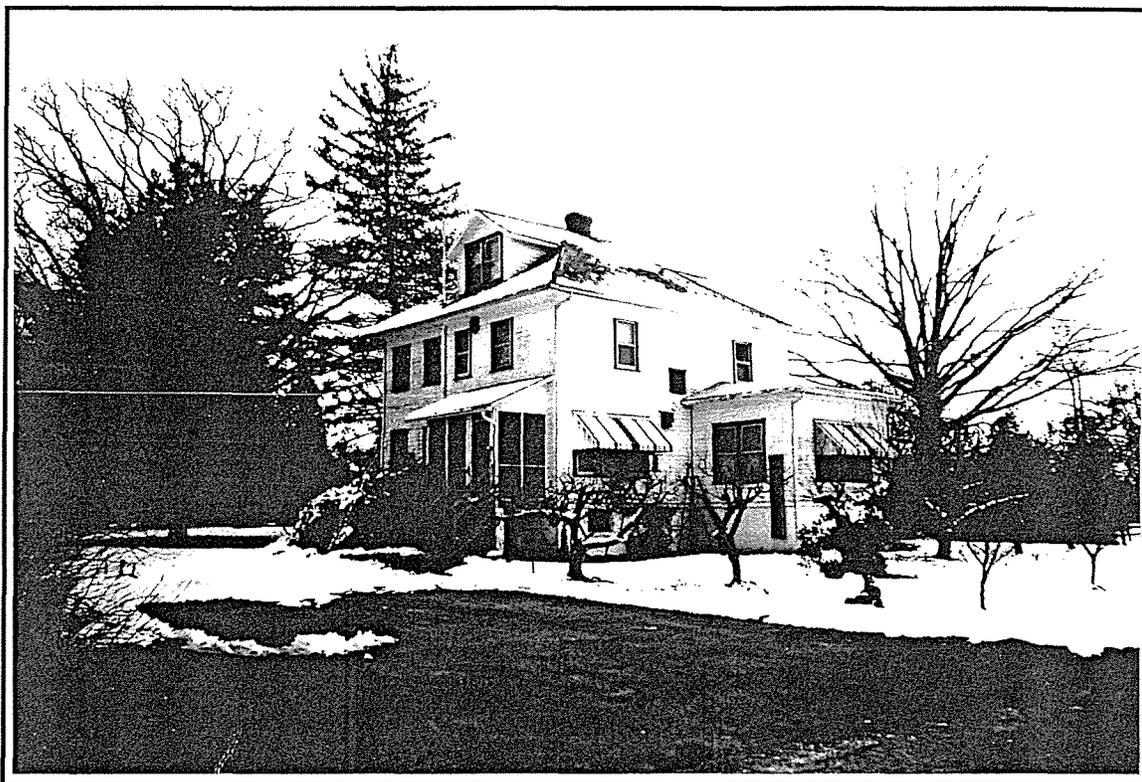
Photo ID: Building 281, North and West Facades, 2/97

Building No.: 281	Master Plan Page: P-1	Grid: G-7
Building Name/Historic Name: House for Poultry Man		
Farm Area/Street Address: Poultry Area		
Date of Construction/Source: 1914/Drawings		
Historic Use/Current Use: Residence
