**HISTORIC SITE SURVEY  
BELTSVILLE AGRICULTURAL RESEARCH CENTER**

**BELTSVILLE, MARYLAND**

**VOLUME VI  
BUILDING FORMS**

STRUCTURE FORMS (1002-1437)  
VOLUME 6

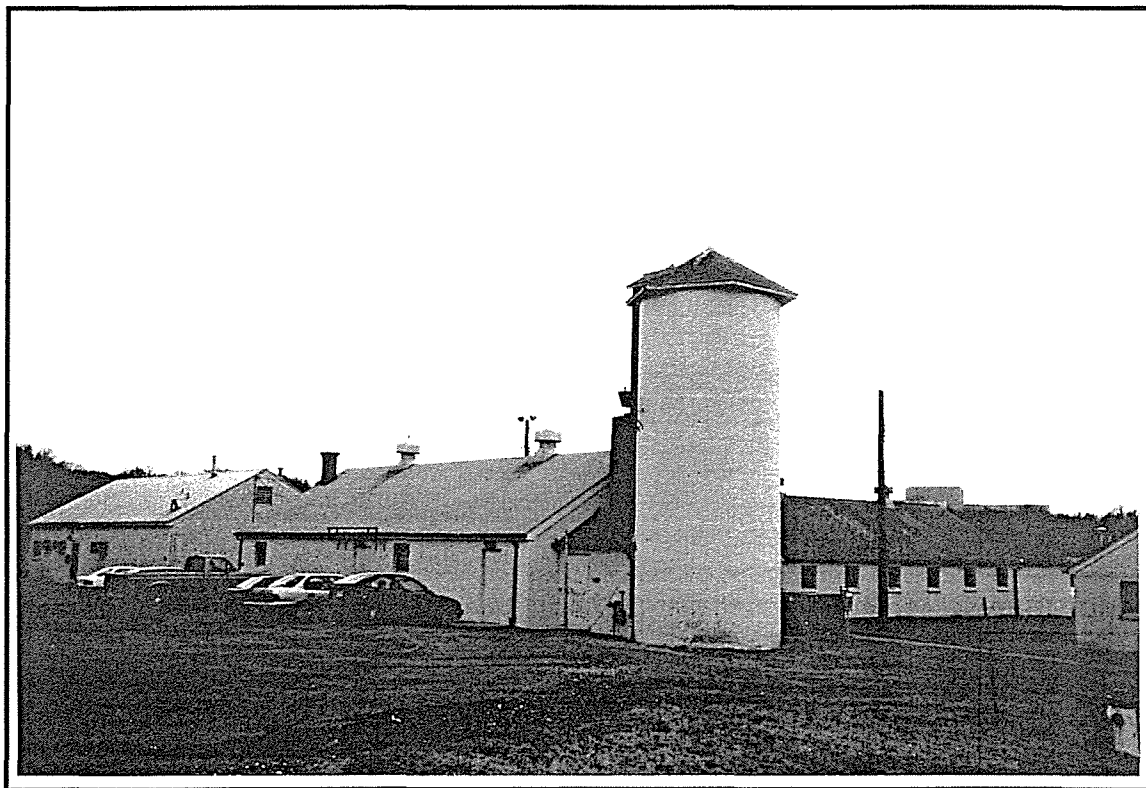
Photo ID: Building 1002, North and East Facades, 4/97

This is a rectangular, side-gable, concrete with stucco, one-story laboratory building with an attached grain silo. The building has a concrete foundation. The main section has four bays. There is a metal, replacement, off-center, main entry door on the east facade. Single-pane replacement windows are located on the east and west elevations. The south facade contains a small shed addition for vehicle storage. The side-gable roof is covered with asphalt roll roofing material. Vents are located in the gable area and there is a replacement gutter system. A small hyphen attaches the main section to the silo. The hyphen is one bay with asphalt roll roofing. The silo is poured concrete construction and has a six-sided roof cap with asbestos shingle covering. The silo's elevator mechanism is side gabled with asphalt covering and a shingle roof. All portions of this building are in good condition.

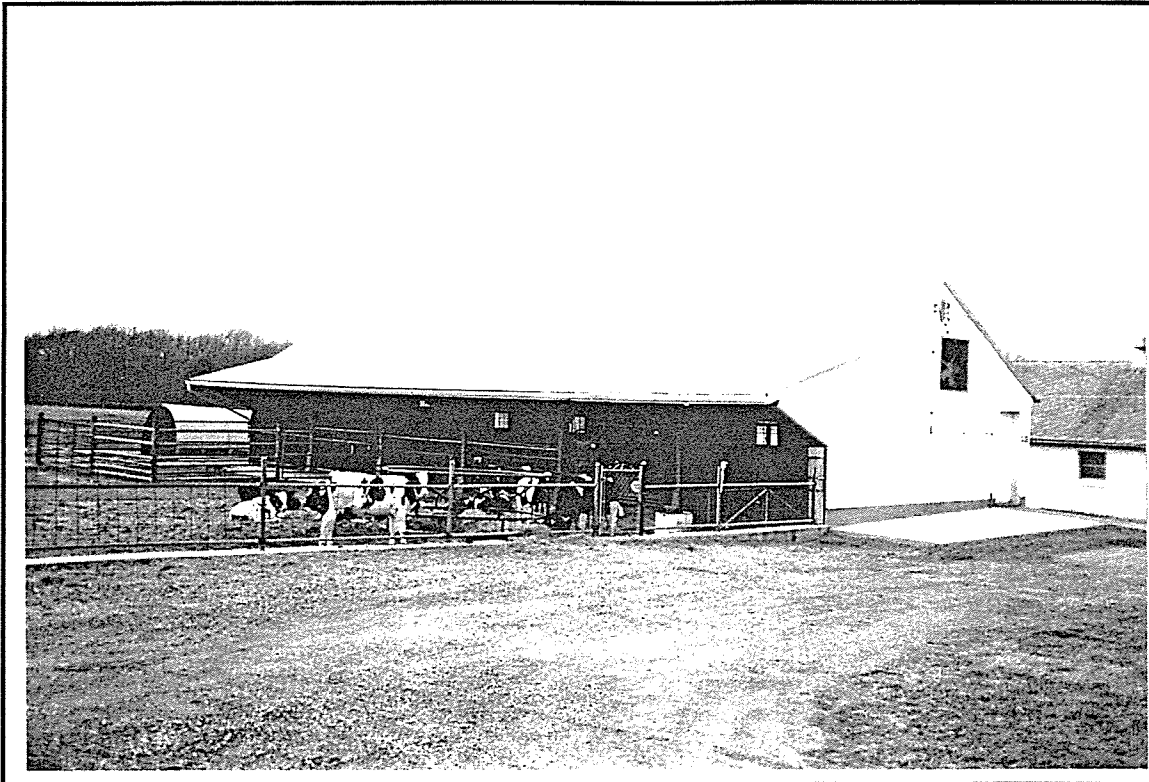
Photo ID: Building 1003, East and South Facades, 4/97

This is a one-story, rectangular, side-gable cattle shed with a shed-roof overhang on the open southeastern facade. The building has a poured-concrete foundation and wood-frame construction covered in vinyl siding. The southeastern facade is open and is enclosed by a fenced feed lot. The southwestern facade contains an off-center wood door which can be accessed by several poured concrete steps. The northwestern facade contains five casement windows, each with six panes of glass. The northeastern facade contains an off-center wood door and a large ventilating fan in the gable. The roof is covered with sheets of corrugated metal and replacement gutters are present.

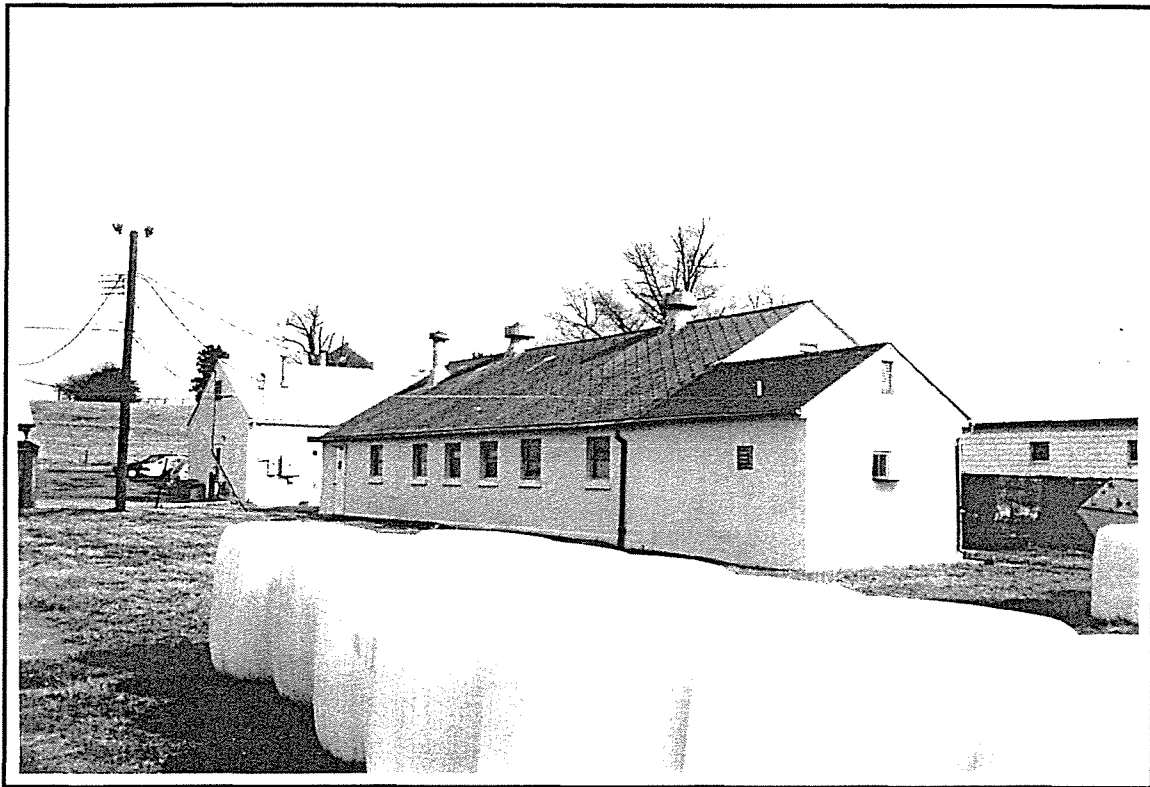
Photo ID: Building 1004, West and North Facades, 4/97

This is a rectangular, front-gable, one-story poured concrete barn with a small gable-end addition on the west elevation. The building has a concrete foundation and there are three bays on the (main) east elevation. The east facade features a metal replacement door and one-over-one metal replacement windows with concrete sills. There are six bays on the north and south elevations. The side gable roof is covered with asbestos shingles covering on the core building. Vents are located in the gable areas. There are aerators on the ridgeline. The gable addition roof is covered with newer red asbestos roofing material and there is also a vent in the gable area. The addition also features similar one-over-one metal replacement windows. Both portions of the building are in good condition.

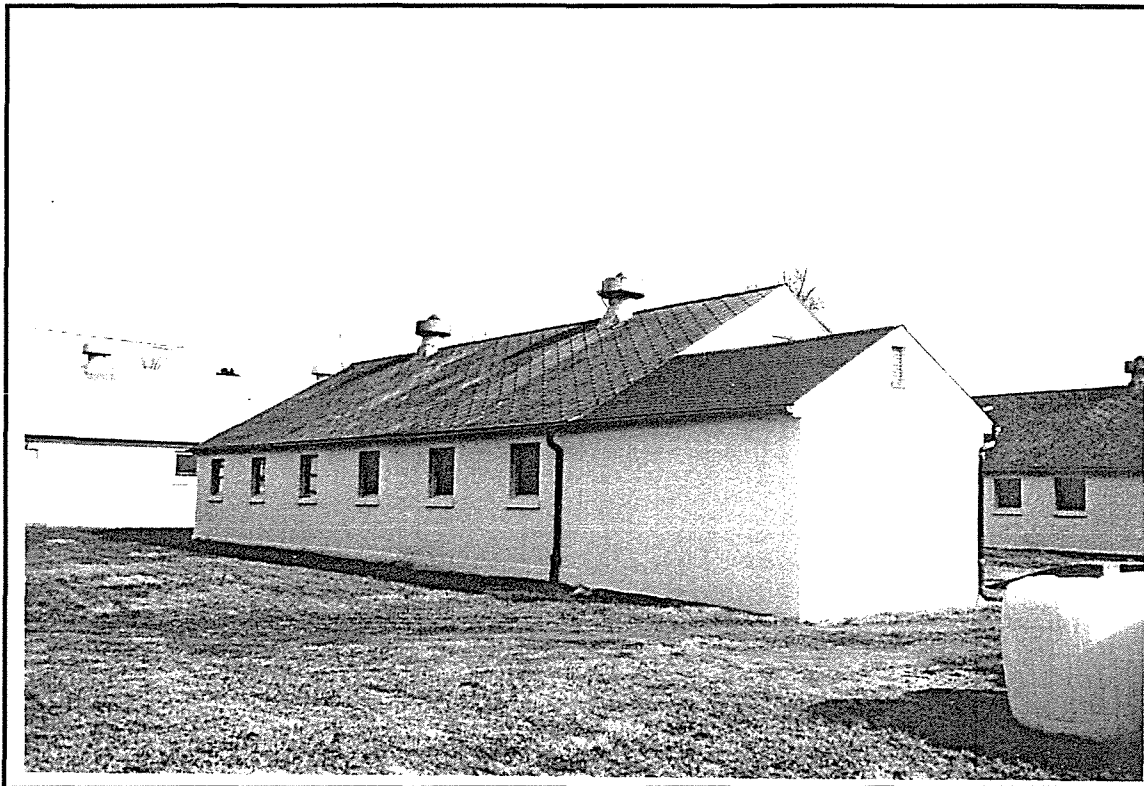
Photo ID: Building 1005, West and North Facades, 4/97

This is a rectangular, one-story, poured concrete barn with a small gable-end addition on the west elevation. The building has a concrete foundation. There are three bays on east elevation, which features a metal replacement door and one-over-one metal replacement windows with concrete sills. There are six bays on the north and south elevations. The side-gable roof is covered with asbestos shingles on the core building. There are vents in the gable areas and aerators on the ridgeline. The gable addition roof is covered with newer, red, asbestos roofing material. There is a vent in the gable area and one-over-one metal replacement windows similar to those on the core building are located on the addition. The building is in good condition.

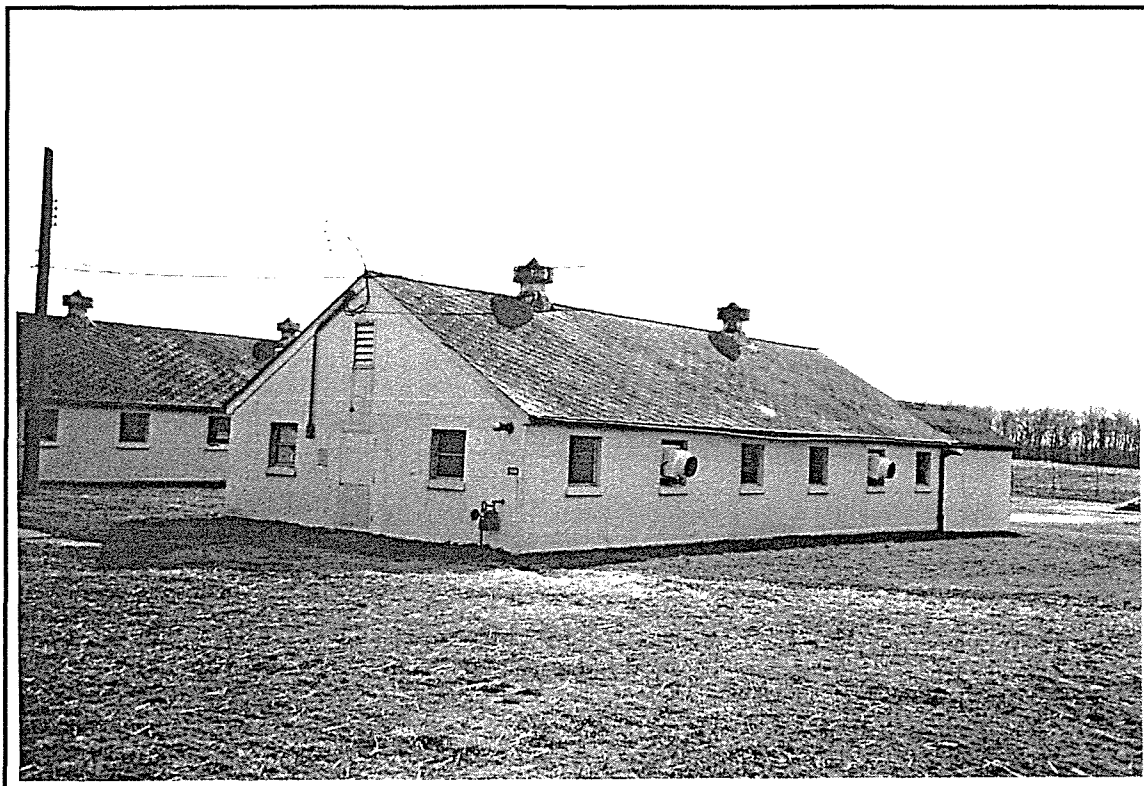
Photo ID: Building 1006, North and East Facades, 4/97

This is a rectangular, front-gable, one-story, poured-concrete barn with a small gable-end addition on the west elevation. The building has a concrete foundation and three bays on the east elevation, which features a metal replacement door on the east facade and one-over-one metal replacement windows with concrete sills. The north and south elevations have six bays each. The side-gable roof is covered with asbestos shingles on the core building and has vents in its gables. Aerators are located on the ridgeline. The roof of the gable addition is covered with newer, red, asbestos material and has a vent in its gable. The addition also features similar one-over-one metal replacement windows. The building is in good condition.

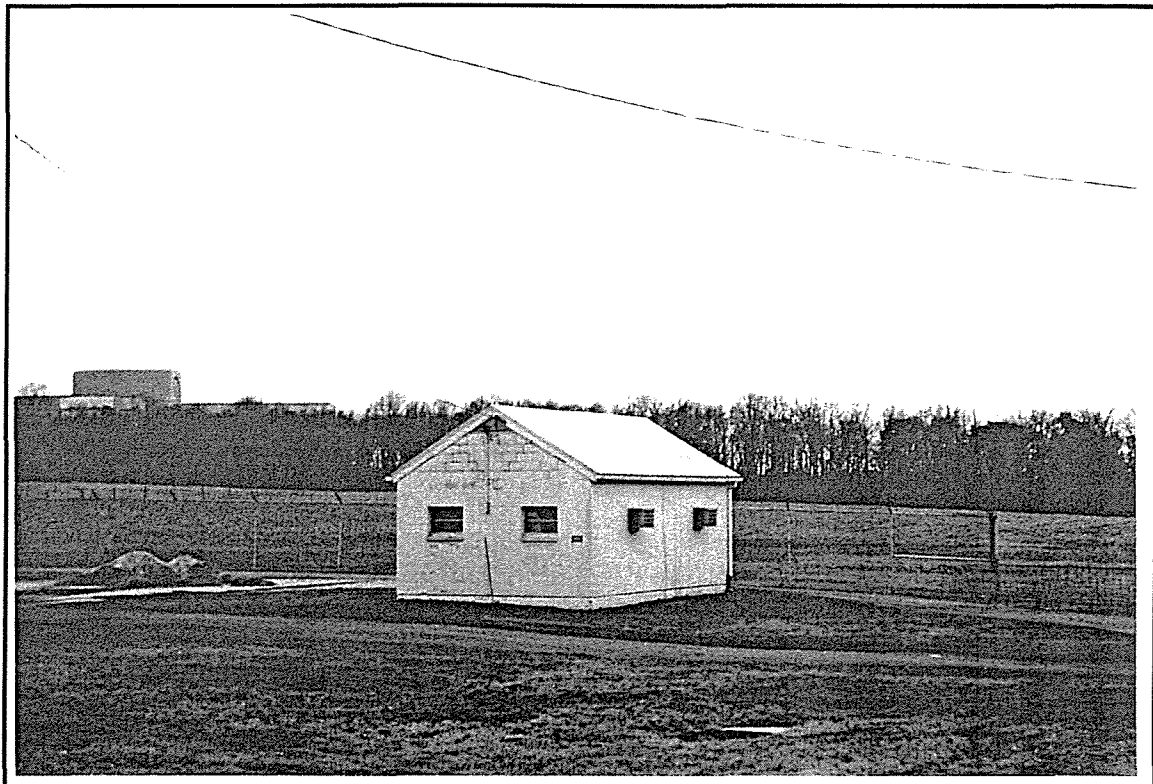
Photo ID: Building 1007, North and East Facades, 4/97

This building has a rectangular footprint. It is constructed of concrete blocks, and has a metal gabled roof on an east-west axis and aluminum gutters. The south facade contains two doors, and the east facade features two two-light windows. The north facade has two windows openings that presently have air-conditioning units in them. The west facade contains two two-light windows.

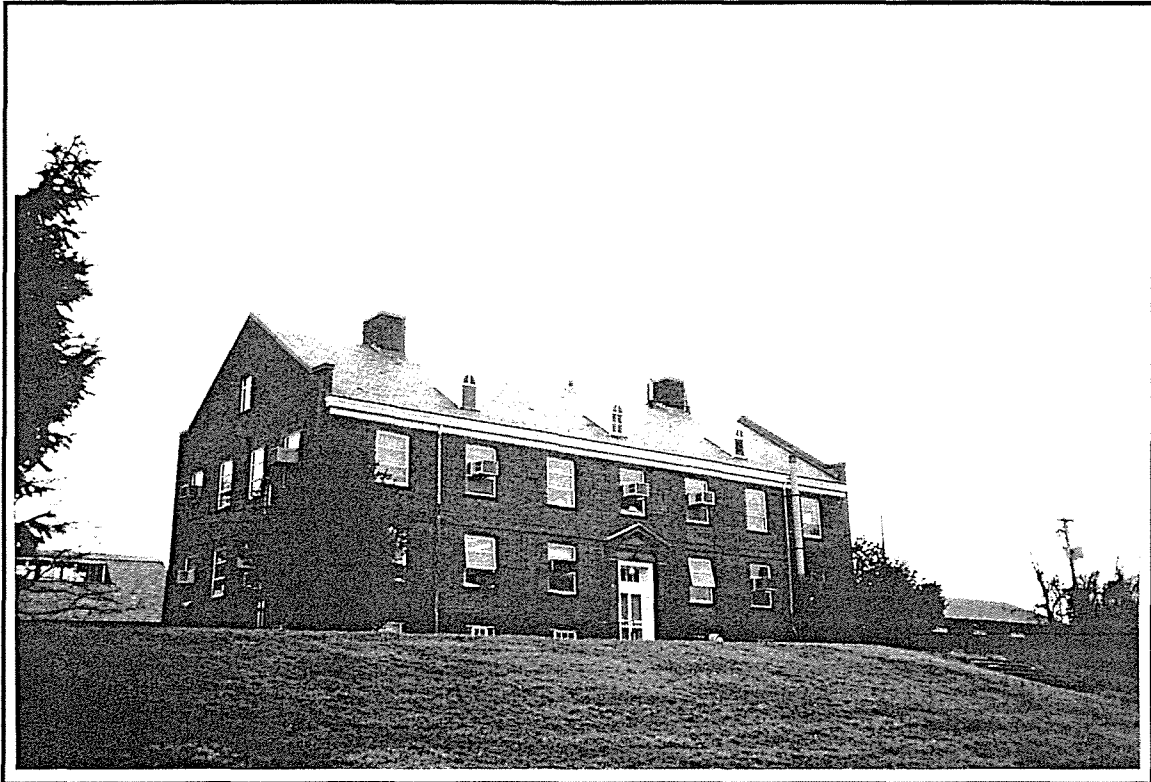
Photo ID: Building 1040, North and East Facades, 4/97

Building 1040 was constructed as the main laboratory for the new Animal Disease Station in 1934. The 1935 Fire Hazard Survey describes the buildings as a two story, basement and attic fire resisting structure with exterior walls of cinder block faced with red brick. The roof structure is wood covered with slate. All sash are steel. Doors are wood." Other correspondence regarding the doors indicates that Dr. W.E. Cotton, Chief of the Experiment Station requested using old oak doors taken from one of the Bethesda buildings in the basement of the new laboratory at BARC. This request was approved, although the Chief of the Bureau of Agricultural Engineering in turn requested that all other doors on the building, which were originally two panel designs, be altered to a five-panel design which would match the reused doors.

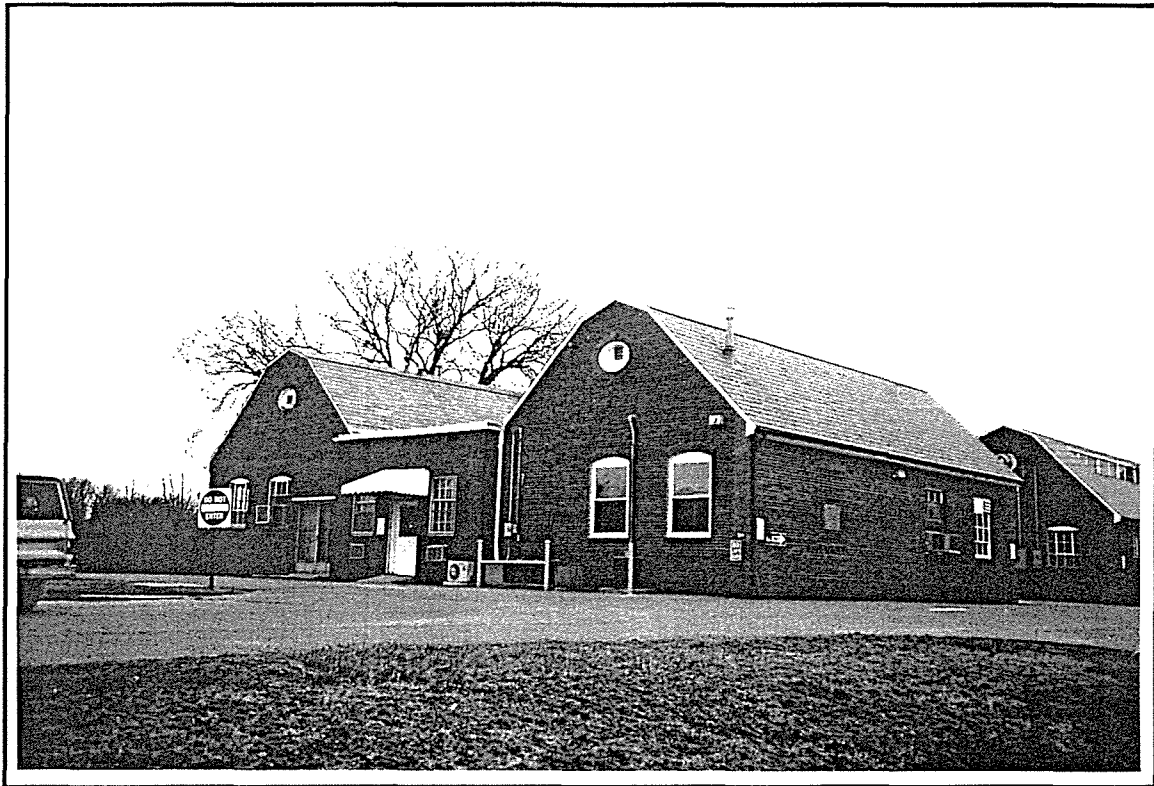
Photo ID: Building 1041 and 1042, North and East Facades, 4/97

This is a one-and-one-half story, rectangular, red-brick, gambrel-roof laboratory building with no visible foundation. It is connected to Building 1042 by a one-story, flat-roof brick hyphen. The north elevation contains three arched window openings, one of which has been filled in with brick. The other two openings contain multipane sash windows which have been altered to accommodate ventilation systems and air-conditioning units. The east elevation also contains three arched window openings, one of which has been filled in with brick. The remaining two openings contain one-over-one replacement windows and all have brick sills. There is a small oval ventilator opening in the gambrel which most likely originally contained a window similar to those in surrounding buildings. This opening is surrounded by decorative brick work. The south side of the building is attached to the connecting hyphen. The west elevation contains a central screen door and an original wood door with a three-pane transom over the doorway. The entrance contains a pedimented gable over the doorway. The hyphen contains a central doorway with a half glazed wood door. The entryway is covered by a metal awning, and is flanked by two multipaned windows. Building 1042 is similar to 1041 in that it is also a red-brick, gambrel-roof building. The north side of the building is connected to the hyphen. The east elevation contains three openings; they are arched windows with decorative brickwork and concrete sills surrounding the openings. The windows are multipaned with four central panes which pivot open. The third opening is a doorway which contains a set of double replacement screen doors. However, this opening has very obviously been added to an area where a window once was present. Evidence to this theory consists of a decorative brick arch in alignment with the other two existing windows. The south elevation contains five multipaned windows with central panes that pivot open, although one of the windows has been altered to accommodate an air-conditioning unit. The west elevation is similar to the west elevation of Building 1041 in that it contains a central entryway with a pedimented cover and is flanked by windows. The roofs of both buildings are covered by slate shingles and copper gutters are present, although replacement downspouts have been installed. A brick chimney is present in the hyphen area of the west elevation. The buildings are in good condition.

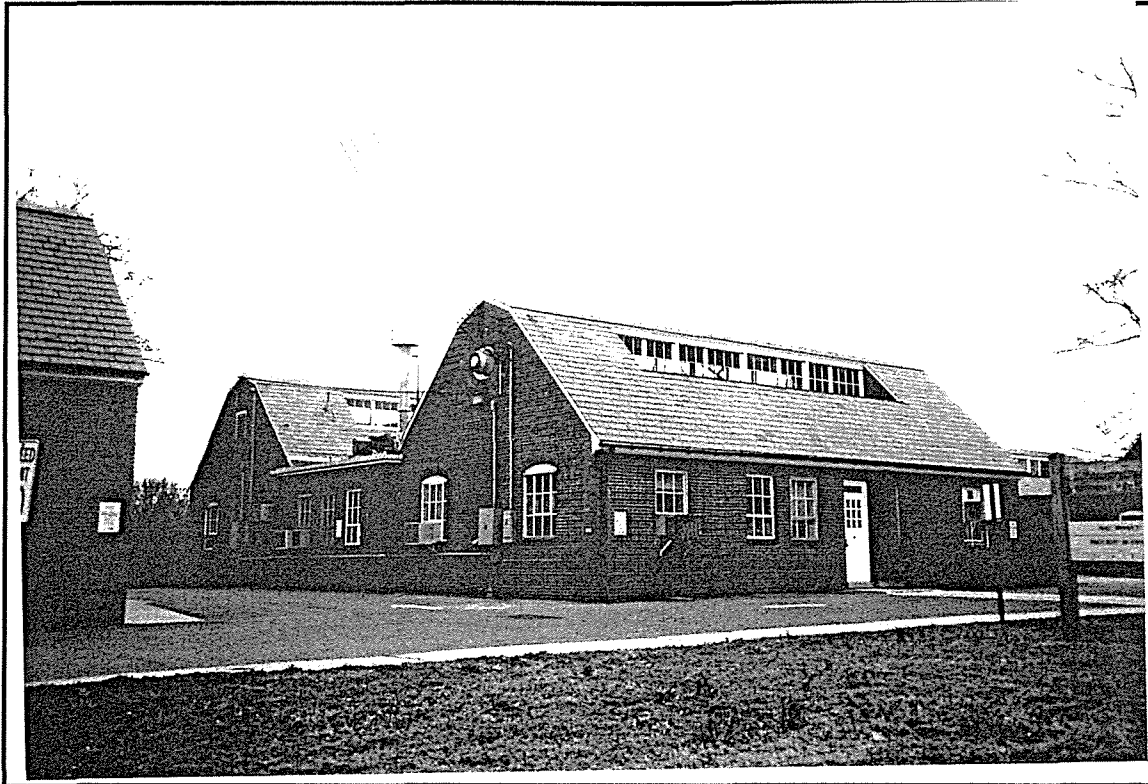
Photo ID: Building 1043, North and East Facades, 4/97

This is a one-and-one-half story, tripart, red-brick laboratory building. Two gambrel roof buildings are joined by a one-story, flat-roof hyphen. The corners of the building contain lighter color brick quoins. The north facade contains an off-center wood door with small panes of glass and a transom above the door. Windows on this facade are double-hung, wood, nine-pane windows, although some have been altered to accommodate air conditioning units. The east facade contains identical windows. The window openings on the two main portions of the building are rounded arches. Each of the gambrel areas contains a vent or aerator. These were originally small, multipaned oval windows similar to those on surrounding buildings that were altered to house the vents. The south facade contains off-center, wood doors, and wood, double-hung, nine-pane windows--some of which have been filled in with boards or obscured by air-conditioning units. The west facade has an off-center paneled door with nine lights. Windows on this facade are consistent with other windows on the building. The roof is covered with slate and contains a row of clerestory windows on the north and south elevations. Ventilators are present on the ridgeline. A copper gutter system is present. The buildings are in good condition.

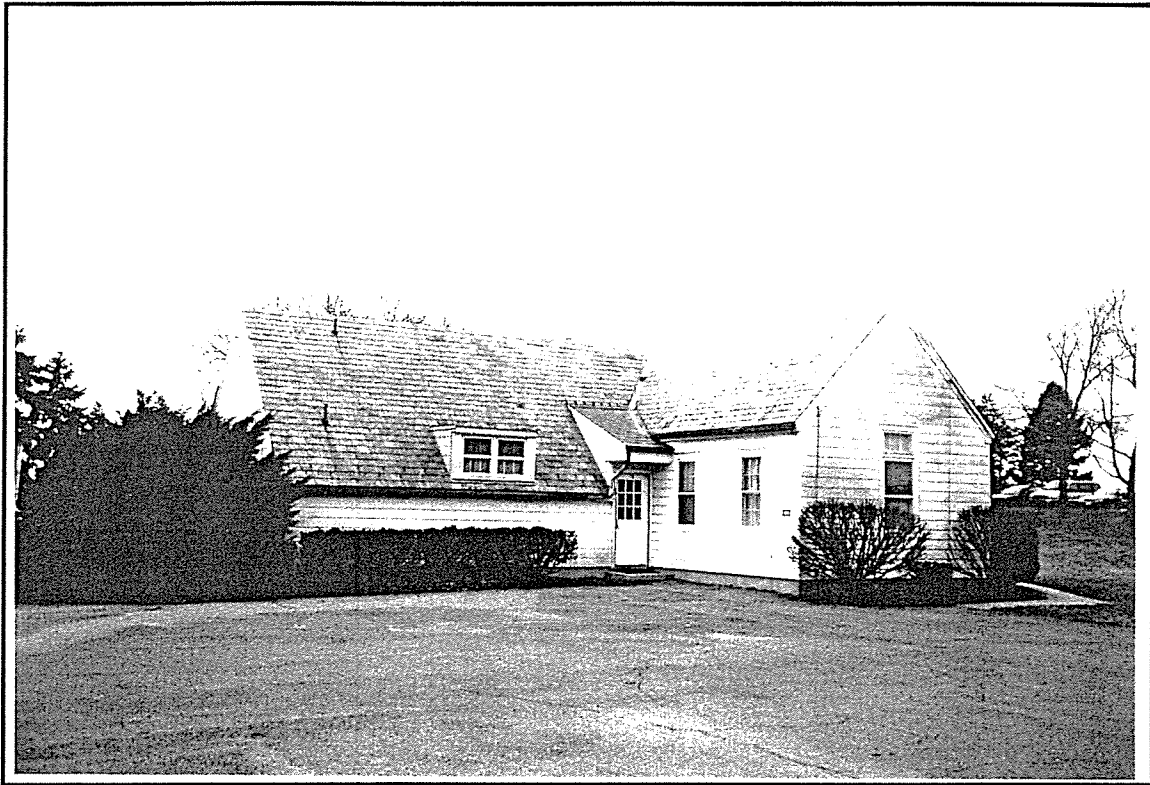
Photo ID: Building 1050, South Facade, 4/97

This is a one-and-one-half-story residence with a complex roof shape and multiple bays. The building is of wood-frame construction with aluminum siding. A poured concrete foundation is present. The south facade contains a cross-gable segment with the entryway located at the intersection of the cross gable. There is storm door over the original wood paneled door which has nine lights. The entryway is covered by a protruding shed-roof extension. The windows are six-over-six, double-hung wood sash. Storm windows obscure some of the original windows. There is also a flat-roof dormer which contains two small windows, each of which has three-over-three panes. The west facade contains three, six-over-six, double-hung wood sash windows and a vent in the gable area. The north facade contains six over six double hung wood windows and fifteen-pane windows. The building form on this facade is complex, with a shed-roof extension and a smaller side-gable addition. The east facade contains only a small vent in the gable area. The roofing material is slate shingle and there is little eave overhang. A brick chimney is present at the north gable end of the core building. Some gutters are present. The building is in good condition.

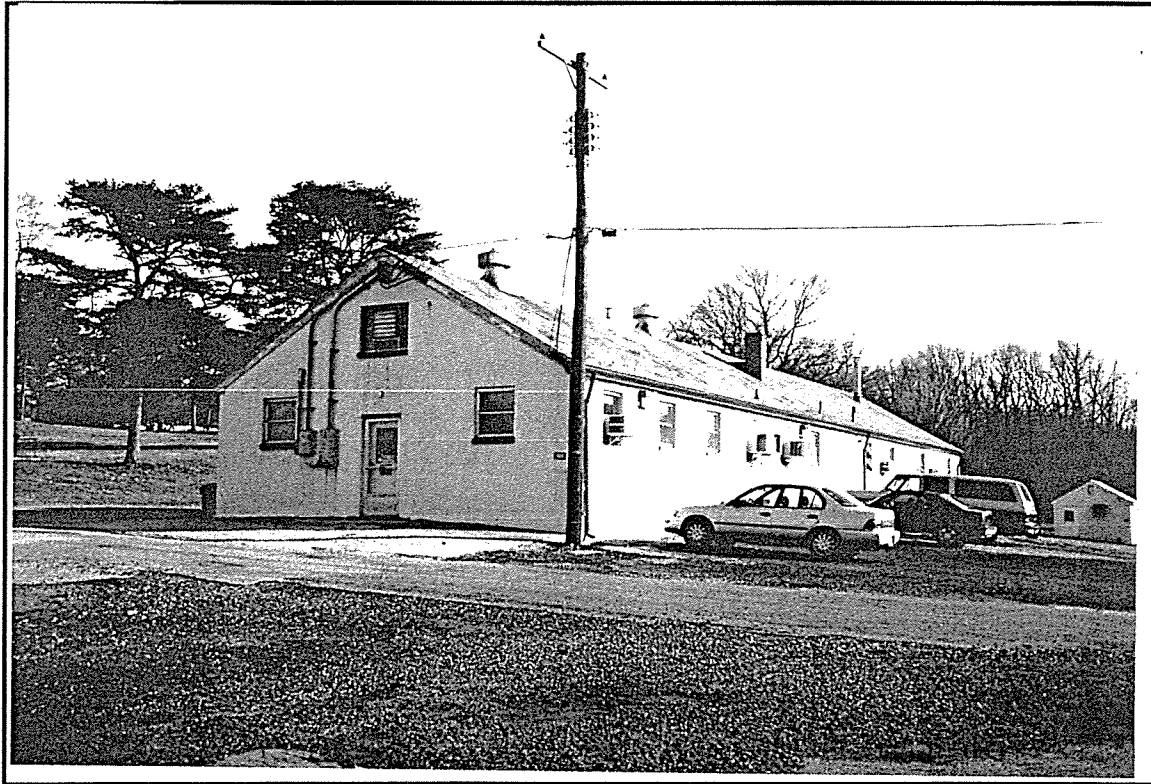
Photo ID: Building 1100, West and North Facades, 4/97

This is a large, rectangular, front-gable, concrete-block building which has been covered with stucco. The north facade features a central entry with a replacement storm door. Metal jalousie windows are located on either side of the door. The windows have red brick sills. A fixed, six-pane window is located in the gable area. A metal vent has been placed in the center of the window, obscuring its original form. The west facade contains an off-center replacement door, and ten irregularly spaced windows. The windows were originally metal jalousie windows, but most have either been filled in with stucco, or obscured by air-conditioning units. Some of the windows have brick sills. The east facade contains a central doorway which has double metal and glass storm doors. The doorway is flanked by metal jalousie windows with brick sills, and a small vent is located in the gable area. The east facade contains an off-center replacement door, and unevenly spaced metal jalousie windows with brick sills. The gable roof is covered with asphalt shingles, and aerators and a brick chimney are present.

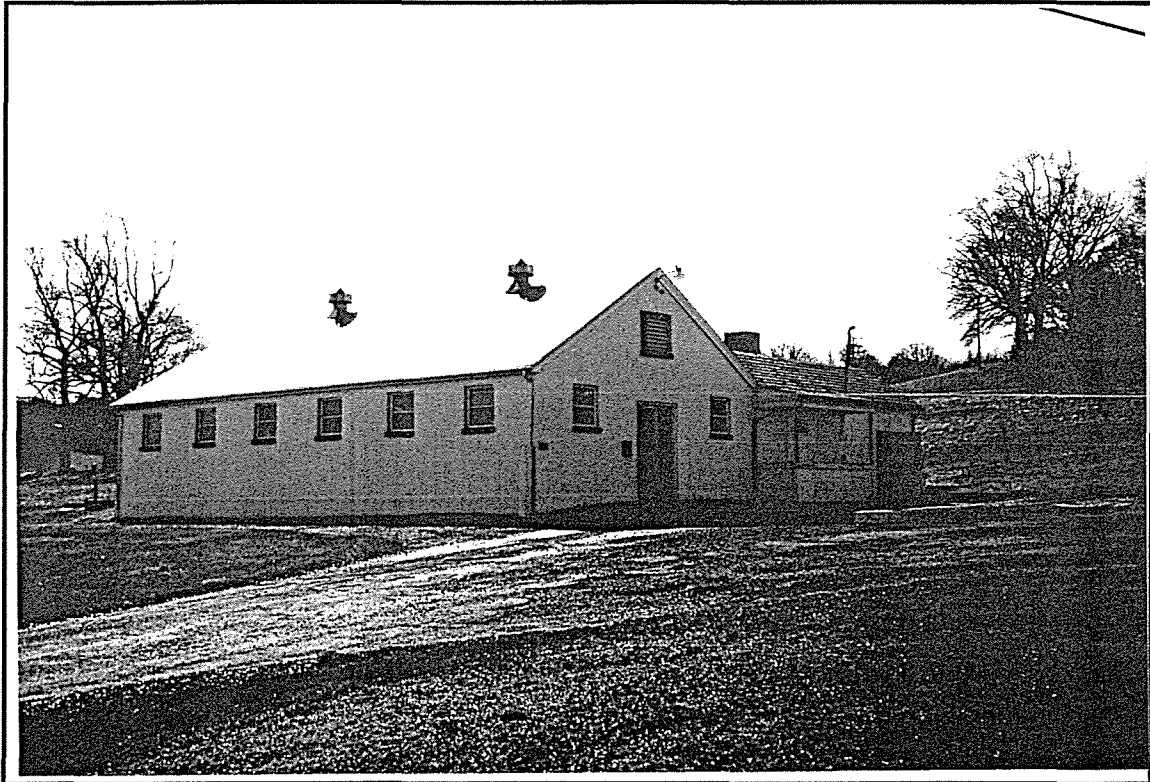
Photo ID: Building 1140, West Facade, 4/97

This is a one-story, cross-gable barn that has an L-shaped footprint. The building is constructed of concrete block and is covered with stucco. The west facade contains the cross-gable extension. The main portion of the building contains a central doorway which has double metal replacement doors flanked by a single metal one-over-one replacement window on each side. The windows have brick sills. There is a vent located in the gable area. The cross-gable extension features a covered, shed-roof, elevated, loading dock area with a wood sliding door, and two metal doors at ground level. The north facade features six, evenly spaced, one-over-one, metal, replacement windows with brick sills. The east facade features a central doorway which has double metal replacement doors flanked by a single, metal, one-over-one replacement window on each side. The windows have brick sills. There is a vent located in the gable area. The south facade contains evenly spaced, one-over-one, metal replacement windows with brick sills. The cross-gable extension features two of the same type of windows, and there is an exterior brick chimney on this portion of the building. The roof is covered with slate, and aerators are located on the ridgeline.

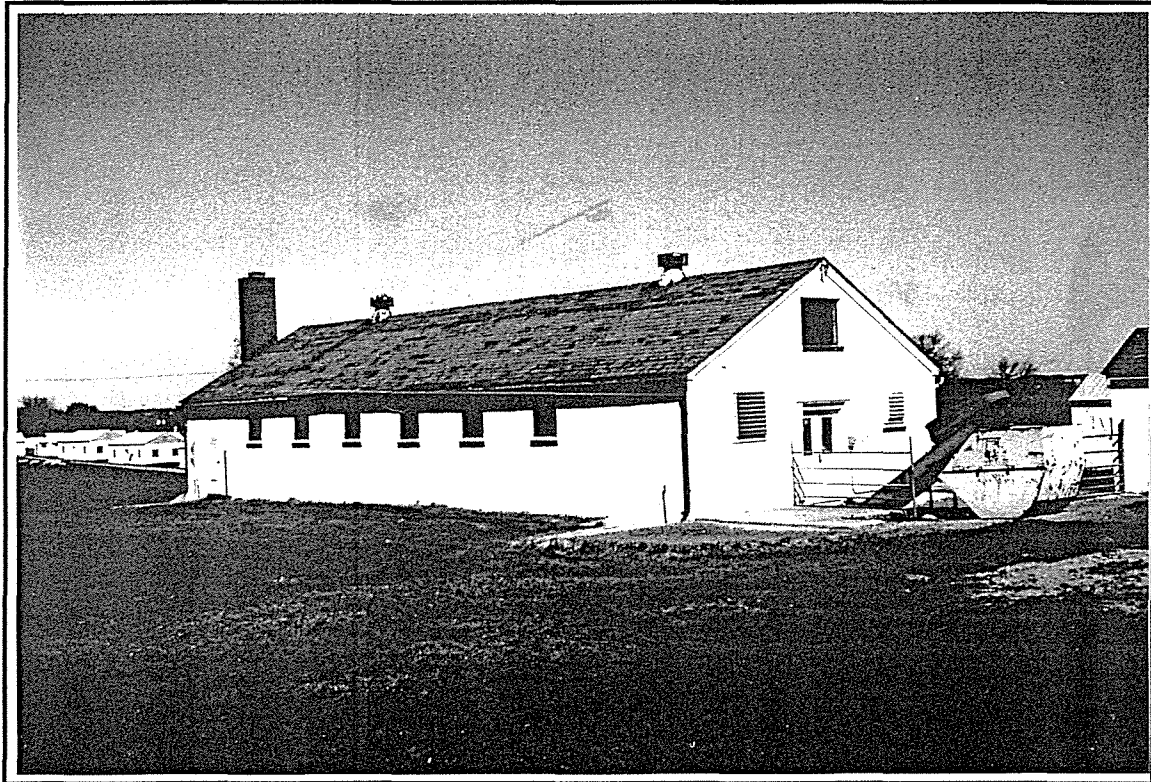
Photo ID: Building 1160, East and South Facade, 4/97

This is a long, rectangular barn with a cross gable. It is constructed of concrete blocks, and covered with stucco. The east facade contains central, double, metal replacement doors that open into a fenced yard. The doors are flanked by rectangular vents. A fixed six-pane window with a brick sill is located in the gable area. The south facade contains six, small, fixed, multipane windows with brick sills. There is a replacement door at the west end of this facade. The west facade contains double metal and glass replacement doors. A set of concrete steps leads to the doors. A small fixed window with a brick sill is located to the left of the window. A similar window is located in the gable area. A large red-brick exterior chimney is located to the right of the entrance. The cross gable forms a shed-roof extension on this facade of the building; it is an elevated loading dock area with a set of sliding wood doors. The north facade contains the cross-gable, and there are a series of fixed multipane windows with brick sills. The cross gable roof is covered with slate, while the main roof of the building is covered with asphalt shingles. A gutter system is present.

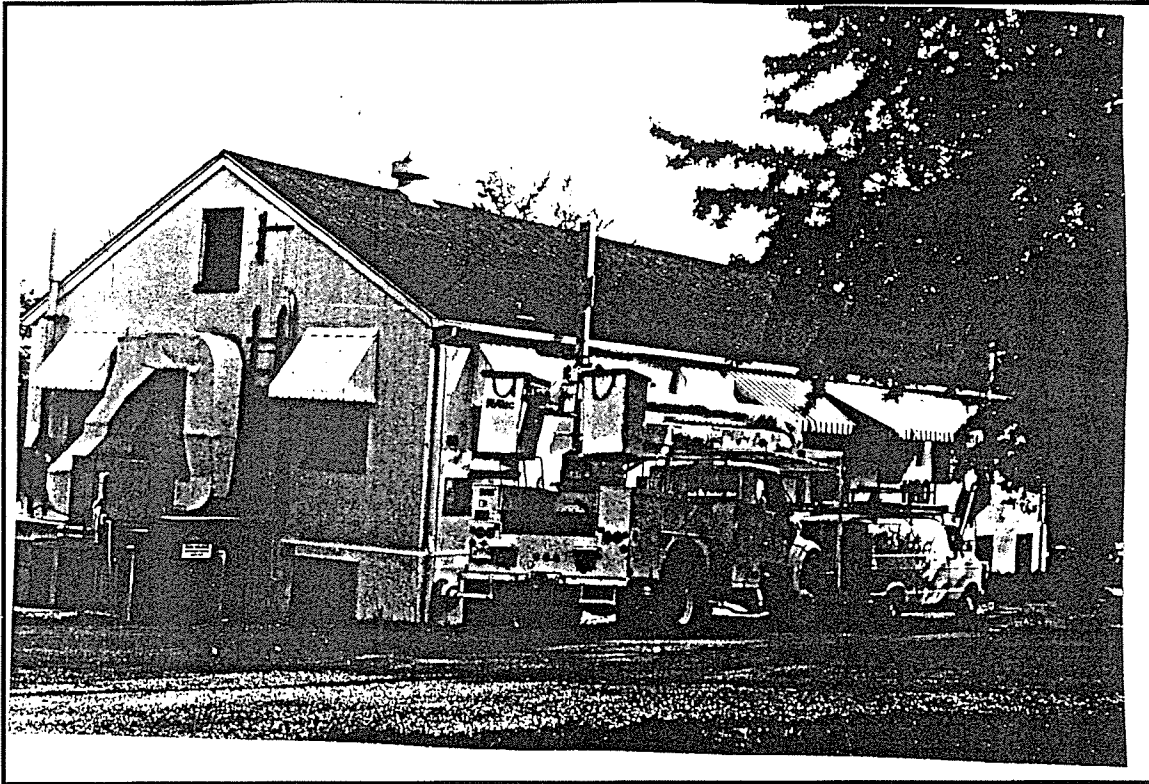
Photo ID: Building 1180, South and West Facades, 9/97

This is a large, rectangular, two-story building with a central cross gable. The building is constructed of concrete block and is covered with stucco, and has been constructed into the slope of a hill. The west elevation contains metal replacement windows with brick sills and metal awnings. A vent is located in the gable area. Several transformer boxes and ventilation tubing are attached to the building. The north facade contains the central cross gable. Large windows on both the first and second stories of the building are of various types. Some are fixed multipane windows, while others are multipane windows with central panes that pivot open. All windows have brick sills. There are double metal replacement doors at the east end of this elevation. The east elevation contains several filled-in windows. A metal stairway leads to a second-story entrance, which has a metal replacement door. A vent is located in the gable area. The south elevation contains a variety of windows. Most are fixed multipane windows with a central portion which pivots outward. The windows on the second story have brick sills and metal awnings. A central entryway with glass replacement doors on the second story is reached by a concrete stairway with a metal railing. The cross-gable roof is covered with asphalt shingles, and various acorn aerators are located on the roof.

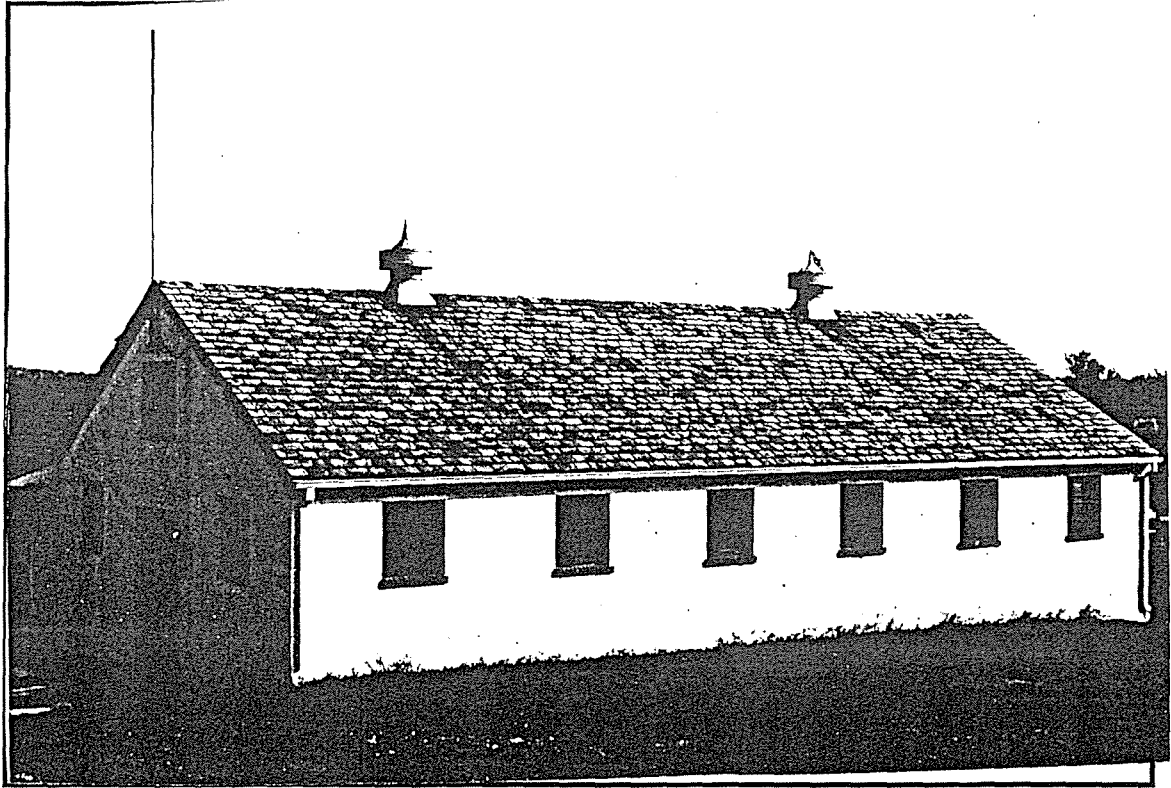
Photo ID: Building 1181, Looking Northeast, 9/97

These eight buildings (Buildings 1061, 1062, 1063, 1064, 1065, 1181, 1182, and 1194) are identical one-story, cross-gable, poured-concrete buildings with concrete foundations. On each building, there are three bays on the north elevation (main facade). This elevation features double replacement storm doors over a boarded up entryway on the north elevation. There are six-paned windows with brick sills located on each elevation. A metal door with a small single pane of glass is located on the west facade. Four-paned windows are located in the gables of the north and south facades. A cross gable is located on the north end of the building. The cross gable has a shed-roof porch on its north elevation. The porch is on a raised platform and forms a loading dock area which has double wood doors. An interior brick chimney is present. The building's roof is covered with asphalt roll, but the cross gable roof is covered with slate shingles. Aerators are on the ridgeline. The building is in good condition.

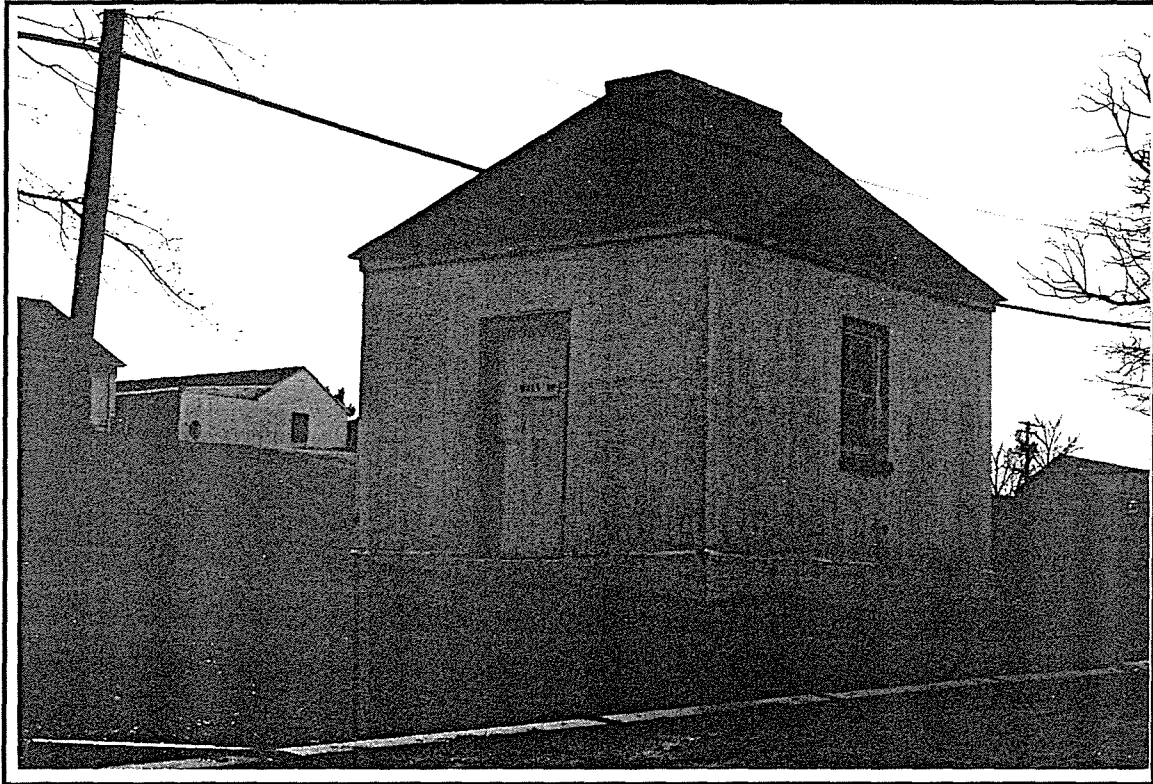
Photo ID: Building 1183, North and East Facades, 2/96

This is a small, one-story, water pumping station that has been constructed of concrete block and covered in stucco. The building has a poured-concrete foundation. The east facade contains a central, wood door. The north elevation has a central, six-over-six, double-hung, wood window with a brick sill. The west elevation has no openings, and the south elevation is identical to the north elevation. The hipped roof is covered with black asphalt shingles. The water pump is no longer in use.

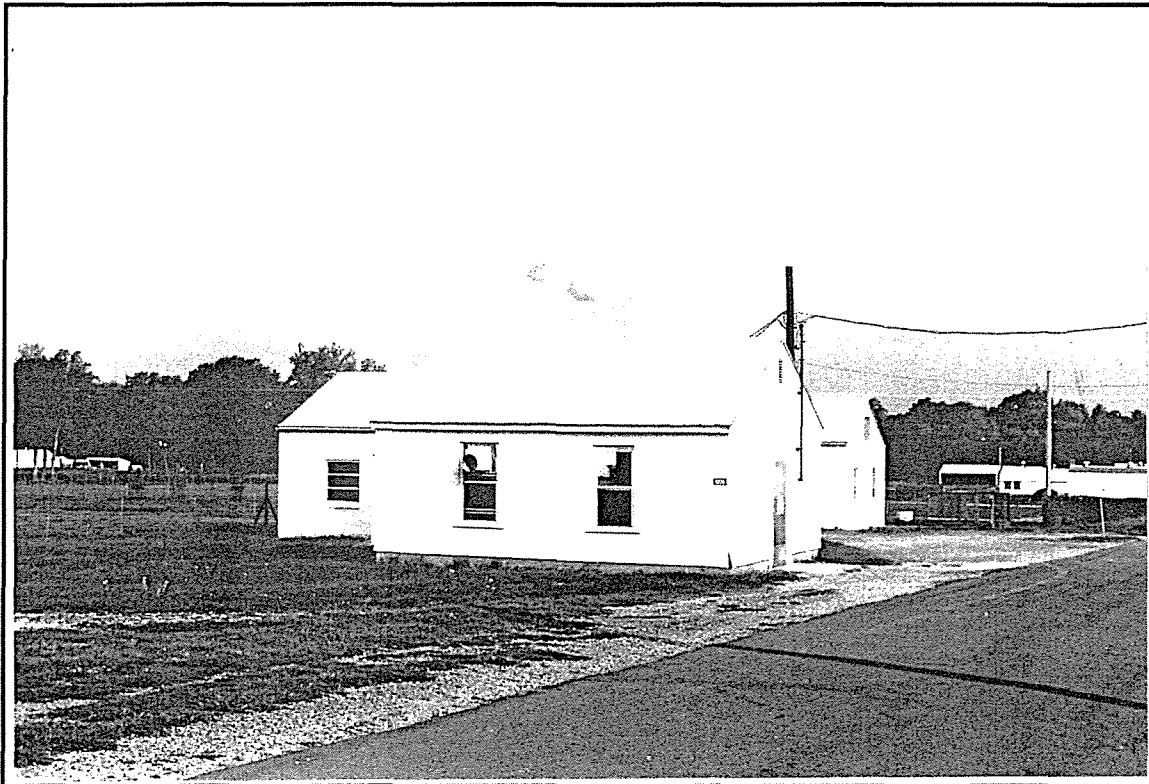
Photo ID: Building 1206, South and East Facades, 9/97

This is a small, frame building that has been sided in clapboard. It has a rectangular footprint and a poured- concrete foundation. The east and west elevations each have a central door which is a double door, and a vent is in the gable area. The north and south elevations are also identical. Each has two large multipane windows. Central portions of the windows pivot open. The gable roof is covered with corrugated metal.

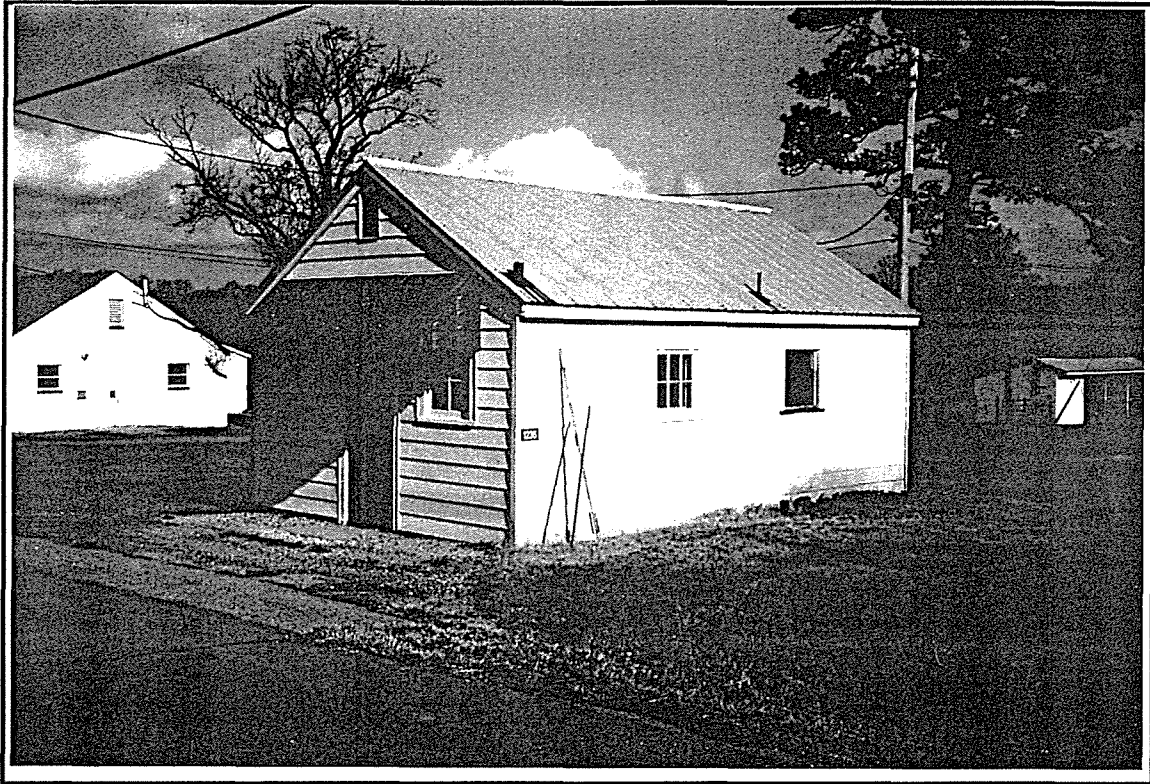
Photo ID: Building 1236, South and West Facades, 12/97

This is a small, rectangular, front-gable, frame building that has been sided in clapboard. It has a poured concrete foundation. The west elevation has a central metal replacement door and a small four-pane, fixed window. There is a large canvas awning covering the length of the facade, and a small, rectangular vent in the gable area. The south elevation has two evenly spaced windows. One is obscured by an air-conditioning unit, and the other is a six-pane replacement window which pivots open. The east elevation also has two identical windows that are also evenly spaced. The north elevation is similar to the south elevation. Two evenly-spaced, six-pane windows are present. The gable roof is covered with standing seam metal. No gutter system is present.

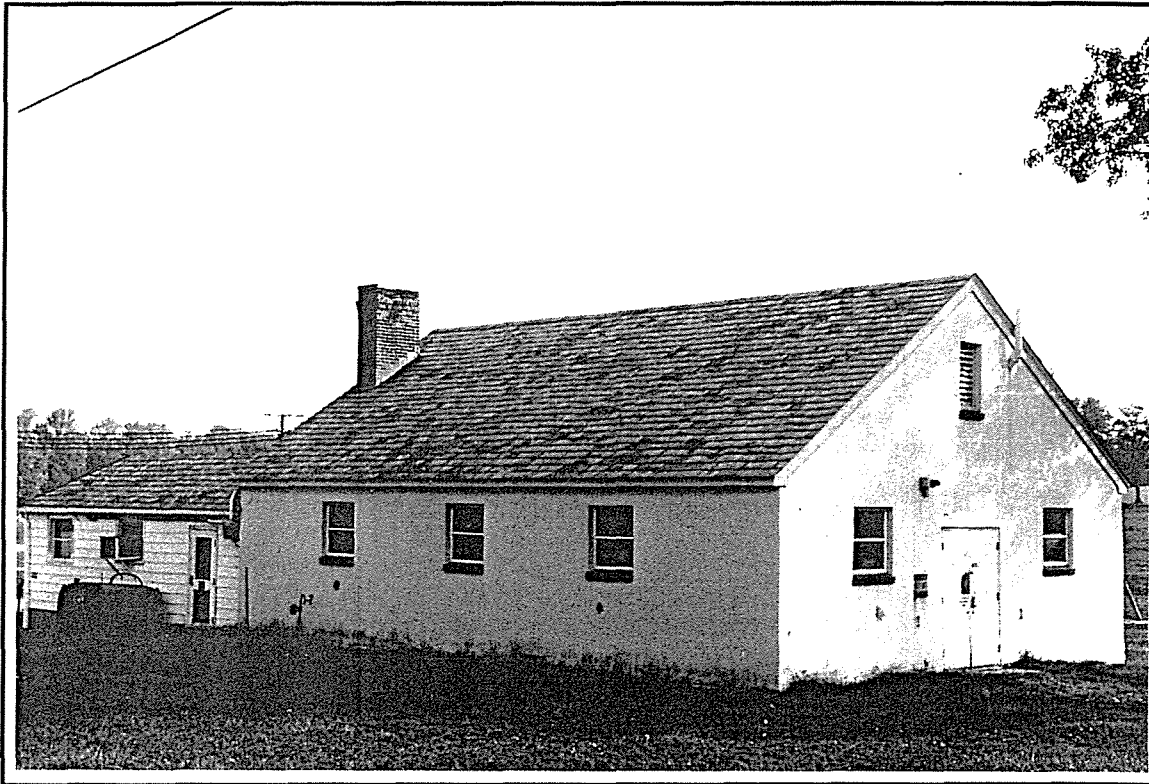
Photo ID: Building 1300, South Facade, 9/97

This is a one-story rectangular barn with two original extensions that have been connected by a small addition. The barn is constructed of concrete blocks that have been covered with stucco, while the extension are clapboard that has been painted white. The small addition which connects the extensions is also concrete, with a clapboard area in the gable. The extensions and the addition are on a raised concrete foundation. The south facade features central double metal doors flanked by metal replacement windows with brick sills. There is a vent in the gable area. The west facade of the main barn contains three metal replacement windows with brick sills. The west facade of the extension contains an original wood door and two metal replacement windows. The north facade contains the two extensions and the additions which connect them. The east extension contains an off-center replacement door. The center addition contains double doors which each have four panes of glass, and there is a vent in the gable area. The western extension contains a central wood door. The east facade contains three metal replacement windows with brick sills on the barn and three metal replacement windows on the extension. The main barn has a gable roof, as does the connecting addition. The two extensions each have hipped roofs. All of the roofs are covered in slate.
