**HISTORIC SITE SURVEY  
BELTSVILLE AGRICULTURAL RESEARCH CENTER**

**BELTSVILLE, MARYLAND**

**VOLUME VI  
BUILDING FORMS**

STRUCTURE FORMS (1002-1437)  
VOLUME 6

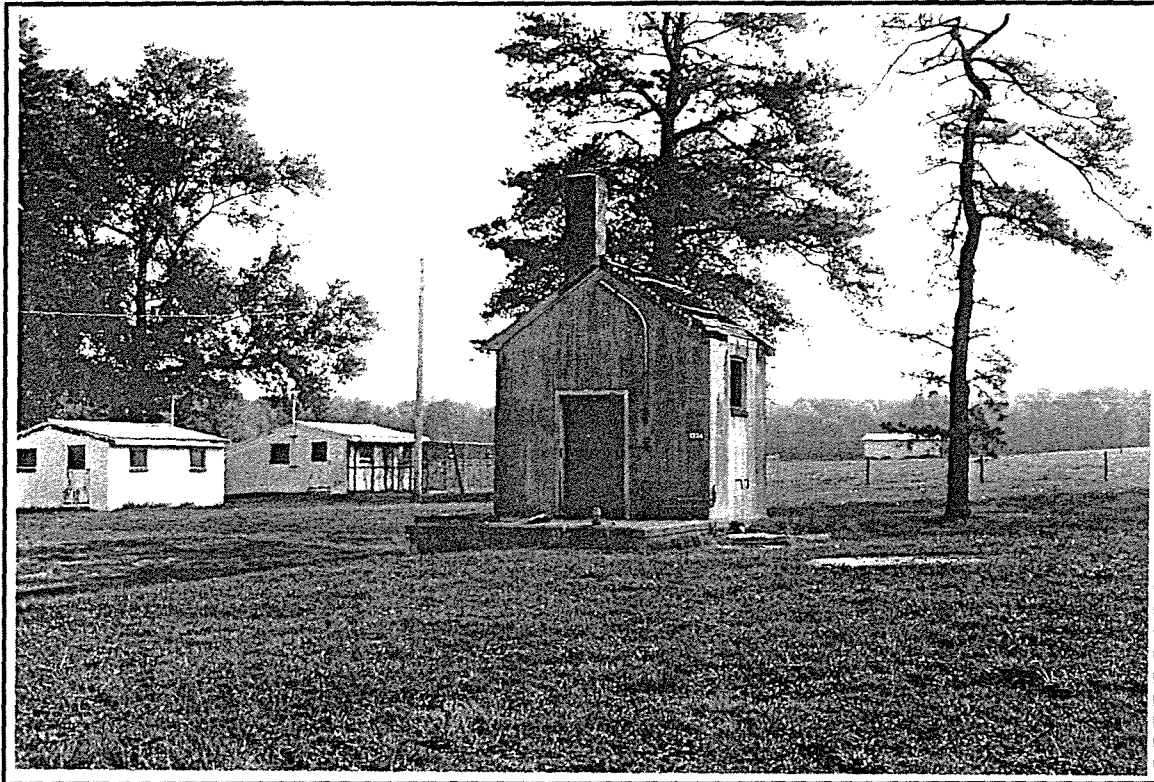
Photo ID: Building 1324, West Facade, 9/97

This is a small, front-gable, concrete-block building with a stucco covering. It has a square footprint and sits atop a raised concrete slab. The west elevation features a central open doorway. There is a metal tank located by the doorway. The north elevation contains a central metal door which is reached by several concrete steps. The east elevation has a small, off-center vent. The south elevation has a central window which has been painted black. It is located high on the building, and has a brick sill. The majority of the asbestos shingles that originally covered the roof are missing, and there is an interior chimney located at the northeast corner of the building.

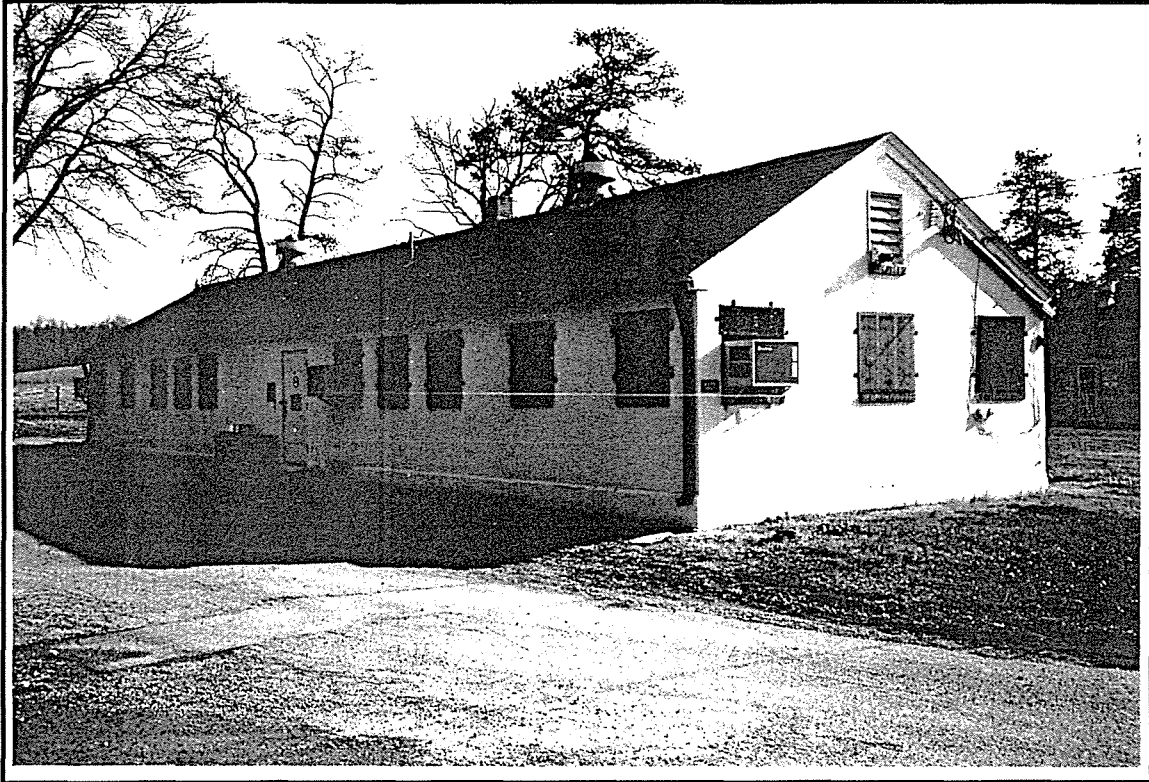
Photo ID: Building 1327, North and West Facades, 12/97

This is a one-story, rectangular, concrete-block, animal barn which has been covered in stucco. The south facade has a central metal replacement door th flanked by four windows on either side. The windows are all fixed, multipane windows with brick sills. The east facade has three, evenly spaced, fixed, multipane windows with brick sills. There is a rectangular vent in the gable area. The south facade has a series of doors that open into pen areas. There is also a wood door with four panes of glass located on the west end of the facade, and there is a series of evenly-spaced windows identical to other windows on the building. There is a tall, red-brick, exterior chimney centrally located on this facade. The west facade is identical to the east facade. The gable roof is covered with slate, and there are aerators on the ridgeline.

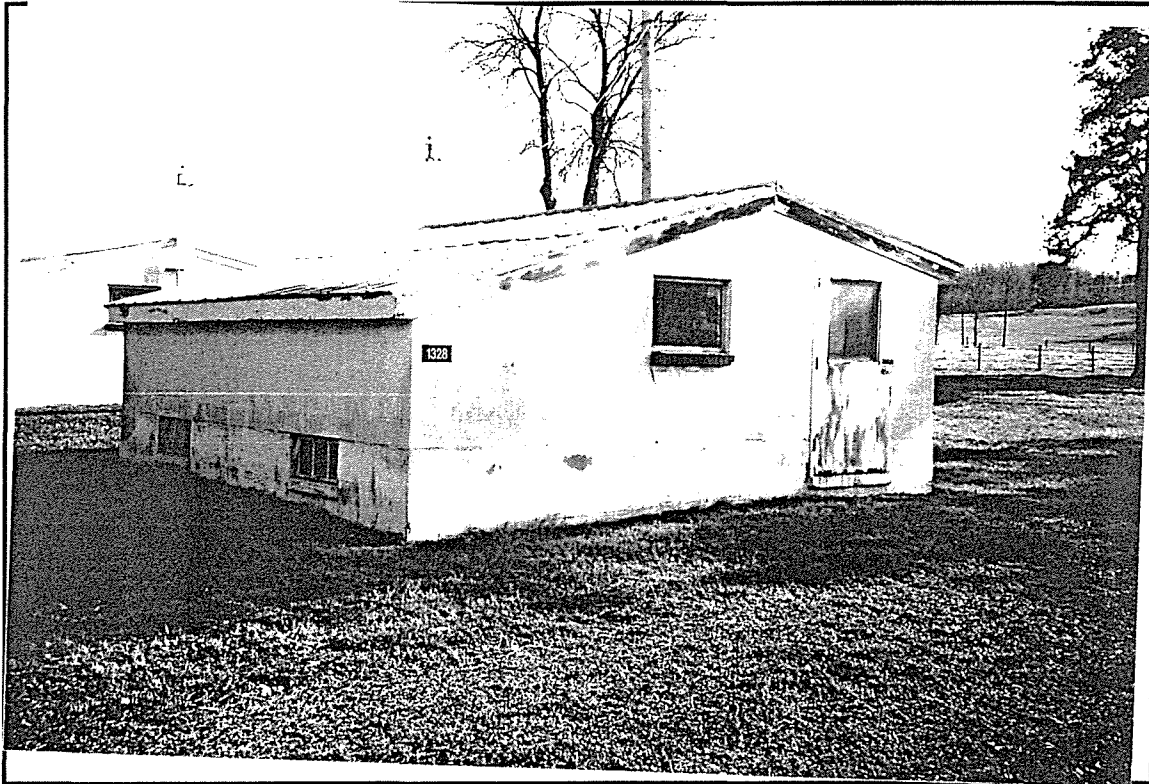
Photo ID: Building 1328, North and West Facades, 12/97

These two identical poultry houses are constructed of concrete block, and both have square footprints and off-center gable roofs. The west facades each have an off-center, wood, half-glazed door and a small, single-pane window with a brick sill. The north facades have each have two, small, evenly spaced doors designed to allow the chickens free entry and exit. The east facades are identical to the west facades, and the south facades contains two evenly spaced metal replacement windows with brick sills. The roofs are covered with sheets of corrugated metal.
