**HISTORIC SITE SURVEY  
BELTSVILLE AGRICULTURAL RESEARCH CENTER**

**U.S. DEPARTMENT OF AGRICULTURE  
AGRICULTURAL RESEARCH SERVICE  
CONTRACT NO. 53-3K15-5-9071  
TASK ORDER NUMBER 14**

**VOLUME V  
BUILDING FORMS**

**JUNE 1998**

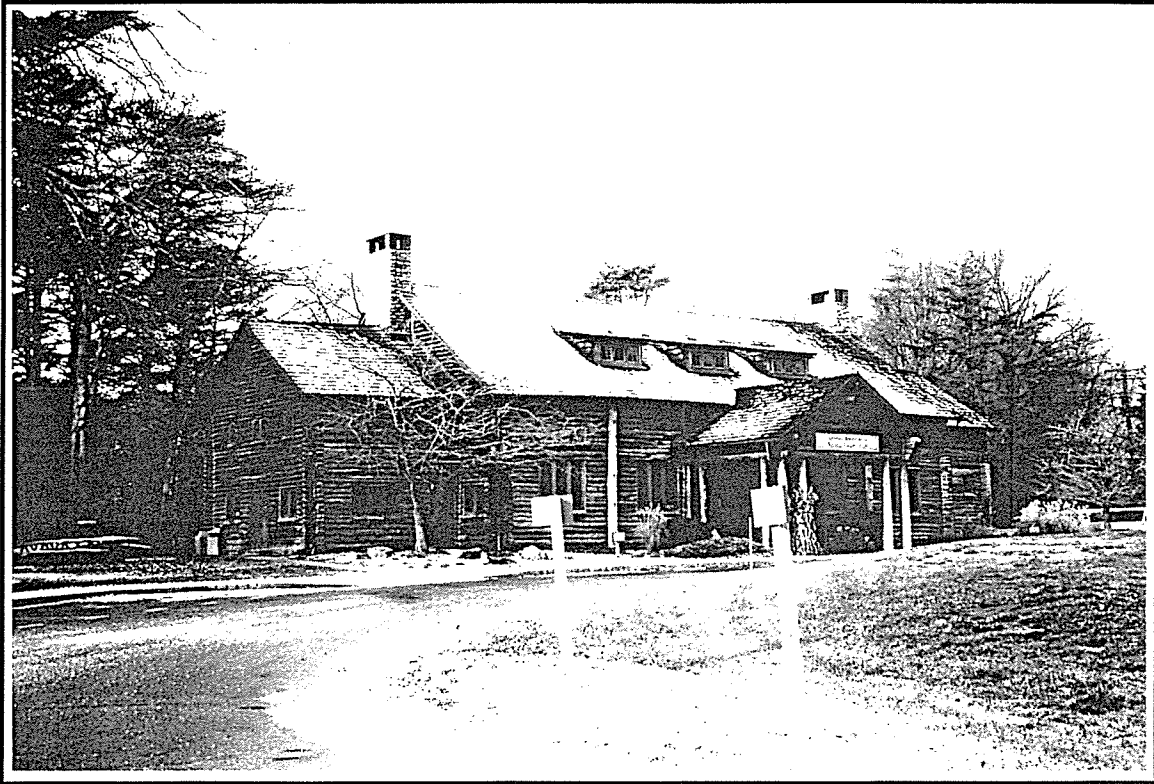
Photo ID: Building 302, East and South Facades, 12/97

The Log Lodge is a large two-story, tripart, log building that consists of a central portion flanked by two smaller wings. The Rustic-style building is constructed of whole logs that are notched at the corners, and mortar chinking is used between the logs. The central portion has a side-gable roof with two end chimneys constructed of stone. A central, cross-gable entryway extends from the east facade. The extension is supported by log posts. Windows on the main block are three-part casement windows with small diamond-shaped panes. The east (front) and west (rear) elevations each have three shed-roof dormers that each have three, small four-pane windows. The flanking wings, which are slightly lower than the central block, also have gable roofs. The windows on the wings are smaller, but are also three-part with diamond-shaped panes. The west facade has a one-story shed roof addition which continues the main roofline. Another addition is a square structure connected to the building by the shed-roof addition. The roof is covered with wood shingles.

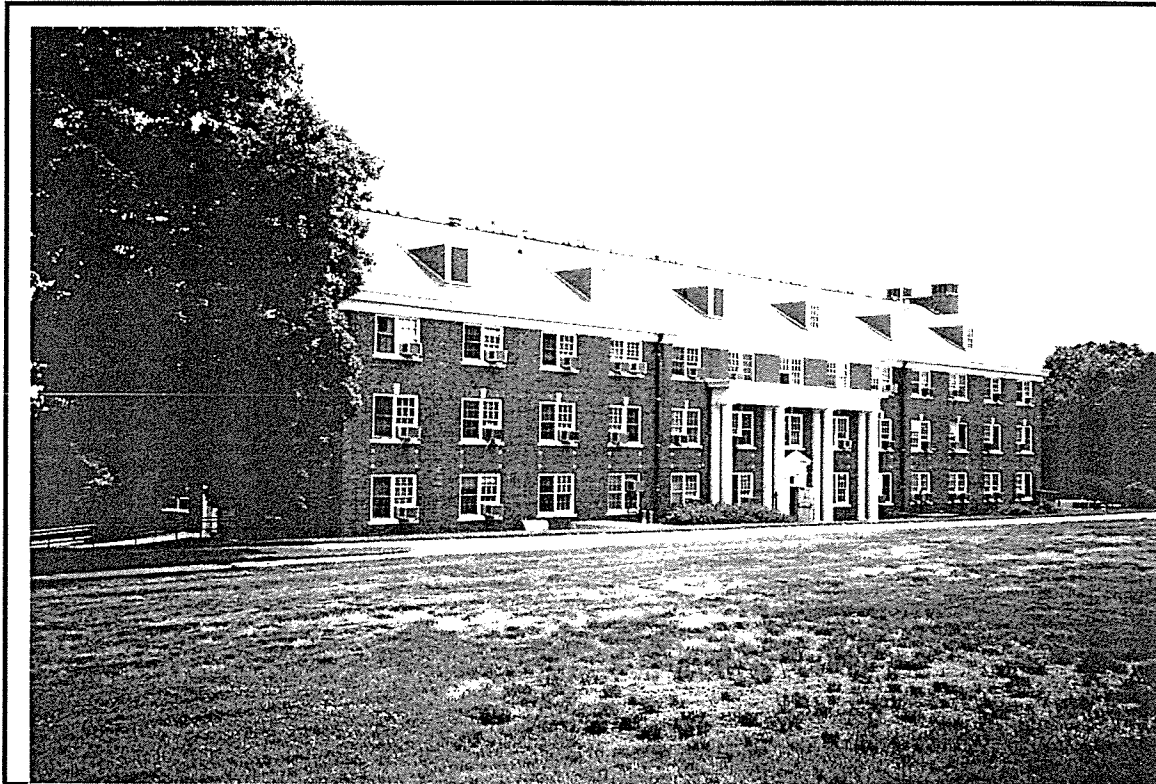
Photo ID: Building 306, West Facade, 6/97

This building is the southern most of a grouping of three similar brick laboratory buildings that together make up the Departmental Laboratories. Building 306 is a three-story, brick Georgian Revival laboratory building. It has a slate, side gable roof, paired six-over-six double-hung sash, and a concrete foundation. The main (east) facade has 15 bays. Prominent features of this facade include the main entrance which consists of a shallow two-story Tuscan portico surrounding the center three bays of the building. The central bay of the portico houses the building's pedimented entrance. Decorative ironwork grills are located on either side of the double wood doors. Above the doors are two-leaded glass windows. The entrance is reached via a platform with slate tiles with concrete aggregate steps. Other decorative elements on this facade include rectangular designs executed in brick and concrete centered under the windows between the first and second floors and concrete keystones above the second floor windows. At the roof level, this facade features six gable-roofed dormers and paired, decorative gable-end chimneys on both ends of the building. The south elevation is three bays wide. Unlike the front facade, windows on this facade are 12-pane units of metal construction, the lower three panes of which pivot open. The central, double wood door on this facade is surmounted by two leaded windows and a simple decorative pediment. At the attic level is a half-round vent. The west (rear) facade mirrors the east facade without the elaborate focal entryway. The north facade is similar to the south facade. Copper gutters and replacement gutters are present. Overall, the building is in good condition. Obvious alterations include the insertion of numerous window-unit air conditioners and a forest of vents at the roof top.

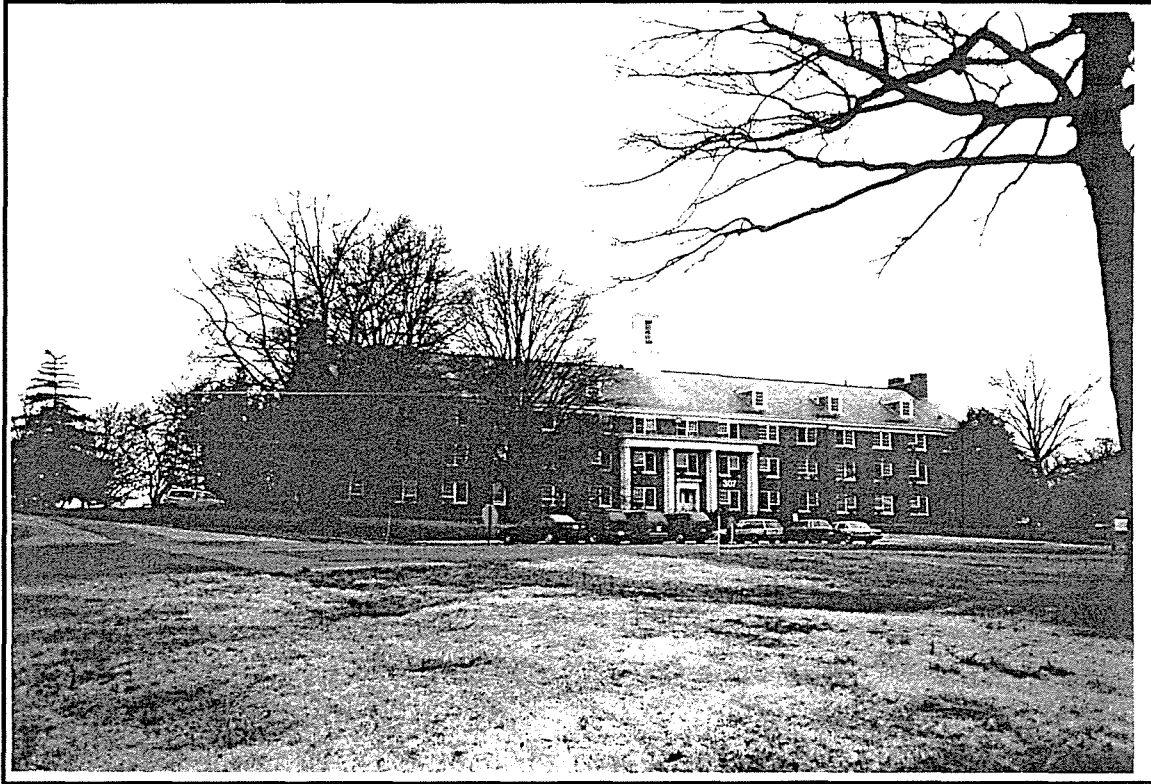
Photo ID: Building 307, East Facade, 4/97

This building is the central element of a grouping of three similar brick laboratory buildings that together make up the Departmental Laboratories. Its central location and prominent occupants (it housed the offices of the Director of the Beltsville Research Center) are marked by a tall central wood cupola. The three-story, rectangular laboratory building has a side-gable roof and a concrete foundation. The main (east) facade has 15 bays. This facade contains the main entrance which is on a raised platform with slate tiles with concrete aggregate steps leading to platform. The central entryway is two stories high and three bays wide with four columns supporting an entablature which contains decorative carved medallions and a carved key pattern. Pilasters surround the doorway, mirroring the placement of the columns. The wood double doors are half-glazed with panels. Vents with decorative ironwork are located on either side of the doors. There is a raised basement. Decorative brick and concrete work occur between the first and second levels. The majority of the windows are six-over-six wood sash. However, some windows have been replaced and contain air-conditioning units. Decorative brick work and popped concrete keystones are located over windows. The south elevation contains an original half-glazed wood door and replacement windows. The west (rear) facade mirrors the east facade without the elaborate focal entryway. The north facade contains double wood paneled doors with leaded glass panes over the doors. Both the north and south facades contain large round vents in the gable ends. Copper gutters and replacement gutters are present. The replacement gutters often use the original copper fasteners to hold new gutters. The side gable roof is covered with slate shingles. There are six gable dormers on the east facade and six gable dormers on the west facade. Each contain six-over-six windows. There are gable end chimneys on both the north and south elevations. The roof contains various ventilator shafts and acorn ventilators. The building is in good condition, although areas need to be painted.

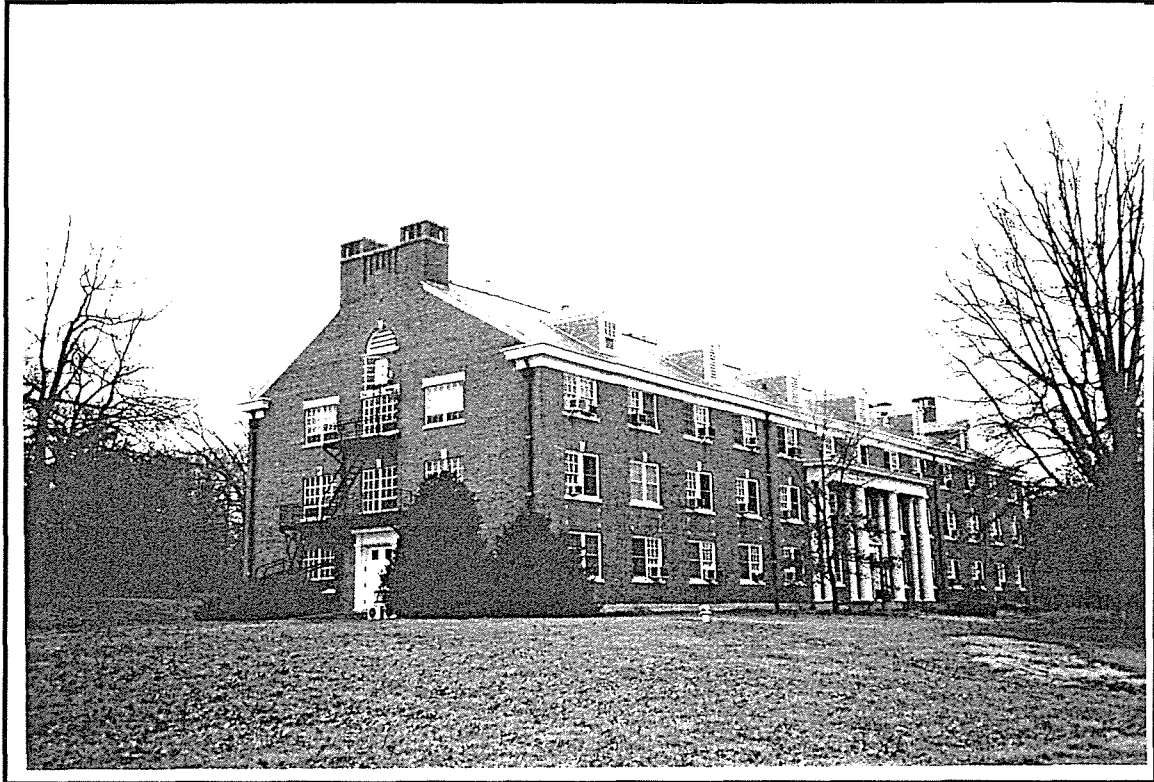
Photo ID: Building 308, East and South Facades, 4/97

This building is the northernmost of a grouping of three similar brick laboratory buildings that together make up the Departmental Laboratories. Building 308 is a three-story, brick, Georgian Revival laboratory building. It has a slate, side gable roof, paired six-over-six double-hung sash, and a concrete foundation. The main (east) facade has 15 bays. Prominent features of this facade include the main entrance which consists of a shallow two-story Tuscan portico surrounding the center three bays of the building. The central bay of the portico houses the building's pedimented entrance. Decorative ironwork grills are located on either side of the double wood doors. Above the doors are two leaded glass windows. The entrance is reached via a platform with slate tiles with concrete aggregate steps. Other decorative elements on this facade include rectangular designs executed in brick and concrete centered under the windows between the first and second floors and concrete keystones above the second floor windows. At the roof level, this facade features six gable-roofed dormers and paired, decorative gable-end chimneys on both ends of the building. The south elevation is three bays wide. Unlike the front facade, windows on this facade are 12-pane units of metal construction, the lower three panes of which pivot open. The central, double wood door on this facade is surmounted by two leaded windows and a simple decorative pediment. At the attic level is a half-round vent. The west (rear) facade mirrors the east facade without the elaborate focal entryway. The north facade is similar to the south facade. Copper gutters and replacement gutters are present. Overall, the building is in good condition. Obvious alterations include the insertion of numerous window-unit air conditioners and a forest of vents at the roof top.

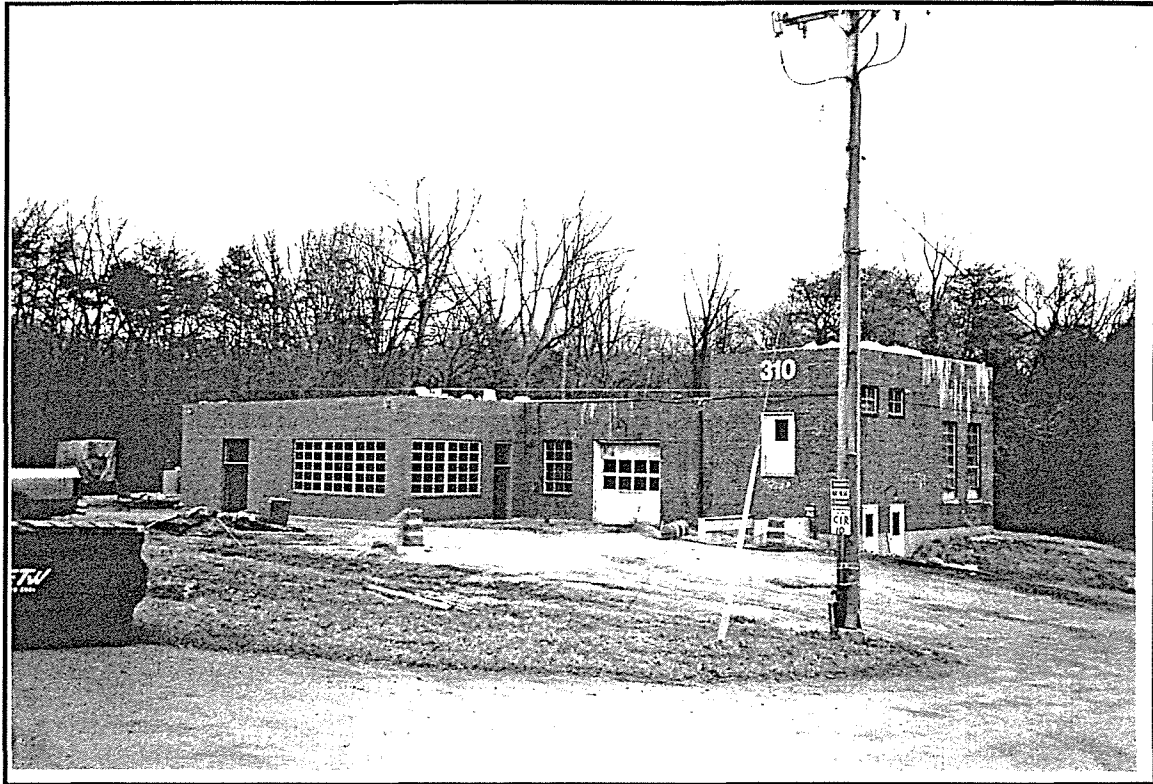
Photo ID: Building 310, South and West Facades, 4/97

The original north facade had a distinct, International style appearance with six pairs of ribbon windows running along the cornice, just below a solid line of concrete coping. These windows are three-over-three in a rectangular shape, which open from the top as an awning window. The plain wooden door was flanked by two large windows with nine panes of glass set on a brick sill. The eastern portion of this original design has been altered by an addition which has removed all evidence of the former appearance. The original windows on this facade have been replaced with two modern, 15-pane metal windows.

The original double garage door on the west facade has been replaced by a common roll-up garage door. The trash access door on the same building face (raised several feet above grade) has likewise been replaced by a more modern door. (See Robinson & Associates Determination of Eligibility Report and MHT Form, BARC Water System, (PG 61-23), 1996.)

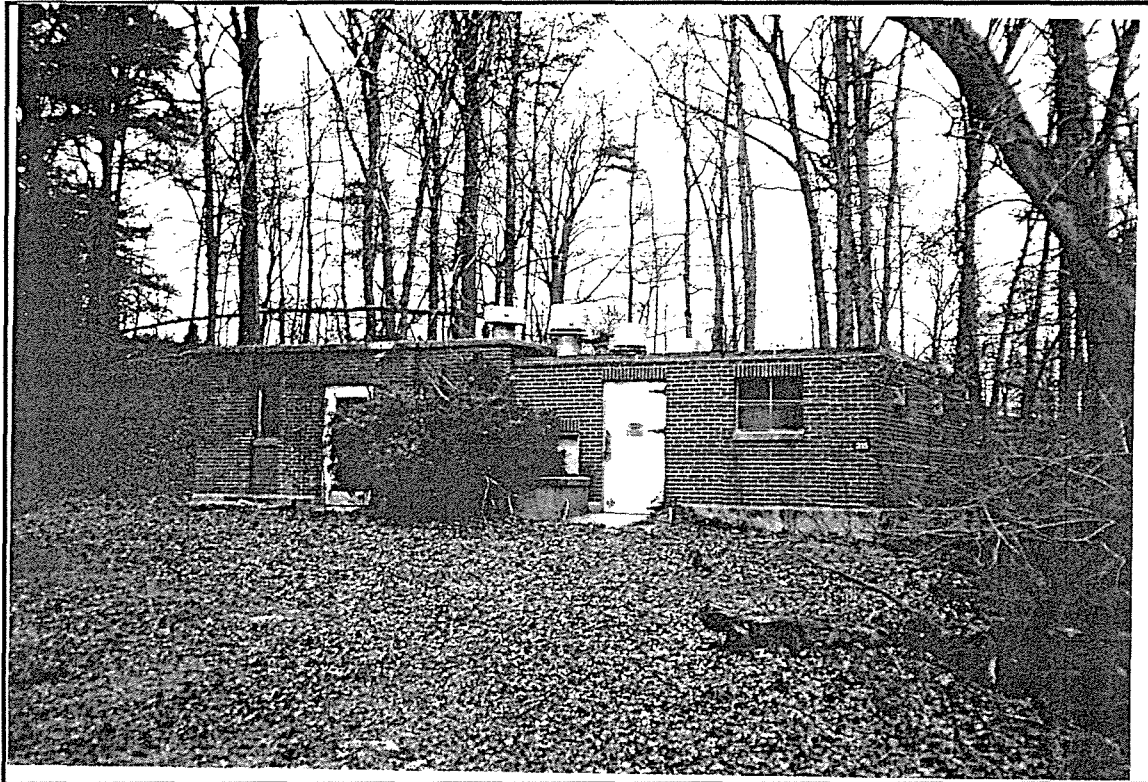
Photo ID: Building 315, South Facade, 4/97

Building 315 is a small, utilitarian, brick building with concrete foundations. The one-story, flat-roofed building was constructed in two component parts. The original north section of the building features projecting vertical panels on either side of the windows and a central front entrance. It also features jack arches and cement sills on the windows and copper gutters. On the front section, it features two, fixed, one-over-one, double-hung windows on either side of a wood door. Small, single-pane windows are located on the side and back of this section. The south portion of the building has a fixed four-pane window on the front facade, a single entrance window, a centrally located refrigerator-type door, and a square opening, likely used for delivery of solvents, located roughly three feet front the ground level. The side facade of this section features high, small, single-pane windows. The rear facade of this section has single four-pane fixed windows on either side of a wood entrance door.

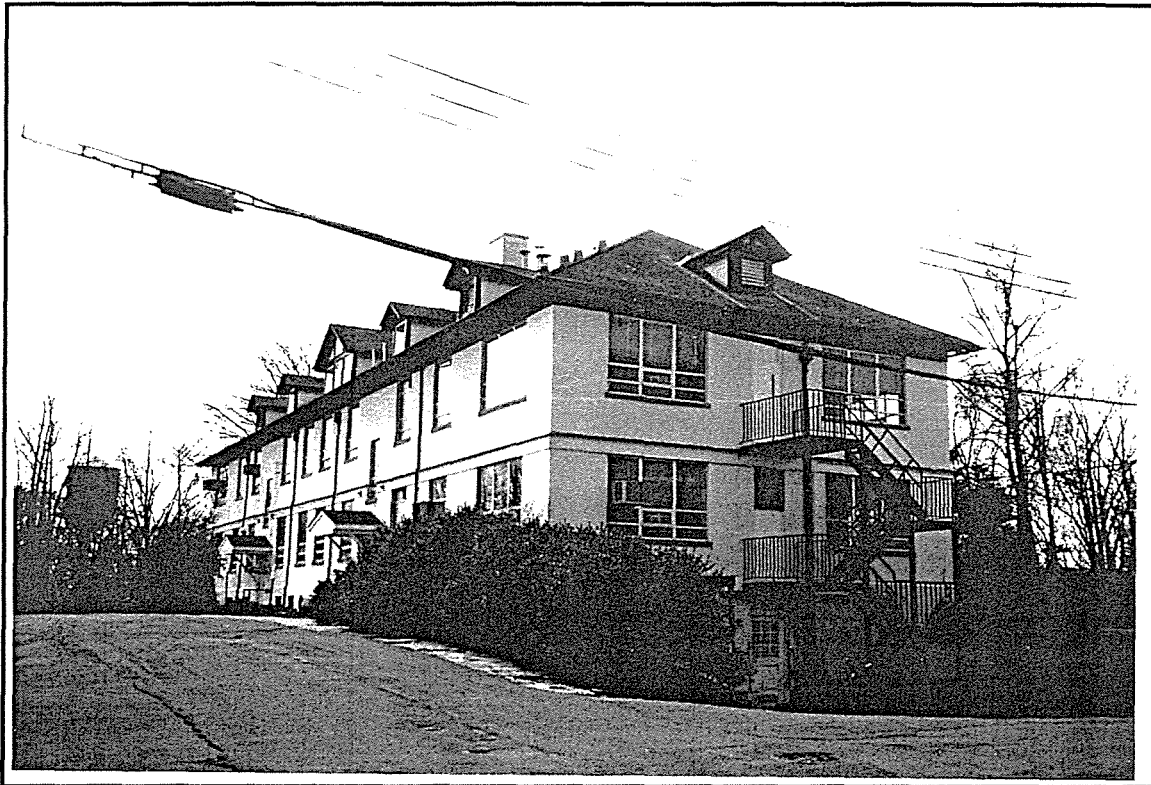
Photo ID: Building 318, North and East Facades, 4/97

This is a rectangular, two-story, concrete-block laboratory building with a stucco finish. There is a raised basement. The west facade has twelve bays and a single entryway. The east facade has twelve bays and two entryways. The entryways each have pedimented overhangs with scrolled wood braces and wood doors with nine panes of glass. The windows on both facades are metal replacement windows which are arranged vertically. Larger lights, which are fixed, are flanked with small panes that swivel open. These windows occur either singly or in sets of three. There are five gable roof dormers on the east facade of the hipped roof. The central dormer is slightly larger and contains three six-pane windows, while two of the smaller dormers contain either six-pane windows or vents. All of the dormers contain green painted areas, which contrast with the ivory color of the stucco. The roof is covered with asphalt shingles and there are acorn ventilators on the ridgeline. An interior concrete chimney, covered in stucco, is also present. The building was vacated in April 1997.

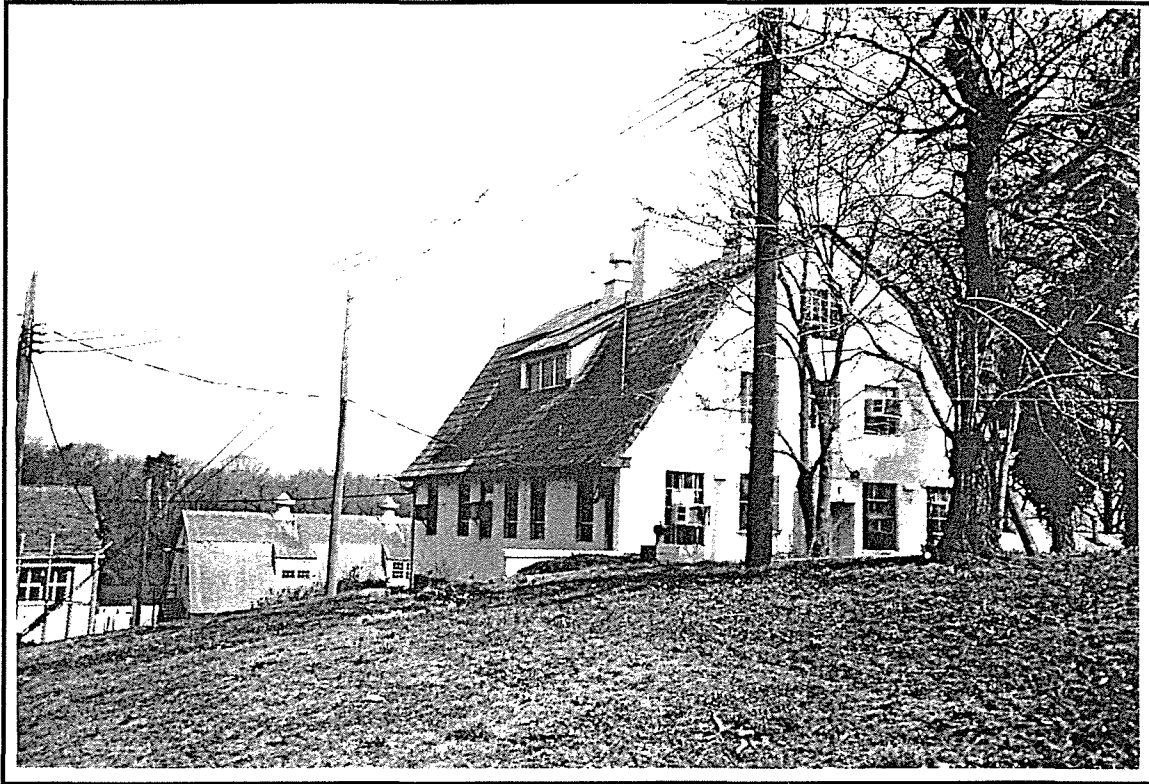
Photo ID: Building 321, South and West Facades, 4/97

This is a two-story barn that has been adaptively reused as a laboratory. The building is constructed in the side of a hill and is of poured concrete construction with a stucco covering. The south facade has a central doorway with a wood tongue and groove door. The entryway is enclosed in a small, flat-roofed addition. The windows on this facade are twelve panes with six center panes that open. The west facade has the same type of windows. There is also a shed-roof dormer with three small six-pane windows on the roof of the west elevation. The north facade has a central metal replacement door, a door directly above this door, and a door in the loft area. Windows on this facade are consistent with the other windows on the building. There is a pointed hood in the gambrel of the roof and a fire escape has been added to the exterior. The east elevation also has consistent windows and a shed-roof dormer. The building also features decorative green painting under the eaves. The gambrel roof is covered with asphalt shingles. There is an interior brick chimney which has been covered in stucco, and various aerators are located on the roof.

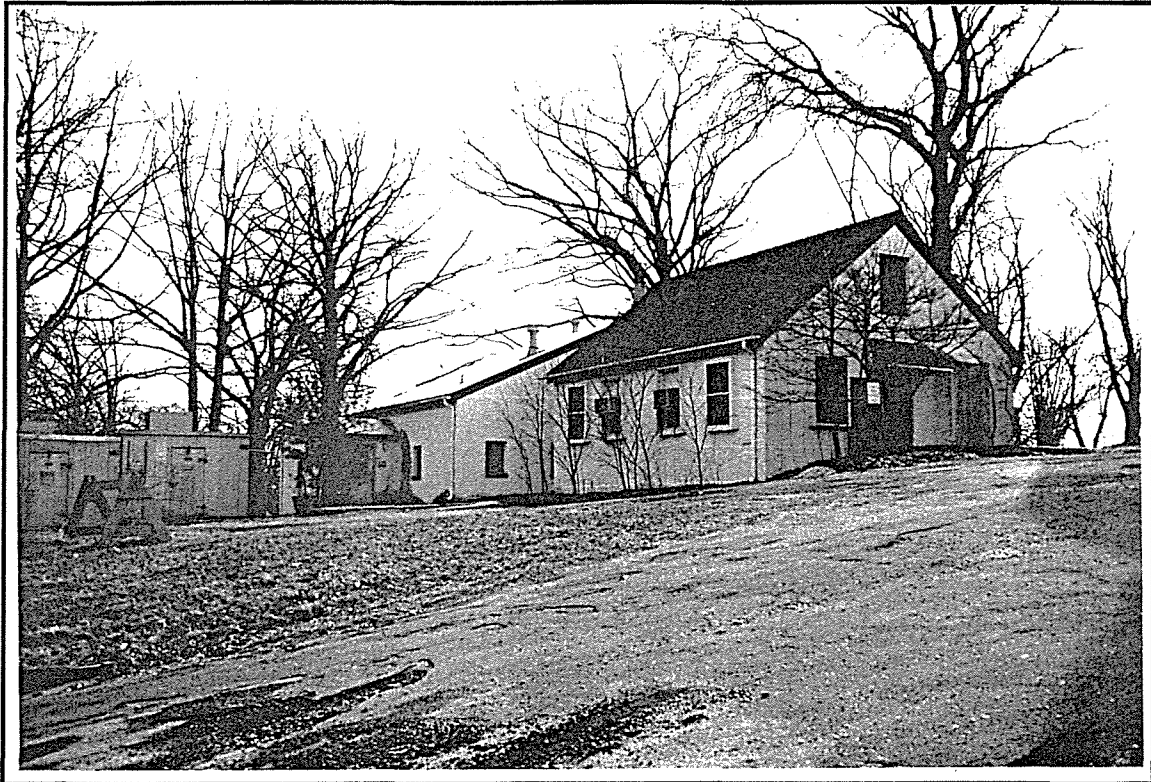
Photo ID: Building 321, West and North Facades, 4/97

This is a one-story concrete block building that has been covered with stucco. The form of the building is two rectangular, side-gable buildings that telescope out from each other. Windows on both buildings are four-over-four double hung, although several have been filled in or now house air-conditioning units. The entry on the west facade has a wood door and a shed roof overhang. The westernmost extension has a shingle roof, while the eastern extension has a metal roof. A concrete chimney is located between the two sections of the building. A replacement gutter system is present.

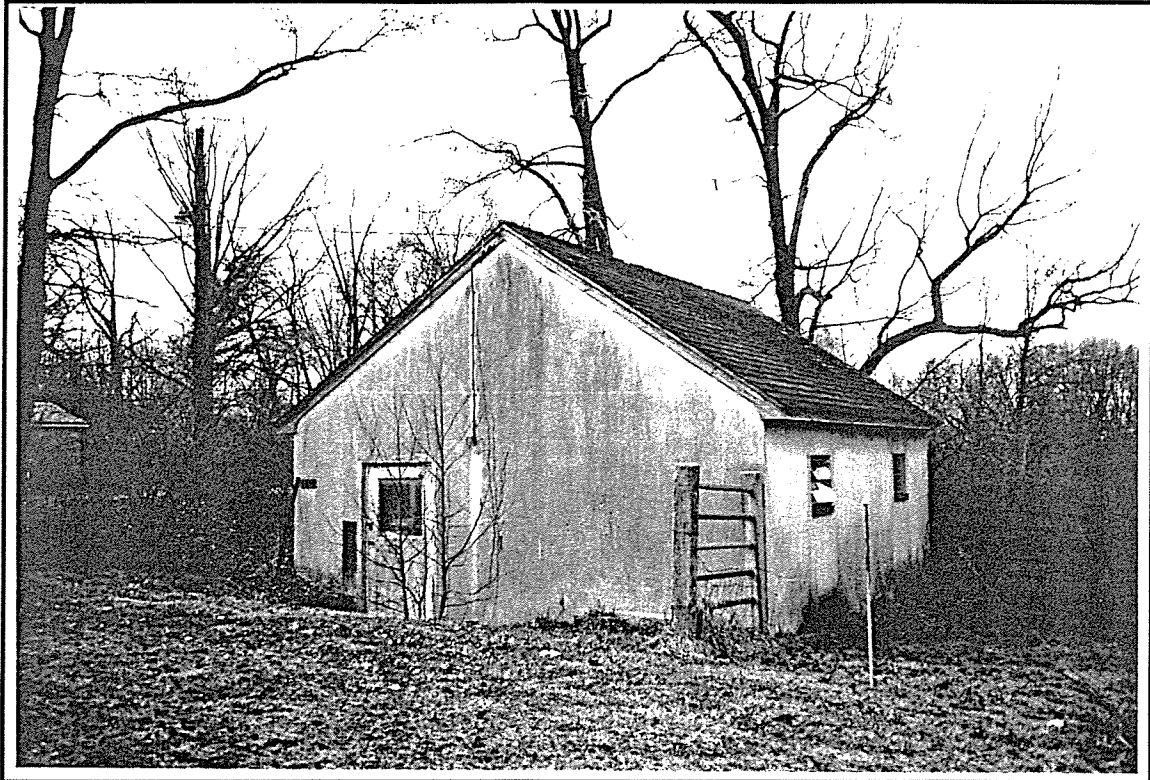
Photo ID: Building 323, North and East Facades, 4/97

This is a small, rectangular building with a gable roof. It is constructed of concrete block, and covered in stucco. The south facade has a metal replacement door that is flanked by two replacement windows. The windows have brick sills. The west facade has no openings. The north facade has two small jalousie windows, also with brick sills. The east facade contains a metal replacement door that contains a single light. The roof is covered with asbestos shingles. There is no gutter system.

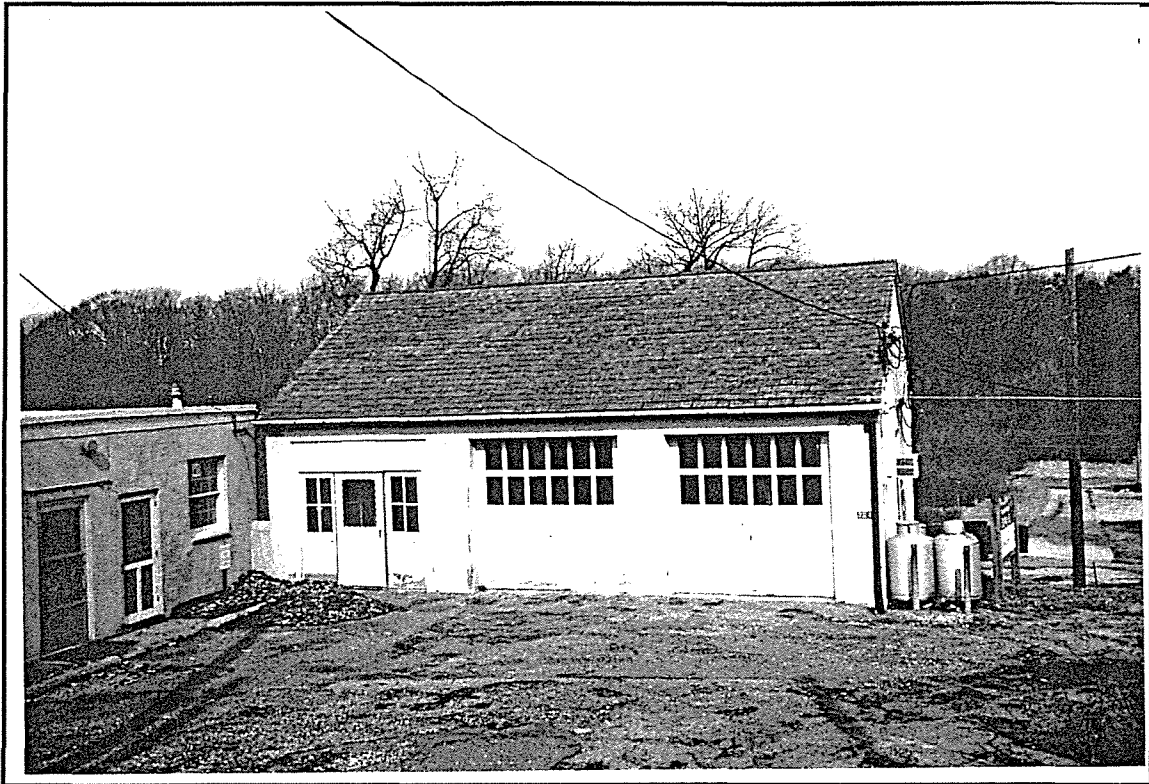
Photo ID: Building 324, South Facade, 4/97

This is a small garage and implement shed constructed of concrete blocks, and covered in stucco. It has been built into the side of a hill, so the south facade is only one story, while the north facade is two stories. The south facade contains three bays. Two bays contain overhung garage doors with multiple panes. The third bay appears to have originally contained a similar door, but it has been partially filled in and now contains a storm door flanked by two, four-paned windows. The east facade contains a single opening, which has been partially filled in to house an air-conditioning unit. The north facade contains three bays. On the first level, there were originally three overhung garage doors, but only the central one remains. The eastern door has been filled in, and the western door has partially been filled in. This space now contains a replacement door and a vent. The second story contains three, nine-pane windows with concrete sills. The west facade is connected to Buildings 324 A and B, which are later additions to the core building. The roof of the core building is covered in asbestos shingles.

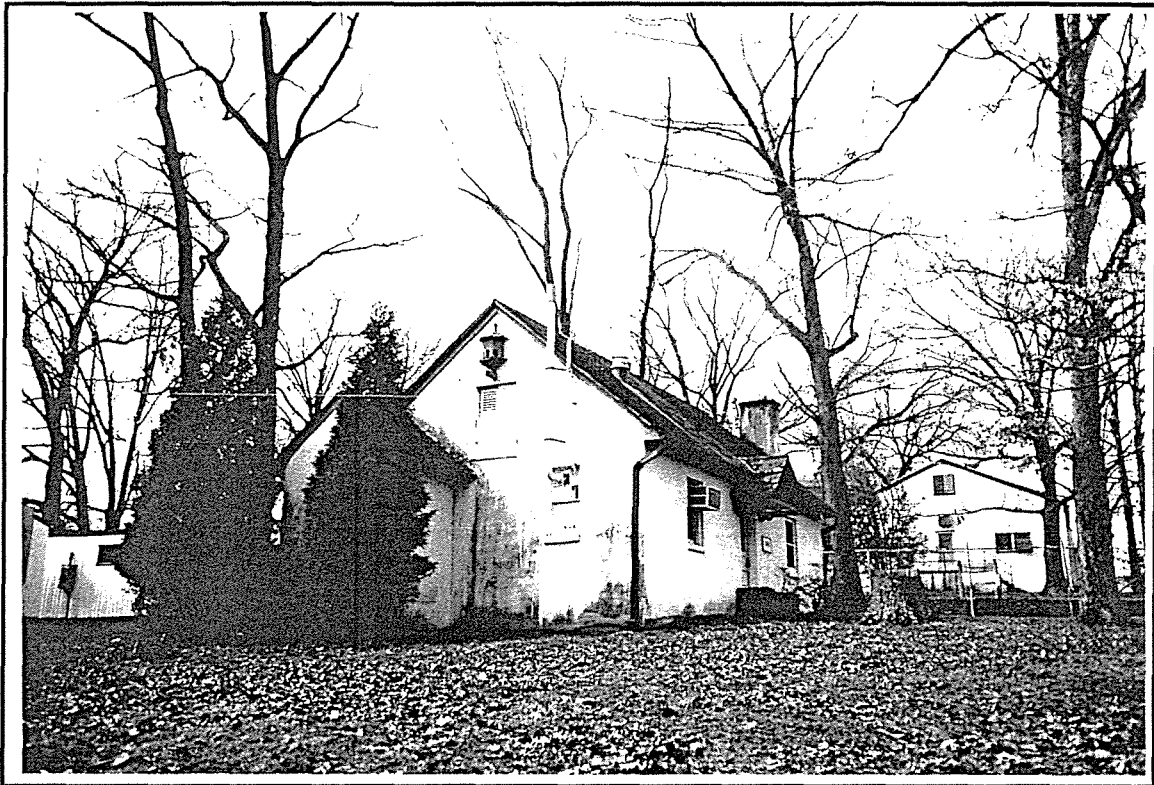
Photo ID: Building 328, North and East Facades, 4/97

This is a rectangular, one-story, side-gable laboratory cottage with a small side-gable addition on the west facade. It is constructed of concrete block and covered in stucco that has been painted a warm cream color. It has a poured concrete foundation and three bays on the south facade. There is a wood paneled door, with four panes of glass, which is centrally located. The doorway is covered by an overhanging pediment which features wood braces. There are two windows on each side of the door; they are six-over-one double-hung windows with metal storm windows obscuring the original wood windows. The east elevation contains a stucco exterior chimney. The north facade also contains three bays, with a centrally located metal replacement door flanked by metal replacement windows. The west elevation contains a filled-in window where a vent has been placed and another window whose glass has been painted. Both the east and west facades contain small bat houses in the gable areas. There is a small side gable addition on this facade. The roof of both the core building and the addition are covered in asphalt shingles. A ventilator shaft is located on the roof and replacement gutters are present. The building is in good condition.

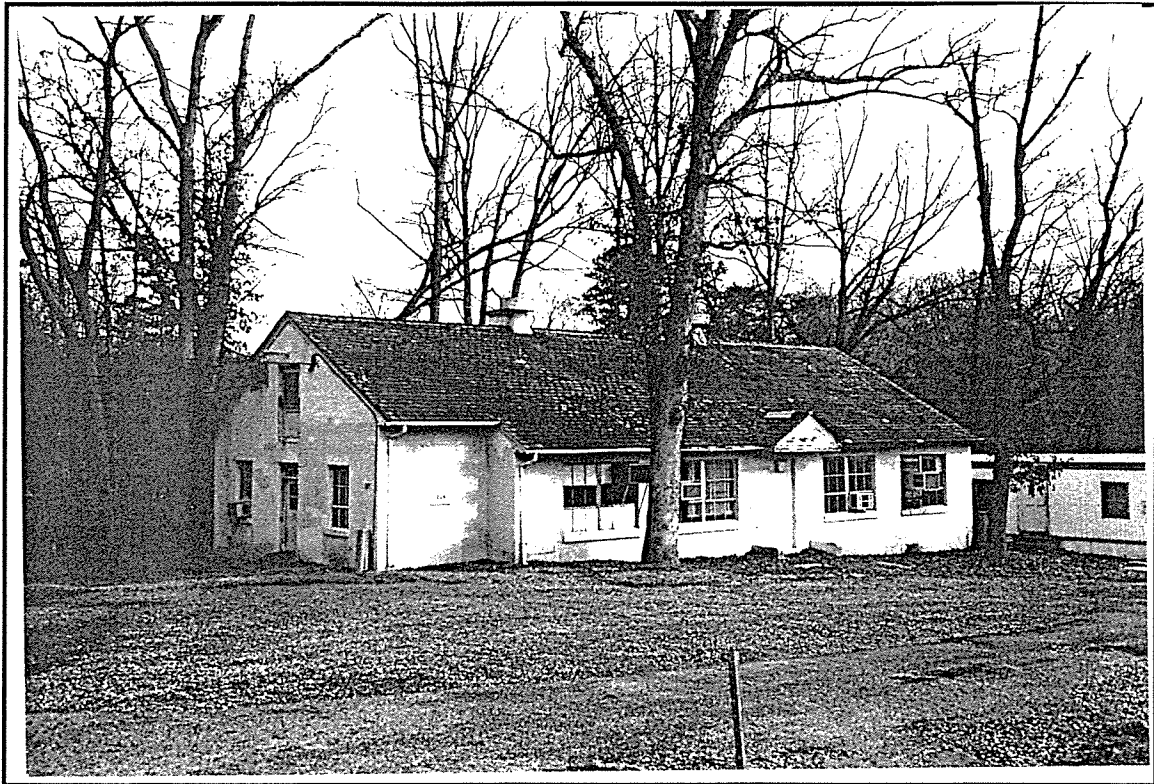
Photo ID: Building 334, South and West Facades, 4/97

This is a one-story, side-gable laboratory building constructed of concrete block with a stucco finish that has been painted a warm cream color. The building has a concrete foundation. The north end of the west facade is set back slightly from the main facade, interrupting the rectangular footprint of the building. A slightly off-center pedimented entryway is located on the west facade. The main door is wood and there are nine-pane windows which occur in pairs on the west facade and singly on east facade. A metal awning covers basement entry with a metal replacement door on the east facade. Nine-pane windows occur in the gables. The side gable roof is covered with asbestos shingles. There is a concrete chimney and metal aerators on the ridgeline. Replacement gutters are in place. The building is in fair condition and is currently vacant.
