## AIRBORNE REMOTE SENSING FOR DETECTION OF IRRIGATION CANAL LEAKAGE<sup>†,‡</sup>

YANBO HUANG<sup>1\*</sup>, GUY FIPPS<sup>2</sup>, STEPHAN J. MAAS<sup>3</sup> AND REGINALD S. FLETCHER<sup>4</sup>

### ABSTRACT

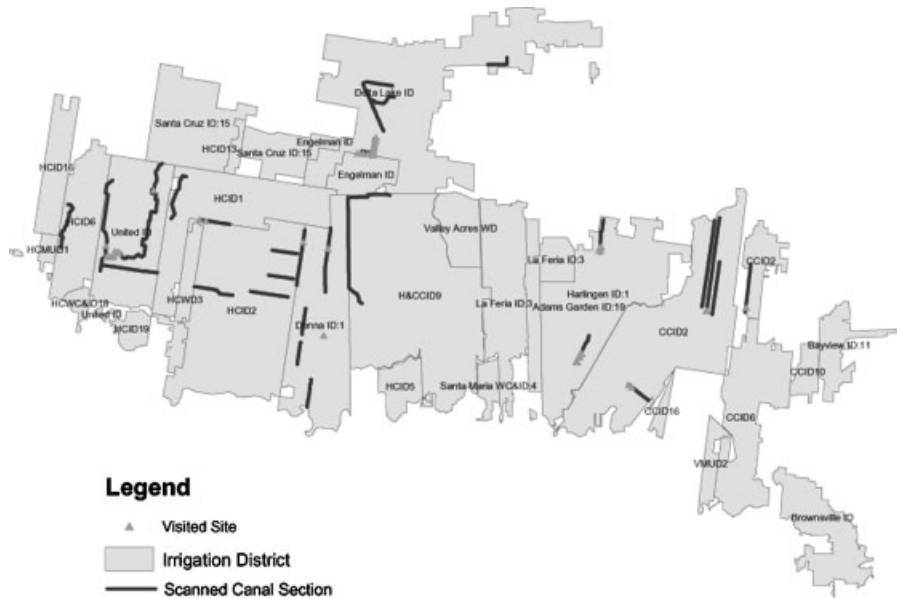
Figure 3. GIS map of scanned canal sections in the overflight and visited sites in field reconnaissance

On February 28, 2005, we conducted a flyover with the imaging system and acquired multispectral imagery of 24 canal sections located within 11 irrigation districts (Figure 3). The flight altitude was 914 m (3000 ft) above ground level, resulting in a spatial resolution of 0.64 m (2.1 ft) per pixel for the red and NIR images and in a spatial resolution of 2.07 m (6.8 ft) per pixel for the thermal imagery. Four hundred and thirty-nine image triplets (439 red, 439 NIR, and 439 thermal images) were obtained during the mission. Fifteen and nine lined and unlined canals, respectively, were present in the 24 sections.

After the overflight, 140 of the 439 imaged canal sites were identified as having possible canal leakage problems (point leak and/or seepage). The image triplets from the 140 sites were processed for further analysis.

Field reconnaissance verified that 26 of the 28 sites inspected had leakage problems (Table II), representing a 93% success rate of image analysis. Three of the leak sites were considered to have major leakage problems. The following three case studies provide details on the sites and interpretation of the imaging.
