# Beltsville Agricultural Research Center Hazardous Materials Assessment Part 2

**Beltsville Agricultural Research Center  
Hazardous Materials Assessment  
Project No. 103144**

**Revision 1  
April 22, 2020**

**Burns & McDonnell Engineering Company, Inc.  
Downers Grove, Illinois**

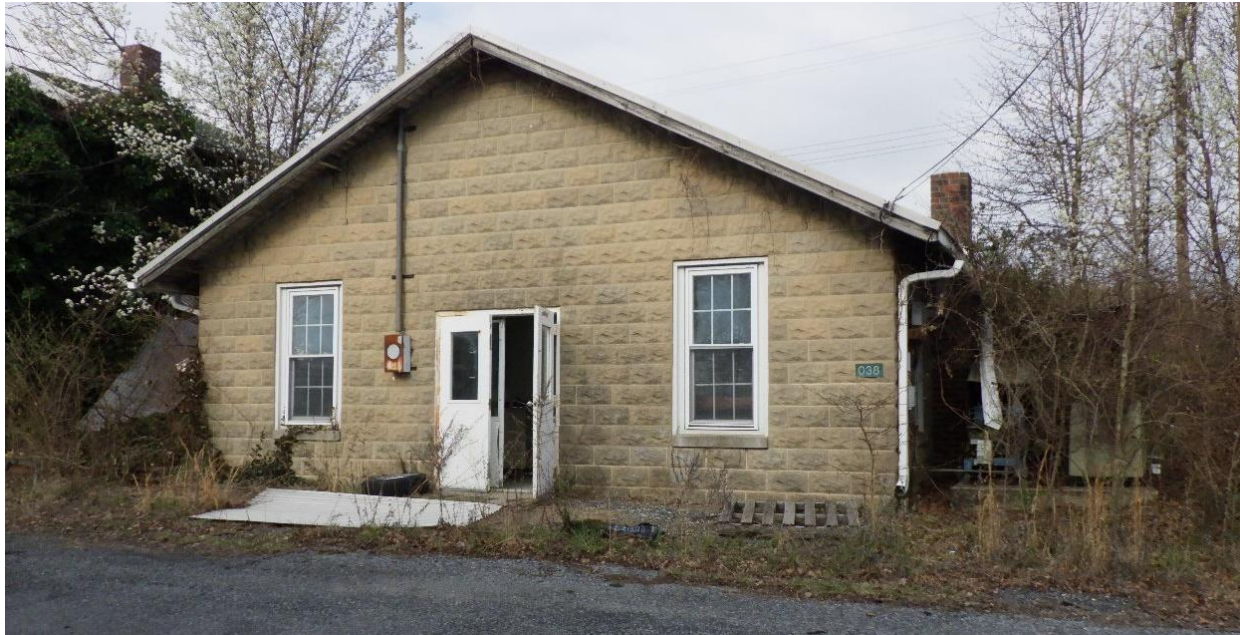
Figure 8-1: Building 38, Facing west, location shown on Appendix A, Figure 2

No presumed asbestos-containing materials were found.

Thermostats were found throughout Building 38 and 8-foot fluorescent bulbs were found in the office.

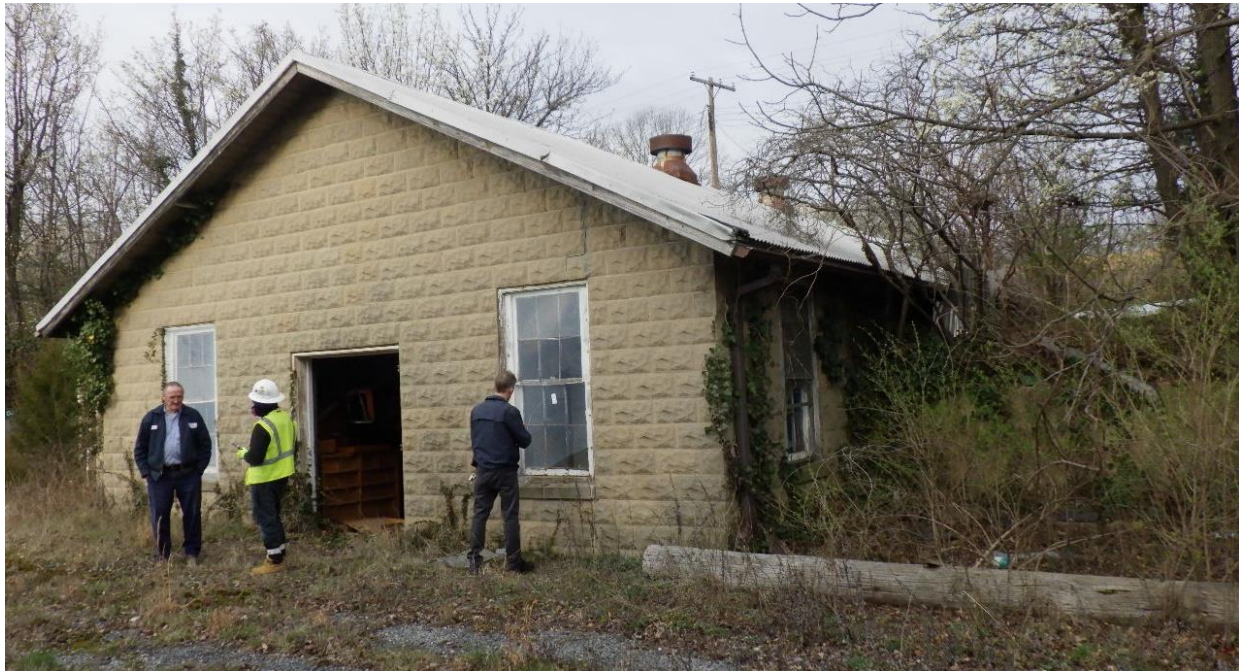
**Figure 8-3: Building 40, facing southwest, location shown on Appendix A, Figure 2**

Sample ID	Building	Type Of Material	Description	Location	Approx. Quantity	Units	Results	Physical Assessment
	40	chemicals	fire extinguishers	lab room	1	each		
040-Pb1	40	lead paint	White Paint - Wood Substrate	Exterior, Front of Building			310000 mg/kg	
040-Pb3	40	lead paint	Teal Paint - Wood Substrate	Room 3			30000 mg/kg	
	40	mercury	fluorescent lamps	lab room	2	each		
	40	mercury	Thermostat	lab room	2	each		
	40	mercury	8 ft fluorescent bulbs	storage room	2	each		
	40	oil	cushman vehicle	office room	1	each		
	40	PCB	Ballast	lab room	1	each		
	40	PCB	Ballast	storage room	1	each

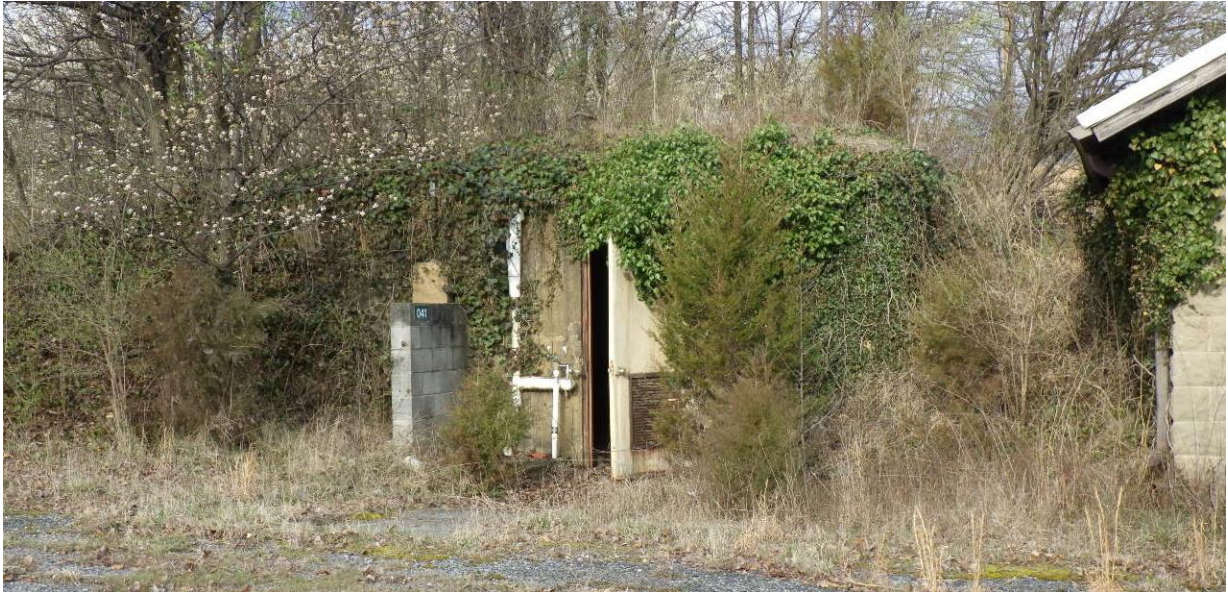
**Figure 8-4: Building 41, facing southwest, location shown on Appendix A, Figure 2**

Sample ID	Building	Type Of Material	Description	Location	Approx. Quantity	Units	Results	Physical Assessment
	41	chemicals	empty fuel tanks	main room	2	each

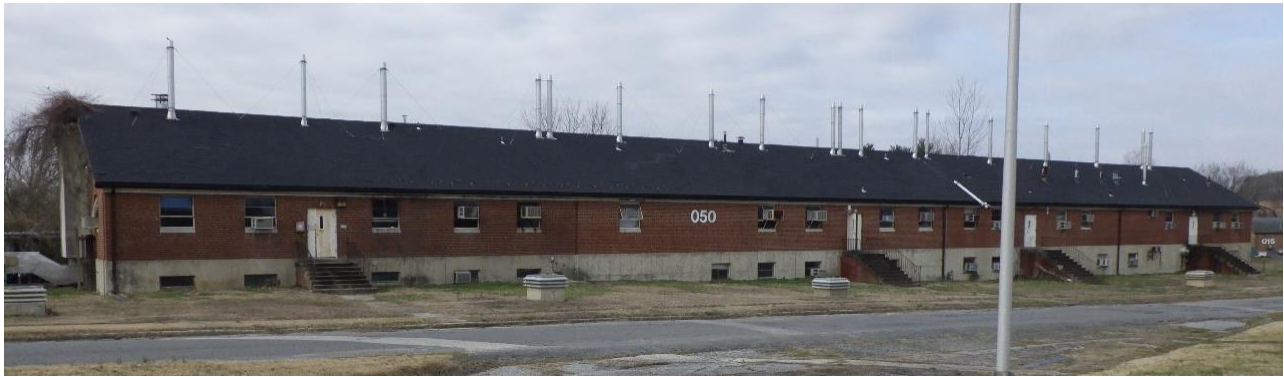
**Figure 8-5: Building 50, facing southwest location shown on Appendix A, Figure 2**

50	PCB	ballast	Greenhouses	4	each		
	50	refrigerant	cryogenic freezer	East greenhouse LL utility room	1	each		
	50	refrigerant	voltage regulators	basement labs	8	each		
	50	refrigerant	walk in refrigerator storage	Central Greenhouse Storage LL	34	each		
	50	refrigerant	AC unit in storage	Central Greenhouse Storage LL	1	each		
	50	refrigerant	refrigerators	Office floor	5	each		
	50	refrigerant	water fountain	Office floor	1	each		
	50	refrigerant	walk in cooler units	West Greenhouse Basement	6	each		
	50	refrigerant	Refrigerators in storage	West Greenhouse Basement	6	each		
	50	refrigerant	freezer	West office LL	3	each		
	50	refrigerant	Window AC	Exterior, North, West, South sides	15	each		
	50	refrigerant	Heat pump compressors	Exterior south side	6	each		
	50	refrigerant	HVAC central	ext compressor, evaps throughout	1	each		
	50	refrigerant	Window AC	North x East B	23	each		
	50	refrigerant	lab cold / hot bath unit	Room 3	3	each

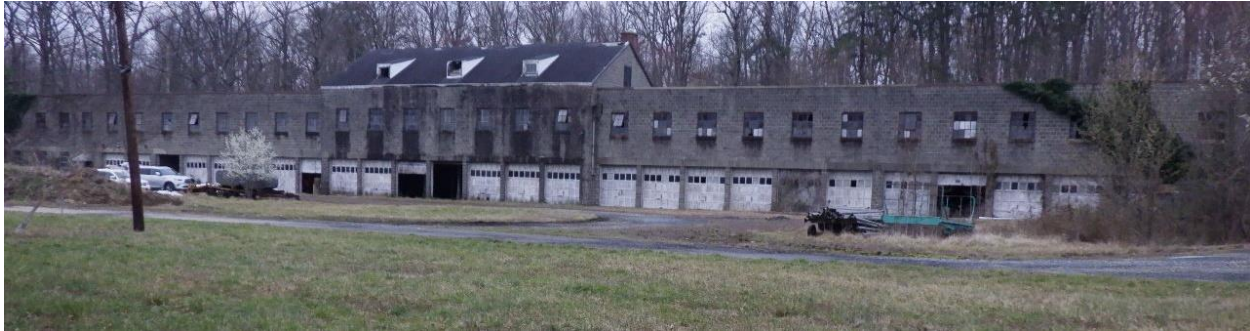
**Figure 8-6: Building 60, facing southeast, location shown on Appendix A, Figure 2**

60	refrigerant	heat pump	main LL garage bay	1	each

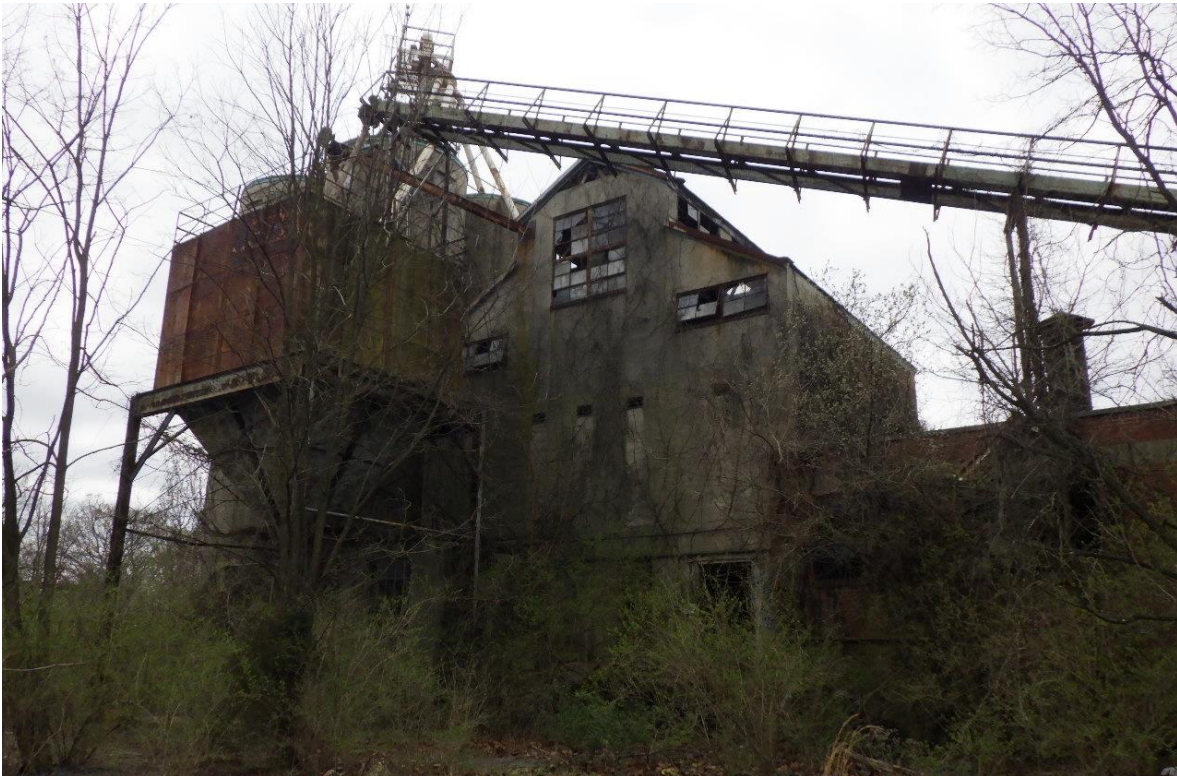
**Figure 8-7: Building 85, facing southwest, location shown on Appendix A, Figure 3**

Sample ID	Building	Type Of Material	Description	Location	Approx. Quantity	Units	Results	Physical Assessment
085PACM	85	asbestos	Pipe Insulation Wrap	exterior between grain silos and v	25	lf	Not Analyzed	Friable
085PACM	85	asbestos	Silo Roof Material	Exterior Grain Silos	700	sf	Not Analyzed	Non-Friable -II
	85	chemicals	epsom salt	50 lb. bags warehouse	8	each		
	85	chemicals	fire extinguisher	center area	2	each		
	85	chemicals	50 lb. bags phosphoric acid	storage	8	each		
085-Pb2	85	lead paint	Gray Paint - Metal Substrate	Back of Building			100000 mg/kg	
085-Pb3	85	lead paint	Green Paint - Metal Substrate	AHU Beam			13000 mg/kg	
085-Pb4	85	lead paint	Yellow Paint - Metal Substrate	Grain Mixer			33000 mg/kg	
	85	oil	residuals gearbox	auger equipment throughout	20	gal		
	85	PCB	Ballast	storage room	8	each		
	85	refrigerant	Heat pump	west of building	1	each

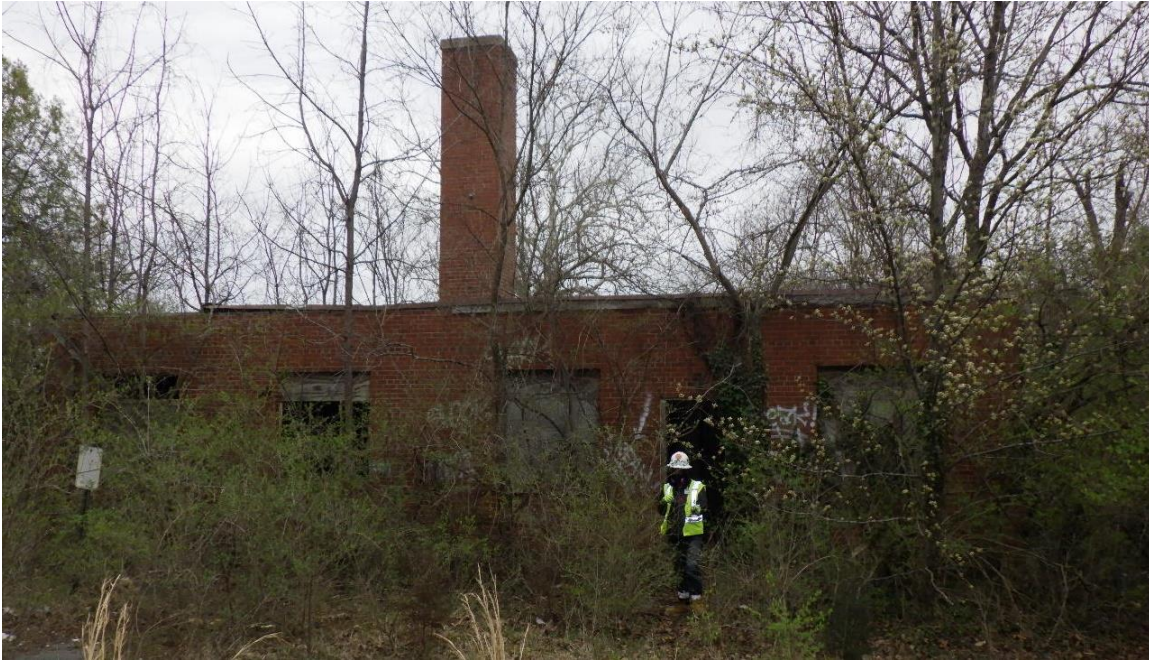
**Figure 8-8: Building 85A, facing east, location shown on Appendix A, Figure 3**

85A	mercury	4 ft fluorescent bulbs	throughout	20	each		
	85A	PCB	Ballast	throughout	10	each

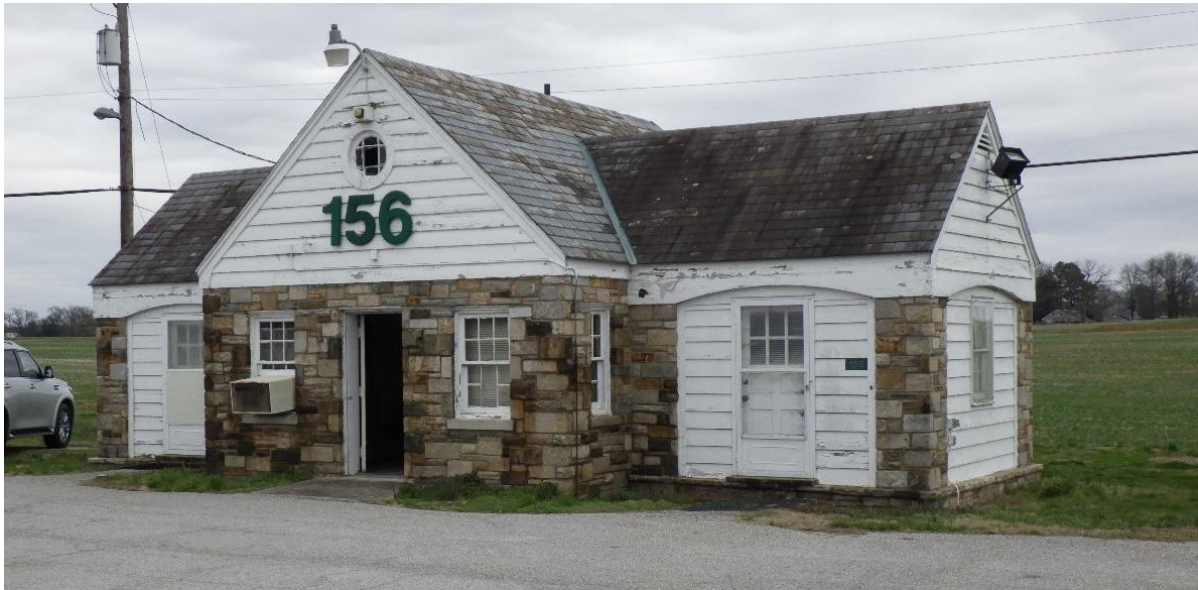
**Figure 8-9: Building 156, facing southeast location shown on Appendix A, Figure 3**

156	mercury	4 ft fluorescent bulbs	throughout	30	each		
	156	PCB	Ballast	throughout	15	each		
	156	refrigerant	window AC	exterior north side	1	each		
	156	refrigerant	water cooler/fountain	central room	1	each

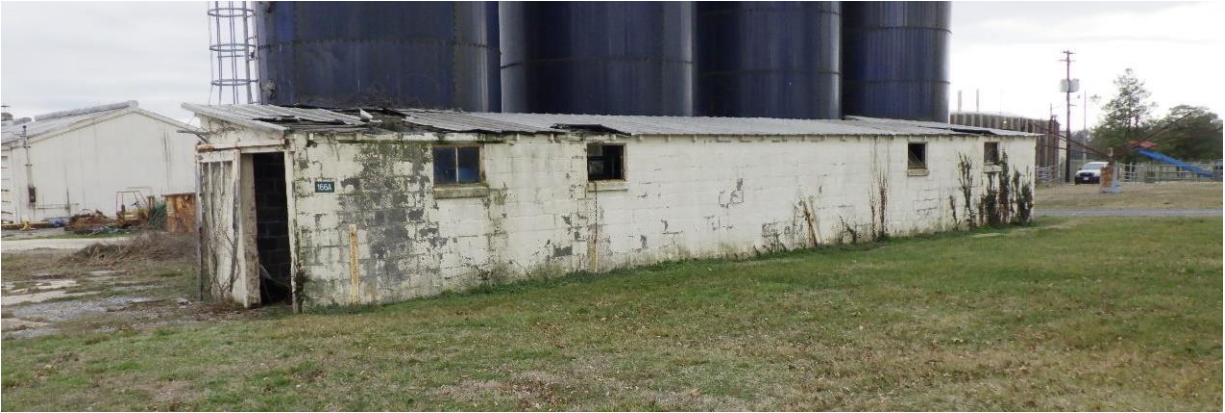
**Figure 8-2: Building 166A, facing southwest, location shown on Appendix A, Figure 3  
ACM**

No asbestos-containing materials were found.

No visible mold was present in the building

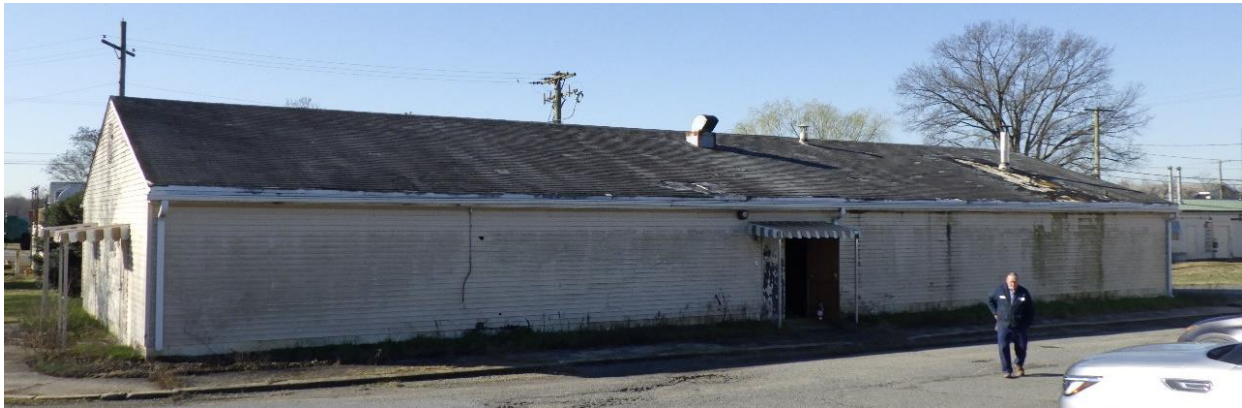
**Figure 8-3: Building 177B, facing southwest, location shown on Appendix A, Figure 3**

177B	PCB	flourescent ballasts	throughout	32	each		
	177B	refrigerant	heat pumps	south side exterior	2	each		
	177B	refrigerant	water fountain cooler	hallway	1	each		
	177B	refrigerant	ice machine	hallway	1	each		
	177B	refrigerant	refrigerator	hallway	1	each		
	177B	refrigerant	mobile frige	room 106	1	each

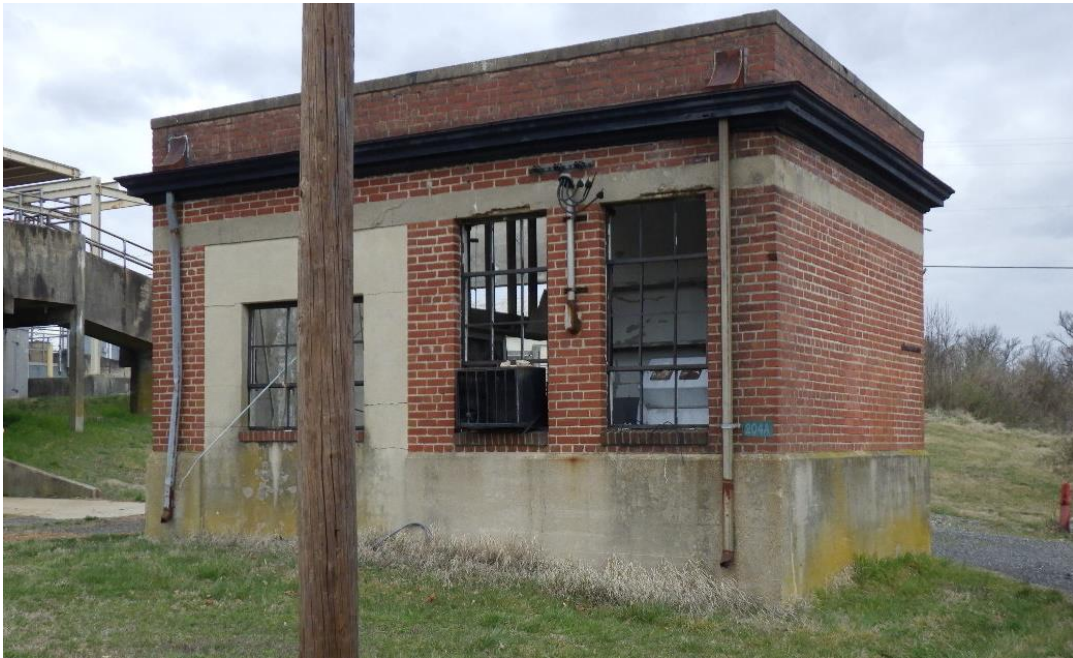
**Figure 8-4: Building 204A, facing northwest, location shown on Appendix A, Figure 3**

Sample ID	Building	Type Of Material	Description	Location	Approx. Quantity	Units	Results	Physical Assessment
204A-PACM	204A	asbestos	Roof Flashing	Exterior Roof	78	lf	Not Analyzed	Non-Friable - I
204A-PACM		asbestos	Roof membrane	Exterior Roof	180	sf	Not Analyzed	Non-Friable - I
	204A	electronics	controls rack mounted	main room	12	each		
	204A	mercury	thermostat	main room	1	each		
	204A	refrigerant	AC unit	main room	2	each

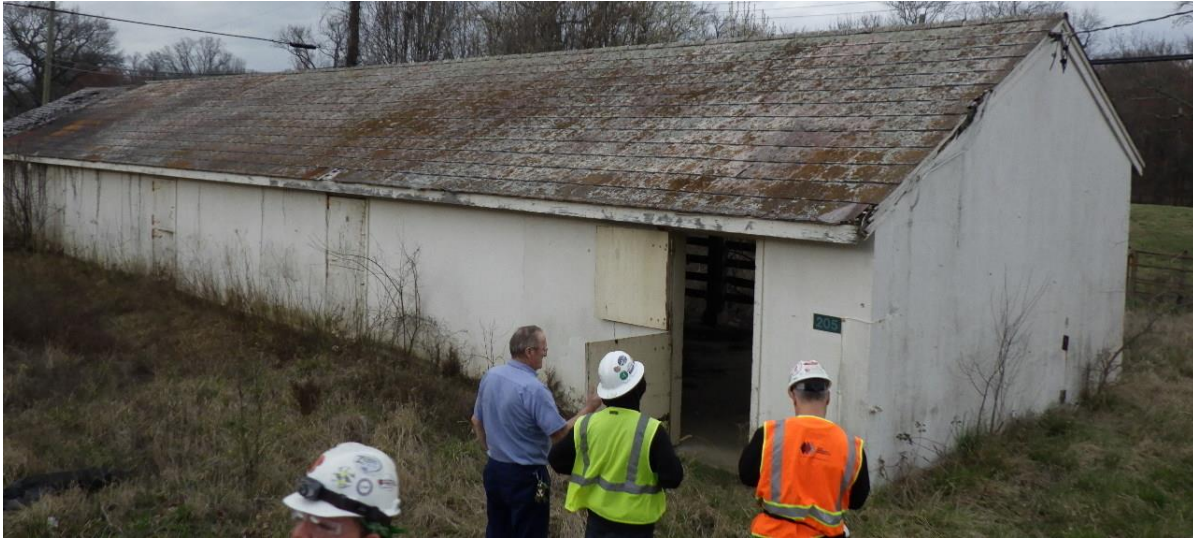
Figure 8-5: Building 205, facing northeast, location shown on Appendix A, Figure 3

Sample ID	Building	Type Of Material	Description	Location	Approx. Quantity	Units	Results	Physical Assessment
205A1	205	asbestos	Roof Shingle	Exterior Roof	2350	sf	Chrysotile 20-25%	Non-Friable - II
205A2		asbestos		Exterior Roof			Chrysotile 20-25%	Non-Friable - II
205A3		asbestos		Exterior Roof			Chrysotile 20-25%	Non-Friable - II

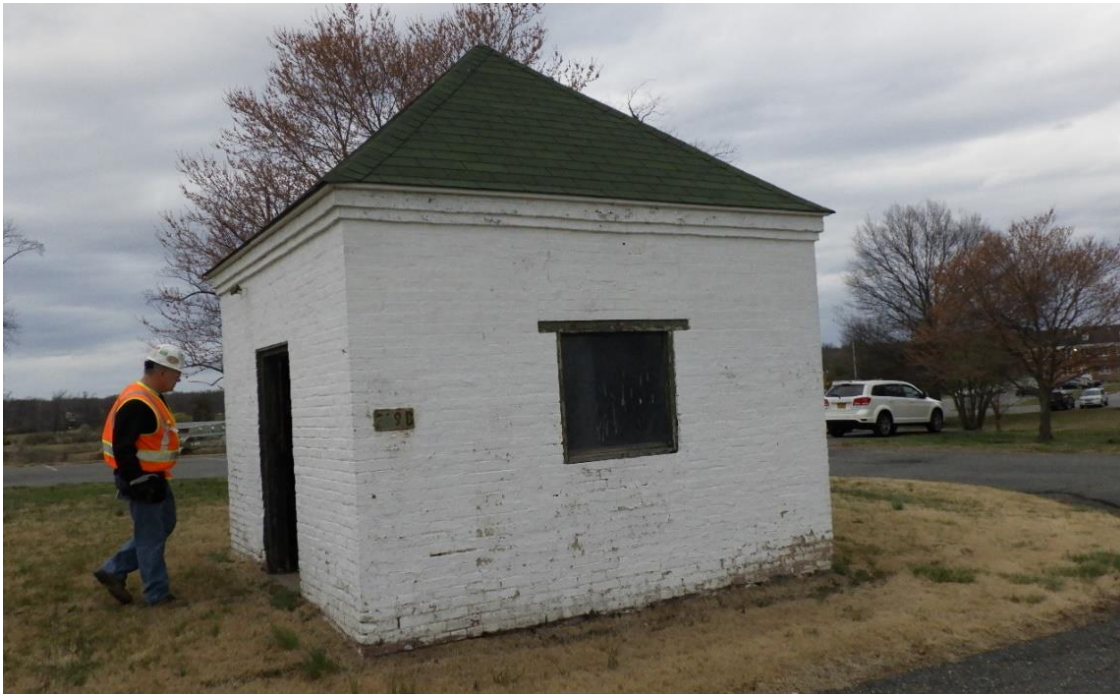
Figure 8-6: Building 209B, facing north, location shown on Appendix A, Figure 3

Sample ID	Building	Type Of Material	Description	Location	Approx. Quantity	Units	Results	Physical Assessment
209B-Pb1	209B	lead paint	White Paint - Concrete Substrate	Exterior of Building			14000 mg/kg

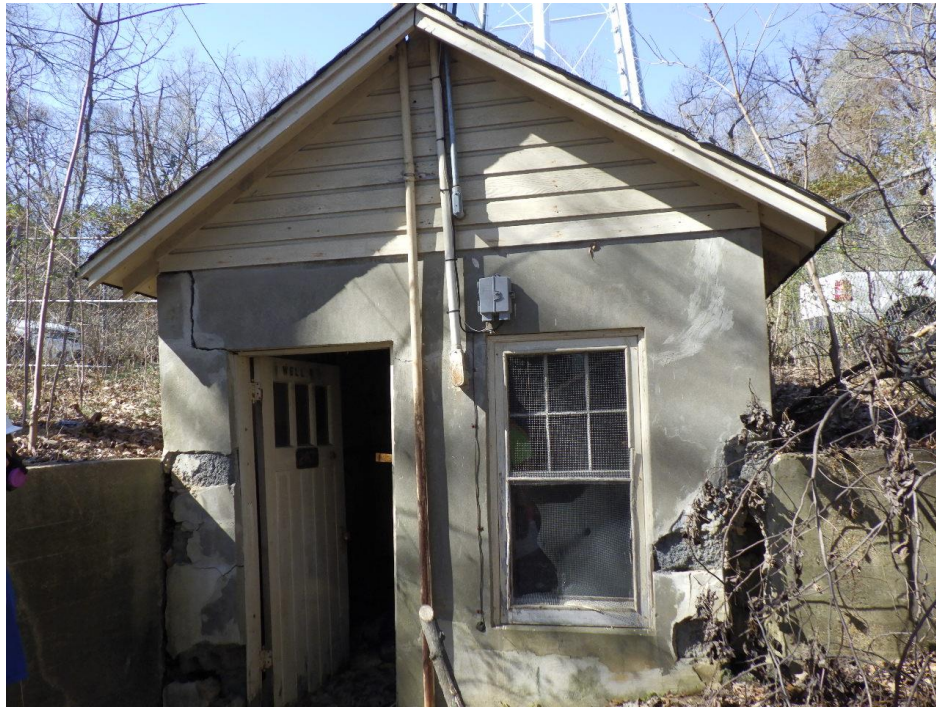
Figure 8-7: Building 287, facing west, location shown on Appendix A, Figure 3

Sample ID	Building	Type Of Material	Description	Location	Approx. Quantity	Units	Results	Physical Assessment
	287	electronics	heater	main room	1	each		
	287	electronics	circuite breaker panels	main room	2	each		
287A-Pb1	287	lead paint	Beige Paint - Wood Substrate	Entrance Door, Front			260000 mg/kg	
287A-Pb3	287	lead paint	Beige Paint - Wood Substrate	Front, Window Casing/Trim			240000 mg/kg	
287A-Pb4	287	lead paint	Beige Paint - Metal Substrate	Front, Pipe/Conduit			460000 mg/kg

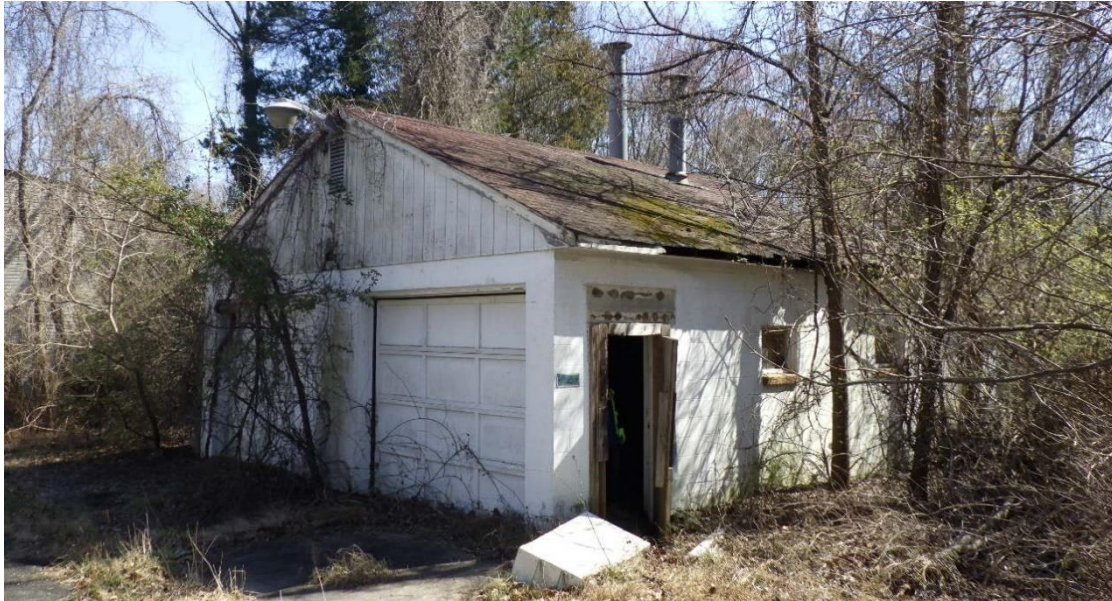
**Figure 8-16: Building 288A, facing southeast, location shown on Appendix A, Figure 3**

Sample ID	Building	Type Of Material	Description	Location	Approx. Quantity	Units	Results	Physical Assessment
	288A	electronics	electrical meter	exterior	1	each		
	288A	electronics	security control panel	interior main room	1	each		
	288A	electronics	elec control panel	interior main room	1	each		
288A-Pb4	288A	lead paint	White Paint - Metal Substrate	Room 1, Fume Hood			6400 mg/kg	
	288A	mercury	thrermostat	interior main room	1	each		
	288A	mercury	HP sodium light	exterior	1	each		
	288A	mercury	flourescent bulbs, 4 ft	throughout	22	each		
	288A	PCB	flourescent ballasts	throughout	11	each		
	288A	refrigerant	AC condenser	exterior	1	each

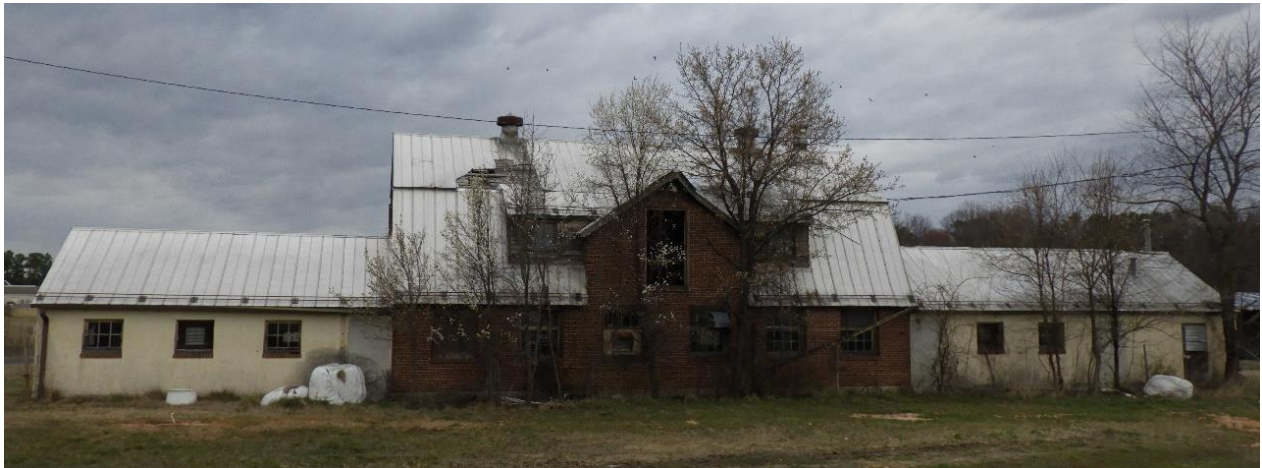
**Figure 8-18: Building 434 view from south, location shown on Appendix A, Figure 3**

Sample ID	Building	Type Of Material	Description	Location	Approx. Quantity	Units	Results	Physical Assessment
343-Pb1	434	lead paint	Beige Paint - Wood Substrate	Exterior, Front of Building			370000 mg/kg	
343-Pb2	434	lead paint	Beige Paint - Wood Substrate	Exterior, Front of Building			390000 mg/kg	
343-Pb3	434	lead paint	Gray Paint - Concrete Substrate	Room 1			30000 mg/kg	
343-Pb4	434	lead paint	Teal Paint - Concrete Substrate	Room 2			10000 mg/kg	
	434	mercury	flourescent bulbs	Goat barn	36	each		
	434	mercury	thermostats	Goat barn	8	each		
	434	PCB	ballast	Goat barn	18	each		
	434	refrigerant	water fountain	Goat barn	1	each

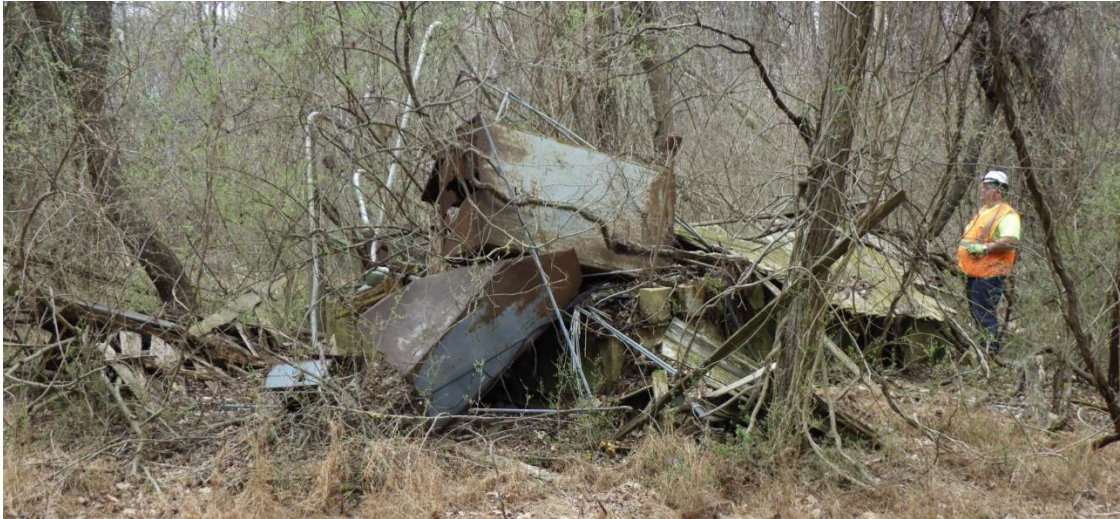
**Figure 8-9: Building 452, facing north, location shown on Appendix A, Figure 3**

Sample ID	Building	Type Of Material	Description	Location	Approx. Quantity	Units	Results	Physical Assessment
452A1	452	asbestos	9 x 9 Green Floor Tile	In Debris Pile	240	sf	Chrysotile 1-5%	Non-Friable - I
452A2		asbestos		In Debris Pile			Chrysotile 1-5%	Non-Friable - I
452B1	452	asbestos	9 x 9 Green Floor Tile	In Debris Pile	240	sf	Chrysotile 1-5%	Non-Friable - I
452B2		asbestos	Mastic	In Debris Pile			Chrysotile 1-5%	Non-Friable - I
452-Pb1	452	lead paint	White Paint - Concrete Substrate	Exterior Around Building			480000 mg/kg

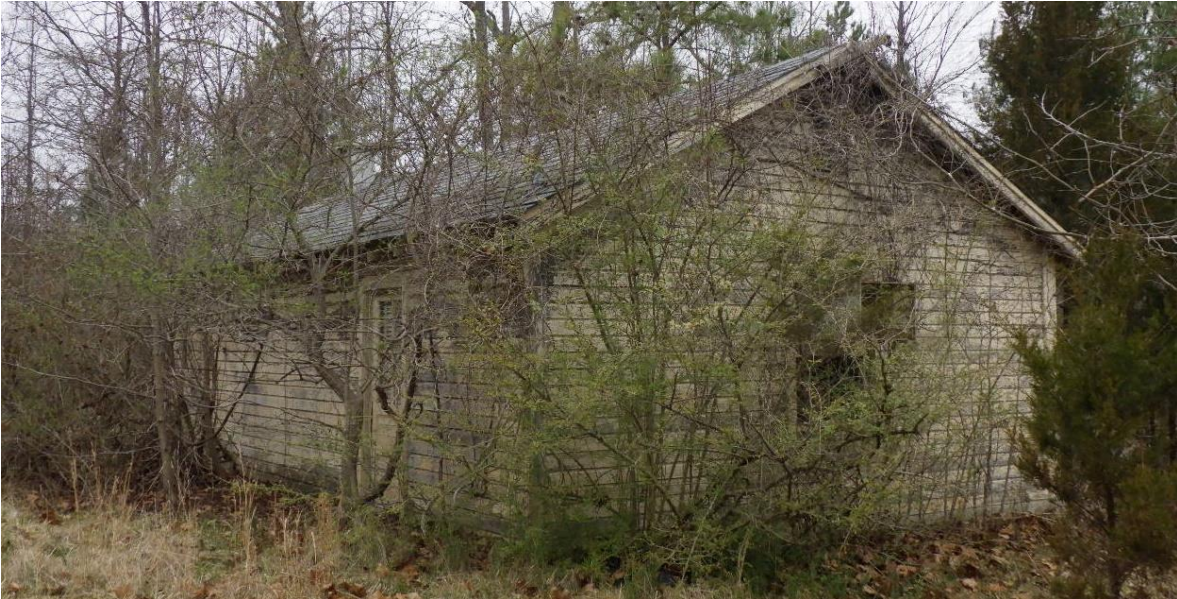
**Figure 8-11: Building 468, facing northwest, location shown on Appendix A, Figure 3**

468-Pb4	468	lead paint	Teal Paint - Wood Substrate	Laboratory Near Side Door			40000 mg/kg

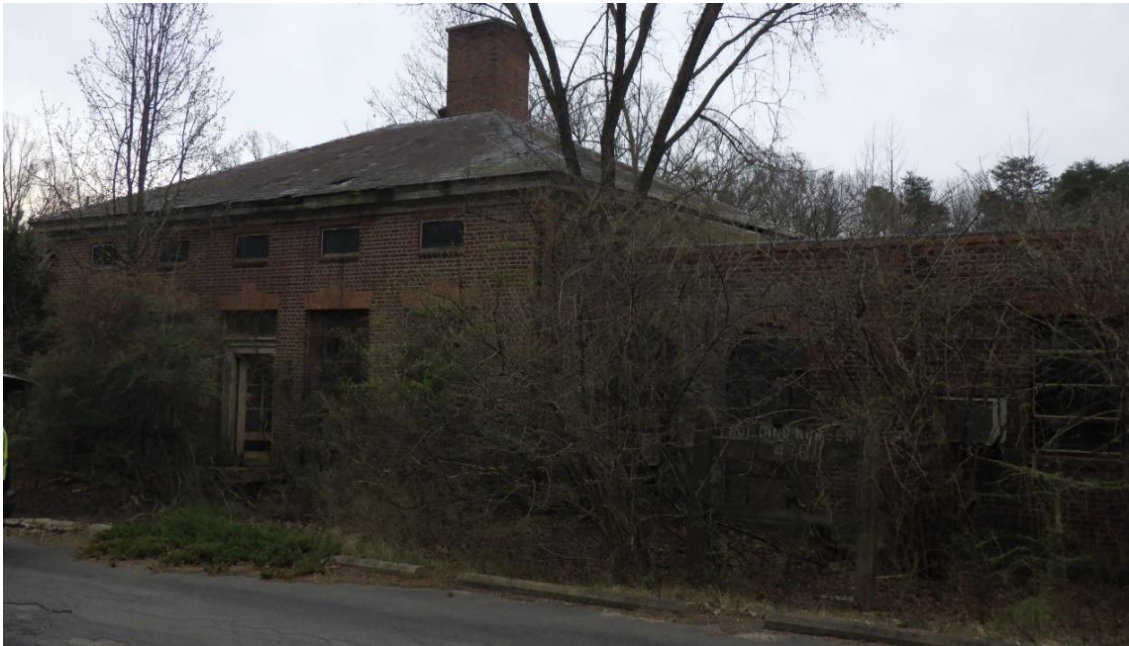
**Figure 8-23: Building 470, facing southeast, location shown on Appendix A, Figure 3**

470-Pb7	470	lead paint	Blue Paint - Concrete Substrate	Greenhouse Hallway			6300 mg/kg

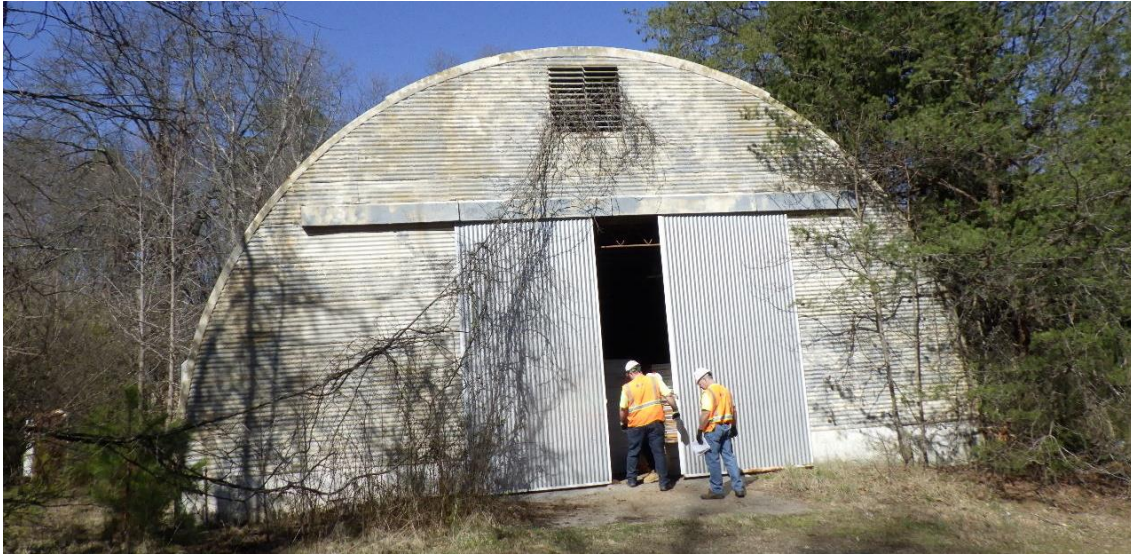
Figure 8-24: Building 470B, facing north, location shown on Appendix A, Figure 3

Sample ID	Building	Type Of Material	Description	Location	Approx. Quantity	Units	Results	Physical Assessment
	470B	chemicals	fire extinguisher	throughout	6	each		
	470B	electronics	unit heaters	storage rooms	2	each		
470-Pb2*	470B	lead paint	Gray Paint - Metal Substrate	Interior wall			7700 mg/kg	
	470B	mercury	flourescent bulbs, 4 ft	throughout	25	each		
	470B	mercury	thermostat	stoage room	1	each		
	470B	mercury	computer CRT monitor	storage room	1	each		
	470B	mercury	CFL bulbs	throughout	4	each		
	470B	mercury	flourescent bulbs, 8ft	climate chambers	16	each		
	470B	mercury	thermostats	climate chambers	4	each		
	470B	PCB	flourescent ballasts	throughout	14	each		
	470B	PCB	flourescent ballasts	climate chambers	8	each		
	470B	refrigerant	refrigerant re-fill tank	storage room	20	lb		
	470B	refrigerant	refrigerator	storage room	1	each		
	470B	refrigerant	heat pumps	attic for climate chamber heating/cooling	4	each

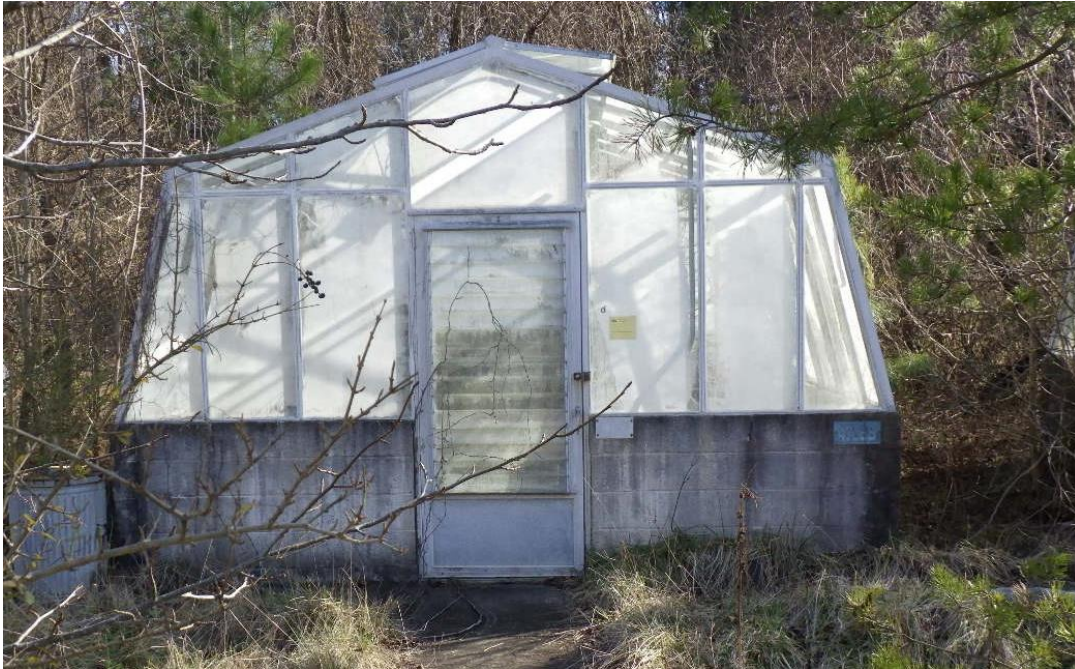
**Figure 8-13: Building 470BB, facing south, location shown on Appendix A, Figure 3**

Sample ID	Building	Type Of Material	Description	Location	Approx. Quantity	Units	Results	Physical Assessment
470-AAA1	470AA-470II	asbestos	Transite Panel	Flower Boxes in Greenhouses	1450	sf	Chrysotile 20-25%	Non-Friable - II
470-AAA2		asbestos		Flower Boxes in Greenhouses			Chrysotile 20-25%	Non-Friable - II
470-AAA3		asbestos		Flower Boxes in Greenhouses			Chrysotile 20-25%	Non-Friable - II
	470BB	electronics	wall/unit heaters	greenhouse	2	each		
	470BB	mercury	thermostats	greenhouse	4	each

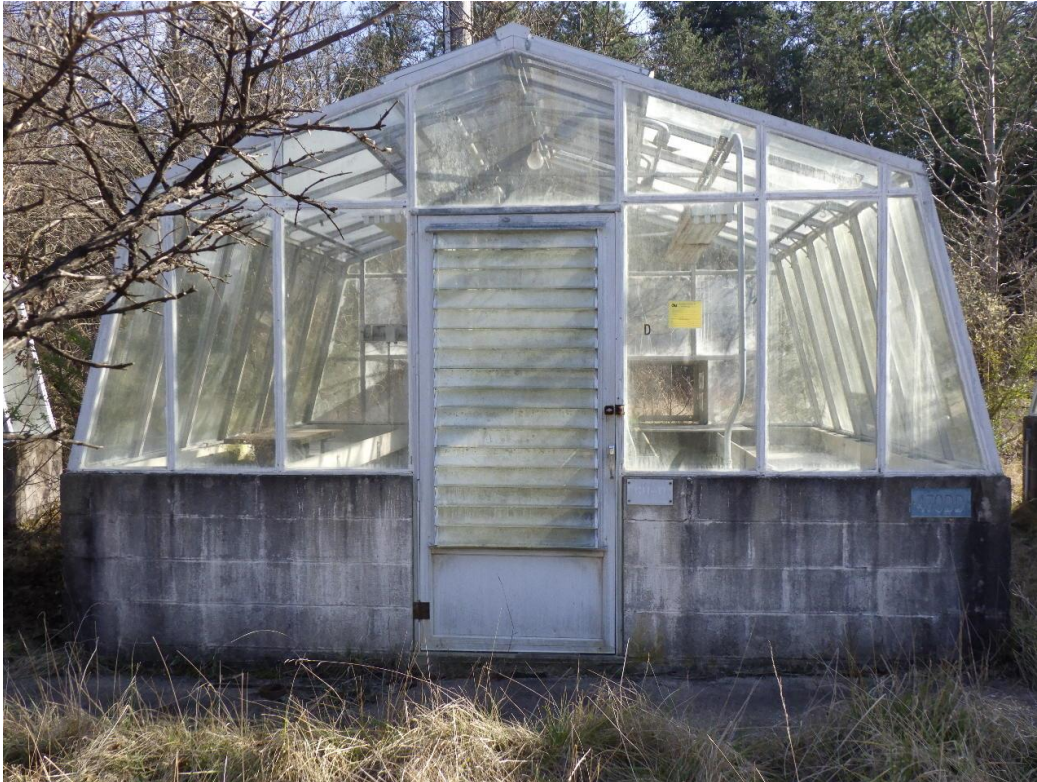
Figure 8-15: Building 470DD, facing south, location shown on Appendix A, Figure 3

Sample ID	Building	Type Of Material	Description	Location	Approx. Quantity	Units	Results	Physical Assessment
470-AAA1	470AA-470II	asbestos	Transite Panel	Flower Boxes in Greenhouses	1450	sf	Chrysotile 20-25%	Non-Friable - II
470-AAA2		asbestos		Flower Boxes in Greenhouses			Chrysotile 20-25%	Non-Friable - II
470-AAA3		asbestos		Flower Boxes in Greenhouses			Chrysotile 20-25%	Non-Friable - II
	470DD	electronics	wall/unit heaters	greenhouse	1	each		
	470DD	PCB	flourescent ballasts	greenhouse	4	each		
	470DD	refrigerant	AC wall unit	greenhouse	1	each

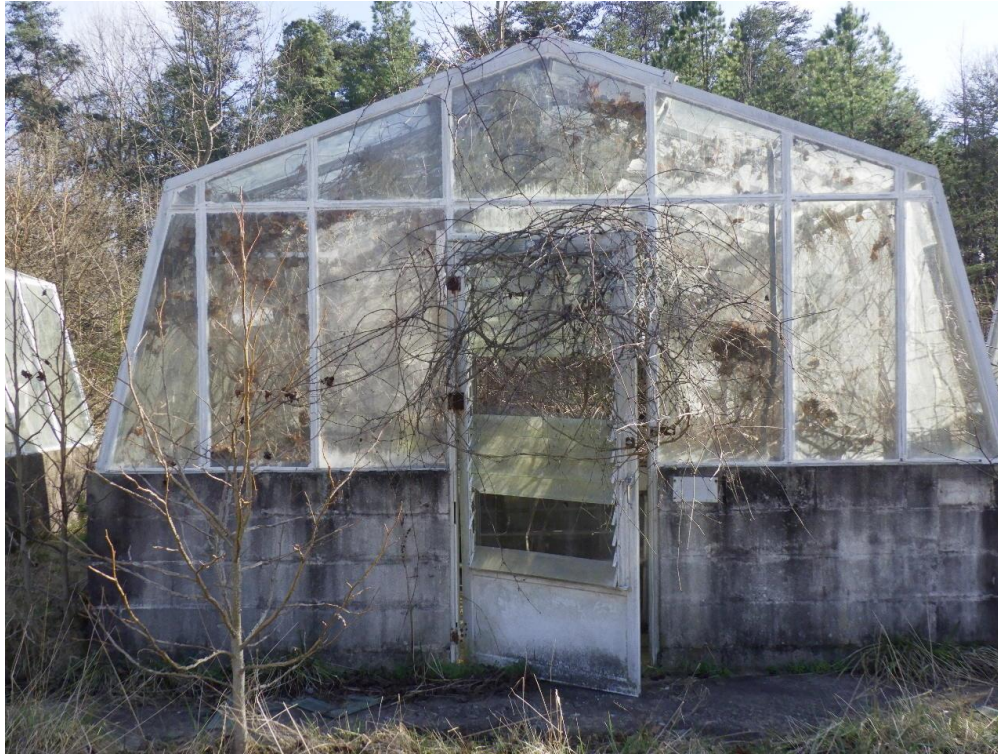
**Figure 8-16: Building 470EE, facing south, location shown on Appendix A, Figure 3**

Sample ID	Building	Type Of Material	Description	Location	Approx. Quantity	Units	Results	Physical Assessment
470-AAA1	470AA-470II	asbestos	Transite Panel	Flower Boxes in Greenhouses	1450	sf	Chrysotile 20-25%	Non-Friable - II
470-AAA2		asbestos		Flower Boxes in Greenhouses			Chrysotile 20-25%	Non-Friable - II
470-AAA3		asbestos		Flower Boxes in Greenhouses			Chrysotile 20-25%	Non-Friable - II
	470EE	electronics	wall/unit heaters	greenhouse	2	each		
	470EE	mercury	thermostats	greenhouse	4	each		
	470EE	refrigerant	AC wall unit	greenhouse	1	each

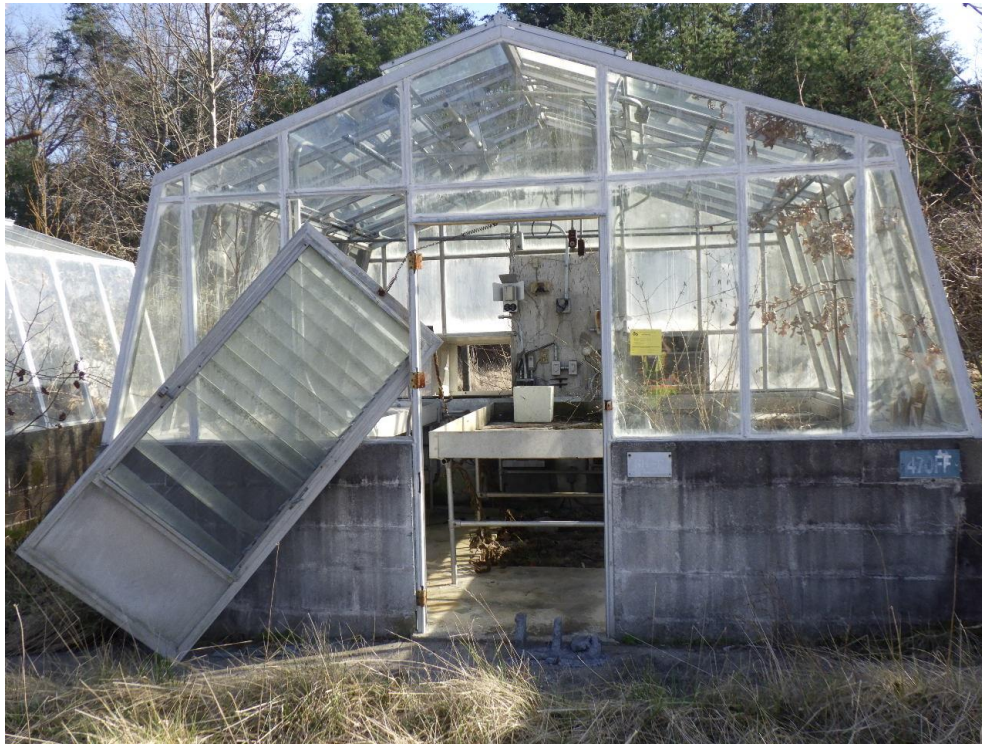
Figure 8-17: Building 470FF, facing south, location shown on Appendix A, Figure 3

Sample ID	Building	Type Of Material	Description	Location	Approx. Quantity	Units	Results	Physical Assessment
470-AAA1	470AA-470II	asbestos	Transite Panel	Flower Boxes in Greenhouses	1450	sf	Chrysotile 20-25%	Non-Friable - II
470-AAA2		asbestos		Flower Boxes in Greenhouses			Chrysotile 20-25%	Non-Friable - II
470-AAA3		asbestos		Flower Boxes in Greenhouses			Chrysotile 20-25%	Non-Friable - II
	470FF	electronics	wall/unit heaters	greenhouse	2	each		
	470FF	mercury	thermostats	greenhouse	4	each		
	470FF	refrigerant	AC wall unit	greenhouse	1	each

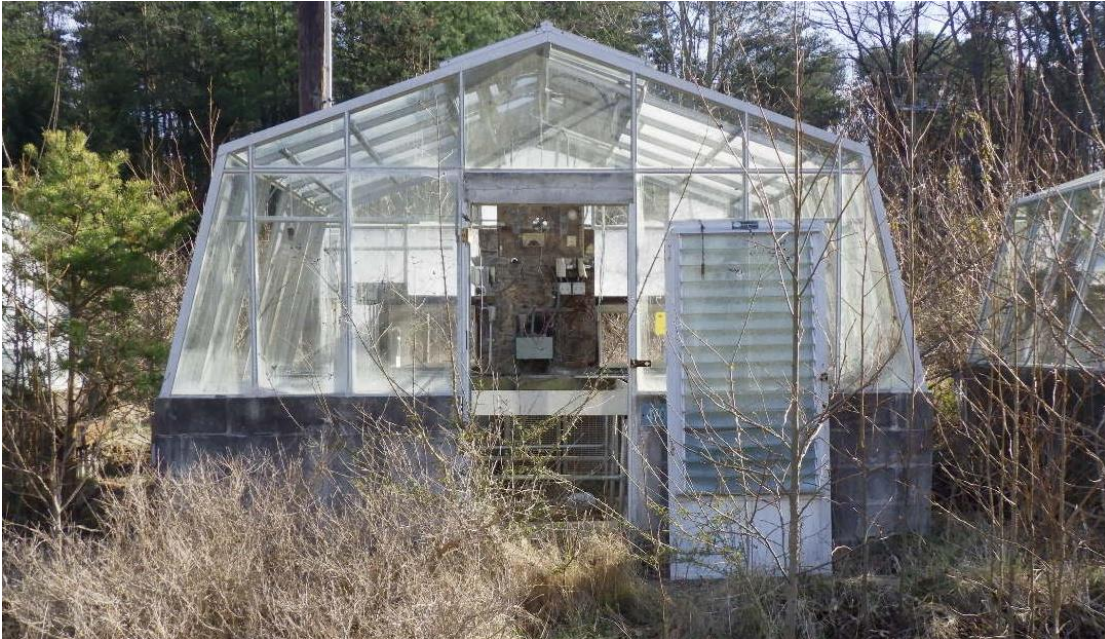
**Figure 8-19: Building 470HH, facing south, location shown on Appendix A, Figure 3**

Thermostats found throughout the greenhouse were identified as mercury-containing materials.

Unit heaters and high intensity light starters were found throughout the greenhouse and were identified as E-Waste.

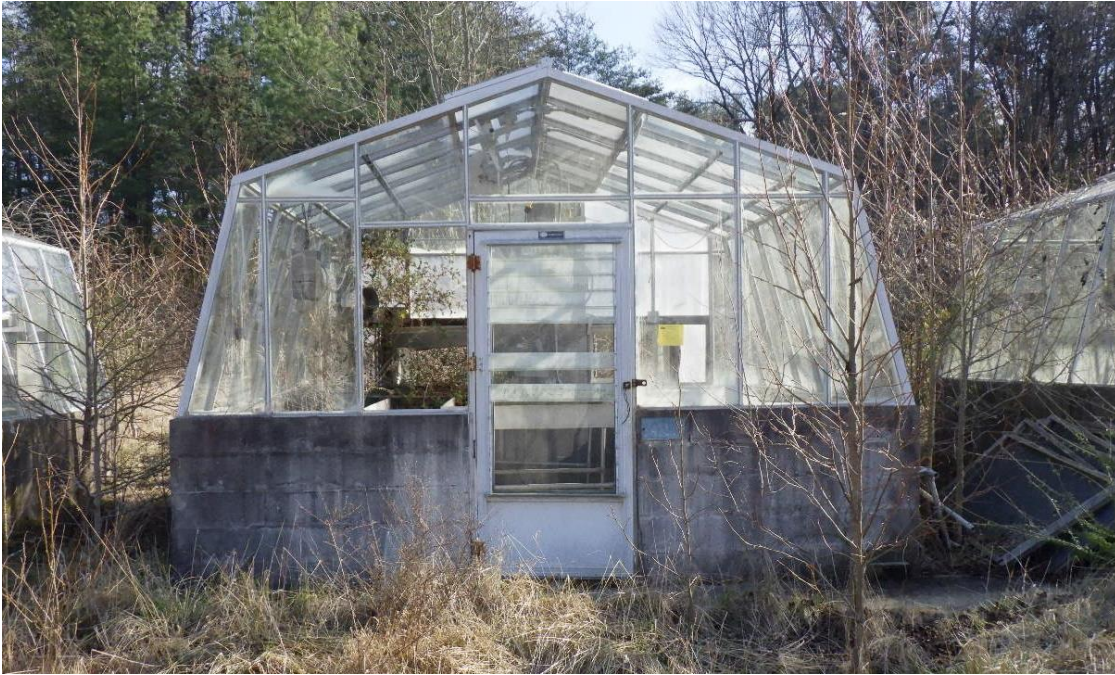
**Figure 8-20: Building 470II, facing south, location shown on Appendix A, Figure 3**

Thermostats found throughout the greenhouse were identified as mercury-containing materials.

Unit heaters and high intensity light starters were found throughout the greenhouse and were identified as E-Waste.

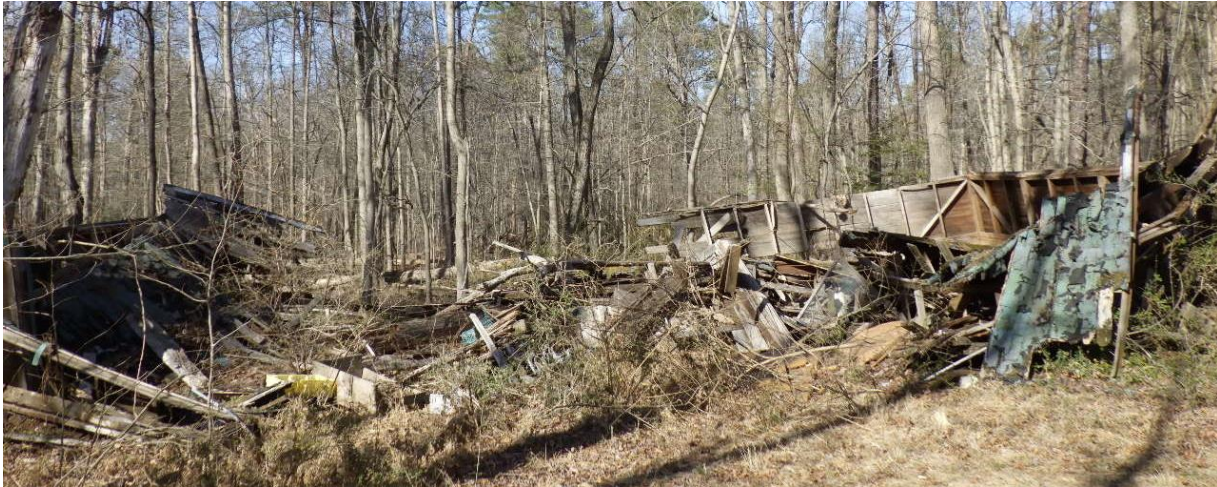
Figure 8-21: Building 471, facing north, location shown on Appendix A, Figure 3

Visible mold was present in the building

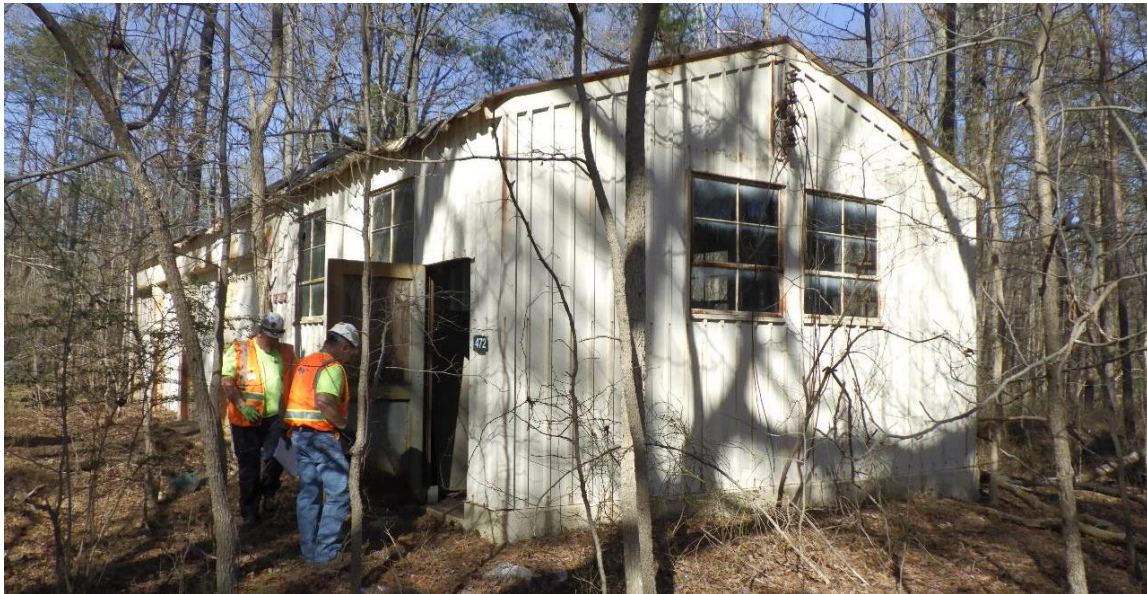
**Figure 8-22: Building 472, facing north, location shown on Appendix A, Figure 3**

Aerosol cans were noted in storage boxes in the building.
