# Beltsville Agricultural Research Center Hazardous Materials Assessment Part 2

**Beltsville Agricultural Research Center  
Hazardous Materials Assessment  
Project No. 103144**

**Revision 1  
April 22, 2020**

**Burns & McDonnell Engineering Company, Inc.  
Downers Grove, Illinois**

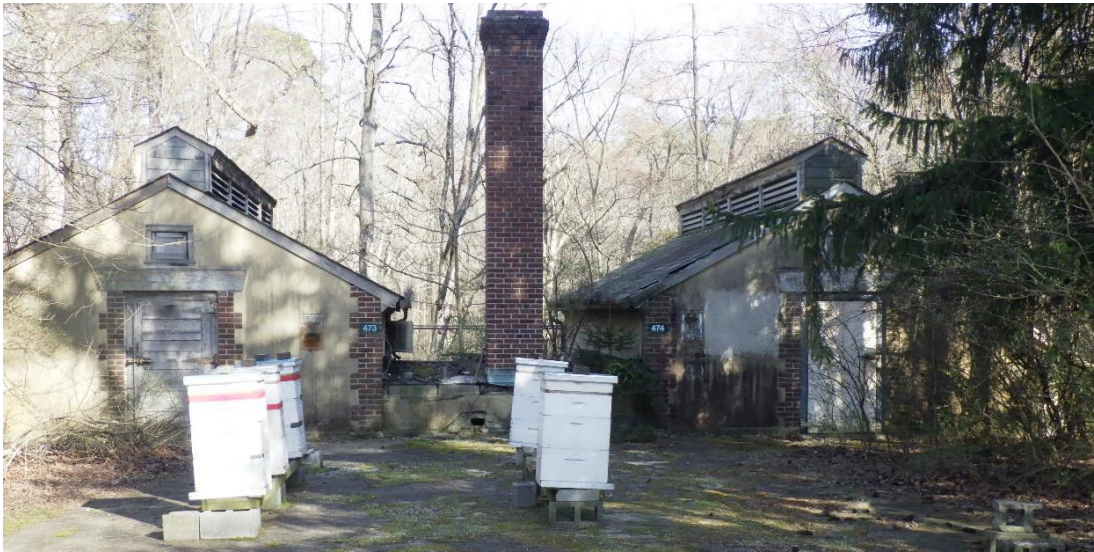
**Figure 8-23: Building 473 (on the left), facing east, location shown on Appendix A, Figure 3  
ACM**

One exterior light was found which appeared to be a high pressure sodium bulb which contains mercury.

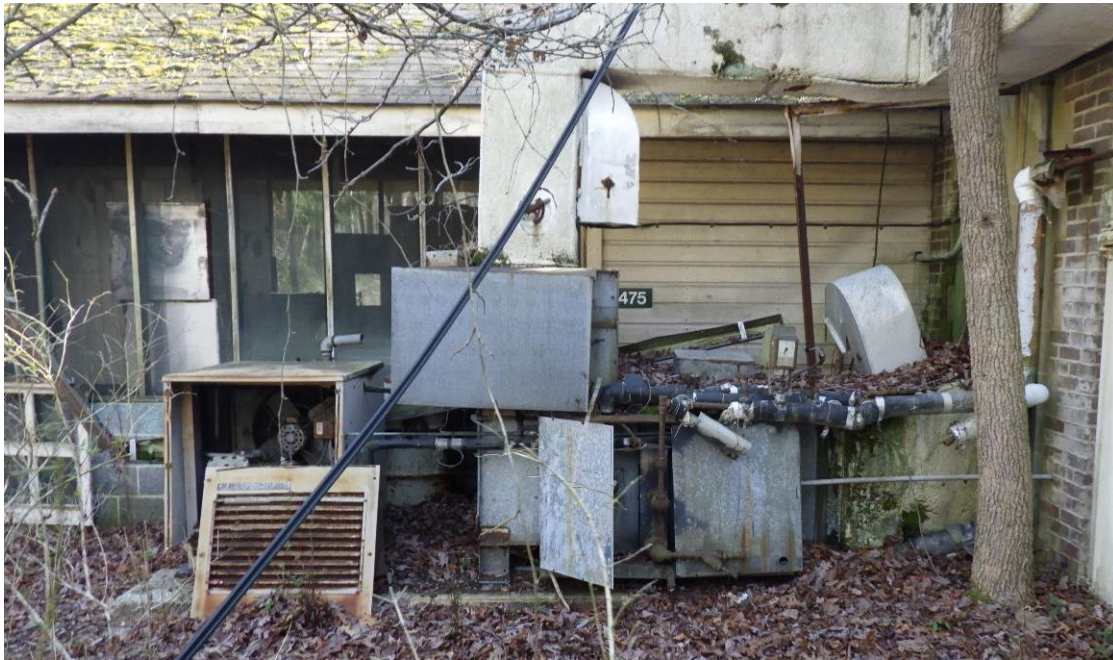
**Figure 8-25: Building 475, facing southeast, location shown on Appendix A, Figure 3**

4-foot fluorescent bulbs and 8-foot fluorescent bulbs found in the lab room were identified as mercury-containing materials.

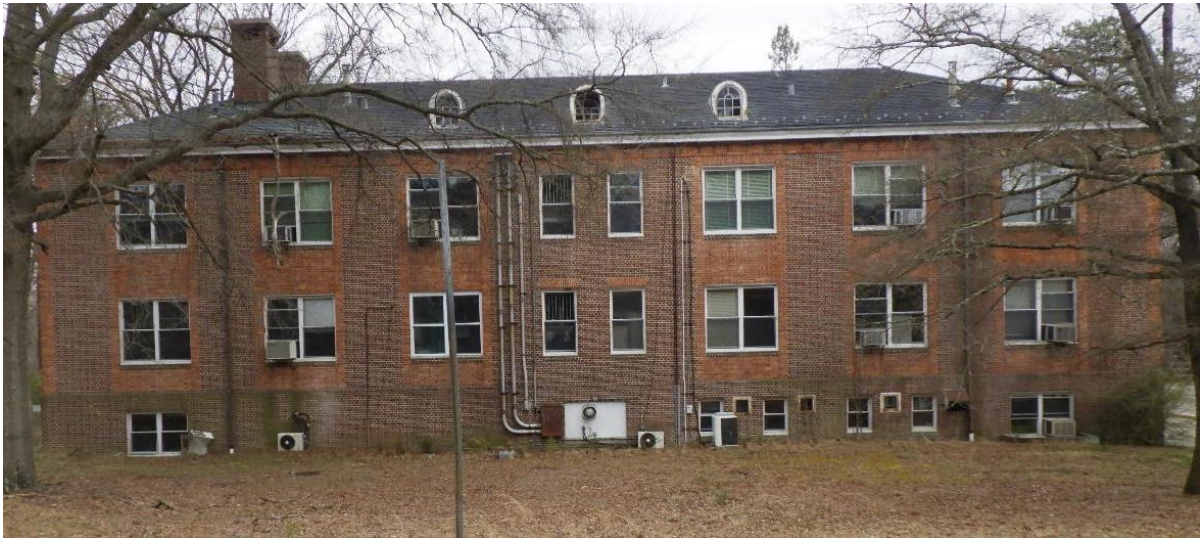
**Figure 8-26: Building 476, facing east, location shown on Appendix A, Figure 3**

Lighting ballast associated with fluorescent light bulbs found throughout the building were identified as PCB-containing.

4-foot fluorescent bulbs, 8-foot fluorescent bulbs, thermostats and CRT monitors found throughout the building were identified as mercury-containing materials. Smoke detectors noted as a mercury-containing material and should also be considered as a low-level nuclear device.

Air conditioning units, lab refrigerators, evaporation units, and a water cooler were noted during the inspection.

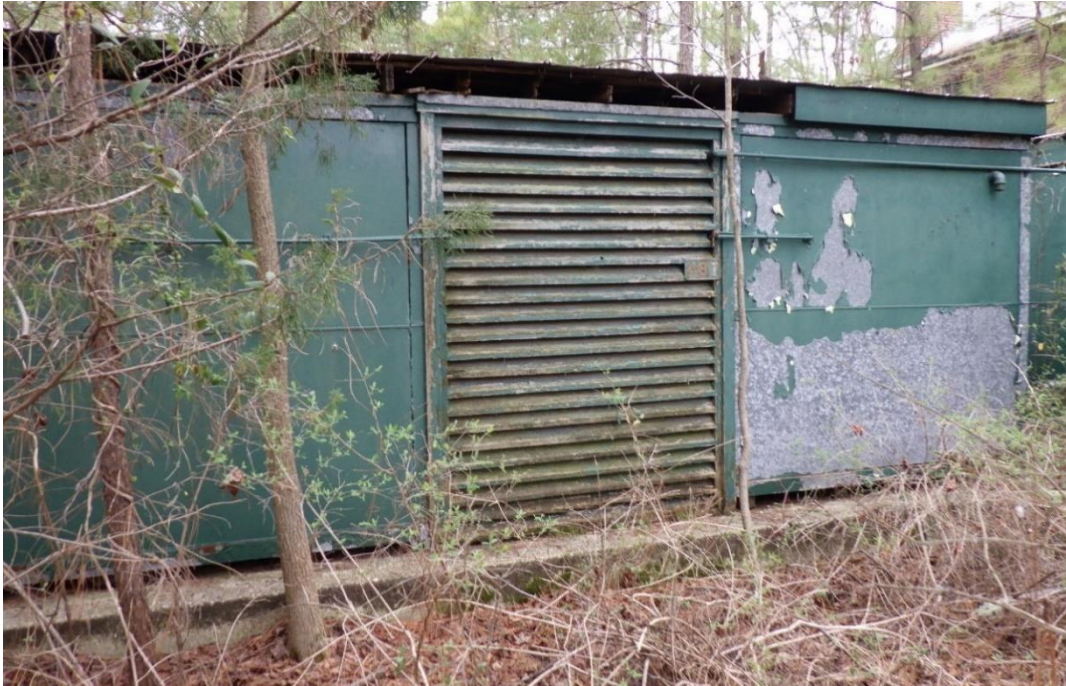
**Figure 8-28: Building 487, facing northwest, location shown on Appendix A, Figure 3**

No asbestos-containing materials were found. Black caulk in exterior portions of the building was sampled and confirmed to not contain asbestos.

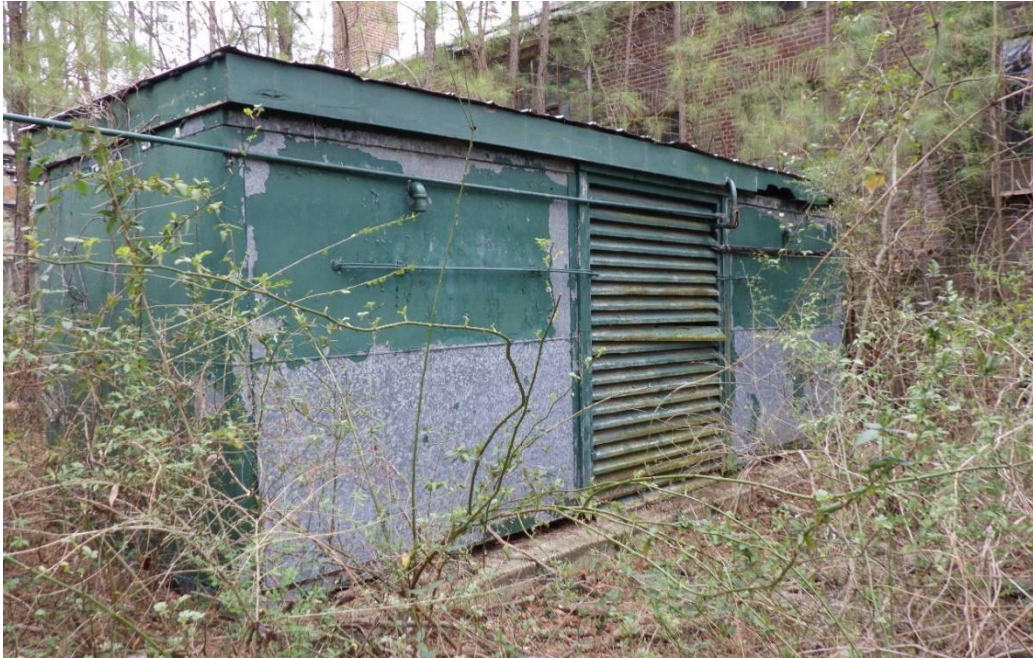
**Figure 8-29: Building 488, facing northwest, location shown on Appendix A, Figure 3**

No asbestos-containing materials were found. Black caulk in exterior portions of the building was sampled and confirmed to not contain asbestos.

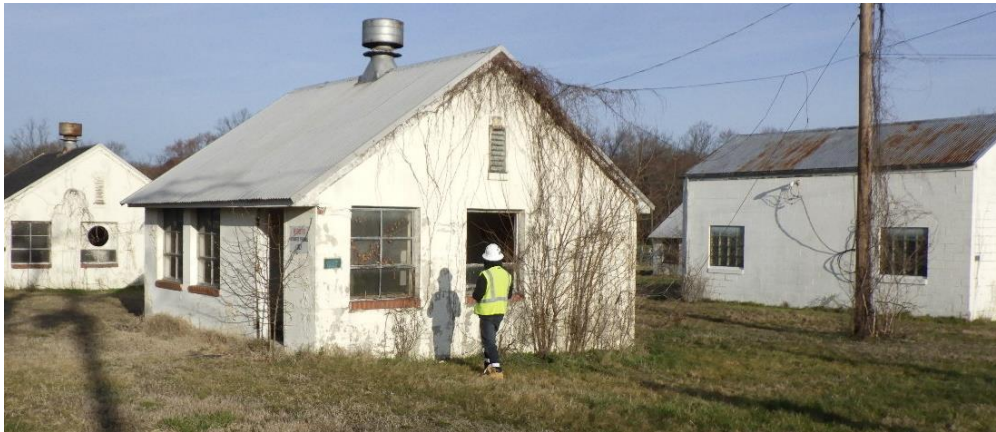
Figure 8-42: Building 1287 – Facing west, location shown on Appendix A, Figure 3

Lead paint was found in the white painted wood in Room 1; the sample exceeded a lead concentration of 5,000 mg/kg.

PCBs are presumed to be found in all of the fluorescent light fixture ballasts.

Mercury was found in the fluorescent bulbs through the lighting system. A mercury vial-based thermostat was also found. Mercury containing CRT monitors were found in the lab.

Refrigerants were found in the water fountain cooler in the lab room, and the AC wall unit.

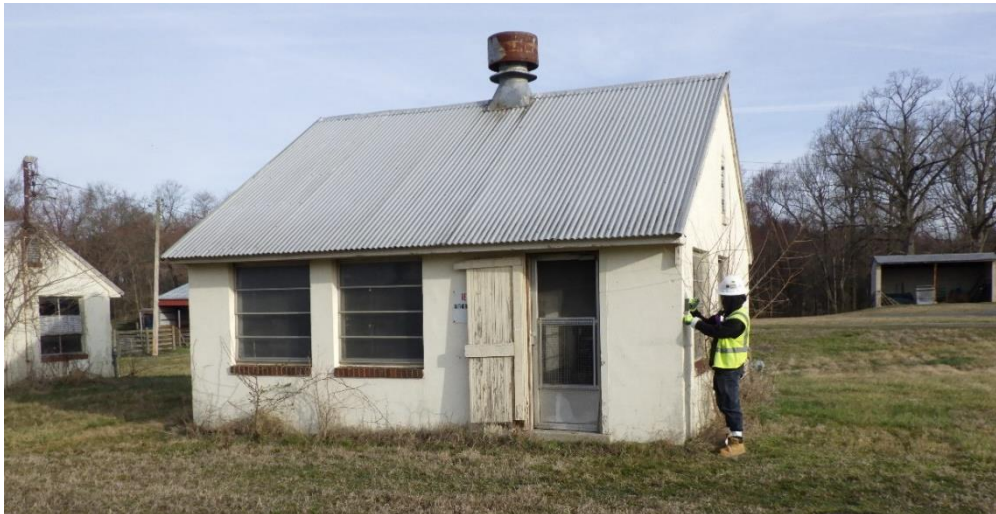
Figure 8-43: Building 1289 – Facing north, location shown on Appendix A, Figure 3

PCBs are presumed to be found in all of the fluorescent light fixture ballasts.

Mercury was found in the fluorescent bulbs through the lighting system. A mercury vial based thermostat was also found.

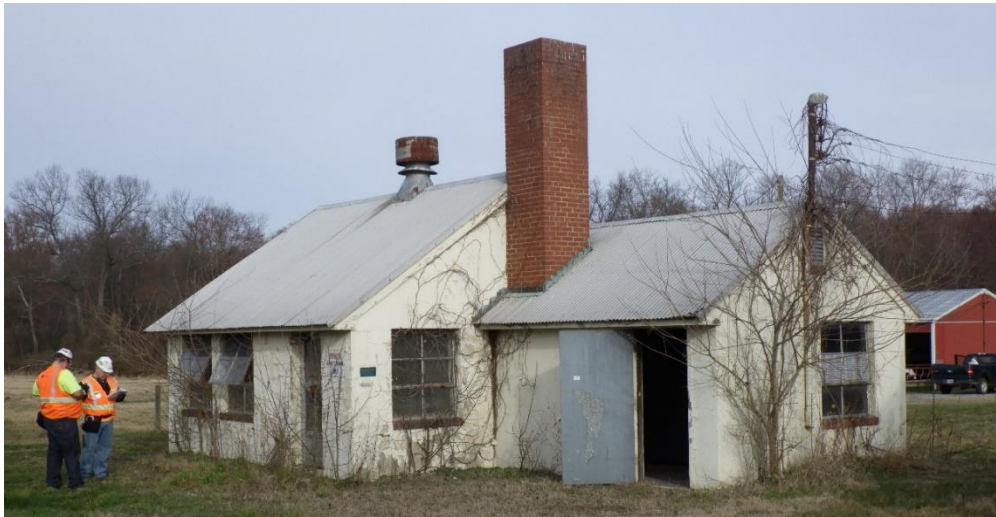
**Figure 8-44: Building 1292 – Facing northwest, location shown on Appendix A, Figure 3**

PCBs are presumed to be found in all of the fluorescent light fixture ballasts.

Mercury was found in the fluorescent bulbs through the lighting system. Several mercury vial based thermostats were also present.

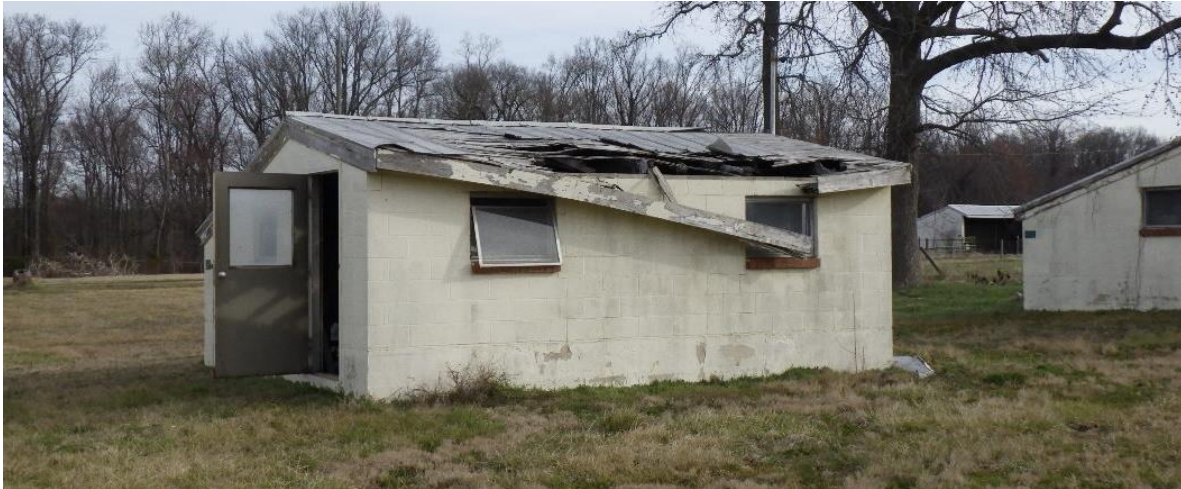
**Figure 8-45: Building 1328 – Facing north, location shown on Appendix A, Figure 3**

Asbestos materials were found in the exterior window glazing. It is noting that because of the small quantity of suspect materials on buildings 1328 and 1329, the window glazing sample set included samples from 1328 and 1329. The asbestos containing sample of the set (1 of 3) was from building 1329.

Lead based paint was found on the exterior beige paint on concrete.

PCBs are presumed to be found in all of the fluorescent light fixture ballasts.

Mercury was found in the fluorescent bulbs through the lighting system.

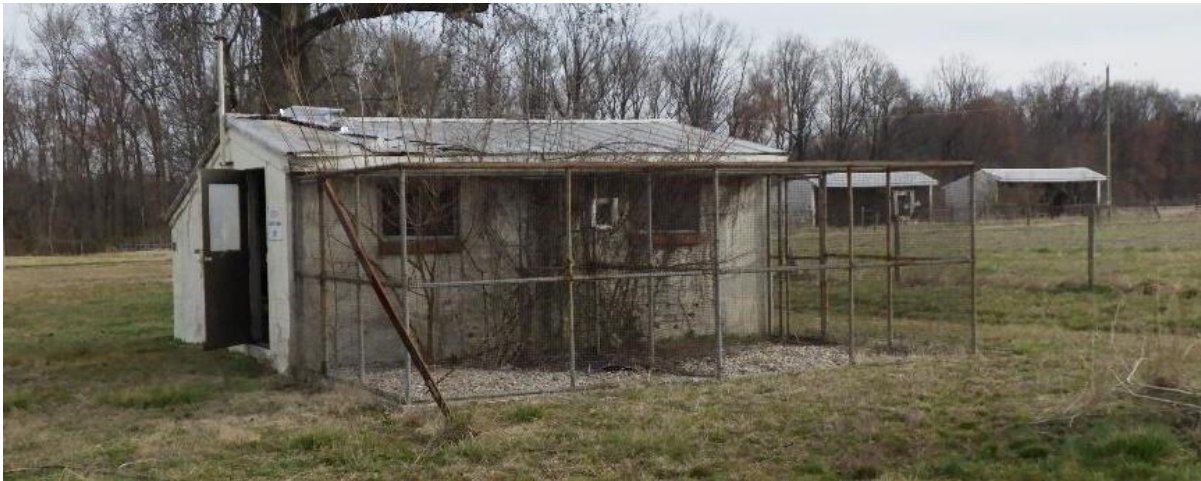
**Figure 8-46: Building 1329 – Facing north, location shown on Appendix A, Figure 3**

Asbestos materials were found in the interior exterior window glazing. It is noting that because of the small quantity of suspect materials on buildings 1328 and 1329, the window glazing sample set included samples from 1328 and 1329. The asbestos containing sample of the set (1 of 3) was from building 1329.

Lead based paint was found on the exterior beige paint on concrete.

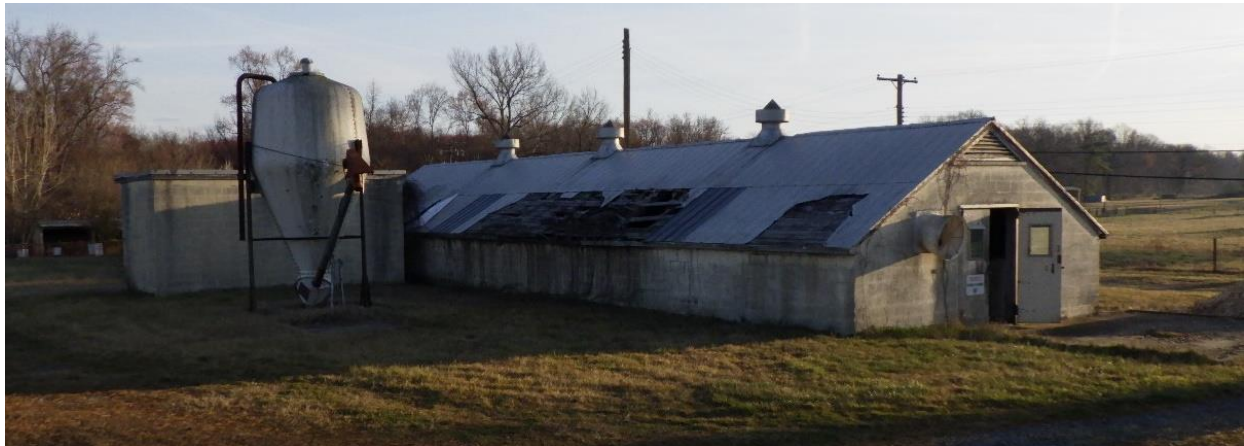
**Figure 8-47: Building 1422 – Facing northwest, location shown on Appendix A, Figure 3  
ACM**

Asbestos transite panels comprise the interior ceiling and wall panels of this swine research building.

Lead based paint was found on the white exterior paint on wood and concrete on all sides of the building.

PCBs are presumed to be found in all of the fluorescent light fixture ballasts.

Mercury was found in the fluorescent bulbs through the lighting system. Several mercury vial based thermostats were also present.

Refrigerants were found in the office window AC unit, and the interior water fountain cooler.
