EXPERIMENT IN STREAM RESTORATION

By F. Douglas Shields Jr.,¹ Member, ASCE, Charles M. Cooper,² and Scott S. Knight³

ABSTRACT: Aquatic habitats in a deeply incised sand-bed channel were modified by adding 1,380 t of stone and planting dormant willow posts. Restoration structures (groin extensions and longitudinal toe protection) were designed as complements to existing channel stabilization works. Prior to restoration, base-flow aquatic habitats were characterized by uniform conditions, little woody debris or riparian vegetation, shallow depths, and sandy bed material. The stage-discharge relationship, channel geometry, and bed material size were unaffected by restoration, but the average depth of scour holes adjacent to extended groins increased from 32 cm to 72 cm, and pool habitat in the lower half of the study reach increased from 2.9% to 14% of water surface area. Median water depth at base flow increased from 9 cm to 15 cm. Woody vegetation cover on one side of the channel increased from 38% to 78%. Fish numbers tripled, median fish size increased by 50%, and the number of species increased from 14 to 19. Groin extensions experienced partial failure due to erosion of sand fr

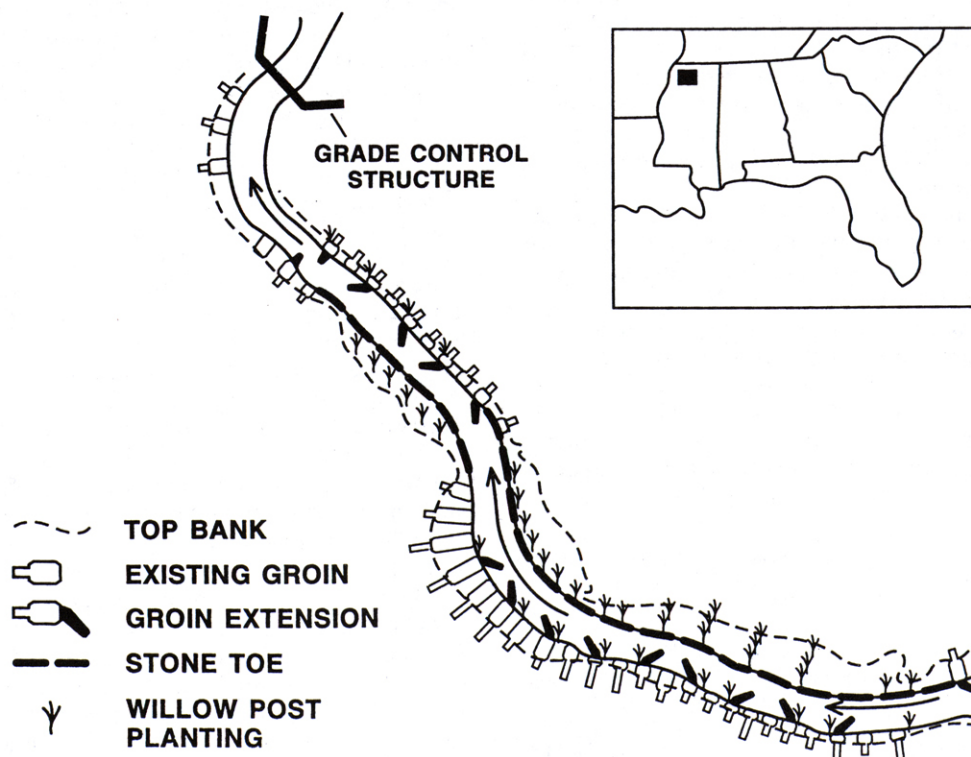
FIG. 1. Location and Layout of Study Reach

Hotophia Creek, an incised channel in the hills of north-west Mississippi, was selected for experimental restoration. The reach selected for restoration was immediately upstream of a grade control structure and was relatively stable (Swanson 1989; Shields et al. 1992). Site location is shown in Fig. 1, a typical view of the upper end of the study reach is shown in Fig. 2, and physical characteristics of the study reach are summarized in Table 1. At the time of this study (1991–1993), only 8% of the watershed was cultivated, while 40% was idle or pasture, and 52% was forested or water area. In general, cultivated areas were limited to valley bottoms. Historically, much of the watershed has been cultivated or timbered. European settlement of the area, which began about 1830, was followed by deforestation, cultivation, rapid erosion of hill-sides, and accelerated valley sedimentation (Happ et al. 1940). Between about 1840 and 1930 individual landowners and drainage districts attempted to reclaim valley lands by channelizing streams. A second round of channelization by federal agencies occurred between about 1930 and 1965. Flood control reservoirs were built on major rivers draining the hill region between 1940 and 1954.

planted. Posts were 2–25 cm in diameter and 150–180 cm long, and were harvested from a thicket within 1 km of the planting site on the same day they were planted. Three planting techniques were used, none of which involved bank shaping or grading (Fig. 1):

- 1,680 posts were placed in a single row of 1–1.5 m deep holes excavated by a 1-m-wide hydraulic hoe bucket just landward of the longitudinal stone toe (Fig. 1). Twelve posts were placed around the perimeter of each hole, and holes were dug on ~4-m centers.
- 600 posts were placed in five 1-m-deep by 2-m-wide trenches excavated across the bar perpendicular to the channel.
- 1,165 posts were planted in holes created in cohesive banks adjacent to groin extensions (White 1991) using a 1.3-m-long 10-cm-diameter metal ram mounted on the hydraulic hoe. Posts were placed on ~1 m centers in three to five rows parallel to the channel.

Measurements of base-flow depth and velocity at regularly spaced grid points detected changes following restoration that were beyond the resolution of the channel surveys. Stages varied about 31 cm across sampling dates, so depths were adjusted to a common stage in the middle of the range. Corrected depths less than zero were not used in computing statistics for comparison. Depths were not normally distributed, so a distribution-free test (Kruskal-Wallis one way analysis of variance on ranks) was used to compare annual median values. Median depth, corrected for stage variation, increased from 9 cm to 22 cm during the first year after restoration, but fell to 15 cm (2 years after restoration (Fig. 6 and Table 3). Depths generally increased more in the downstream half of the study reach than upstream, possibly due to the effects of local acceleration as flow approached the sharp-crested weir of the grade-control structure (Fig. 1).

The slight decrease in mean scour-hole depth mirrored the trends in reachwide depth described earlier. Declining scour-hole depths reflected the gradual failure of the groin extensions: by 16 months after construction, the 12-m-long angled extensions were only 8–10 m long. Failure of groin extensions appeared to be caused by leaching or winnowing of sand from underneath stones. Stones generally subsided in place rather than launching into scour holes. In contrast to the angled extensions, the straight extensions placed on opposite banks at the downstream end of the restored area (Fig. 1) were shortened by about 6 m when they failed in the first major event following construction.

^aNone of the entries include the upstream-angled structure at the extreme upstream end of the restoration reach (Fig. 1).

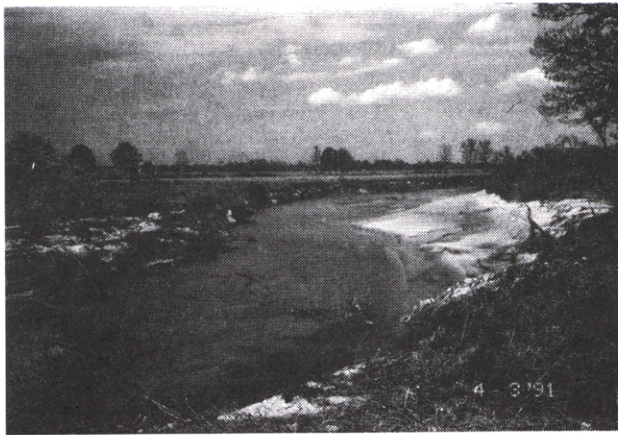
FIG. 2. Prerestoration Conditions

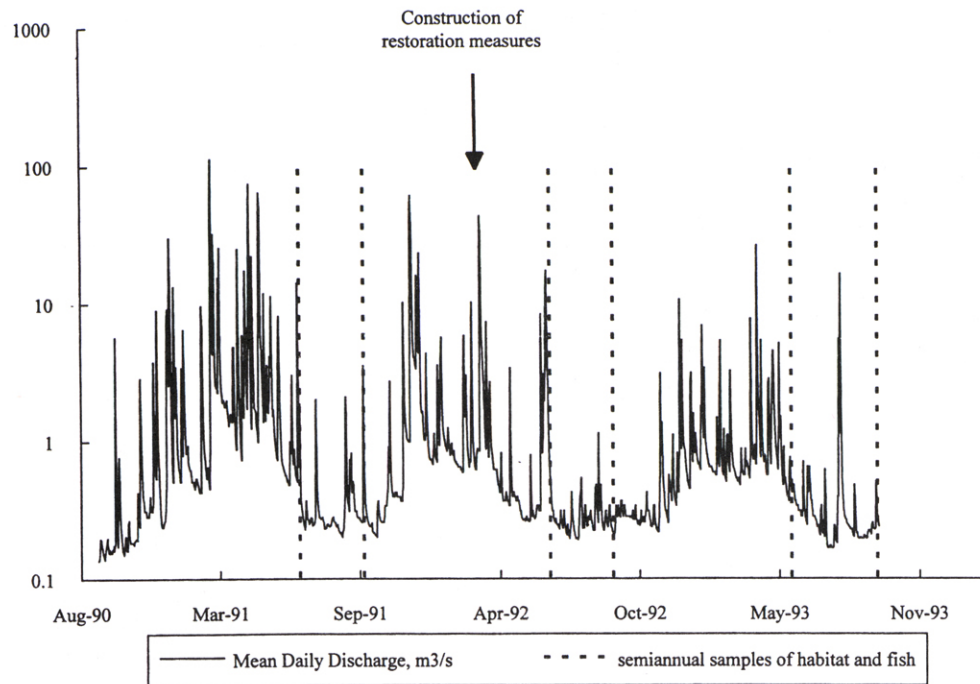
FIG. 3. Mean Daily Discharge Hydrograph for Study Site

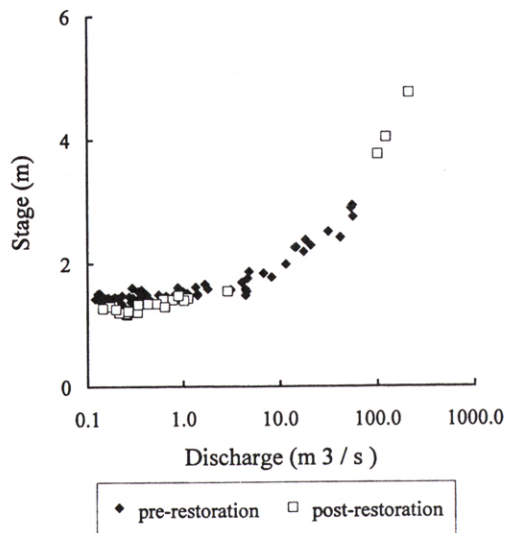
FIG. 4. Manual Discharge and Stage Measurements Obtained by U.S. Geological Survey for Midpoint of Study Reach

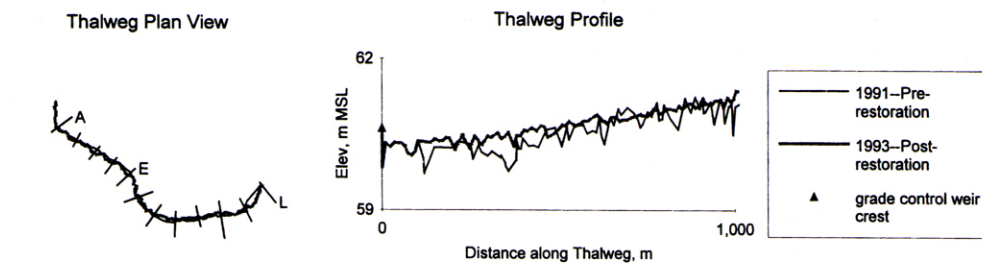
FIG. 5. Pre- and Postrestoration Thalweg Plan and Profile and Channel Cross Sections

Comparison of channel surveys taken before and after restoration showed minimal changes (Fig. 5). Mean cross-sectional area changed less than 5%. Thalweg sinuosity increased slightly (from 1.34 to 1.39), and about 20 cm of aggradation occurred along the thalweg profile. Visual observations indicate that this level of aggradation is typical of episodic, cyclical behavior driven by antecedent hydrology or spatiotemporal variations in sediment availability. The two cross sections immediately upstream from the grade-control structure displayed 1–6 m of bank recession, but the other 10 sections were very stable. Based on computation of depths using the cross-section surveys and stage-duration curves, pool-habitat availability was similar before and after restoration: about 60% of the water area was shallower than 40 cm for the stage equaled or exceeded 20% of the time. Computations were performed using more frequently observed stages (i.e., the 80% duration stage), but were judged unrealistic as episodic scour and fill of the sand bed creates instability in the lower end of the stage-discharge relationship and, at times, nonuniform water-surface slopes.

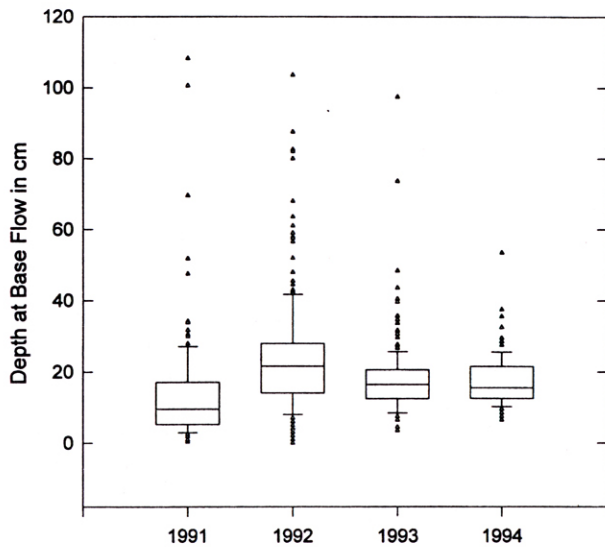
FIG. 6. Distribution of Base-Flow Depth before (1991) and after (1992–1994) Restoration. Depths Were Measured in Spring (May–June) and Fall (September) each Year (Only Spring Data Were Available for 1994); Restoration Was Completed in February 1992 (Upper Limit, Central Line, and Lower Limit of Boxes Represent the 75th, 50th, and 25th Percentiles, while Error Bars Show 10th and 90th Percentiles, and Triangles Show Outliers)

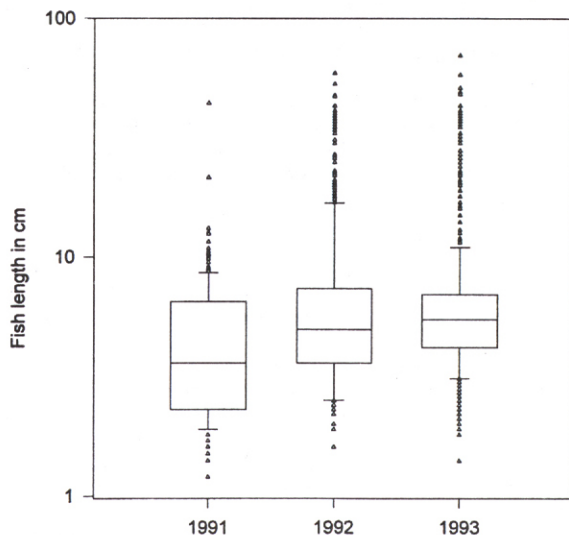
FIG. 7. Distribution of Fish Length before (1991) and after (1992 and 1993) Restoration. Fishes Were Sampled in Spring (May–June) and Fall (September) each Year. Restoration Was Completed in February 1992 (See Fig. 6 for Meaning of Symbols)

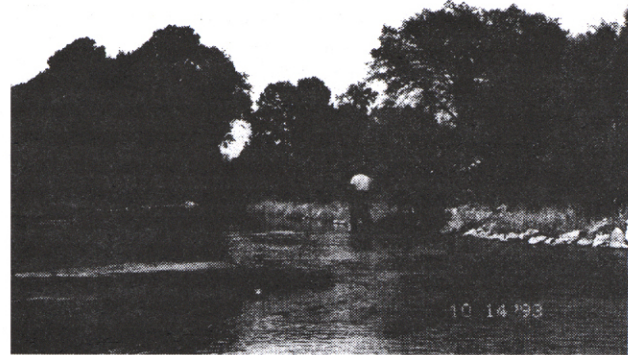
FIG. 8. Willow Posts Two Growing Seasons after Planting

Labor requirements for harvesting and planting willow posts averaged five posts per man-hour. A storm event produced near bank-full stages 11 days after planting was completed, but less than 1% of the posts were washed away. Green buds appeared on all remaining posts within 1 month of planting, and dense foliage, with limbs reaching an average height of about 2 m above the adjacent ground surface developed (Fig. 8). Most of this growth occurred during the first growing season. Signs of beaver (*Castor canadensis*) activity and herbivory were plentiful, but did not seem to affect willow survival, as plants resprouted vigorously after cutting by beaver. The stone toe and willow posts have prevented channel migration in response to the groin extensions, and the stone toe has protected existing stands of natural woody vegetation.
