National Sedimentation Laboratory
Channel and Watershed Processes Research Unit
Oxford, Mississippi

Acoustic Imaging of Sediment Impounded Within USDA-NRCS Flood Control Dams, Wisconsin

By John A. Dunbar, Paul D. Higley, and Sean J. Bennett

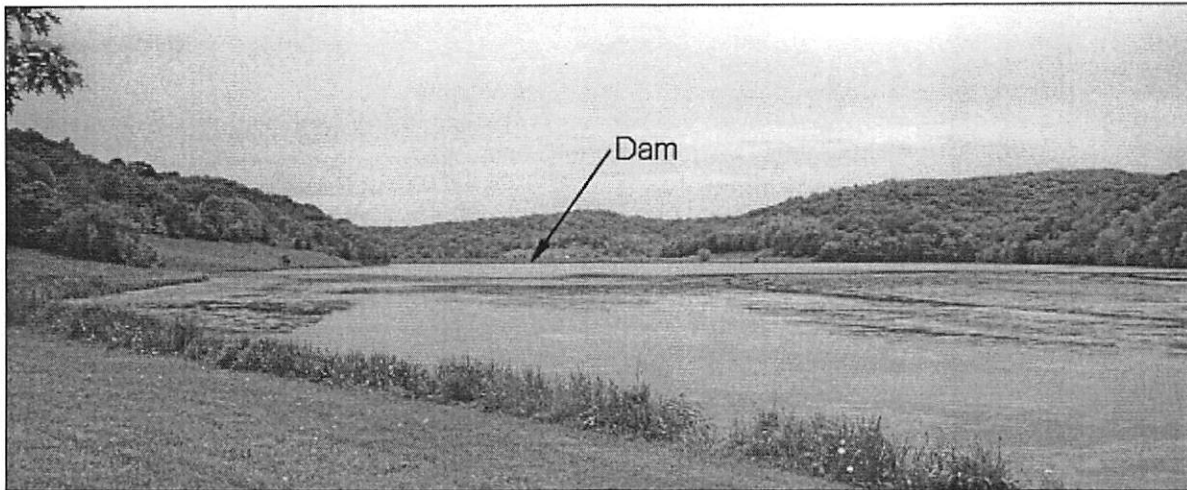
Figure 2-3. The photograph of White Mound Lake taken from the boat ramp area and facing south. Areas of the lake with 4 m of water depth or less contain aquatic vegetation that extends from the bottom to the lake surface as shown in distance.

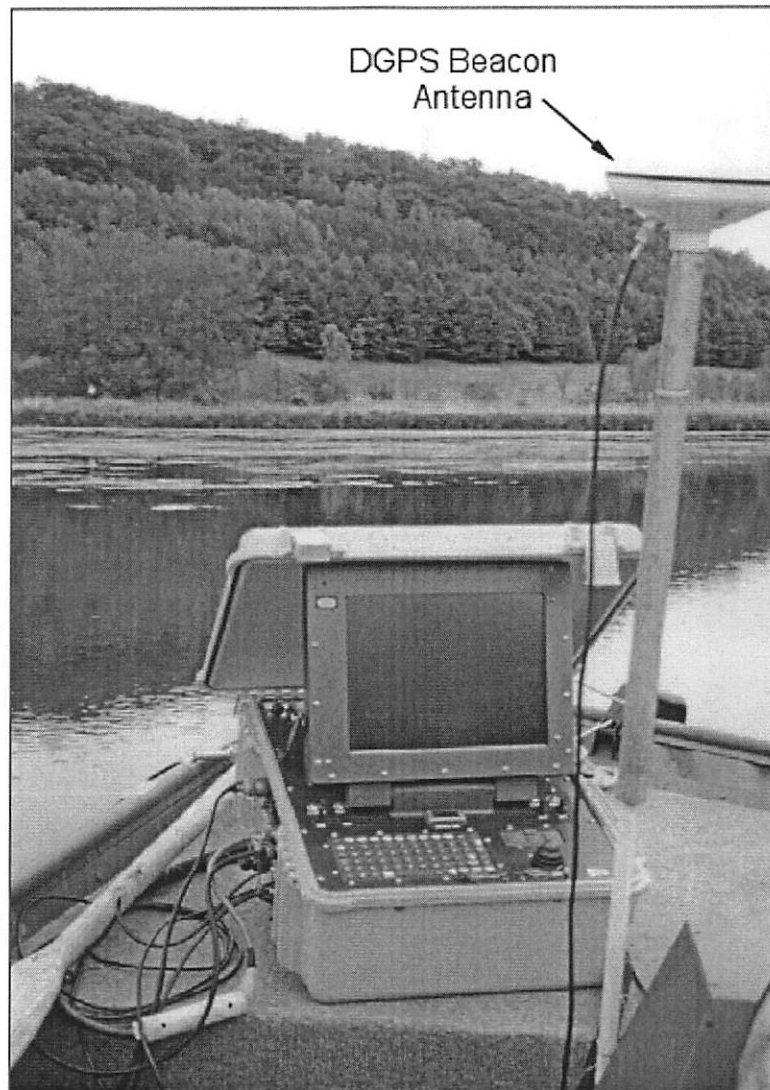
Figure 3-1. Photograph of acoustic profiler control module. All acoustic profiling and DGPS navigation electronics are contained in a compact, water-resistant control module.

The acoustic profiling system used herein was developed in a collaboration between Baylor University and Specialty Devices, Inc., Plano, TX (SDI; Dunbar, et al., 1999; Figures 3-1 and 3-2). The system was designed for sediment surveys of large water supply reservoirs, but the commercialized version has been used to survey lakes, harbors, and rivers as well. The prototype electronics module includes one computer that controls the acoustic profiling, another that controls navigation, a built-in computer monitor, and a differential GPS navigation system. All of these components are contained in one, suitcase-sized water-resistant box. The prototype module weighs 15 kg. In the commercialized version, both subsurface profiling and navigation operations are controlled by a single, faster computer, resulting in an electronics module that is smaller and lighter. Power for the electronics and acoustic source is supplied by a 12-volt marine battery. Depending on the number and type of acoustic transducers used, the sound source may weigh between 15 and 30 kg. Hence, even though the system was designed for large reservoir surveys, deployment in small floodwater retention reservoirs is logistically practical.

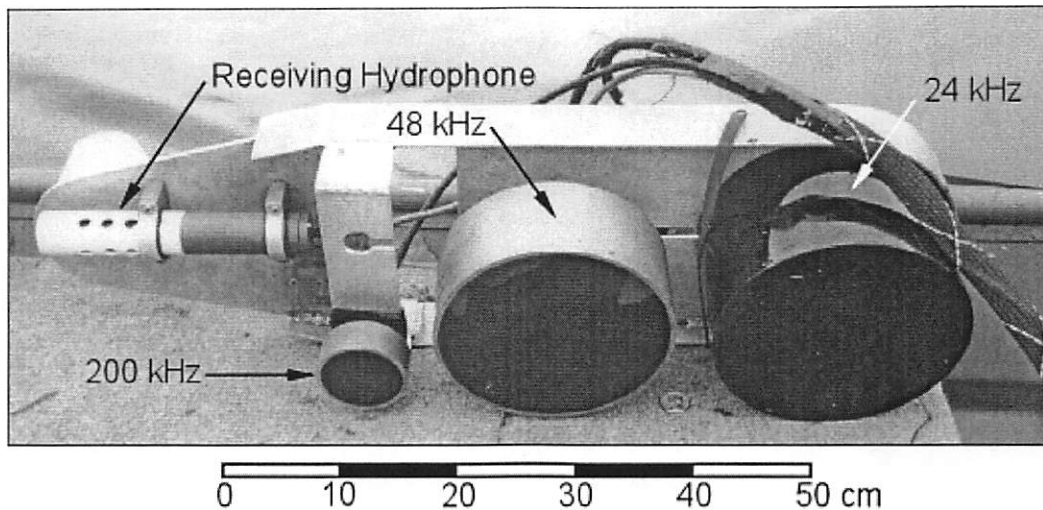
Figure 3-2. Picture of acoustic profiler transducer array. The profiling system produces acoustic signals with three widely separated frequencies (200, 48, and 24 kHz) in rapid succession as the profiles are traversed.

The system images the bottom and sub-bottom sediments with up to five widely separated acoustic frequencies at a time. For large reservoirs, with water depths of 5 to 50 m and sediment fill thickness of 1 to 10 m, acoustic transducers with central frequencies of 200, 48, 24, 12, and 3.5 kHz are used. During acquisition the system collects traces using each transducer independently in rapid succession in round-robin fashion. The high-frequency signals provide a sharp image of low-density fluid mud at the water bottom, whereas the low-frequency signals penetrate many meters of sediment to image the base of sediment fill, even in areas of high sediment accumulation. The limitation of the 12 and 3.5 kHz transducers is that they require a minimum of 3 to 5 m of water depth to produce usable records while adding significantly to the weight of the sound source (50 kg). The 24 and 48 kHz transducers require 1 to 2 m of water depth to produce usable records. For the present applications, acoustic transducers with central frequencies of 200, 48, and 24 kHz were used (Figure 3-2).

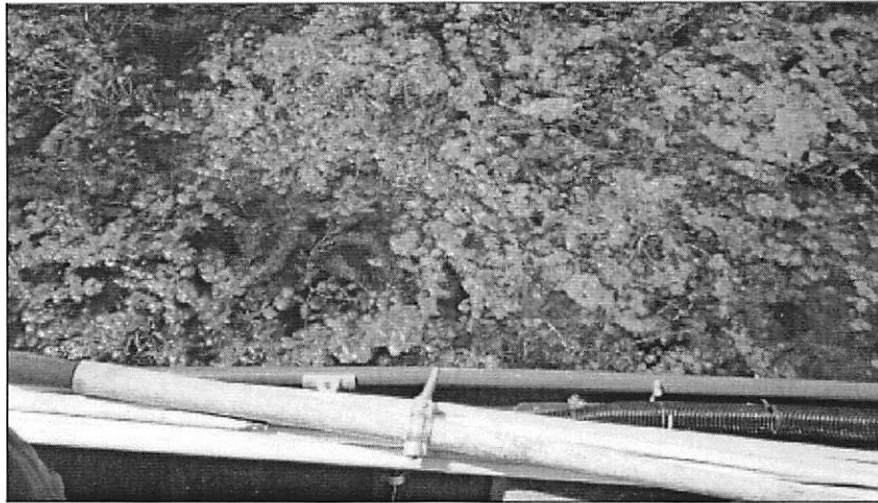
Figure 3-3. Picture of aquatic vegetation. Both White Mound Lake and Twin Valley Lake contain vegetation that extends from the water bottom to the surface in areas of 4 m water depth and less. The vegetation scatters the 200 kHz acoustic signals.

An additional surveying difficulty was caused by the occurrence of thick aquatic vegetation in areas of the reservoirs with 4 m of water depth or less (Figure 3-3). During the surveys, the weeds fouled the outboard propeller and transducer array. It was discovered during post-processing, that the vegetation efficiently scatters high frequency sound, making the 200 kHz data useless in heavily vegetated areas. Fortunately, the vegetation was nearly transparent to the 48 kHz signal. Hence, the water bottom was traced using the 48 kHz data alone in the vegetated areas.

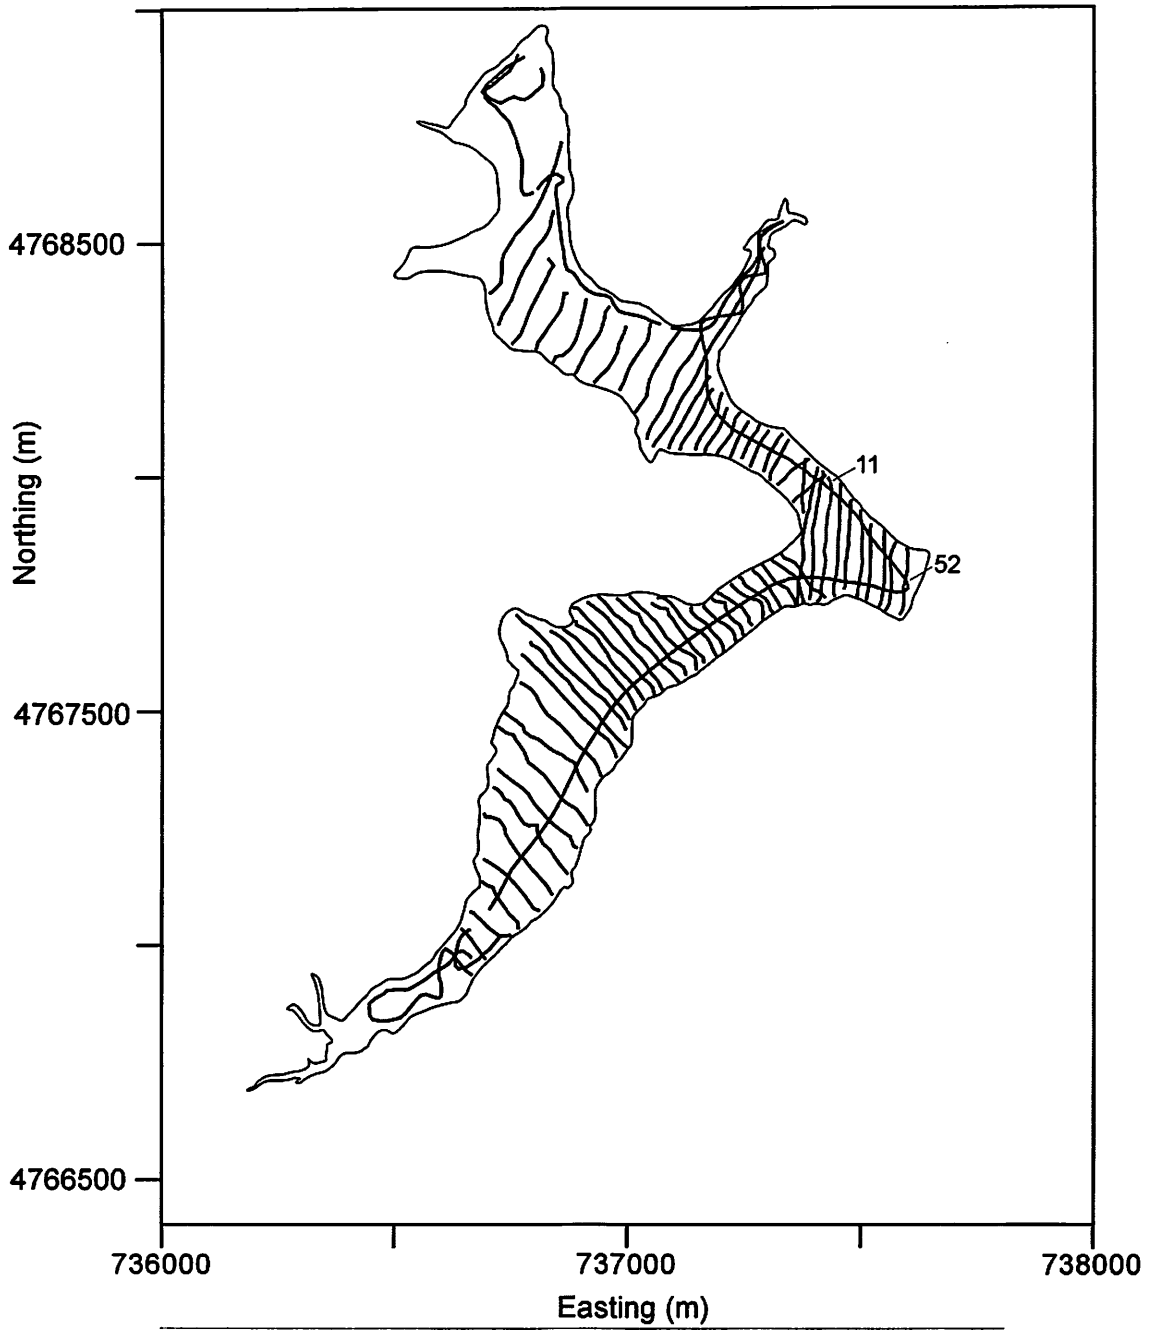
Figure 4-1. Profile map of Twin Valley Lake acoustic survey. The survey contains 17 km of profile lines. Profiles 11 and 52, highlighted in red, are shown as example profiles in accompanying figures. Coordinates are in meters (UTM Zone 15).

The survey of Twin Valley Reservoir was conducted on May 30, 2002. The survey began by collecting track lines across the main body of the reservoir near the dam at 25 m spacing. Line-spacing was then switched to 50-m for the tributary arms, in order to complete the survey in one day (Figure 4-1).

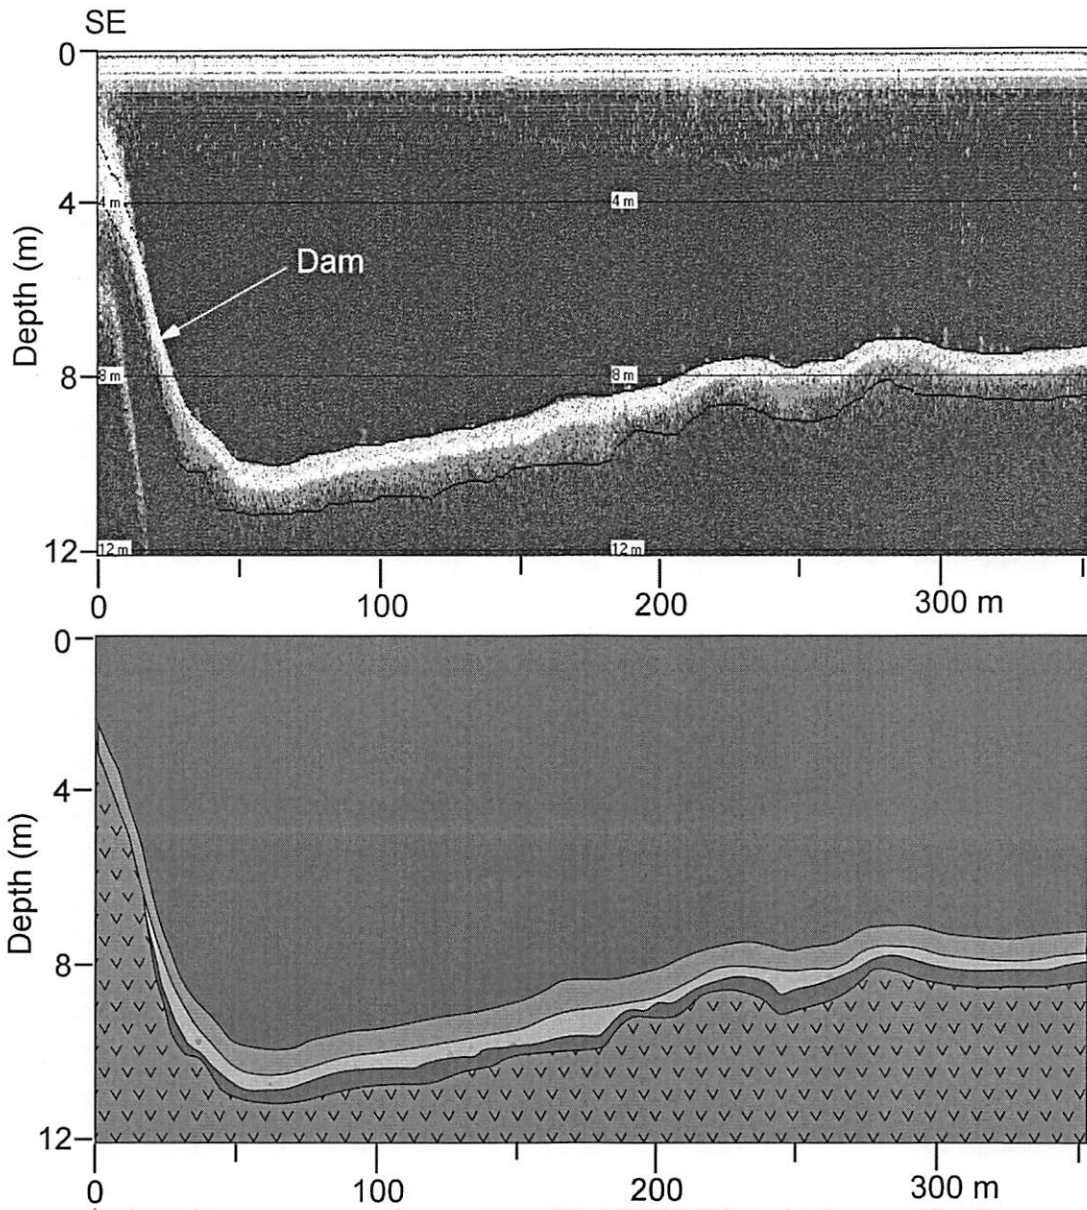
Figure 4-2. Southeast end of Twin Valley Lake axial profile, Line 52 (see Figure 4-1 for line location). Three acoustic intervals are seen within the sub-bottom in Twin Valley Lake. All three onlap onto the dam face. Hence, all three must be part of the post-impoundment sediment fill package.

The acoustic response of sediments onlapping the dam face show three distinct acoustic layers (Figure 4-2). The upper-most layer appears white on the multifrequency displays, indicating scattered returns from all three frequencies. Such a response commonly corresponds to fine-grain, water-rich sediments. This layer has a nearly uniform thickness, 0.3 to 0.4 m, throughout the reservoir and appears to drape bottom topography. The layer beneath the first appears light blue in the false-color display, indicating returns from the 48 and 24 kHz signals, but not the 200 kHz. This interval preferentially fills the lows and channel axes, is 0.6 m thick near the dam, and thins upstream (Figures 4-2 and 4-3). In the upper reaches of the tributary arms, the light blue layer is only present at the base of the channel axes. The bottom-most layer deposited on the dam face appears dark blue, indicating returns from only the 24 kHz signal. This interval is relatively thin (0.1 to 0.2 m) over most of the reservoir, but reaches considerable thickness in the channel axes.

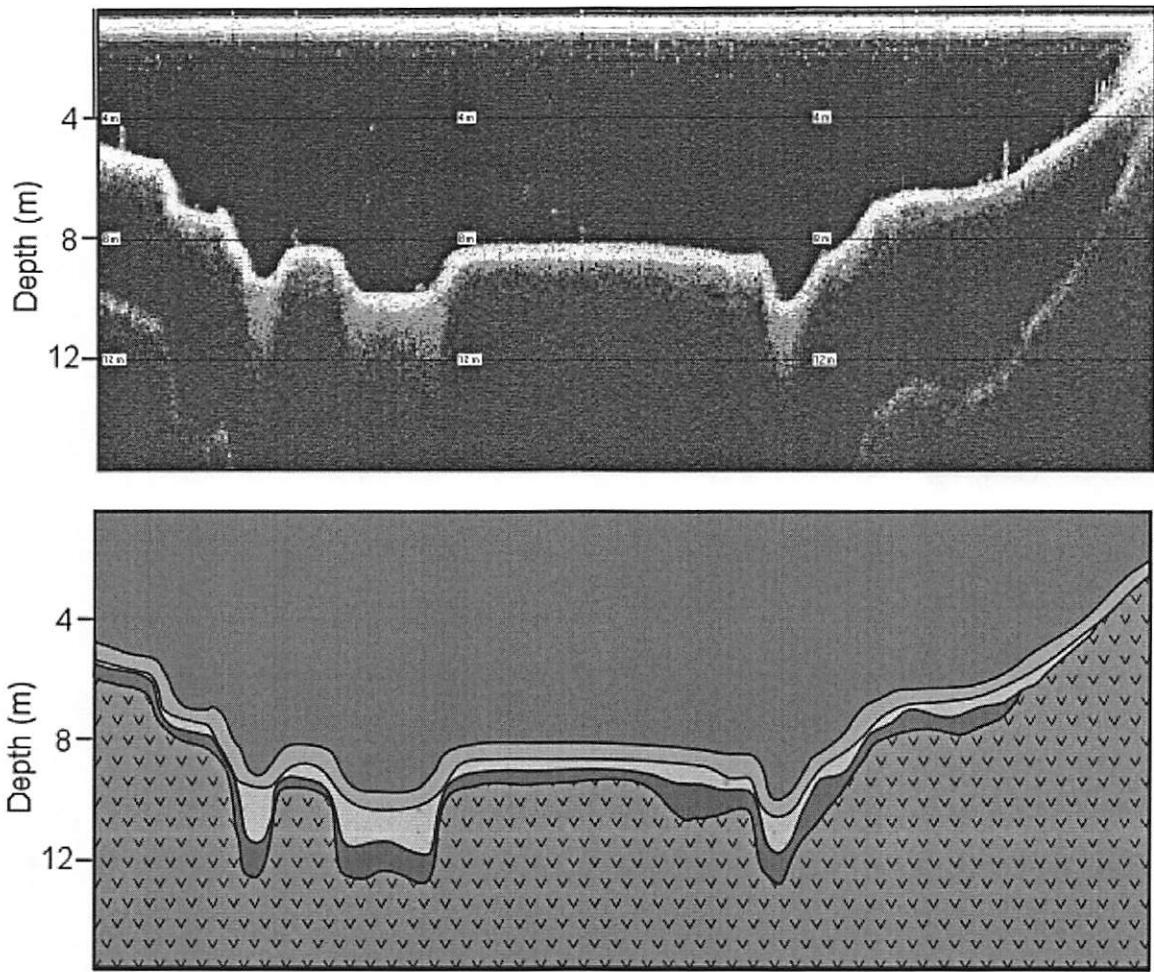
Figure 4-3. Processed Line 11 with interpretation (see Figure 4-1 for line location). The multifrequency acoustic profiles show three distinct sediment layers within the post-impoundment fill.

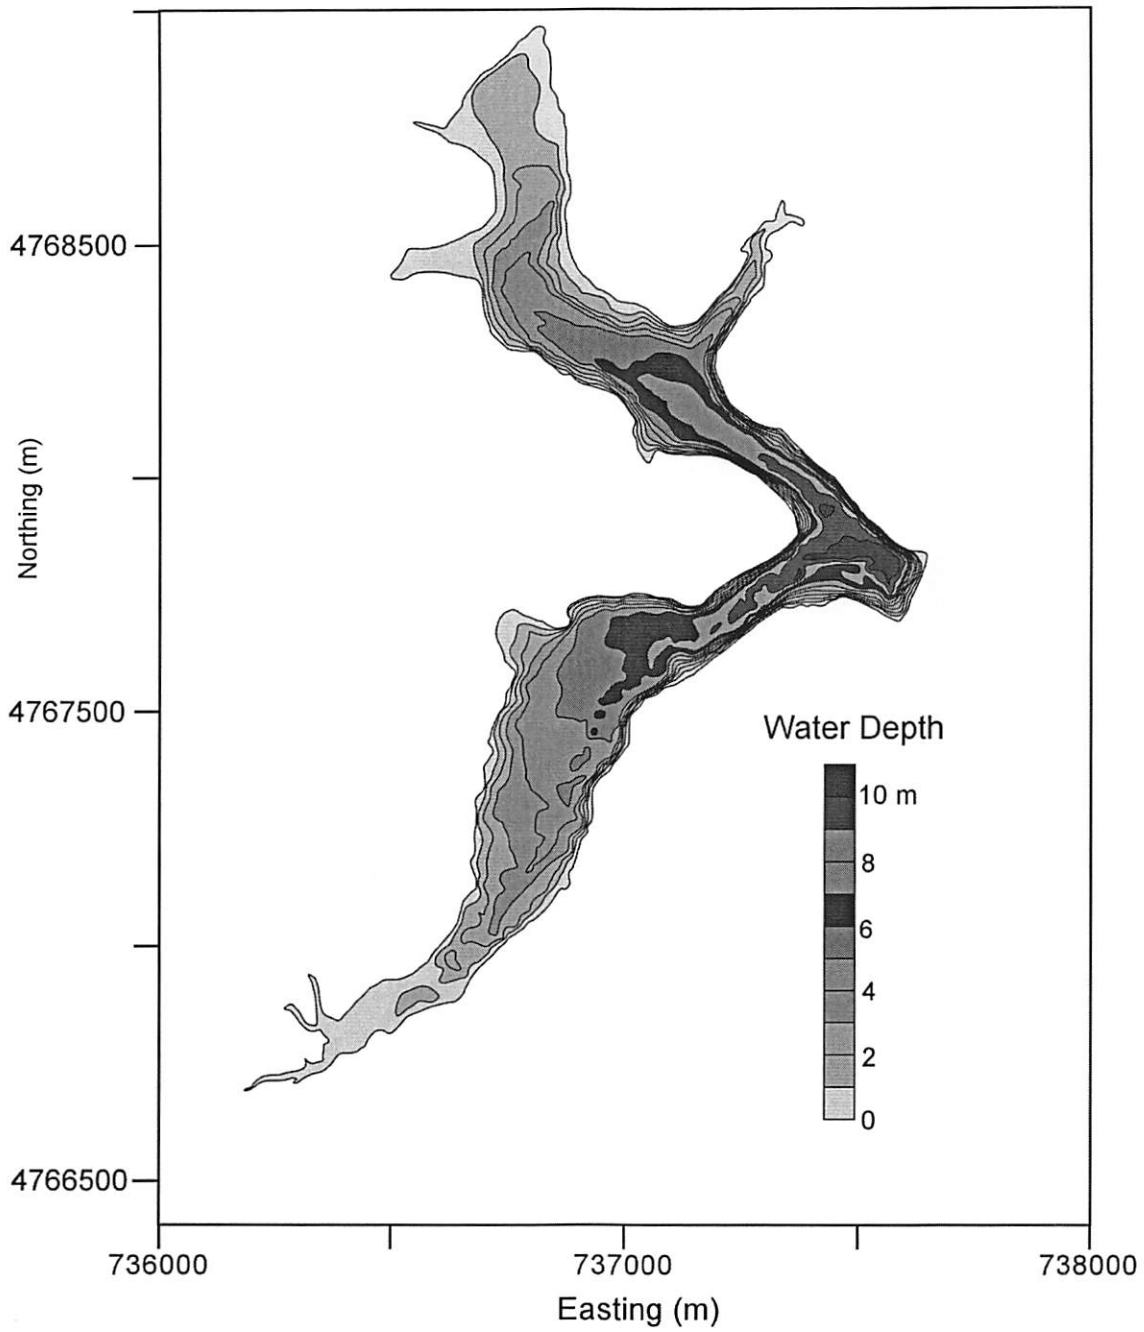
Figure 4-4. Contour map of water depth in Twin Valley Lake, WI. Depth is measured from the water surface at an elevation of 277.4 m (910 ft). Coordinates are in meters (UTM Zone 15).

The resulting map of the water depth indicates a maximum depth of 10.2 m (33.4 ft) near the dam and a total current water capacity of 2,089,500 m³ (1693.6 acre-ft; Figure 4-4). The sediment isopach map indicates a maximum thickness of 3.1 m, in a small area along the main channel axis, and a total volume of post-impoundment sediment of 458,659 m³ (371.8 acre-ft; Figure 4-5).

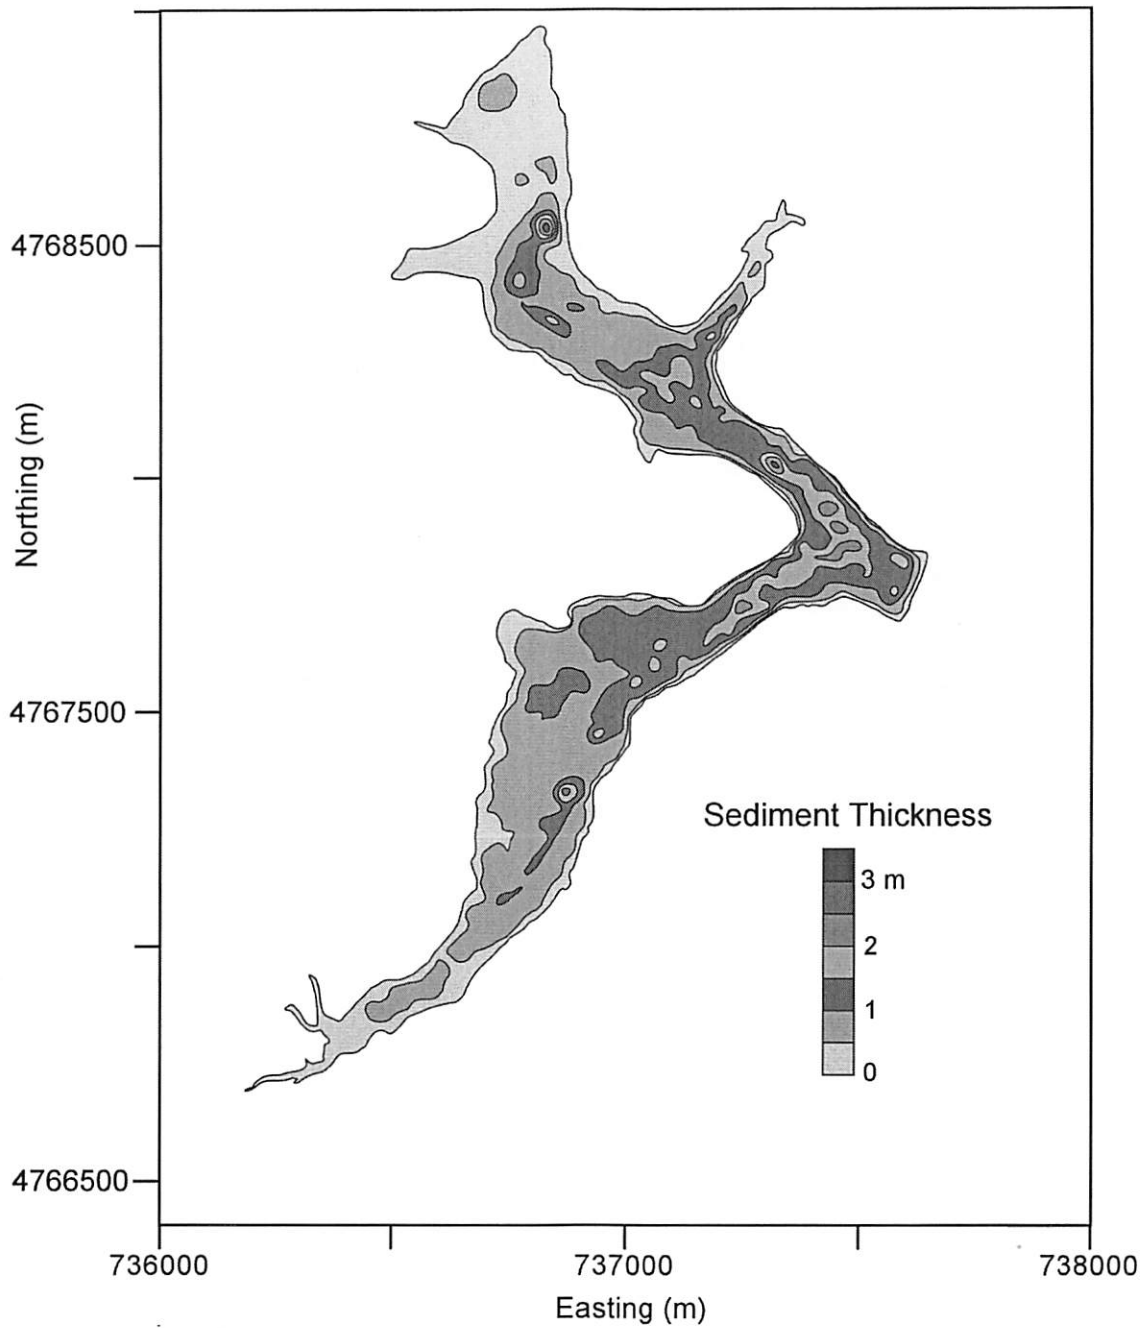
Figure 4-5. Contour map of sediment thickness in Twin Valley Lake, WI. Sediment thickness is measured from the water bottom to the interpreted base of post-impoundment fill. Coordinates are in meters (UTM Zone 15).

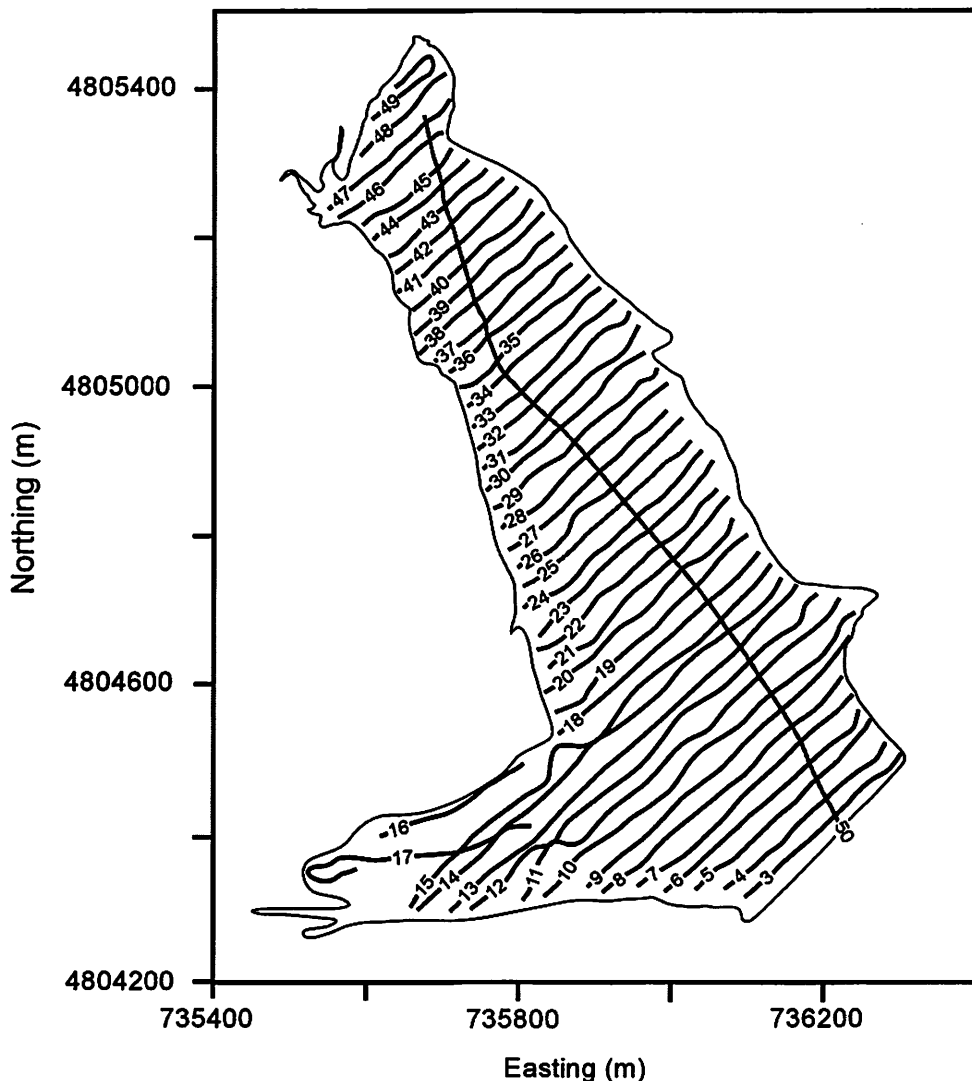
Figure 4-6. Profile map of White Mound Lake acoustic survey. Profiles 25 and 50, highlighted in red, are shown as example profiles in accompanying figures. Coordinates are in meters (UTM Zone 15).

White Mound Reservoir was surveyed on May 31, 2002. The entire survey was conducted with a 25-m track line spacing (Figure 4-6). Acoustic intervals similar to those seen in Twin Valley Lake were observed in White Mound Lake onlapping onto the dam face (Figure 4-7) and thinning upstream (Figure 4-8). The resulting maps indicate a maximum water depth of 8.6 m (28.3 ft) and a current water storage capacity of 1,462,460 m³ (1,185.4 acre-ft; Figure 4-9). The sediment thickness map indicates a maximum thickness of 1.4 m (4.6 ft) and a total volume of post-impoundment sediment of 203,205 m³ (164.7 acre-ft; Figure 4-10).

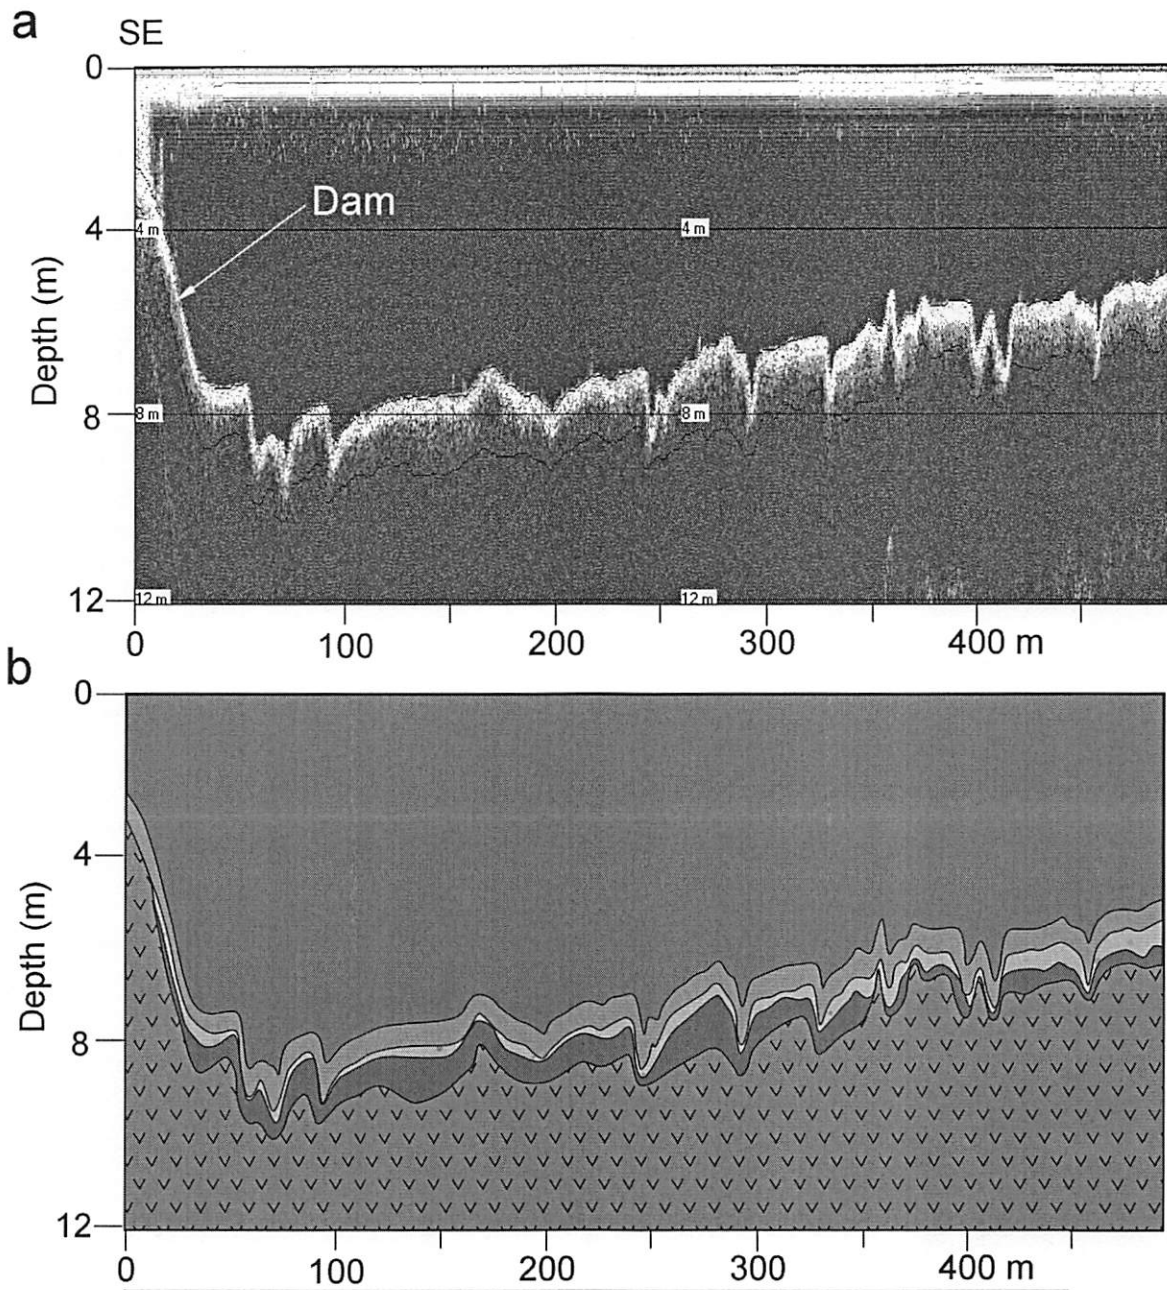
Figure 4-7. Southeast end of White Mound Lake axial profile, Line 50 (see Figure 4-6 for line location). Three acoustic intervals are seen within the sub-bottom in White Mound Lake. All three onlap onto the dam face. Hence, all three must be part of the post-impoundment sediment fill package.

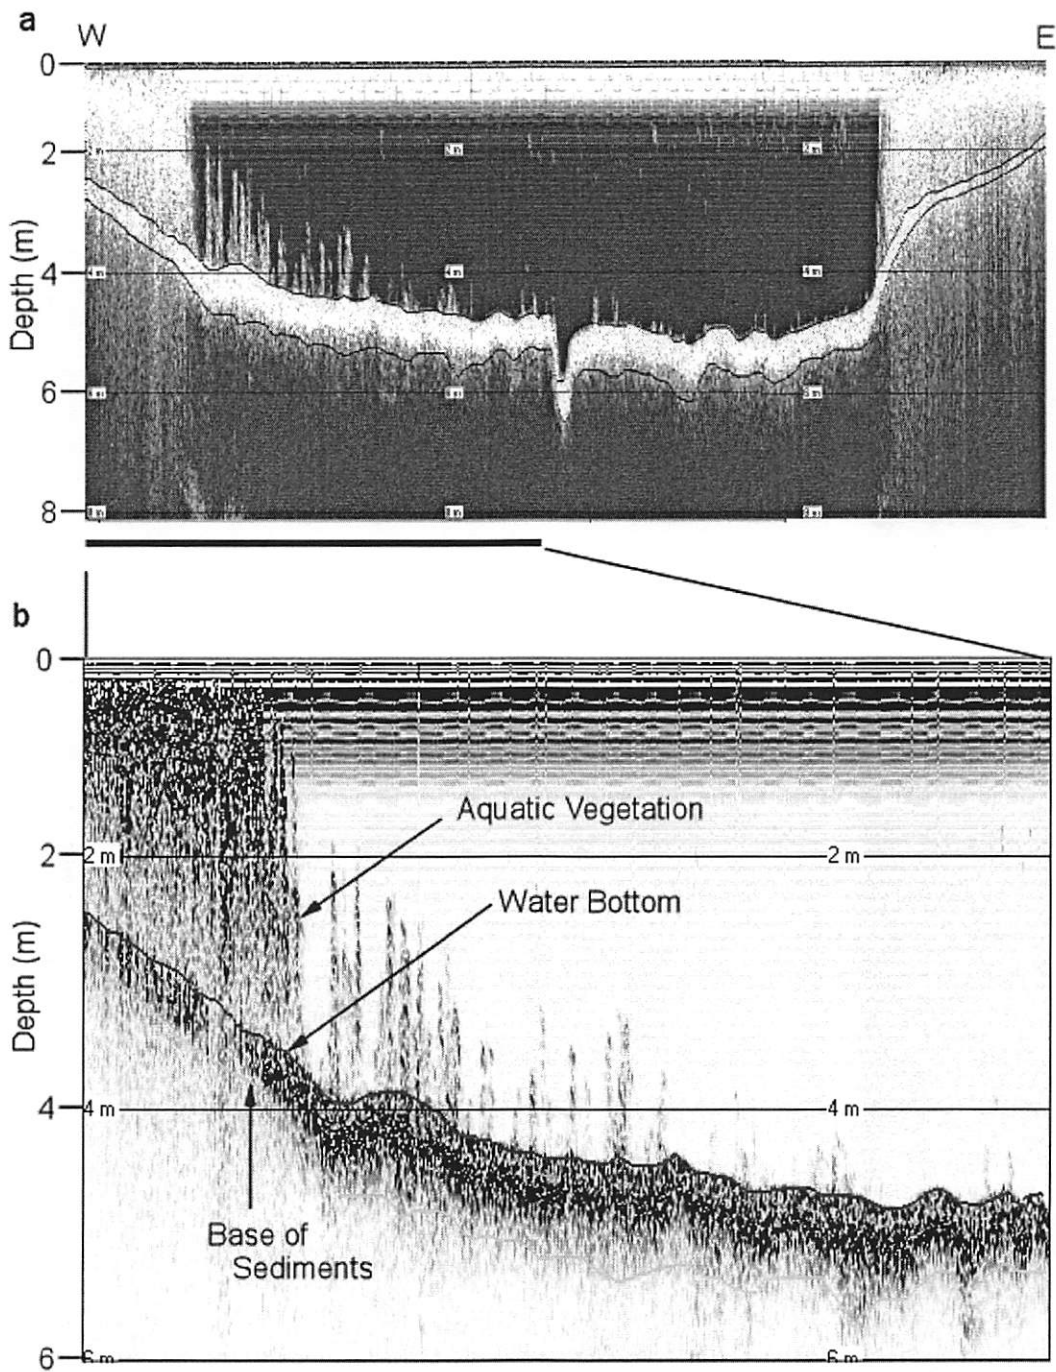
Figure 4-8. Acoustic profile 25 of the White Mound survey (see Figure 4-6 for line location). (a) Multifrequency display in which 200 kHz is red, 48 kHz in green and 24 kHz is blue intensity in the RGB image. The interpreted top and base of the post-impoundment fill are marked with black lines. (b) Aquatic vegetation blocks the 200 kHz signal, but is relatively transparent to the 48 kHz signal.

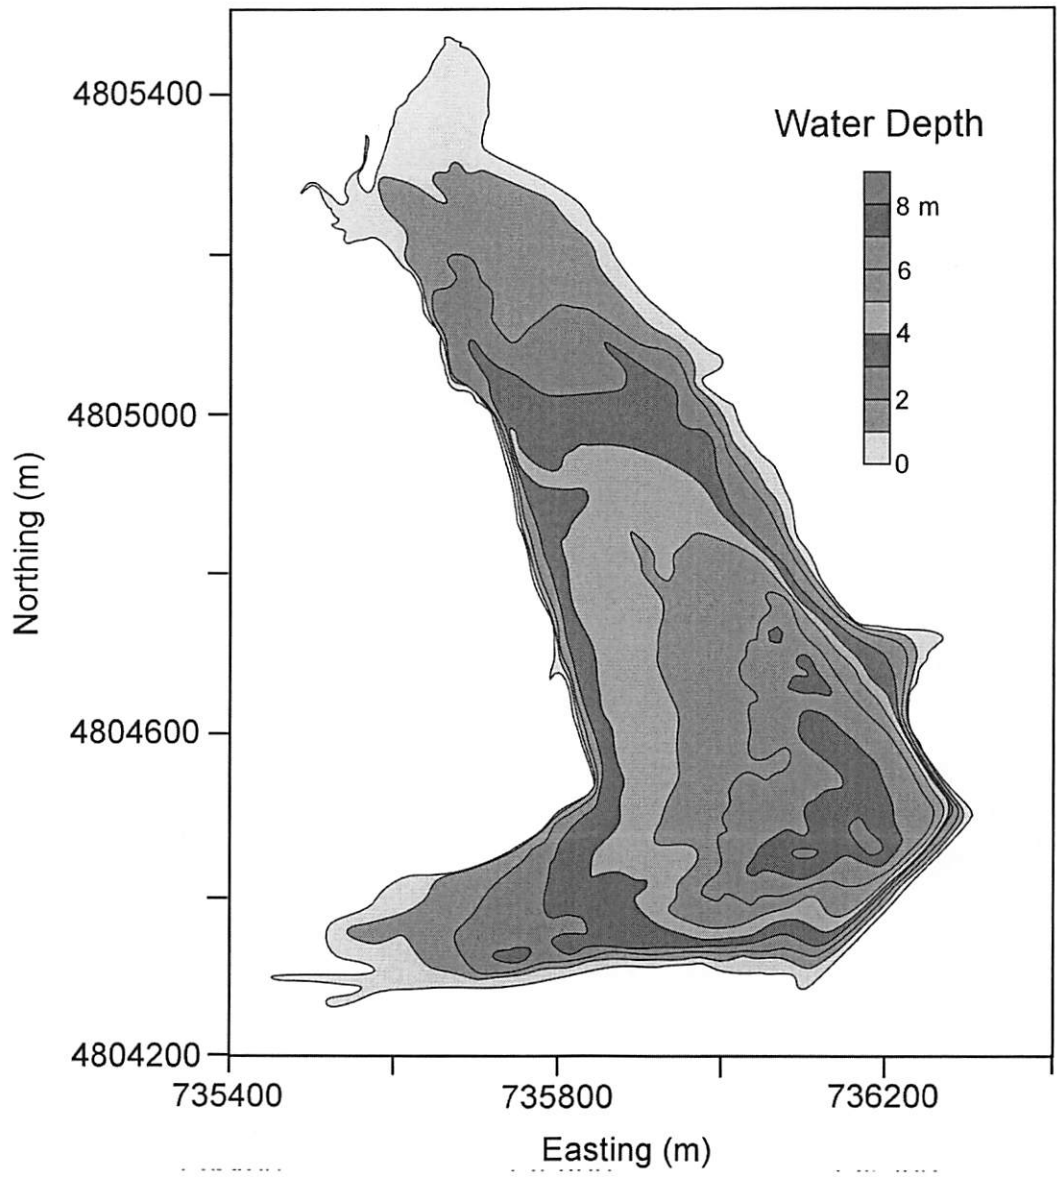
Figure 4-9. Contour map of water depth in White Mound Lake, WI. Depth is measured from the water surface at an elevation of 278.4 m (913 ft). Coordinates are in meters (UTM Zone 15).

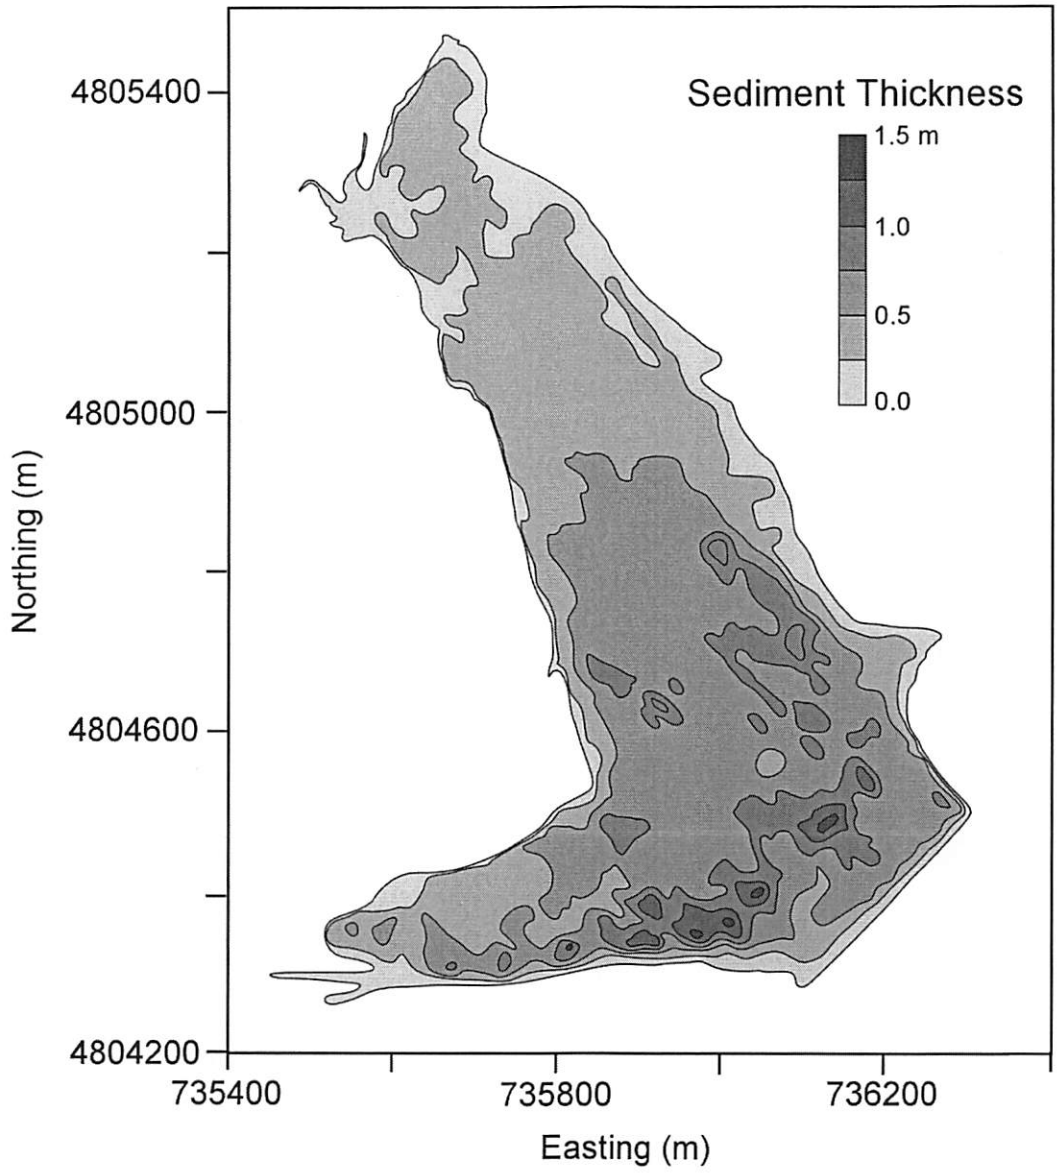
Figure 4-10. Contour map of sediment thickness in White Mound Lake, WI. Sediment thickness is measured from the water bottom to the interpreted base of post-impoundment fill. Coordinates are in meters (UTM Zone 15).
