# Beltsville Agricultural Research Center Hazardous Materials Assessment Part 2

**Beltsville Agricultural Research Center  
Hazardous Materials Assessment  
Project No. 103144**

**Revision 1  
April 22, 2020**

**Burns & McDonnell Engineering Company, Inc.  
Downers Grove, Illinois**

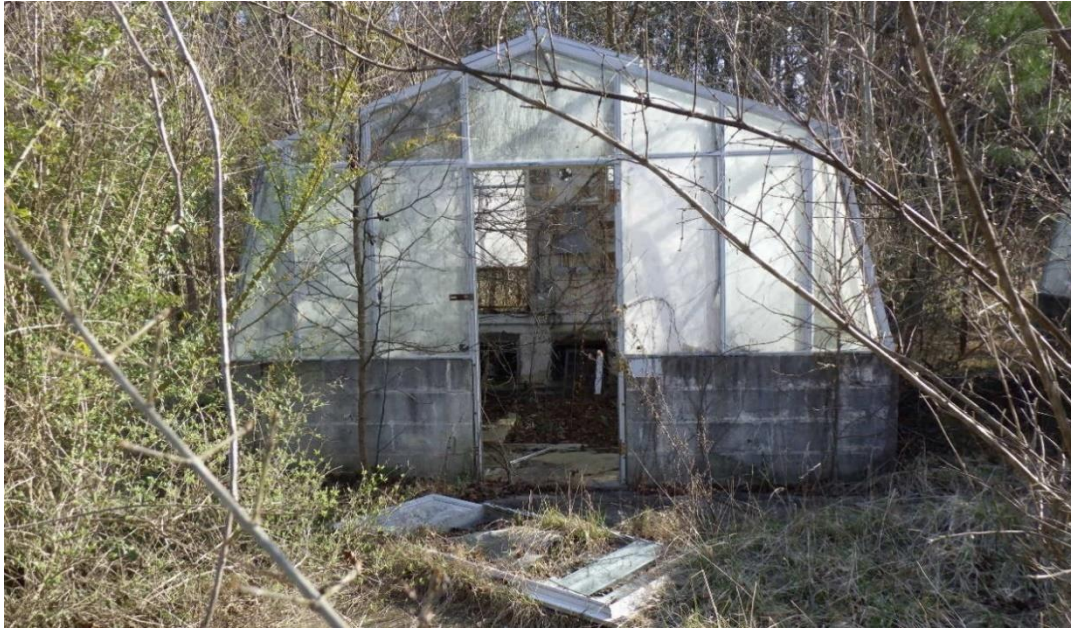
**Figure 8-12: Building 470AA, facing south, location shown on Appendix A, Figure 3**

Sample ID	Building	Type Of Material	Description	Location	Approx. Quantity	Units	Results	Physical Assessment
470-AAA1	470AA-470II	asbestos	Transite Panel	Flower Boxes in Greenhouses	1450	sf	Chrysotile 20-25%	Non-Friable - II
470-AAA2		asbestos		Flower Boxes in Greenhouses			Chrysotile 20-25%	Non-Friable - II
470-AAA3		asbestos		Flower Boxes in Greenhouses			Chrysotile 20-25%	Non-Friable - II
	470AA	electronics	wall/unit heaters	greenhouse	2	each		
	470AA	mercury	thermostats	greenhouse	4	each		
	470AA	refrigerant	AC wall unit	greenhouse	2	each

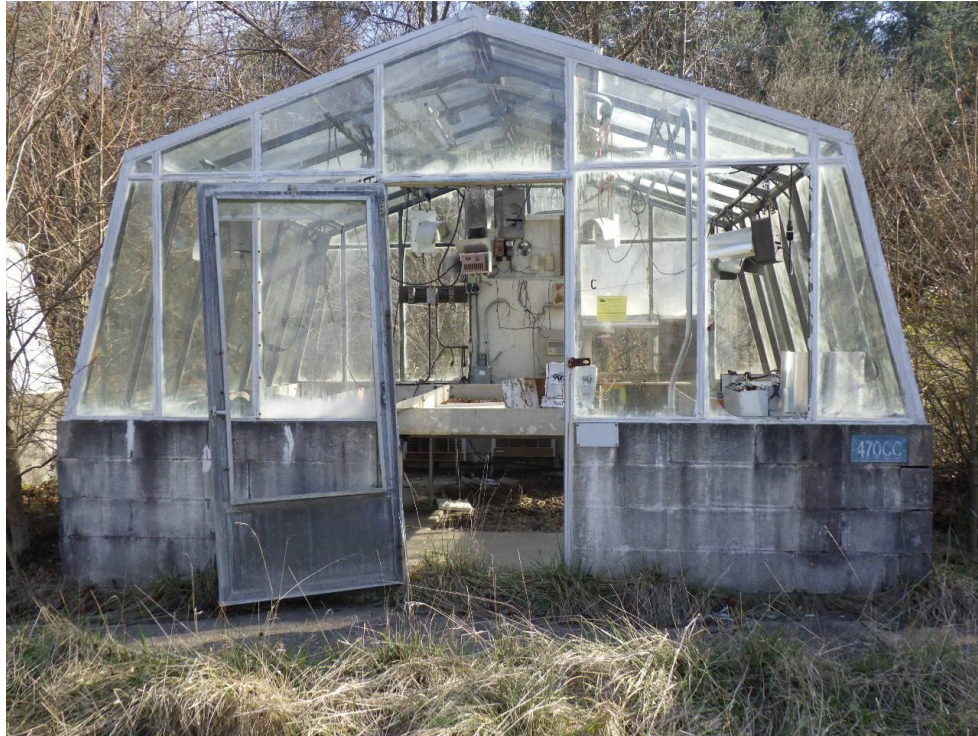
Figure 8-14: Building 470CC, facing south, location shown on Appendix A, Figure 3

Sample ID	Building	Type Of Material	Description	Location	Approx. Quantity	Units	Results	Physical Assessment
470-AAA1	470AA-470II	asbestos	Transite Panel	Flower Boxes in Greenhouses	1450	sf	Chrysotile 20-25%	Non-Friable - II
470-AAA2		asbestos		Flower Boxes in Greenhouses			Chrysotile 20-25%	Non-Friable - II
470-AAA3		asbestos		Flower Boxes in Greenhouses			Chrysotile 20-25%	Non-Friable - II
	470CC	electronics	wall/unit heaters	greenhouse	2	each		
	470CC	electronics	high intensity light starters	greenhouse	16	each		
	470CC	mercury	thermostats	greenhouse	10	each

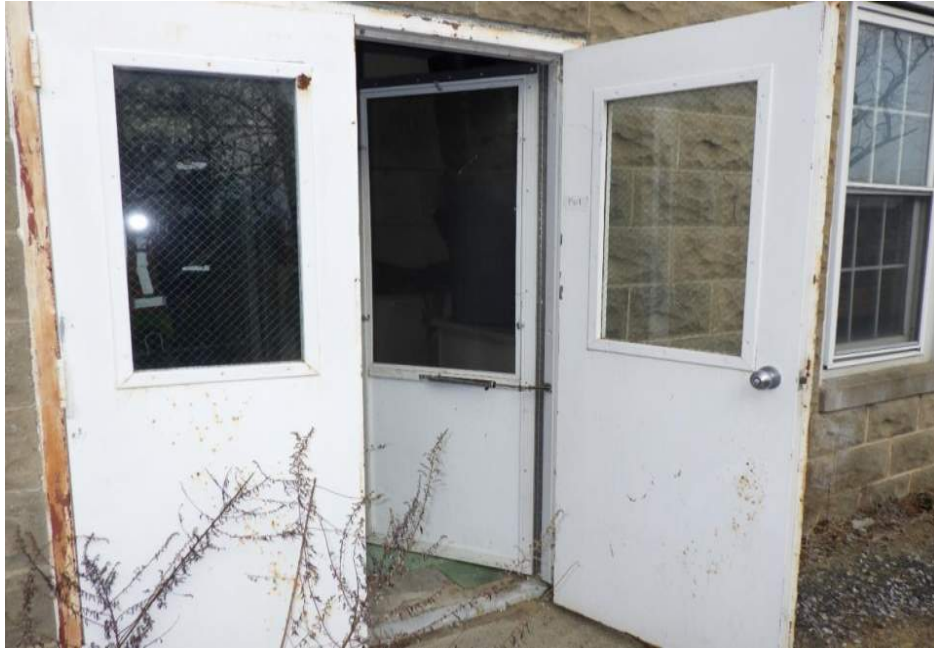
**Building/Unit:** 38

**Description:** white paint sample on exterior metal door

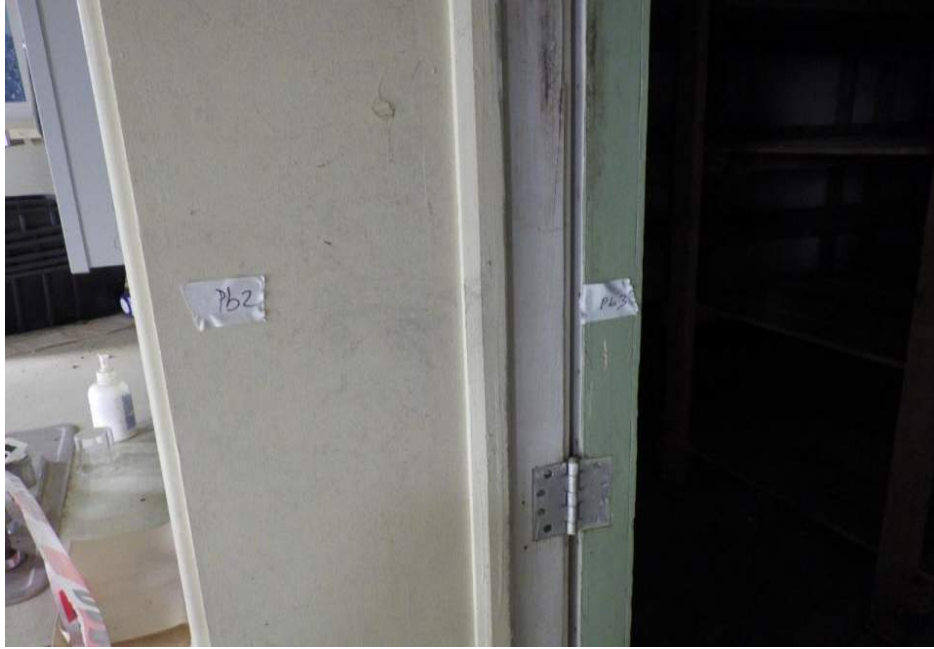
038-Pb2

**Results:** 18000 ppm

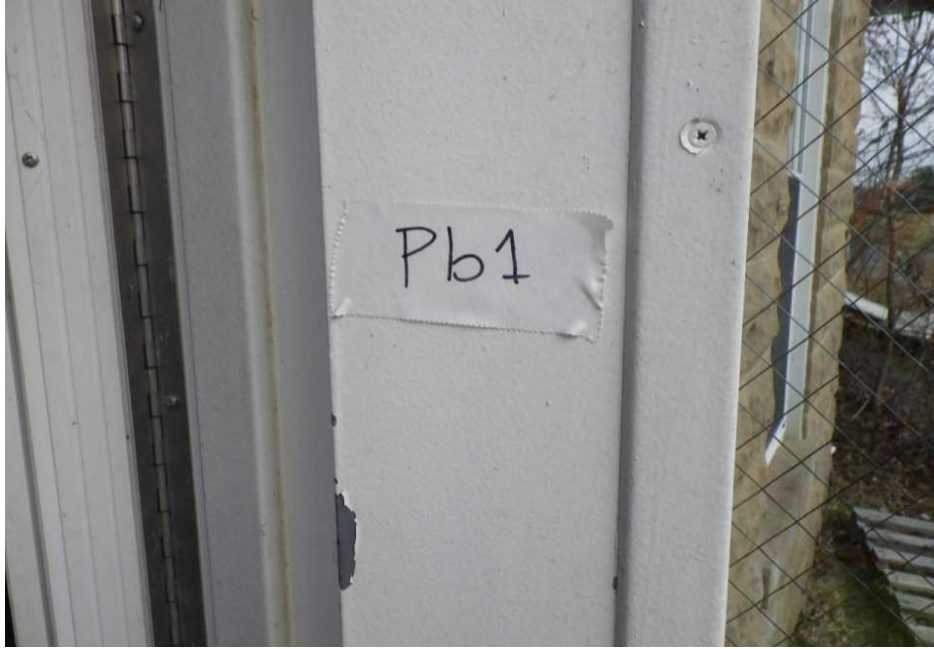
038-Pb1

**Results:** 330 ppm

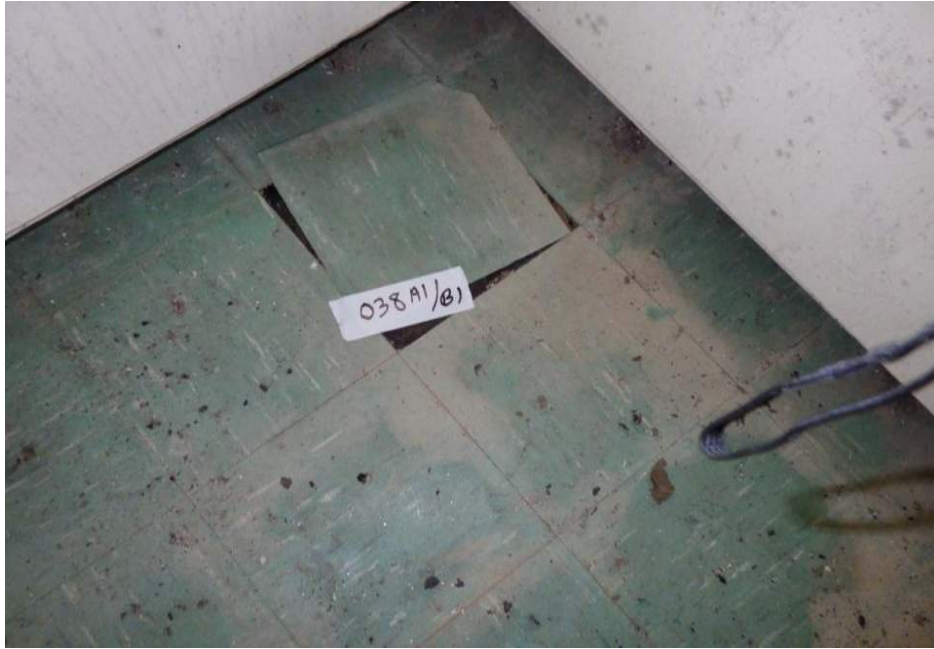
038A1

**Results:** Chrysotile 1-5%

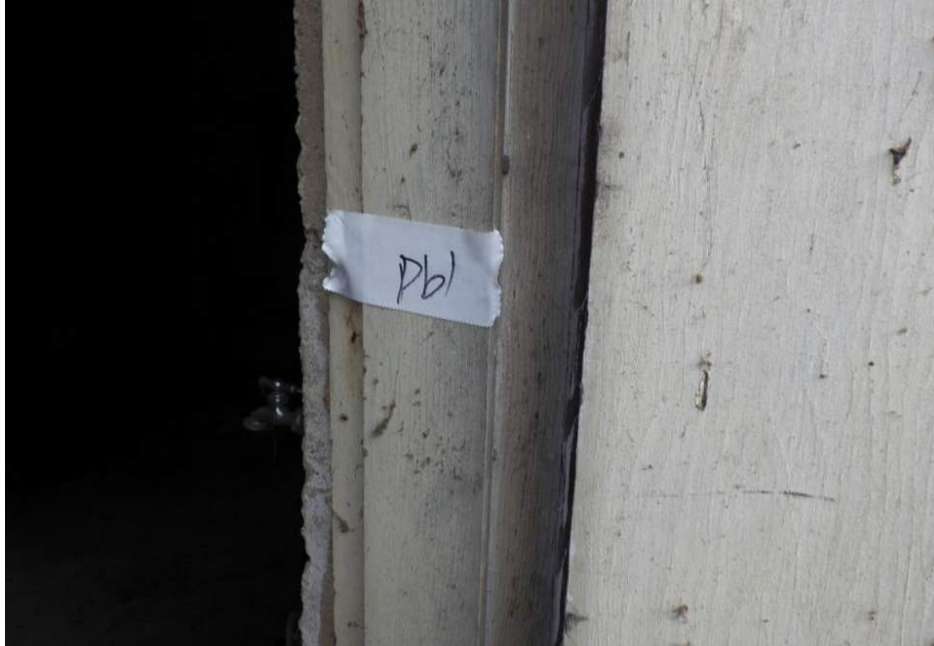
039-Pb1

**Results:** 9900 ppm

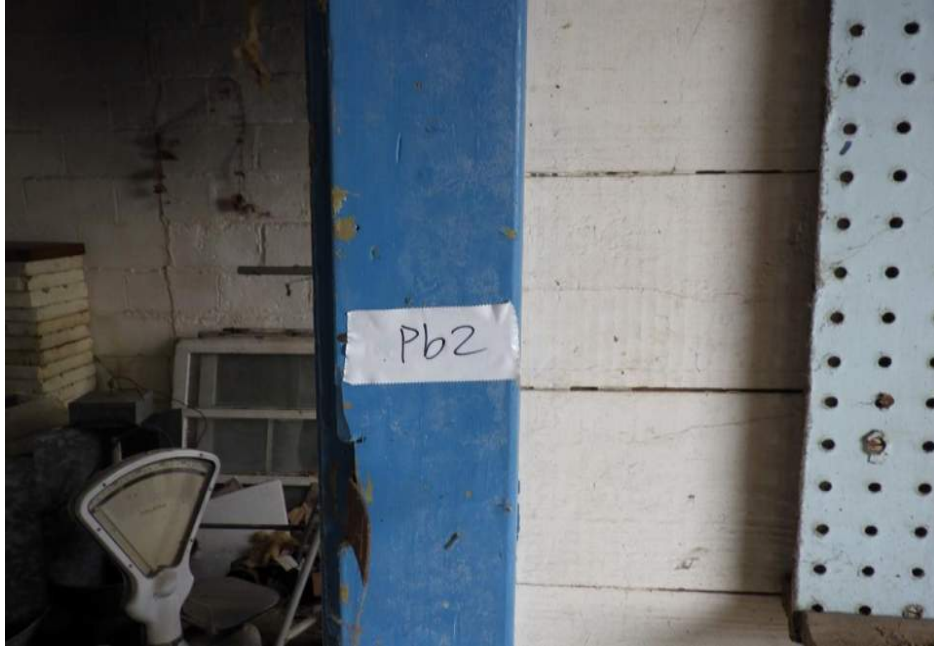
040-Pb2

**Results:** 3300 ppm

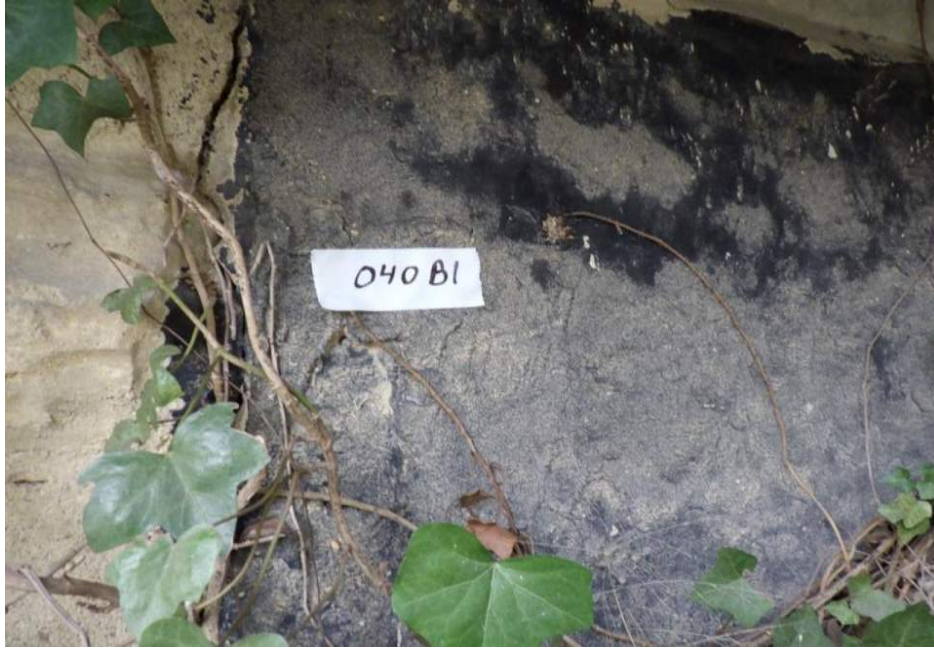
040B1

**Results:** 3300 ppm

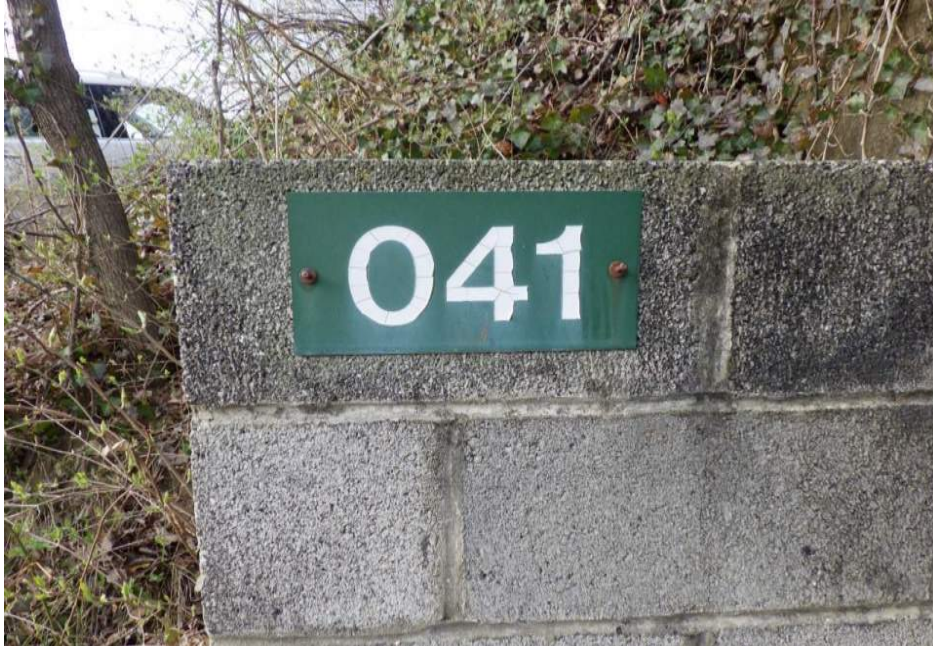
**Results:** 310000 ppm

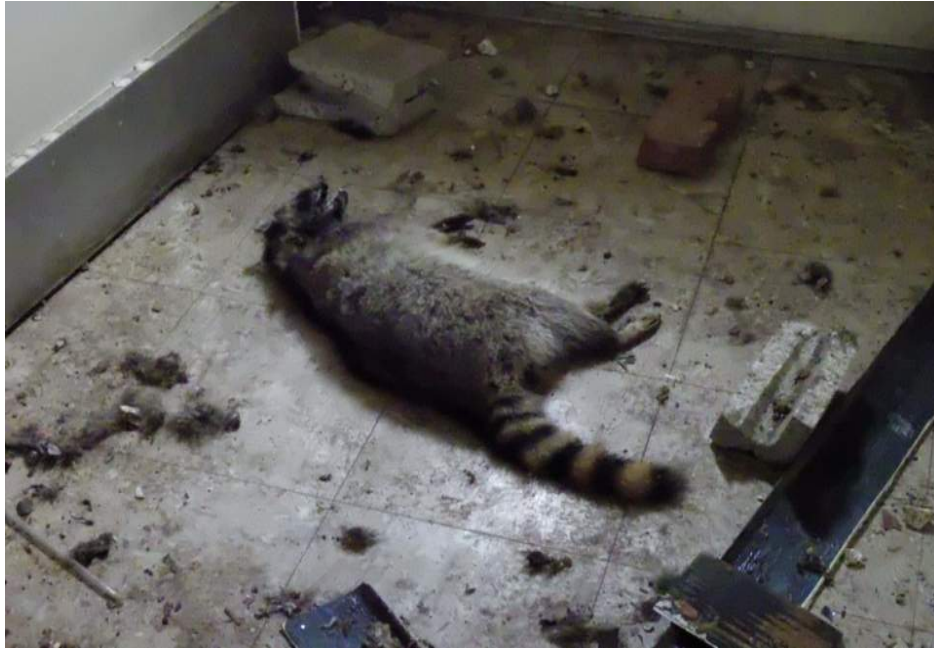
**Building/Unit:** 50

**Description:** dead racoon at east entrance door, rodents, and birds present in building

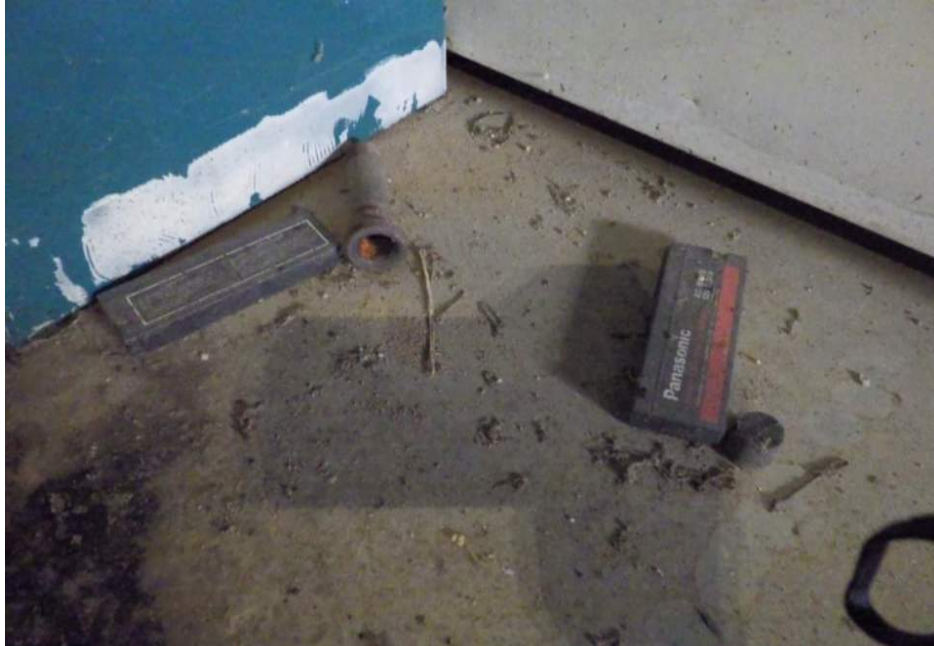
**Building/Unit:** 50

**Description:** Lithium Ion batteries in storage

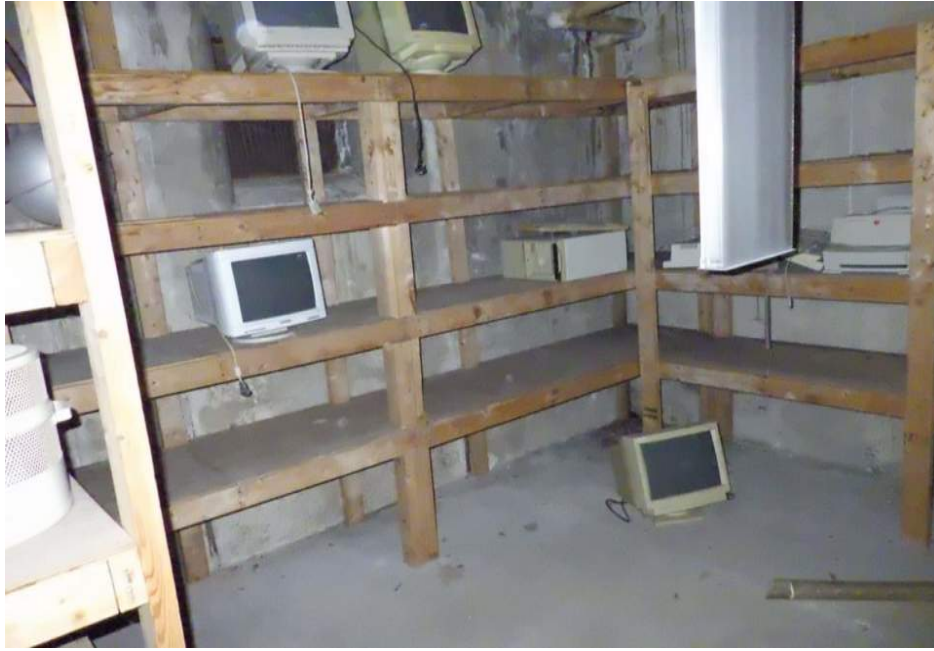
**Building/Unit:** 50

**Description:** computer CRT monitors in storage

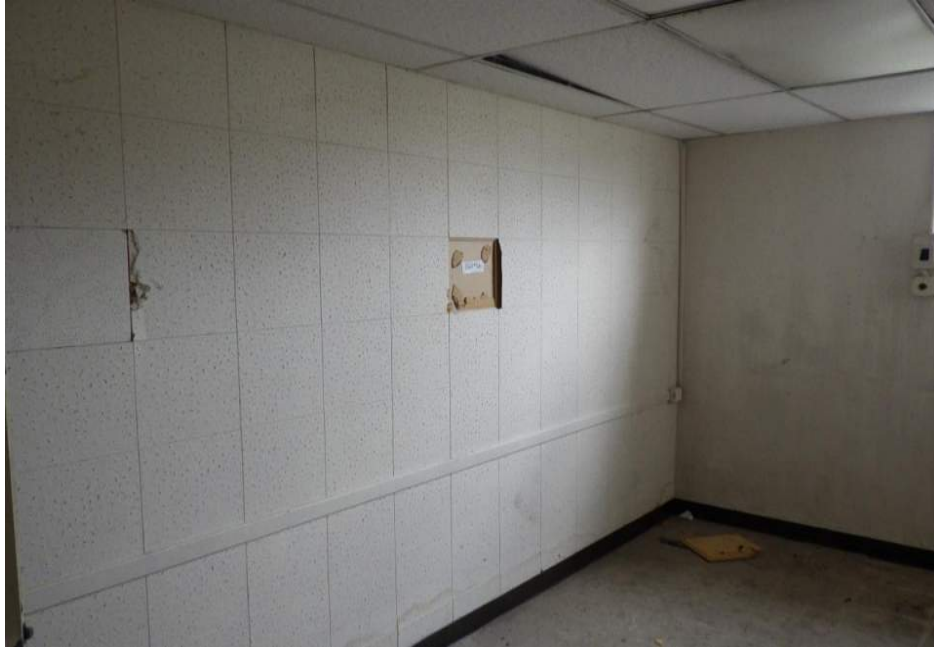
**Building/Unit:** 50

**Description:** interior basement room with ceiling tiles on the wall

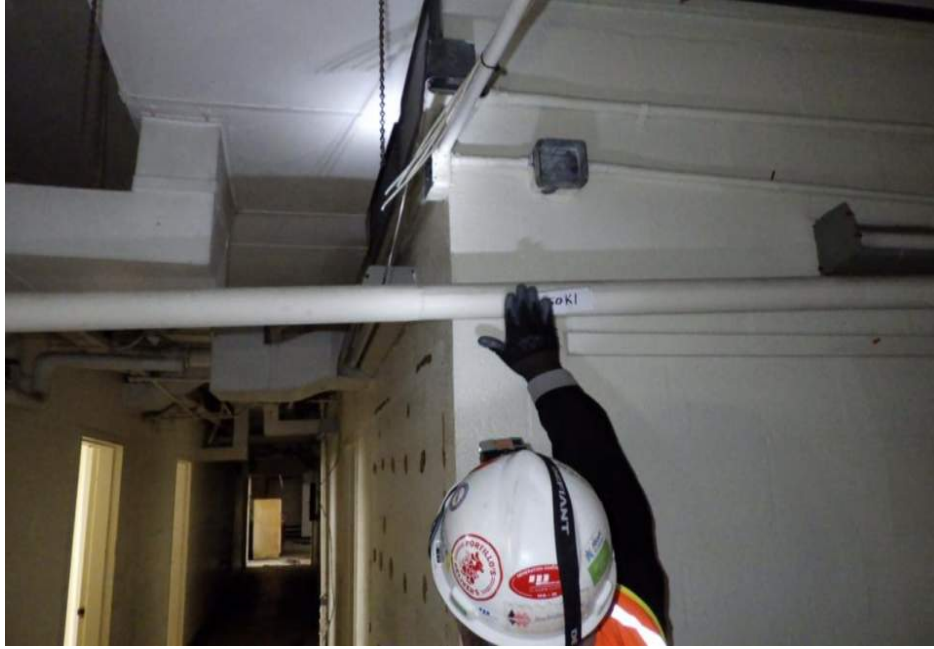
**Building/Unit:** 50

**Description:** asbestos sample pipe thermal system insulation

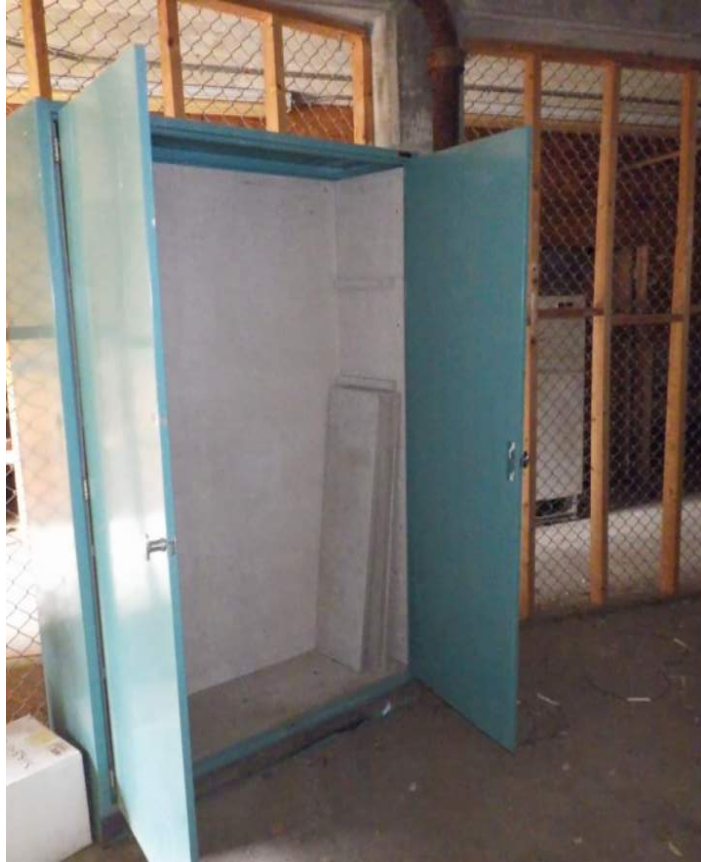
**Building/Unit:** 50

**Description:** blue empty cabinet, transite panel interior

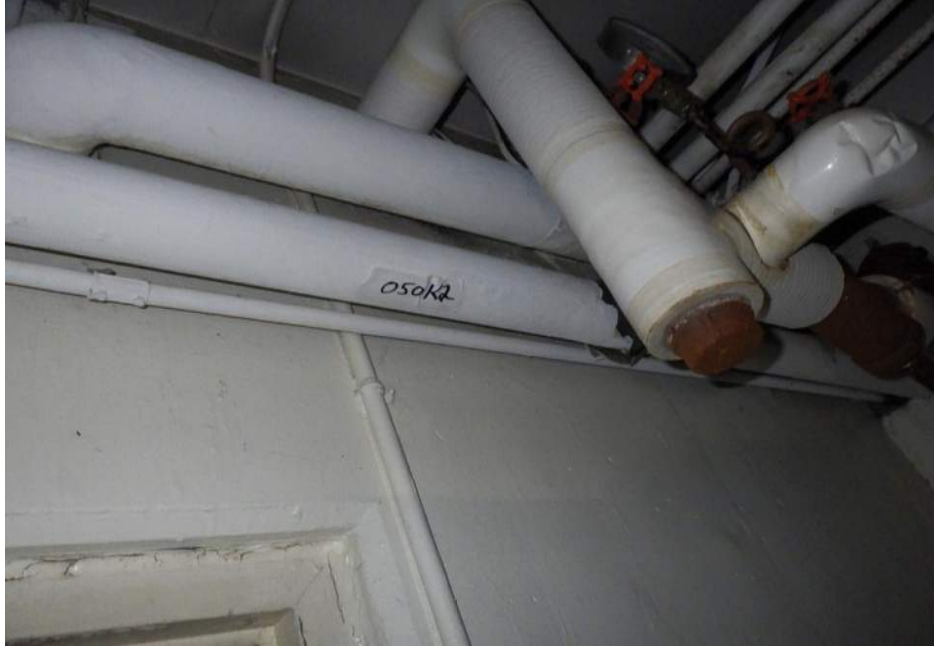
050K2

**Results:** Chrysotile 5-10% Amosite 5-10%

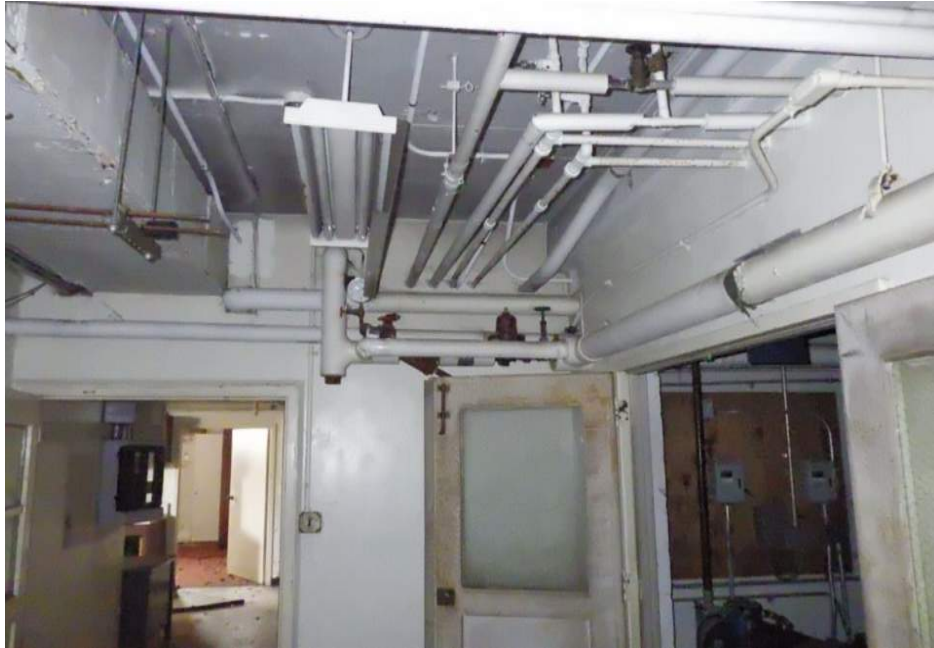
**Building/Unit:** 50

**Description:** pipe thermal insulation and typical fluorescent lighting

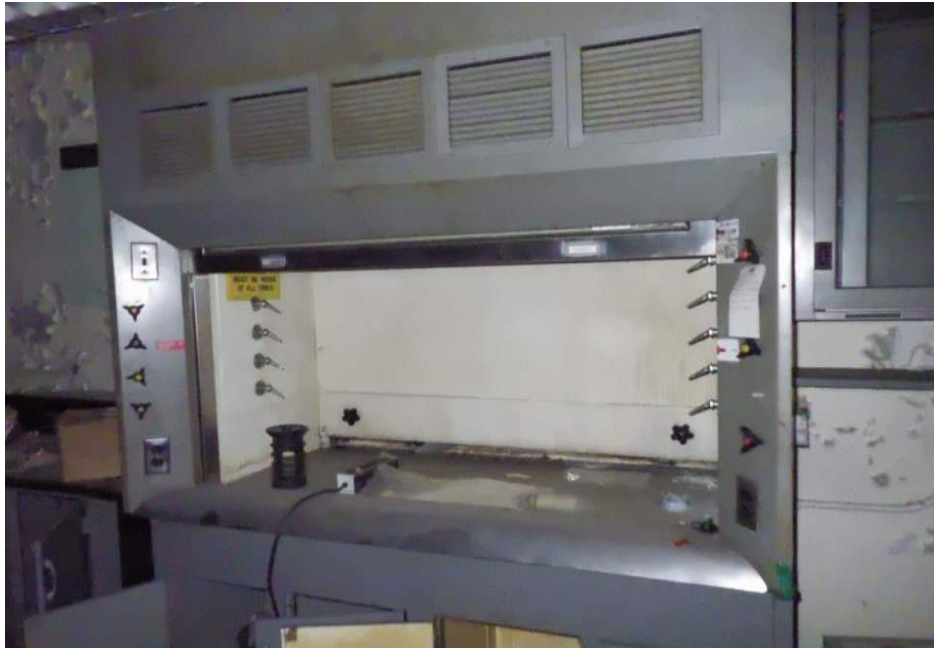
050F3

**Results:** Chrysotile 20-25%

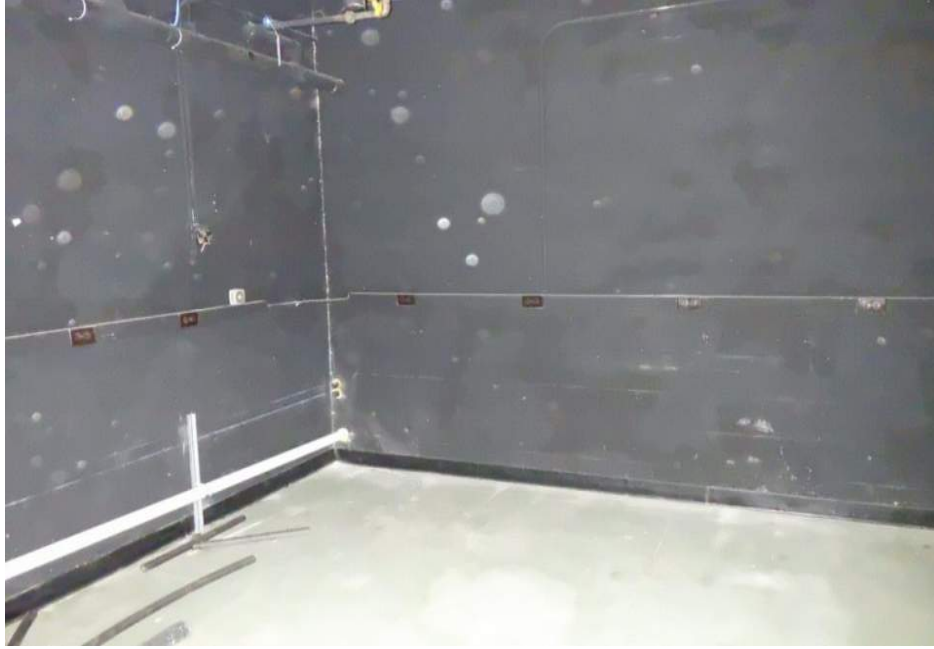
**Building/Unit:** 50

**Description:** interior of photographic dark room

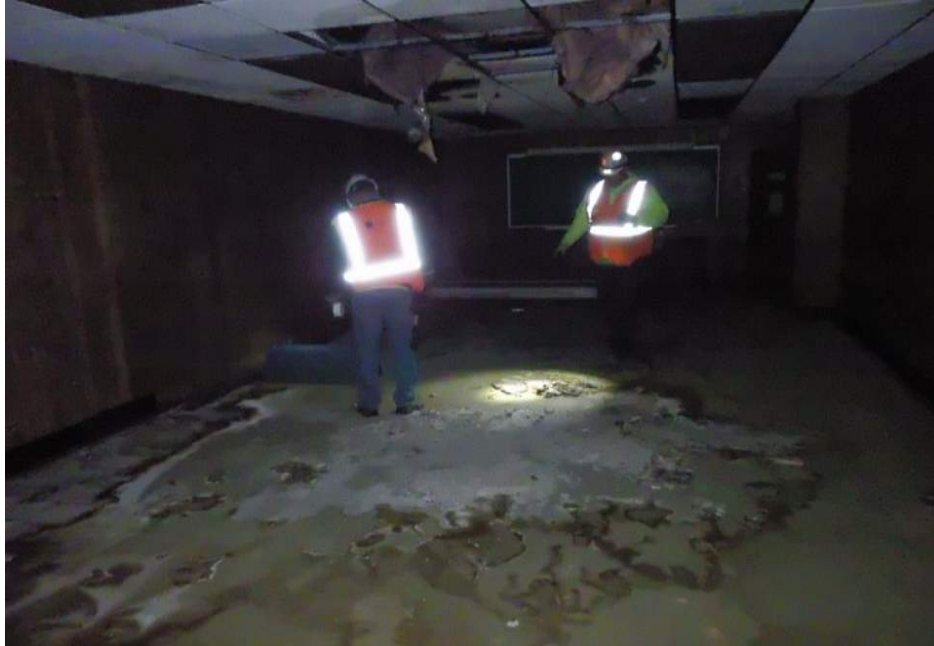
**Building/Unit:** 50

**Description:** interior basement conference room, moldy carpet over floor tiles

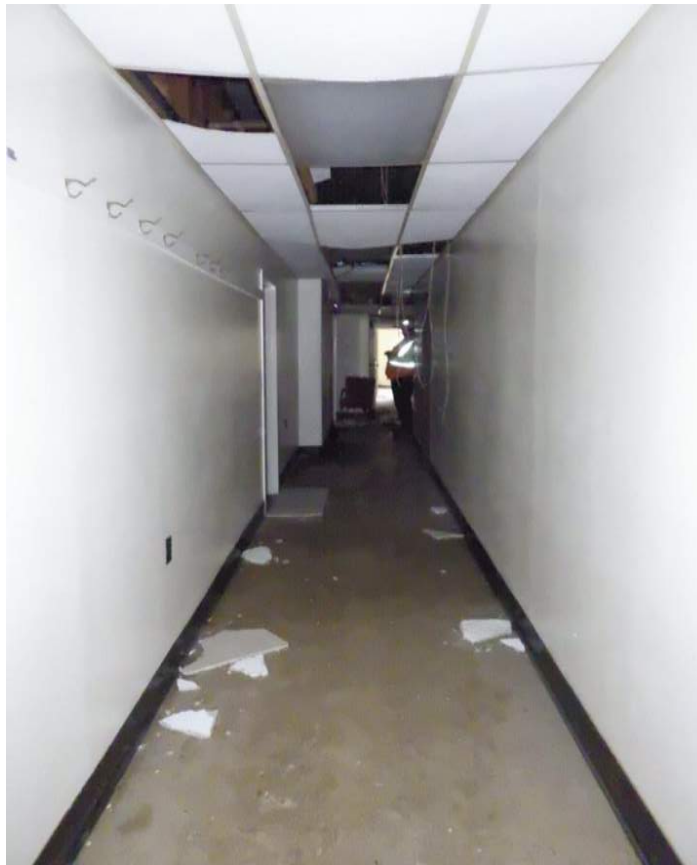
**Building/Unit:** 50

**Description:** basement hallway, typical fluorescent lighting

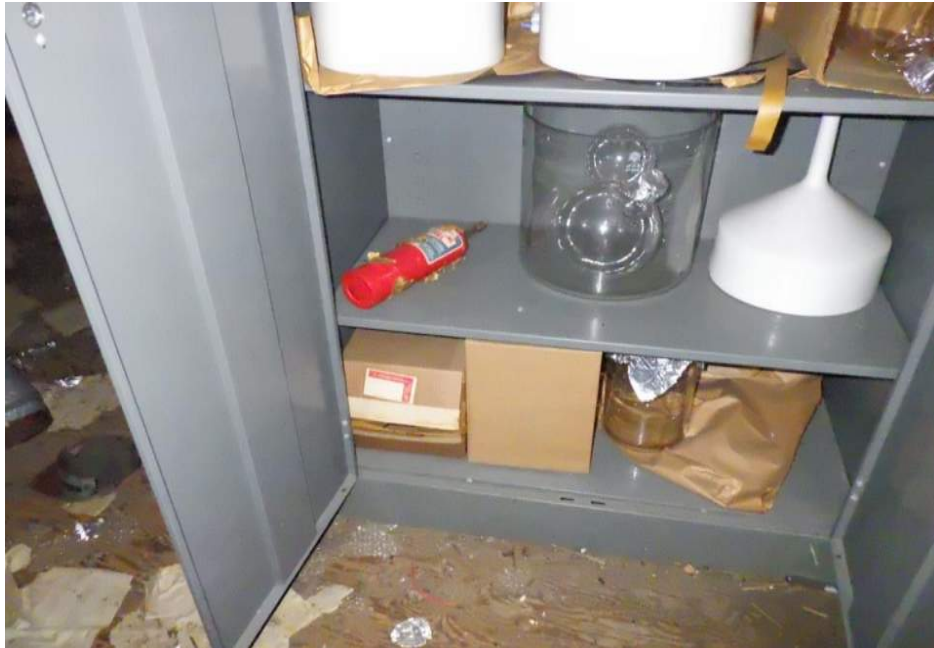
**Building/Unit:** 50

**Description:** attic storage cabinet with 5# gas cylinder

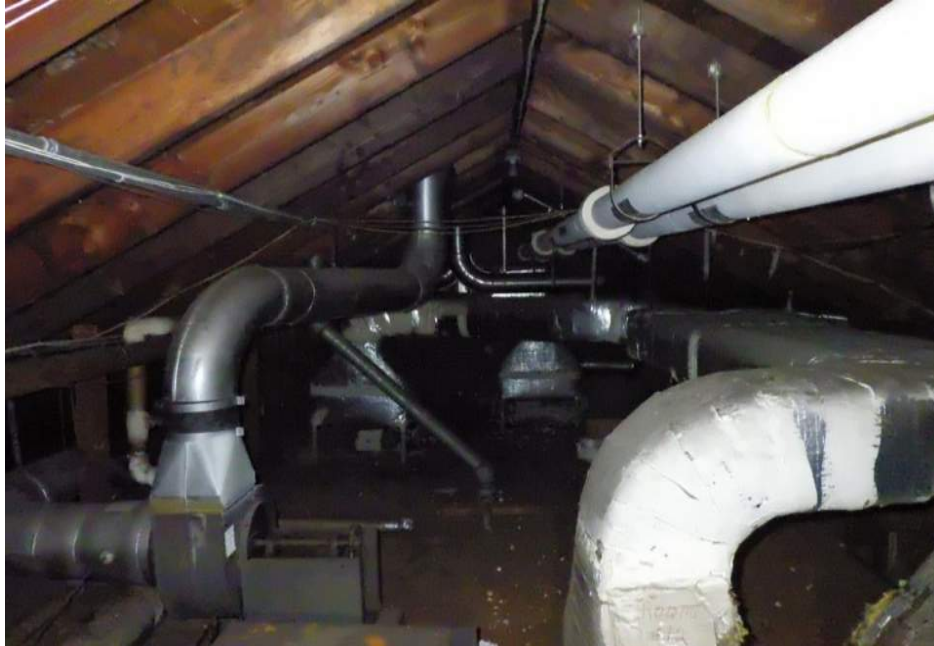
**Building/Unit:** 50

**Description:** interior central attic, air handling and duct insulation

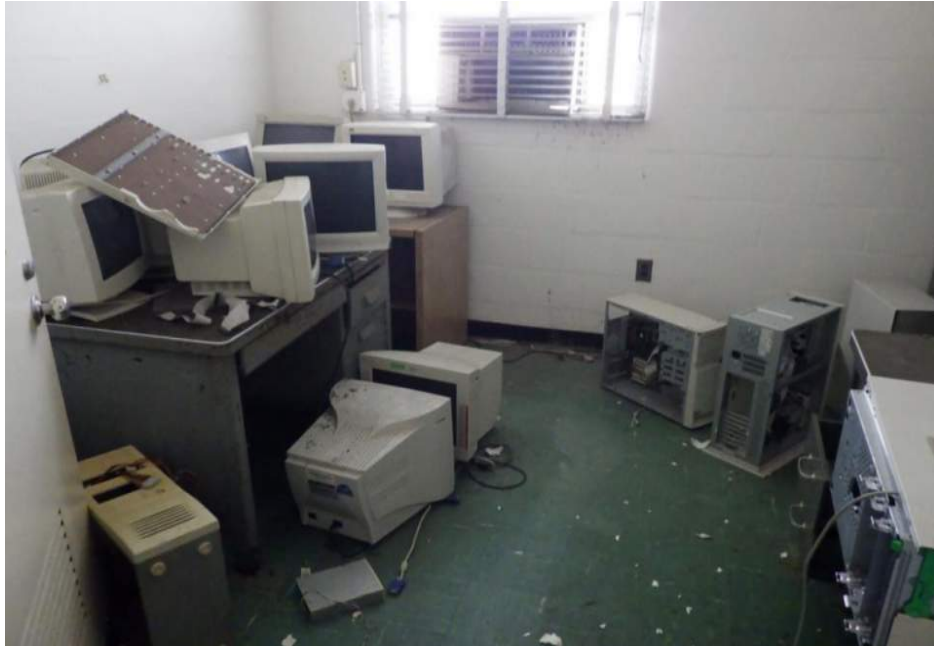
**Building/Unit:** 50

**Description:** main floor office, abandoned Computer CRT monitors and CPUs

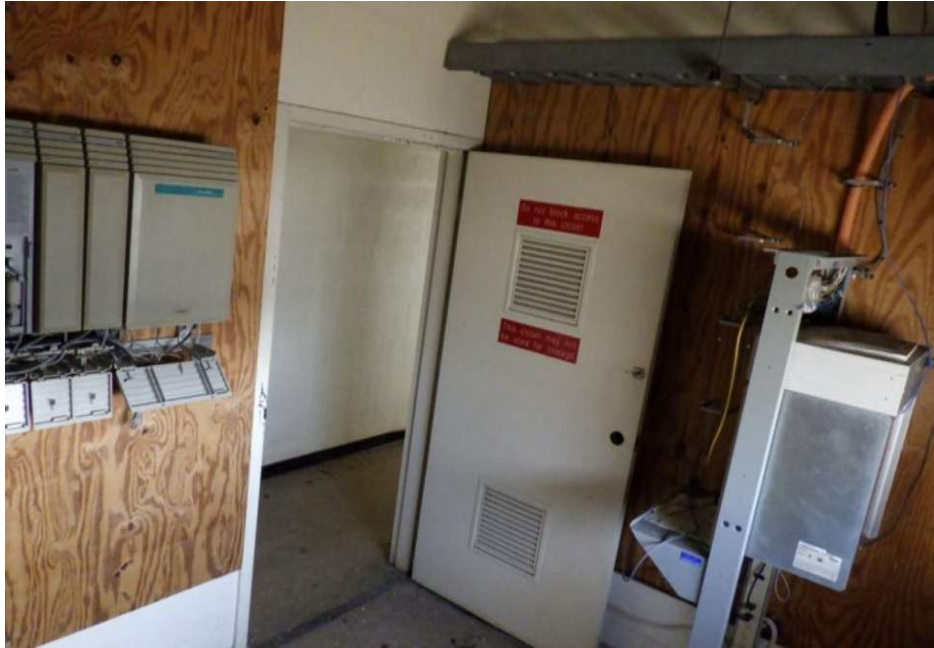
**Building/Unit:** 50

**Description:** main floor electronics servers

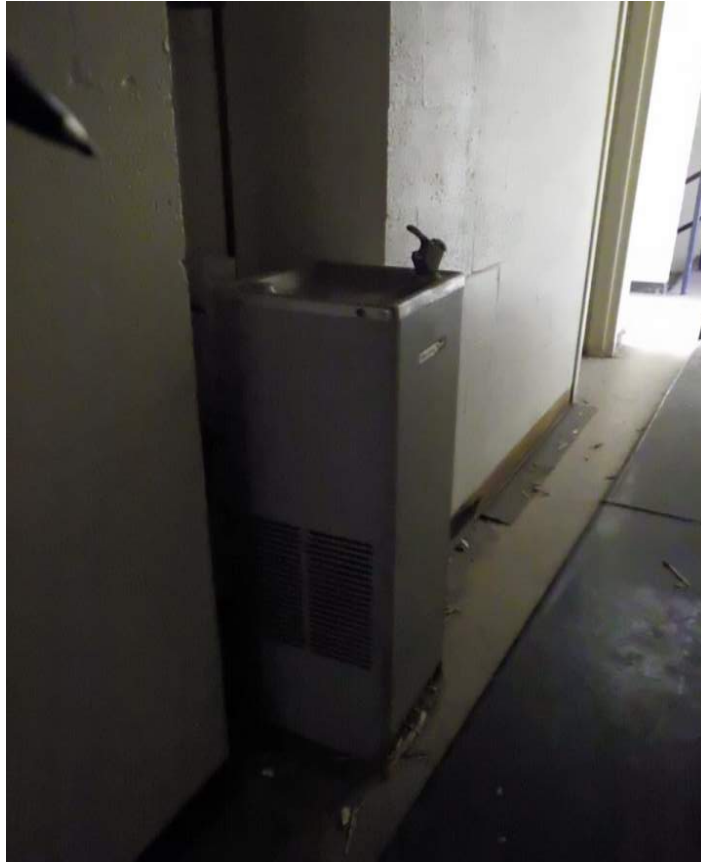
**Building/Unit:** 50

**Description:** water fountain with refrigerant, hallway

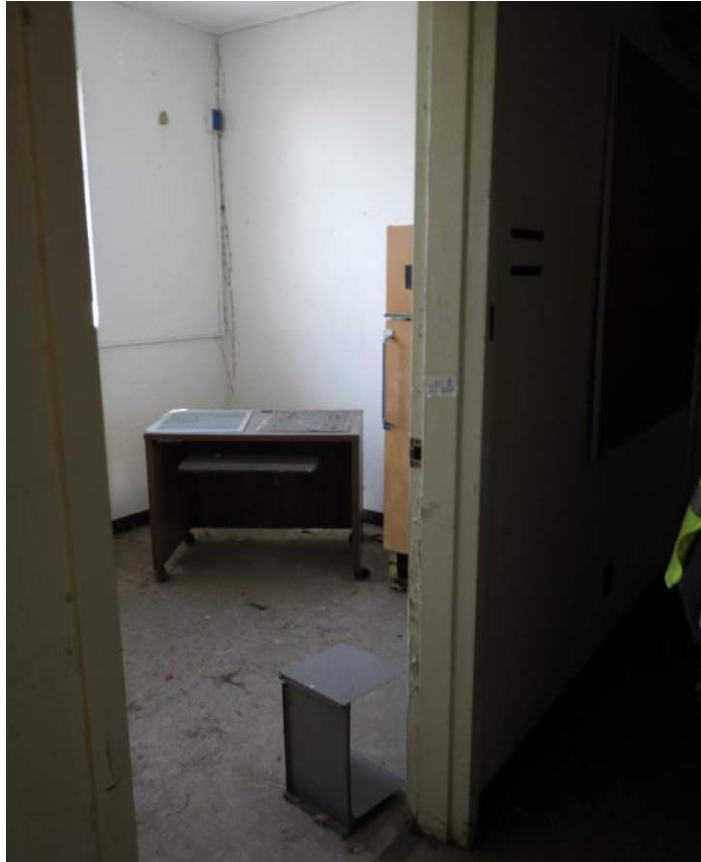
**Building/Unit:** 50

**Description:** beige door frame paint on metal

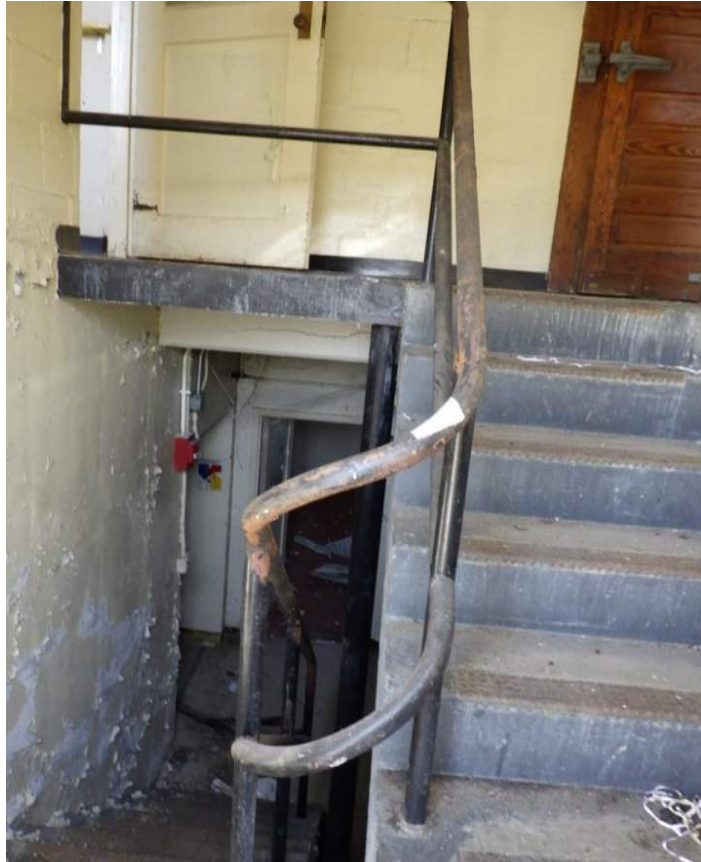
050-Pb2

**Results:** 2400 ppm

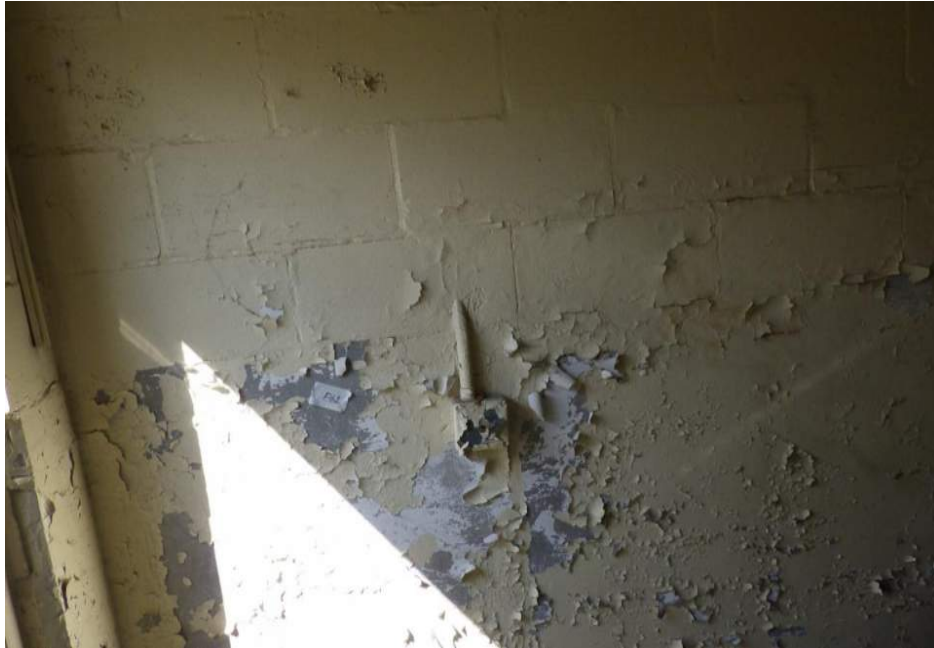
050-Pb1

**Results:** 4200 ppm

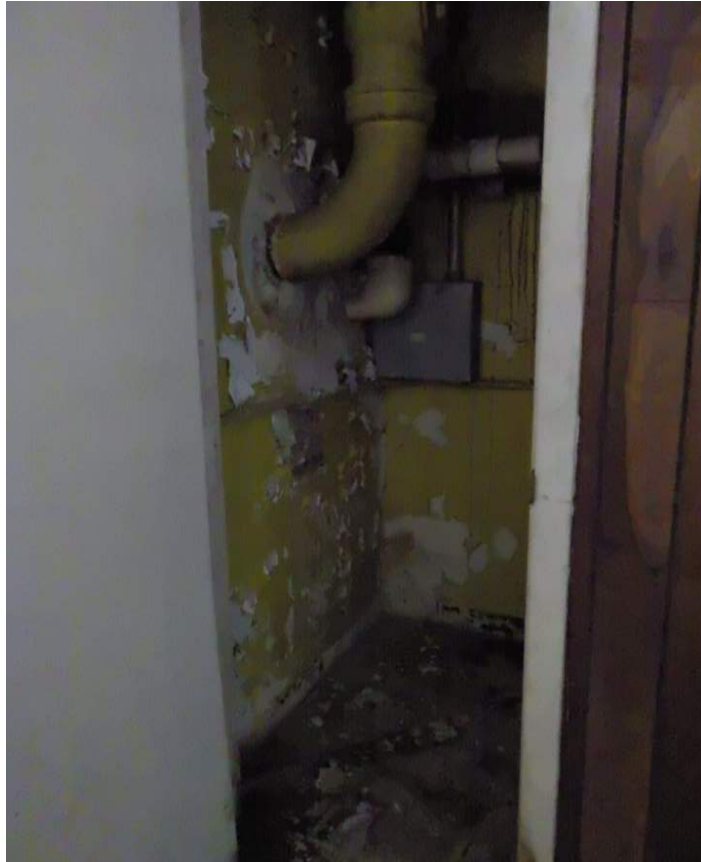
050-Pb8

**Results:** 5700 ppm

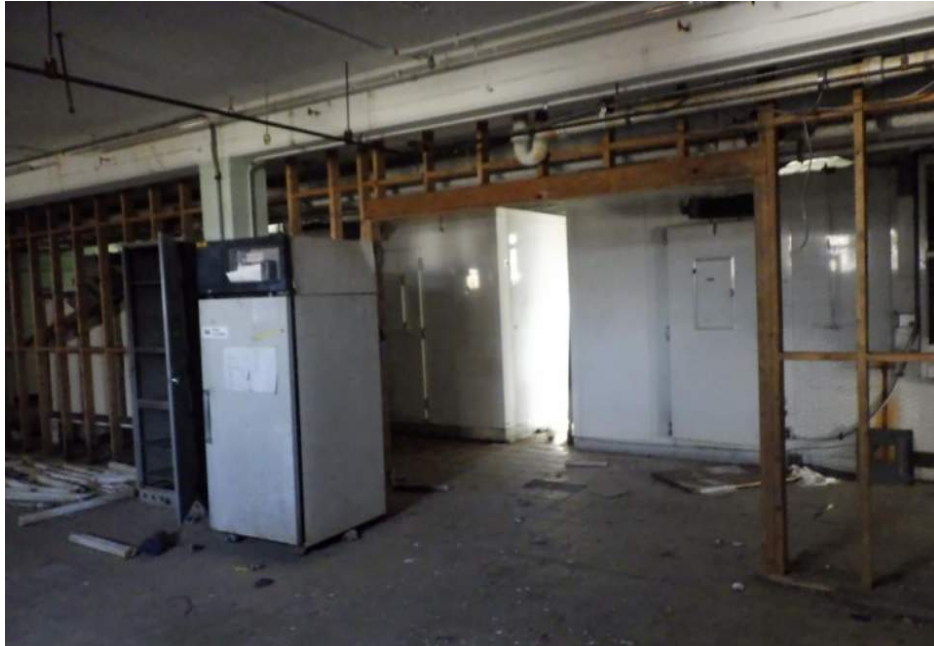
**Building/Unit:** 50

**Description:** refrigerator in storage in basement

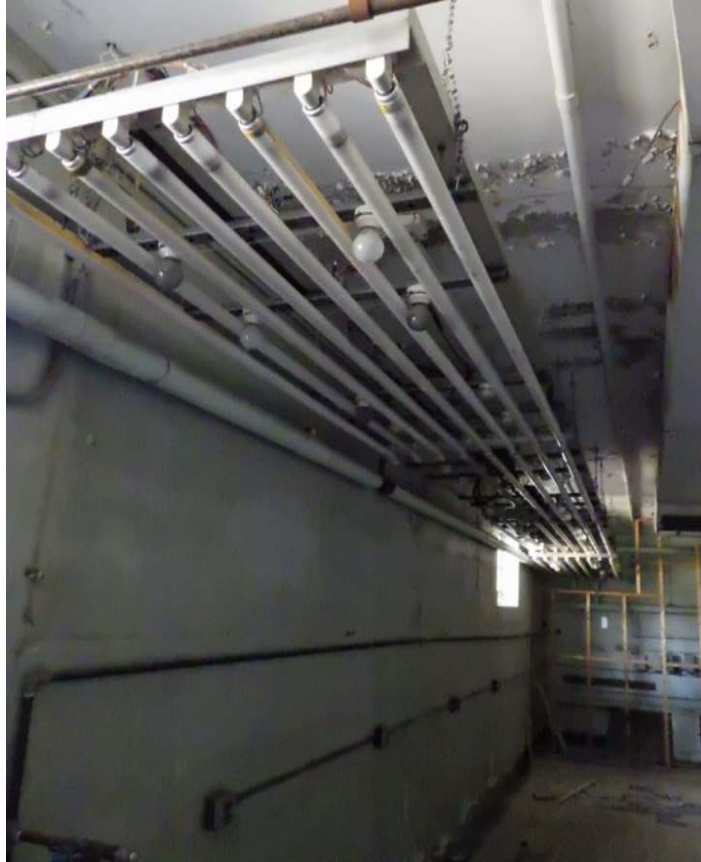
**Building/Unit:** 50

**Description:** fluorescent lamps basement, unknown use

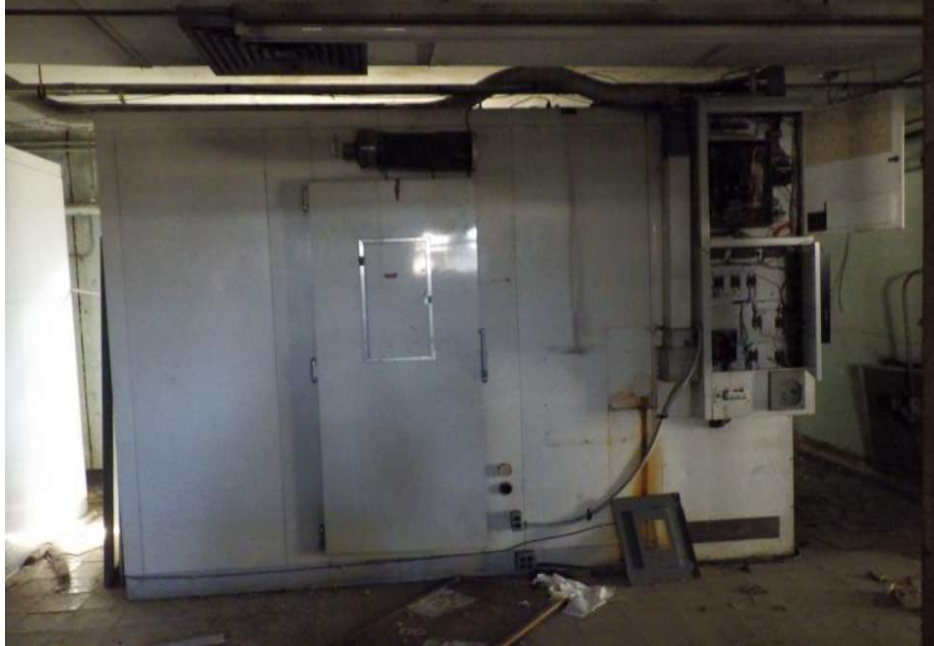
**Building/Unit:** 50

**Description:** walk in refrigerator in basement

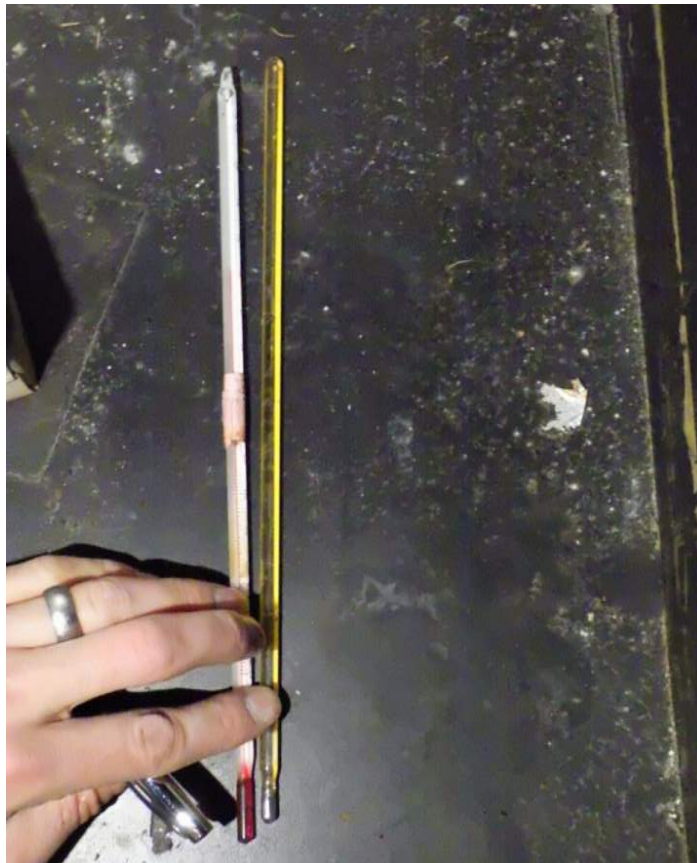
**Building/Unit:** 50

**Description:** building 050 mercury thermometers

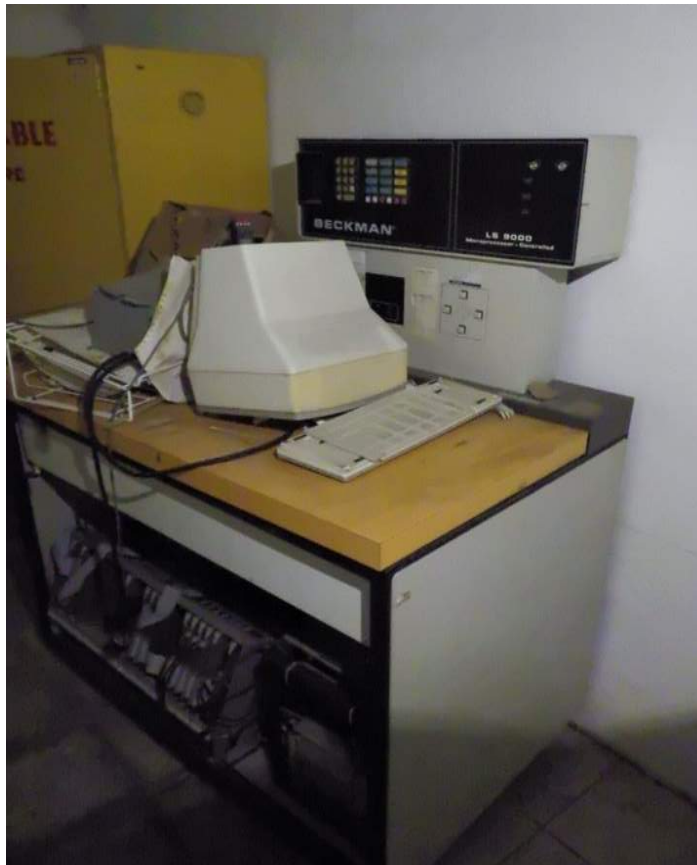
**Building/Unit:** 50

**Description:** electrical equipment, centrifuge, and computer CRT monitor
