# Beltsville Agricultural Research Center Hazardous Materials Assessment Part 2

**Beltsville Agricultural Research Center  
Hazardous Materials Assessment  
Project No. 103144**

**Revision 1  
April 22, 2020**

**Burns & McDonnell Engineering Company, Inc.  
Downers Grove, Illinois**

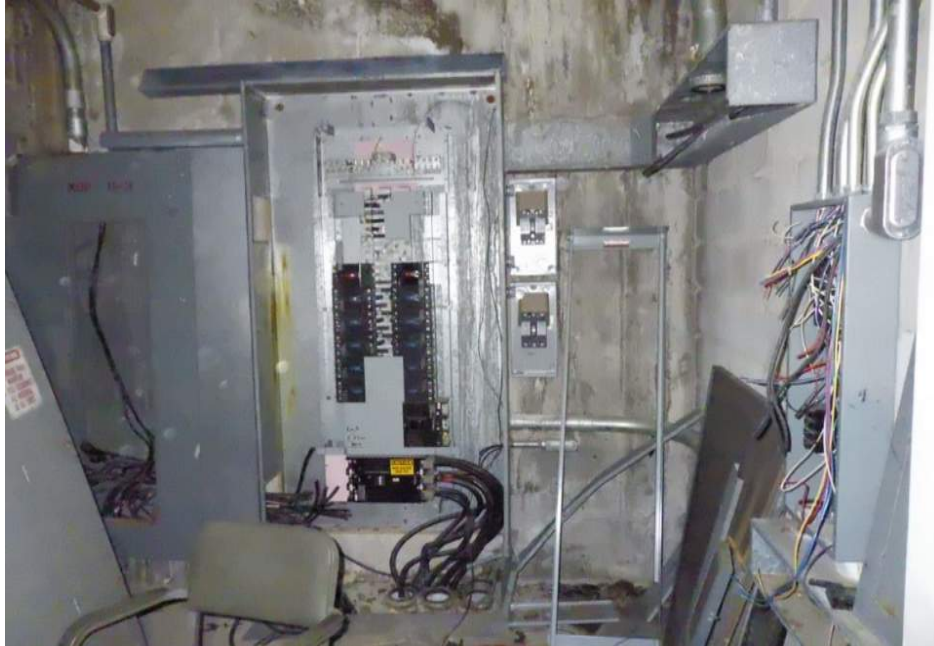
**Building/Unit:** 50

**Description:** electrical circuit breakers in basement

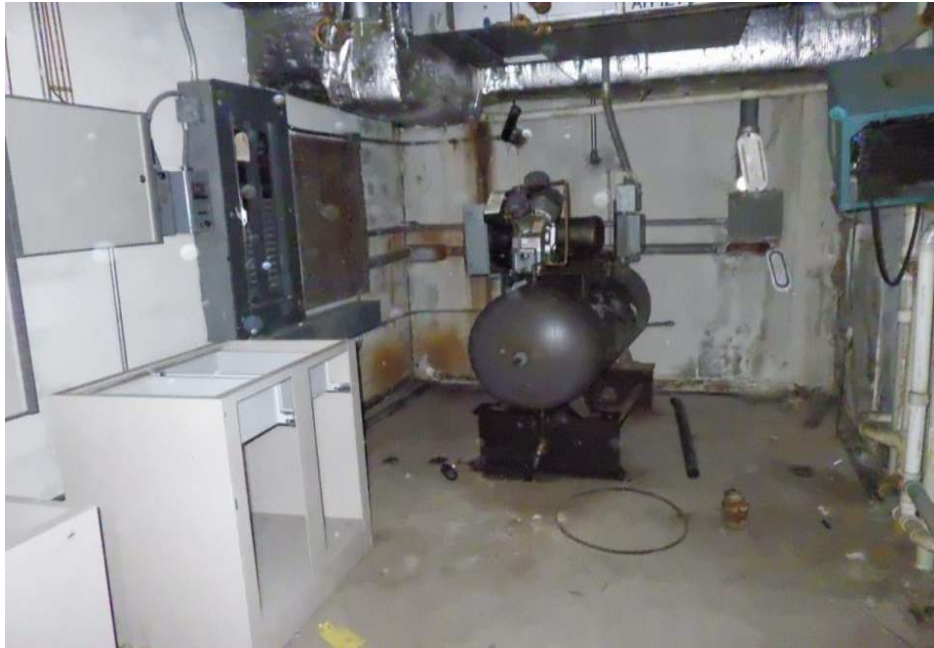
**Building/Unit:** 50

**Description:** large air compressor in basement

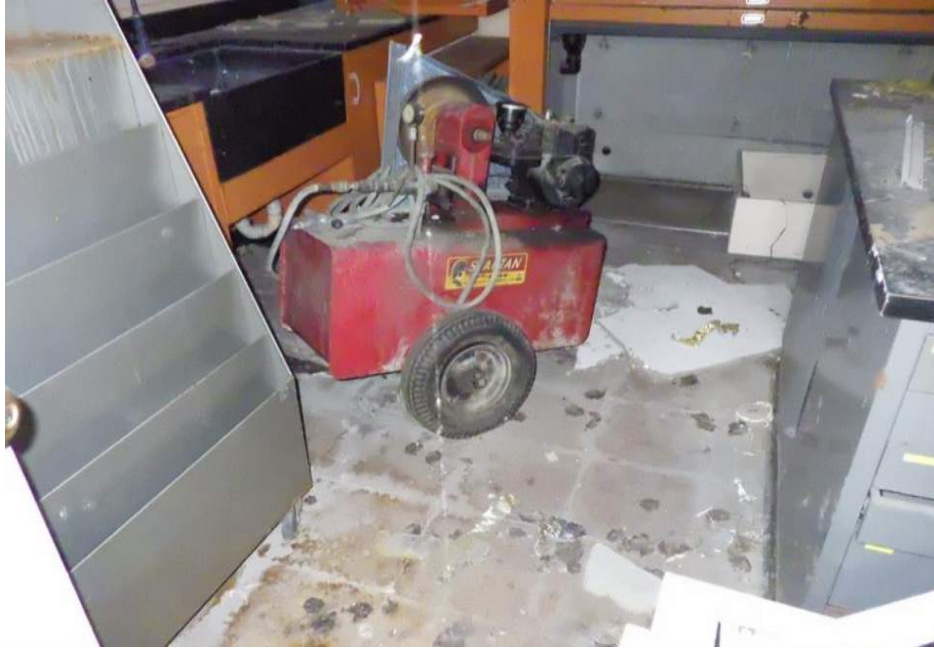
**Building/Unit:** 50

**Description:** portable air compressor in basement, may have been used as greenhouse herbicide spraying equipment

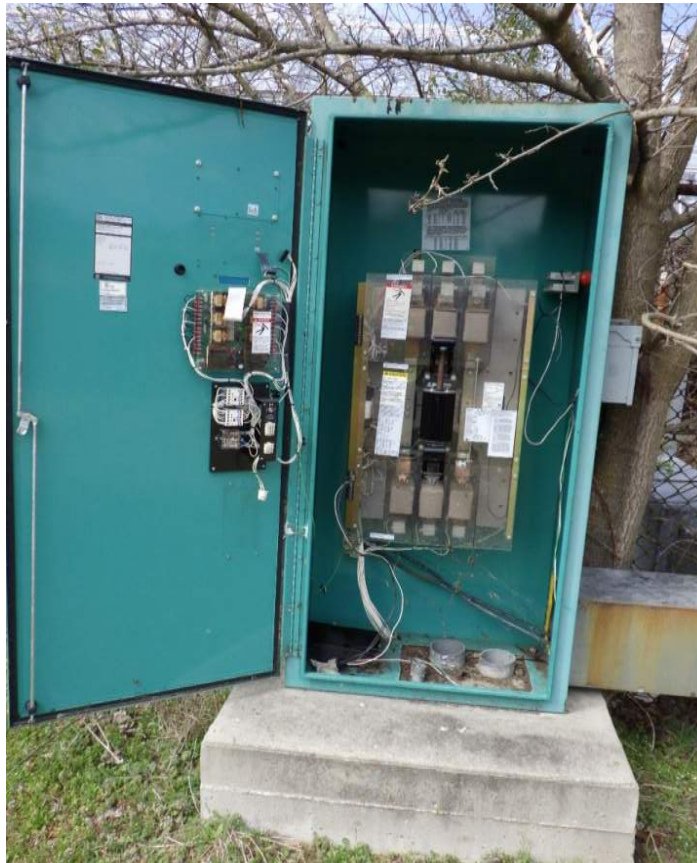
**Building/Unit:** 50

**Description:** building 050 exterior automatic transfer switch

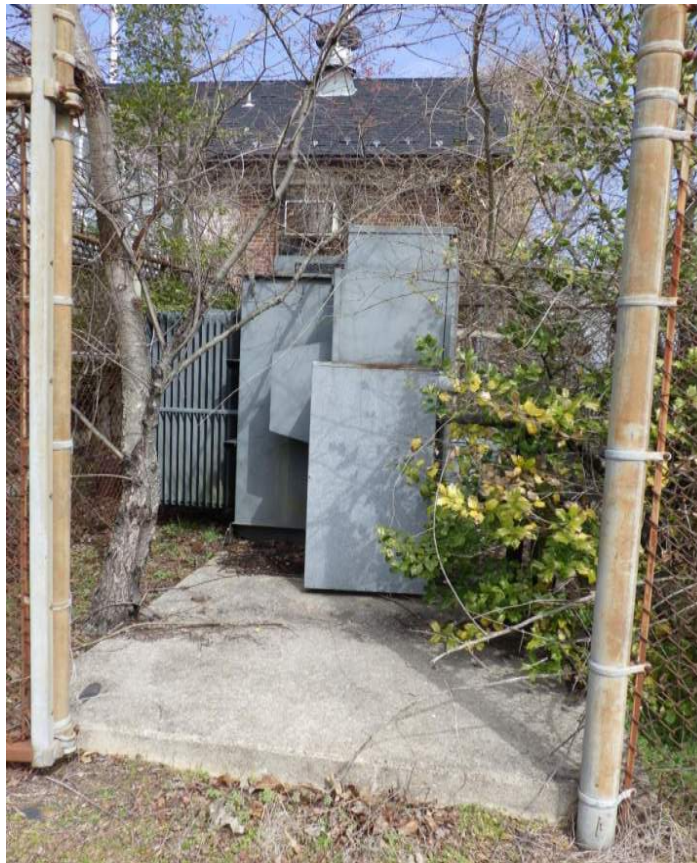
**Building/Unit:** 50

**Description:** building 050 exterior transformer

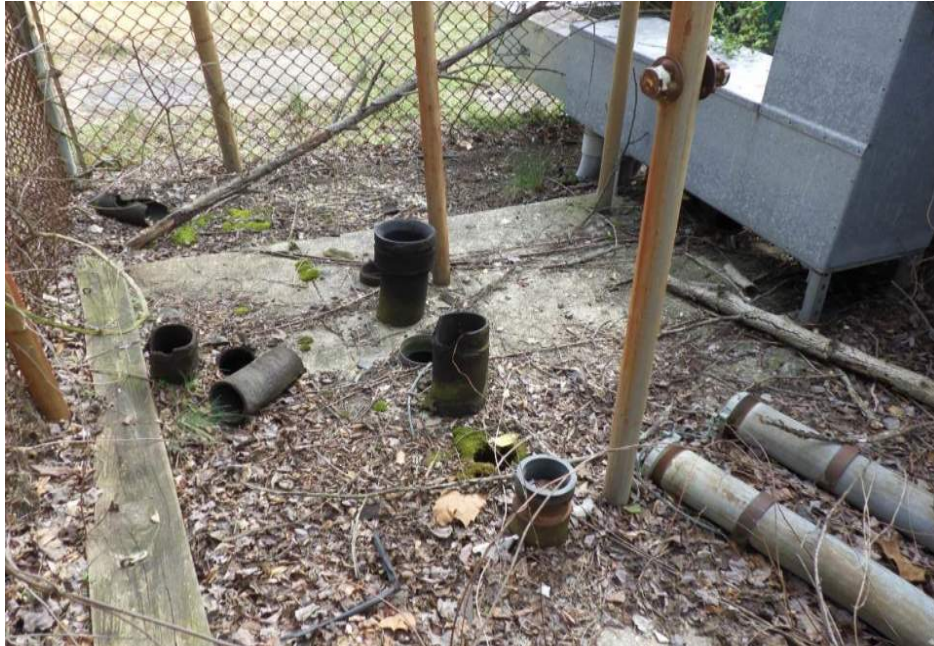
**Building/Unit:** 50

**Description:** transite asbestos conduits at former transformer location

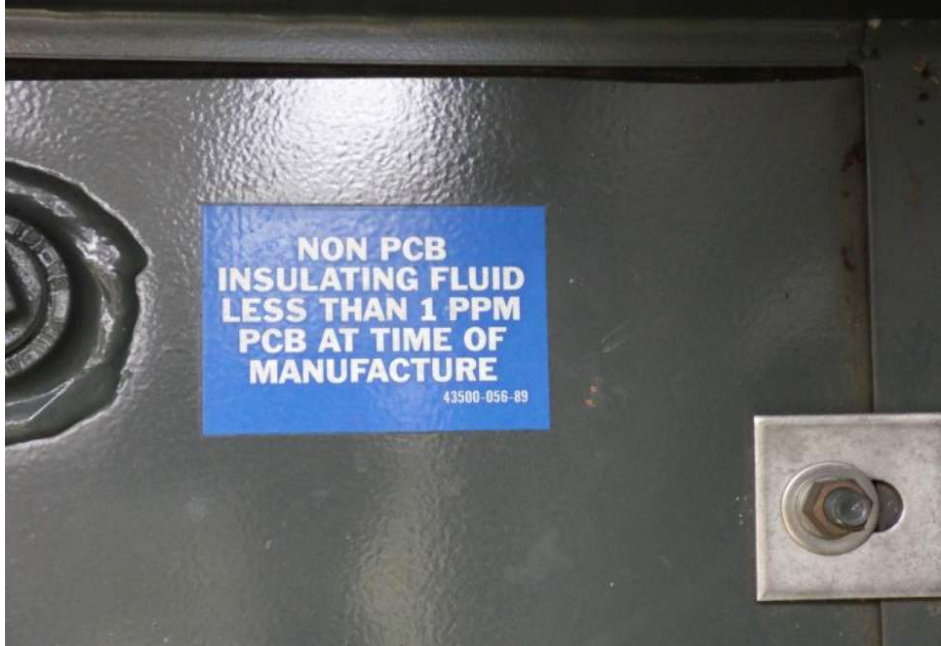
**Building/Unit:** 50

**Description:** Non PCB sticker from manufacturer on transformer oil tank

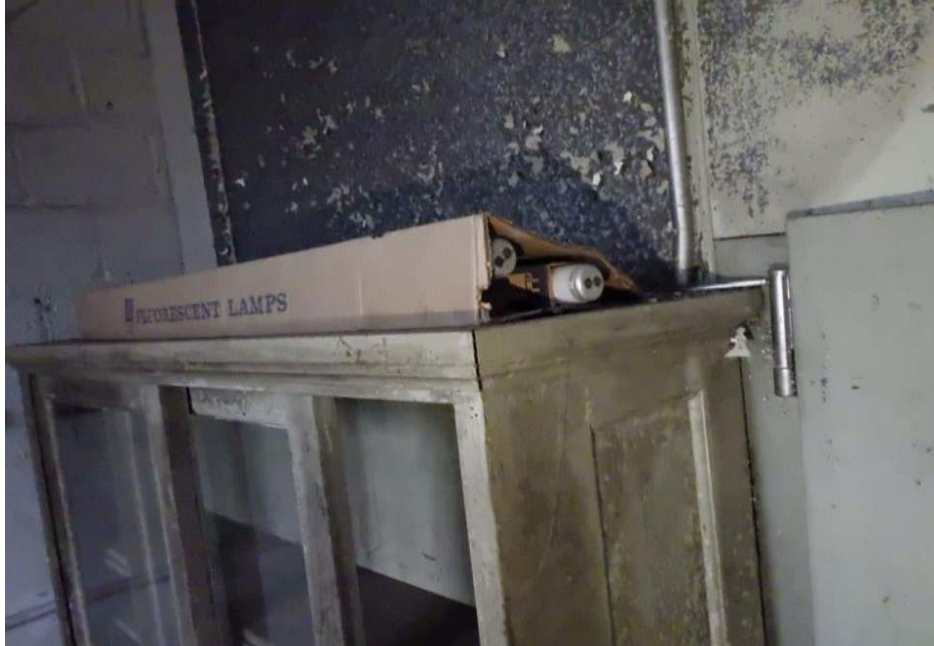
**Description:** fluorescent lamps in storage

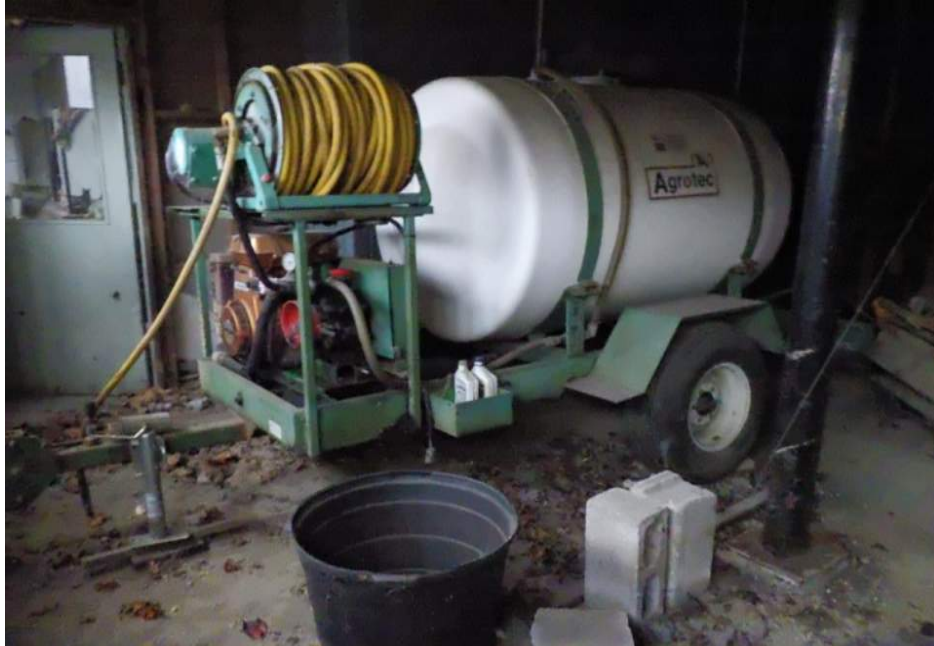
**Description:** rolling stock, agricultural sprayer with gas motor, fuel, lube oil

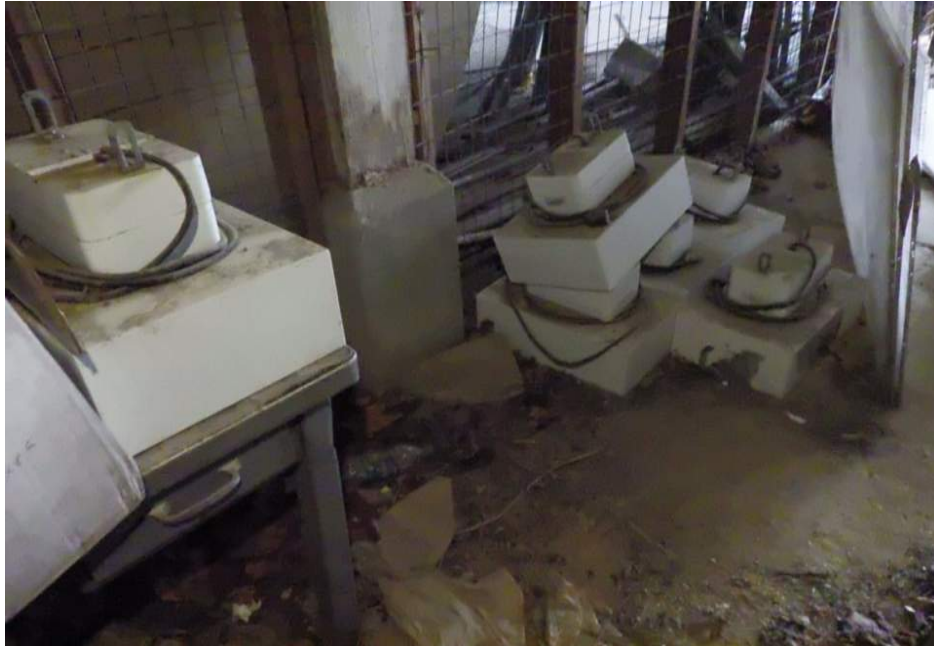
**Description:** HD light ballasts in storage

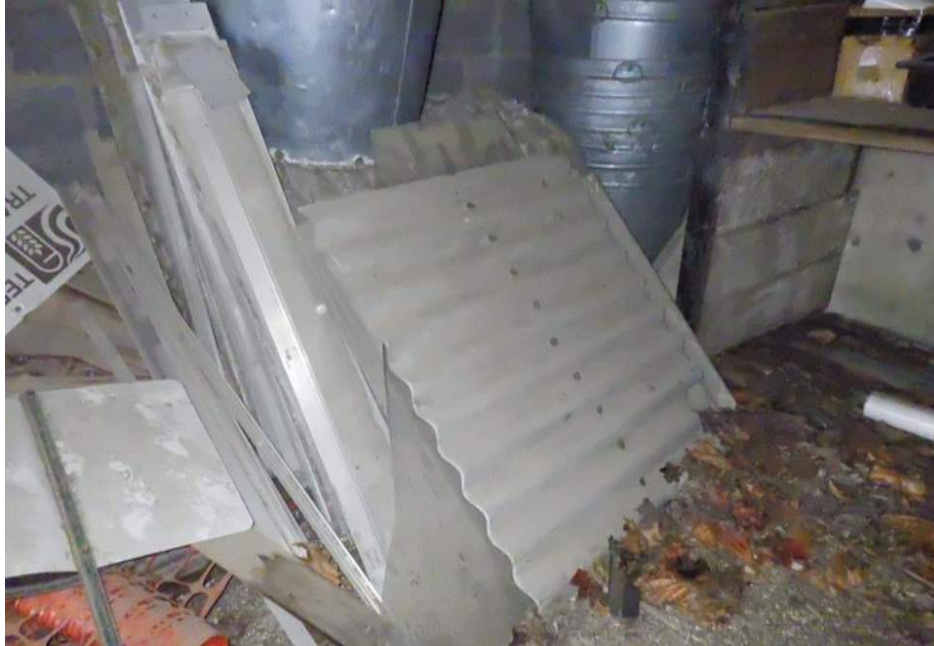
**Description:** PACM transite panels in storage

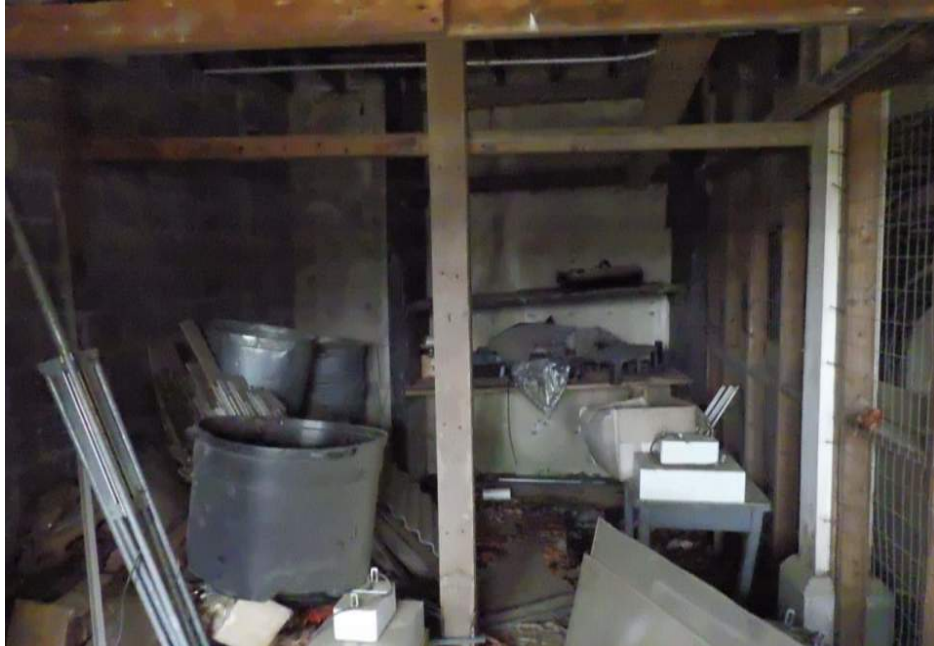
**Description:** PACM transite panels in storage

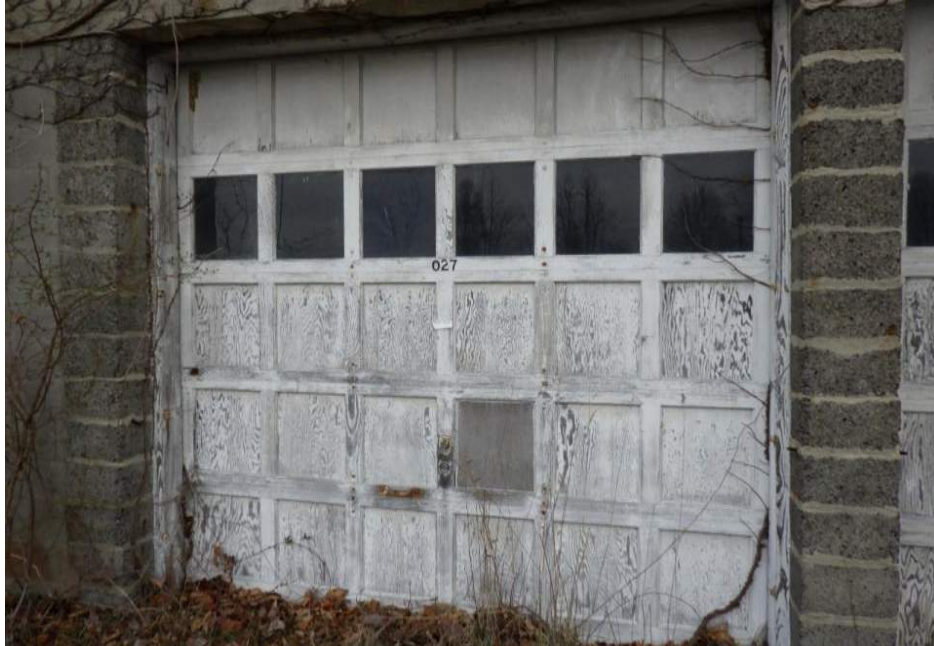
060-Pb1

**Results:** 270000 ppm

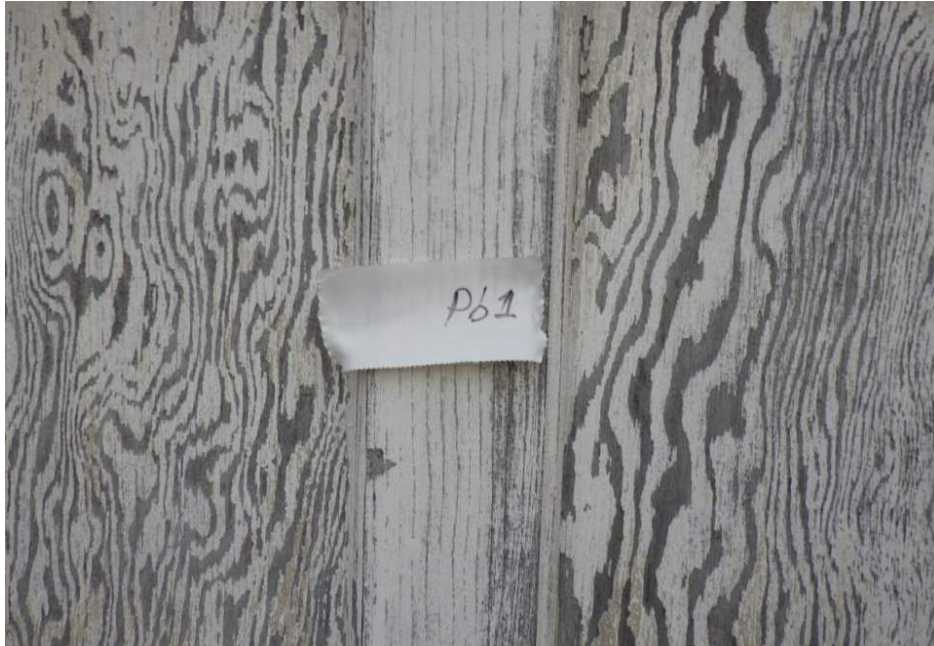
060-Pb1

**Results:** 270000 ppm

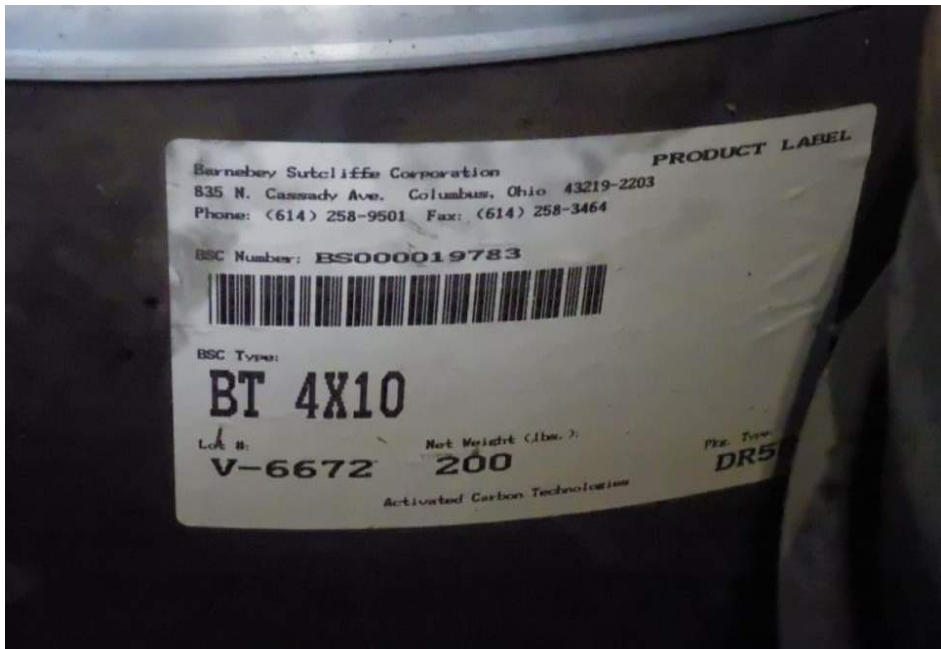
**Description:** drums label, chemicals in storage

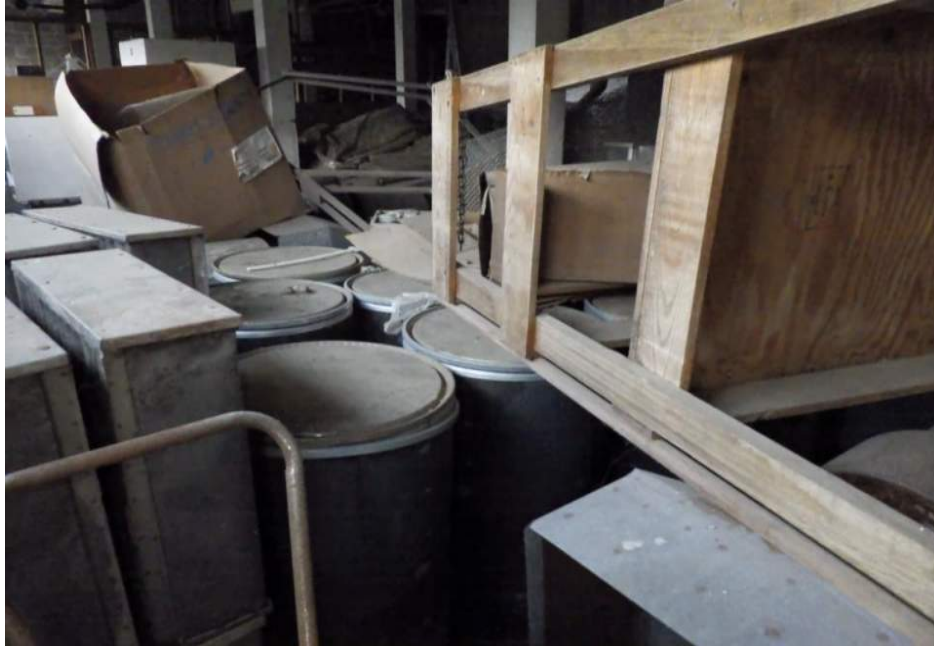
**Description:** drums, chemicals in storage

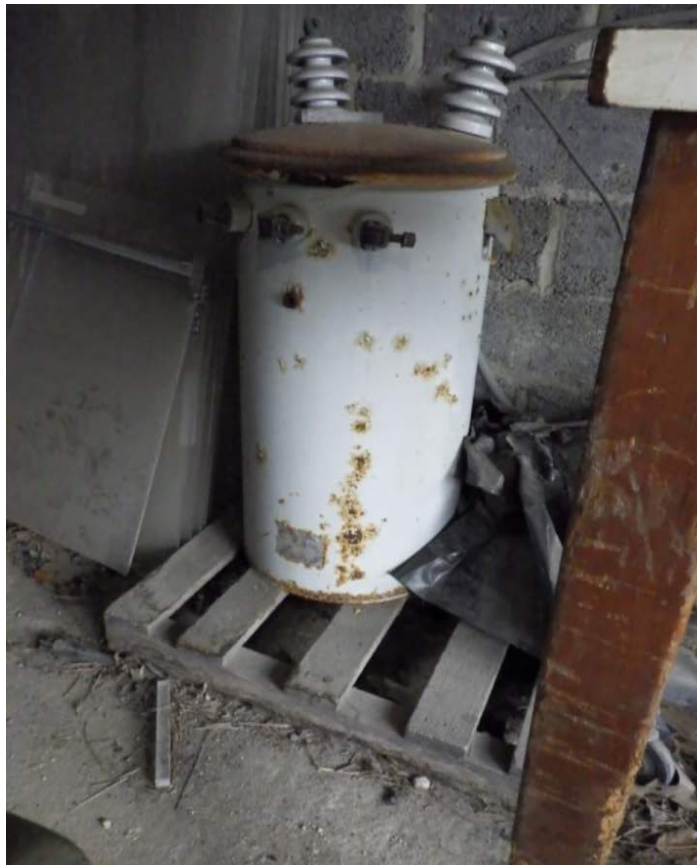
**Description:** oil filled transformer in storage

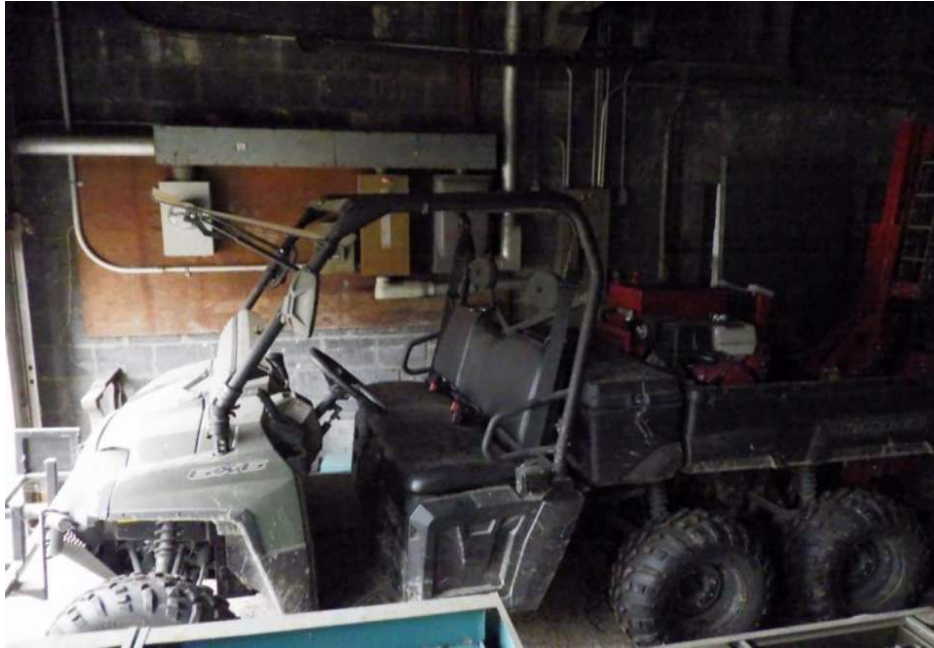
**Description:** UTV rolling stock, fuel and lube oil. UTV will be removed by USDA prior to structure demolition

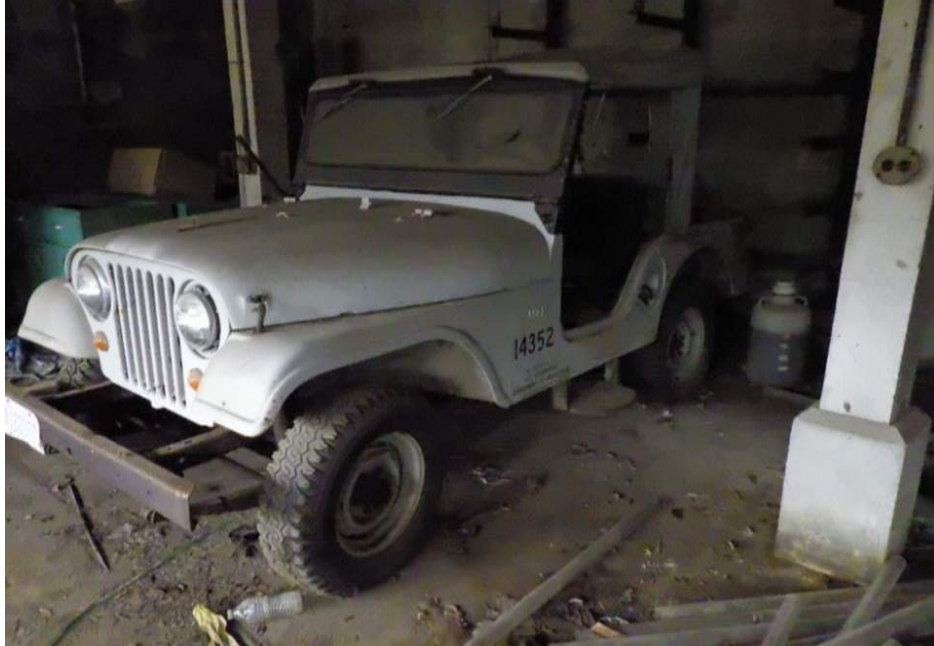
**Description:** Jeep rolling stock, fuel and lube oil, Jeep will be removed by USDA prior to structure demolition

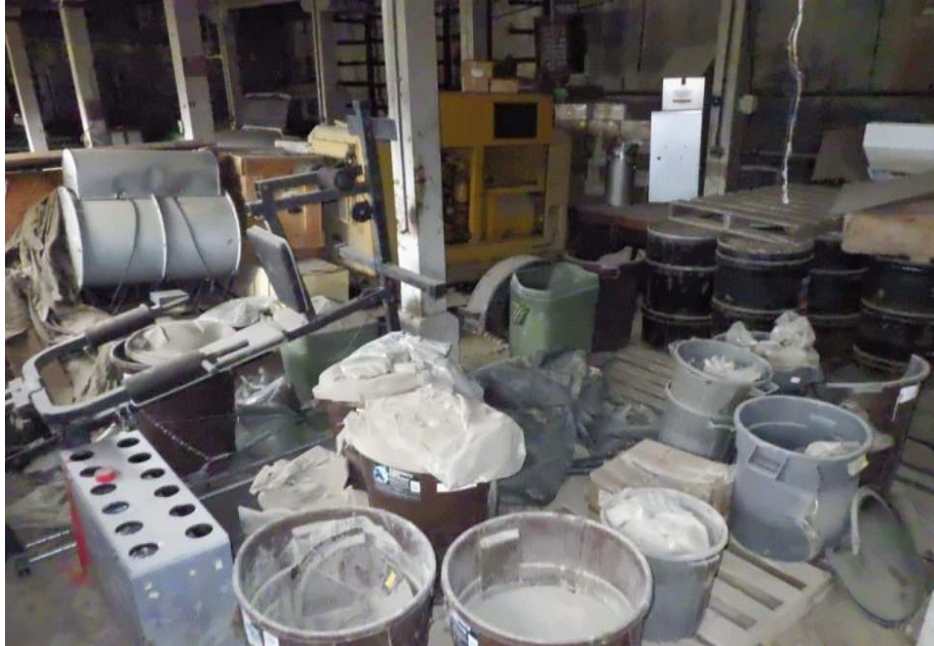
**Description:** second floor storage area with drums of powders

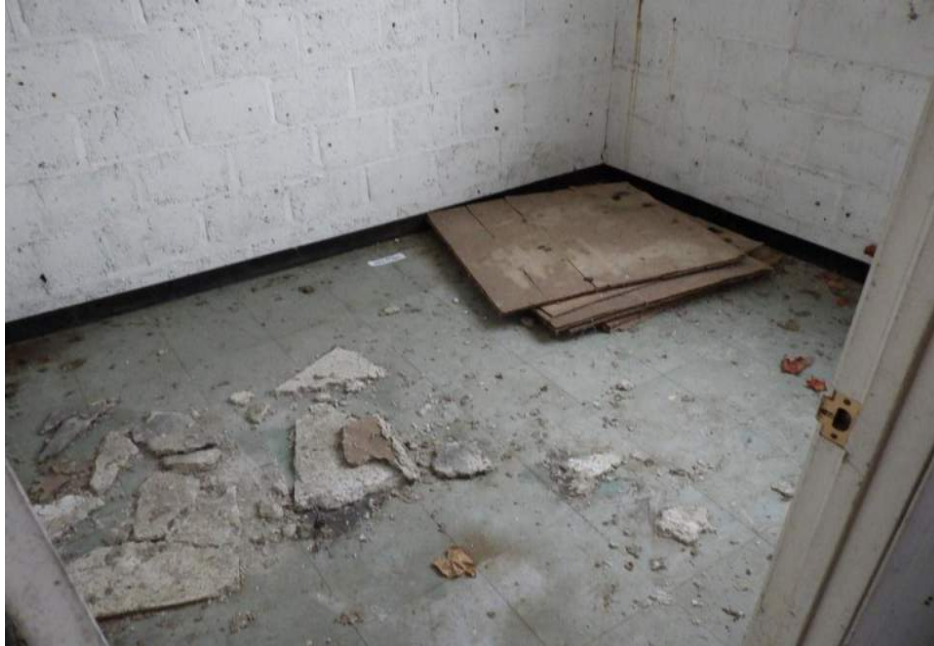
060A1

**Results:** Chrysotile 1-5%

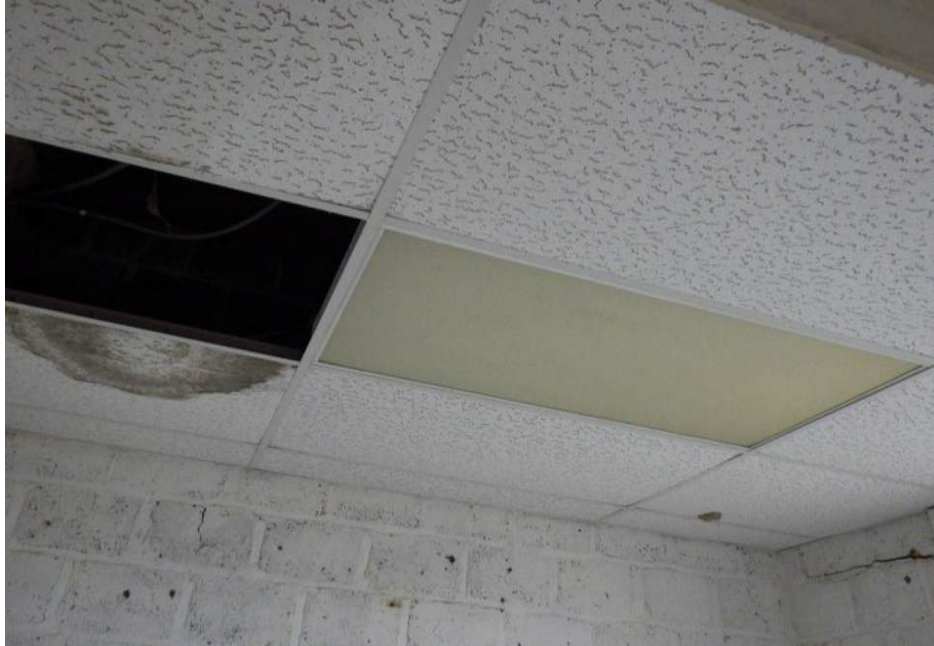
**Description:** building 060 interior office, moldy ceiling tiles

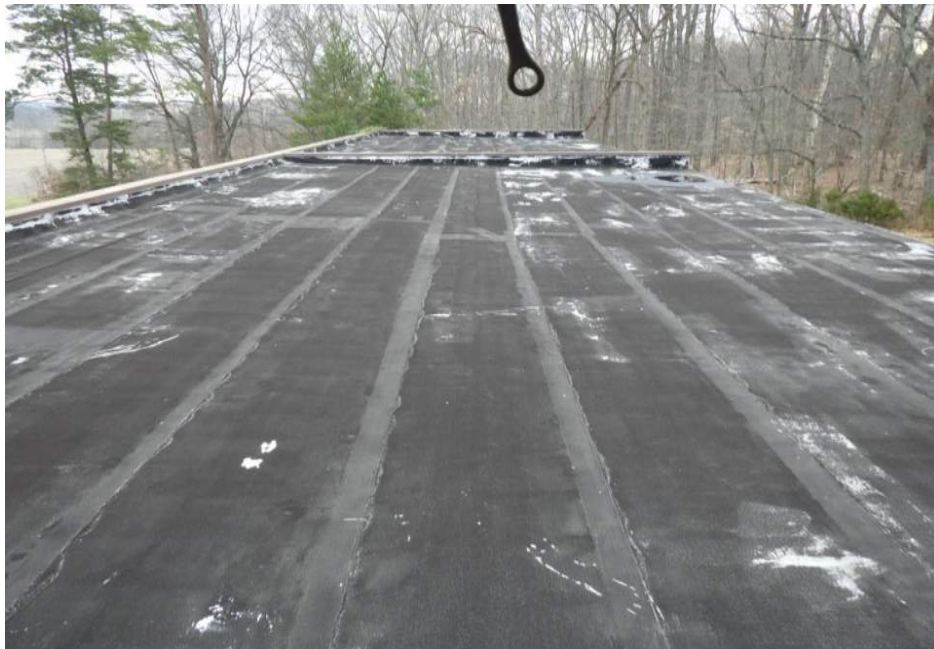
060PACM

**Results:** Not Analyzed

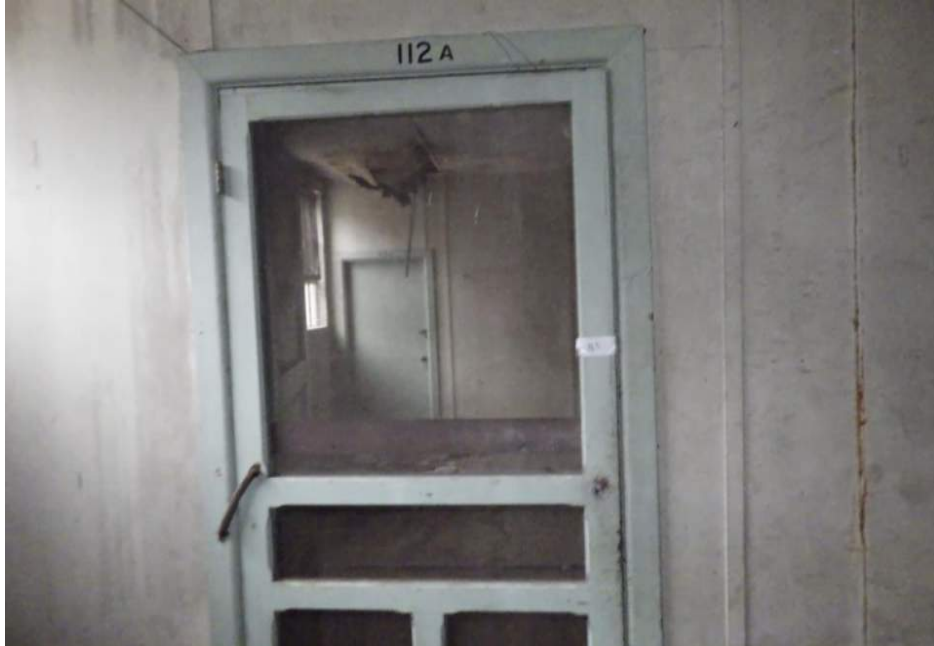
060-Pb3

**Results:** Not Analyzed

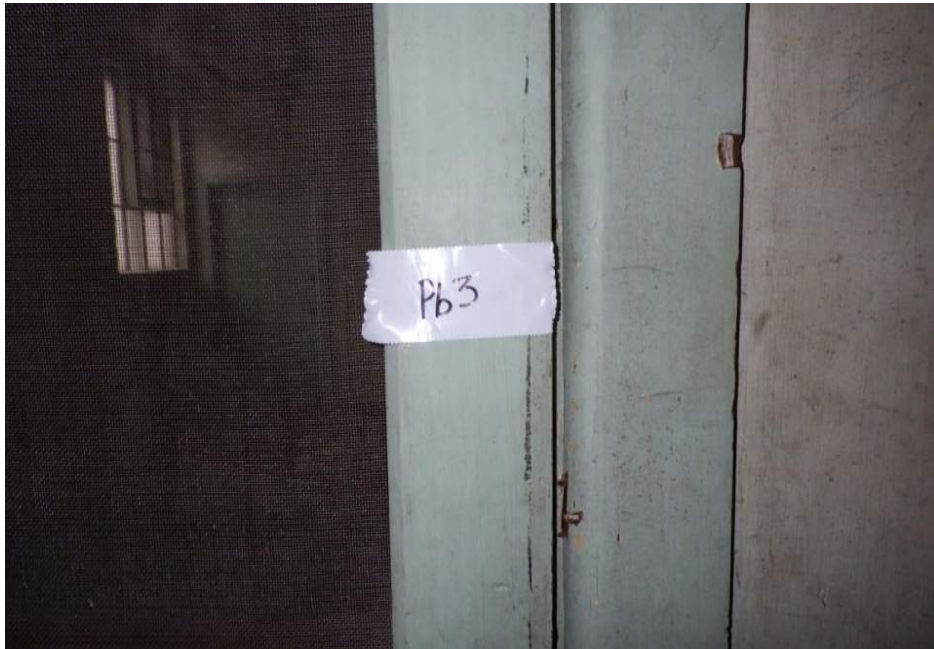
060-Pb3

**Results:** 95000 ppm

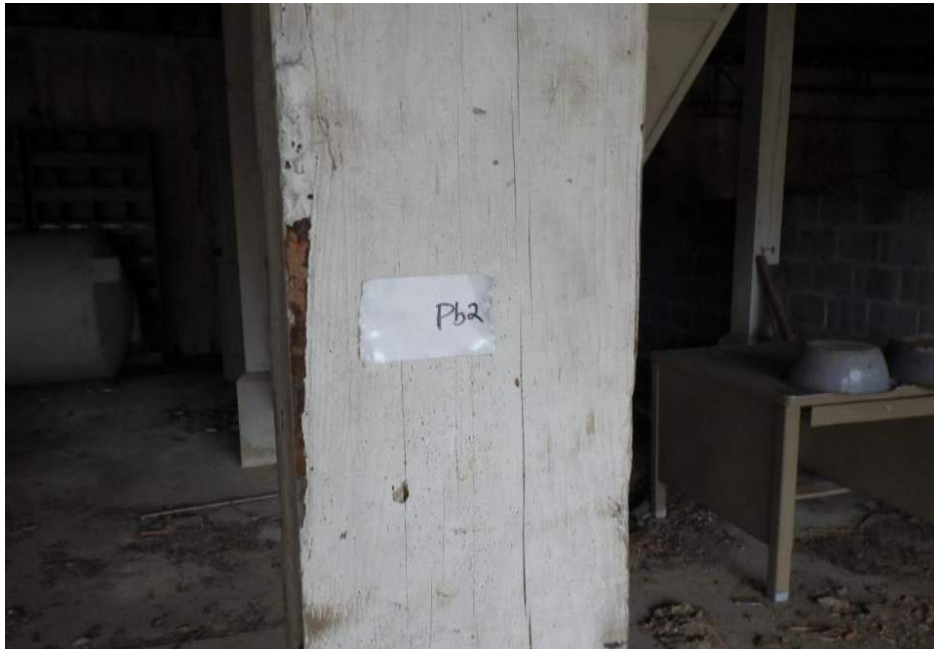
060-Pb2

**Results:** 1800 ppm

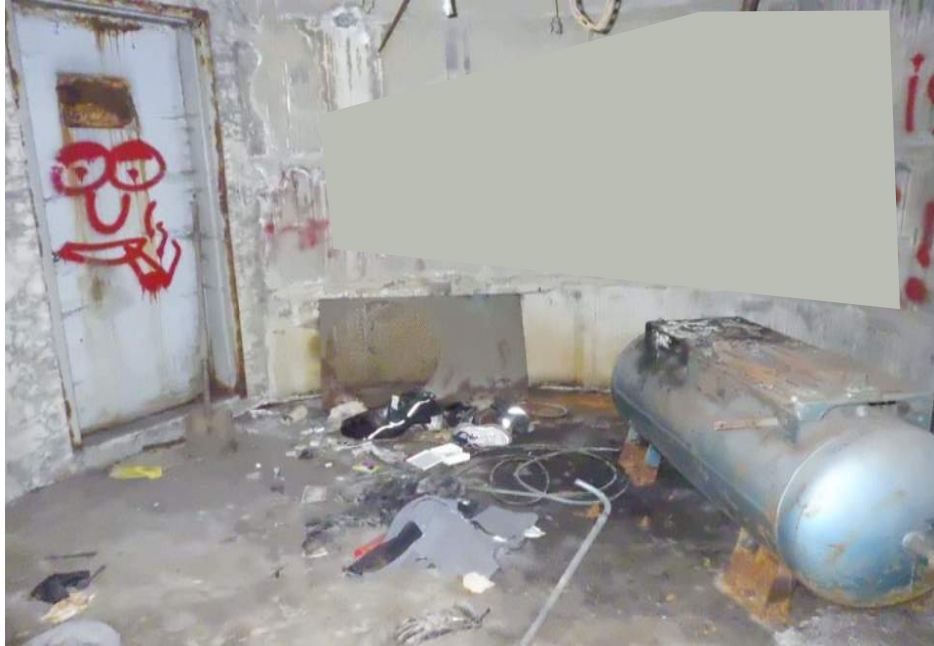
**Description:** building 085 interior, crawlspace under grain silo, with tank

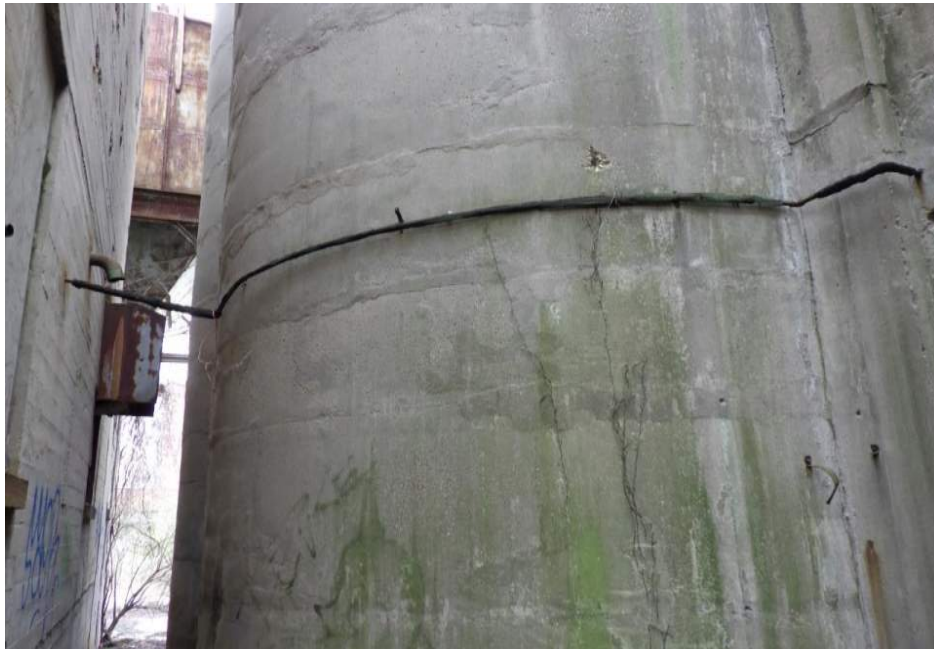
085PACM

**Results:** Not sampled

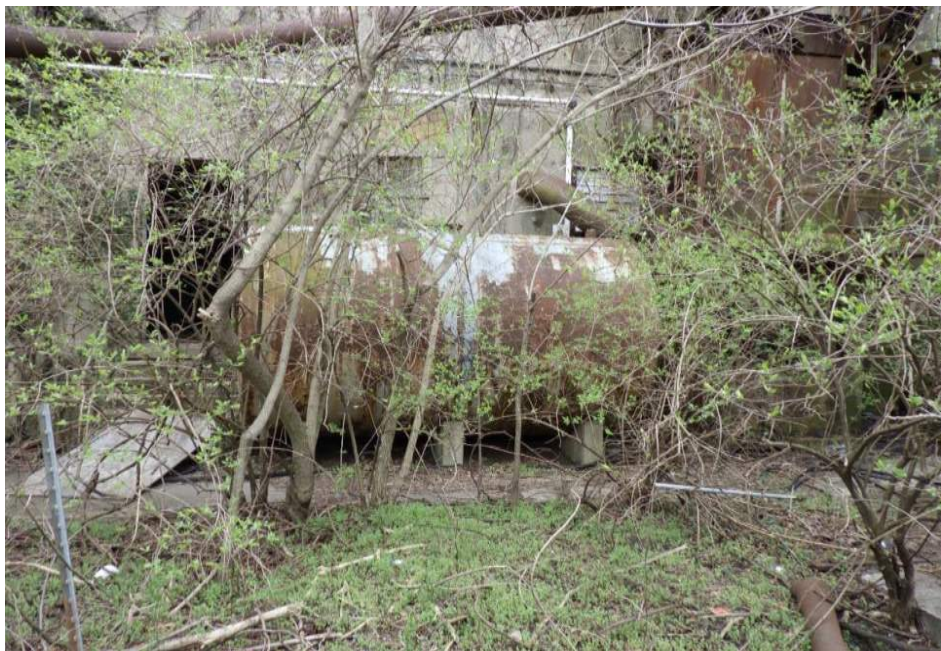
**Description:** 3000 gal molasses tank, west of building, presumed 6-inch residual

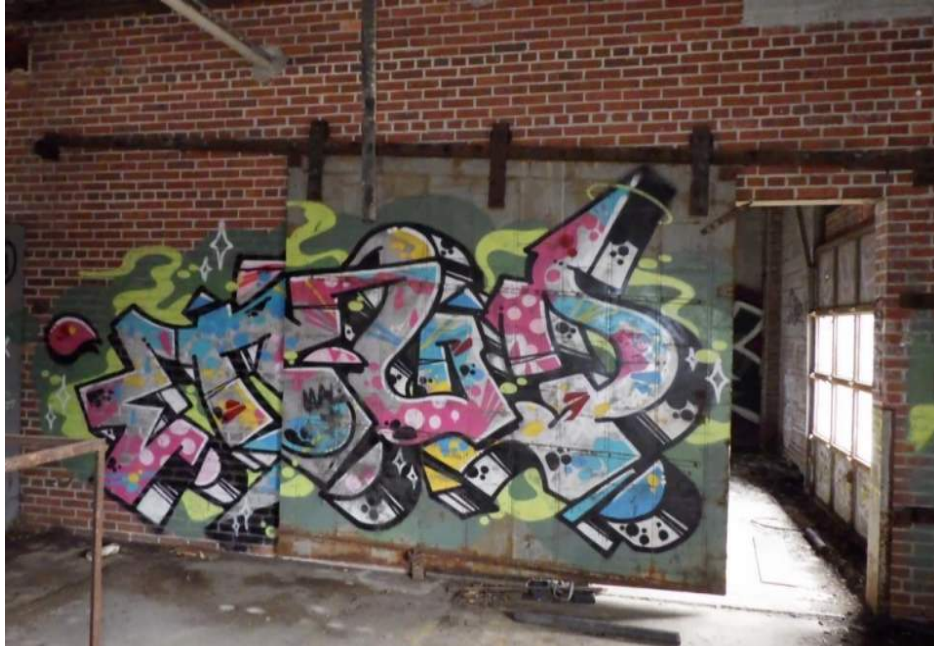
**Description:** presumed asbestos fire door separating warehouse bays

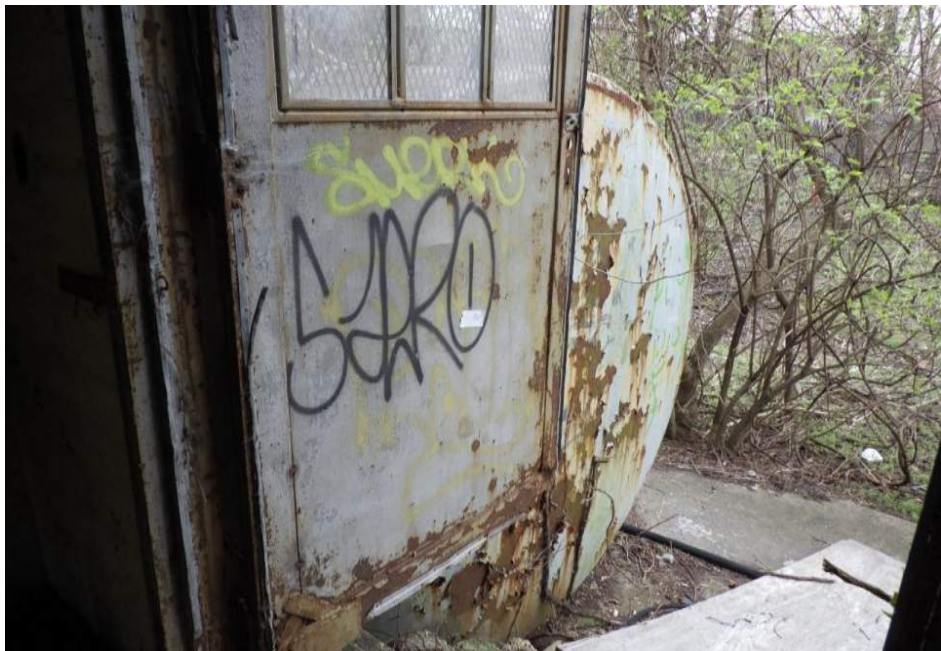
085-Pb2

**Results:** 100000 ppm

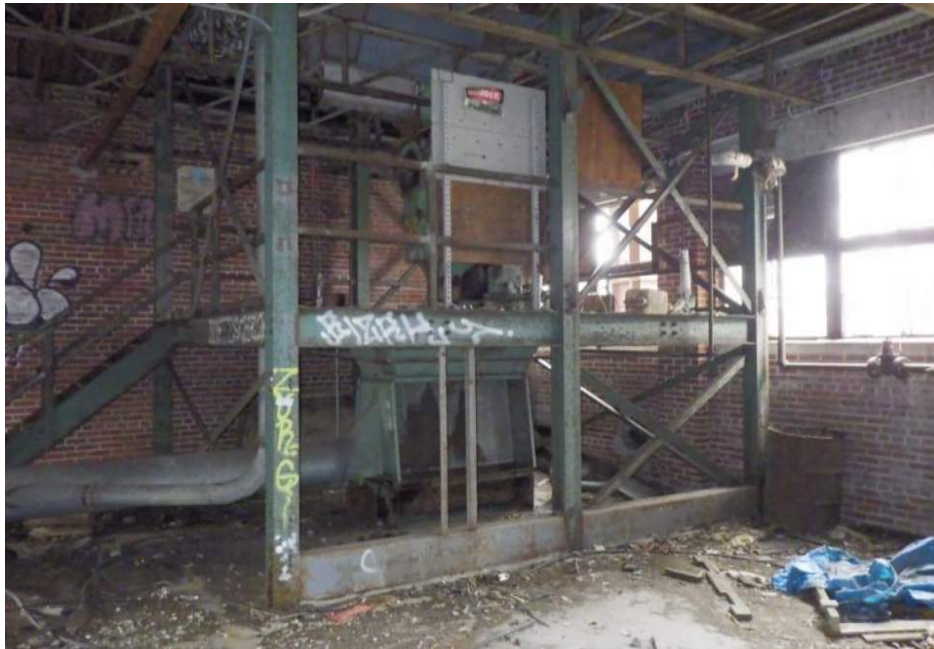
085-Pb3

**Results:** 13000 ppm

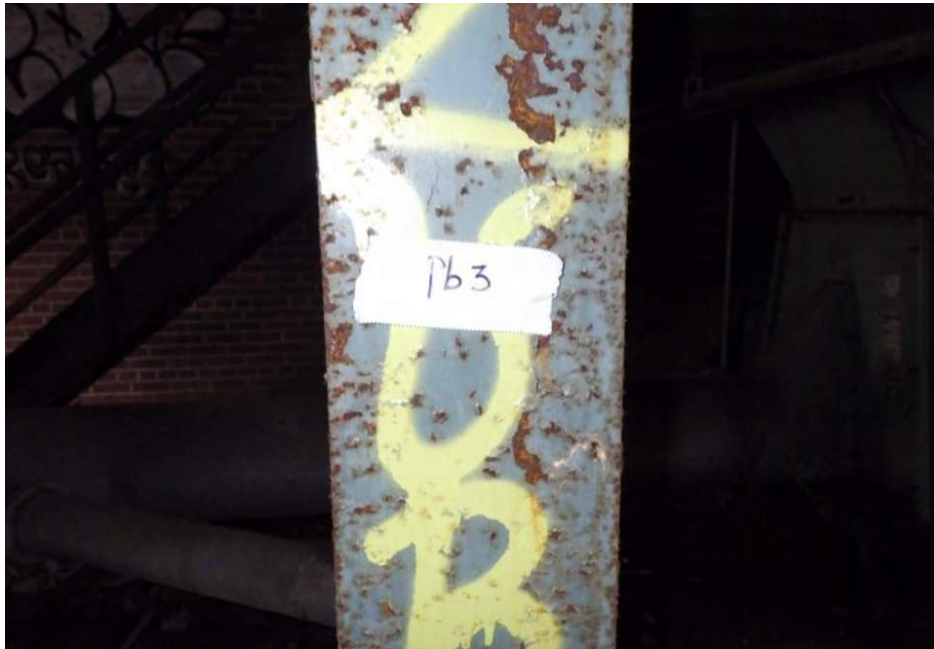
085-Pb3

**Results:** 13000 ppm

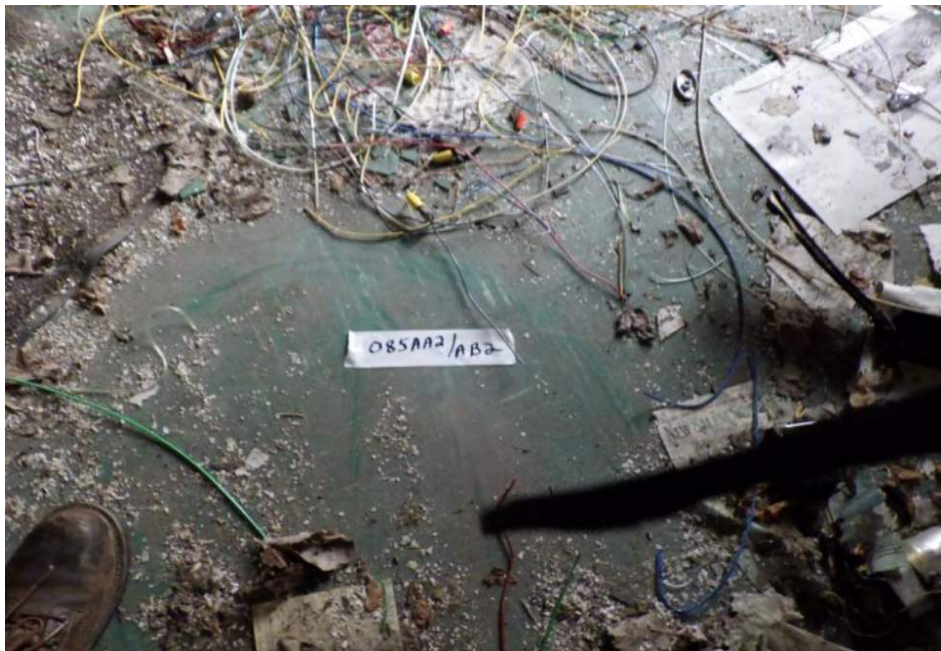
085AA2

**Results:** Chrysotile 1-5%

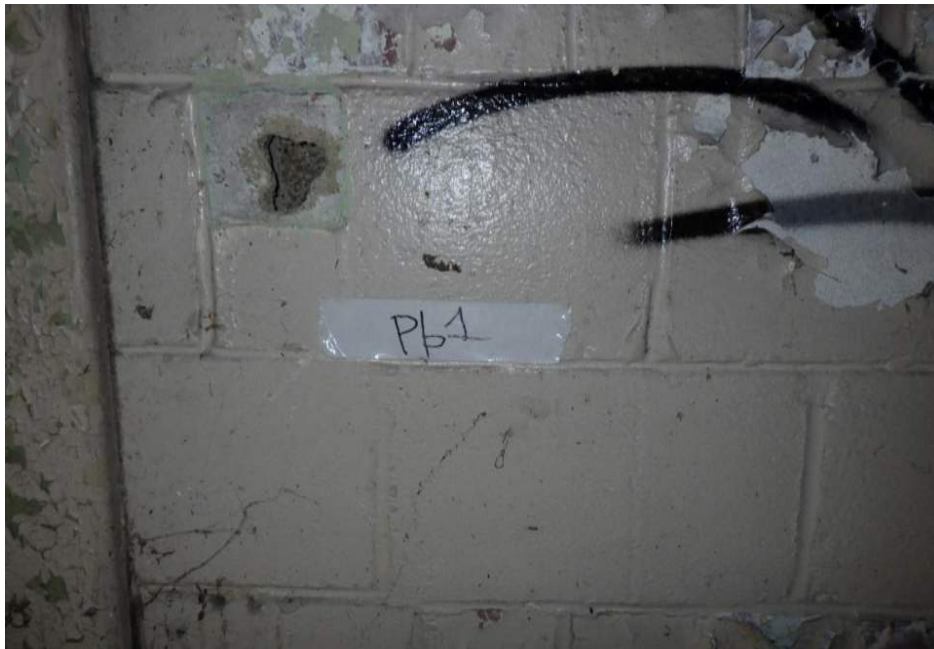
085A-Pb1

**Results:** 520 ppm

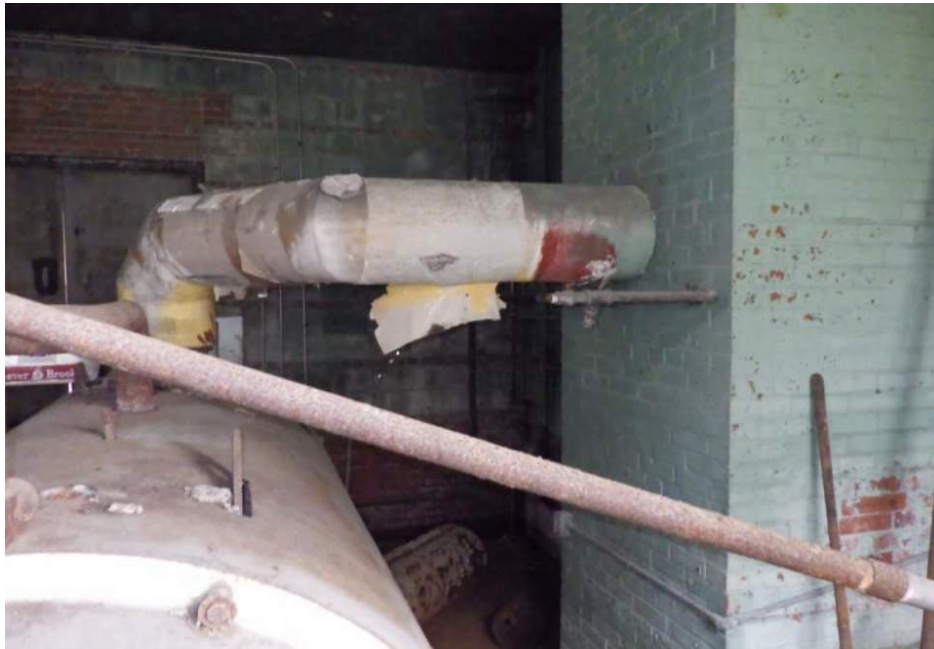
085AE2

**Results:** None Detected

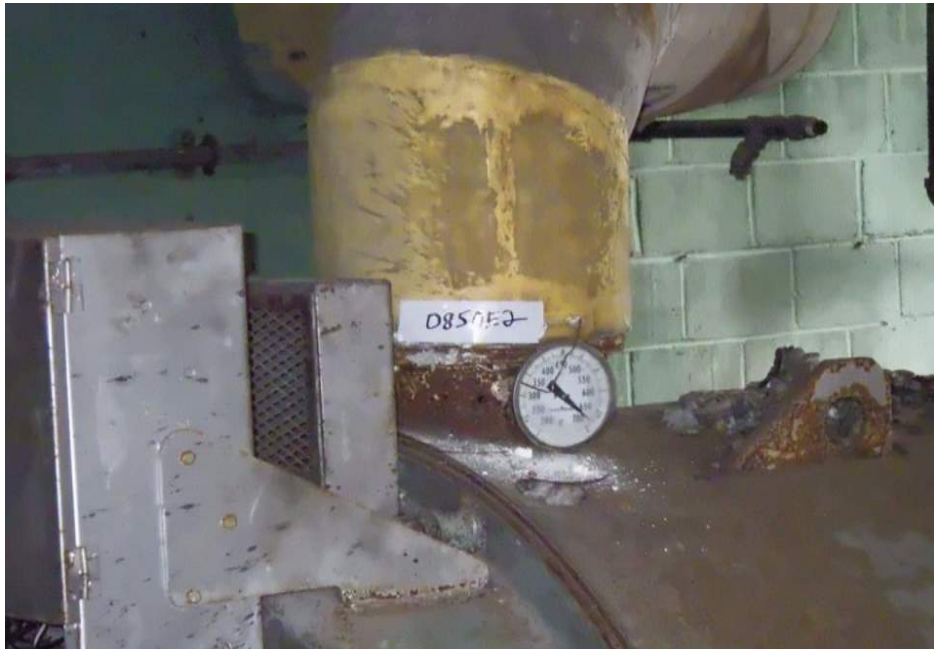
085AE2

**Results:** None Detected
