# Beltsville Agricultural Research Center Hazardous Materials Assessment Part 2

**Beltsville Agricultural Research Center  
Hazardous Materials Assessment  
Project No. 103144**

**Revision 1  
April 22, 2020**

**Burns & McDonnell Engineering Company, Inc.  
Downers Grove, Illinois**

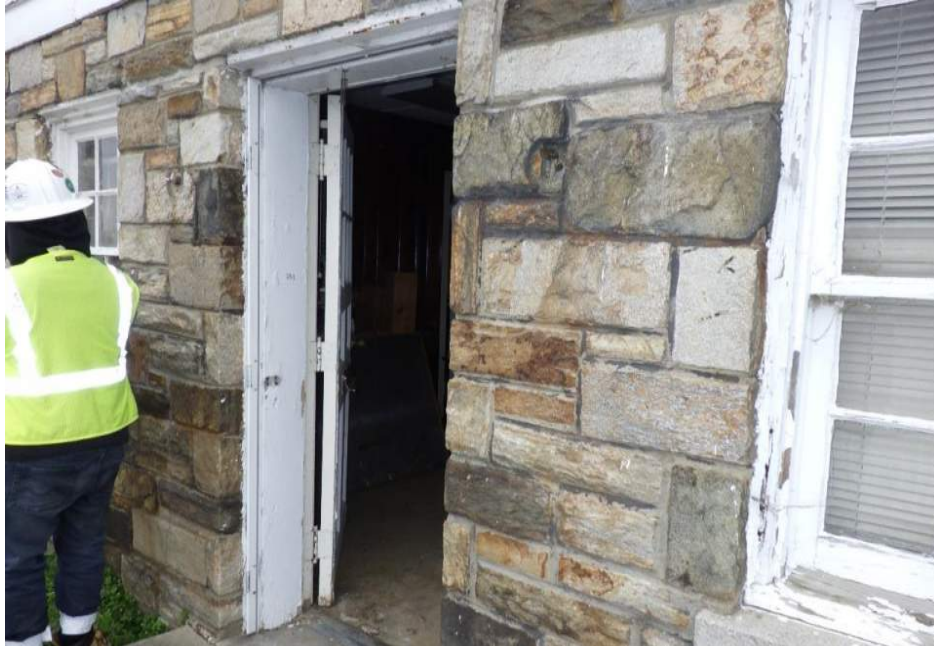
156-Pb1

**Results:** 370000 ppm

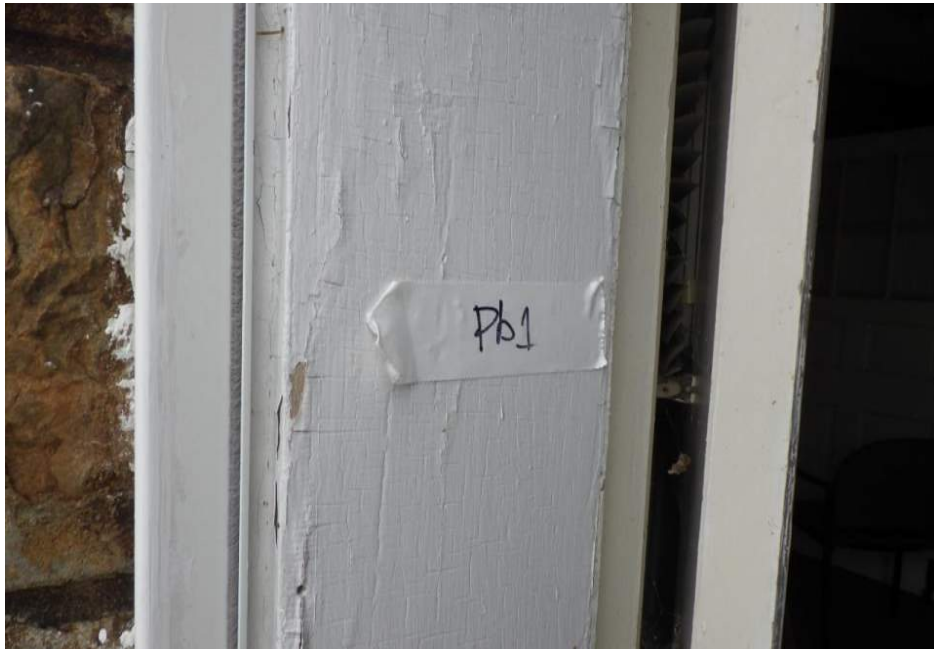
156-Pb1

**Results:** 370000 ppm

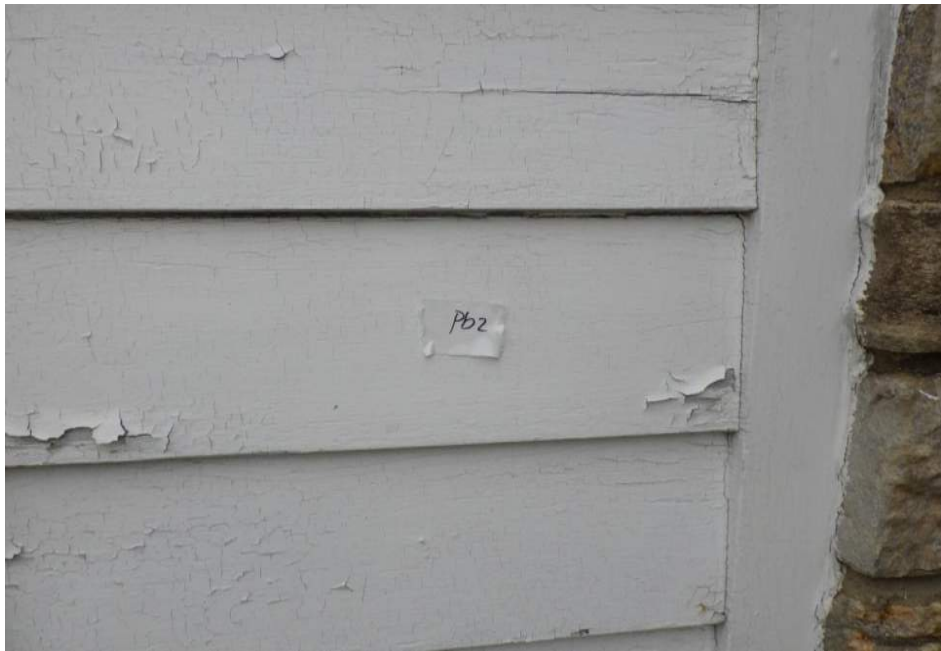
156-Pb2

**Results:** 240000 ppm

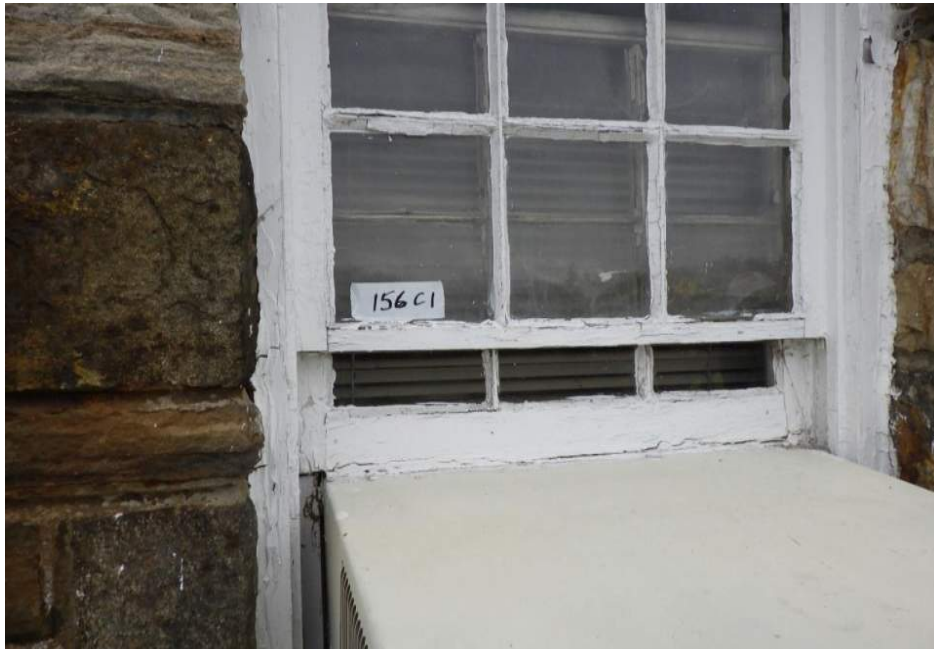
156C1

**Results:** None Detected

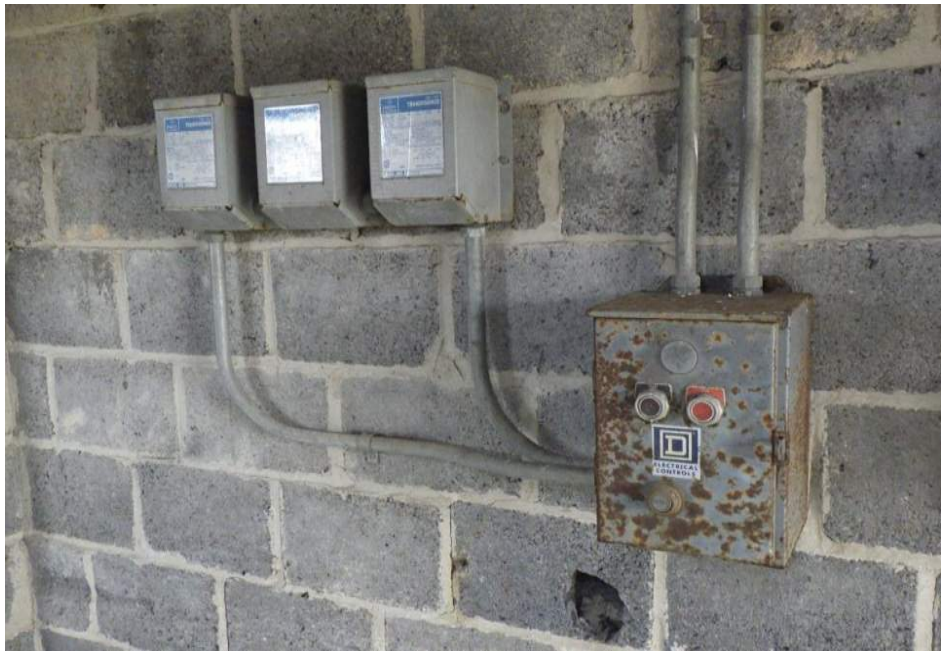
**Description:** electrical enclosures for motor switches

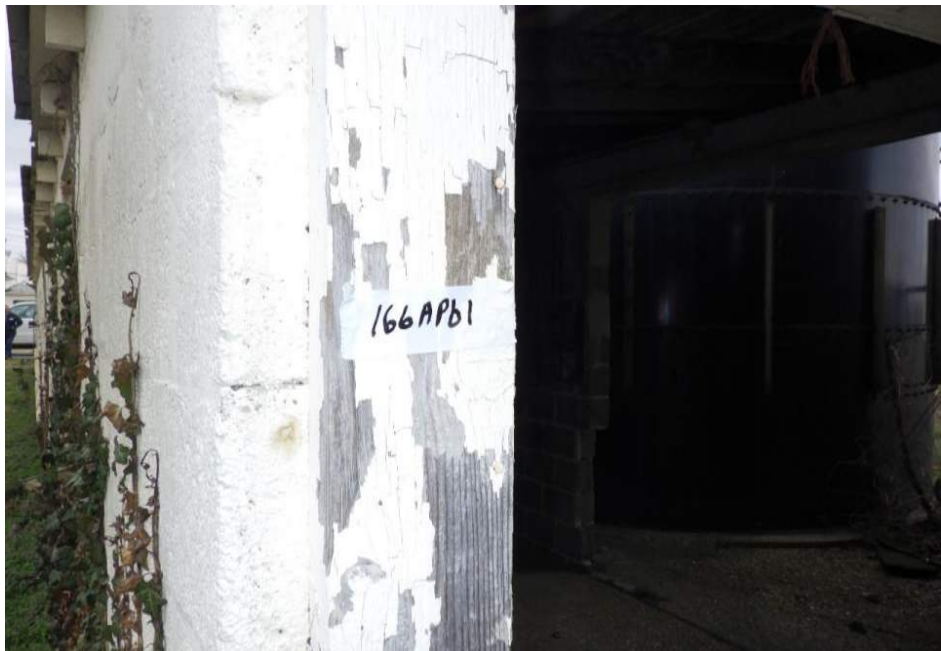
166A-Pb1

**Results:** 140000 ppm

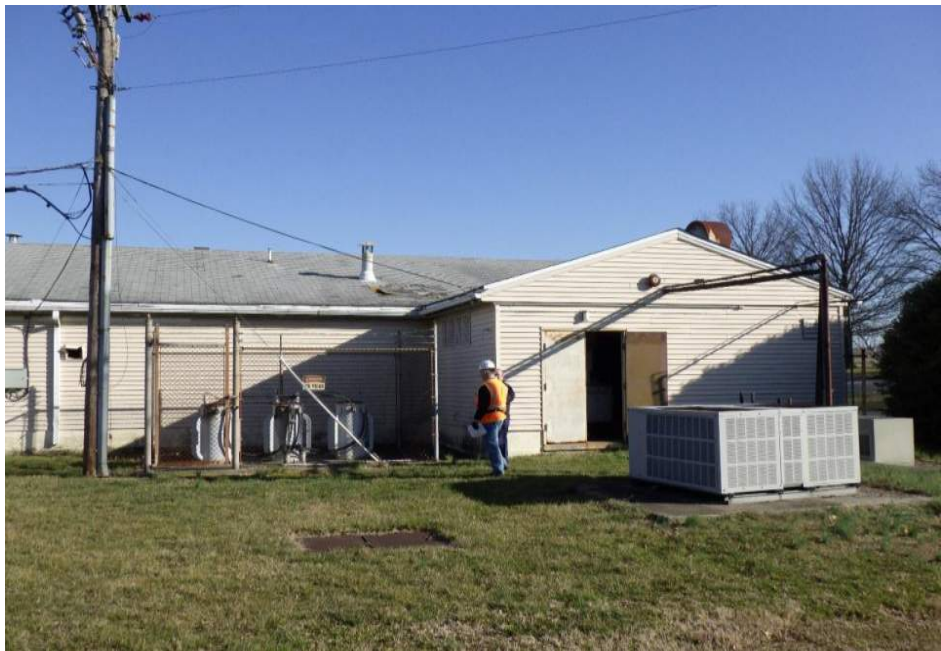
**Description:** Building 177B facing north, heat pump compressors and wet transformers

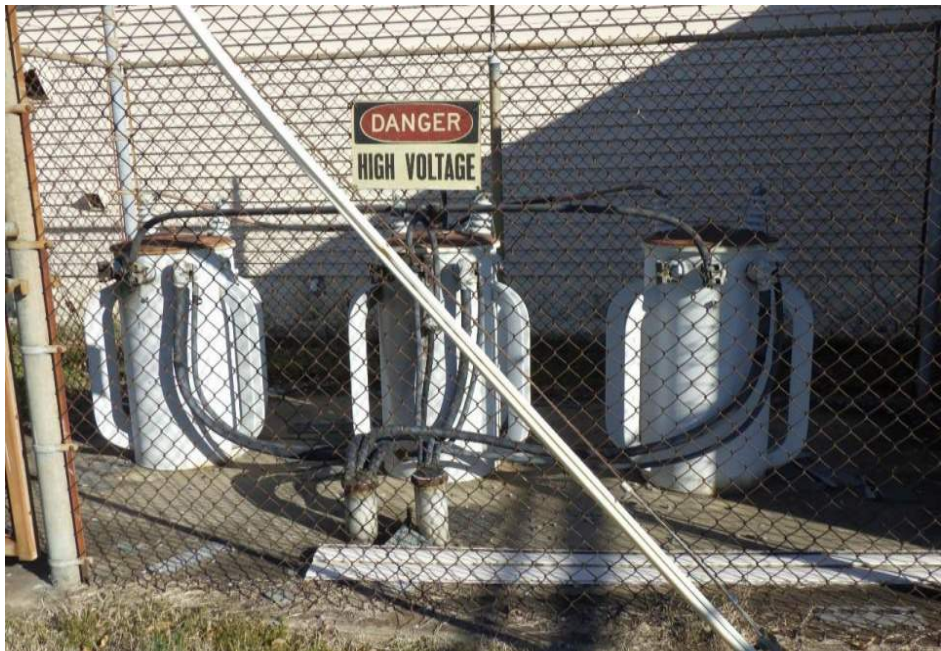
**Description:** oil filled transformers, serving 177B and surrounding buildings

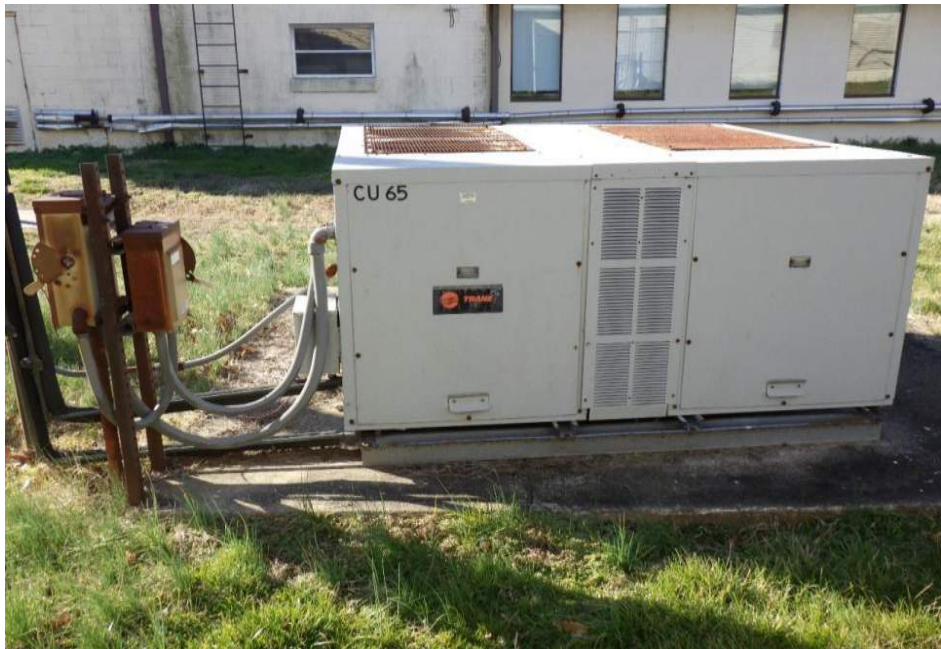
**Description:** heat pump condenser serving building 177B

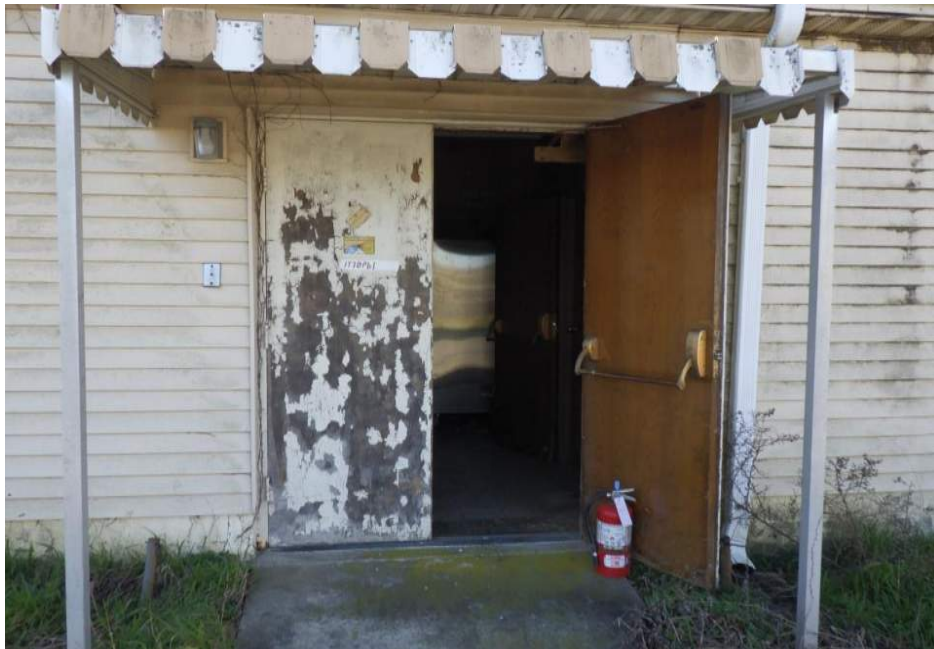
177B-Pb1

**Results:** 130 ppm

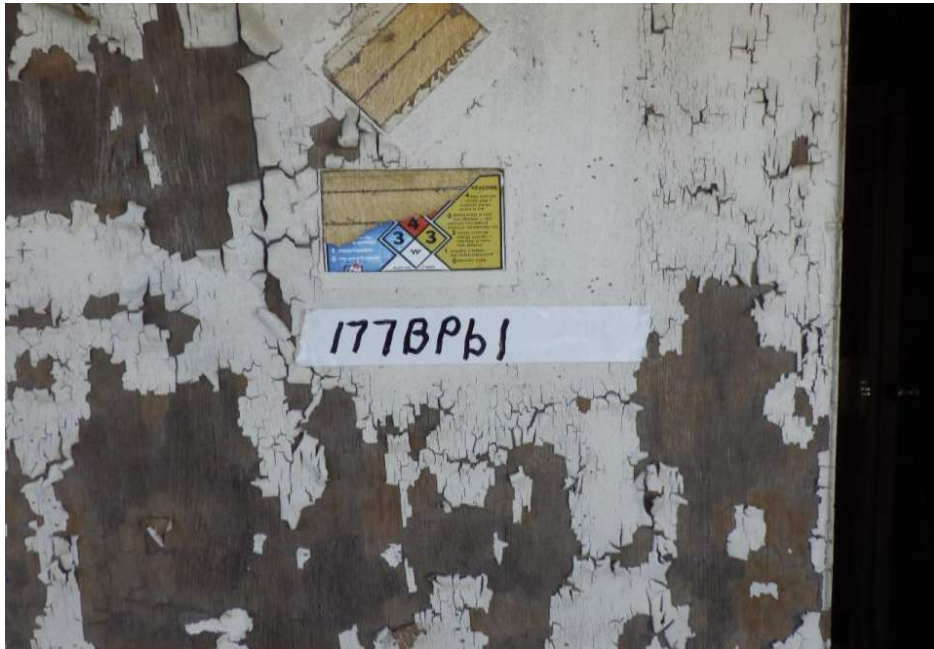
177B-Pb1

**Results:** 130 ppm

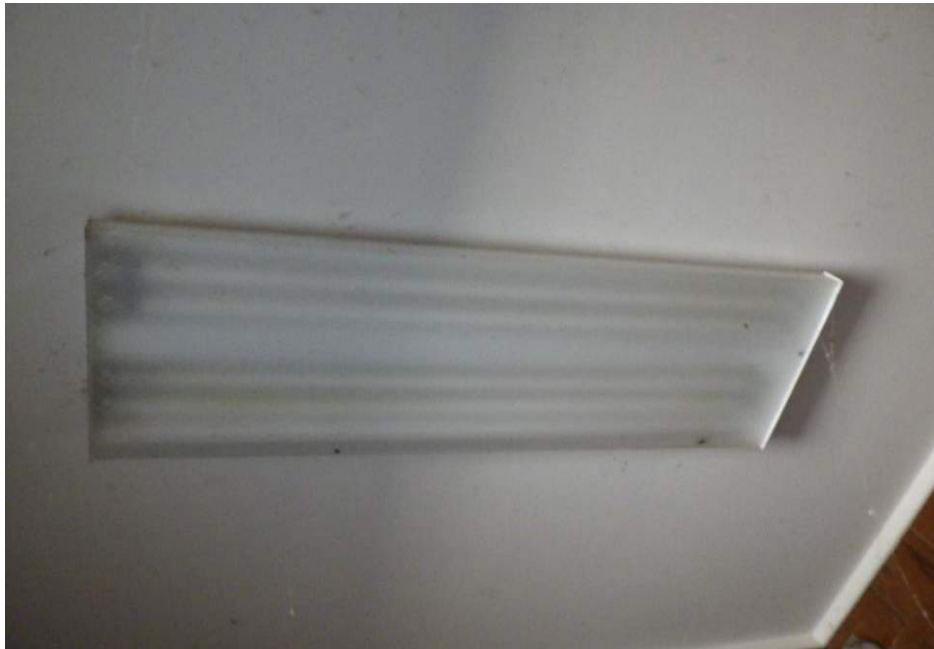
**Description:** typical interior fluorescent light fixtures

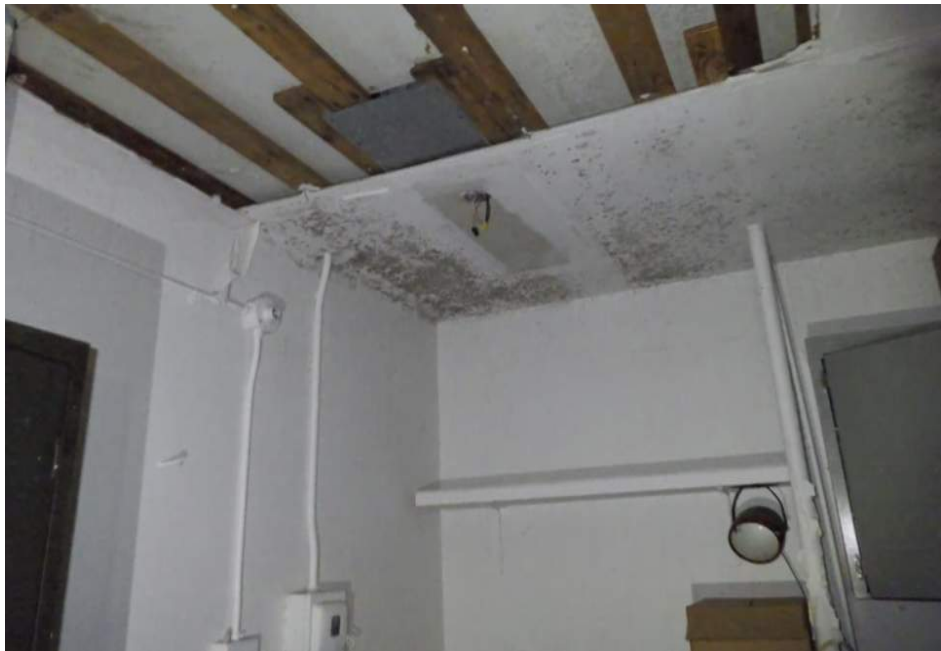
**Description:** typical interior mold on drywall and suspended ceilings

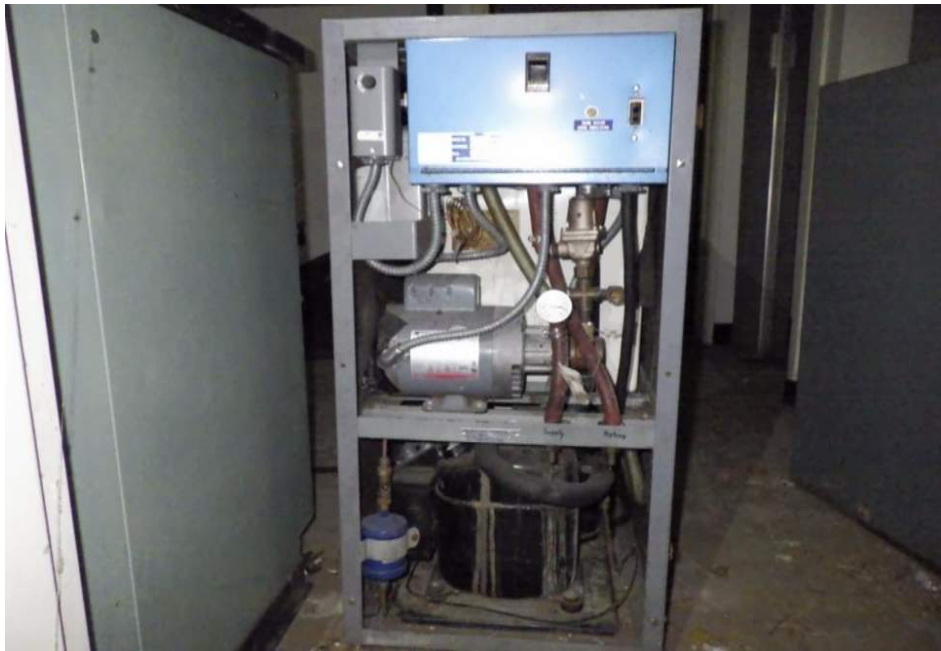
**Description:** disconnected refrigeration unit

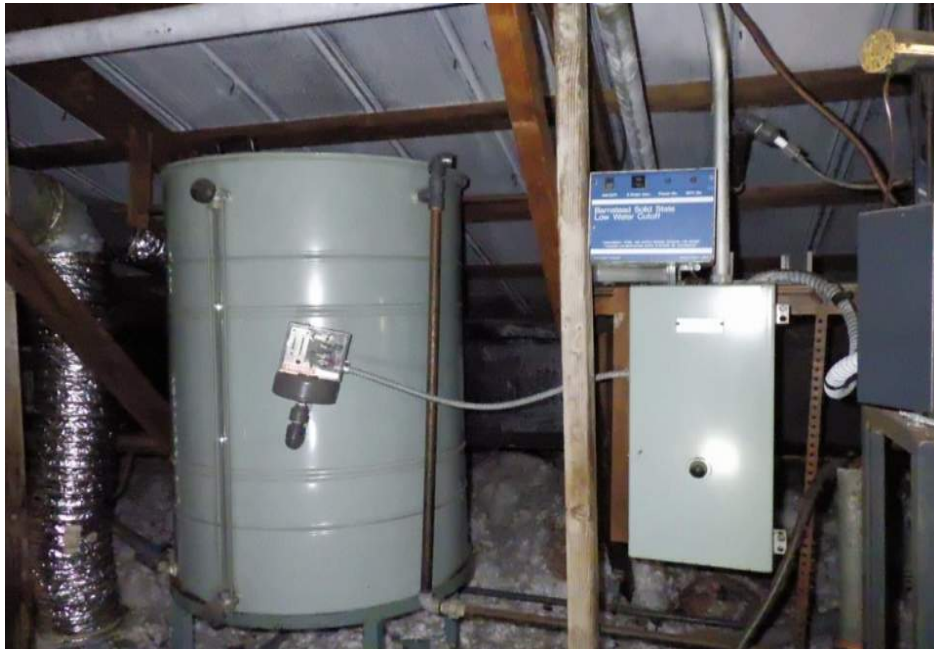
**Description:** water heater in attic with electronic temperature controls with mercury thermostat

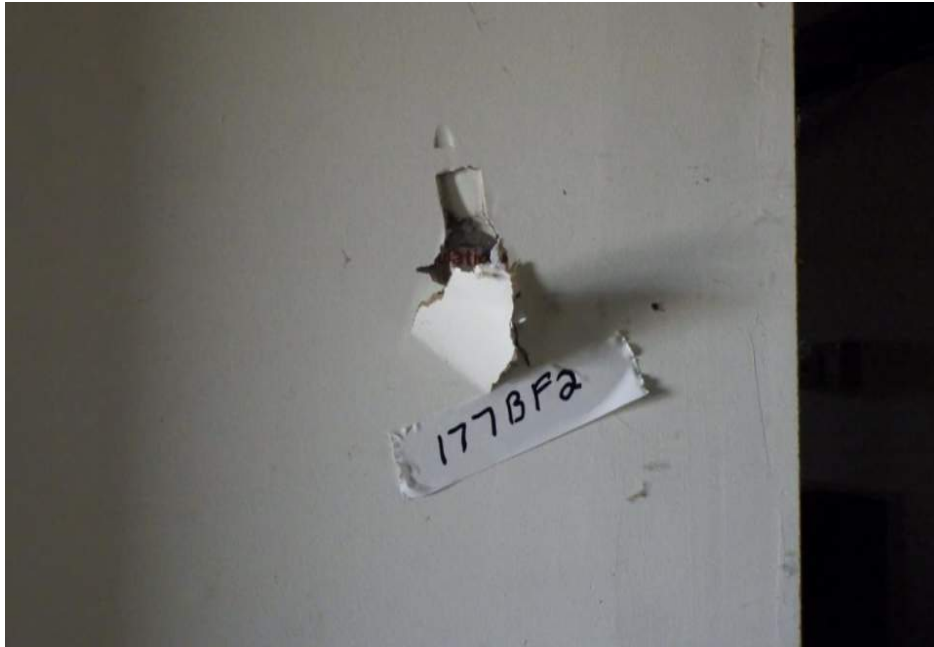
177BF2

**Results:** None Detected

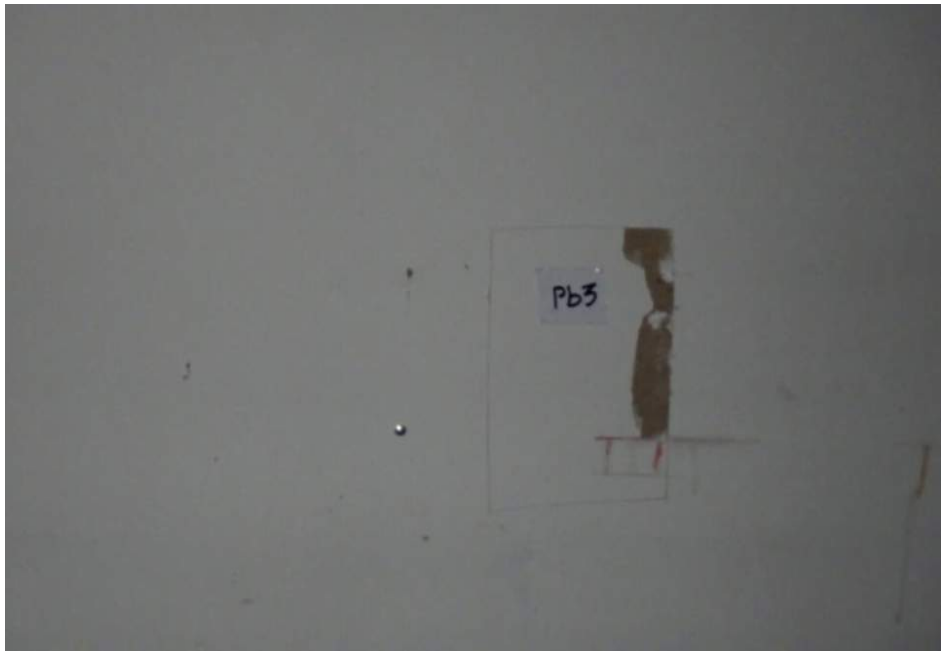
177B-Pb3

**Results:** < 98 ppm

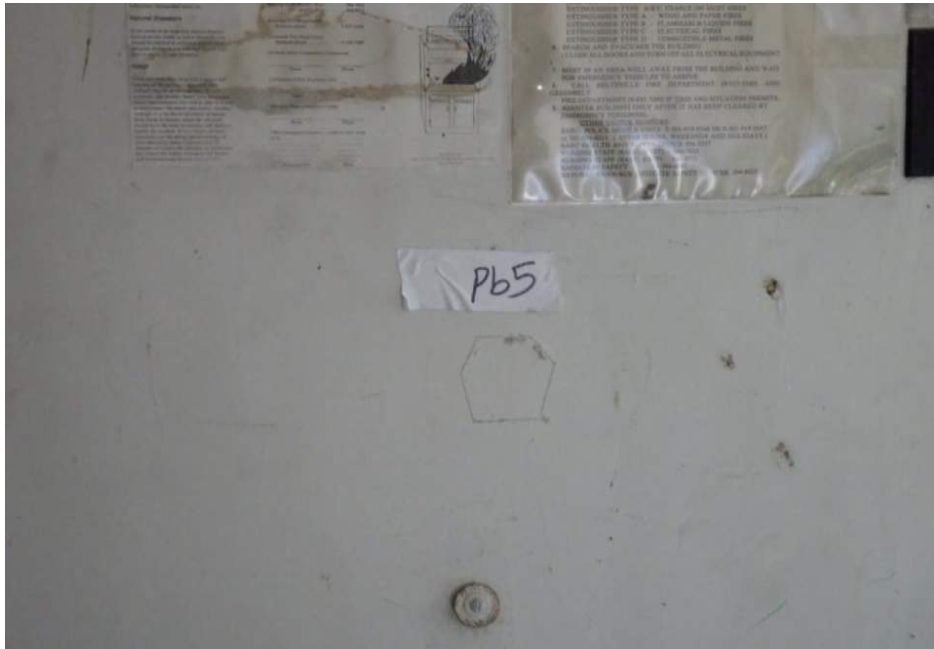
177B-Pb5

**Results:** 1100 ppm

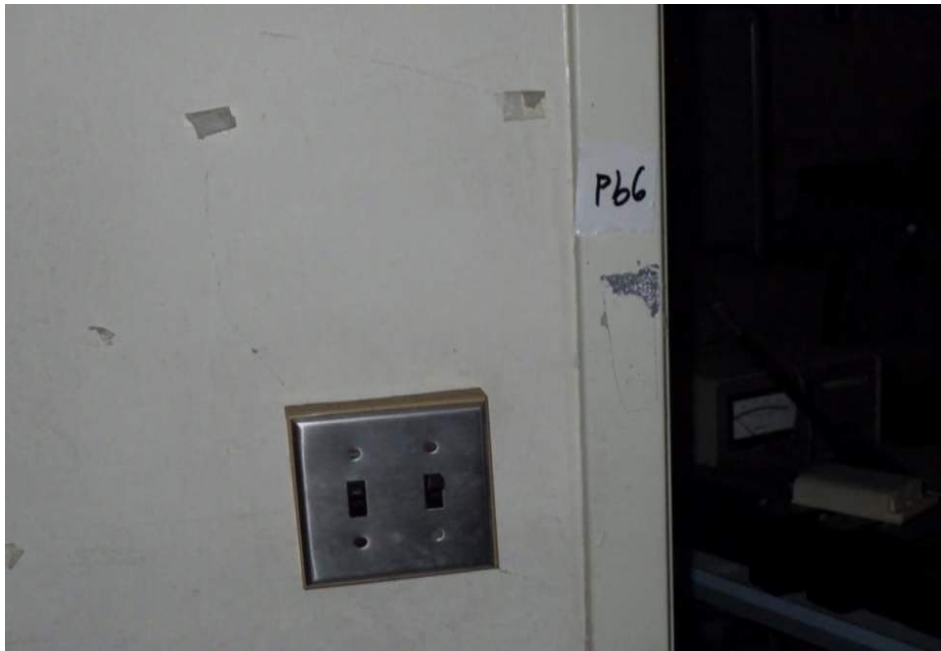
177B-Pb6

**Results:** 2400 ppm

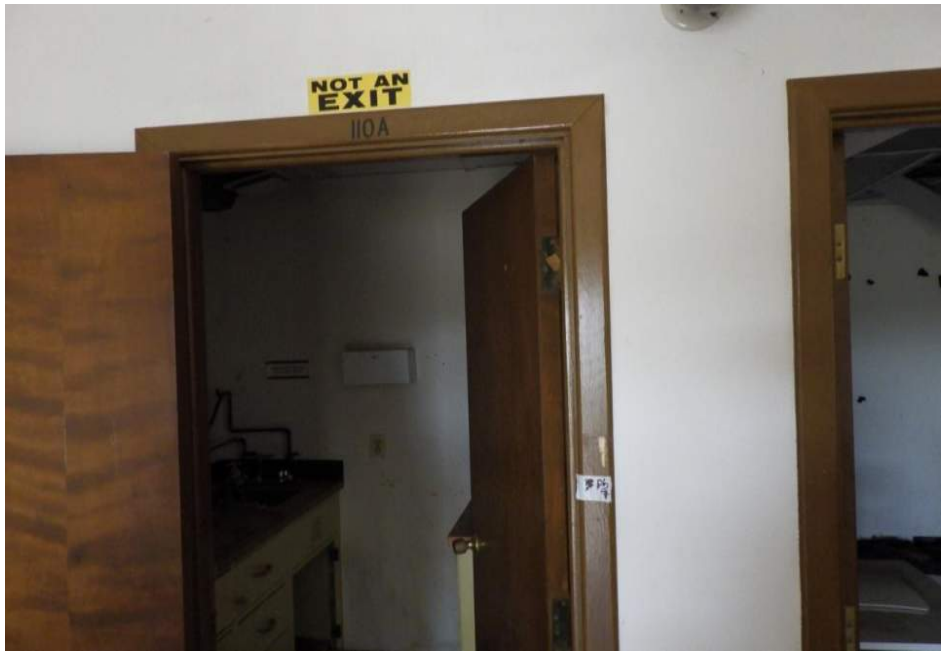
177B-Pb7

**Results:** 5100 ppm

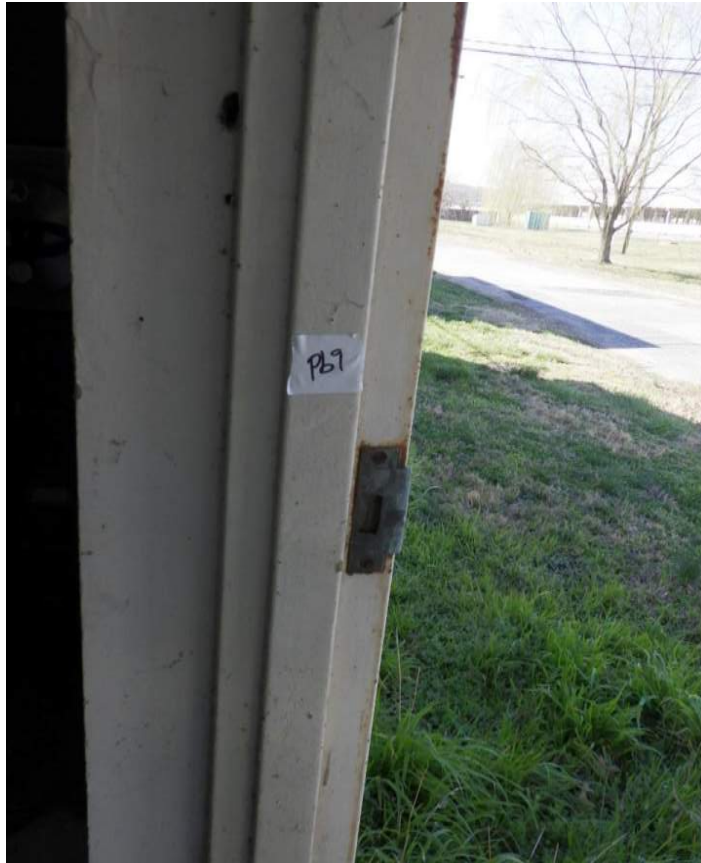
177B-Pb9

**Results:** 15000 ppm

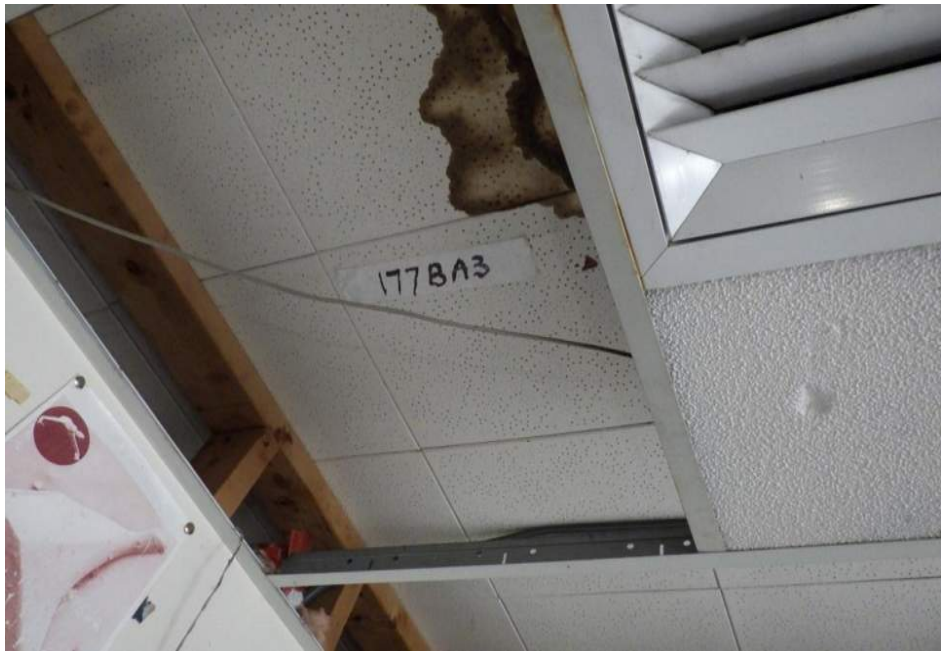
177BA3

**Results:** None Detected

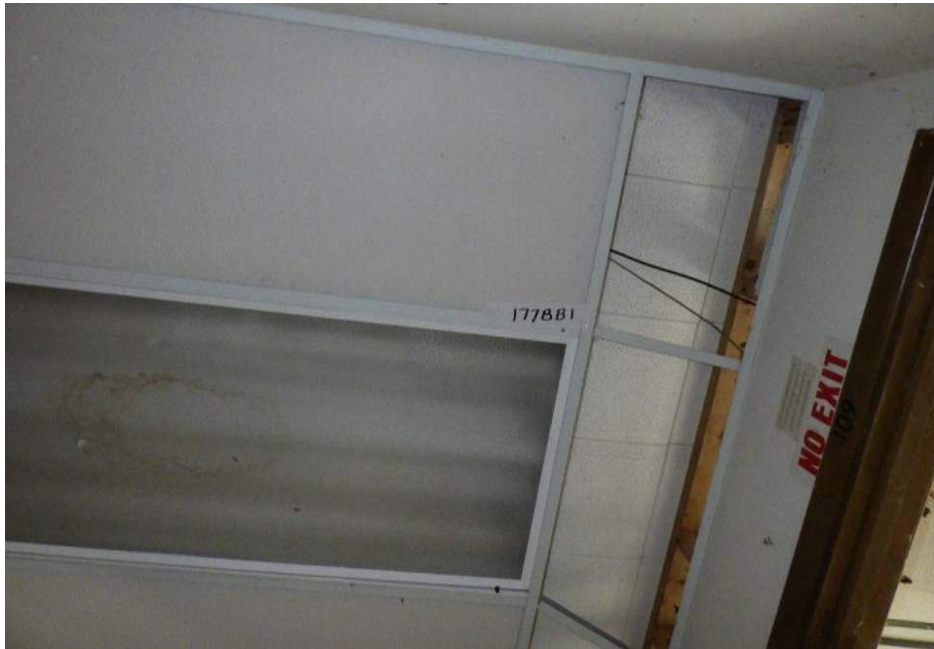
177BB1

**Results:** None Detected

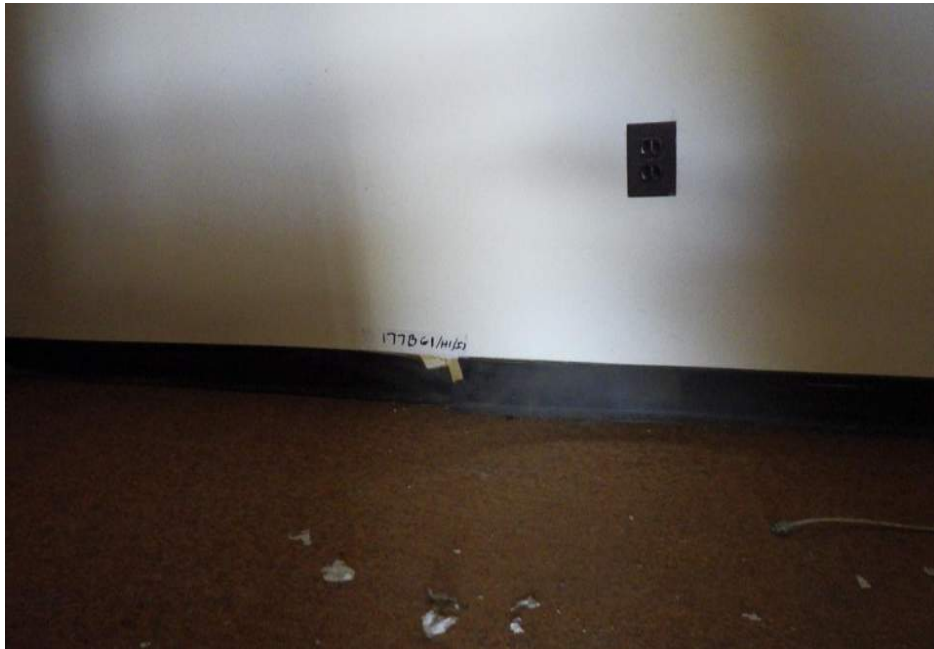
177BG1

**Results:** None Detected

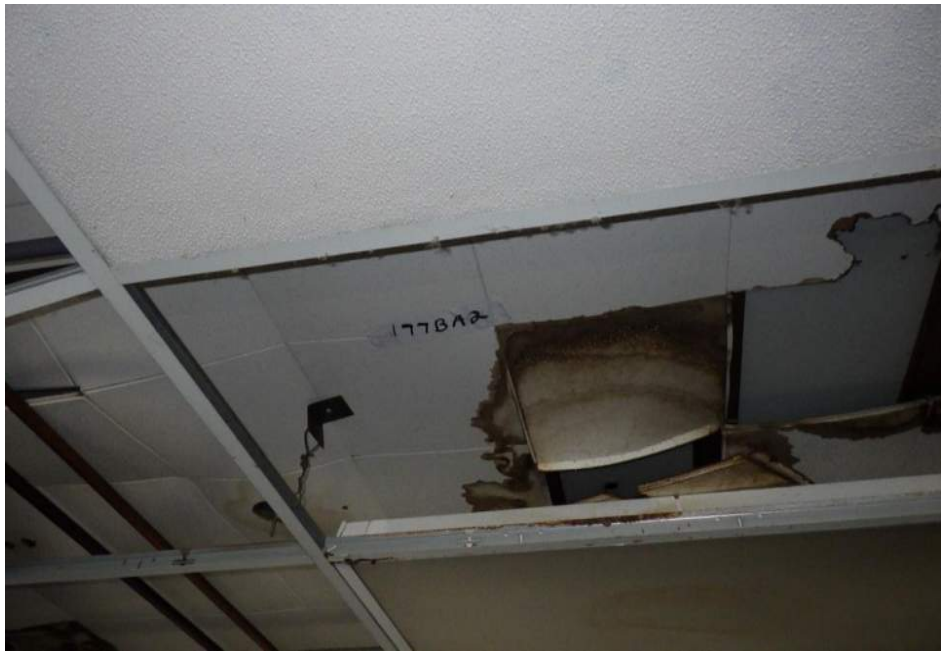
177BA2

**Results:** None Detected

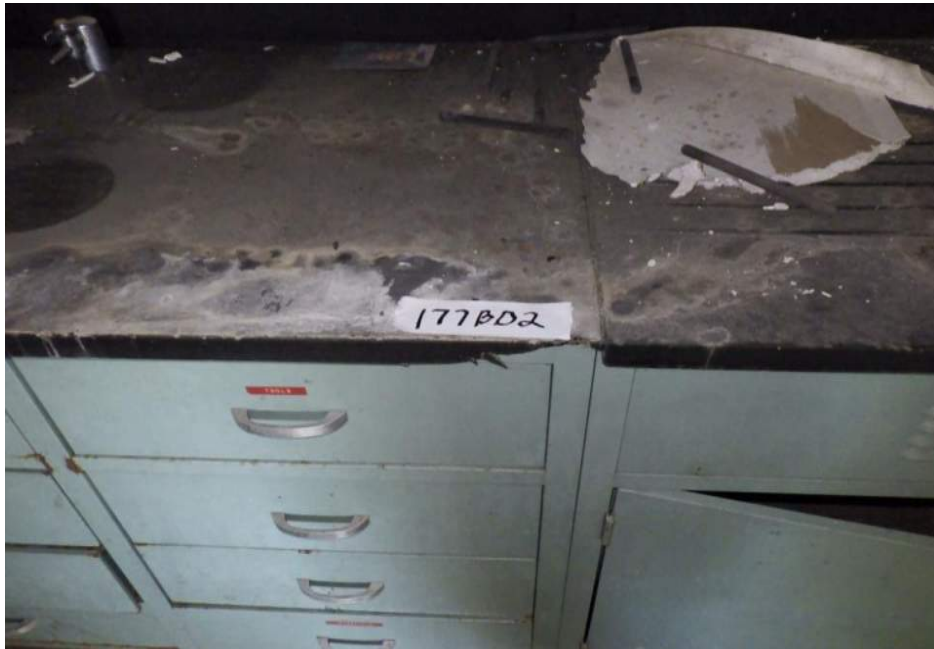
177BD2

**Results:** None Detected

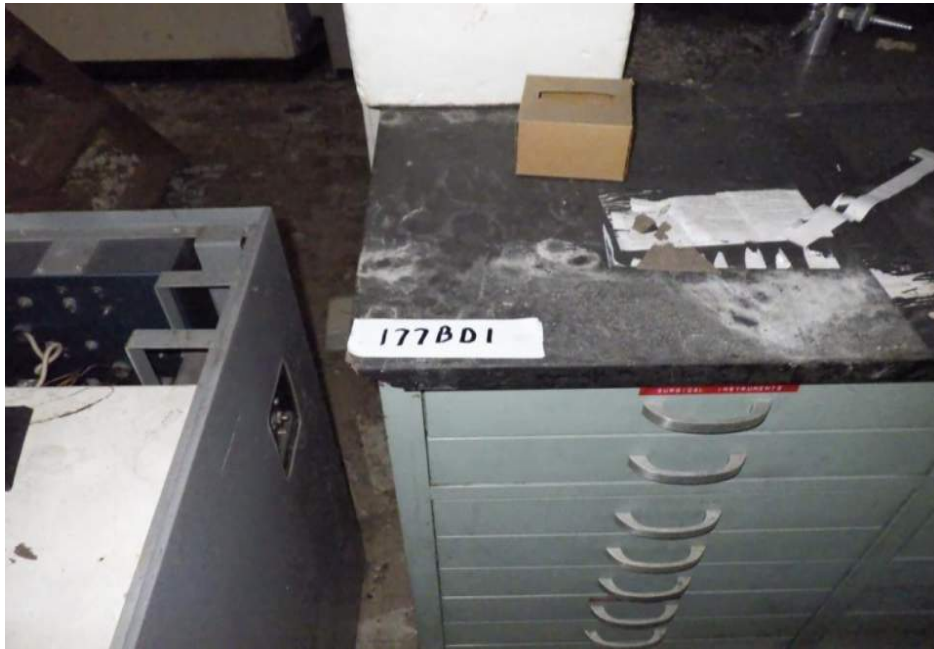
177BD1

**Results:** Chrysotile 20-25%

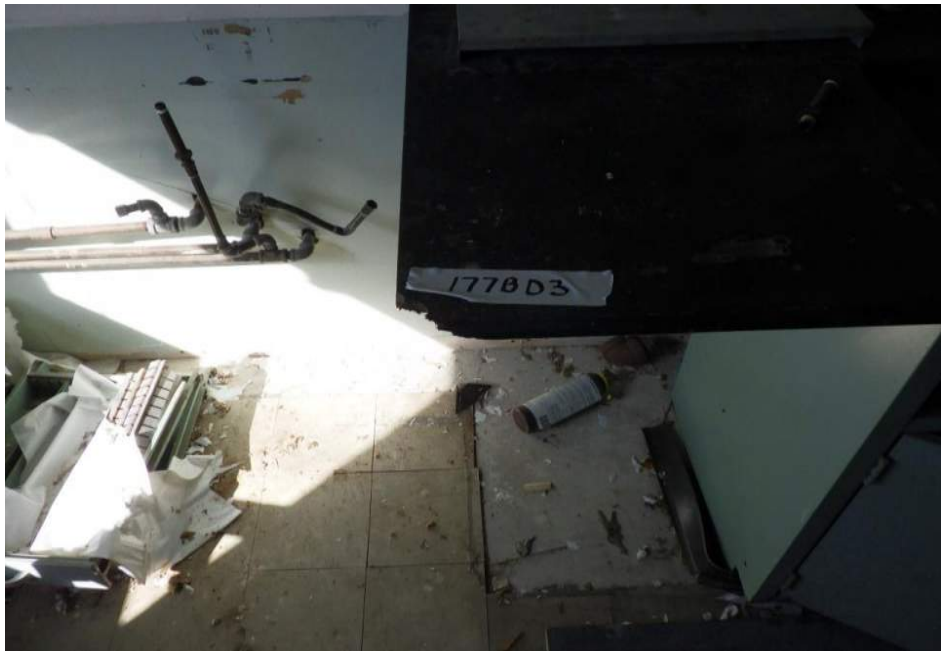
177BD3

**Results:** Chrysotile 20-25%

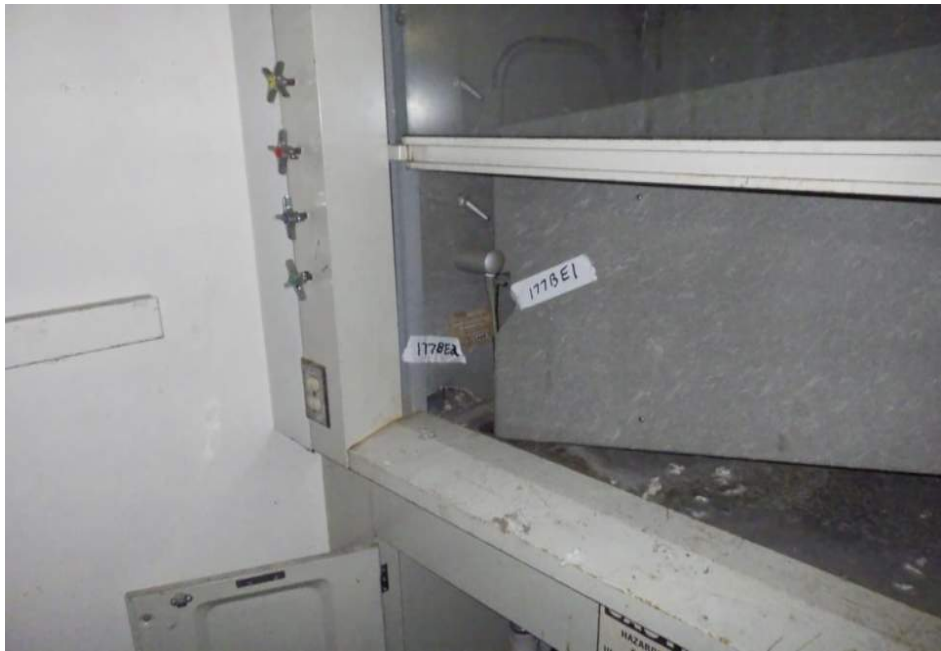
177BE1

**Results:** Chrysotile 20-25%

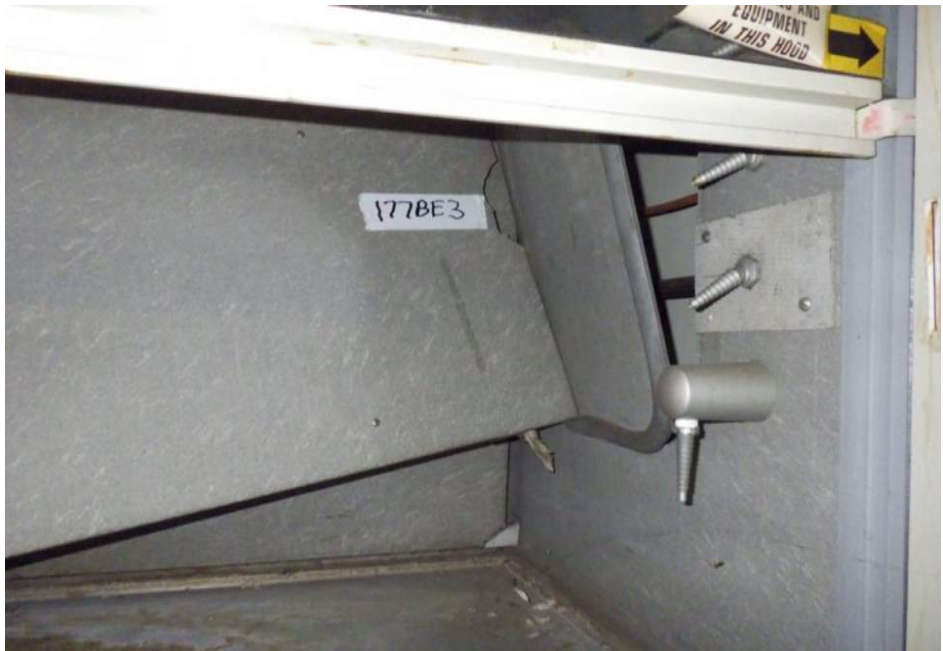
177BE3

**Results:** Chrysotile 20-25%

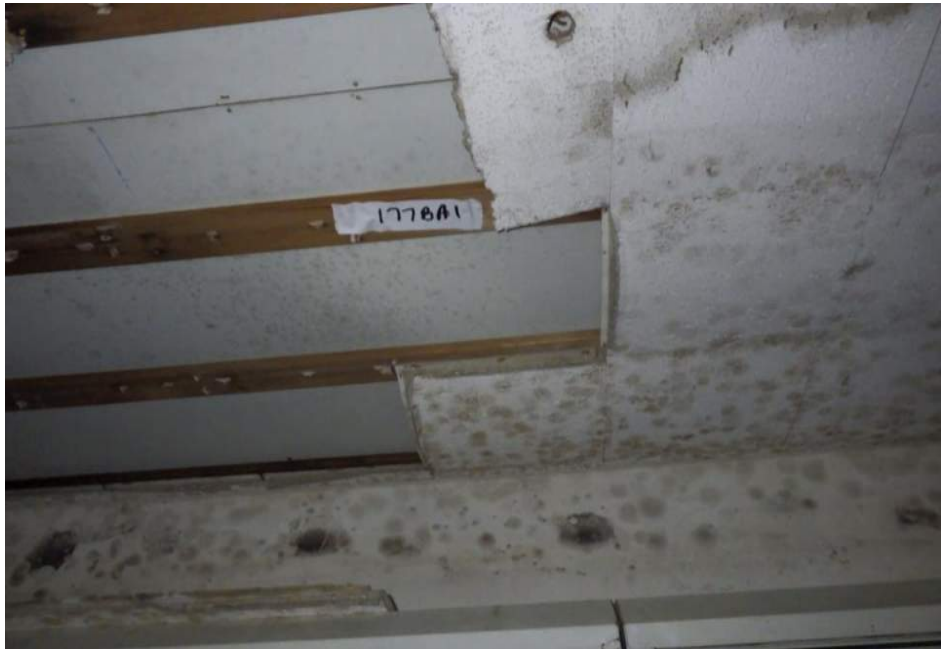
177BA1

**Results:** Chrysotile 20-25%

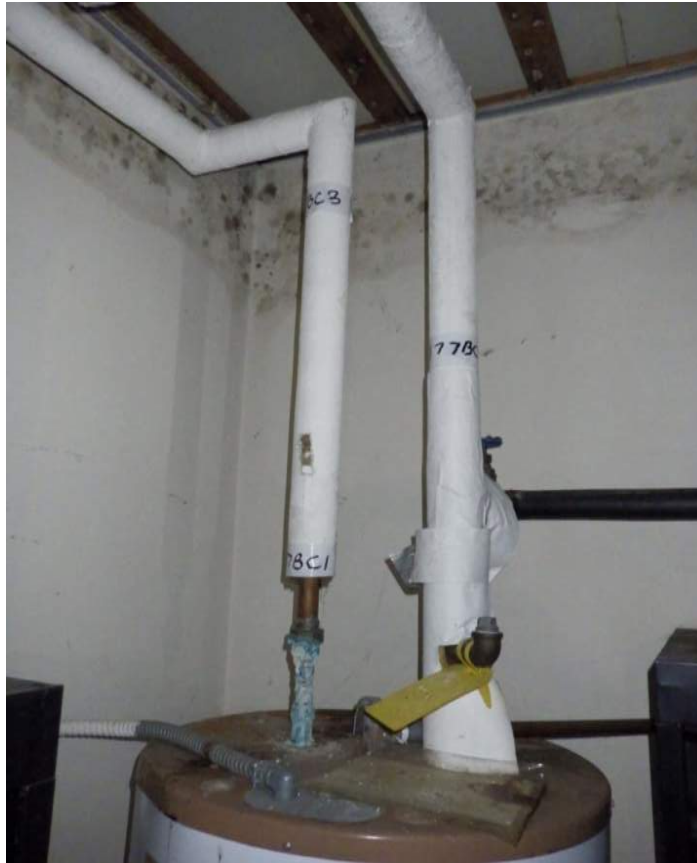
177BC1

**Results:** None Detected

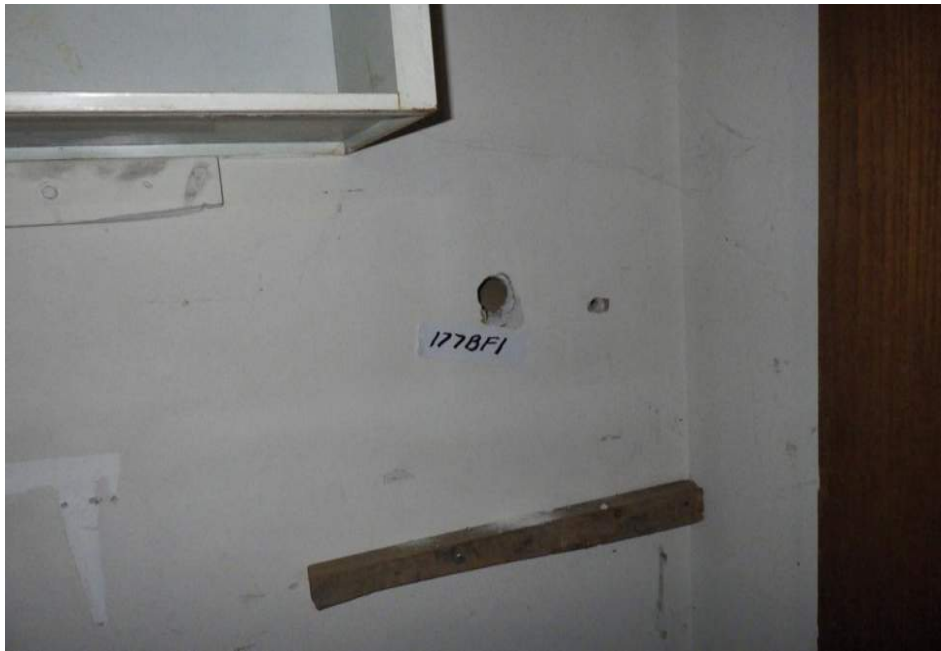
177BF1

**Results:** Chrysotile 5-10%

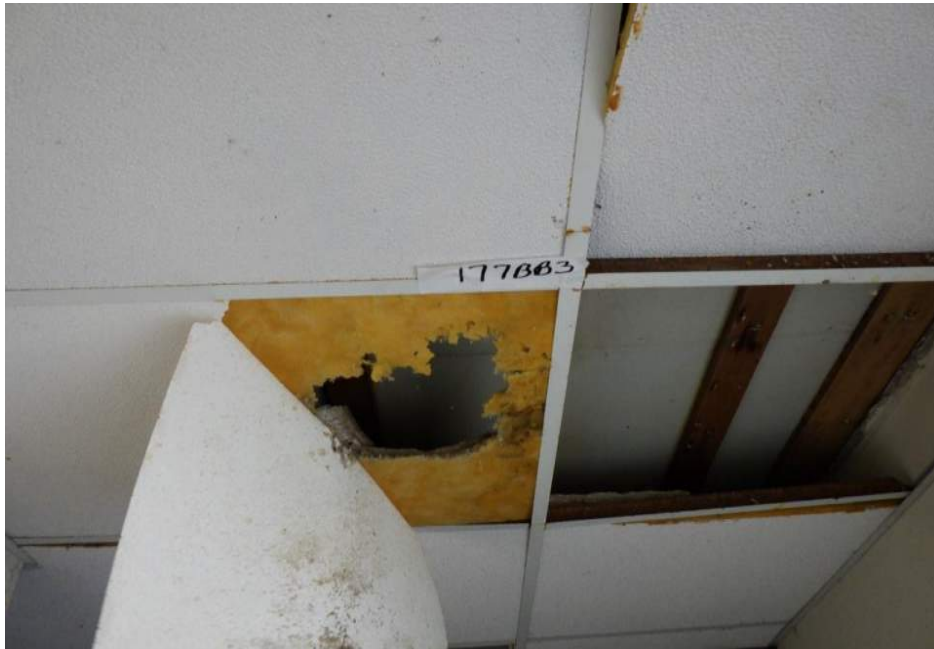
177BB3

**Results:** None Detected

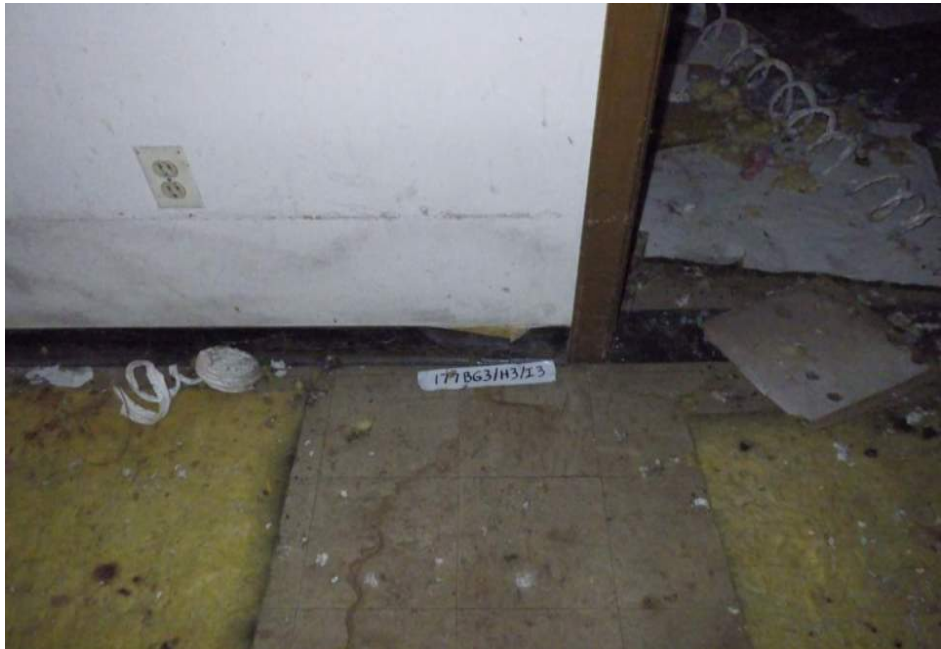
177BG3

**Results:** None Detected

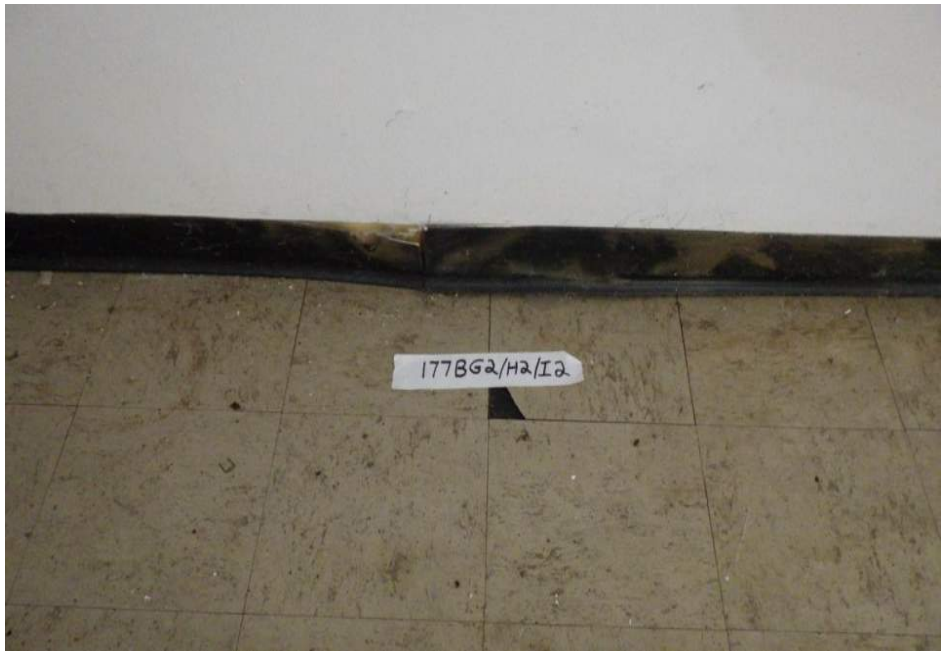
177BG2

**Results:** None Detected

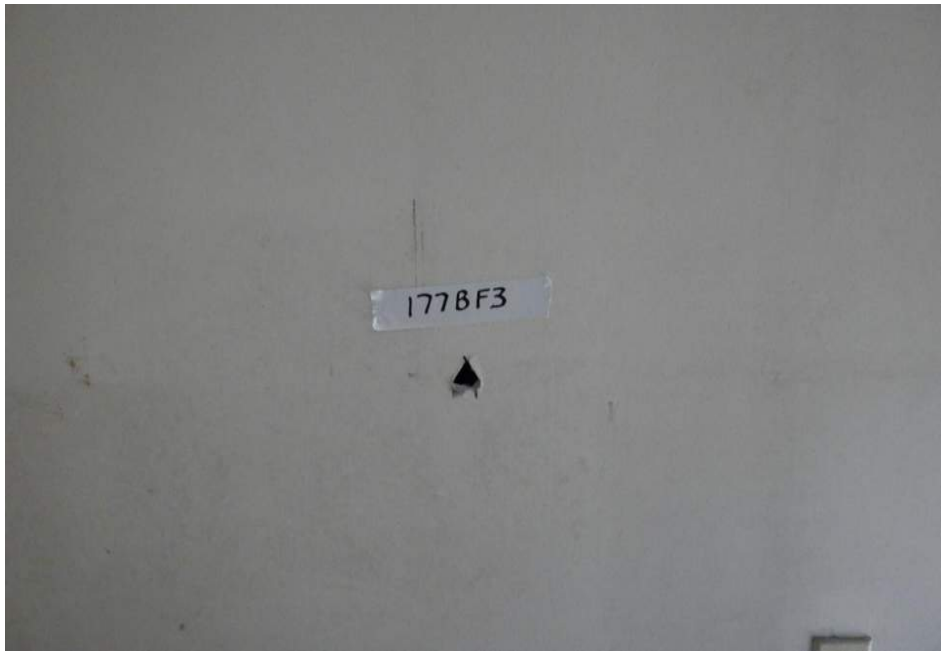
177BF3

**Results:** None Detected
