# Beltsville Agricultural Research Center Hazardous Materials Assessment Part 2

**Beltsville Agricultural Research Center  
Hazardous Materials Assessment  
Project No. 103144**

**Revision 1  
April 22, 2020**

**Burns & McDonnell Engineering Company, Inc.  
Downers Grove, Illinois**

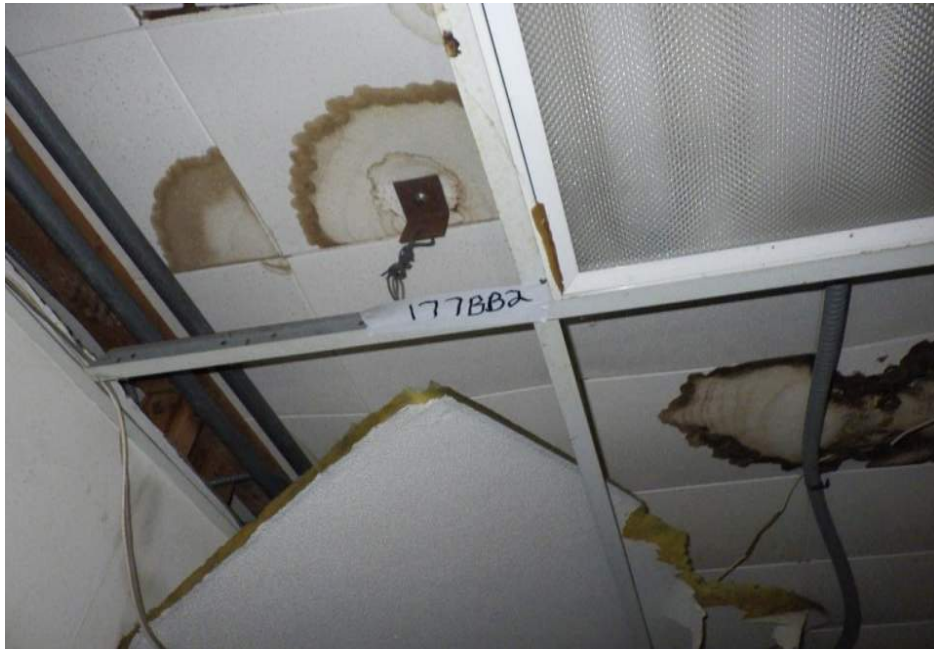
177BB2

**Results:** None Detected

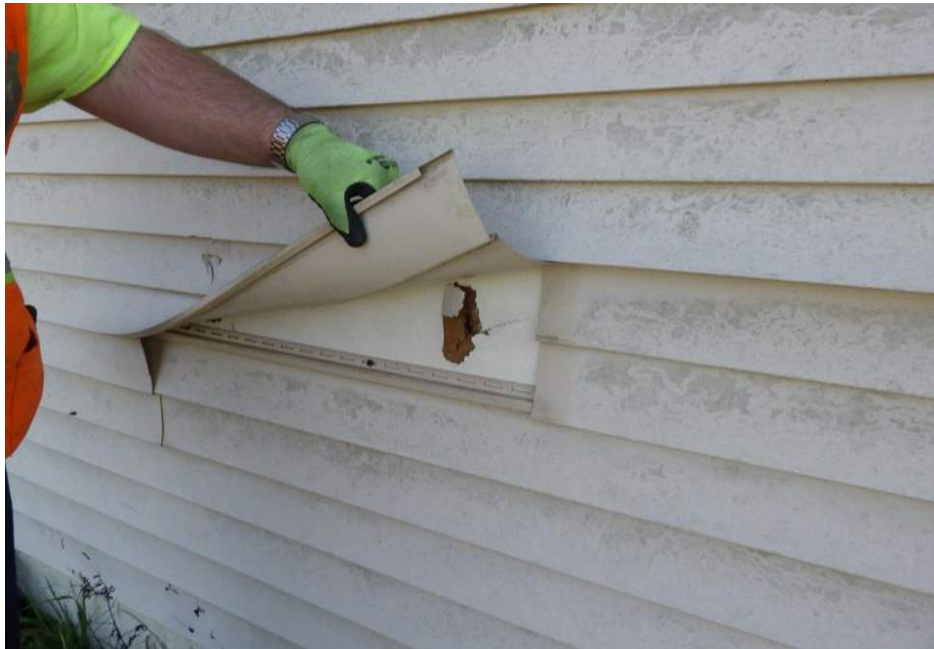
177B-Pb2

**Results:** None Detected

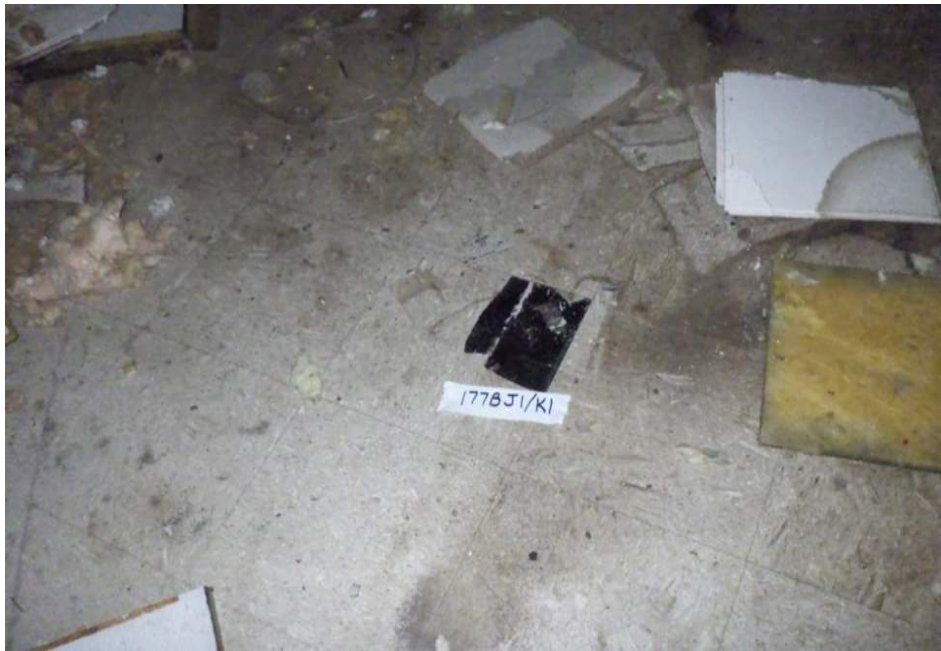
177BJ1

**Results:** 1200 ppm

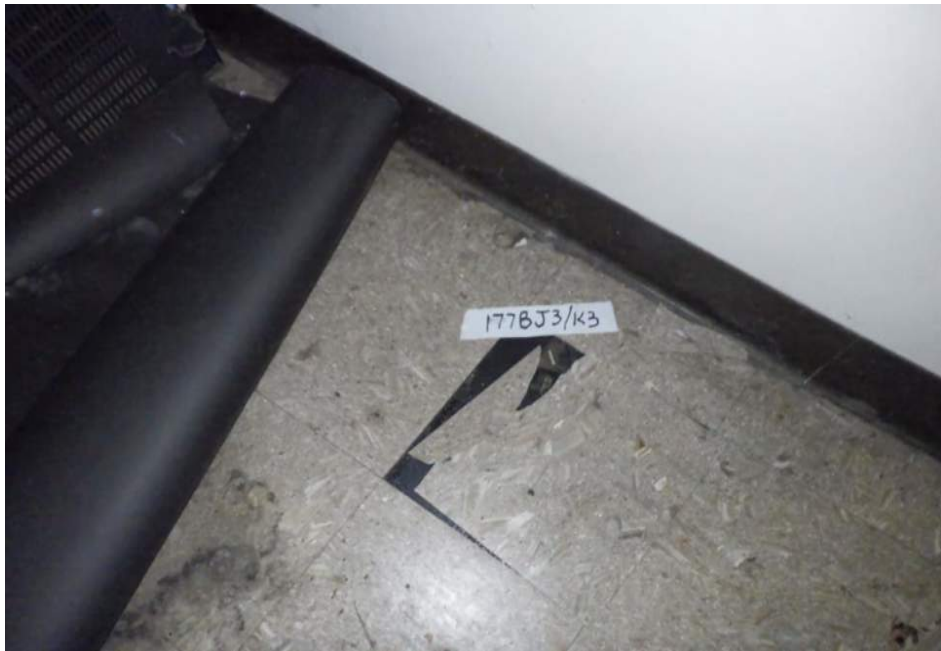
177BJ3

**Results:** Chrysotile 1-5%

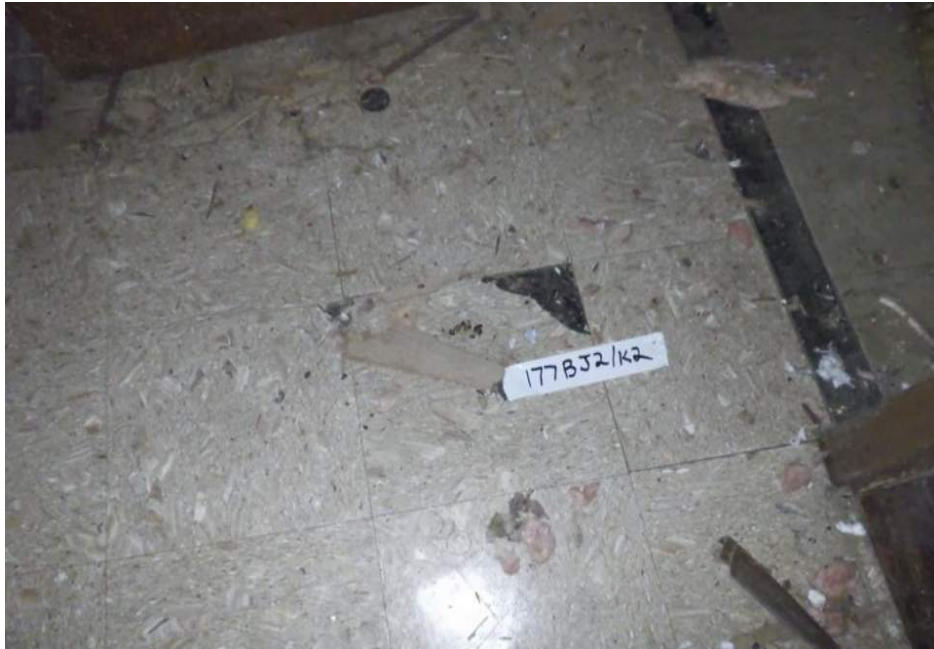
177BJ2

**Results:** Chrysotile 1-5%

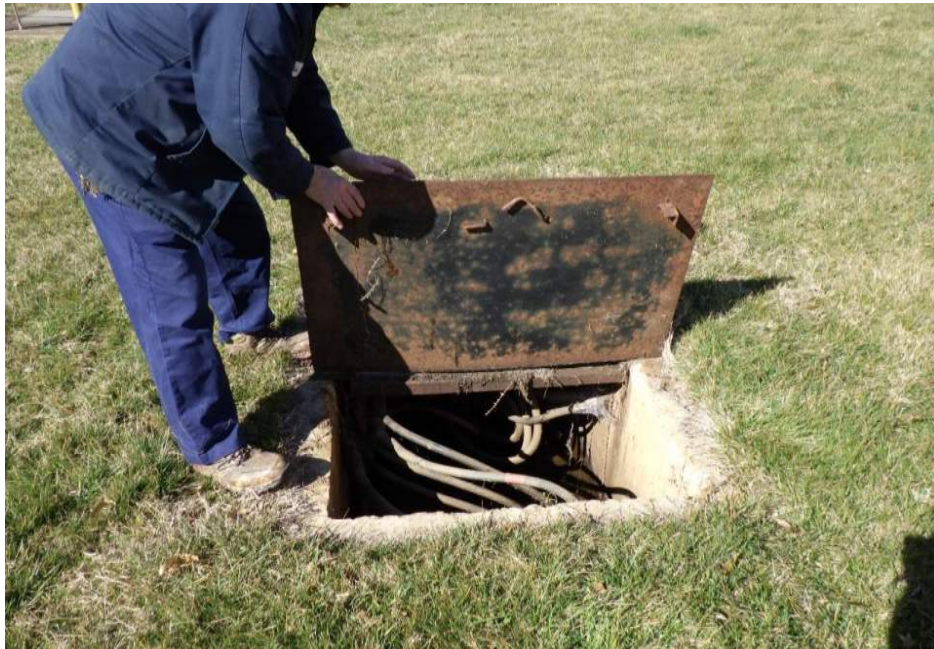
**Results:** Chrysotile 1-5%

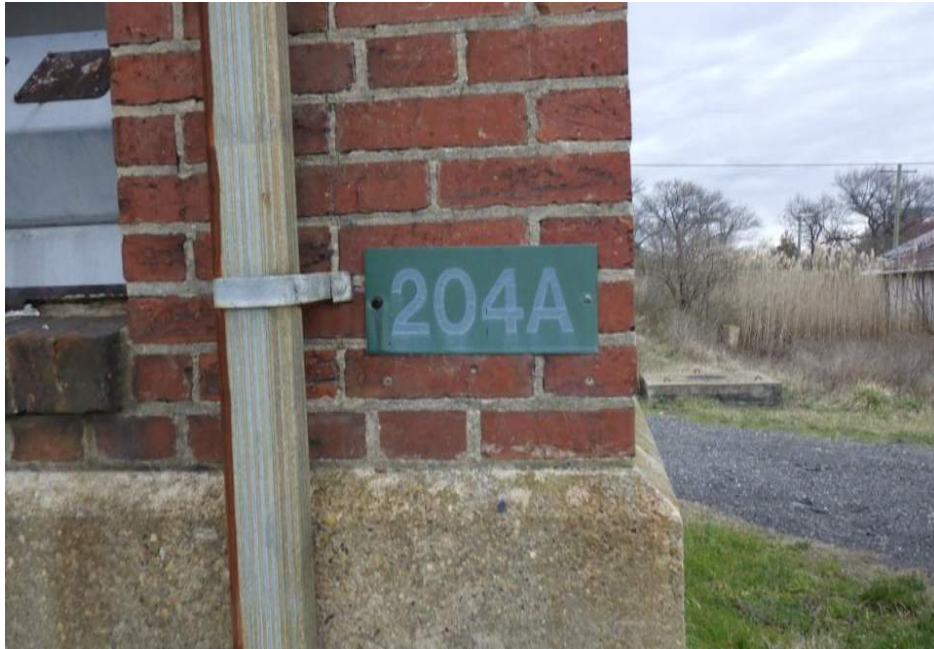
**Results:** Chrysotile 5-10%

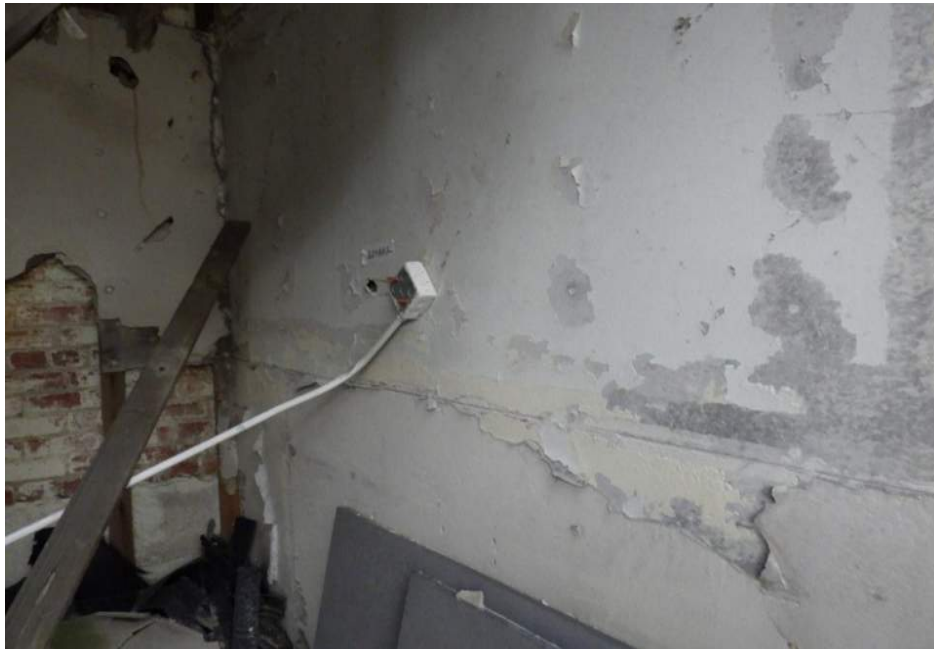
204AA2

**Results:** None Detected

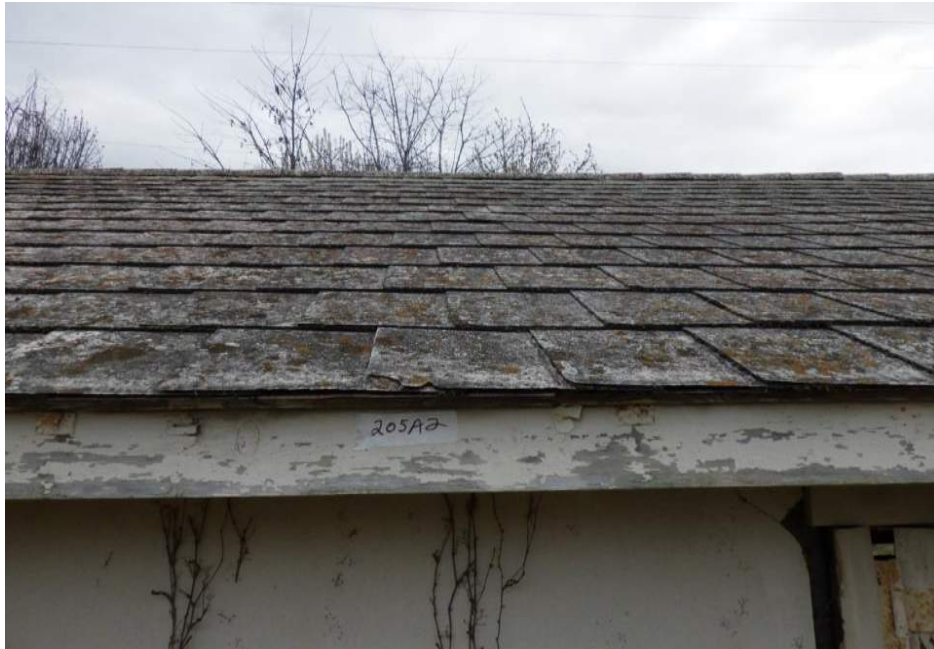
205A2

**Results:** Chrysotile 20-25%

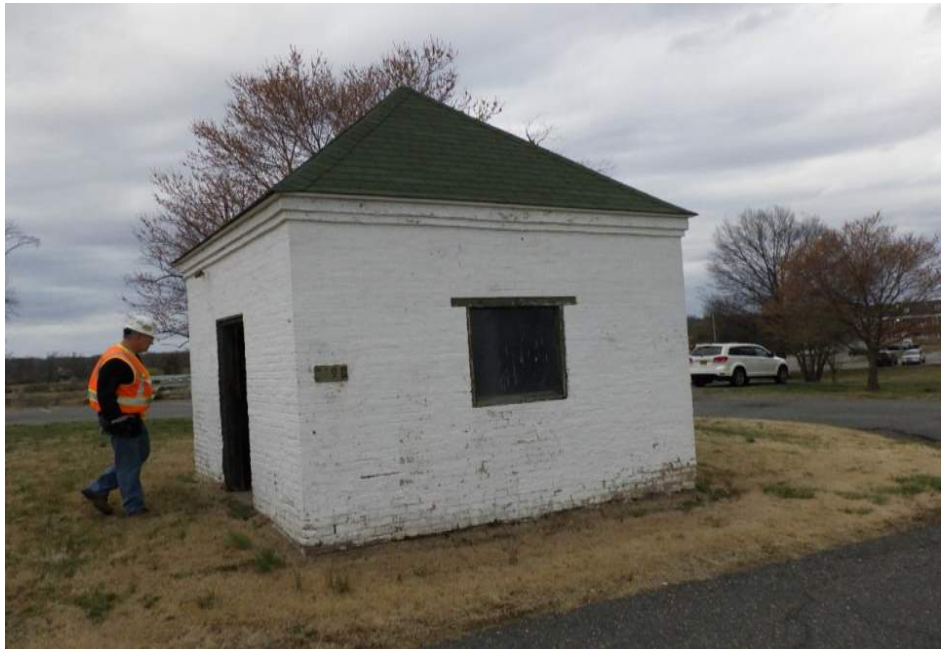
**Results:** Chrysotile 20-25%

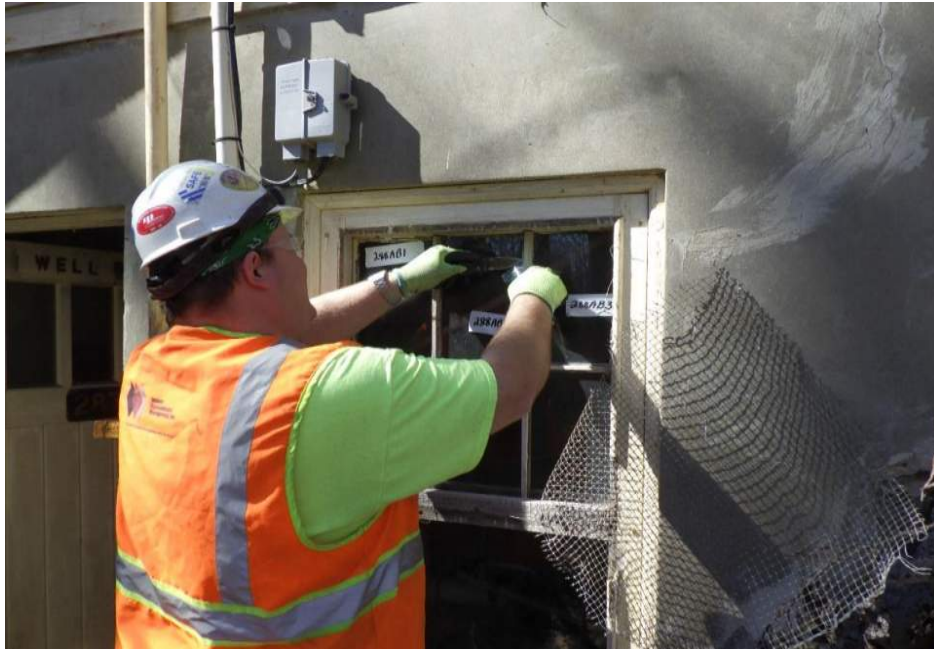
287A-Pb1

**Results:** 260000 ppm

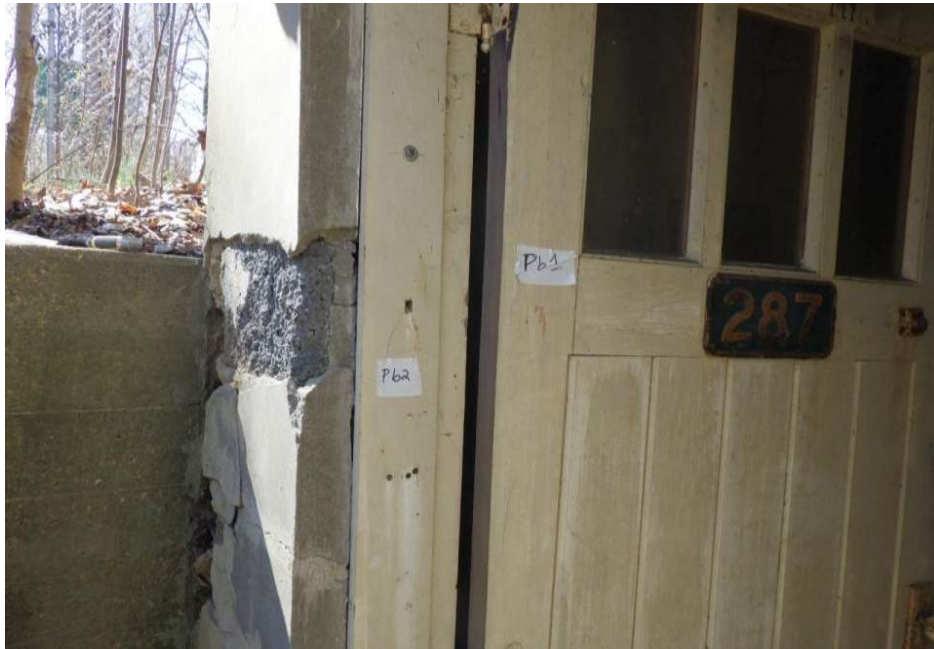
287A-Pb4

**Results:** 460000 ppm

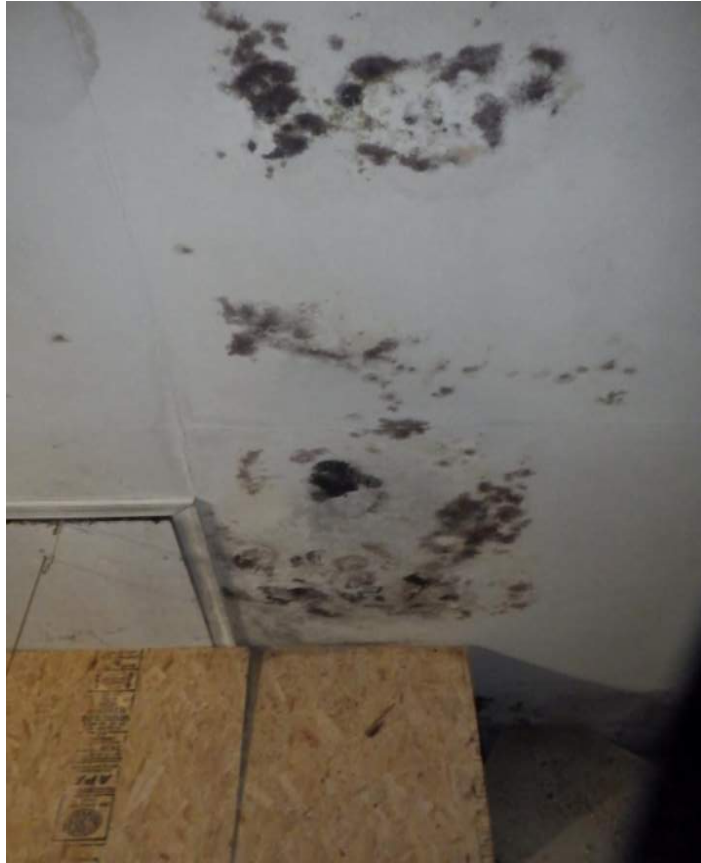
**Description:** typical moldy ceiling drywall in 288A

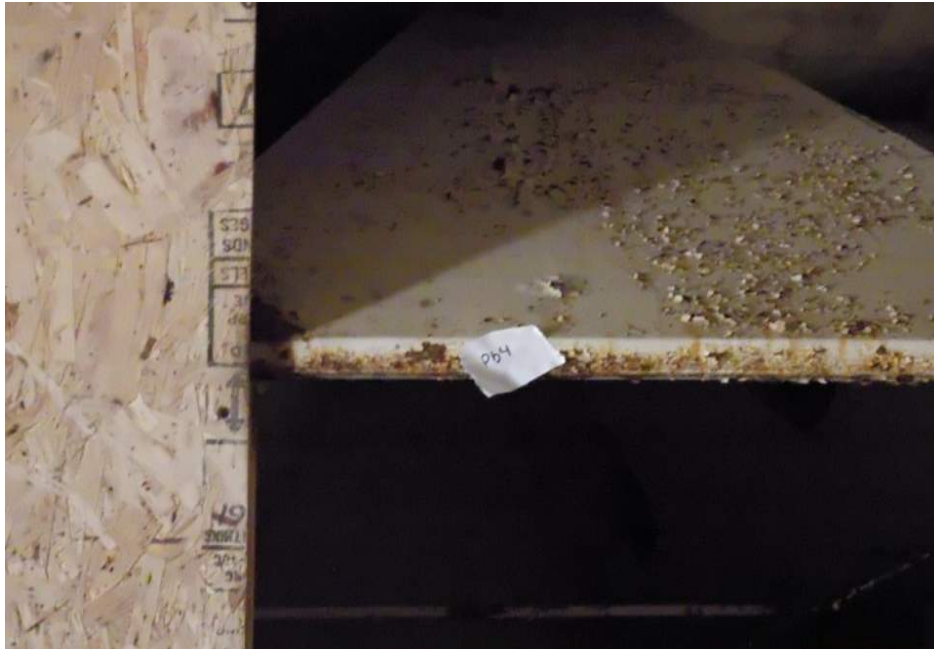
288A-Pb4

**Results:** 6400 ppm

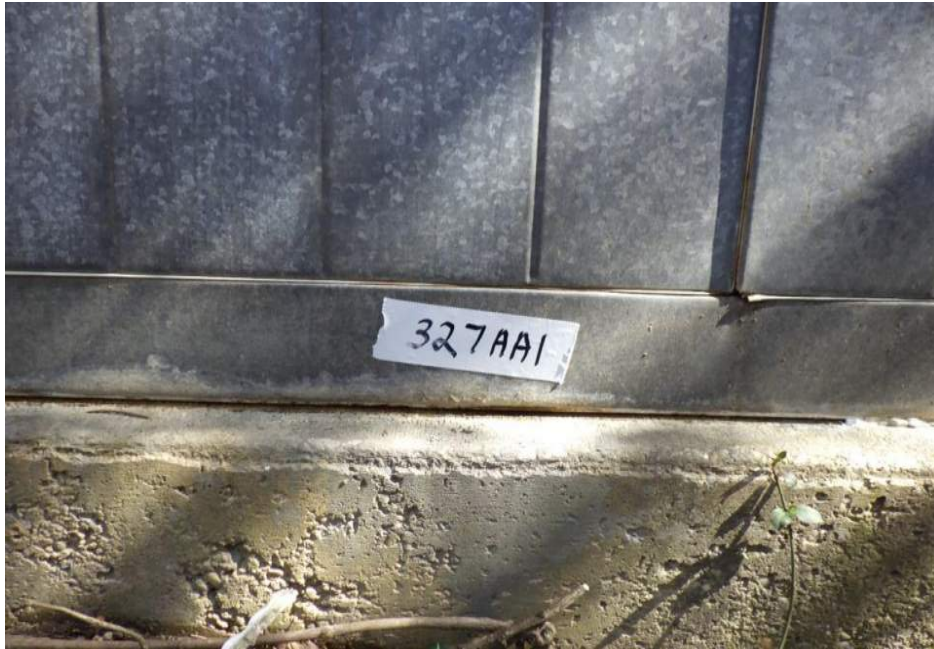
**Description:** asbestos sample of caulk between building and concrete slab

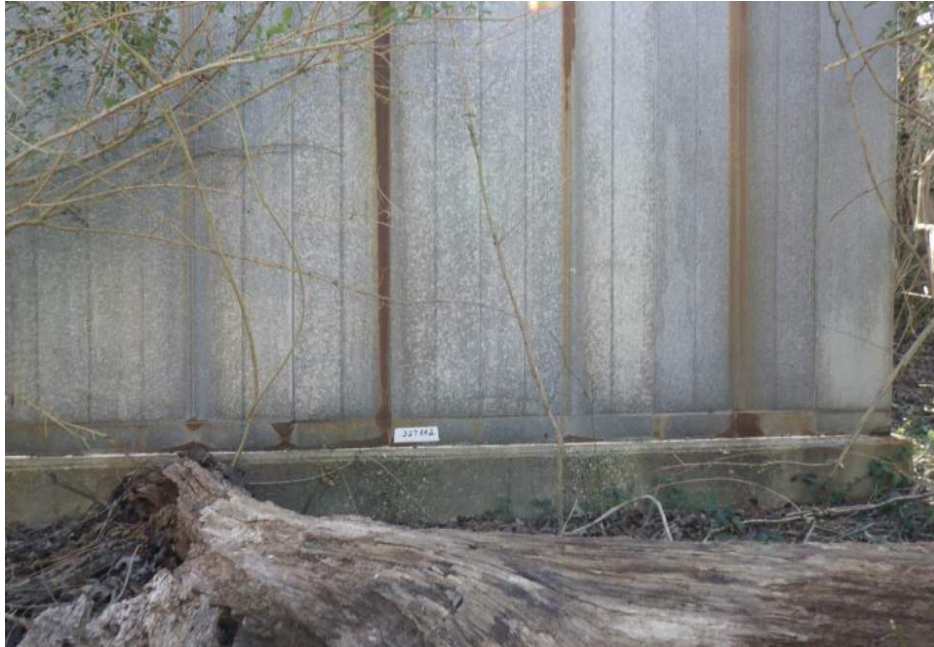
**Description:** asbestos sample of caulk between building and concrete slab

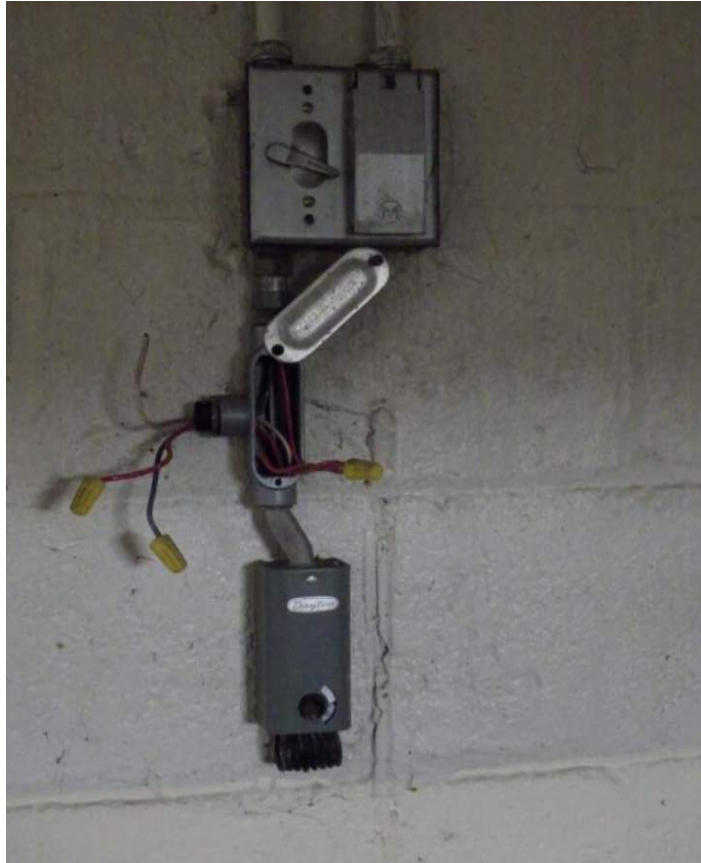
**Description:** thermostatic controls

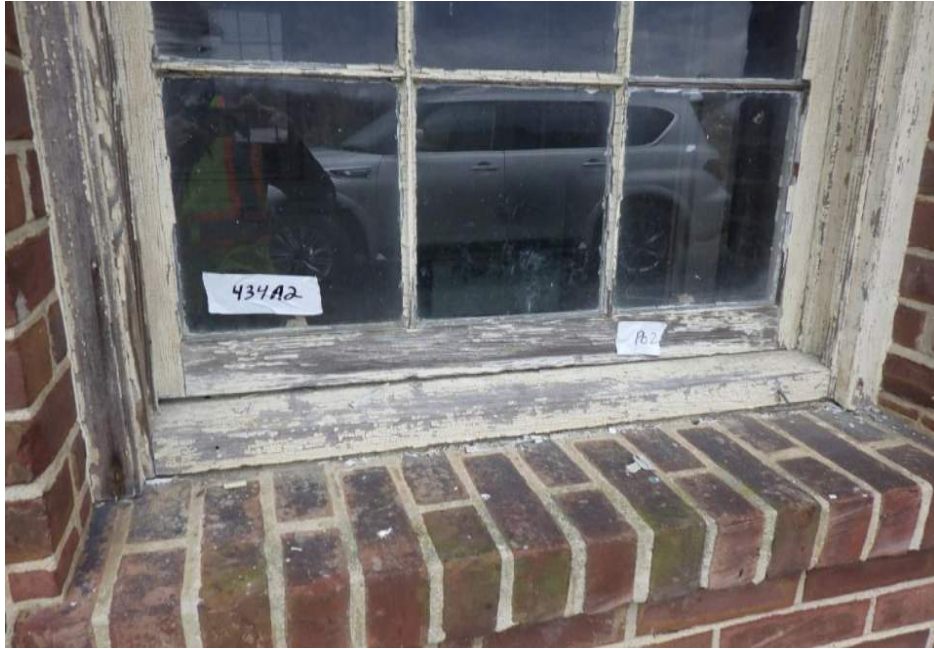
434A2

**Results:** None Detected

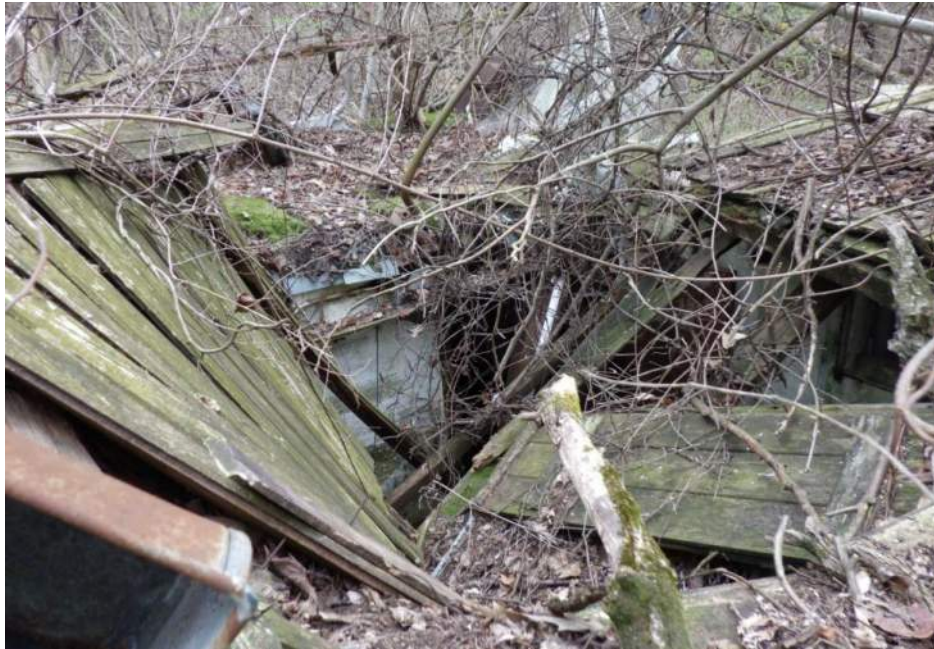
**Description:** building 452 interior, collapsed structure

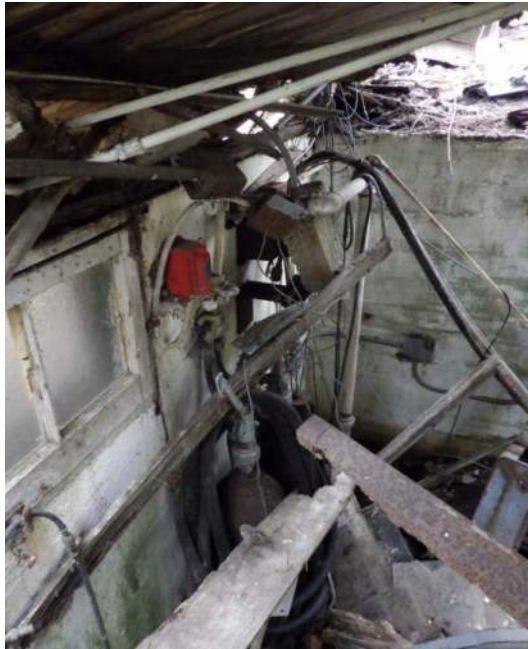
**Description:** building 452 interior, collapsed structure

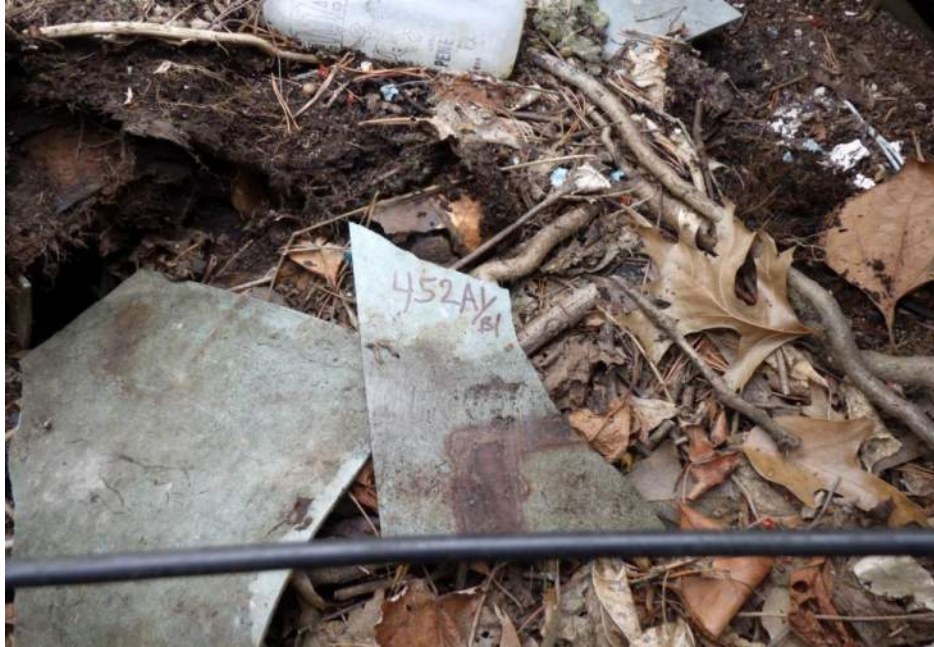
452A1

**Results:** Chrysotile 1-5%

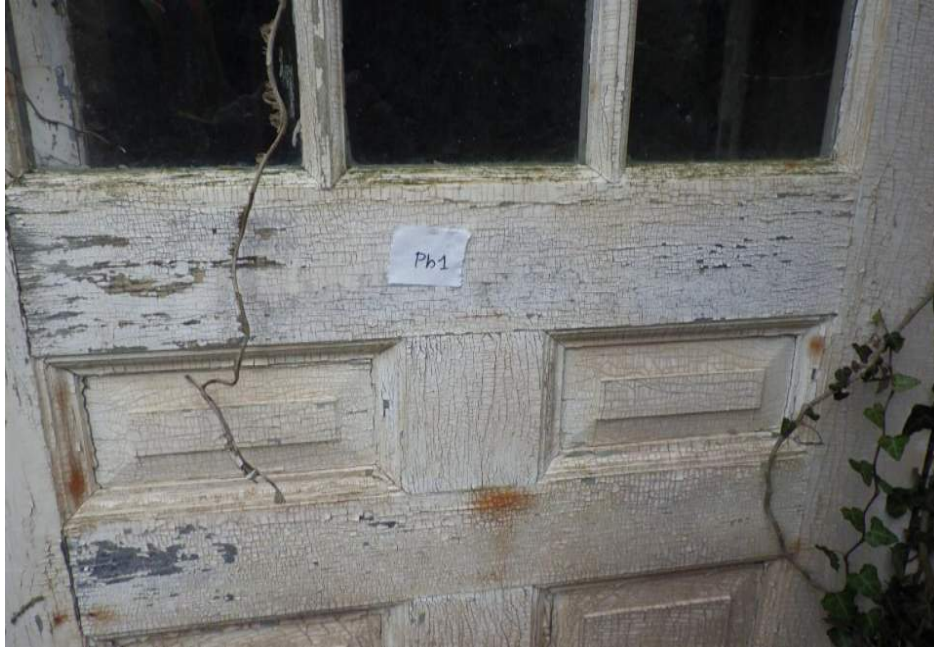
467-Pb1

**Results:** 390000 ppm

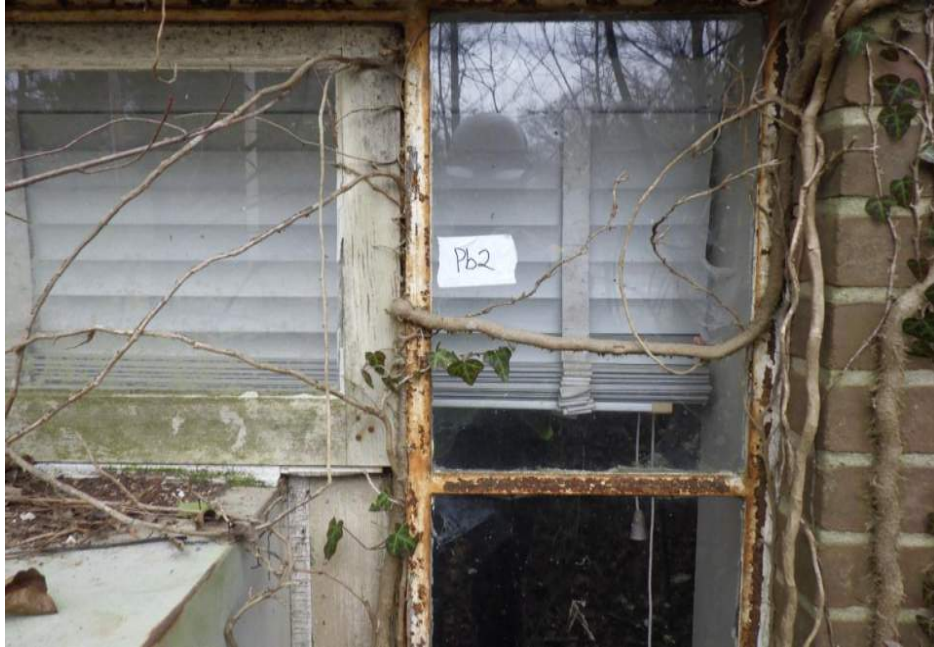
467-Pb2

**Results:** 290000 ppm

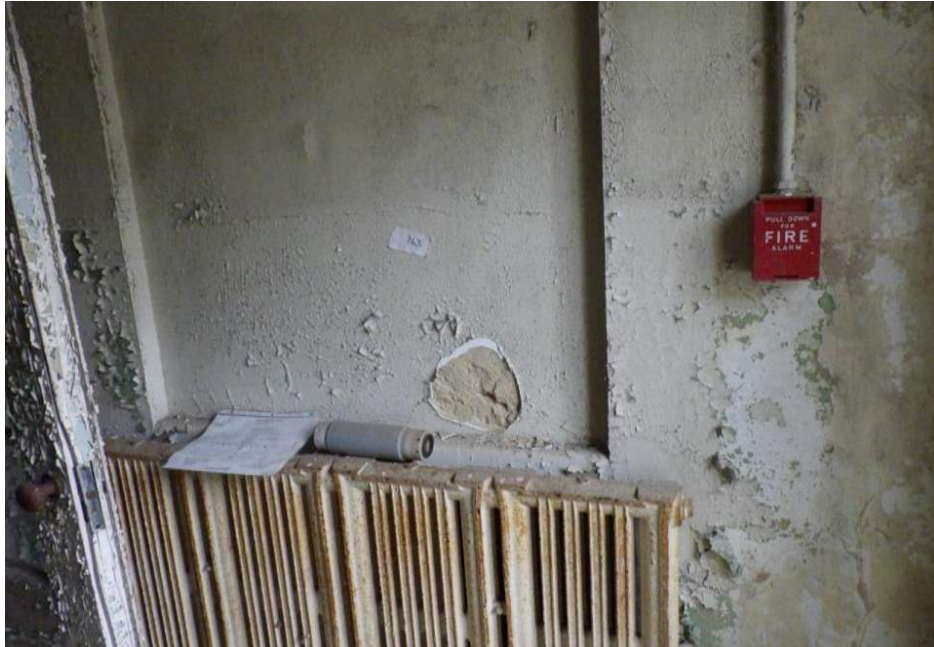
467-Pb3

**Results:** 2600 ppm

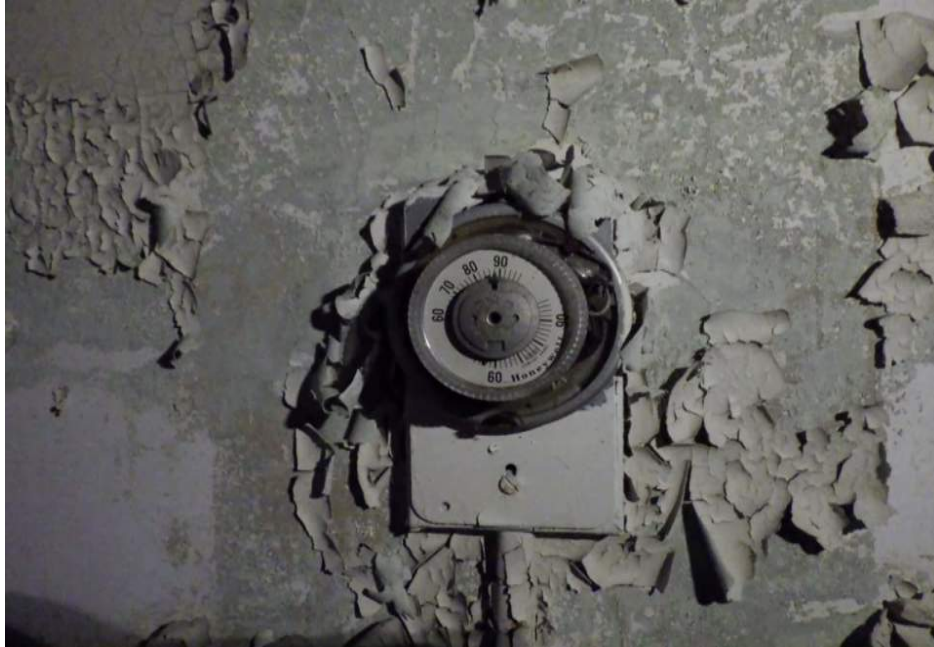
**Description:** typical mercury vial containing thermostat

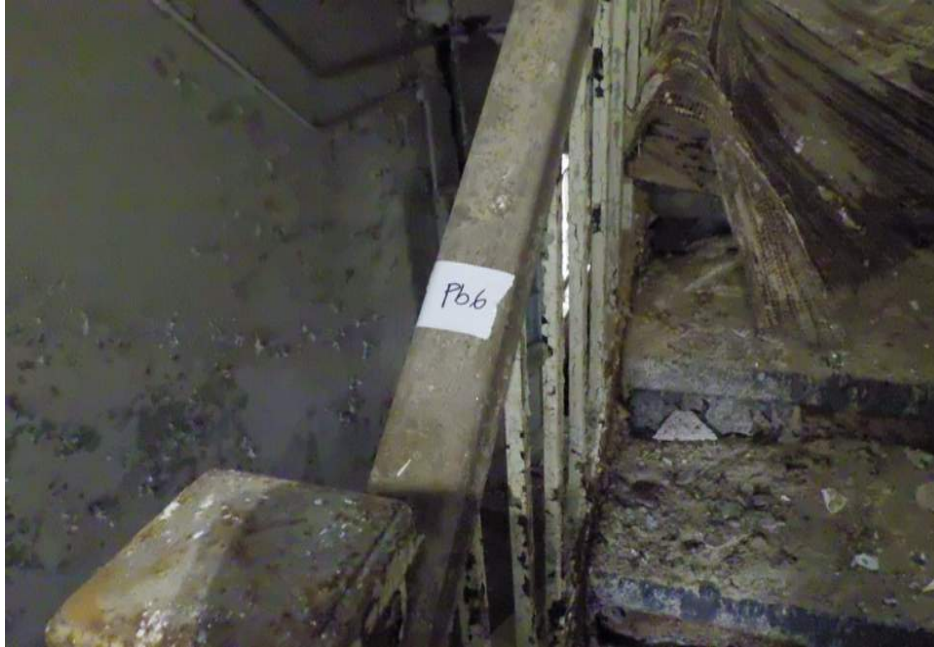
467-Pb6

**Results:** 14000 ppm

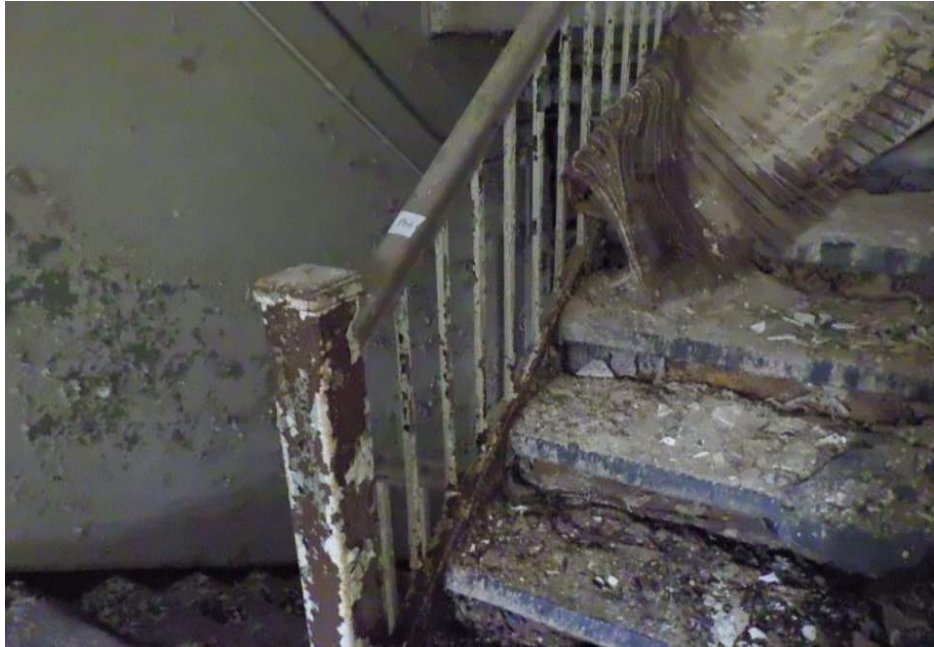
467-Pb6

**Results:** 14000 ppm

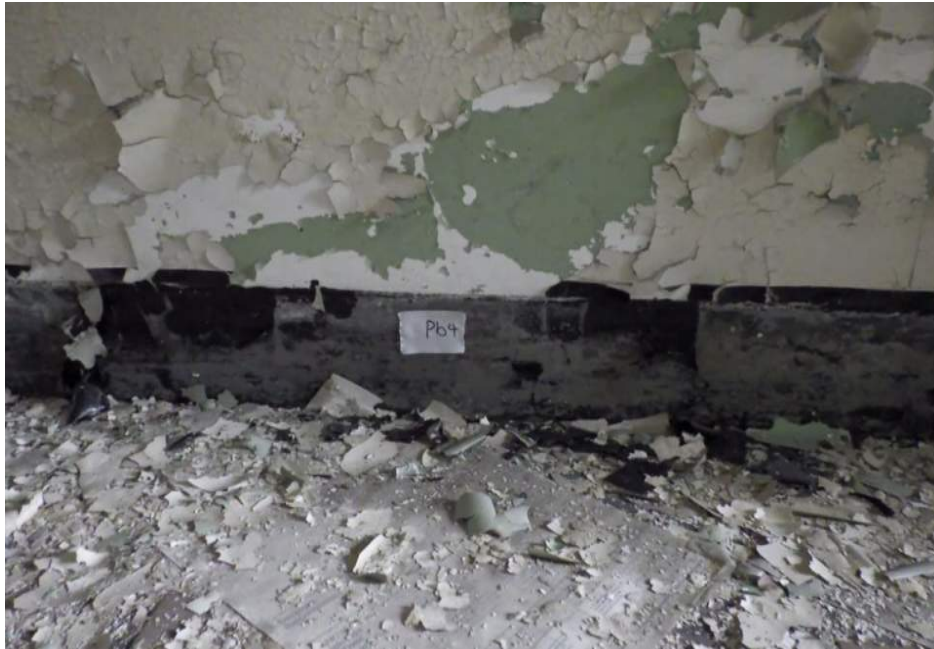
467-Pb4

**Results:** 7700 ppm

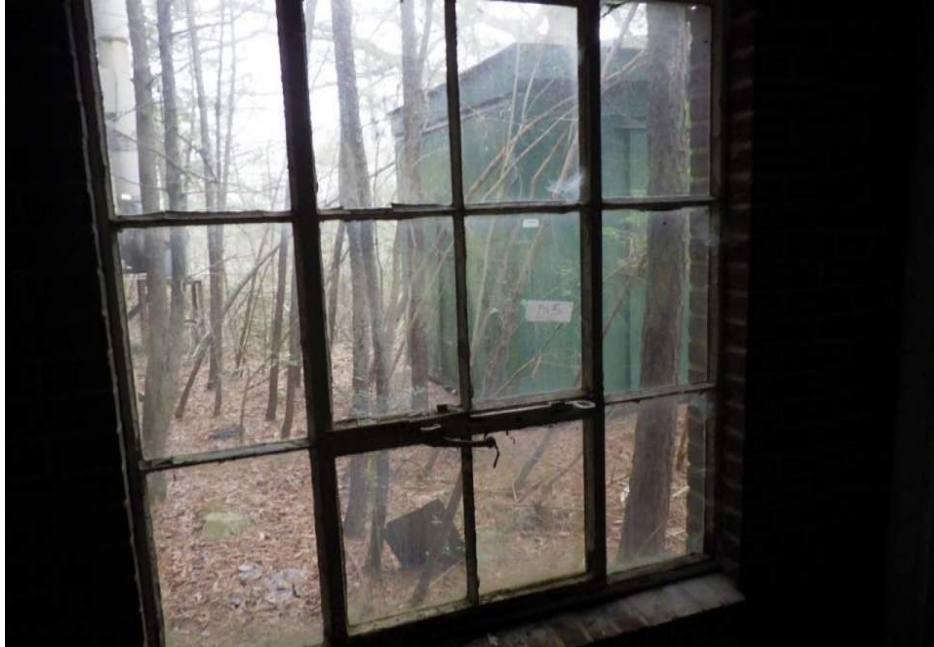
467-Pb5

**Results:** 8900 ppm

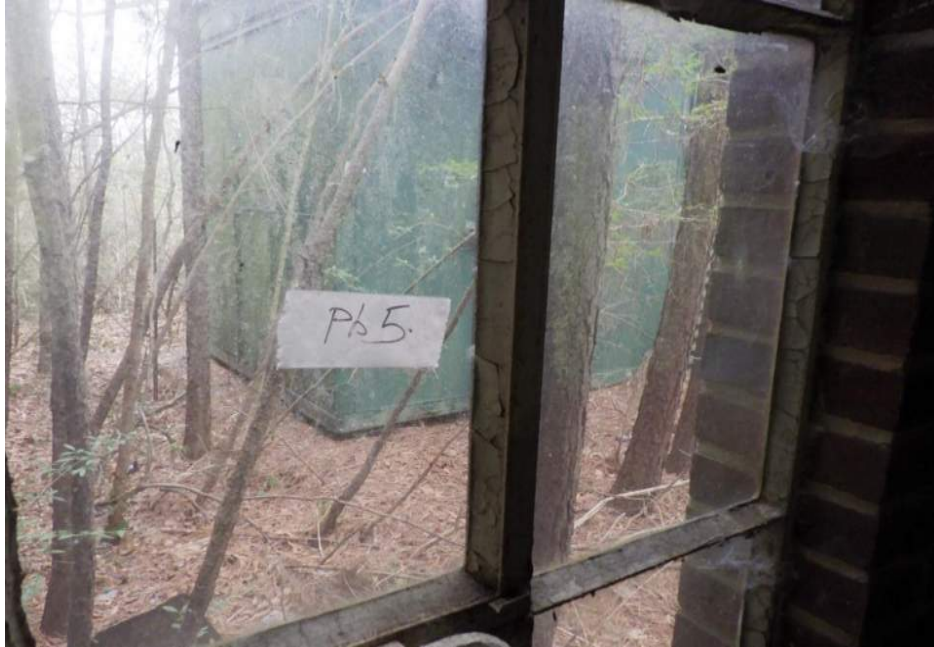
467-Pb5

**Results:** 8900 ppm

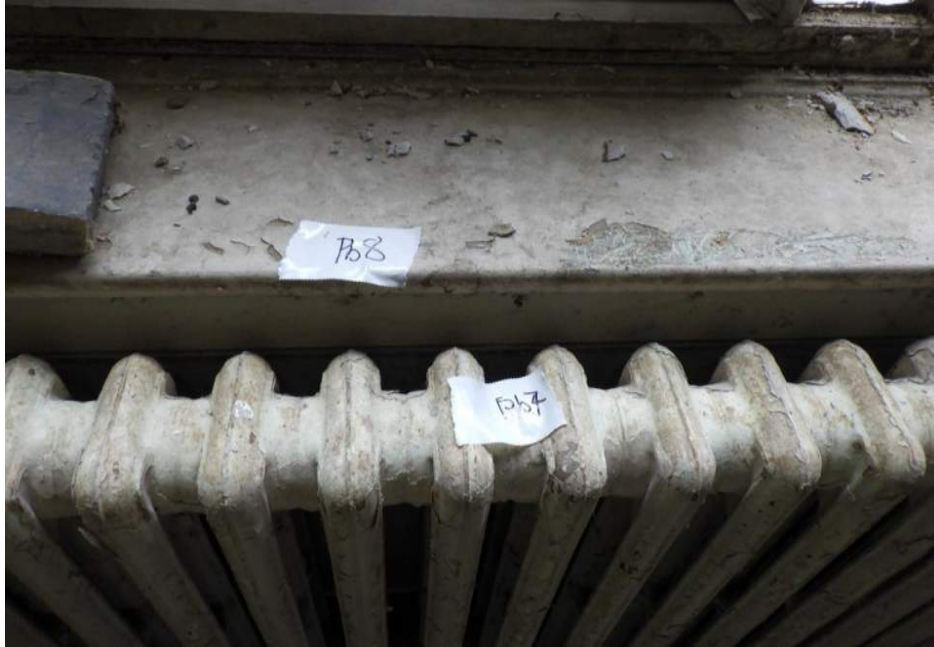
467-Pb8

**Results:** 2200 ppm

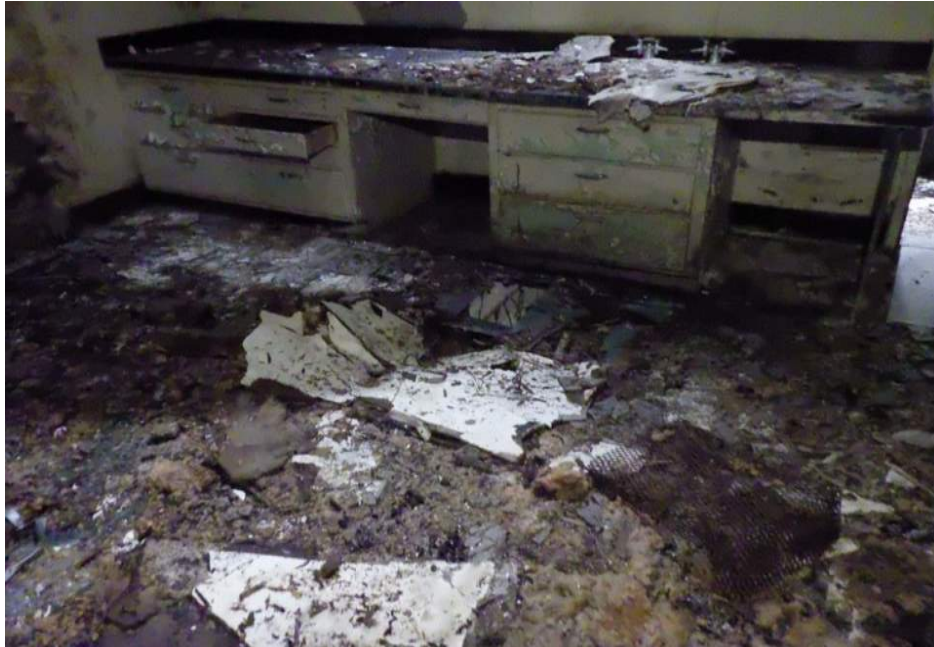
**Description:** typical second floor rooms with collapsed ceilings

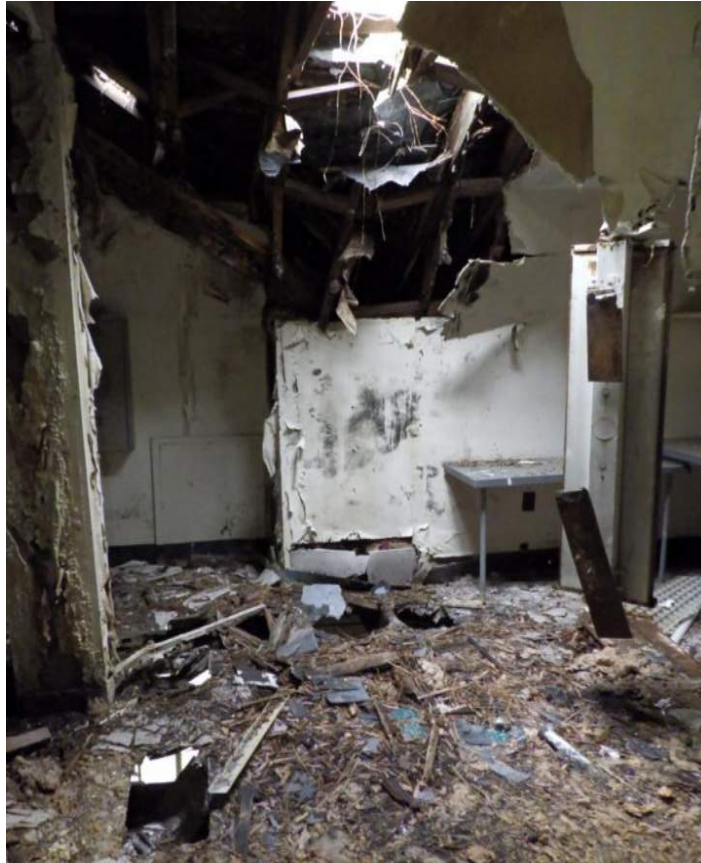
**Description:** typical second floor rooms with collapsed ceilings

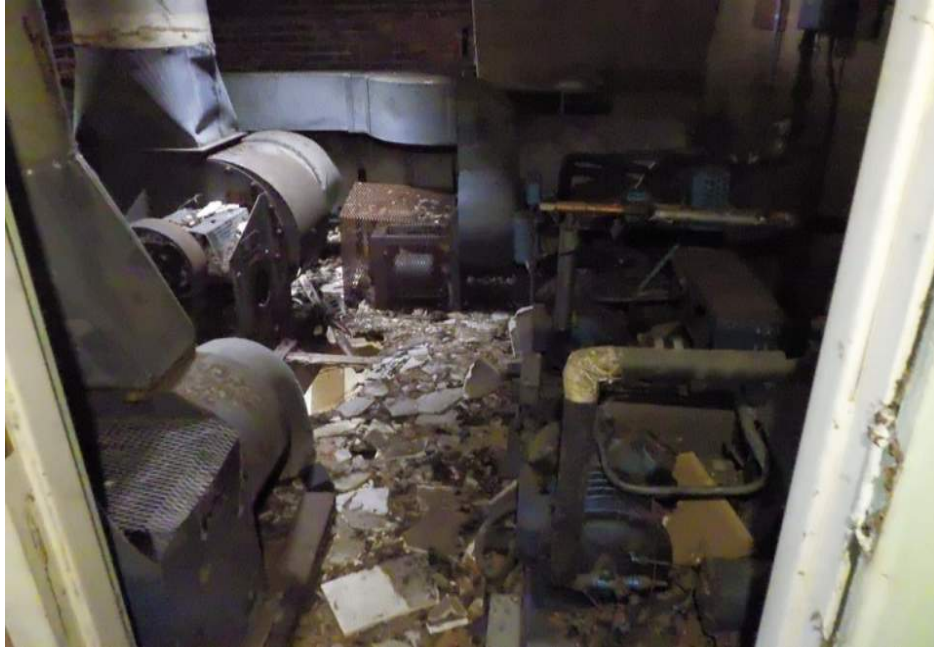
**Description:** second floor mechanical room

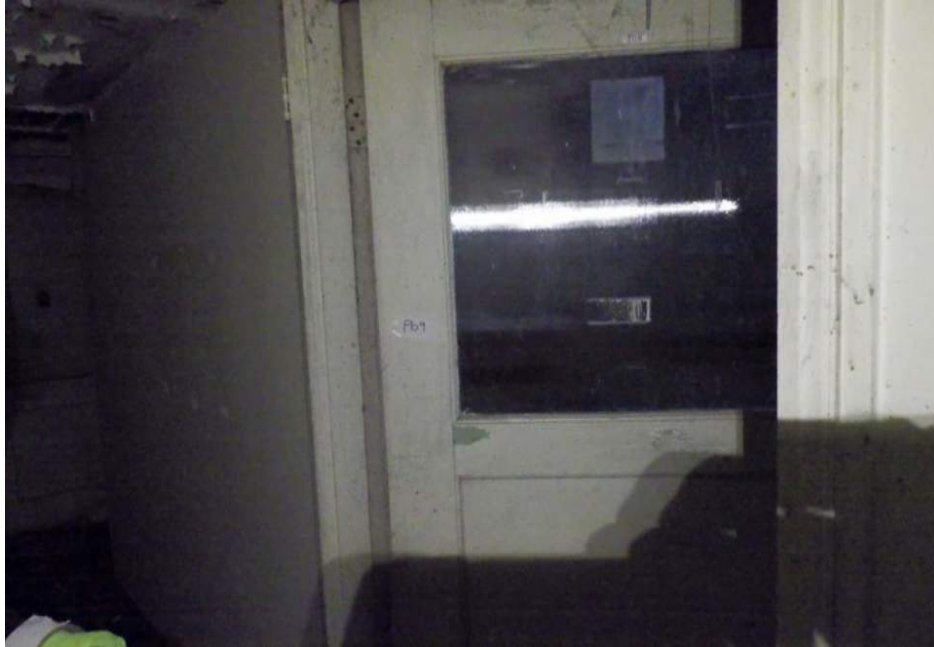
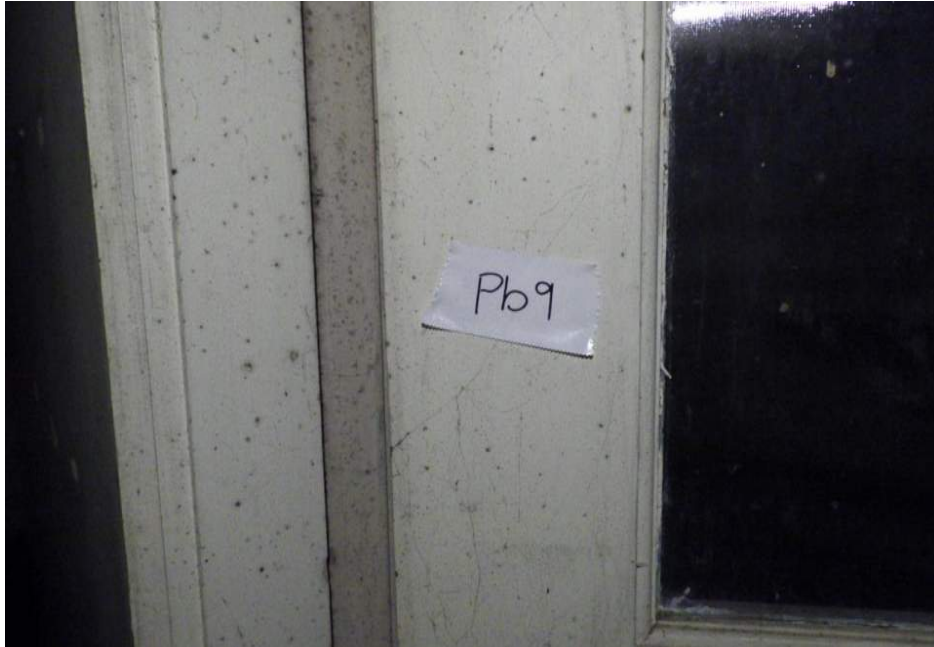
467-Pb9

**Results:** 7000 ppm

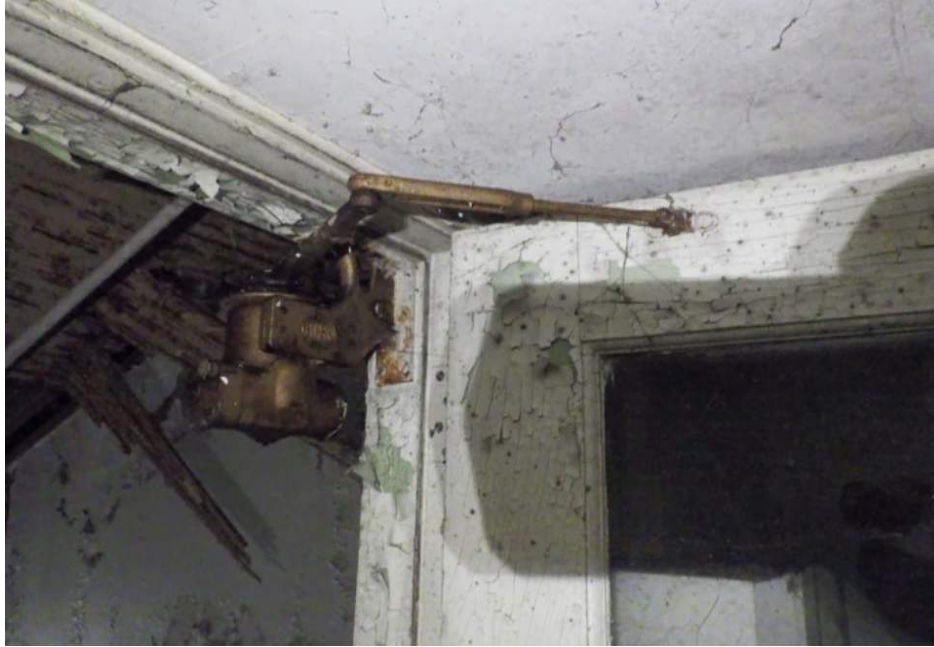
**Description:** typical hydraulic door closer

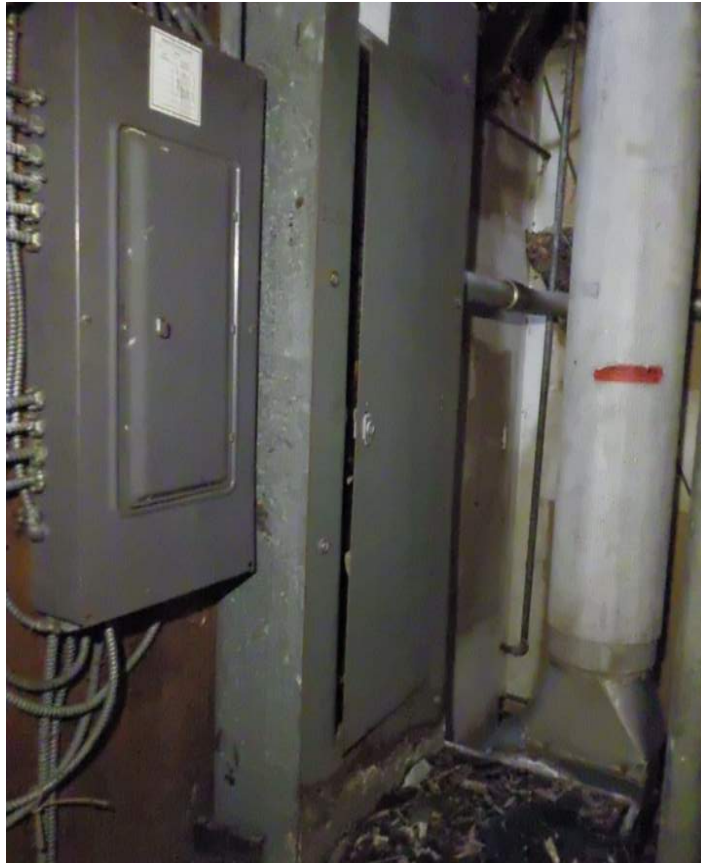
**Description:** transite asbestos exhaust flue
