# Beltsville Agricultural Research Center Hazardous Materials Assessment Part 2

**Beltsville Agricultural Research Center  
Hazardous Materials Assessment  
Project No. 103144**

**Revision 1  
April 22, 2020**

**Burns & McDonnell Engineering Company, Inc.  
Downers Grove, Illinois**

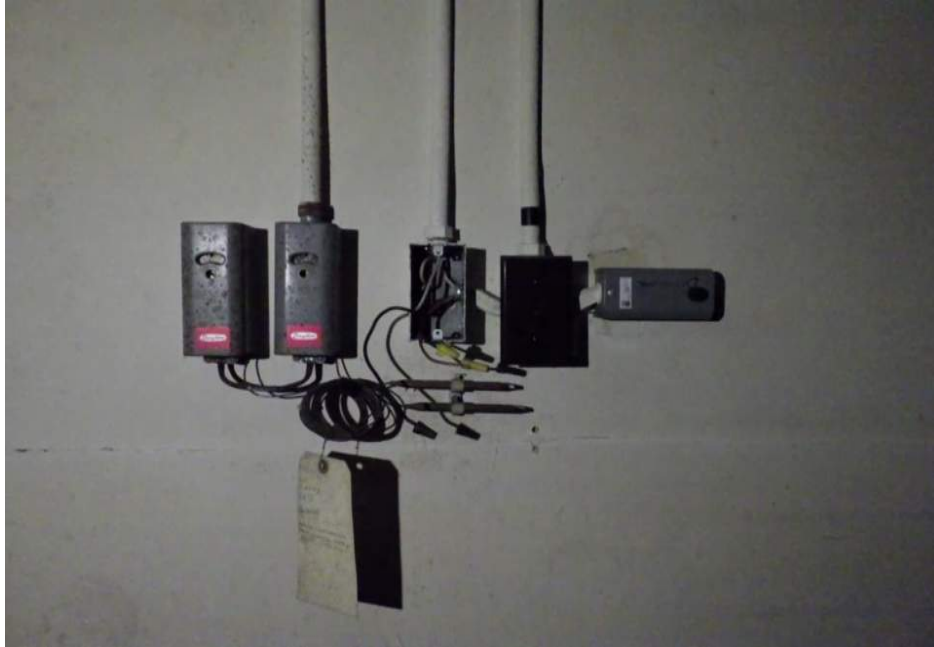
**Description:** thermostatic controls

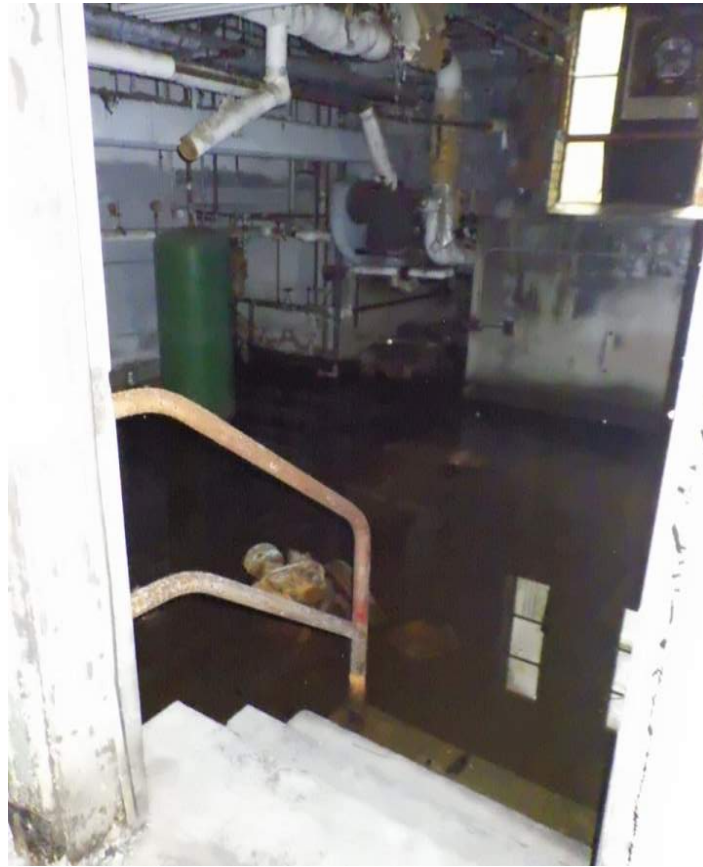
**Description:** basement mechanical rooms, contains 2 ft of standing water

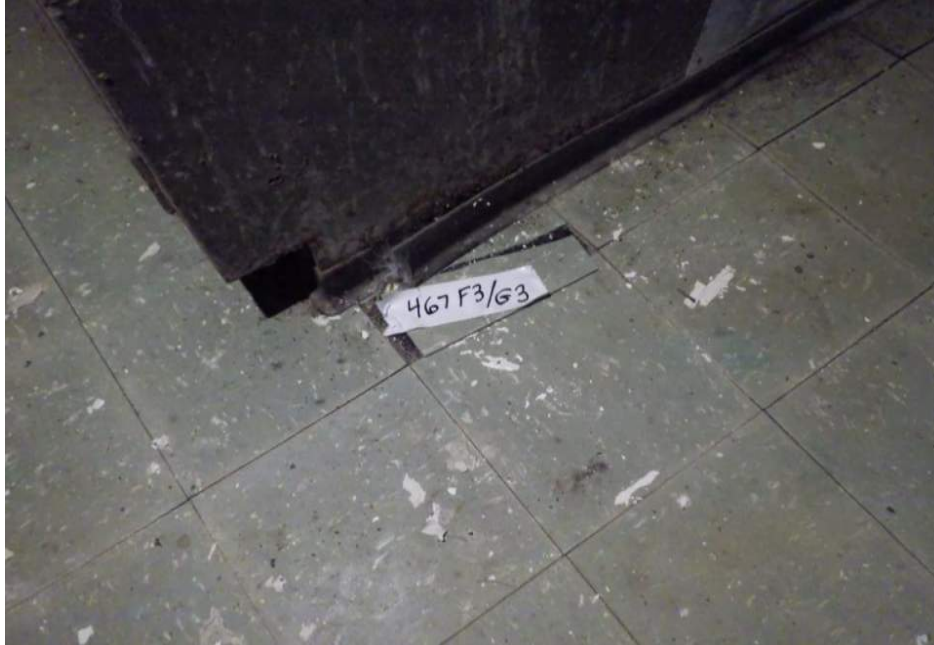
467F3

**Results:** Chrysotile 1-5%

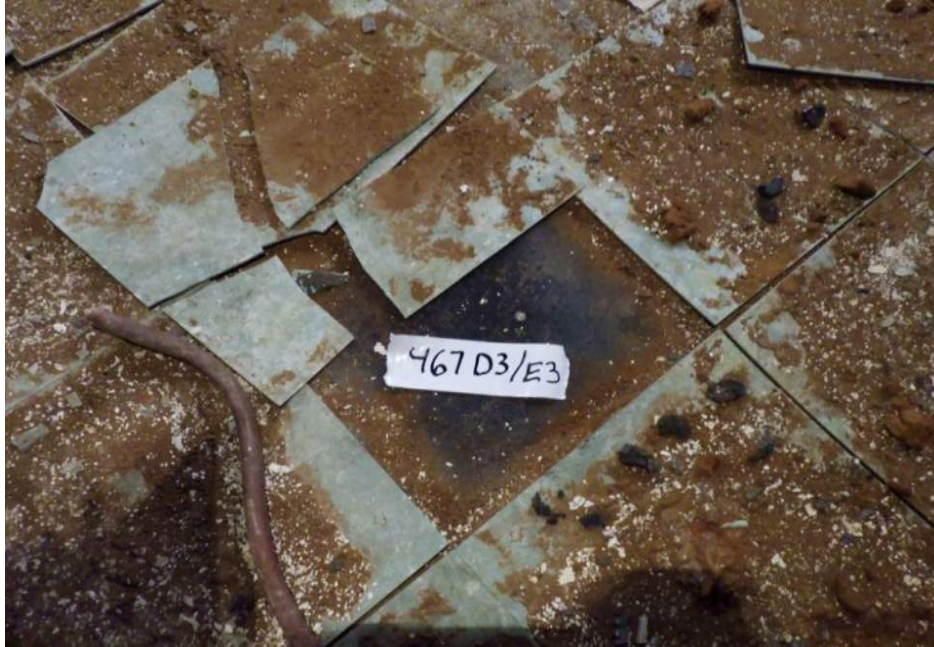
467D3

**Results:** Chrysotile 1-5%

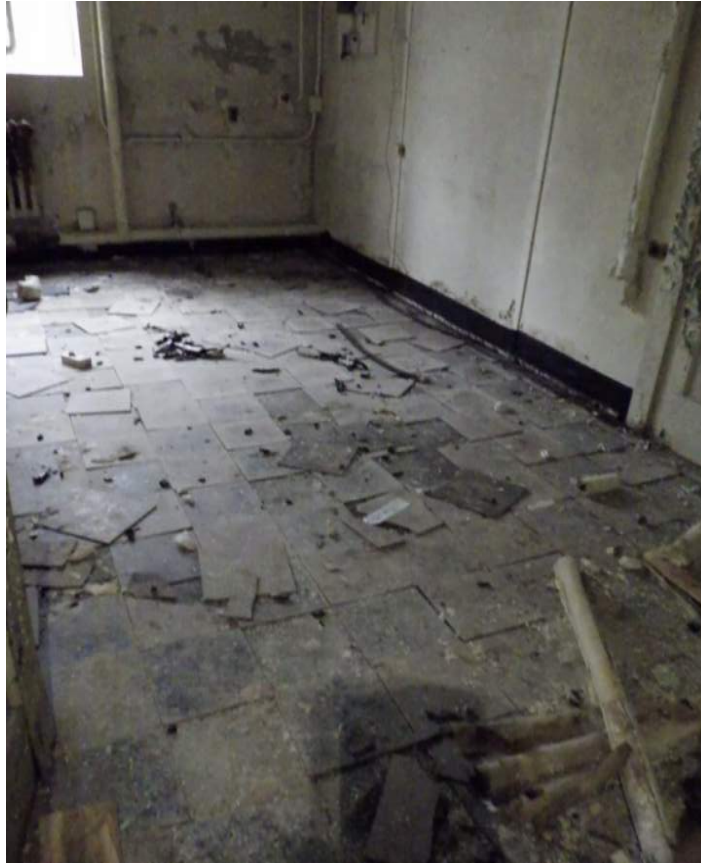
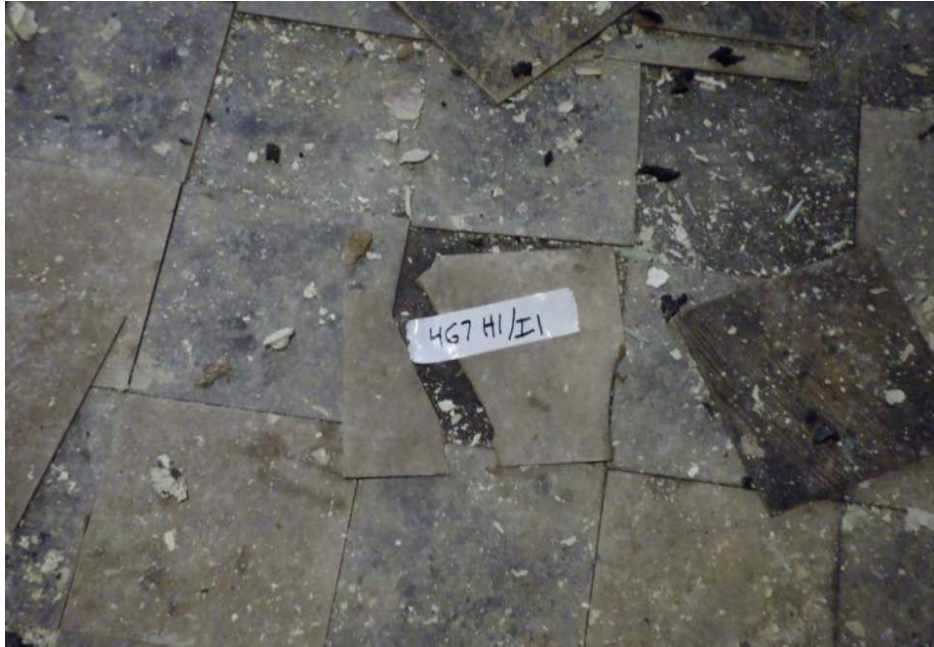
467H1

**Results:** Chrysotile 5-10%

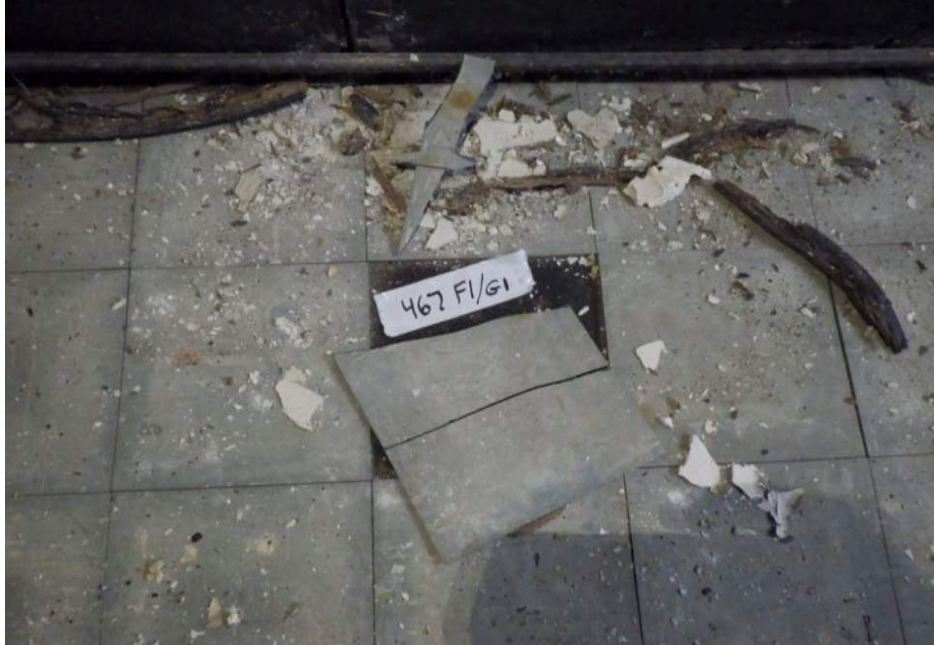
467F1

**Results:** Chrysotile 1-5%

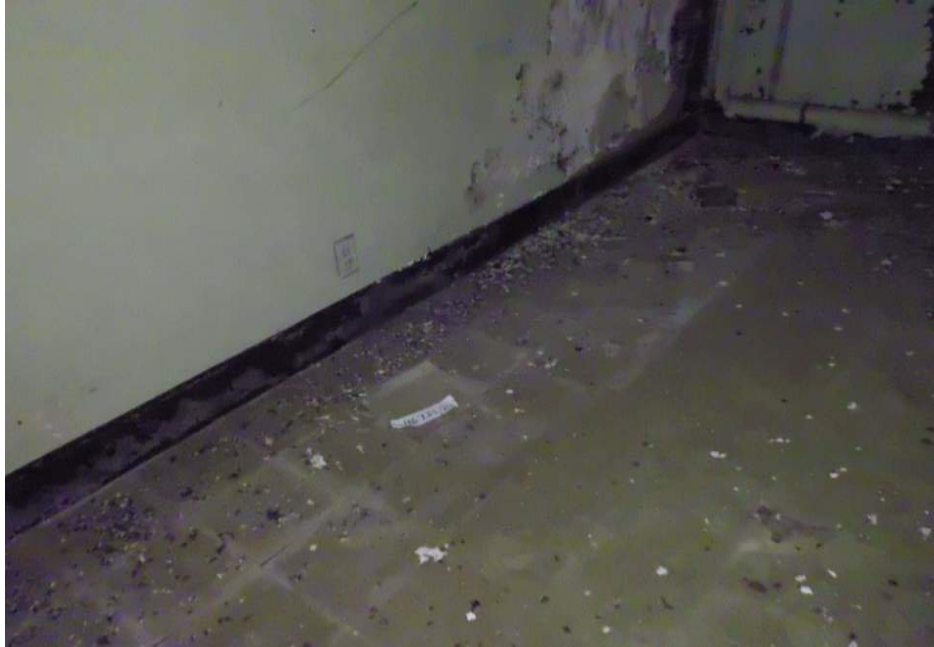
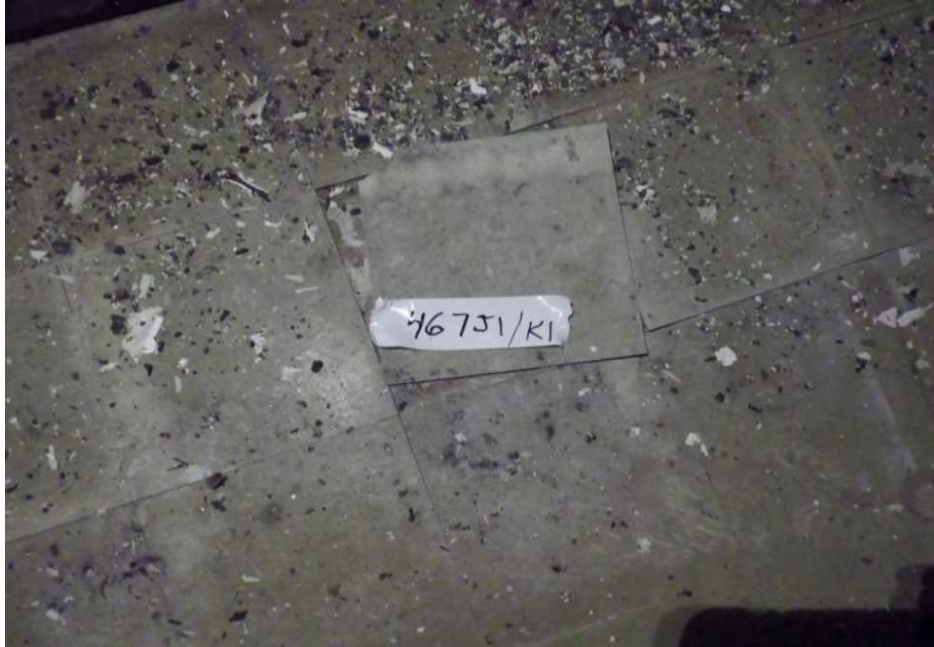
467J1

**Results:** None Detected

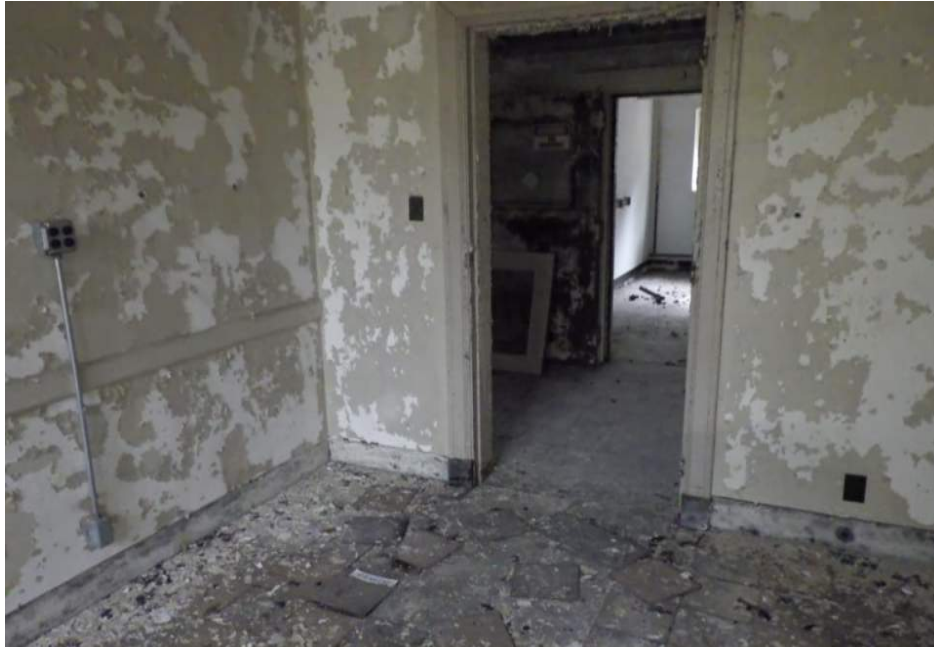
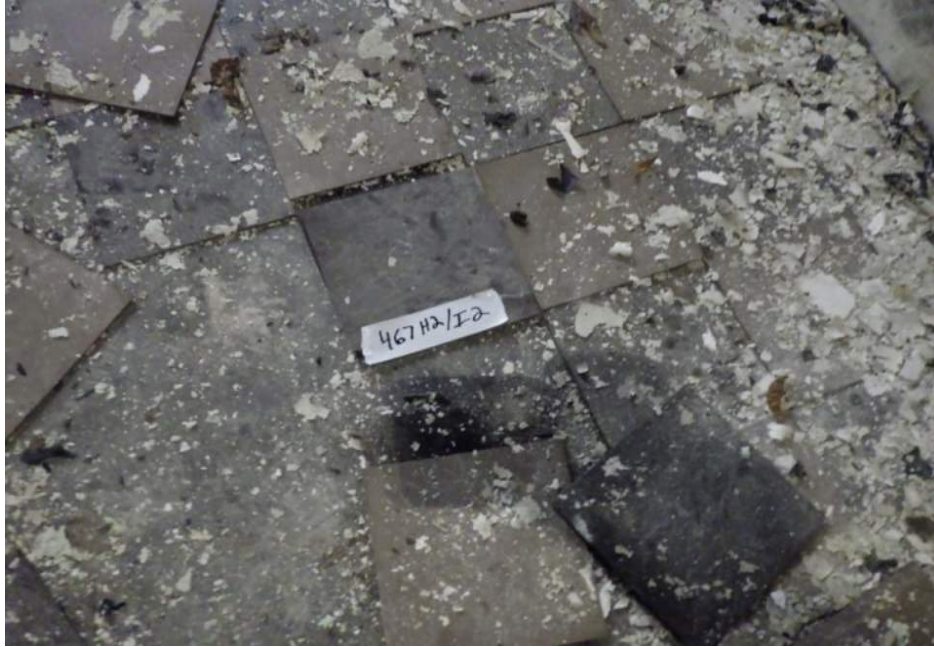
467H2

**Results:** Chrysotile 5-10%

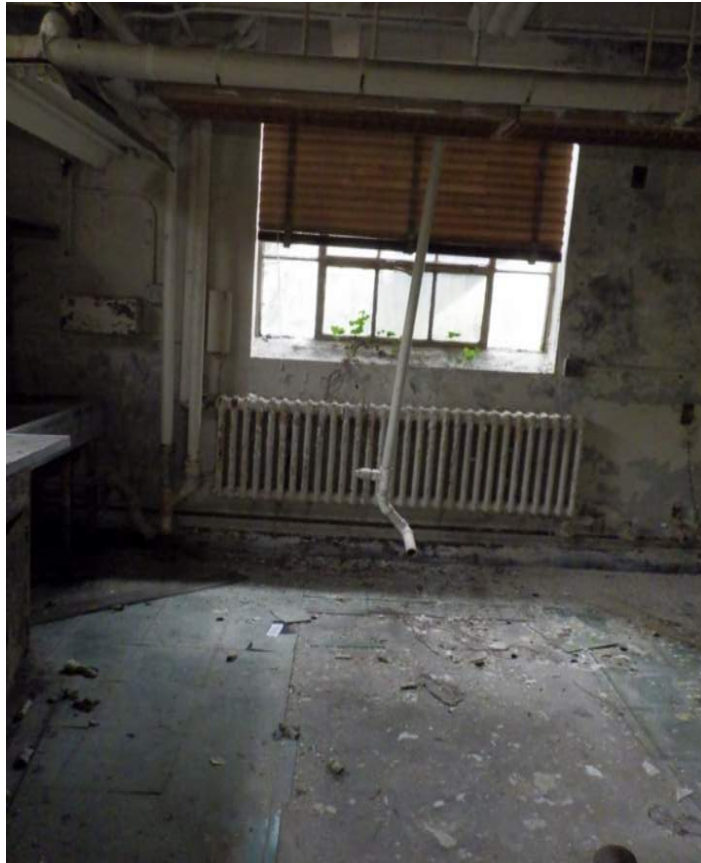
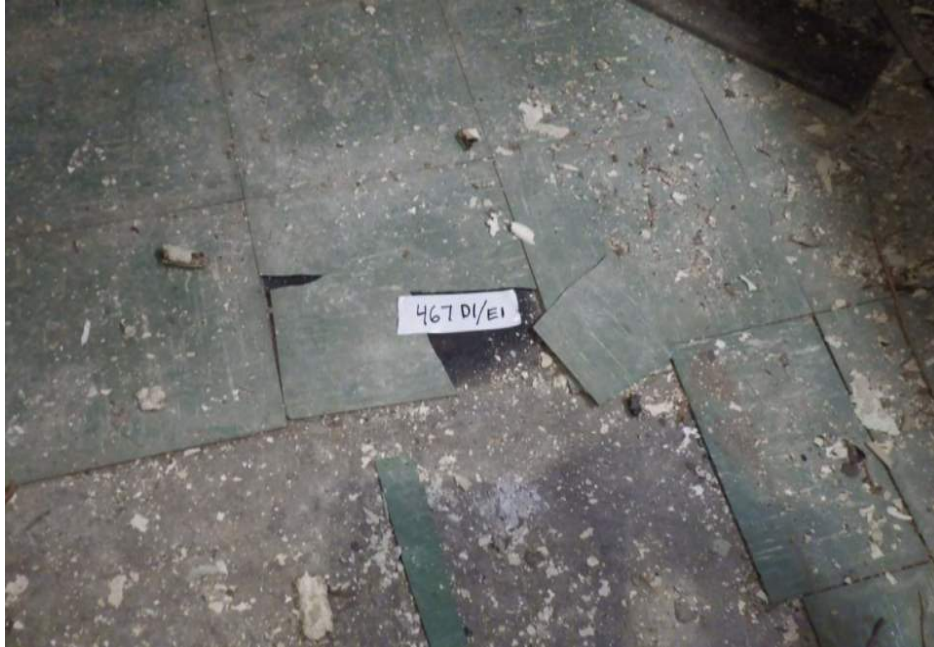
467D1

**Results:** Chrysotile 1-5%

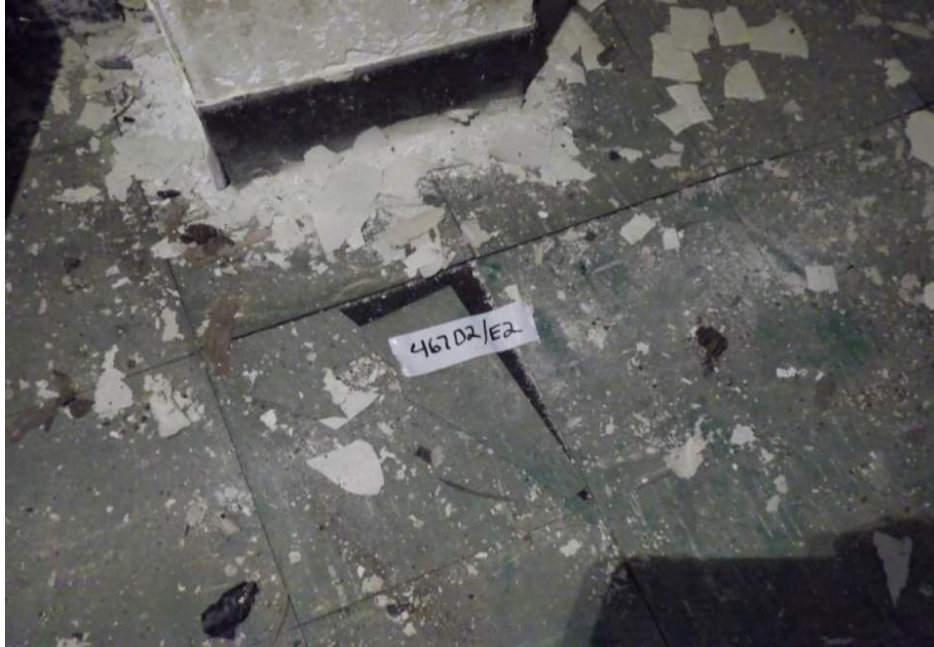
467D2

**Results:** Chrysotile 1-5%

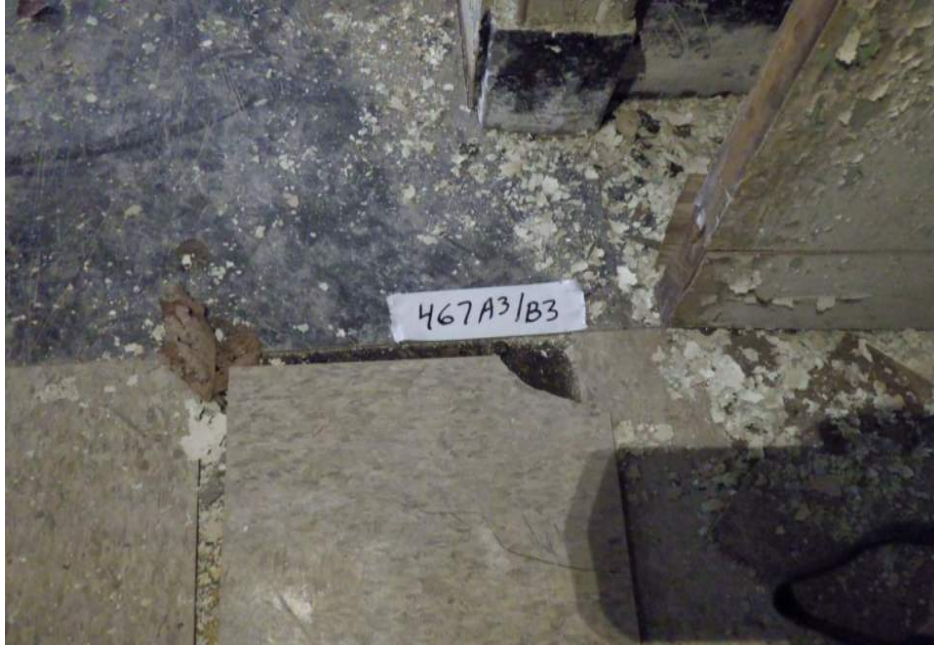
467A3

**Results:** None Detected

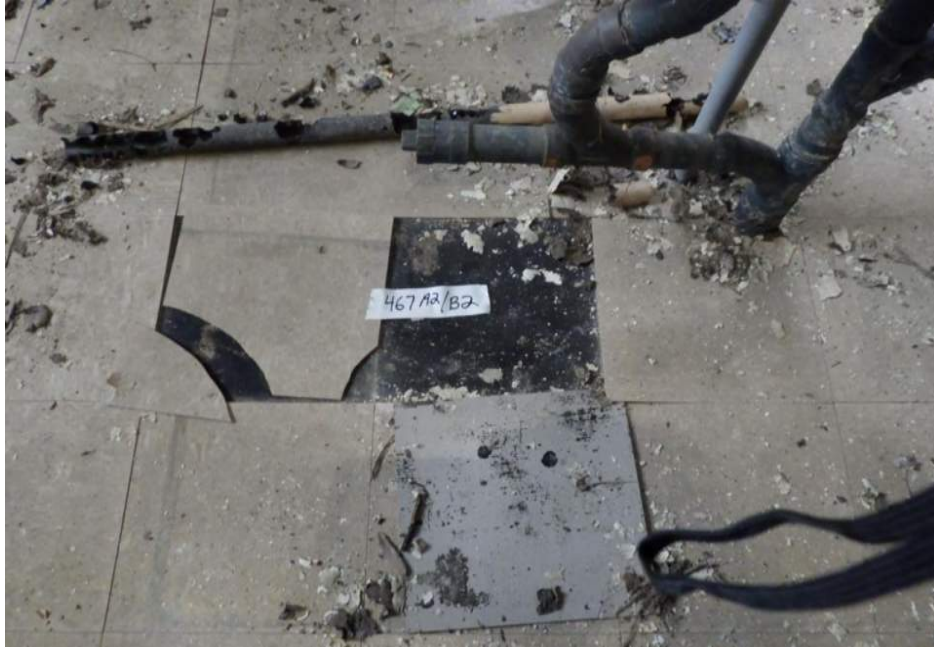
467A2

**Results:** None Detected

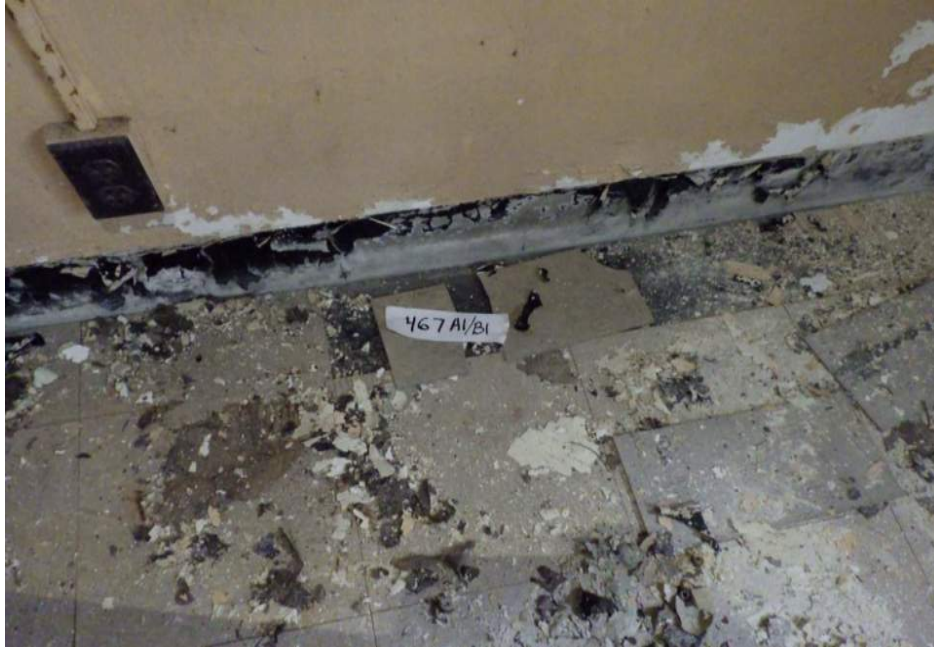
467A1

**Results:** None Detected

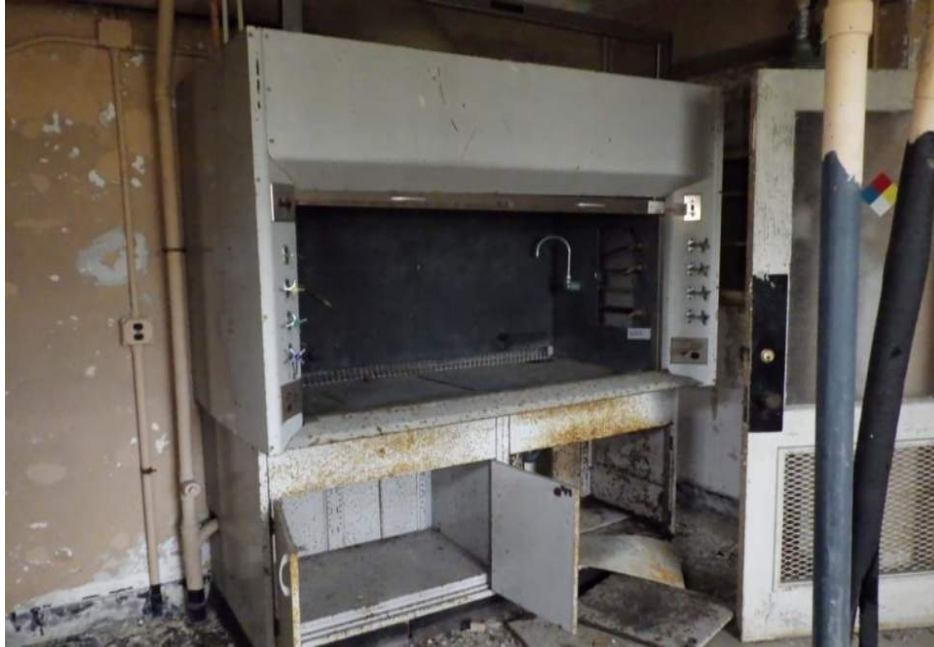
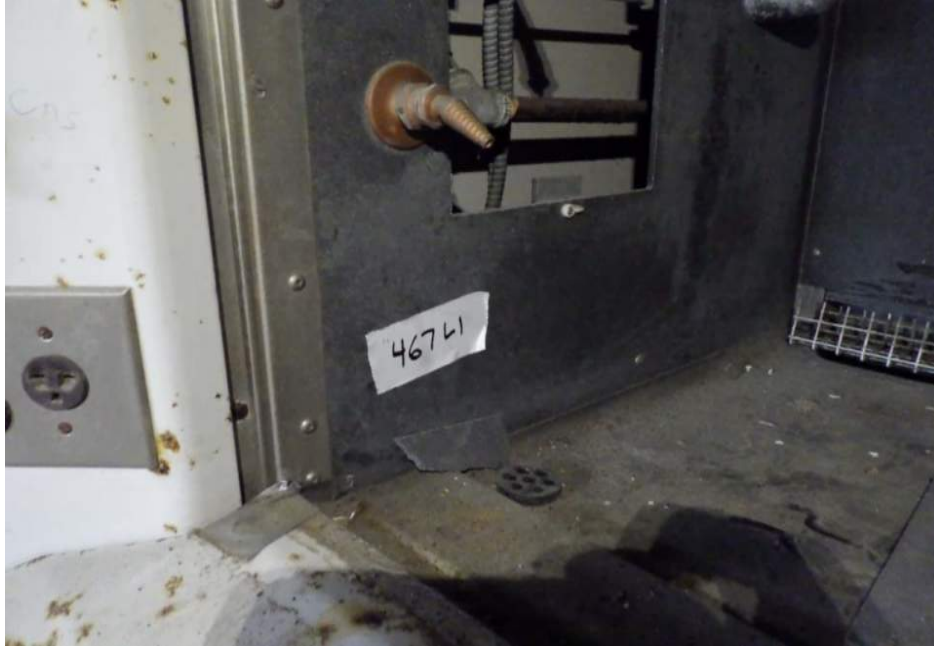
467L1

**Results:** Chrysotile 20-25%

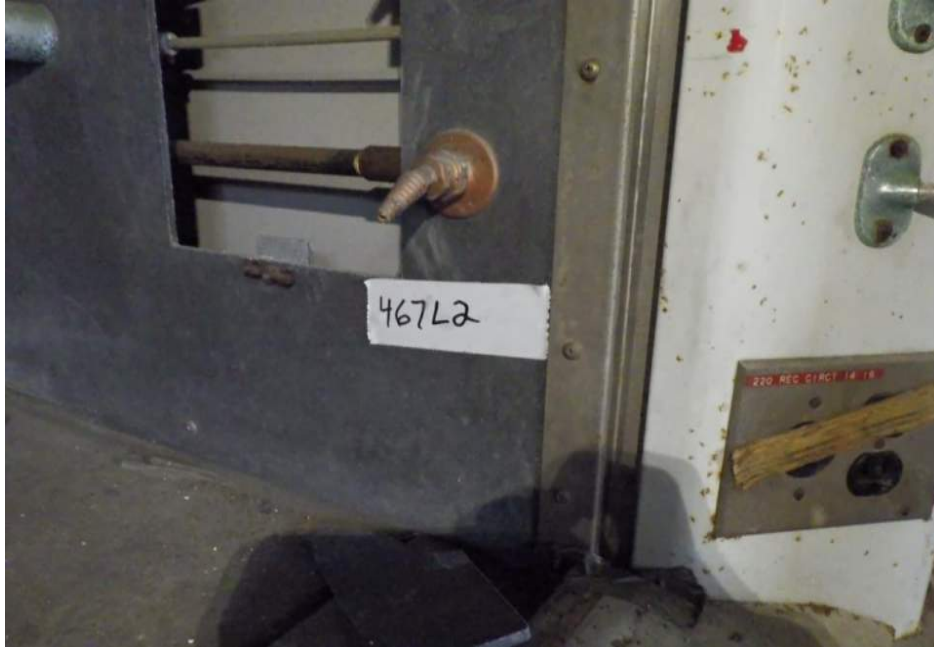
467L2

**Results:** Chrysotile 20-25%

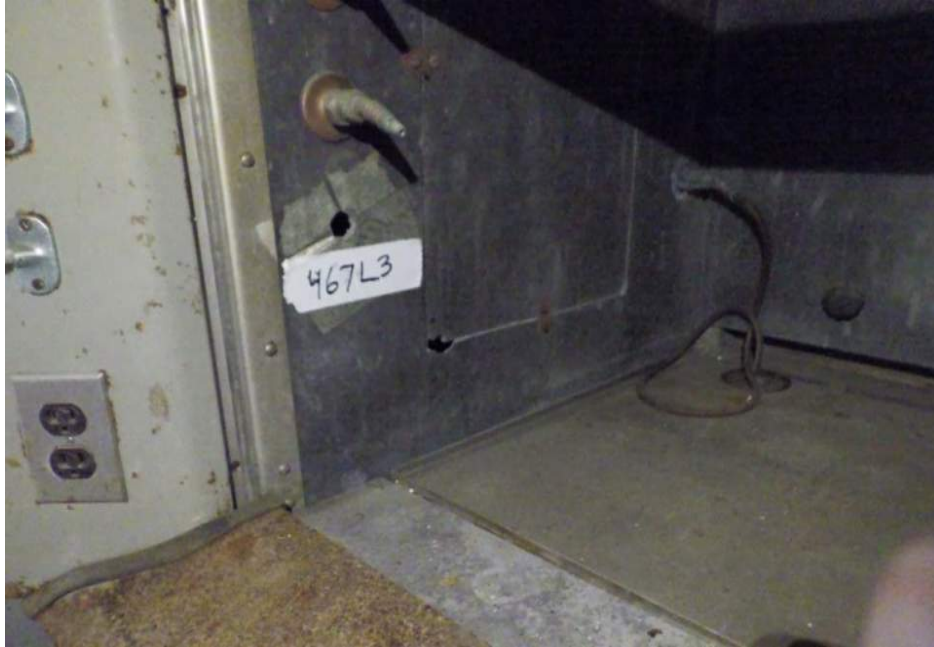
467L3

**Results:** Chrysotile 20-25%

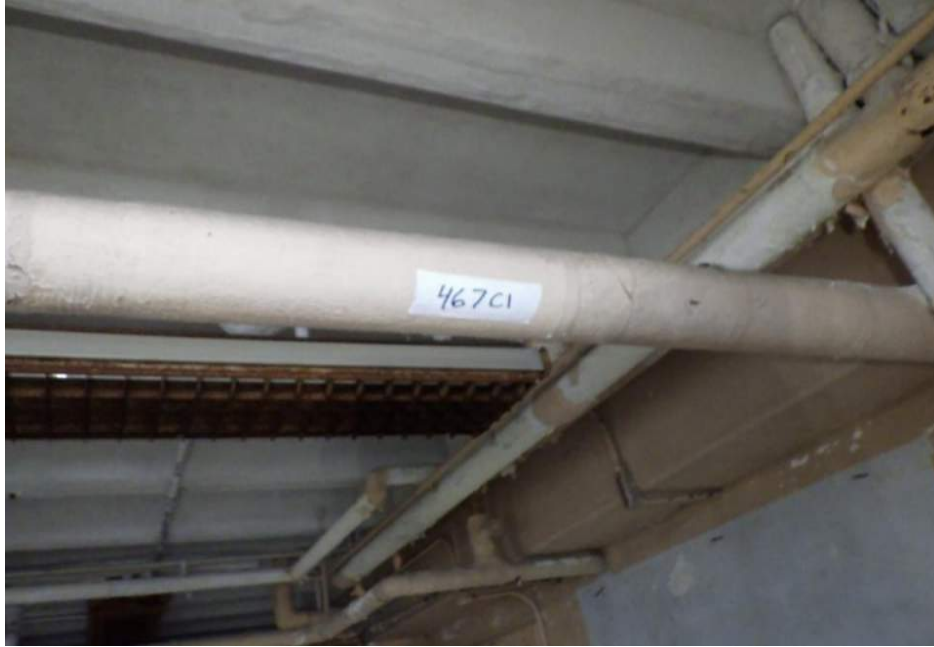
467C1

**Results:** Chrysotile 5-10% Amosite 5-10%

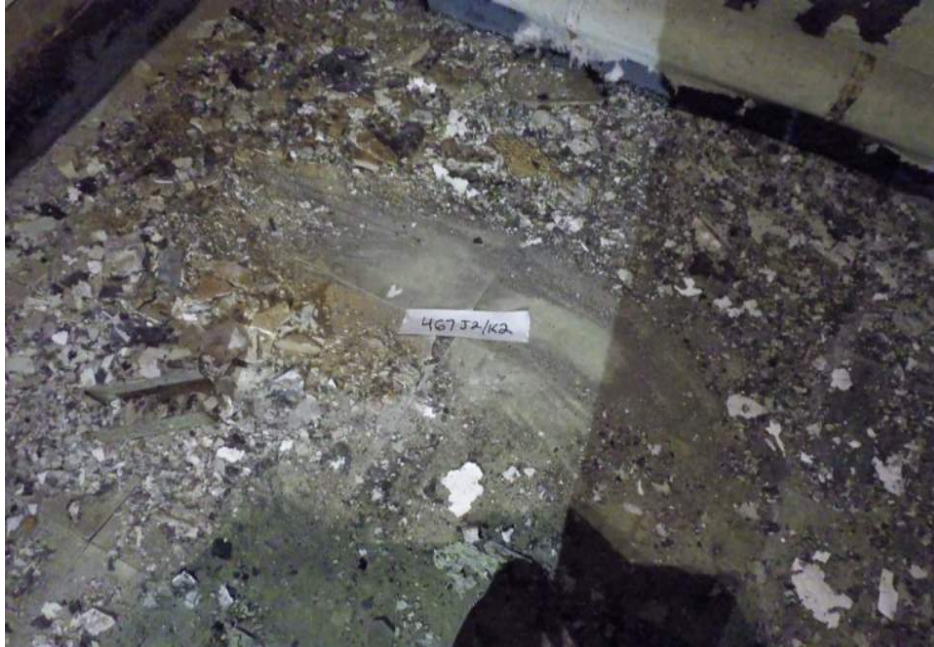
467J2

**Results:** None Detected

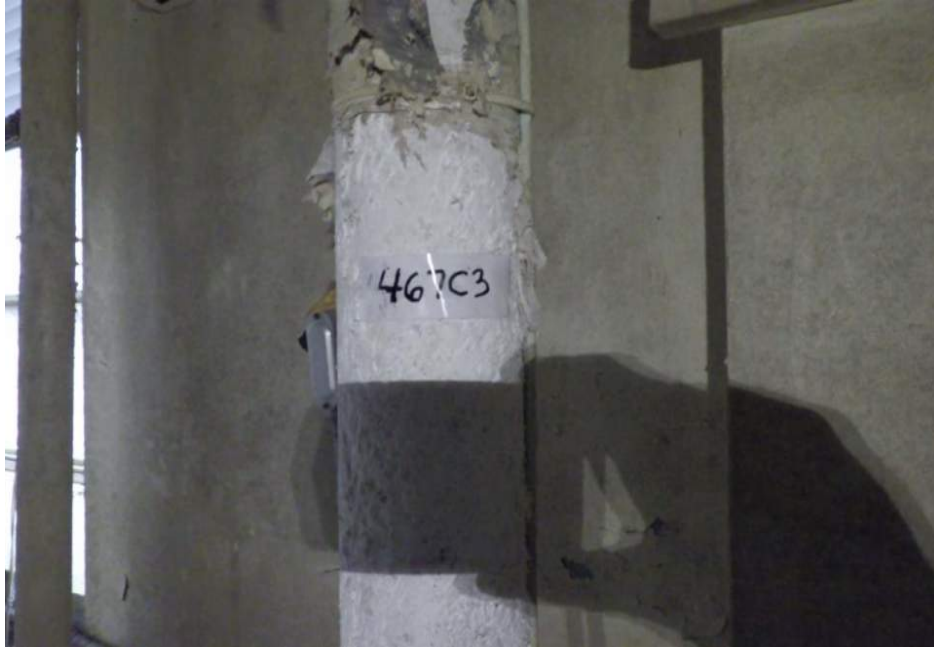
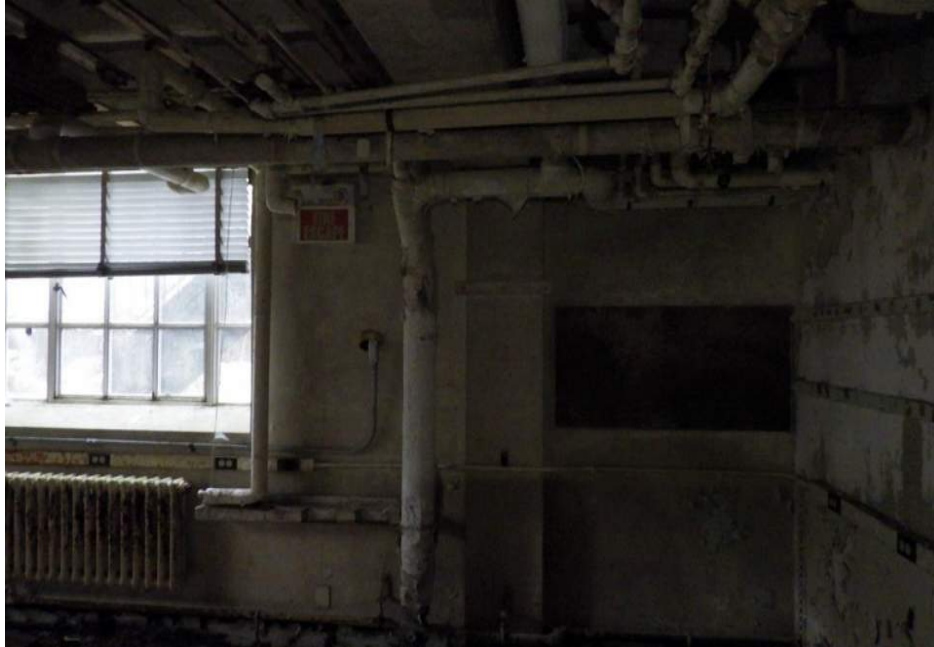
467C3

**Results:** Chrysotile 5-10% Amosite 5-10%

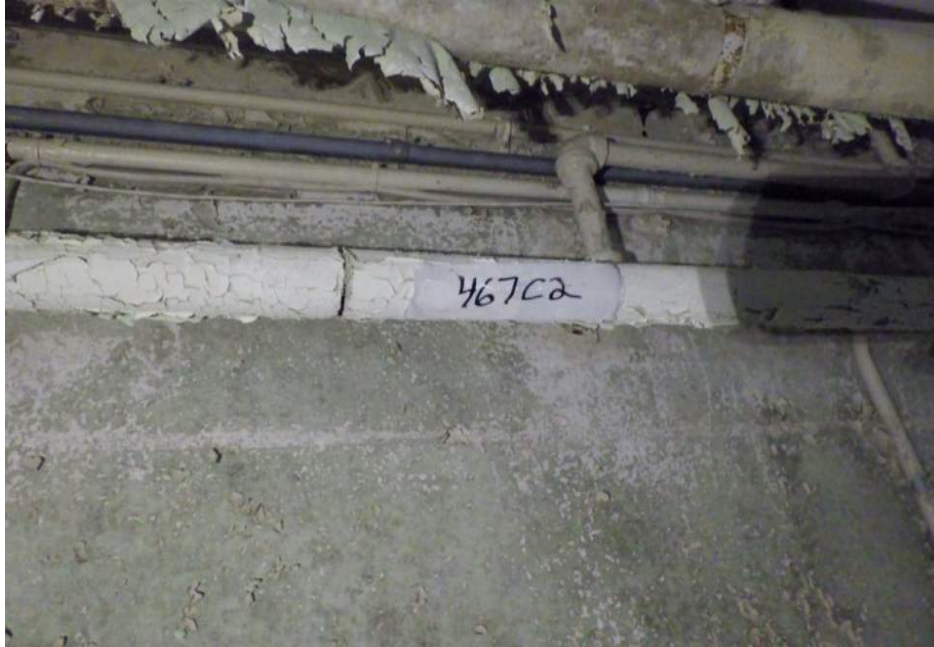
467C2

**Results:** Chrysotile 5-10% Amosite 5-10%

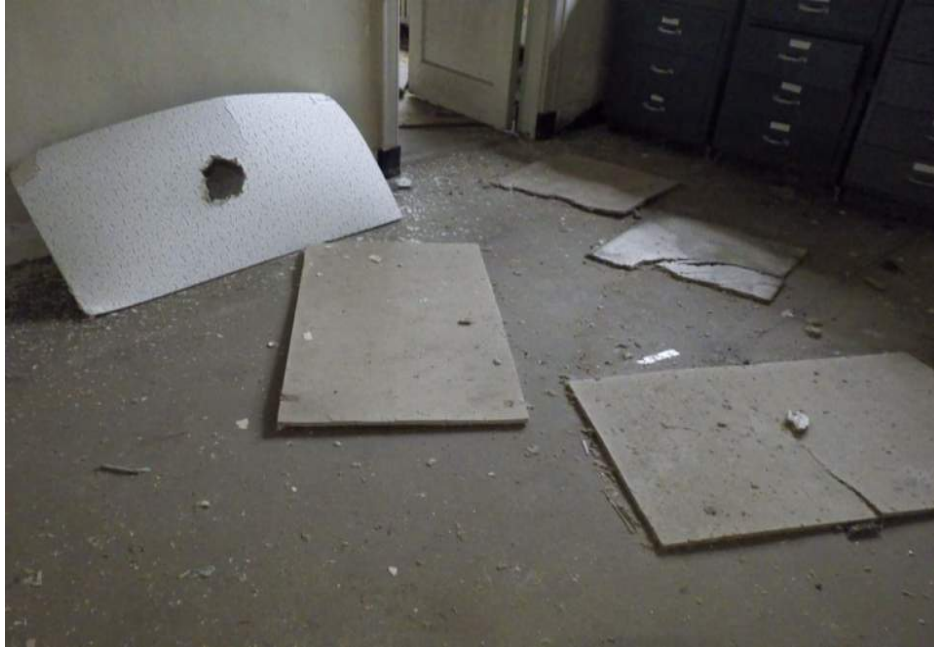
467M1

**Results:** Chrysotile 5-10% Amosite 5-10%

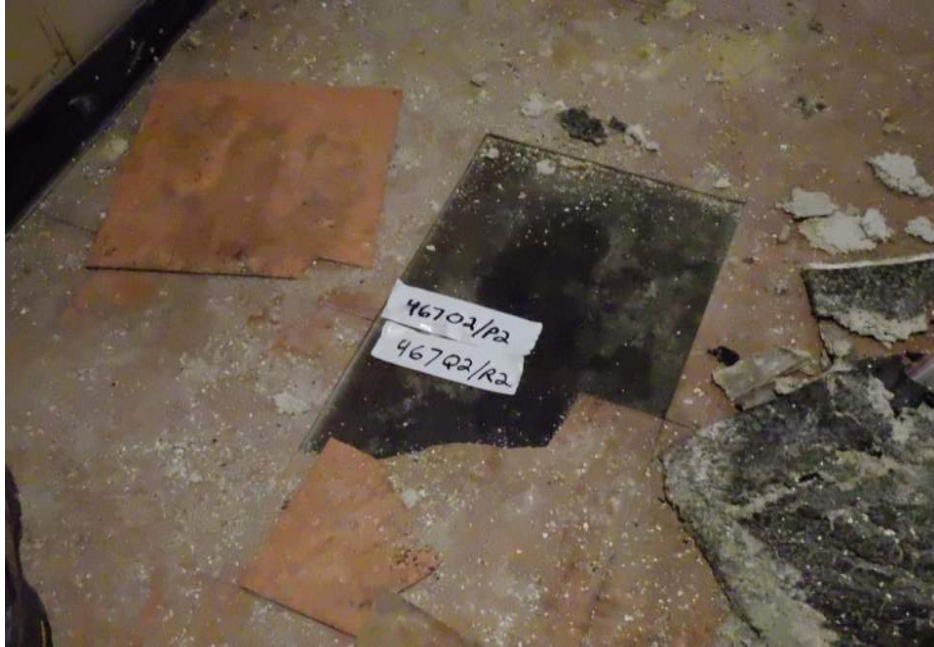
46702

**Results:** Chrysotile 5-10%

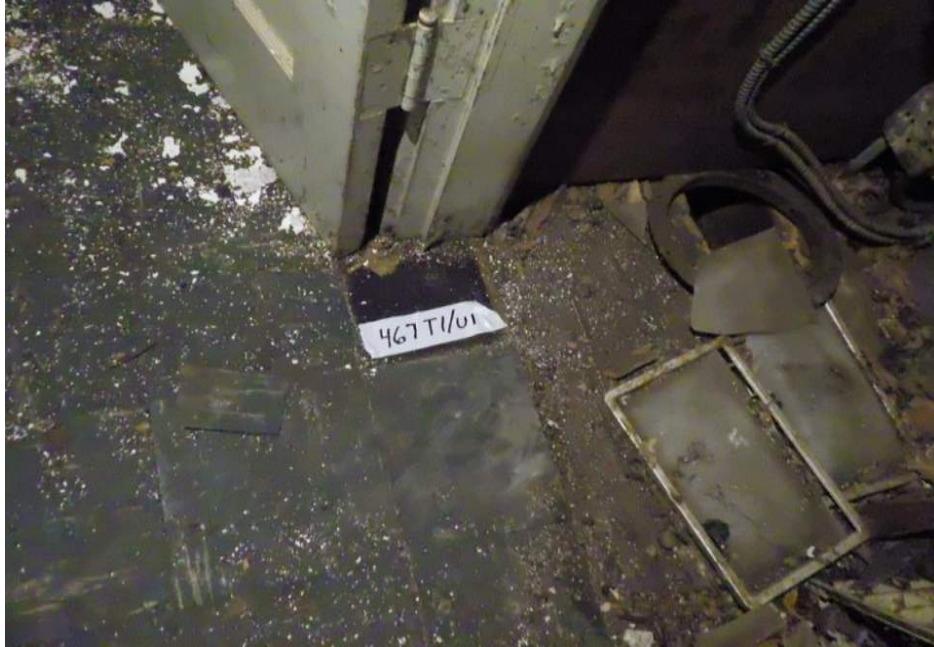
467T1

**Results:** Chrysotile 20-25%

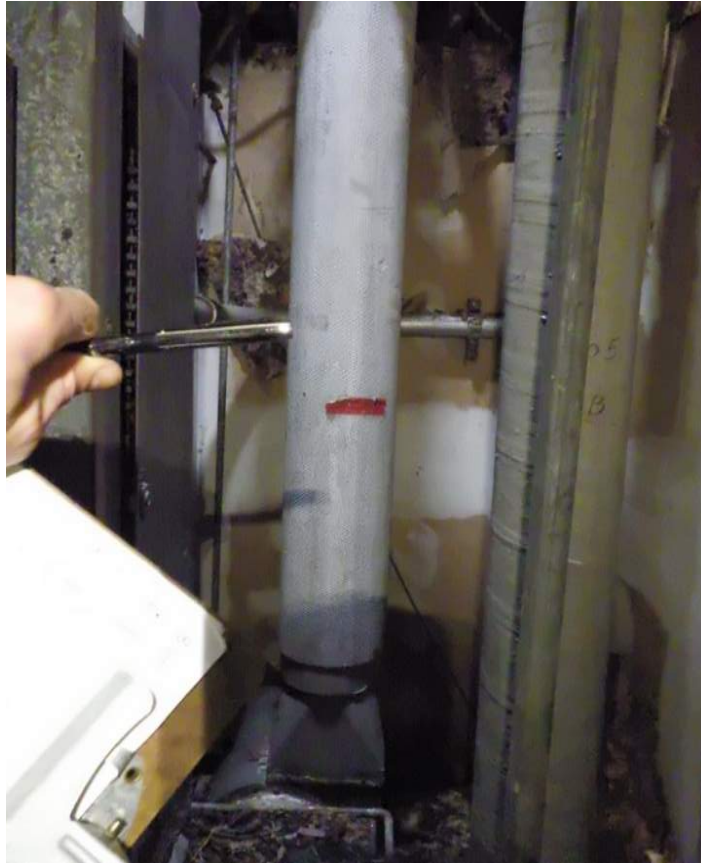
PACM

**Results:** Chrysotile 1-5%

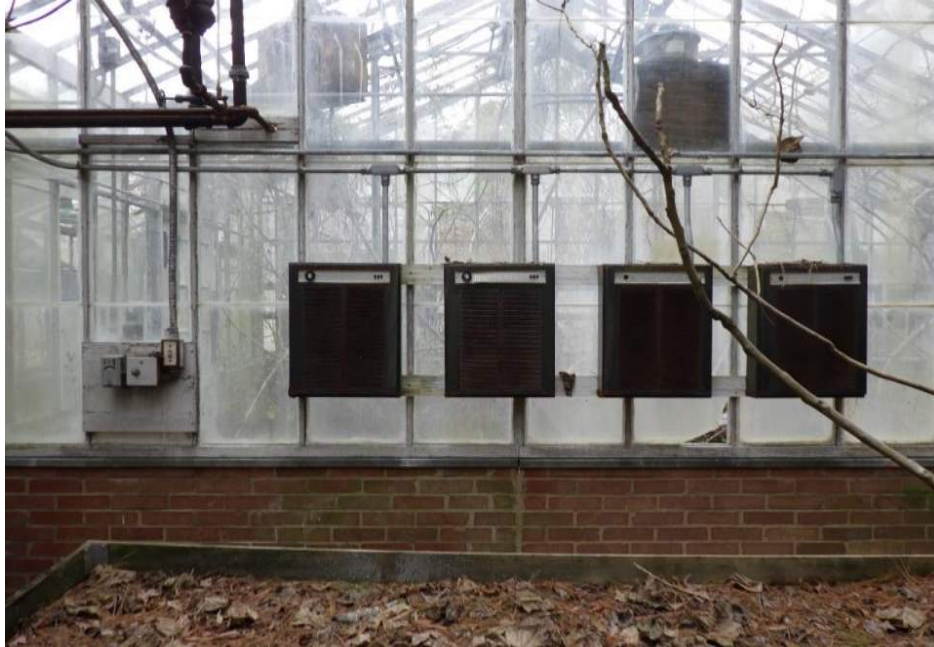
**Results:** Chrysotile 20-25%

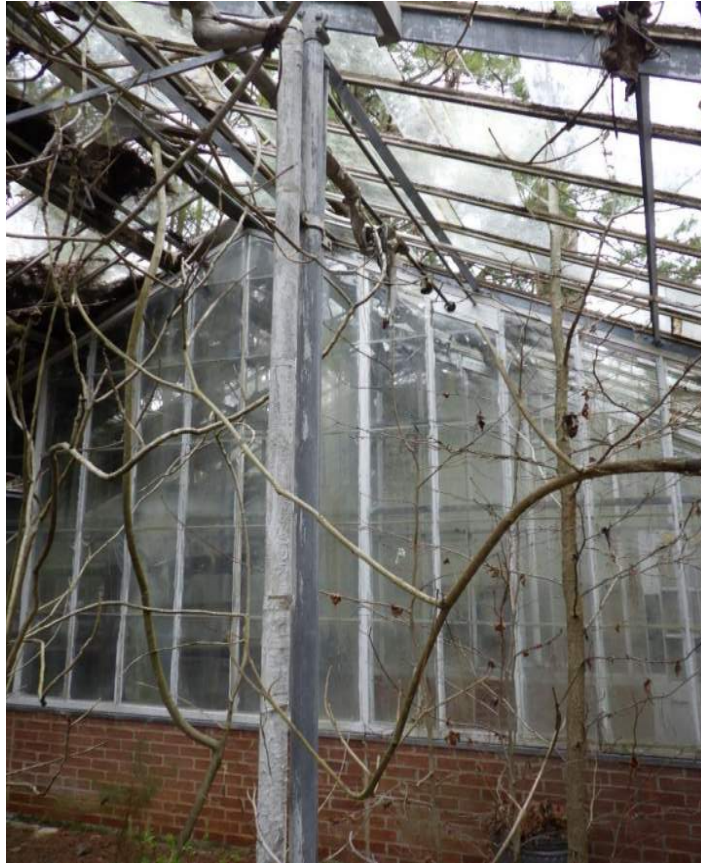
**Description:** greenhouse piping asbestos TSI

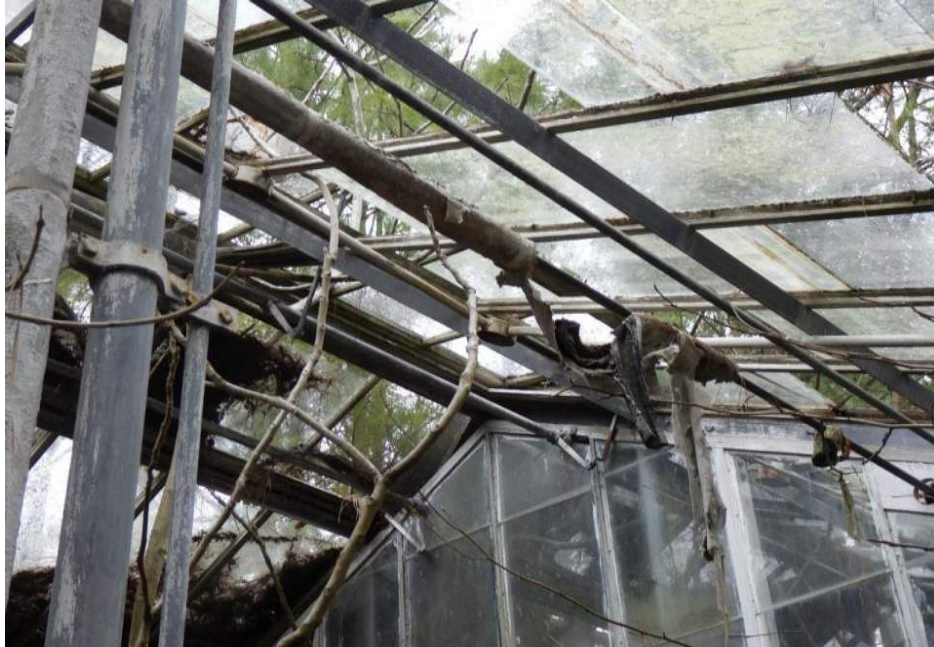
**Description:** greenhouse piping asbestos TSI

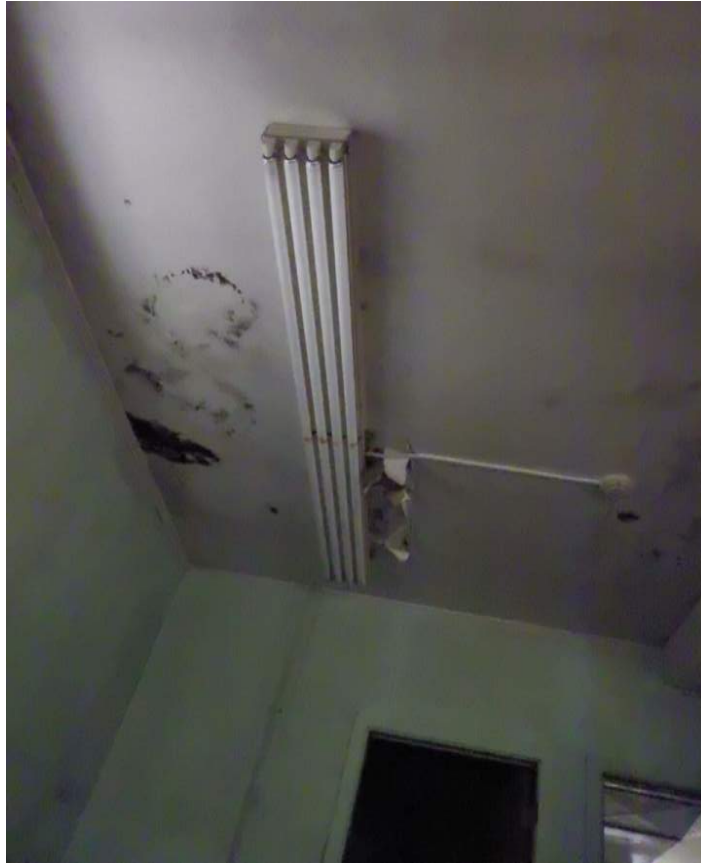
**Description:** typical fluorescent light fixture and mold, 468 interior

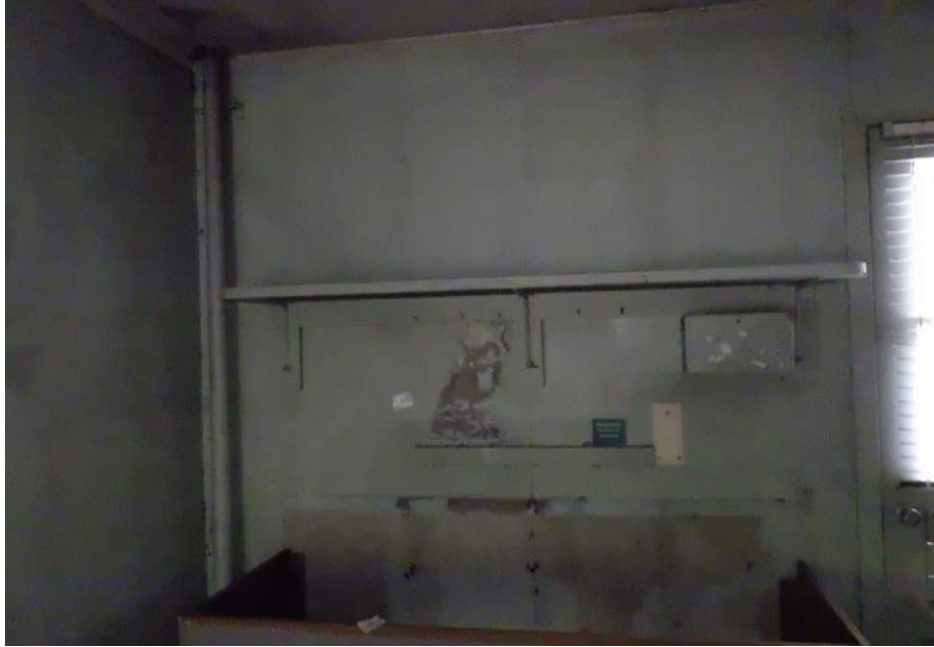
468-Pb2

**Results:** 250 ppm

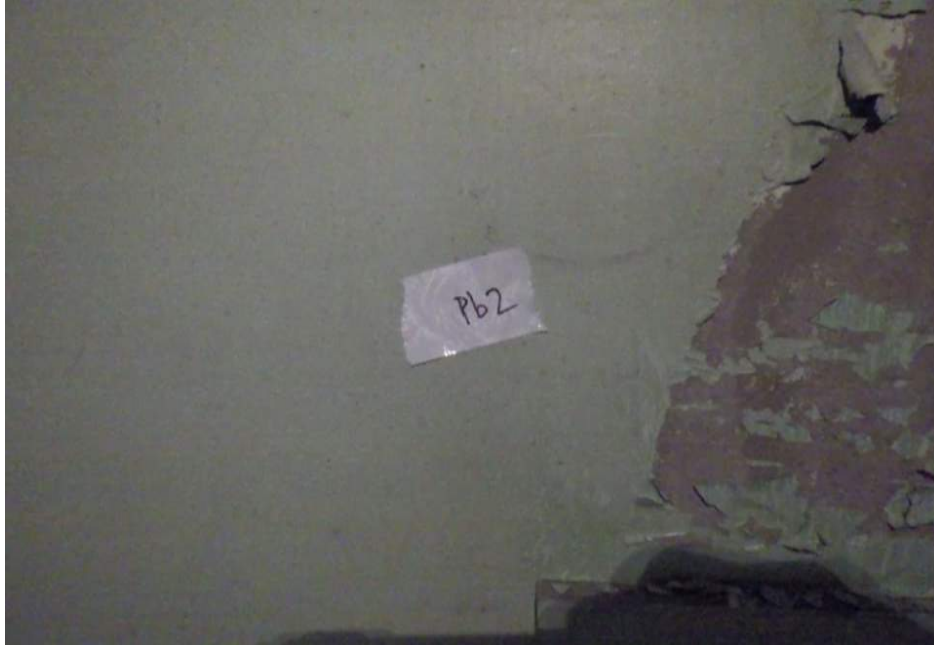
468-Pb2

**Results:** 250 ppm

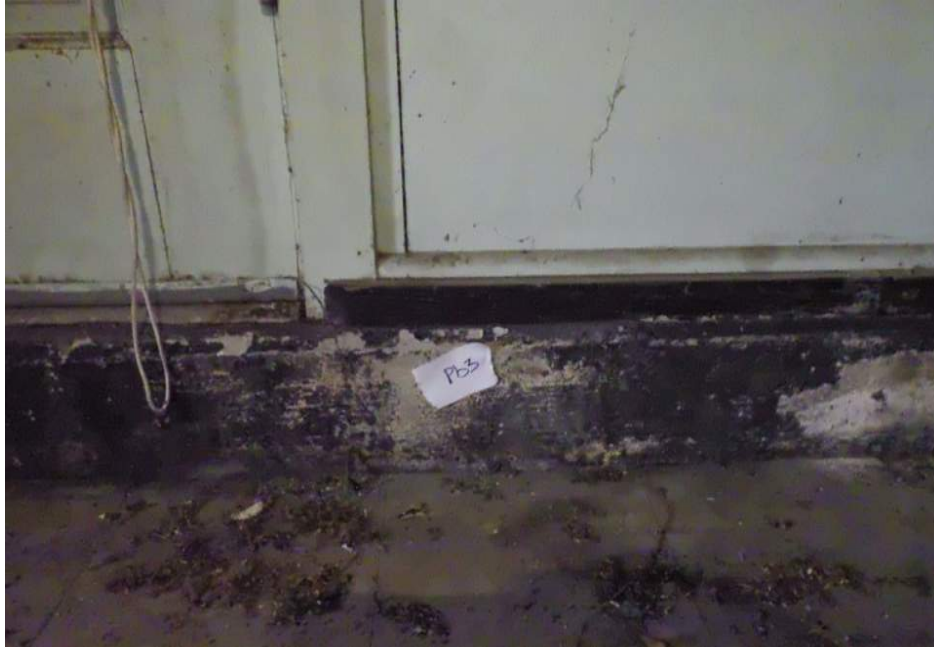
468-Pb3

**Results:** 4600 ppm

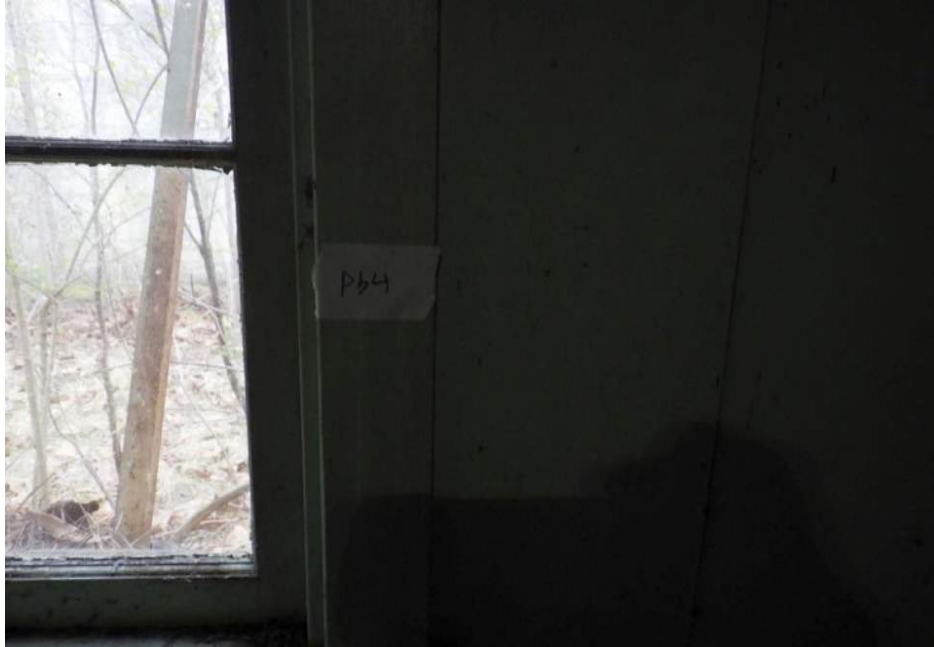
468-Pb4

**Results:** 40000 ppm
