# Beltsville Agricultural Research Center Hazardous Materials Assessment Part 2

**Beltsville Agricultural Research Center  
Hazardous Materials Assessment  
Project No. 103144**

**Revision 1  
April 22, 2020**

**Burns & McDonnell Engineering Company, Inc.  
Downers Grove, Illinois**

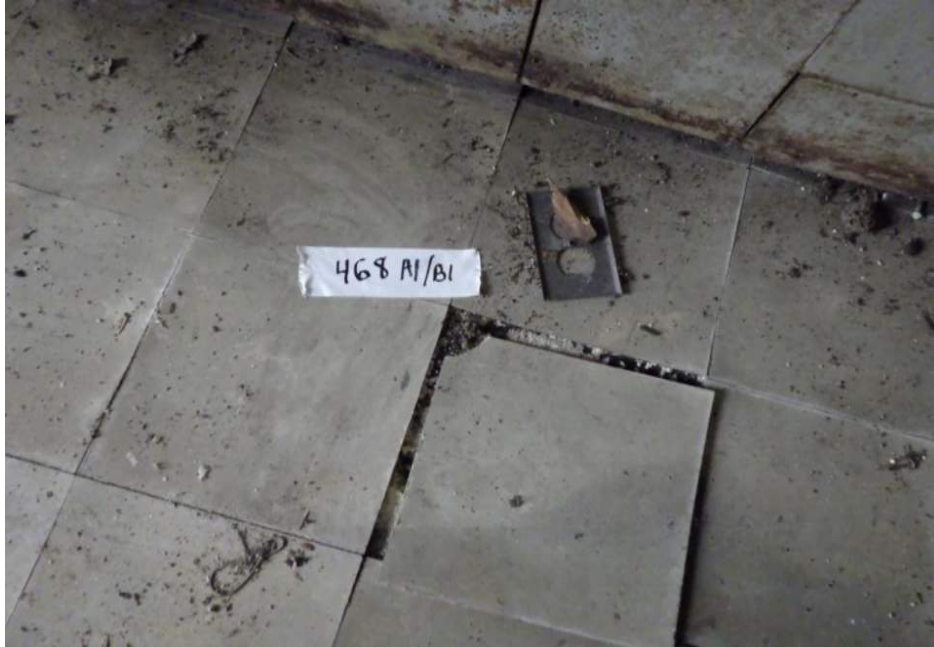
468A1

**Results:** Chrysotile 20-25%

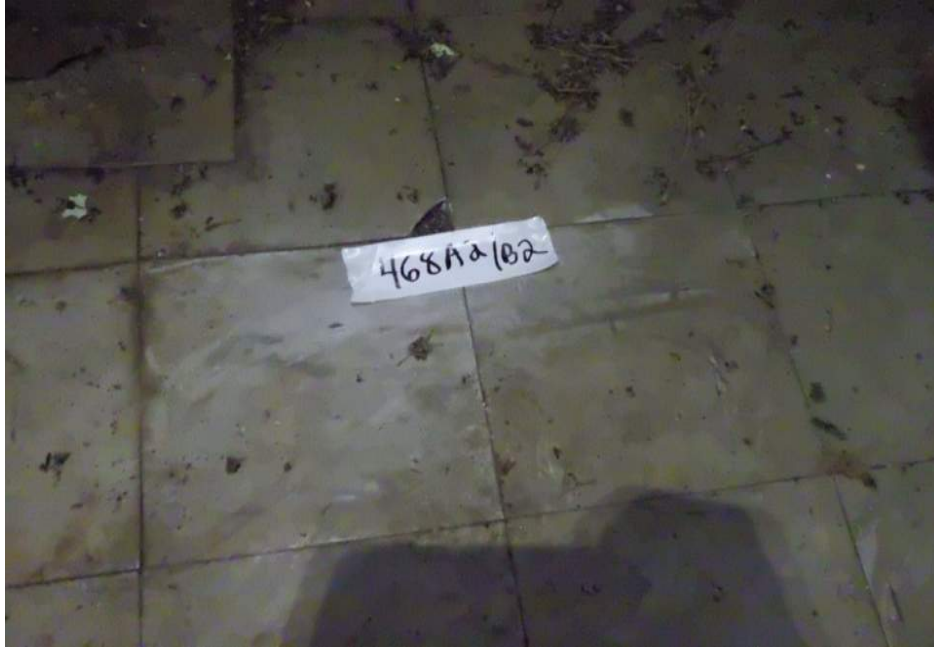
468A2

**Results:** Chrysotile 1-5%

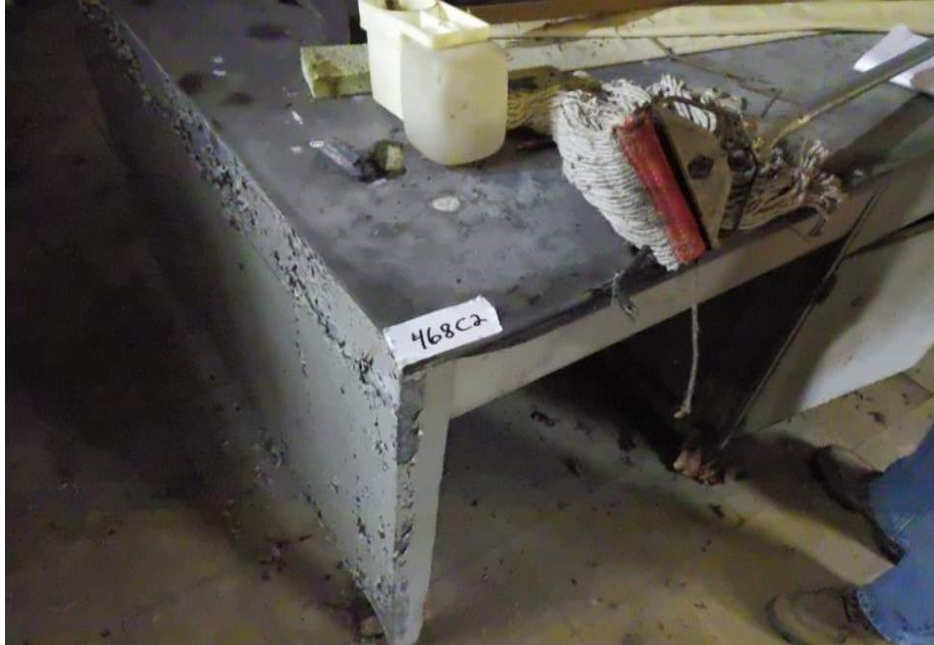
468C2

**Results:** Chrysotile 1-5%

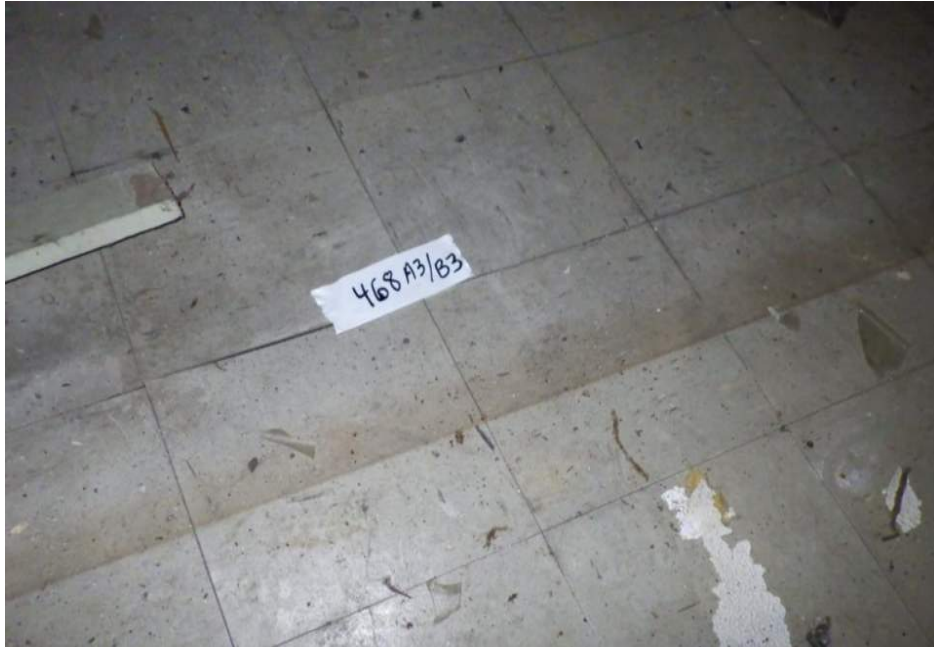
468A3

**Results:** Chrysotile 20-25%

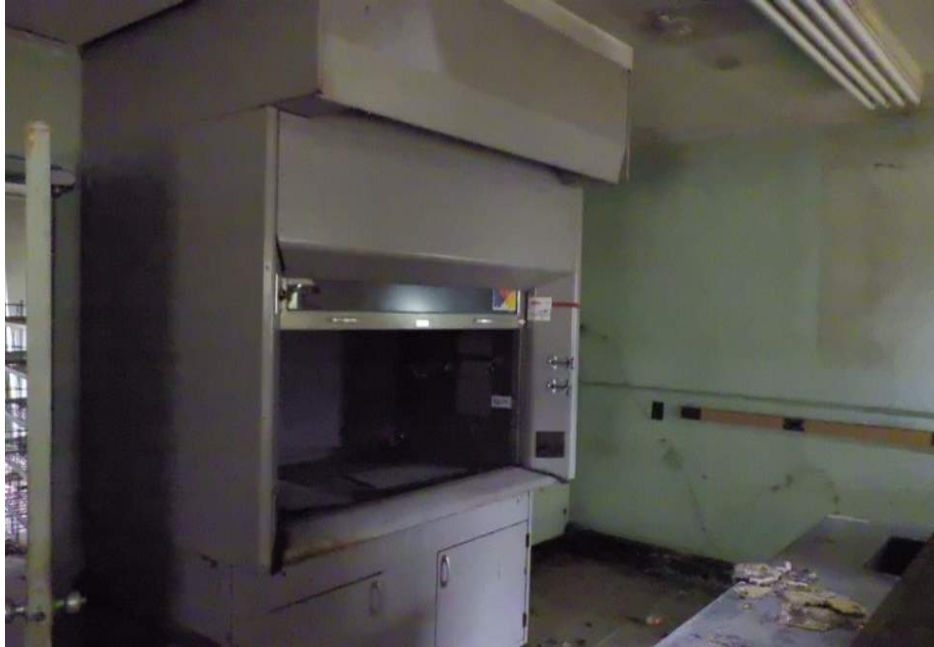
468D1

**Results:** Chrysotile 1-5%

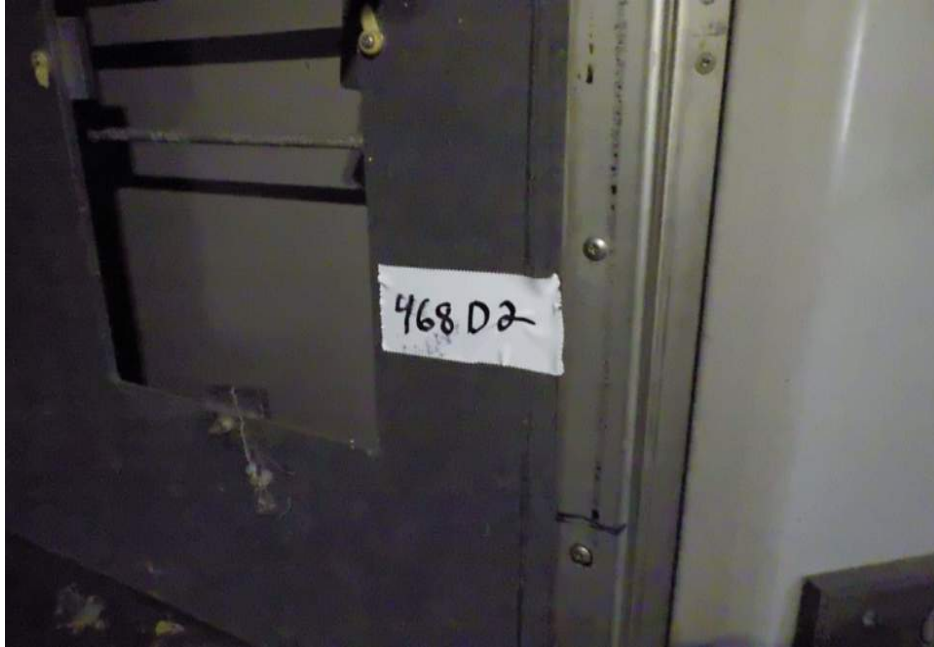
468D2

**Results:** Chrysotile 20-25%

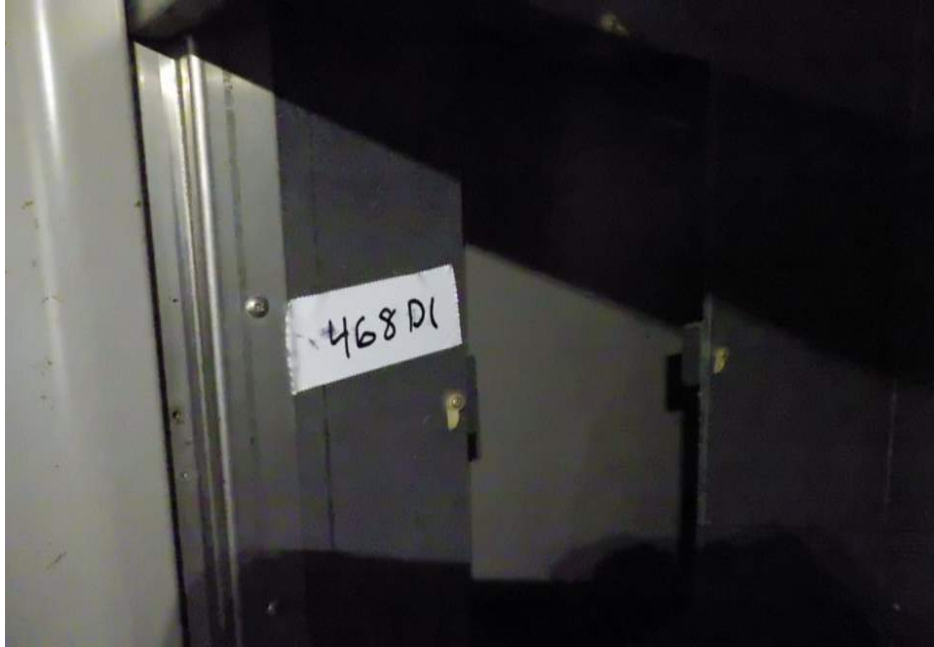
468D1

**Results:** Chrysotile 20-25%

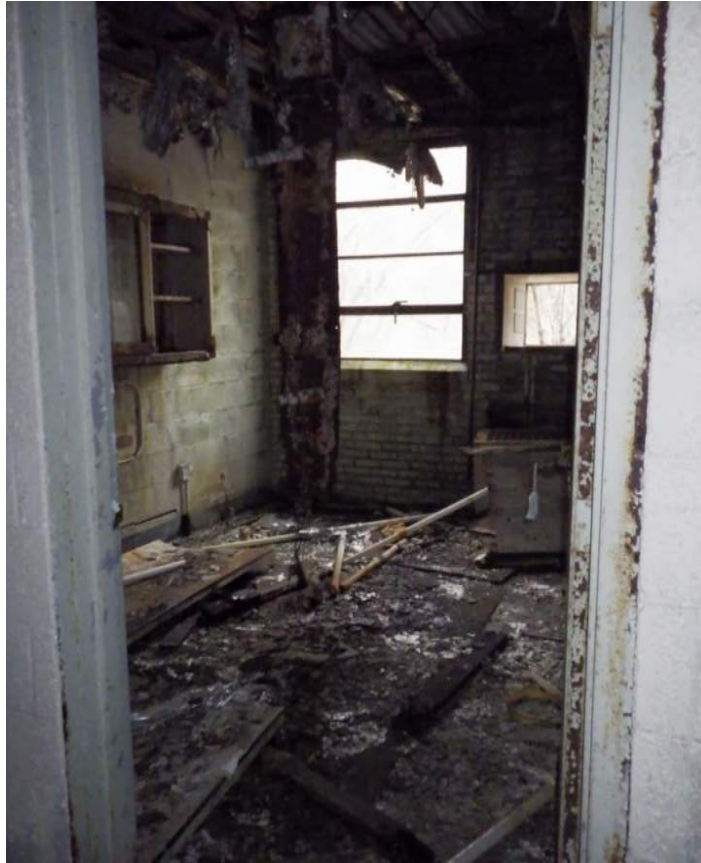
**Description:** typical lab interior, fluorescent bulbs on floor

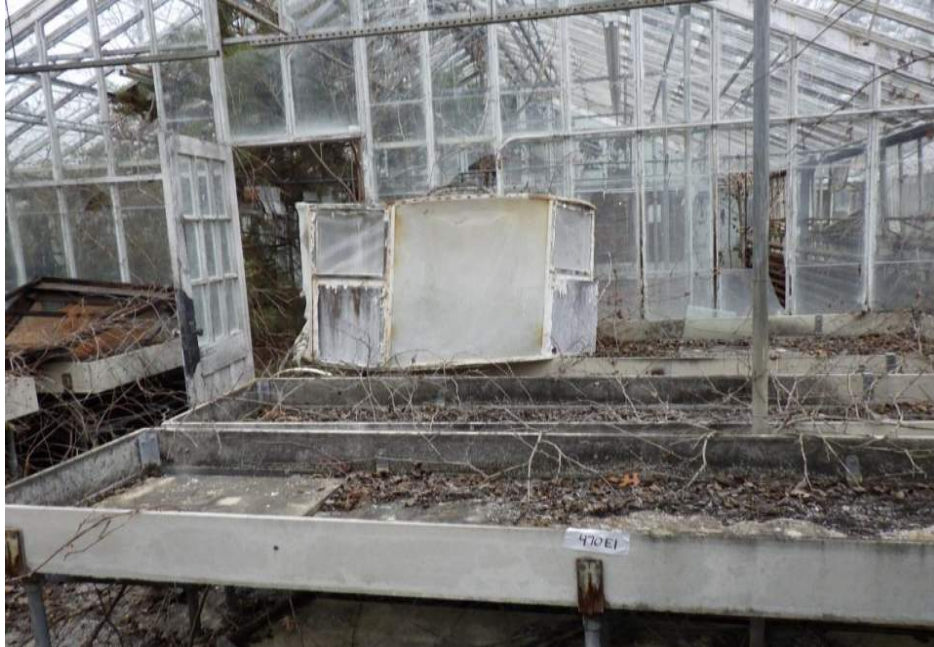
4.70E+03

**Results:**

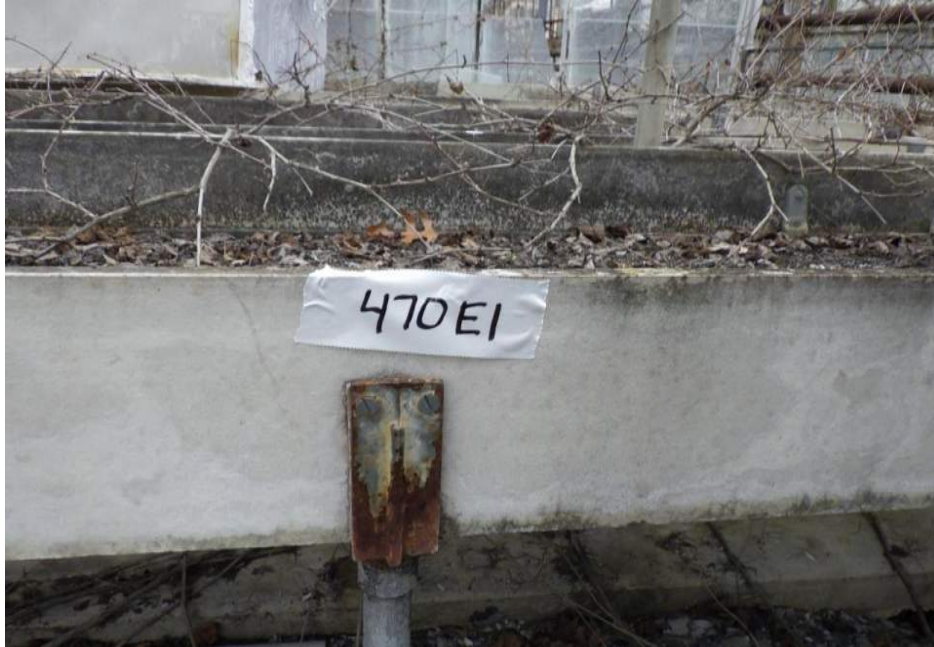
4.70E+03

**Results:** Chrysotile 20-25%

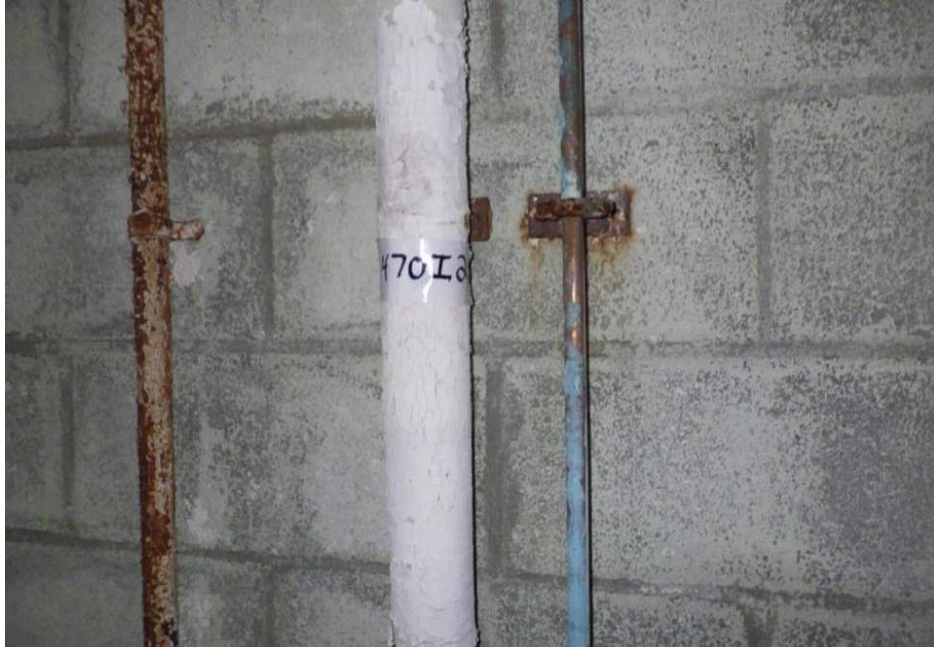
47012

**Results:** Chrysotile 20-25%

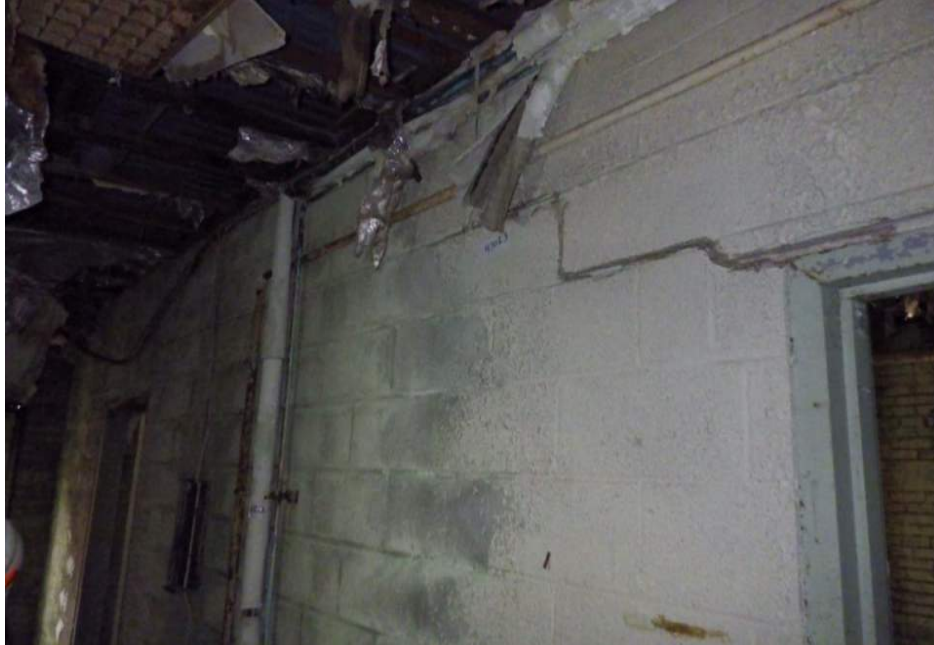
47013

**Results:** Chrysotile 10-15%

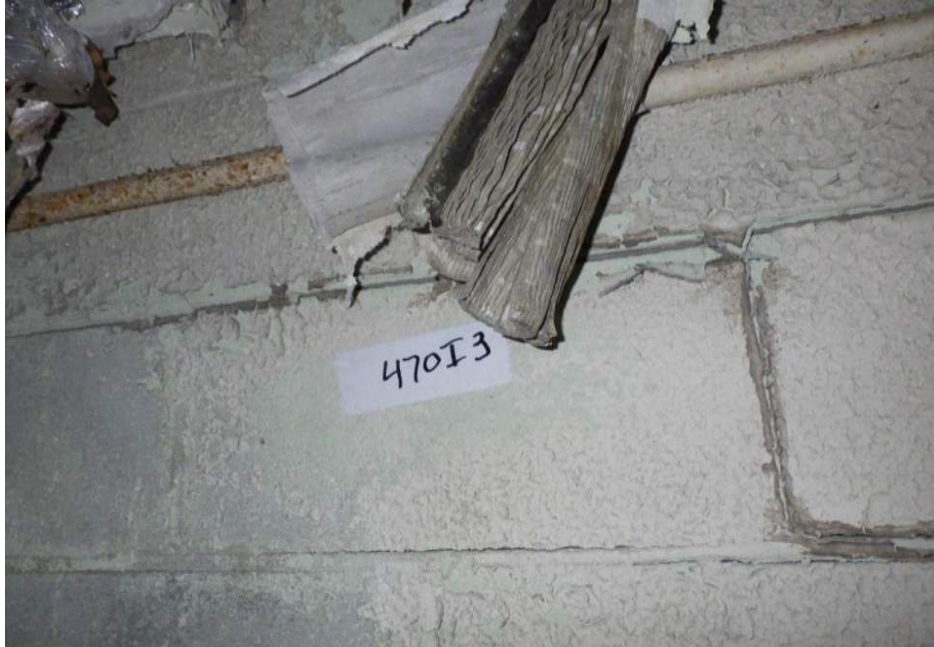
470I3

**Results:** Chrysotile 10-15%

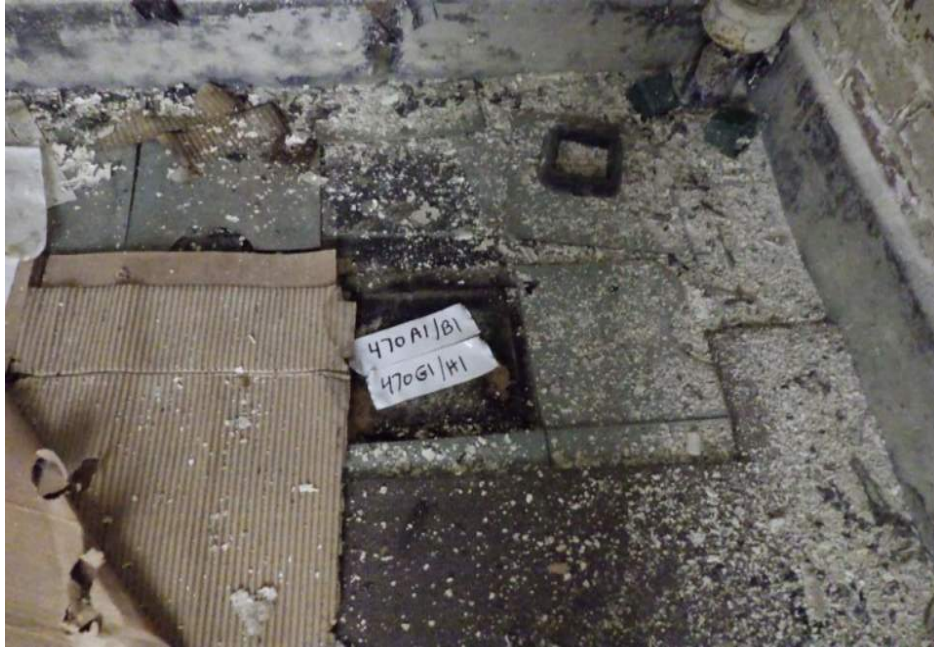
470A1

**Results:**

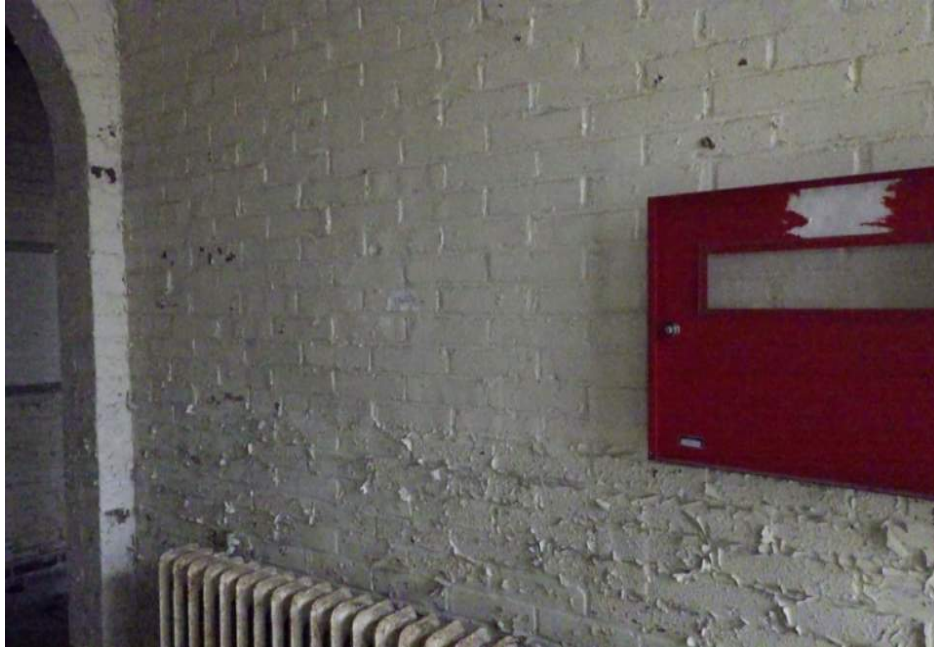
470-Pb2

**Results:** Chrysotile 1-5%

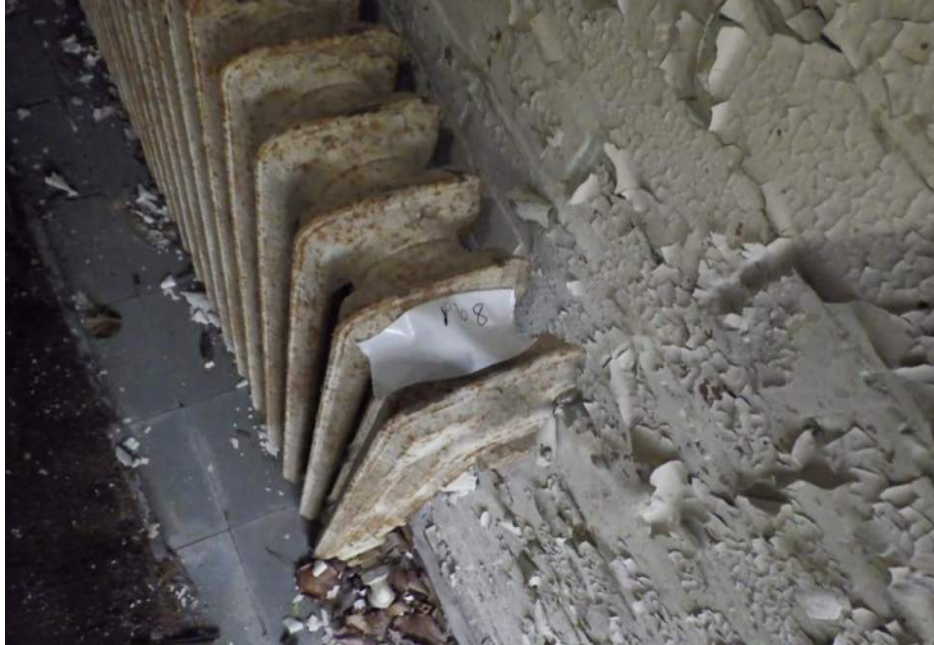
470-Pb8

**Results:** 16000 ppm

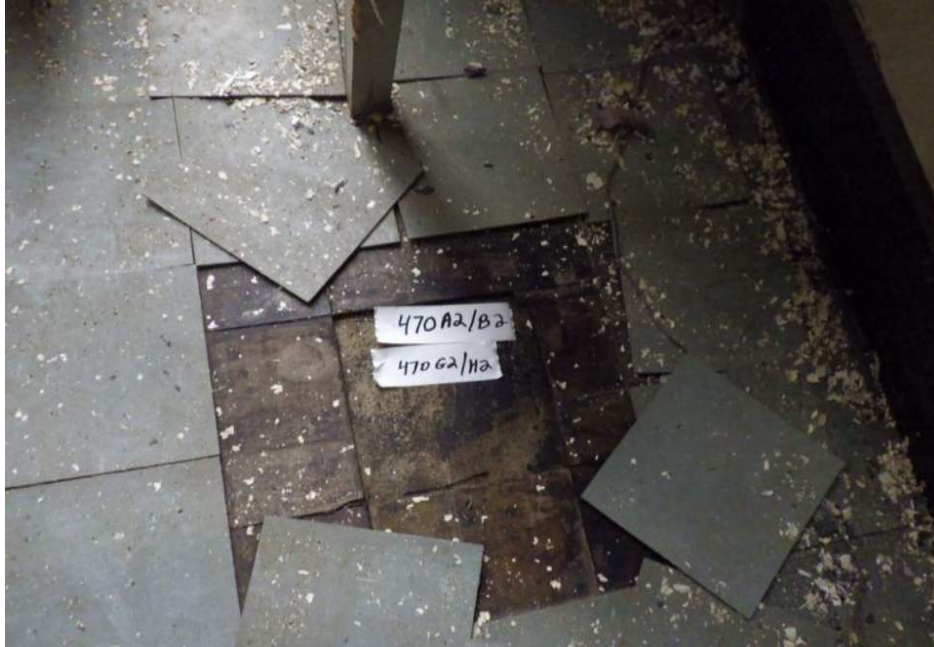
470A2

**Results:**

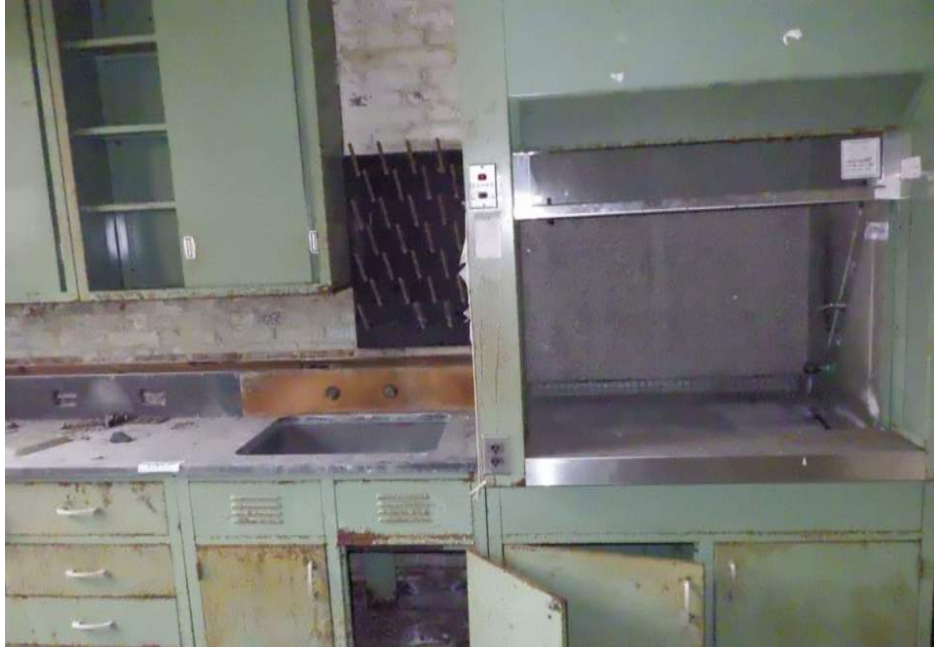
470F2

**Results:** Chrysotile 1-5%

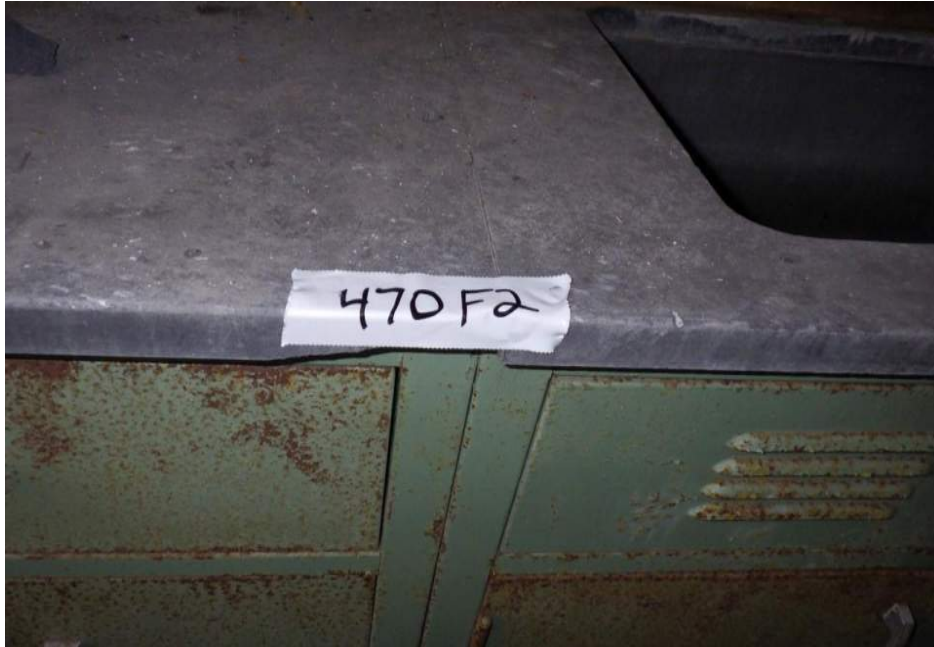
470F2

**Results:** Chrysotile 20-25%

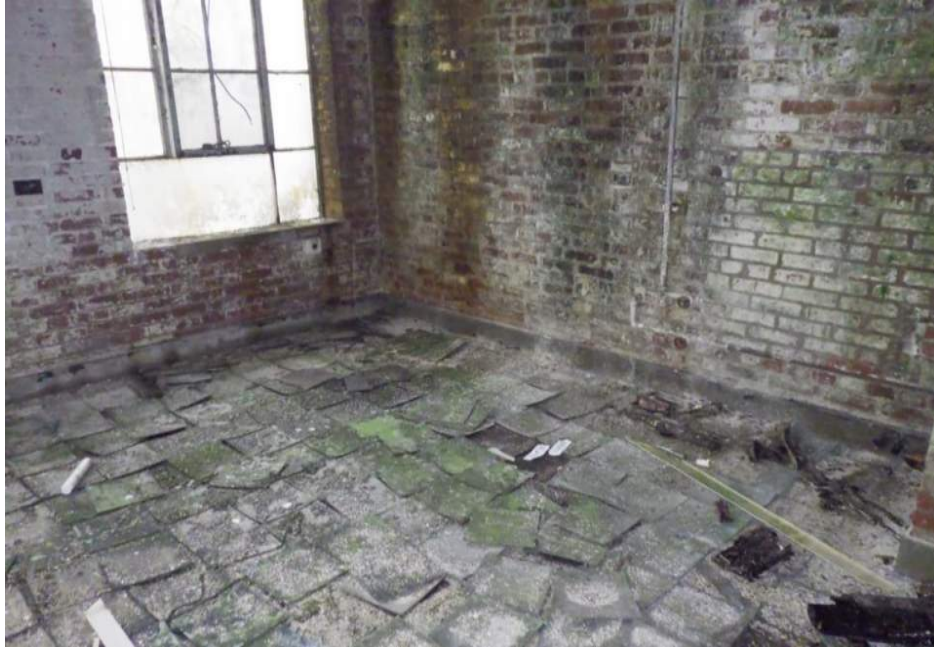
470A3

**Results:** Chrysotile 20-25%

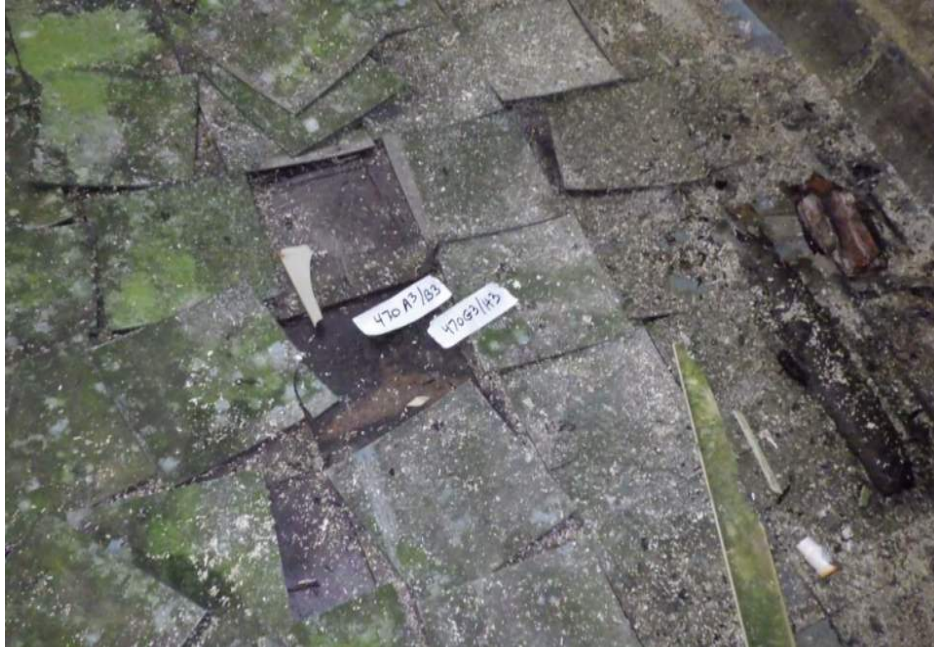
470A3

**Results:** Chrysotile 1-5%

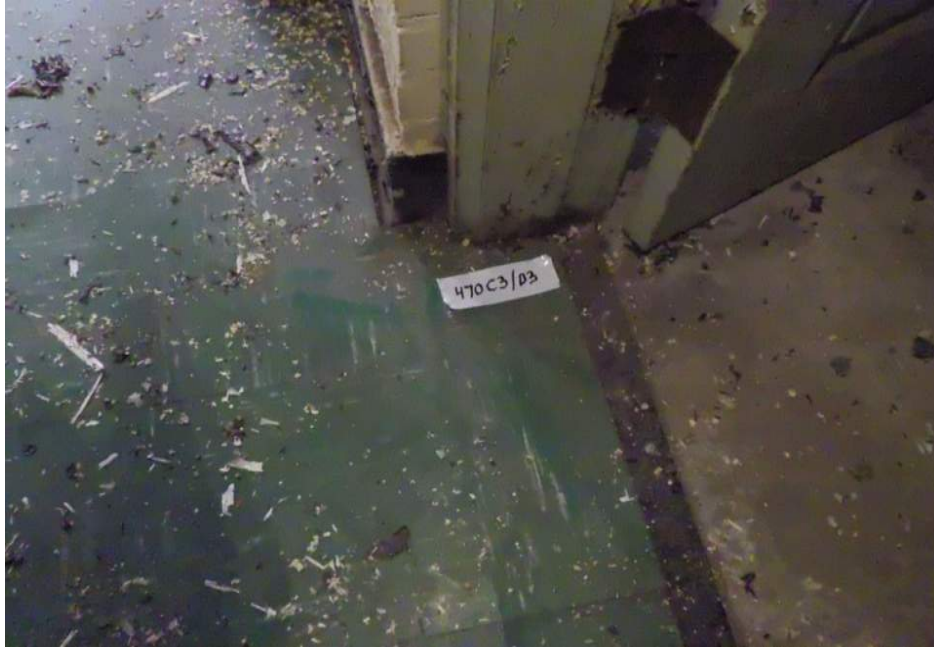
470C3

**Results:** Chrysotile 1-5%

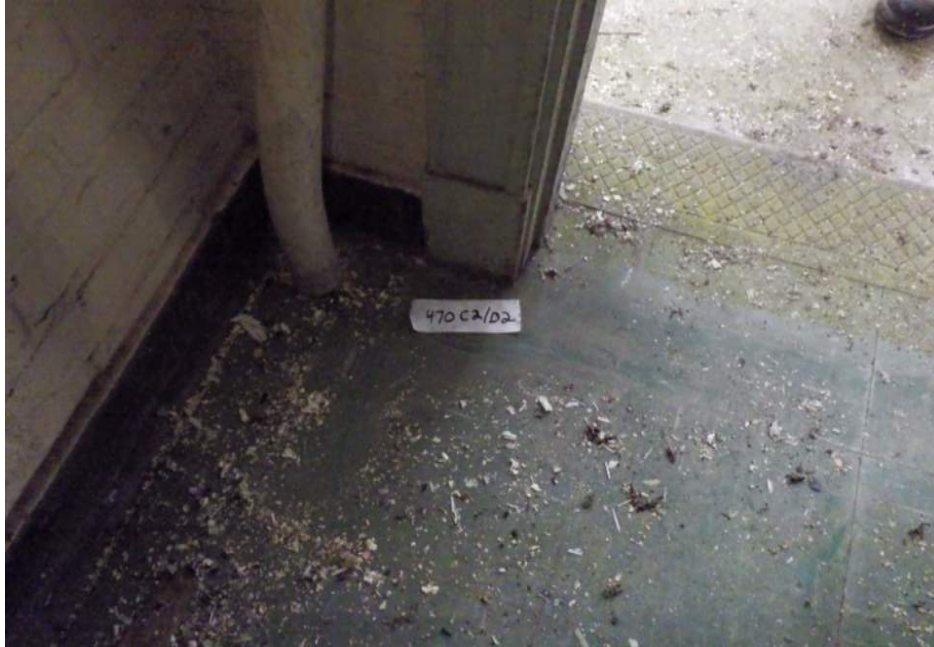
470C2

**Results:** Chrysotile 1-5%

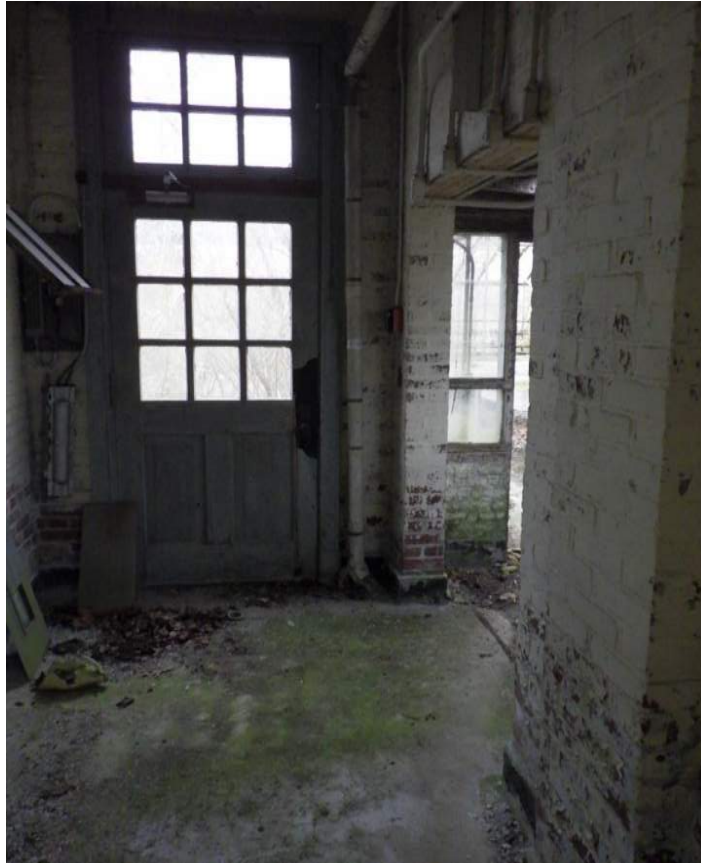
47011

**Results:** Chrysotile 1-5%

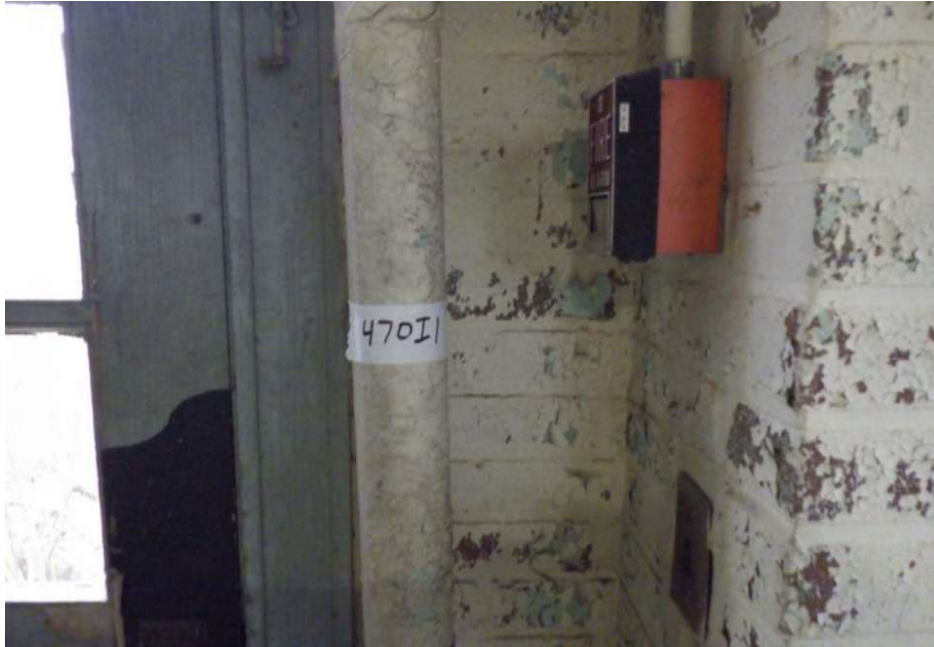
47011

**Results:** Chrysotile 10-15%

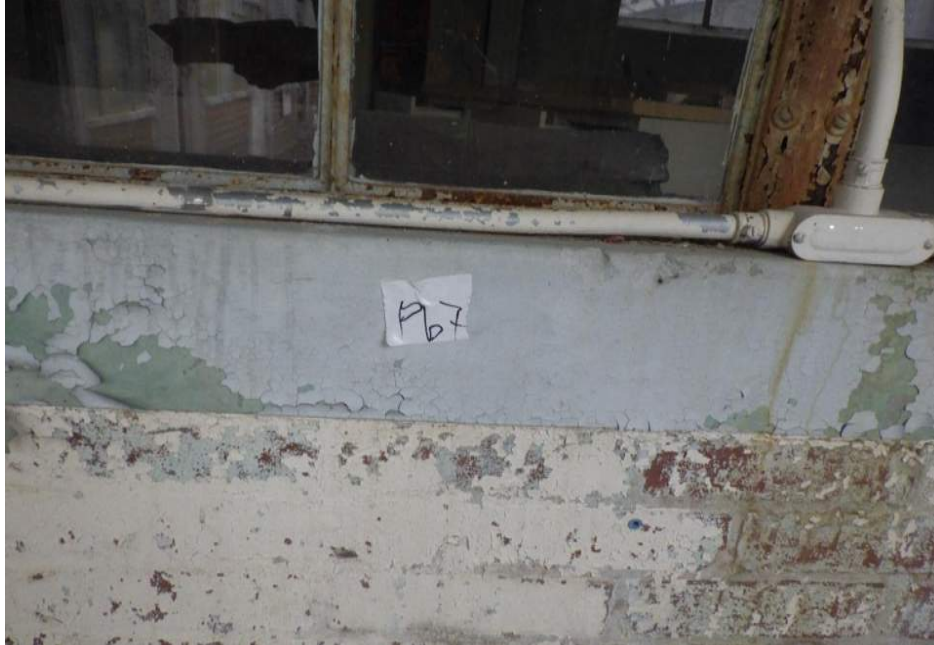
470-Pb7

**Results:** Chrysotile 20-25%

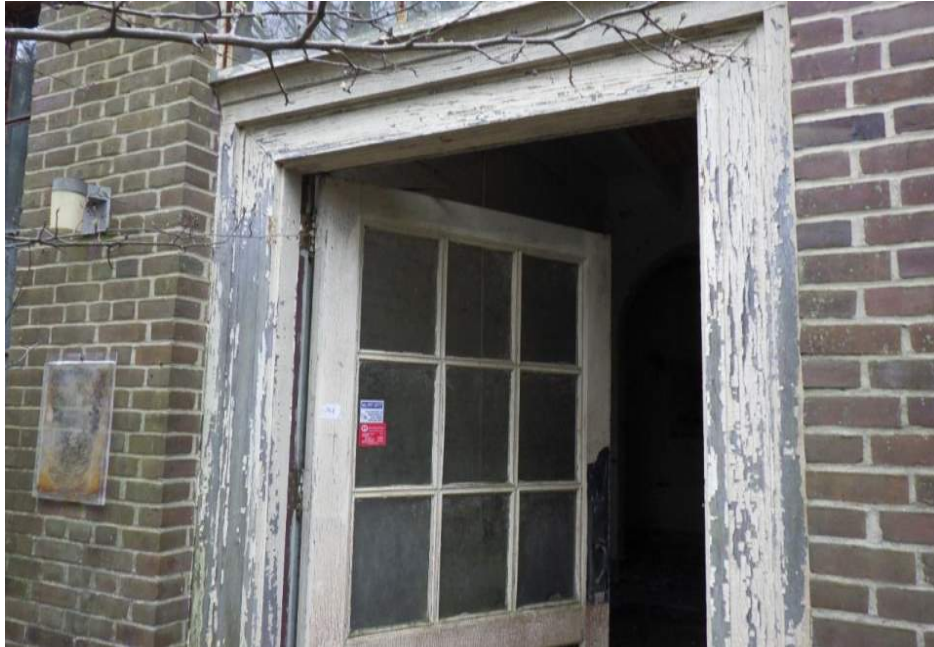
470-Pb1

**Results:** 6300 ppm

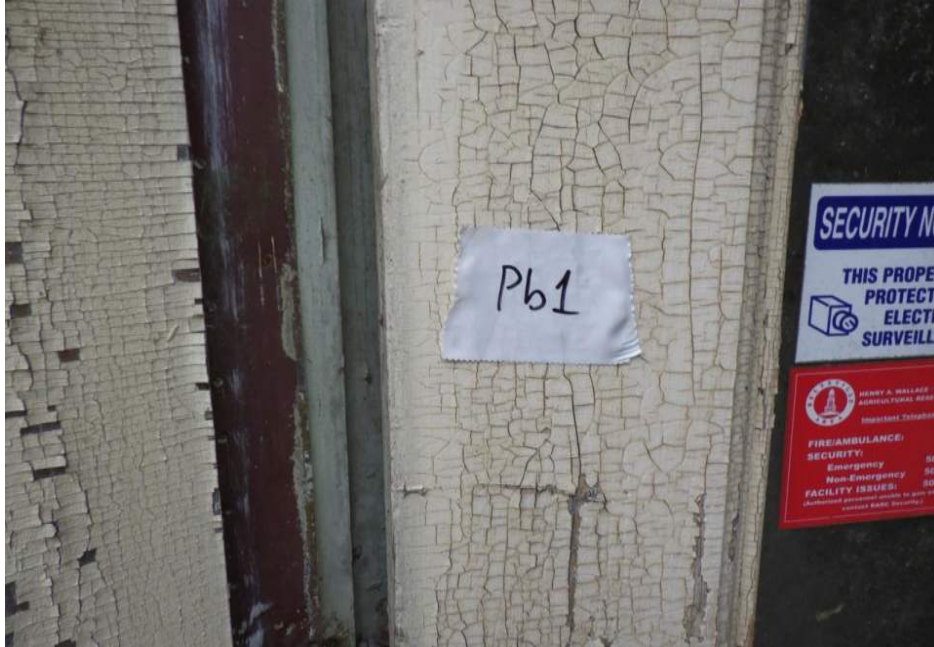
470-Pb1

**Results:** 460000 ppm

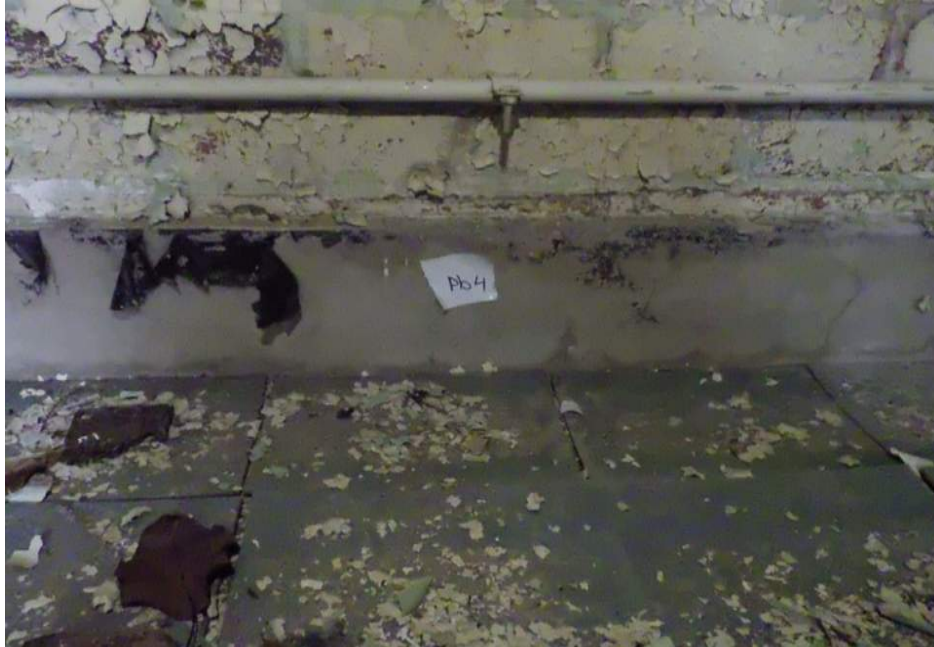
470-Pb4

**Results:** 460000 ppm

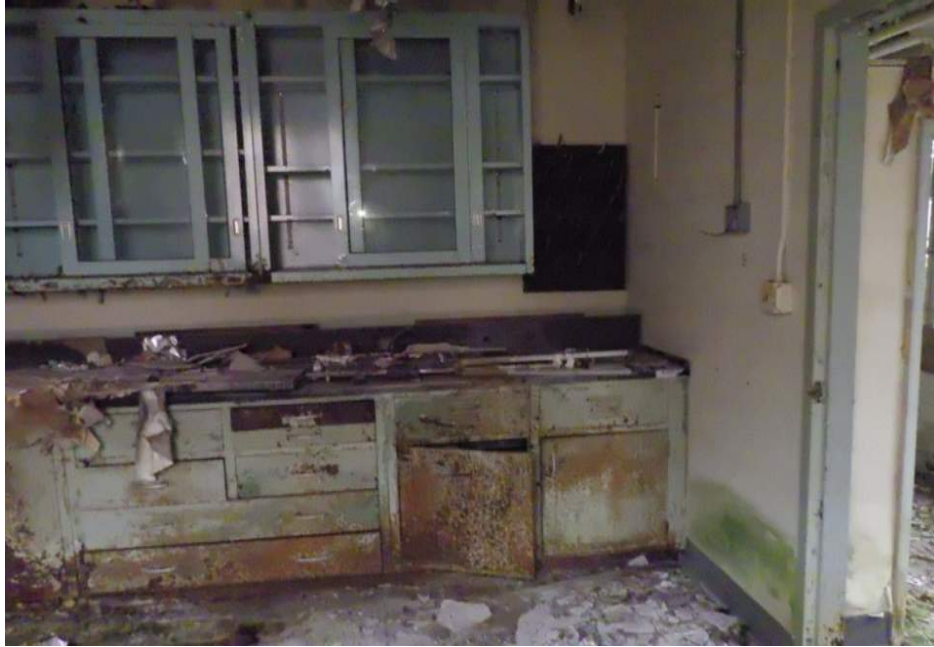
470F3

**Results:** 120000 ppm

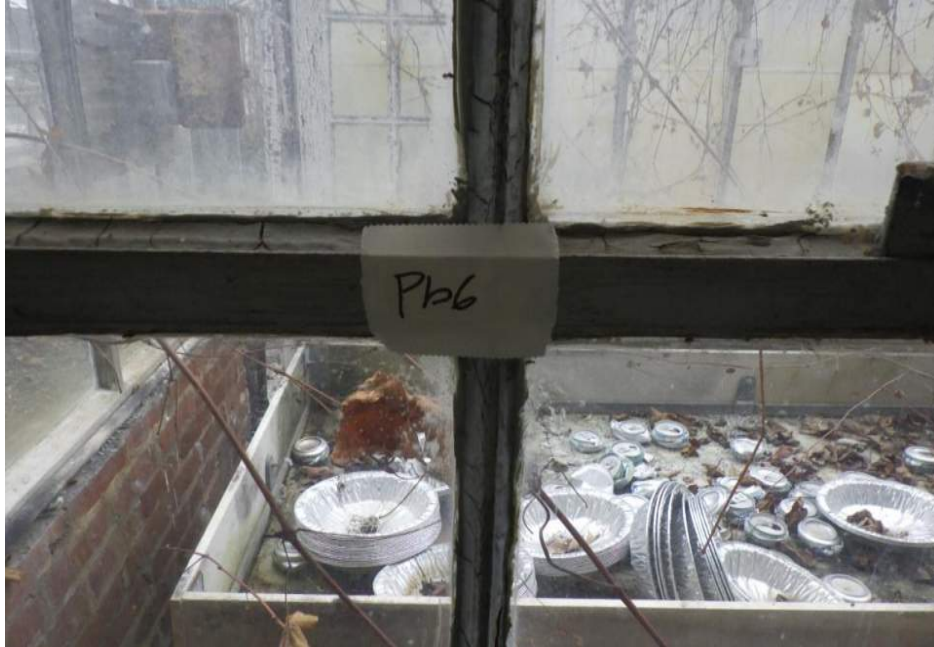
470-Pb6

**Results:** 65000 ppm

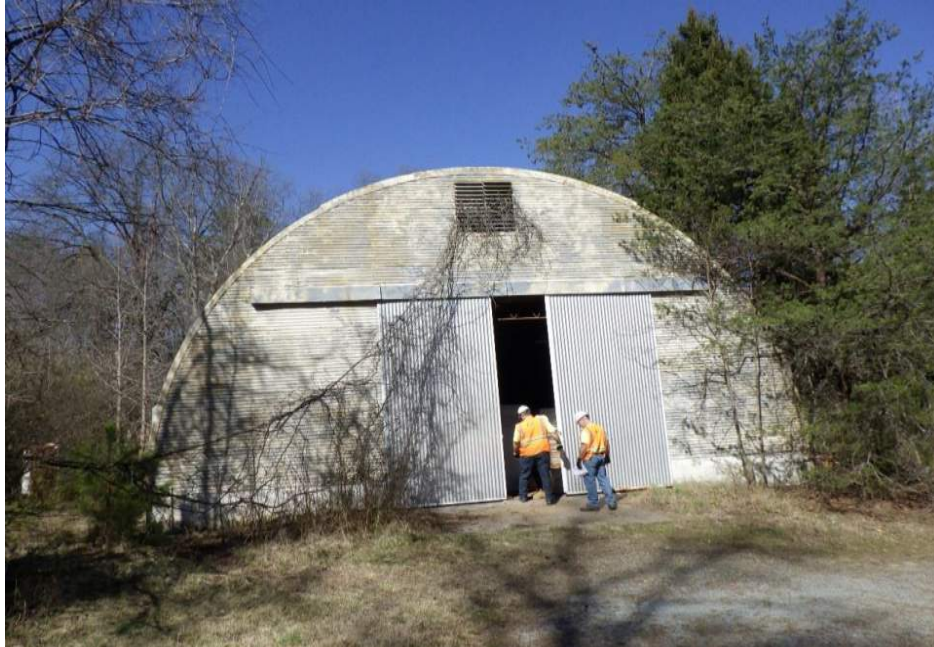
**Description:** exterior of building 470B from south

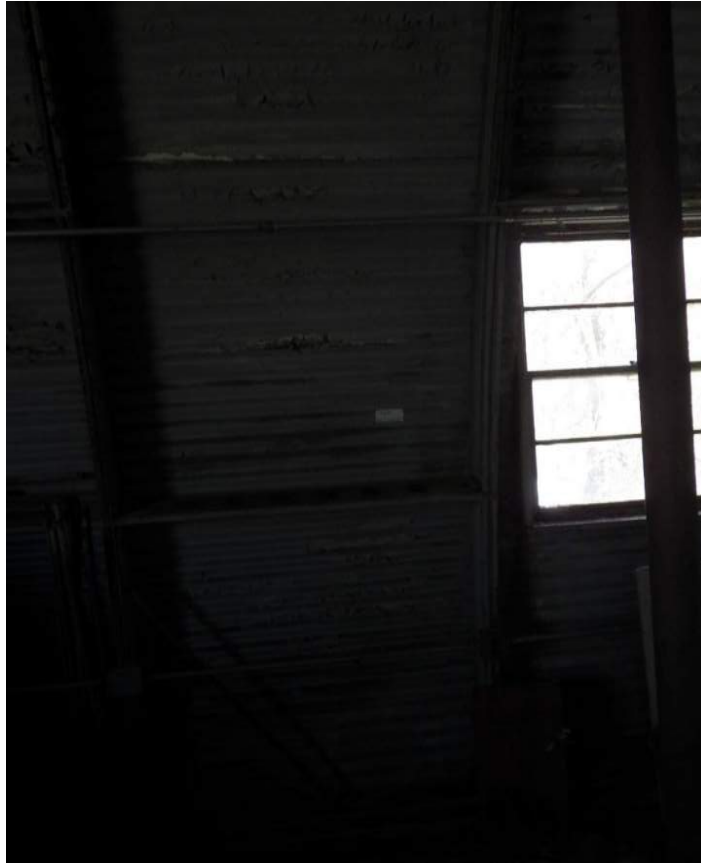
**Description:** interior of metal Quonset hut

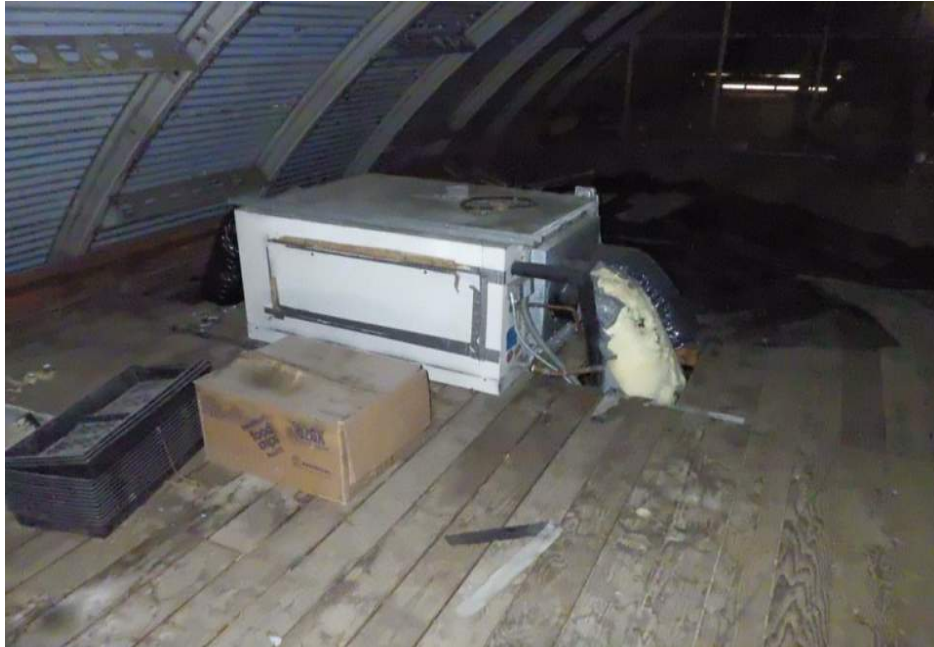
**Description:** typical heat pump condenser in attic for climate controlled chambers

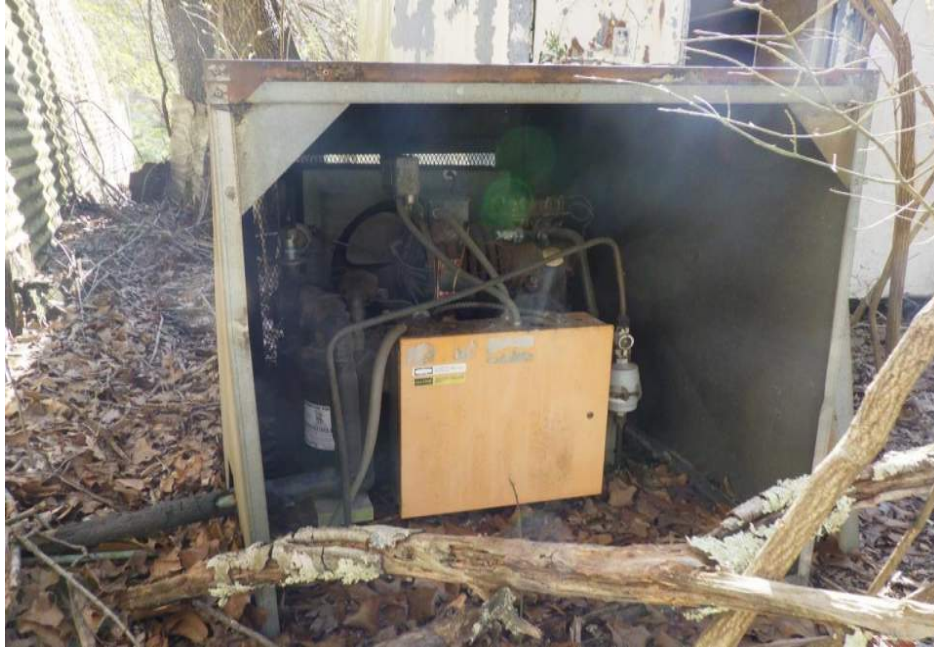
**Description:** typical exterior heat pump condenser

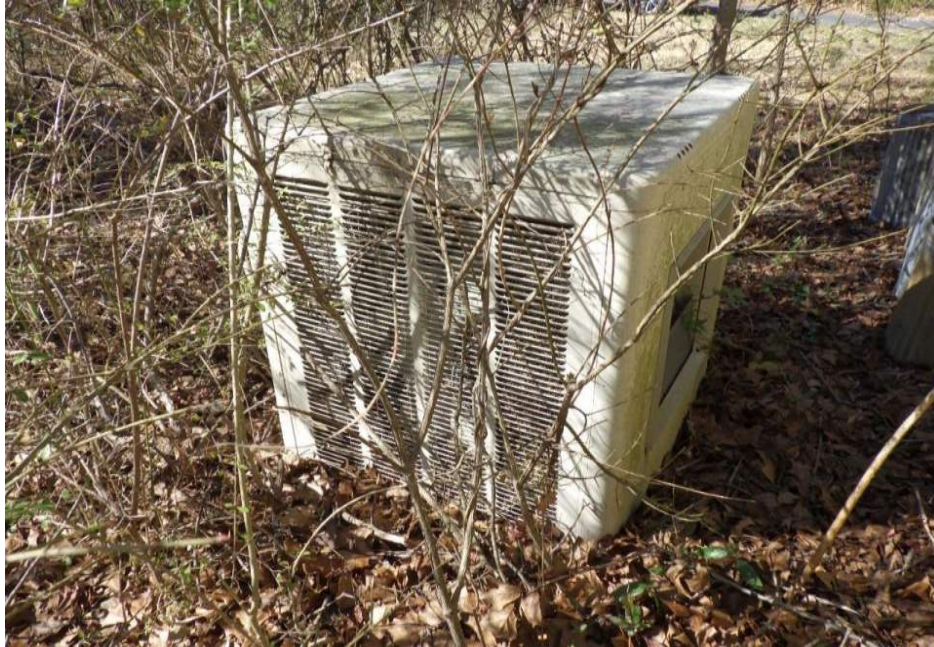
**Description:** typical exterior AC units

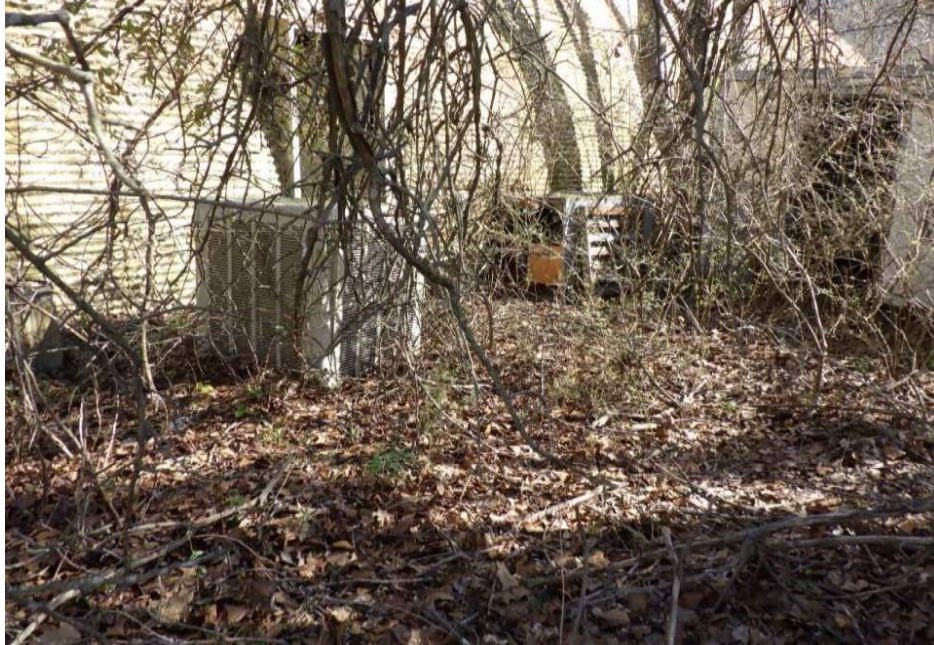
**Description:** typical exterior AC units south of building

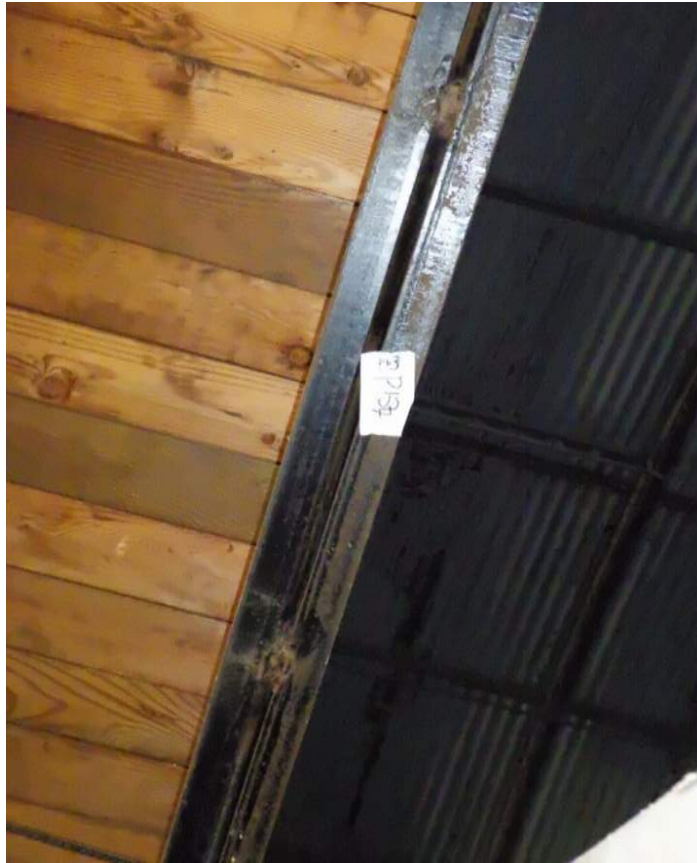
470B-Pb3

**Results:** < 95 ppm
