# Beltsville Agricultural Research Center Hazardous Materials Assessment Part 2

**Beltsville Agricultural Research Center  
Hazardous Materials Assessment  
Project No. 103144**

**Revision 1  
April 22, 2020**

**Burns & McDonnell Engineering Company, Inc.  
Downers Grove, Illinois**

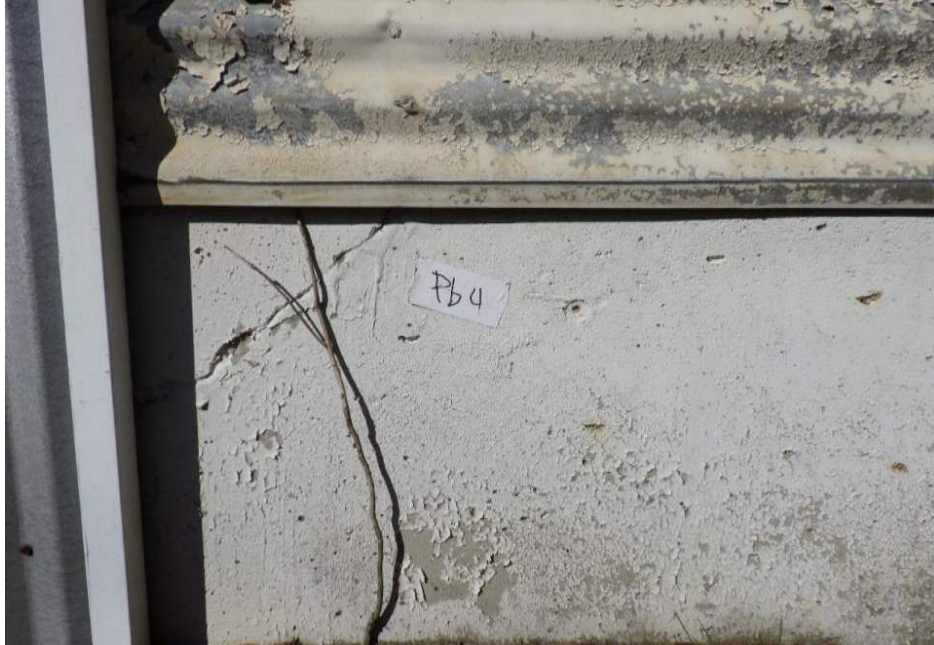
470B-Pb4

**Description:** tan paint sample on concrete foundation wall

**Results:** 780 ppm

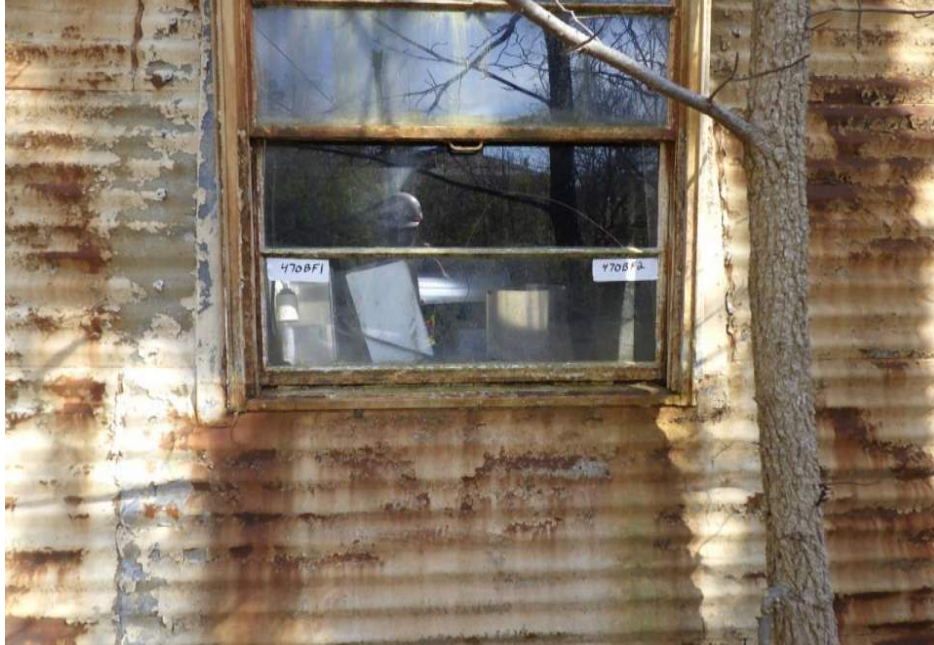
470BF1

**Results:** None Detected

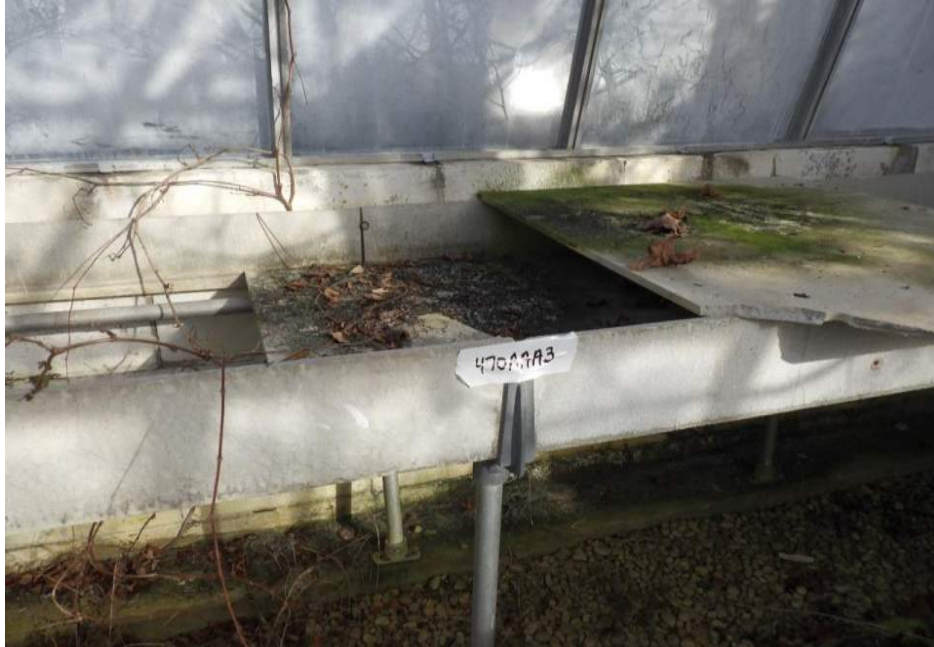
470AAA3

**Results:** Chrysotile 20-25%

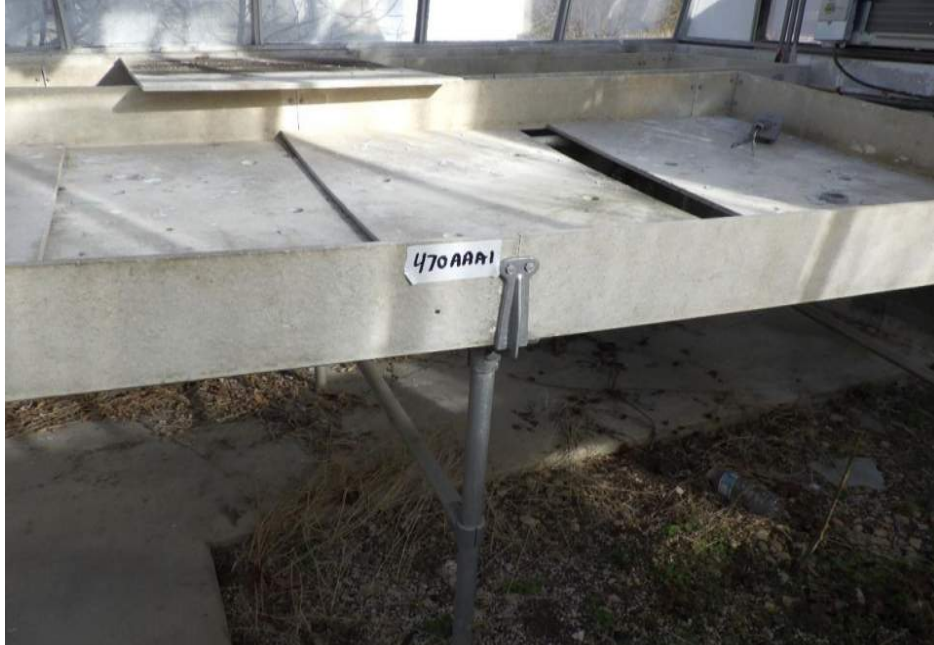
470AAA1

**Results:** Chrysotile 20-25%

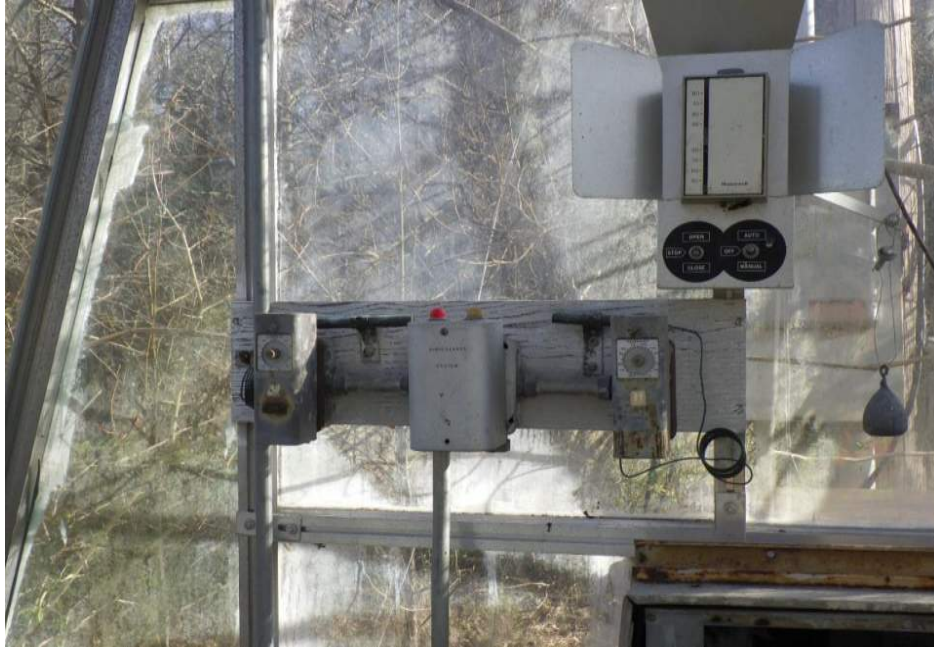
**Description:** typical greenhouse thermostatic and humidity controls

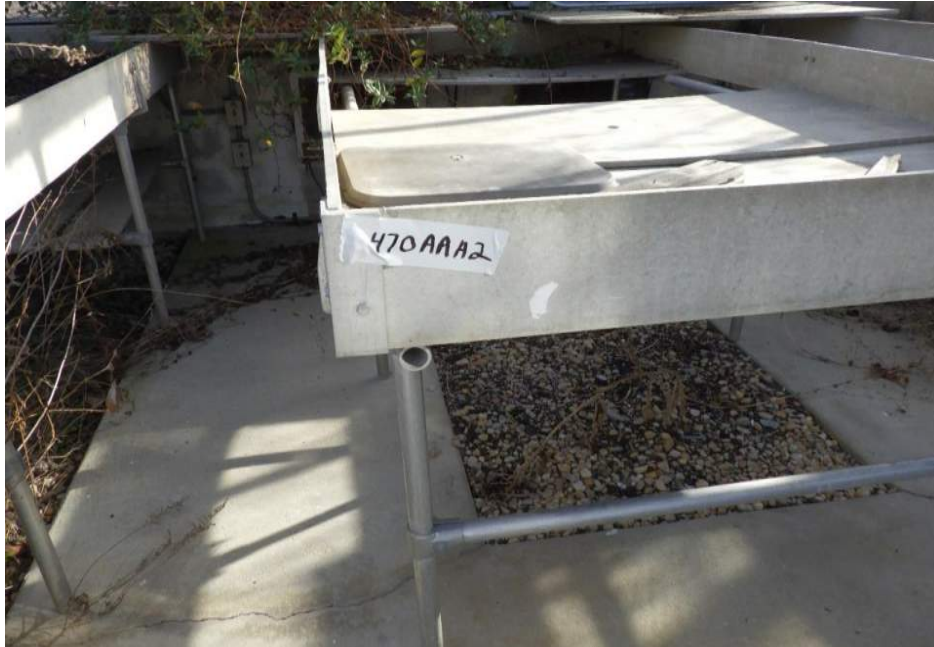
470AAA2

**Results:** Chrysotile 20-25%

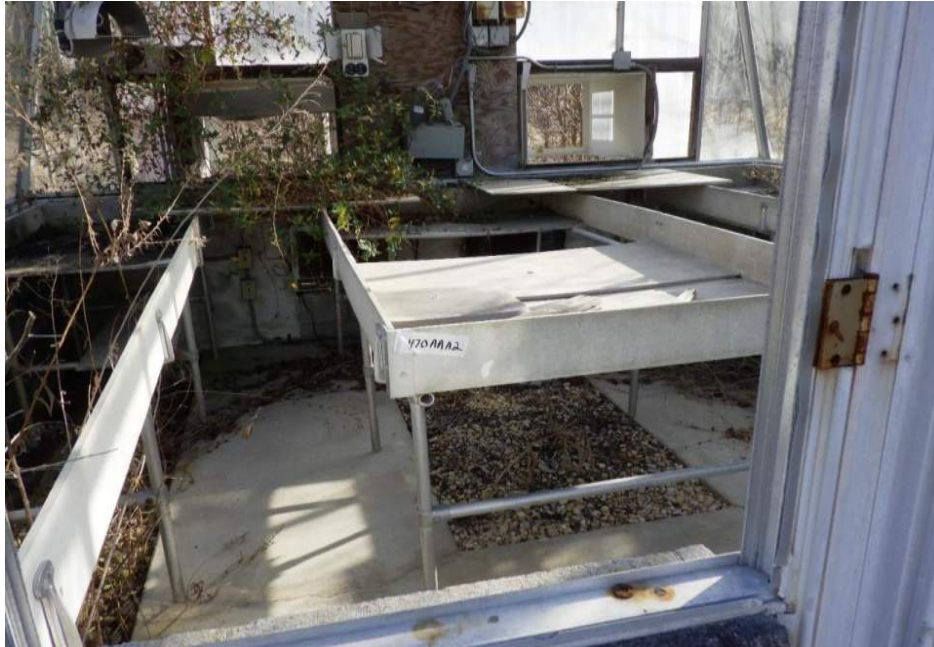
470AAA2

**Results:** Chrysotile 20-25%

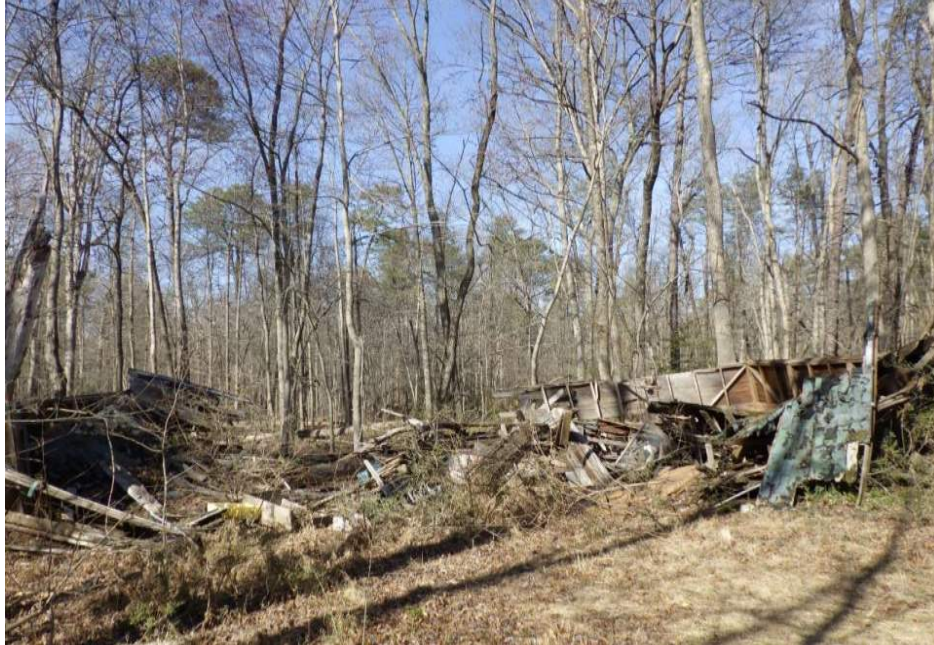
**Description:** structure 471 exterior north, appears to be a collapsed garage

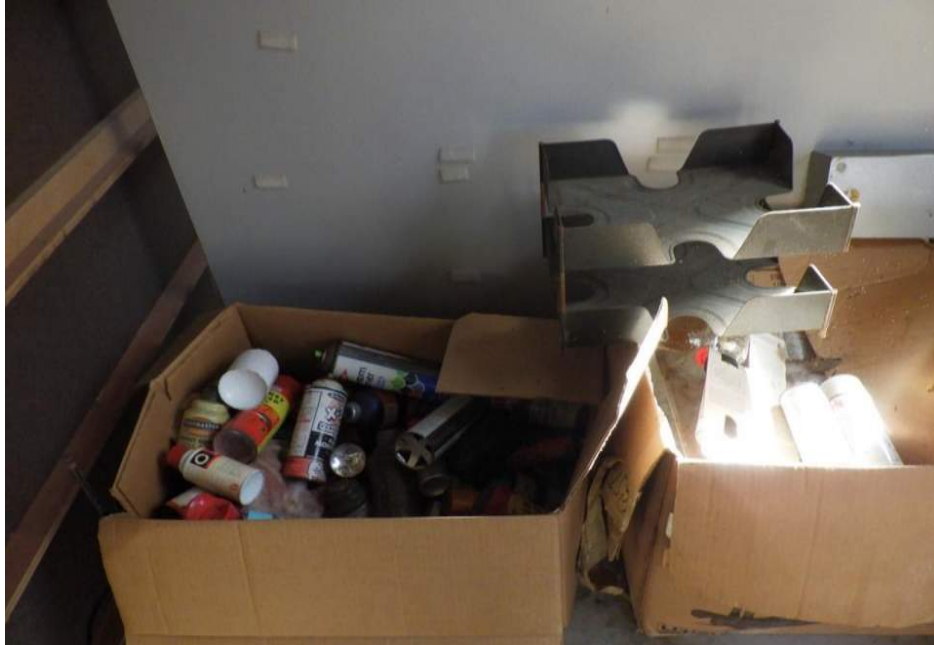
**Description:** aerosol lubricant cans in storage box

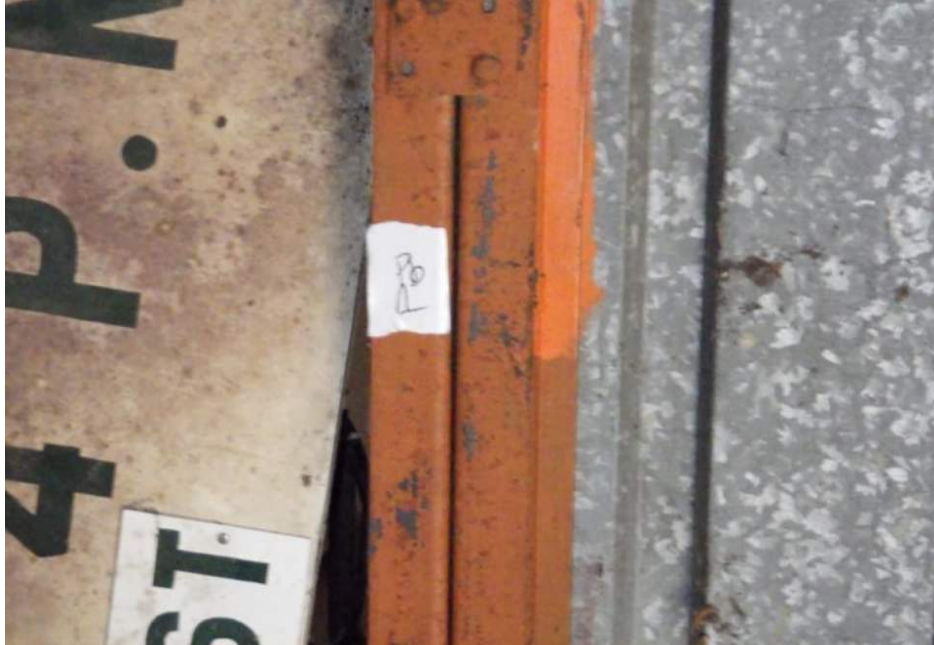
472-Pb1

**Results:** 170000 ppm

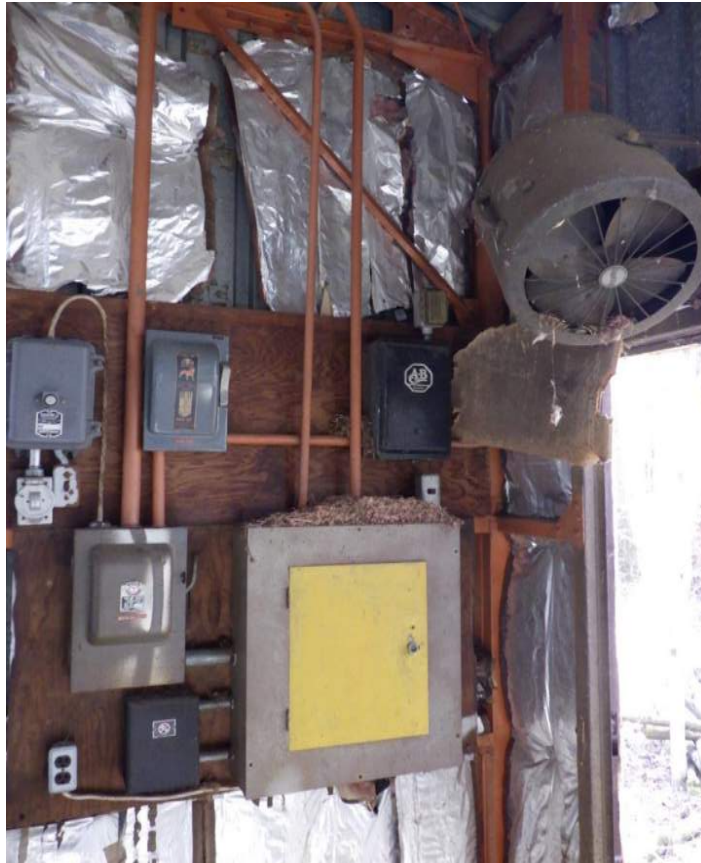
**Description:** electrical equipment in building 472, unit heater and breaker panels

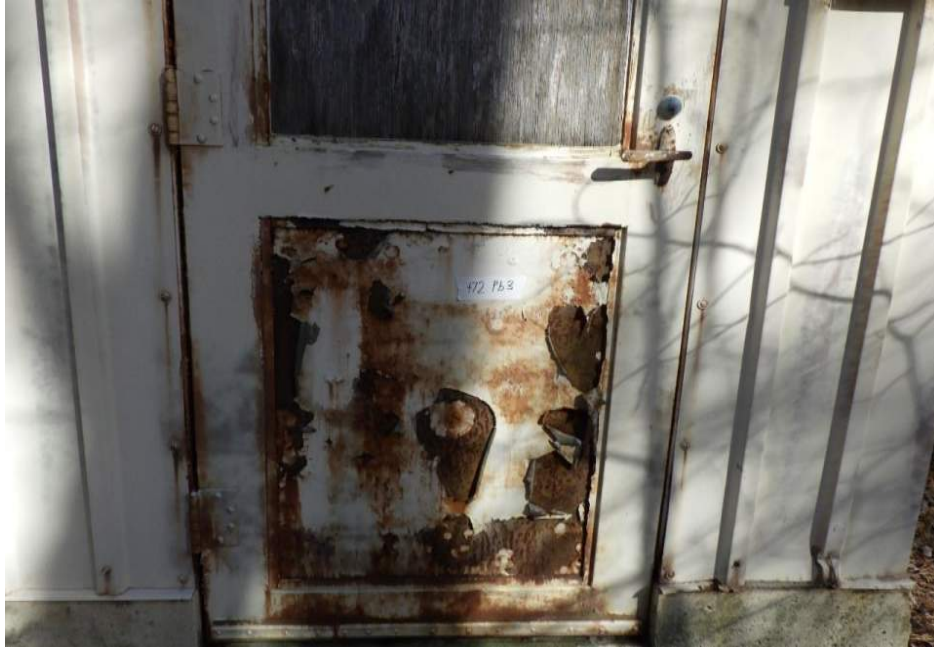
472-Pb3

**Results:** 1400 ppm

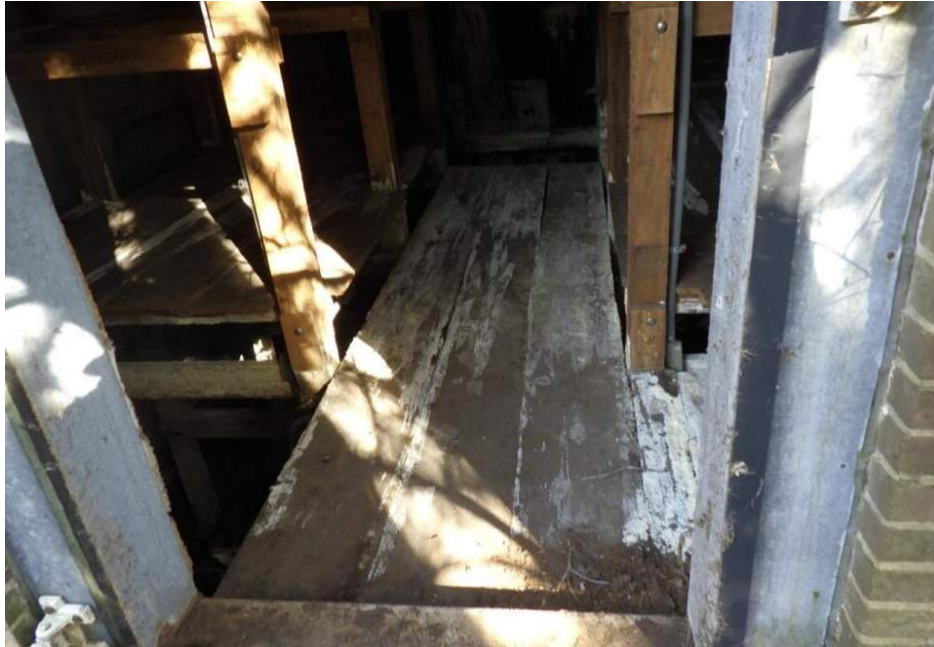
**Description:** interior of building 474, moldy wood substructure with spray foam wall insulation

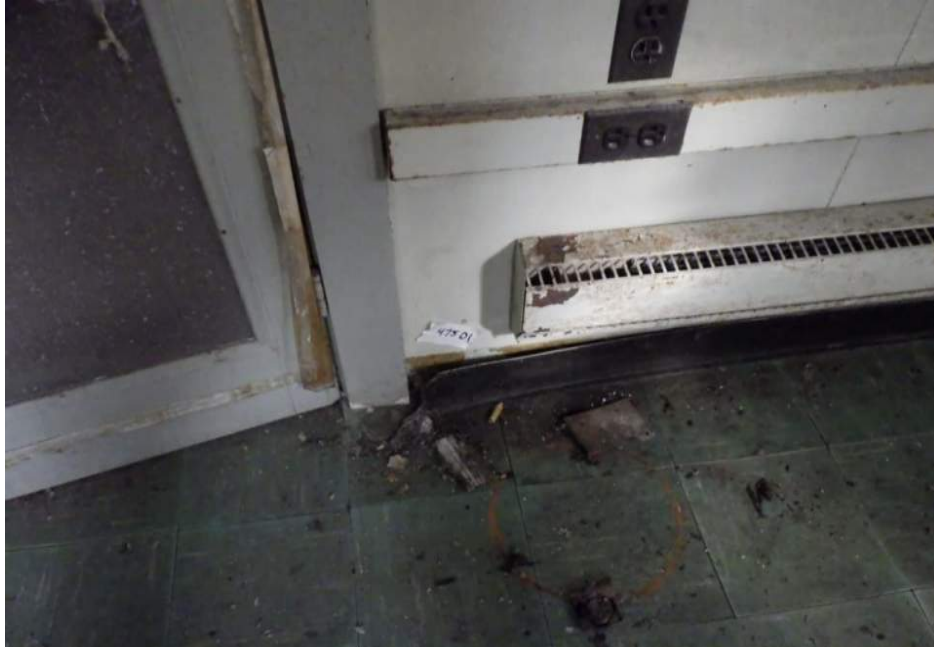
475D1

**Results:** None Detected

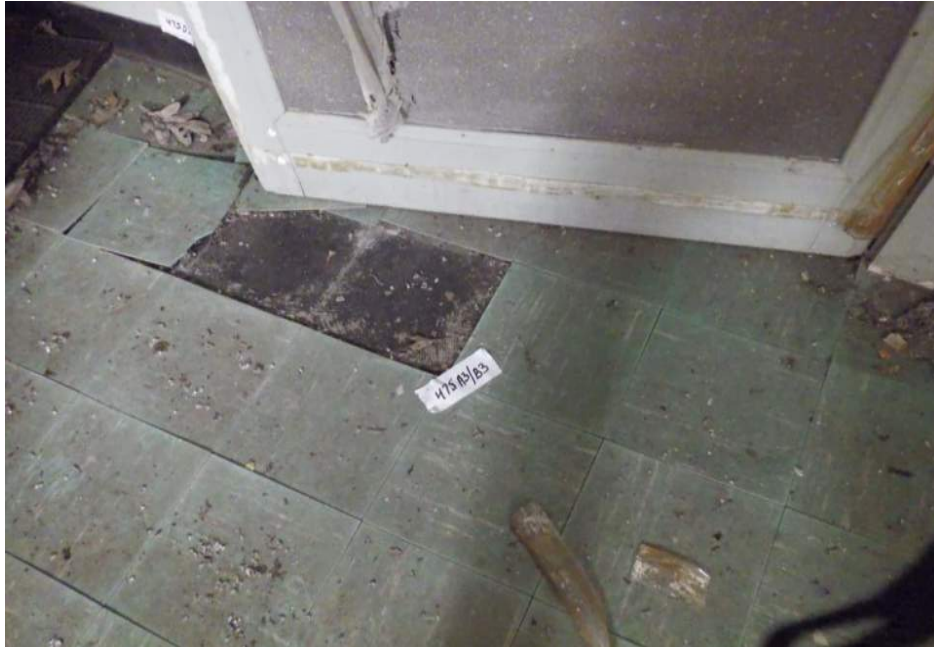
475A3

**Results:** Chrysotile 1-5%

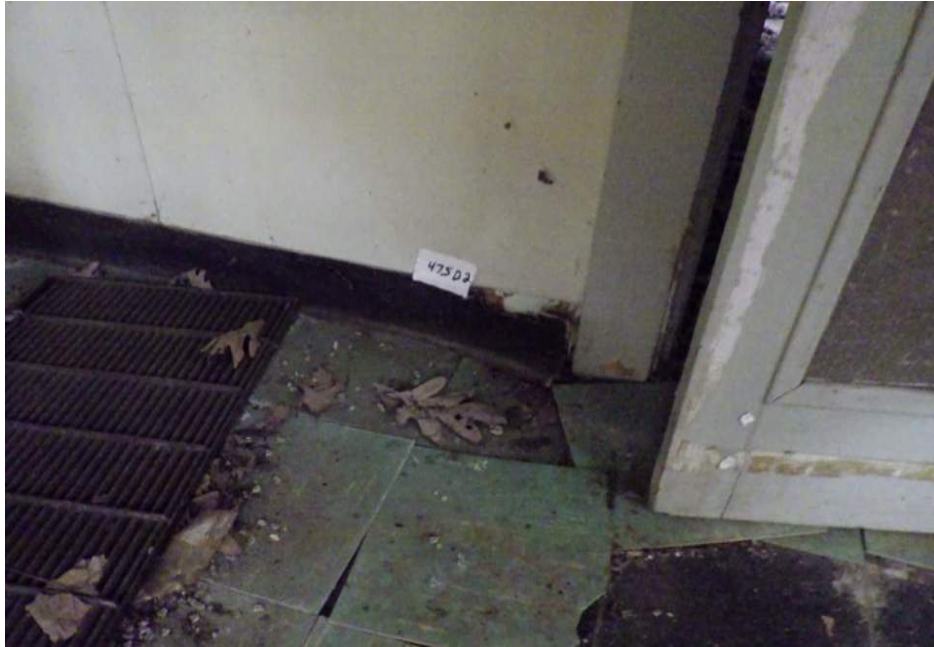
475D2

**Results:** None Detected

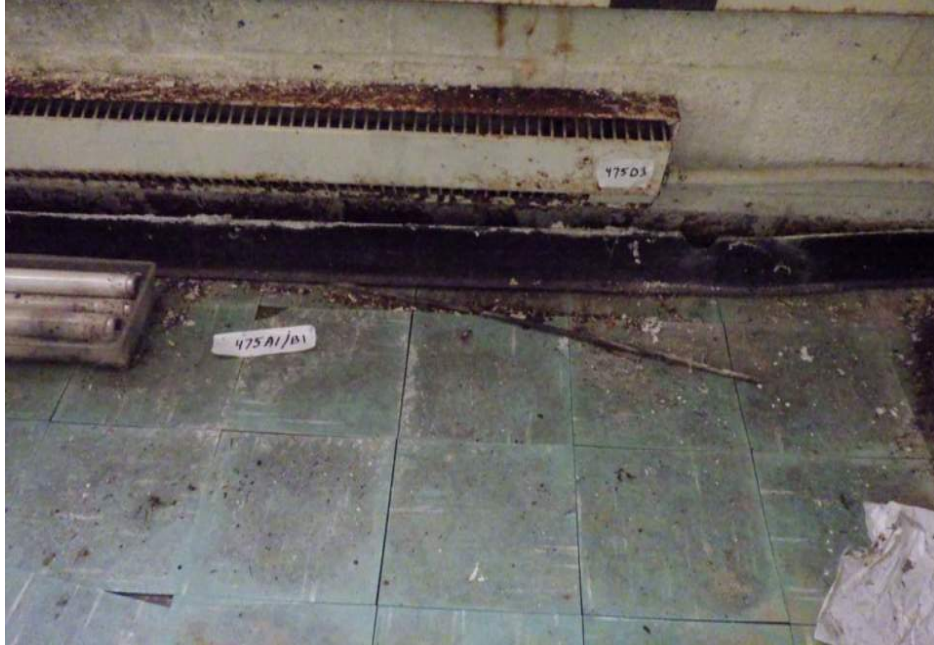
475A1

**Results:** Chrysotile 1-5%

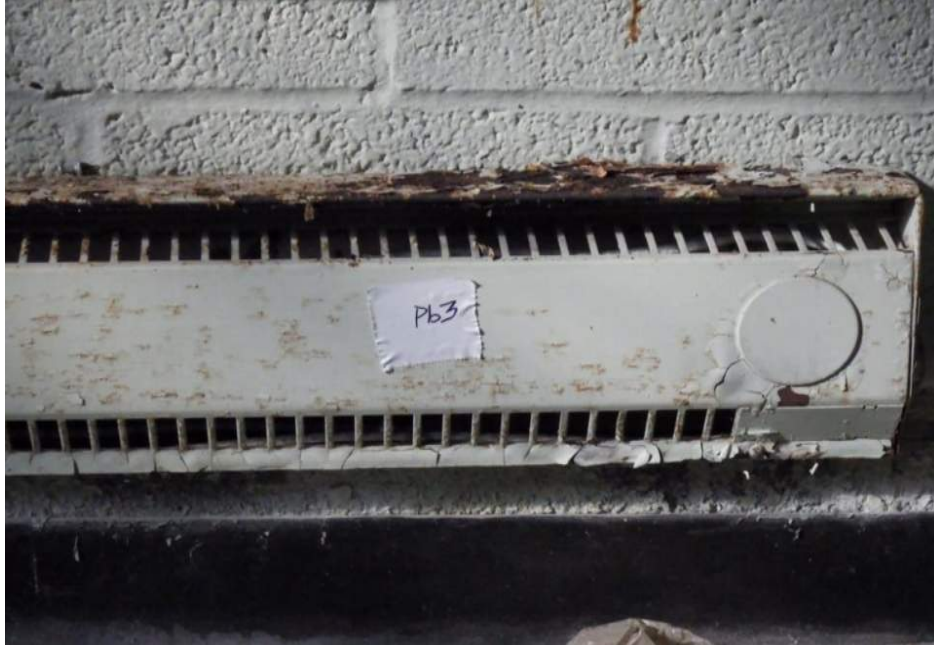
475-Pb3

**Results:** 1400 ppm

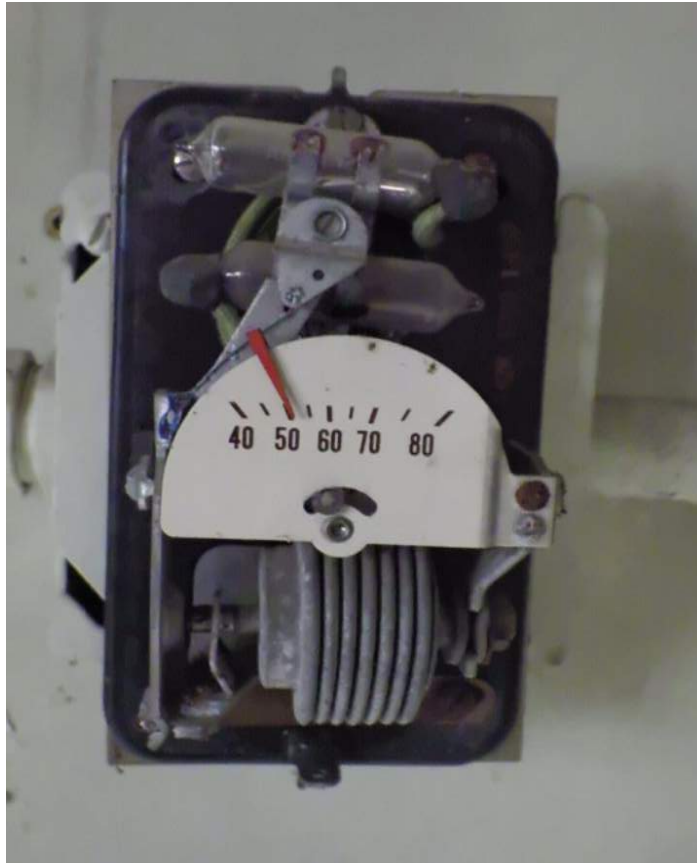
**Description:** typical mercury vial thermostat, building 475

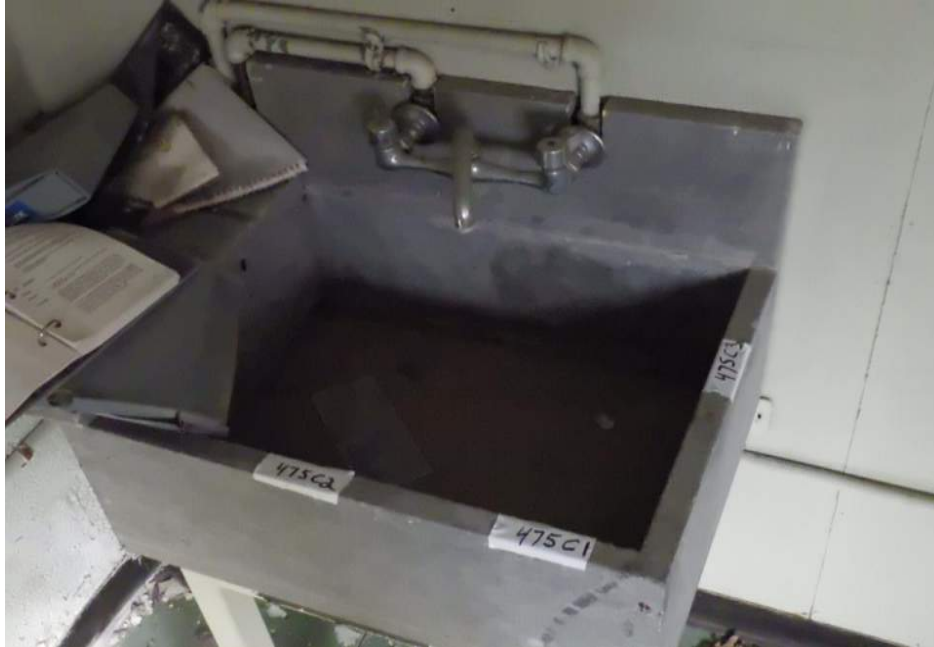
475C1

**Results:** None Detected

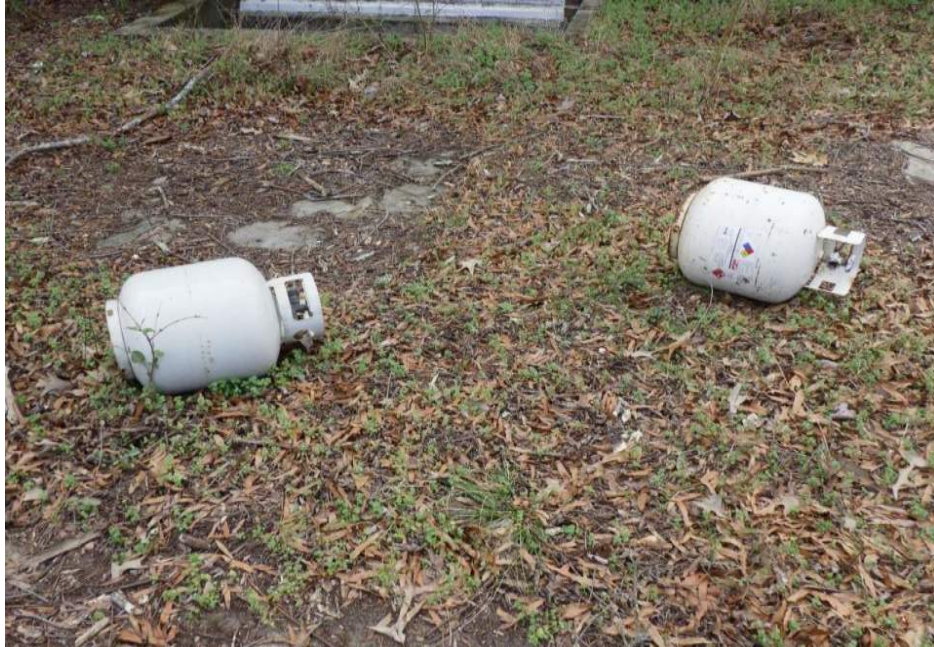
**Description:** propane tanks, 5lb size, laying on ground north of building

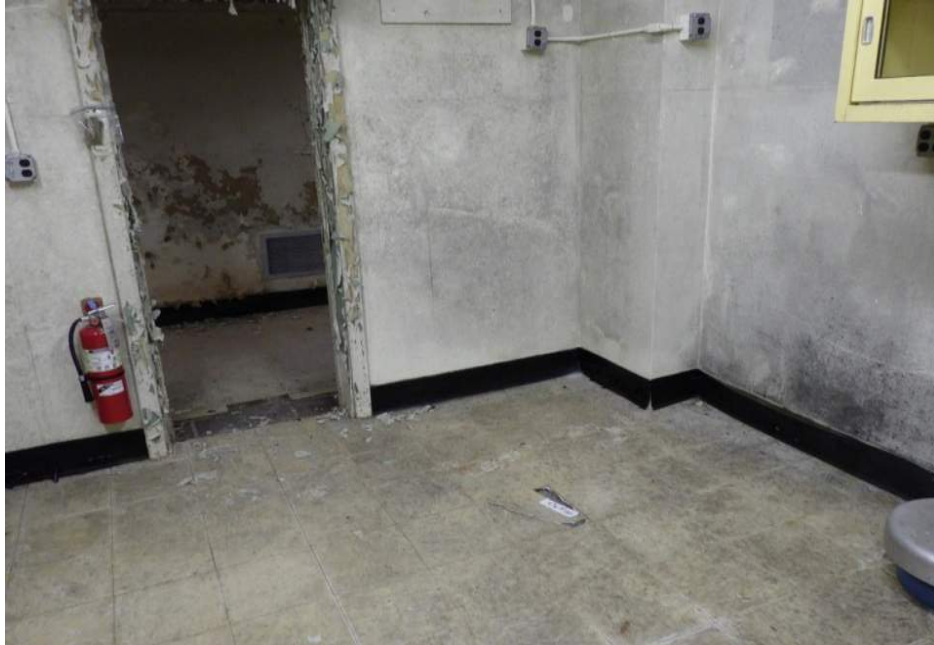
476A1

**Results:** None Detected

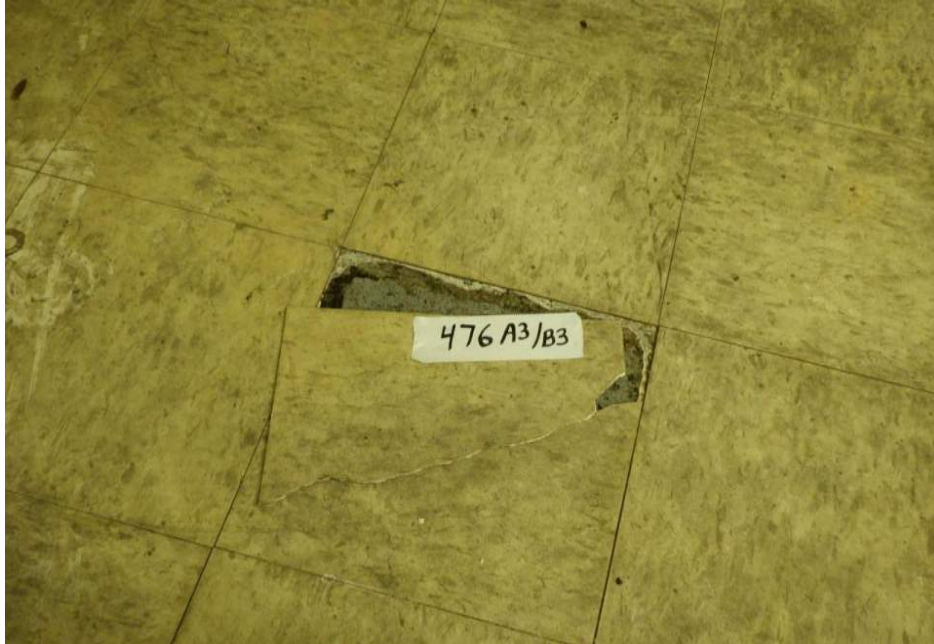
476A1

**Results:** None Detected

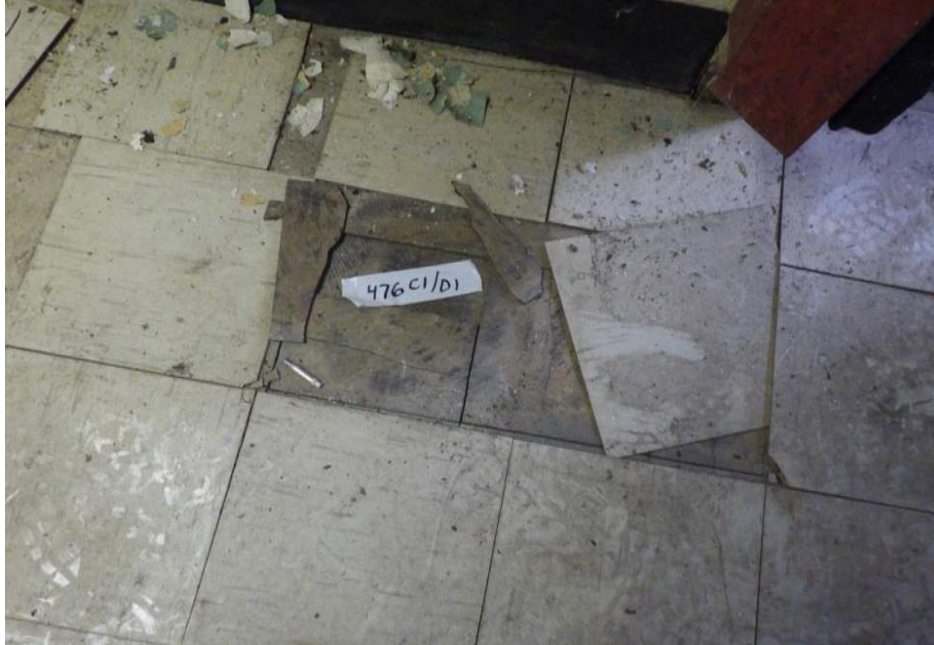
476C1

**Results:** Chrysotile 5-10%

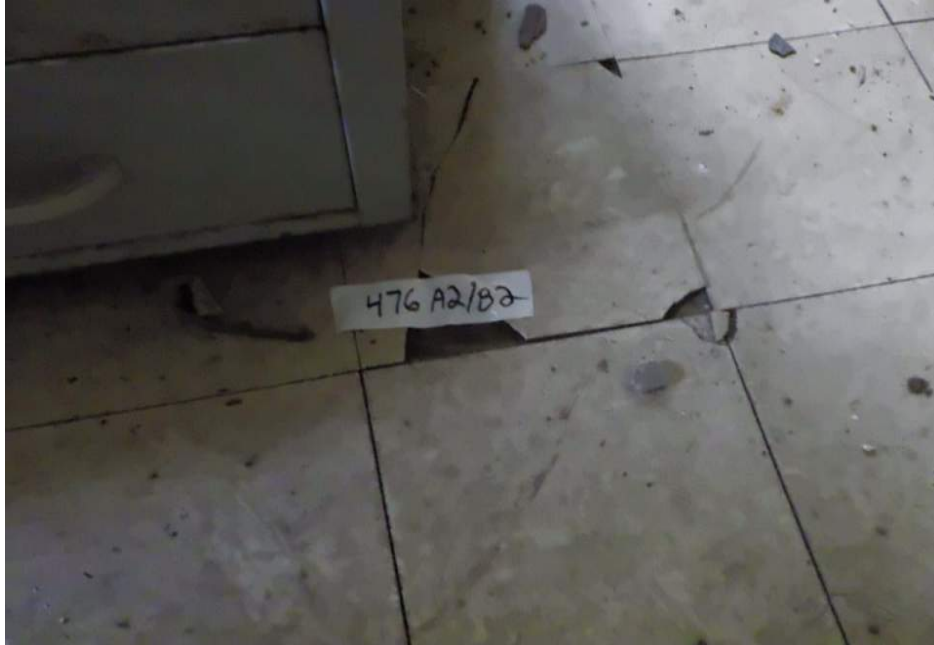
476A2

**Results:** None Detected

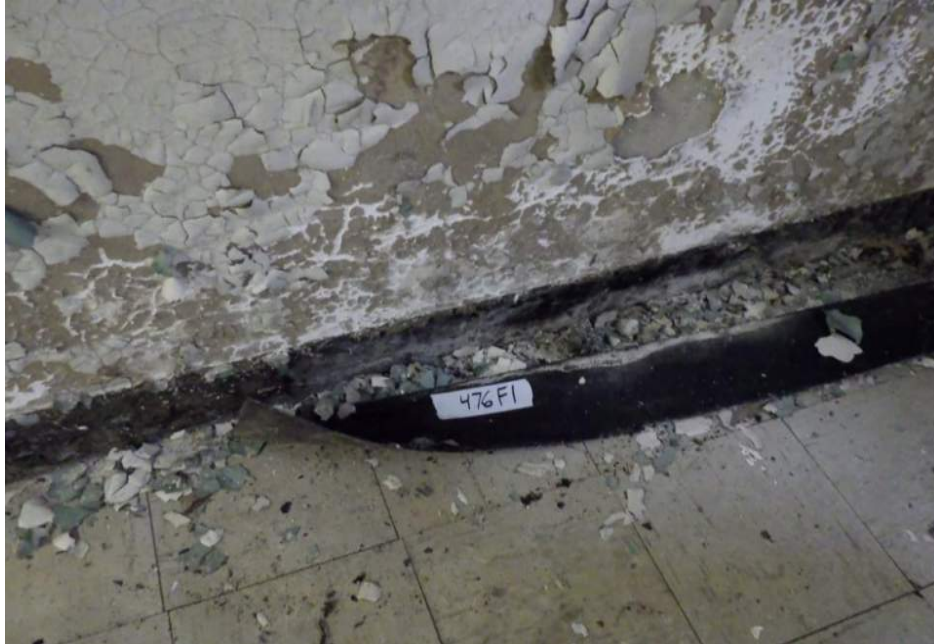
476F1

**Results:** None Detected

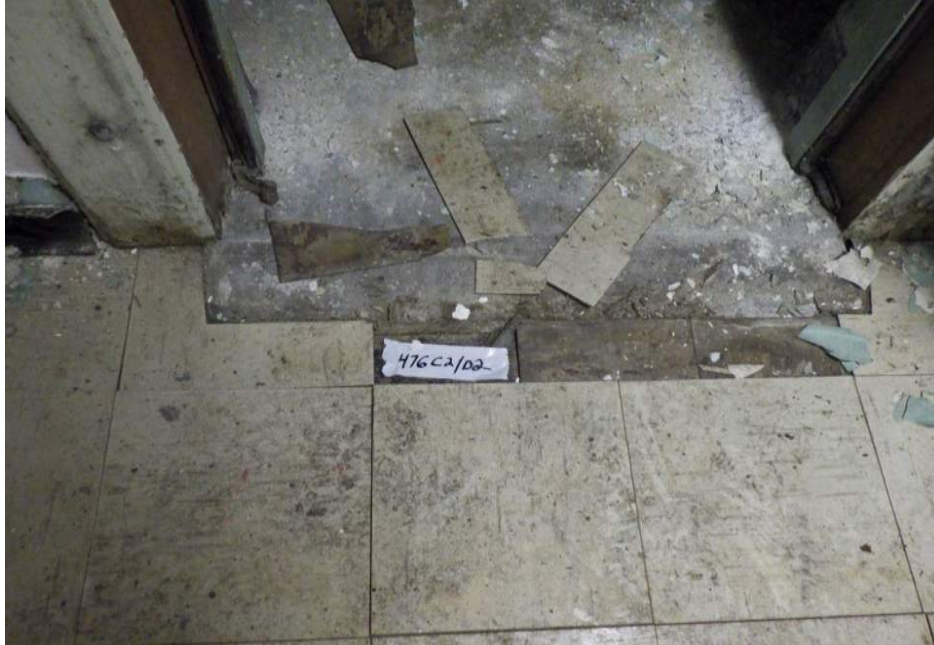
476C2

**Results:** None Detected

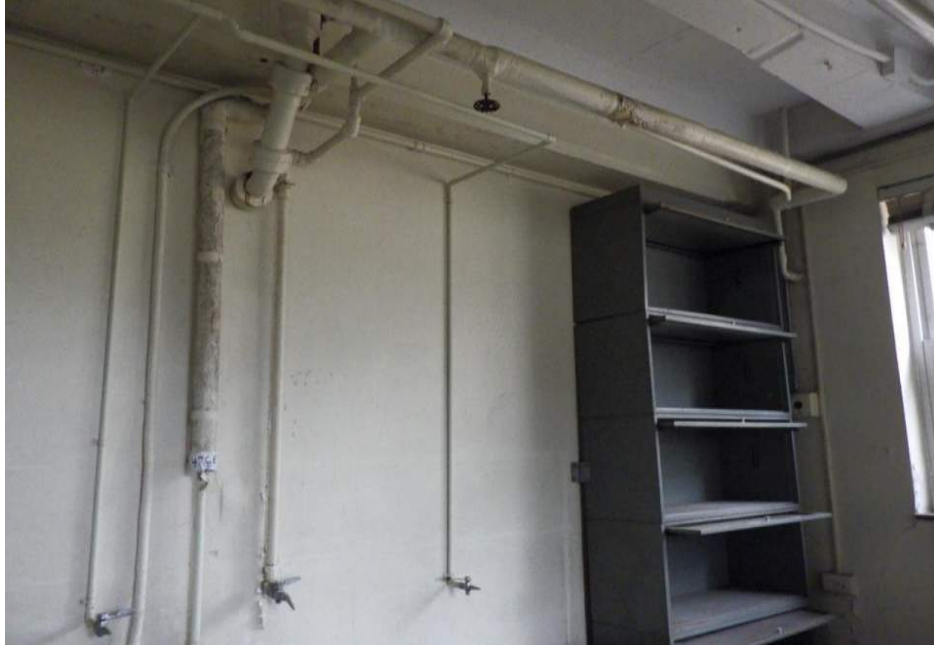
4.76E+03

**Results:** Chrysotile 5-10%

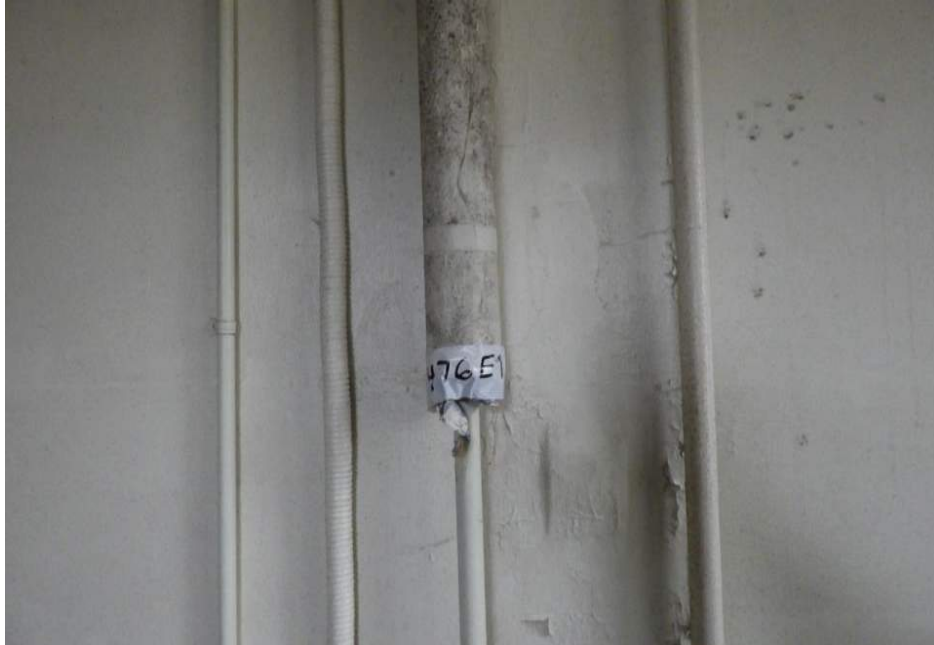
4.76E+03

**Results:** Chrysotile 10-15%

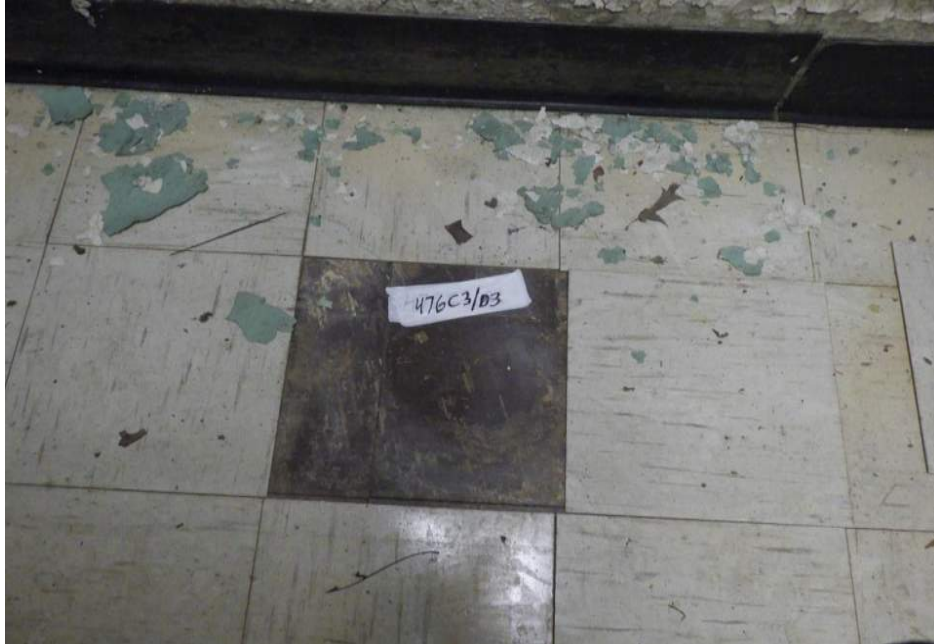
476C3

**Results:** Chrysotile 10-15%

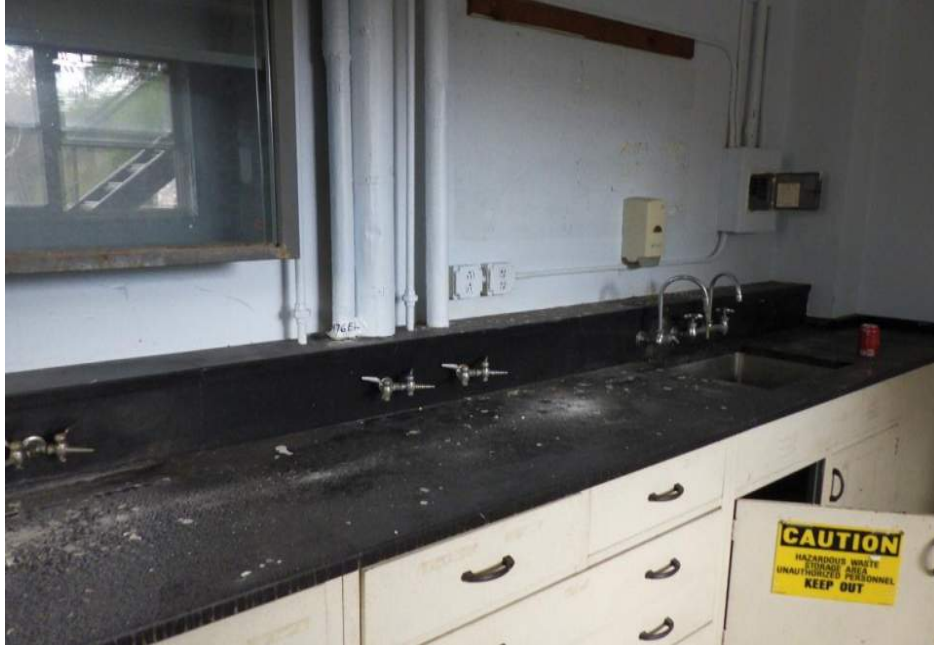
4.76E+04

**Results:** Chrysotile 5-10%

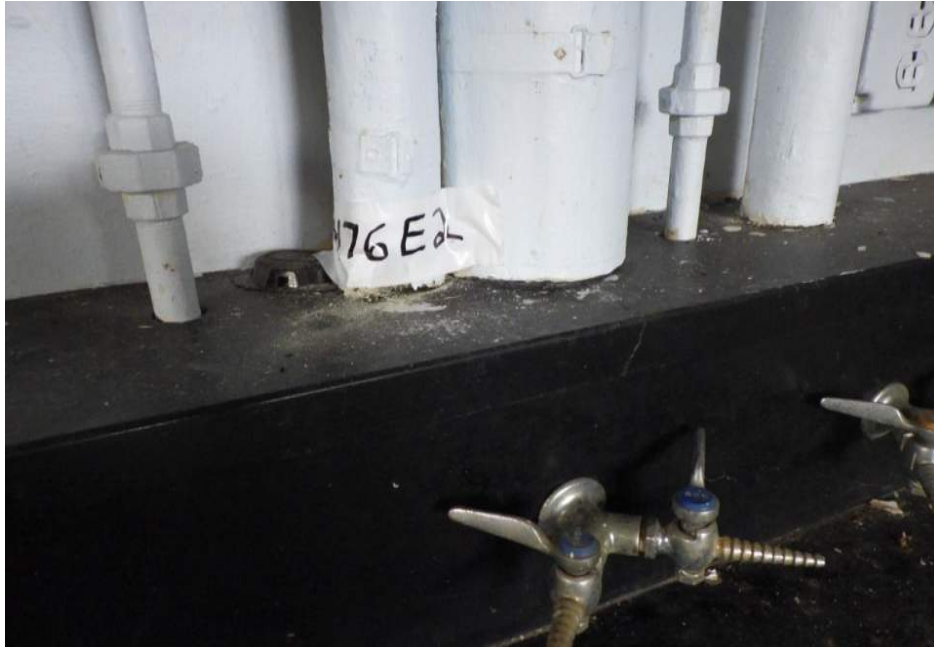
4.76E+04

**Results:** Chrysotile 10-15%

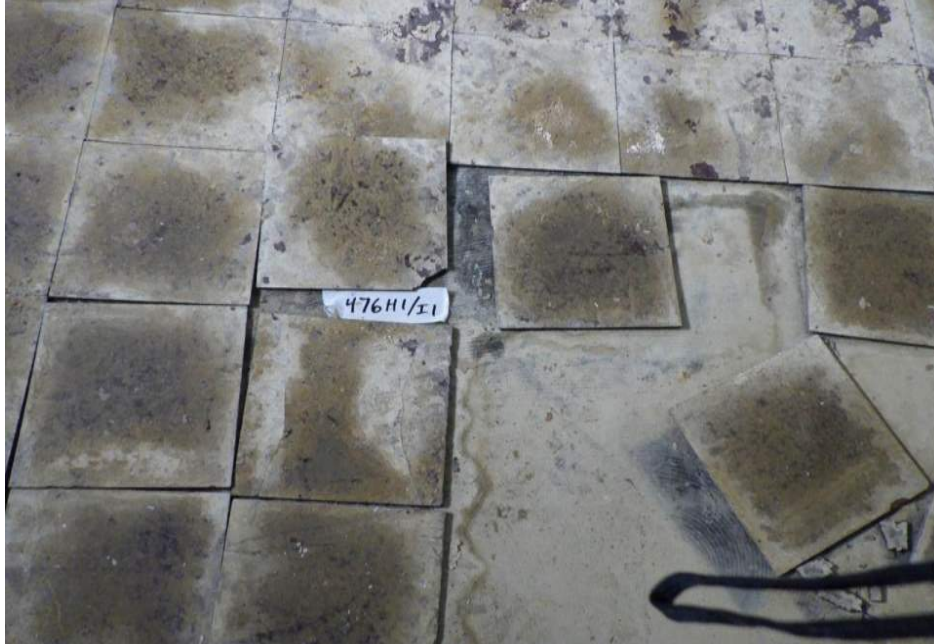
476H1

**Results:** Chrysotile 10-15%

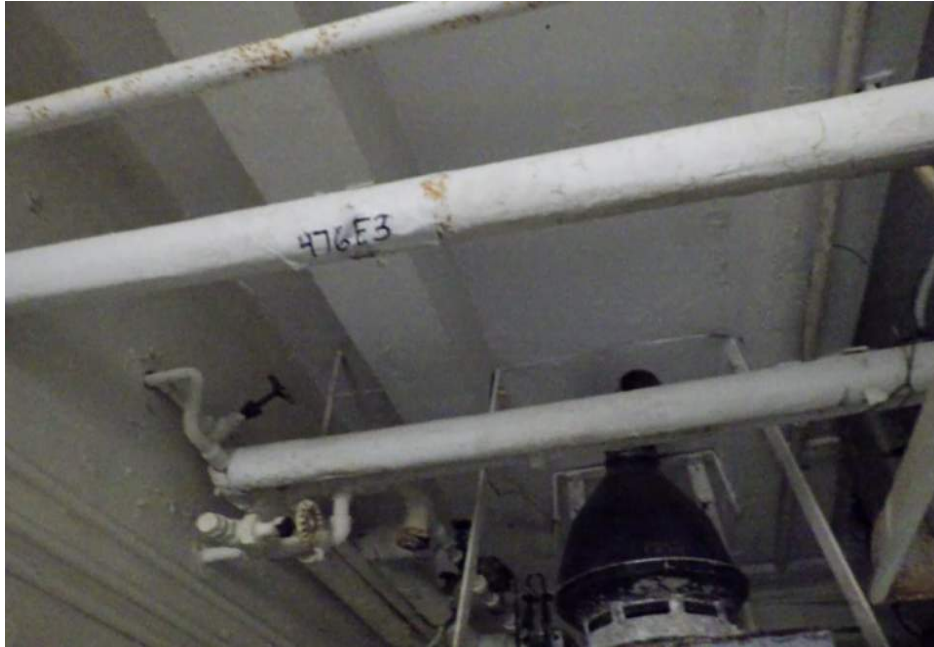
4.76E+05

**Results:** Chrysotile 5-10%

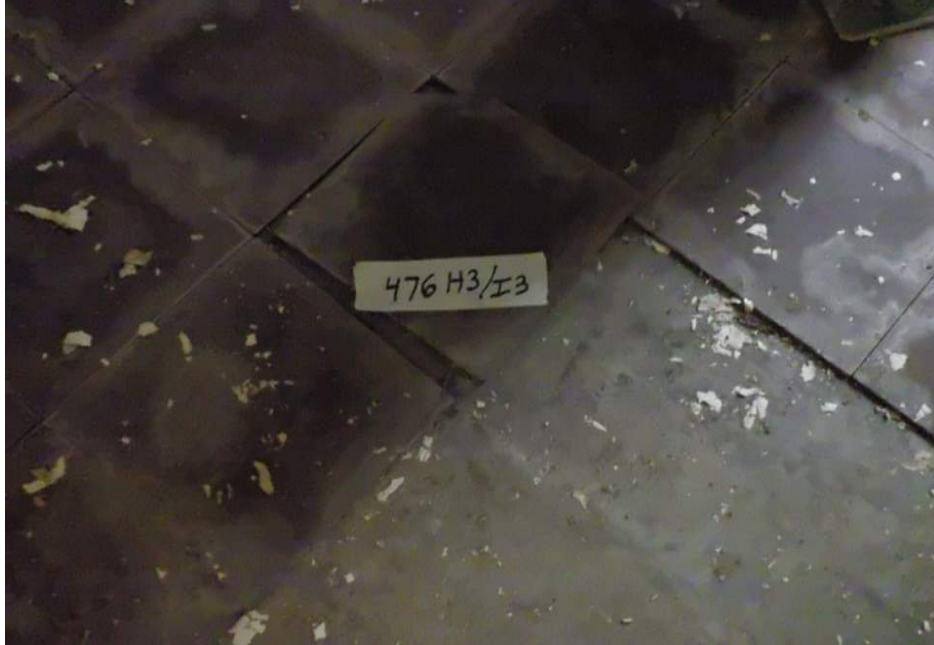
476H3

**Results:** Chrysotile 10-15%

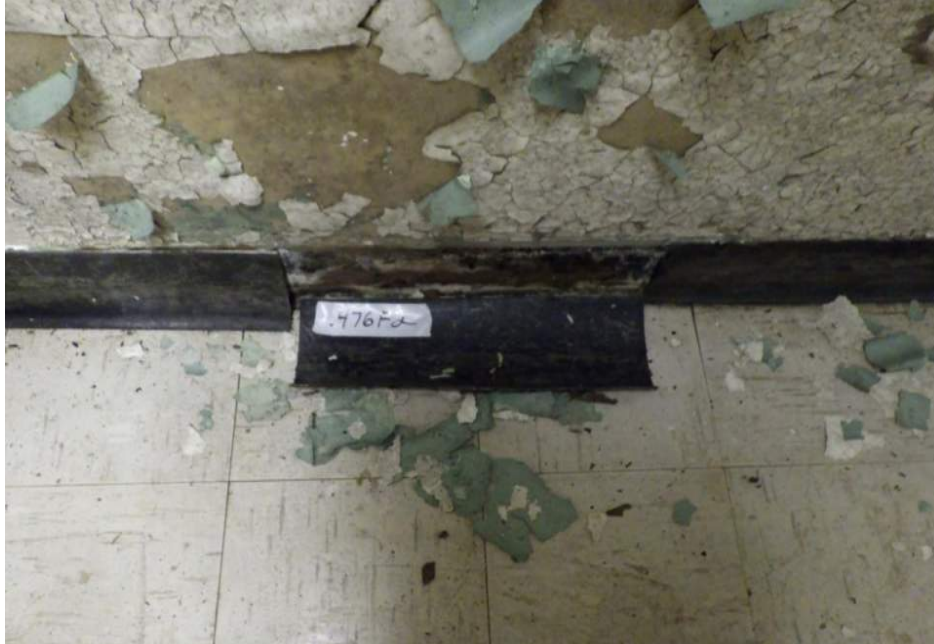
476F2

**Results:** Chrysotile 5-10%

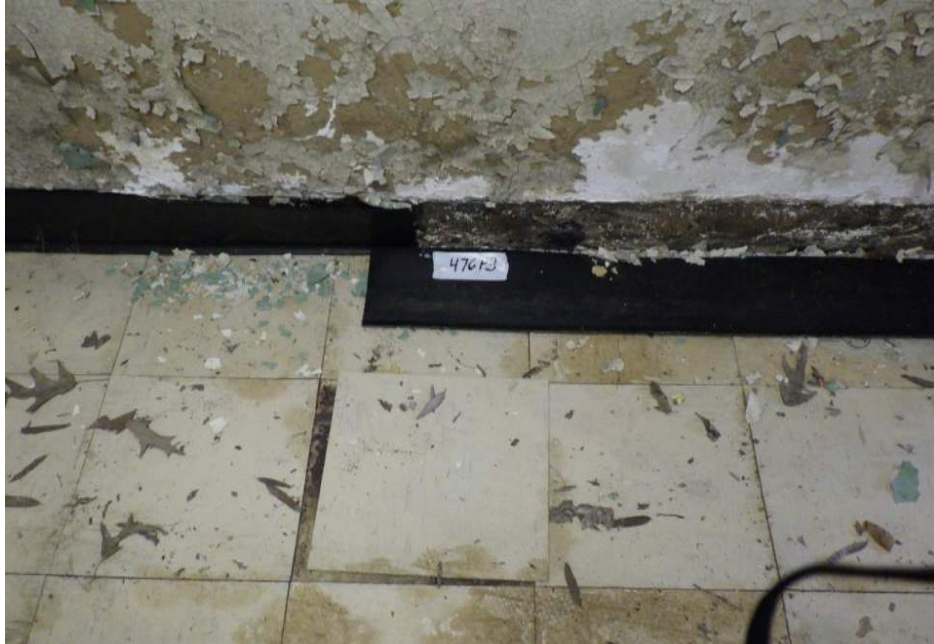
476F3

**Results:** None Detected
