# Beltsville Agricultural Research Center Hazardous Materials Assessment Part 2

**Beltsville Agricultural Research Center  
Hazardous Materials Assessment  
Project No. 103144**

**Revision 1  
April 22, 2020**

**Burns & McDonnell Engineering Company, Inc.  
Downers Grove, Illinois**

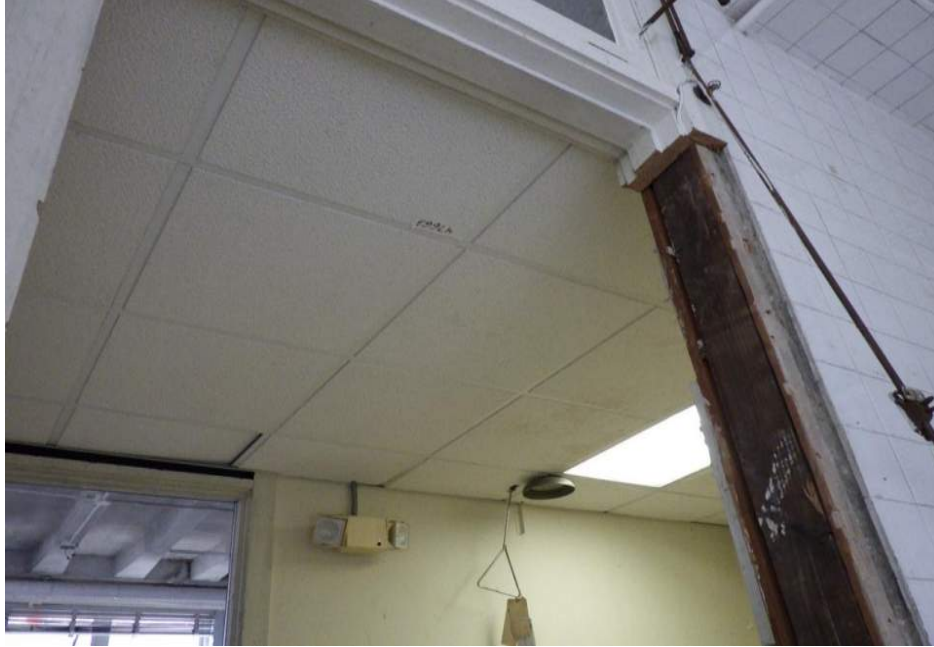
476G3

**Results:** None Detected

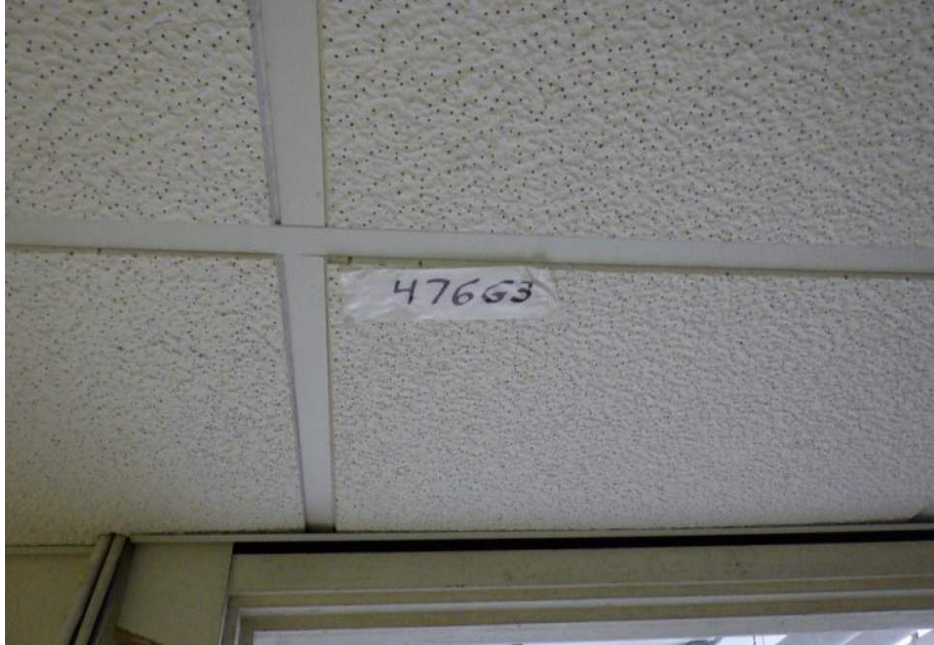
476G3

**Results:** None Detected

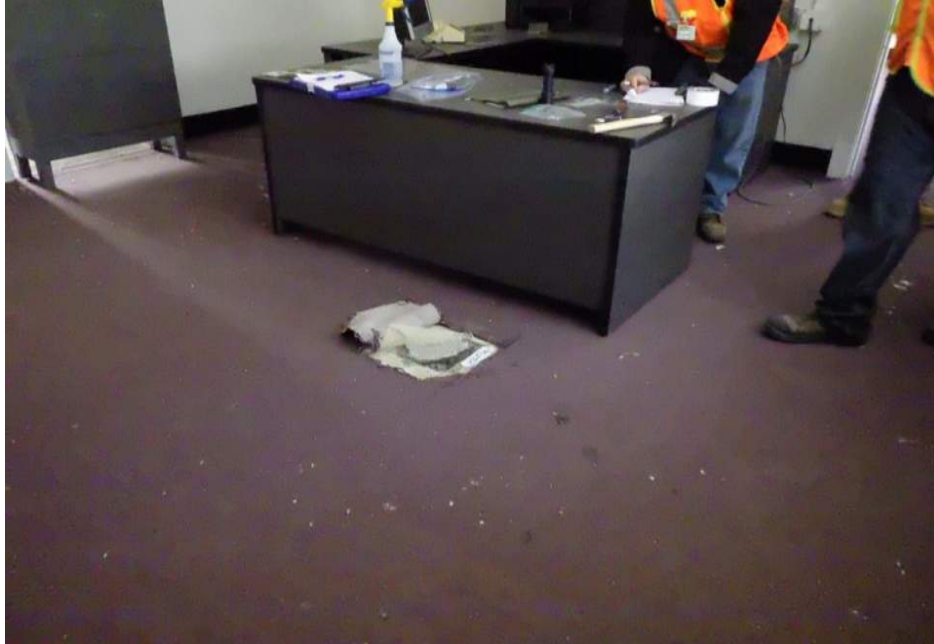
476J1

**Results:** None Detected

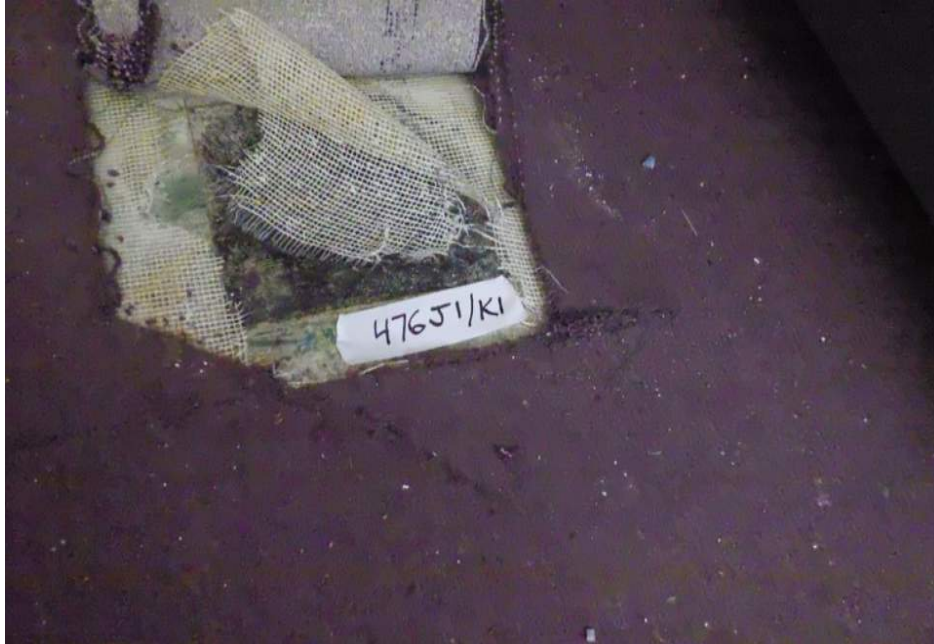
476J1

**Results:** Chrysotile 1-5%

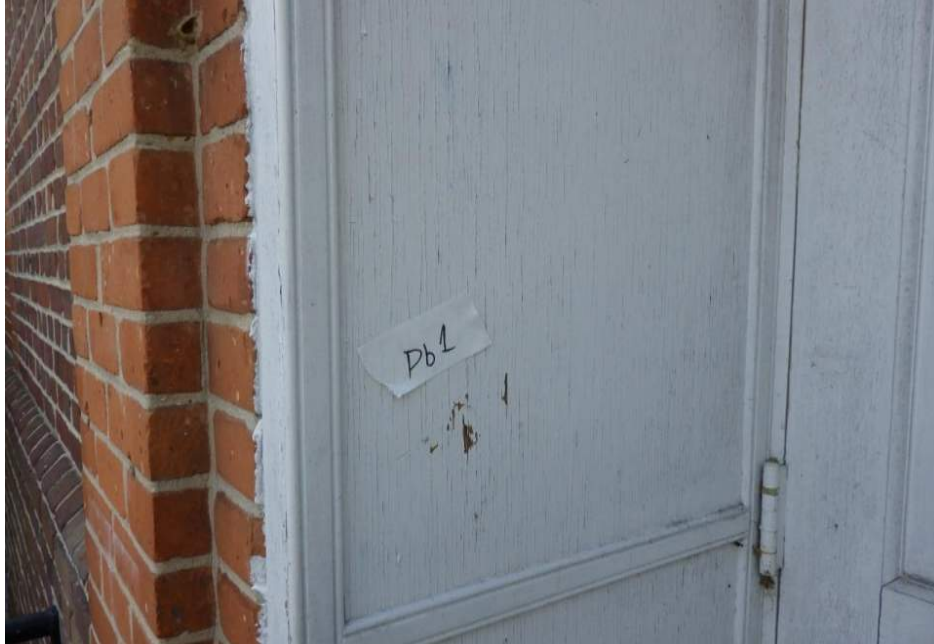
476-Pb1

**Results:**

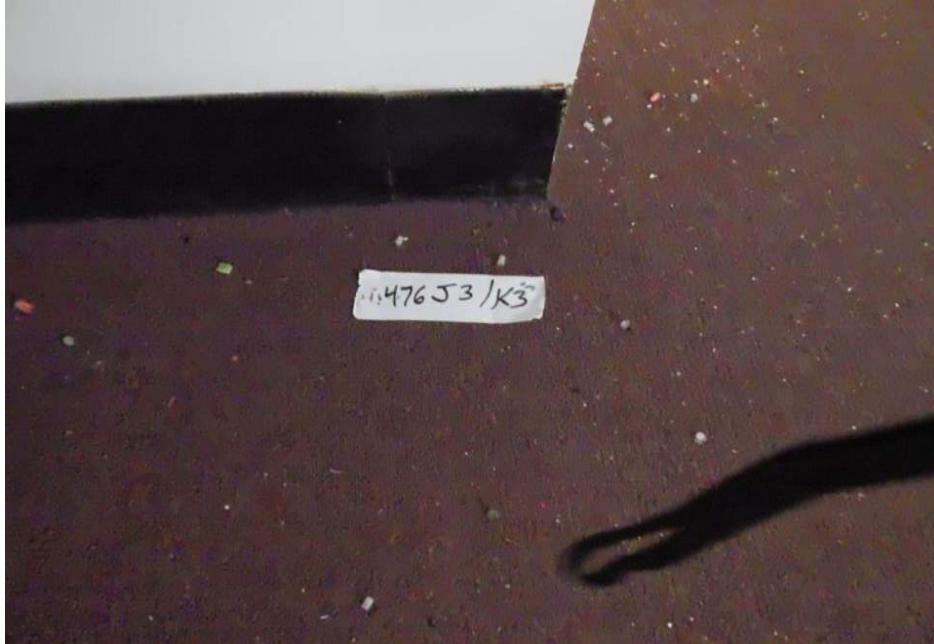
476J3

**Results:** < 98 ppm

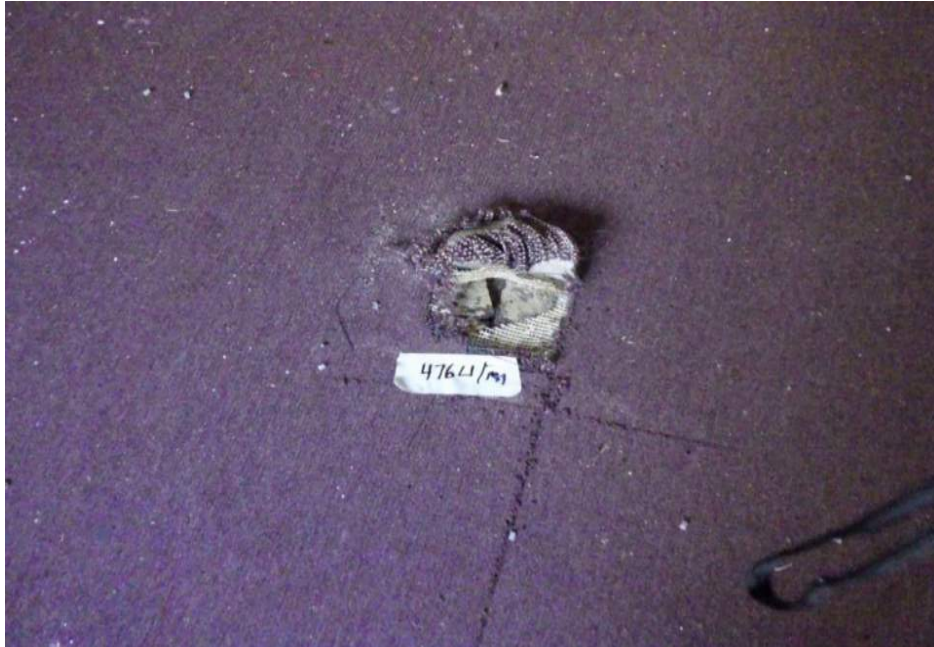
476L1

**Results:** Chrysotile 1-5%

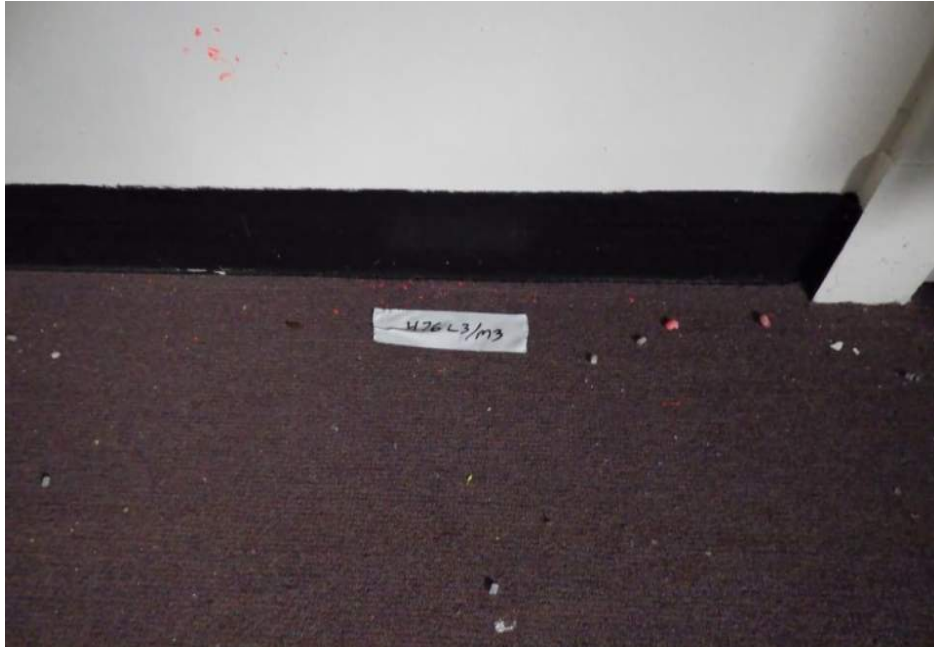
476L3

**Results:** Chrysotile 5-10%

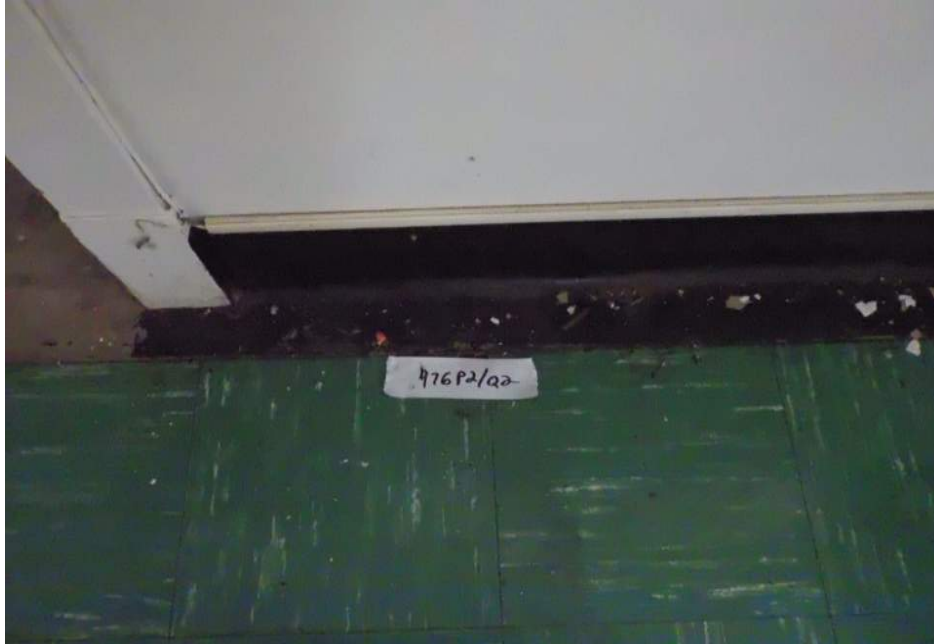
476P2

**Results:** Chrysotile 5-10%

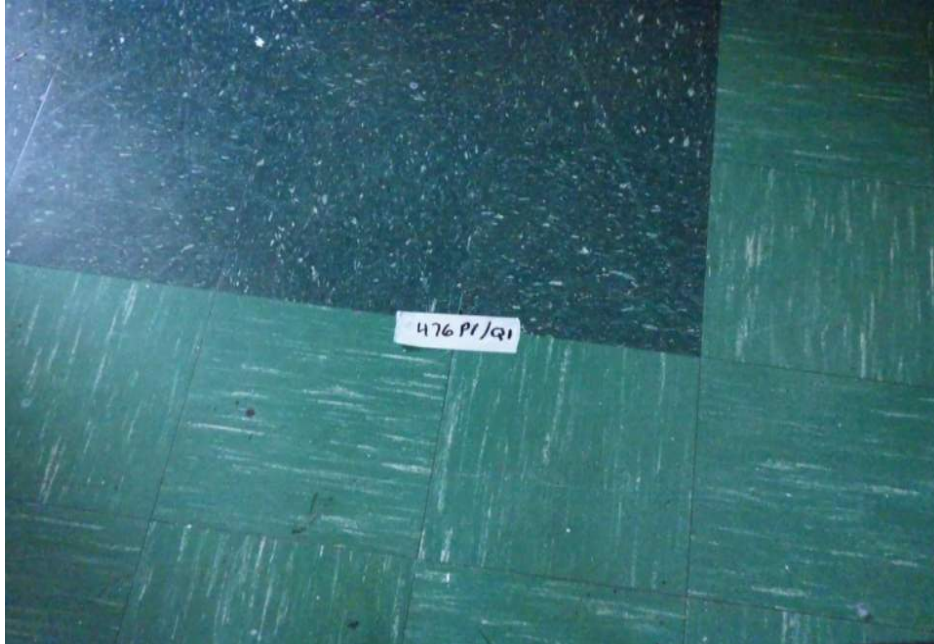
476P1

**Results:** Chrysotile 1-5%

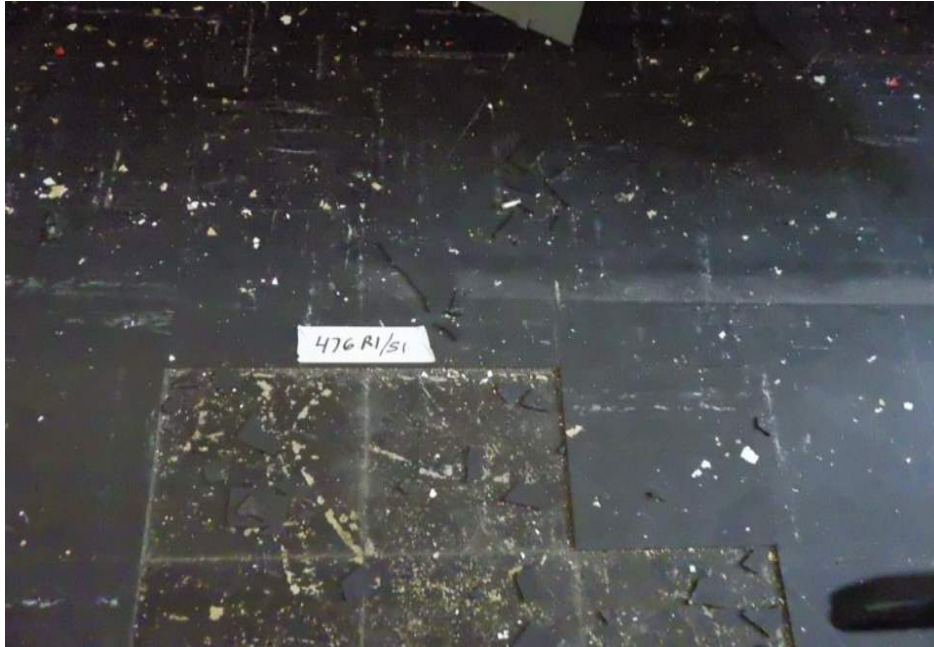
476R1

**Results:** Chrysotile 1-5%

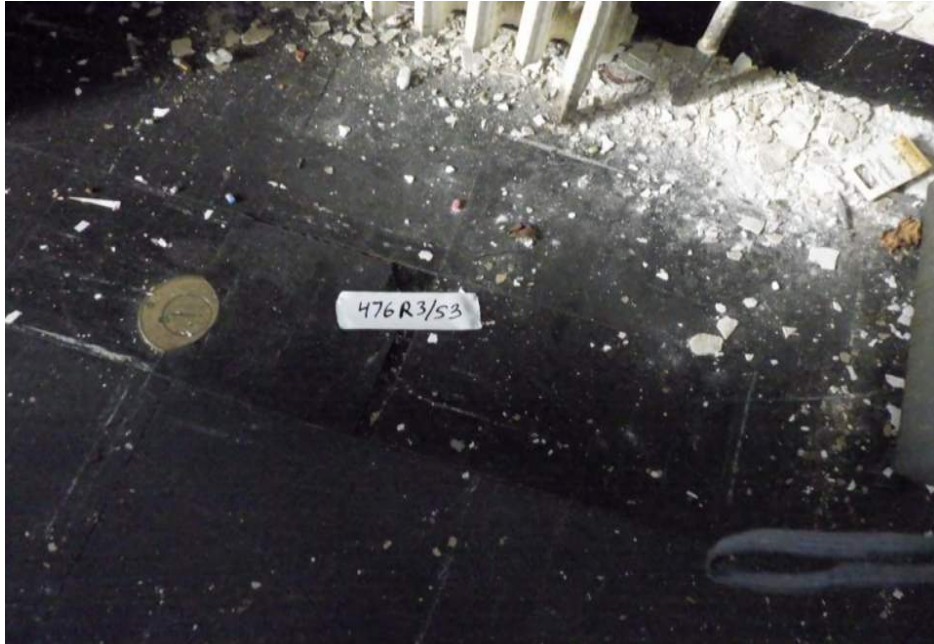
476R3

**Results:** Chrysotile 1-5%

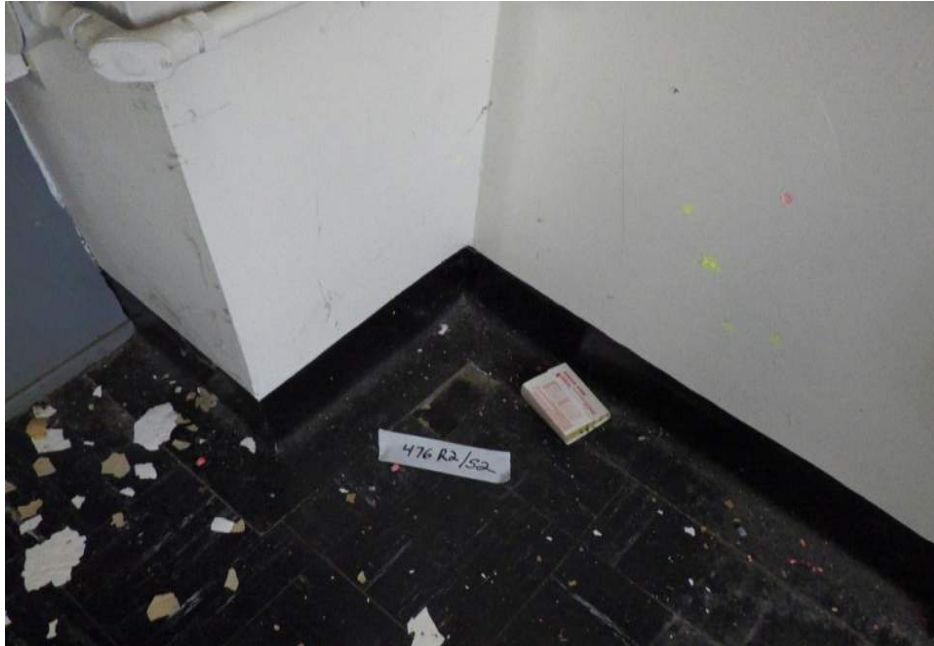
476R2

**Results:** Chrysotile 1-5%

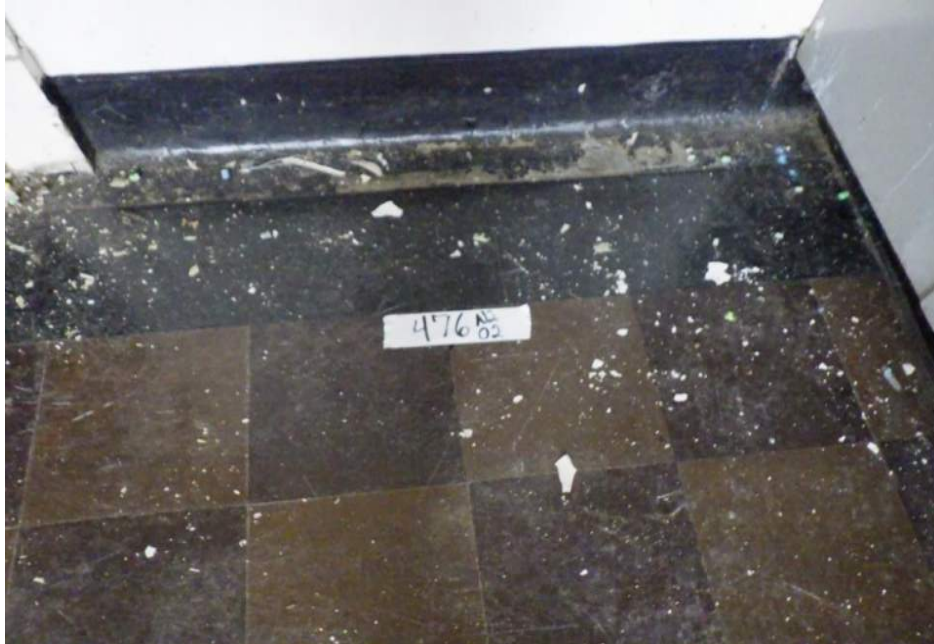
476N2

**Results:** Chrysotile 1-5%

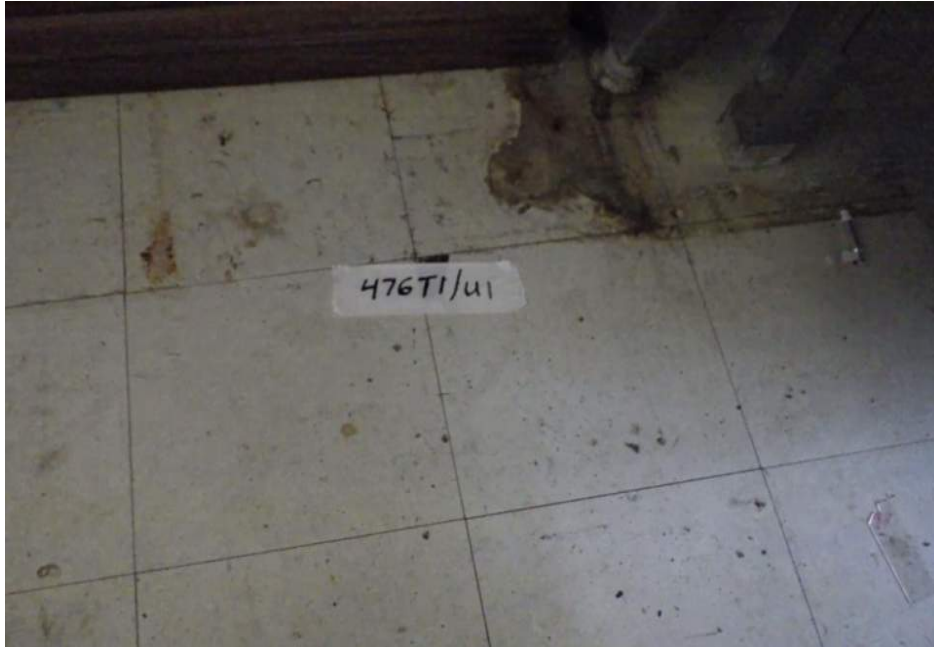
476T1

**Results:** Chrysotile 5-10%

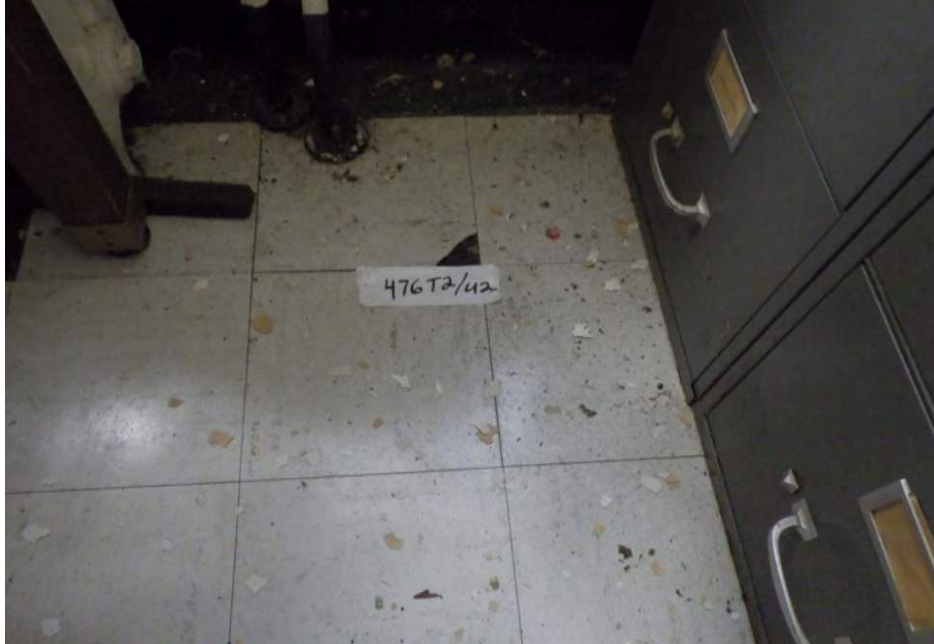
476T2

**Results:** Chrysotile 1-5%

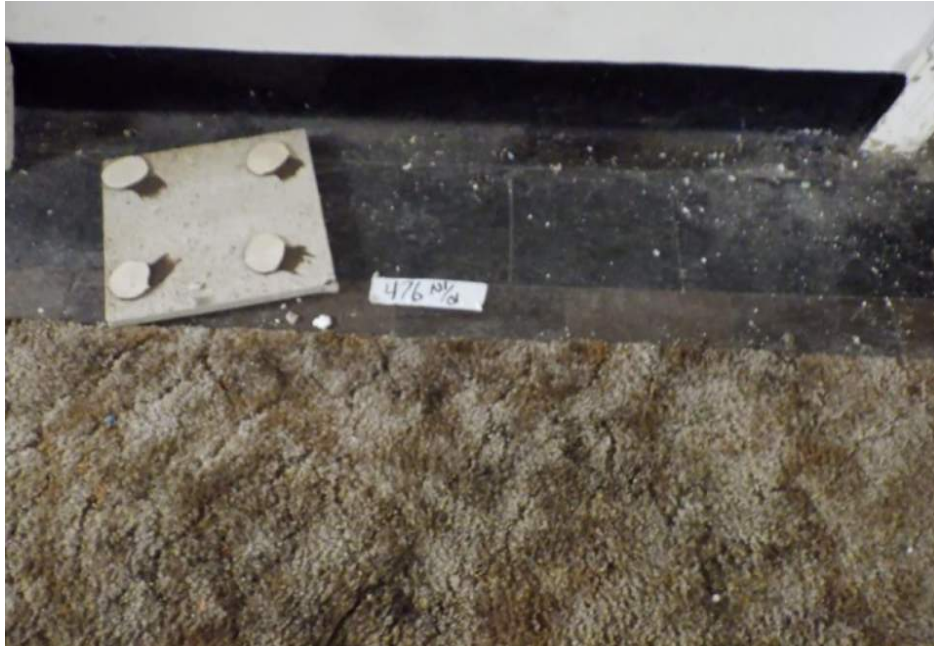
476N1

**Results:** Chrysotile 1-5%

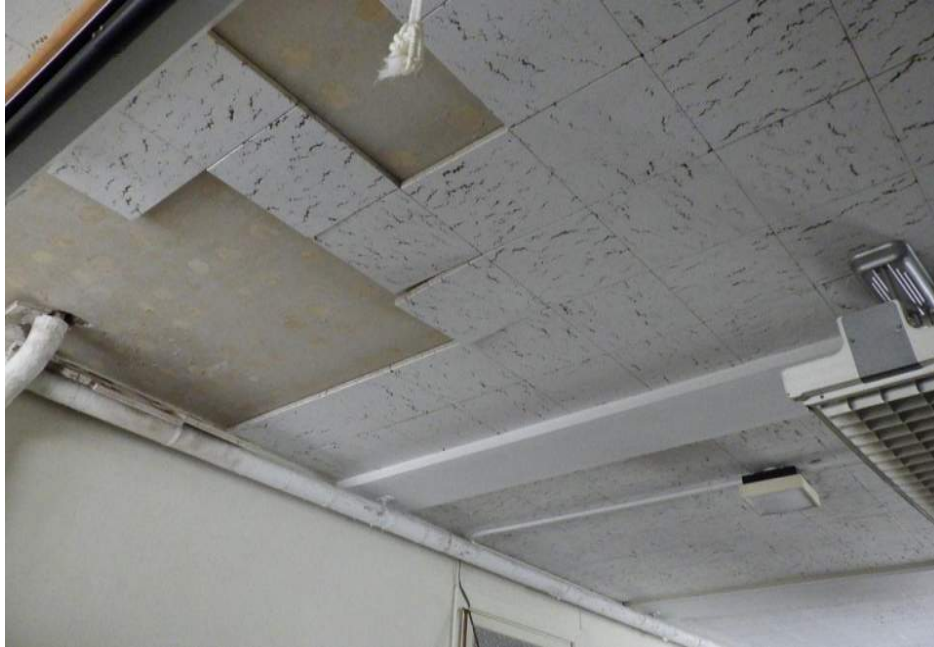
476V2

**Results:** Chrysotile 5-10%

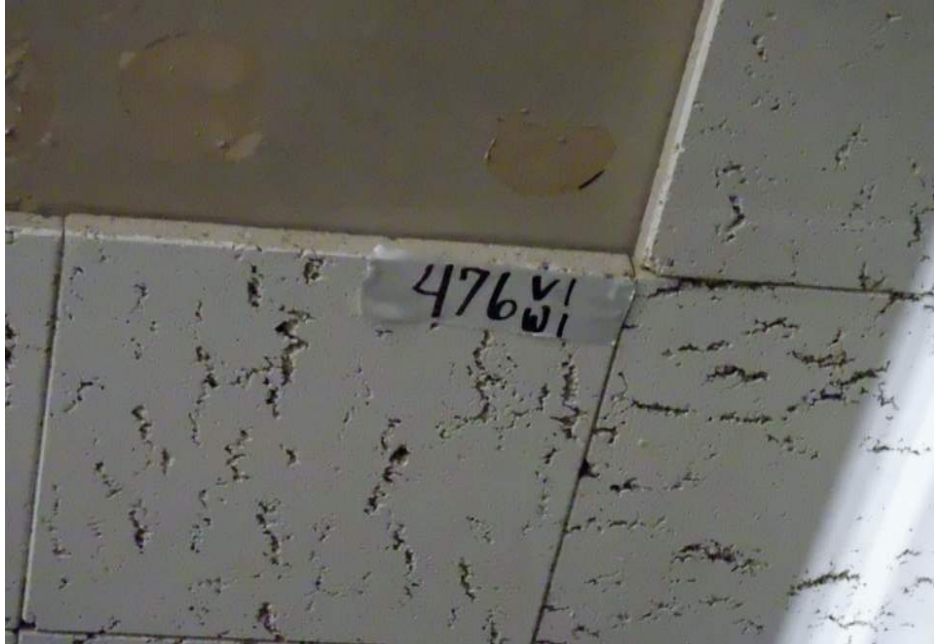
476V1

**Results:** None Detected

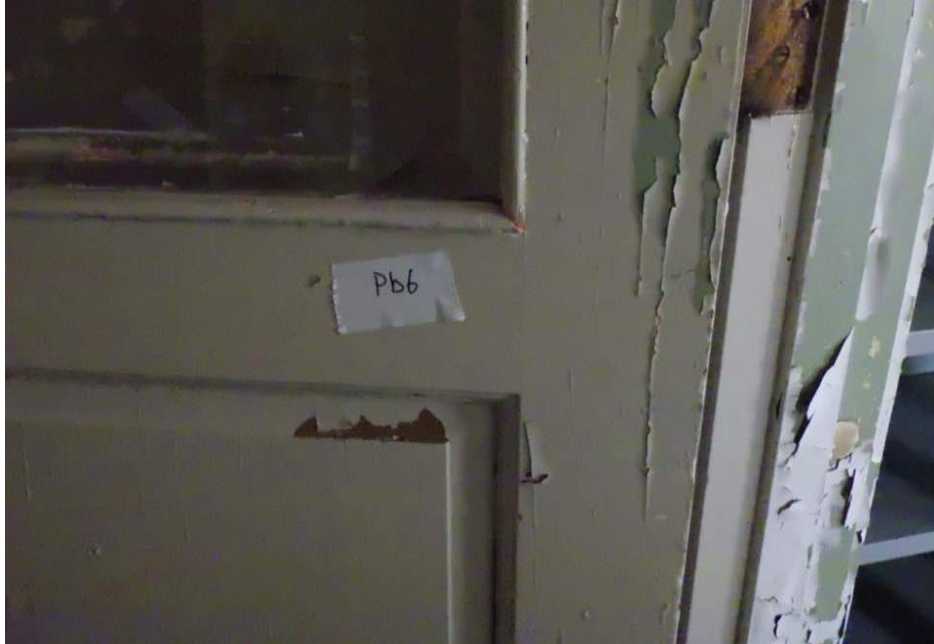
476-Pb6

**Results:** None Detected

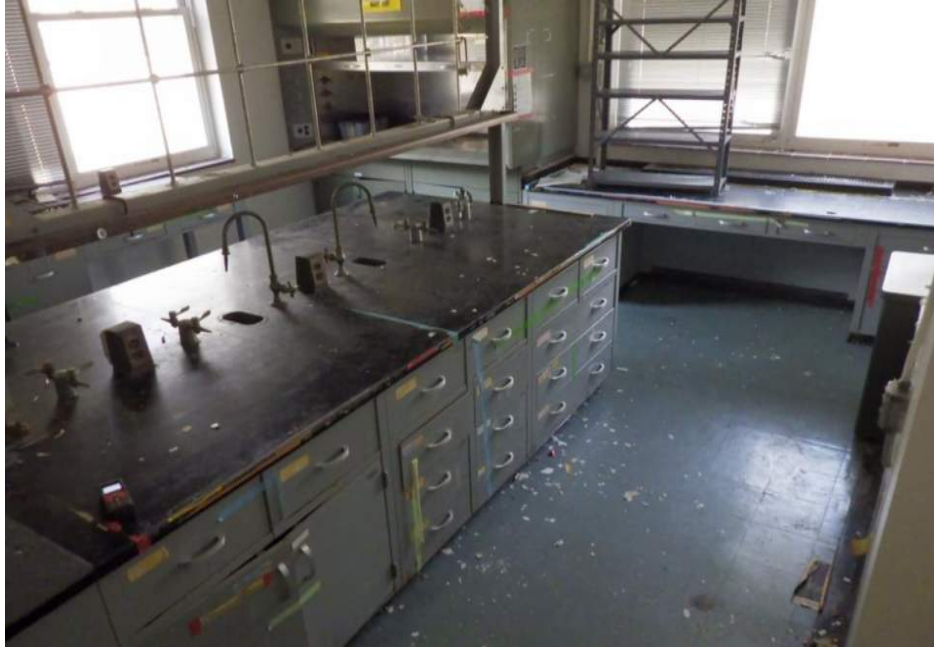
476X2

**Results:** 1300 ppm

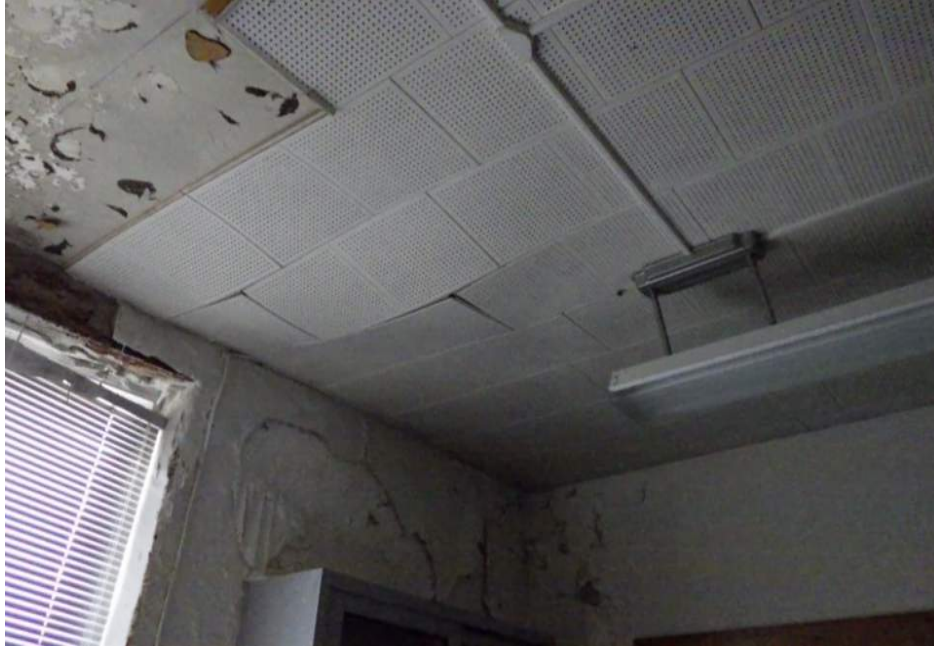
476EE1

**Results:** Chrysotile 1-5%

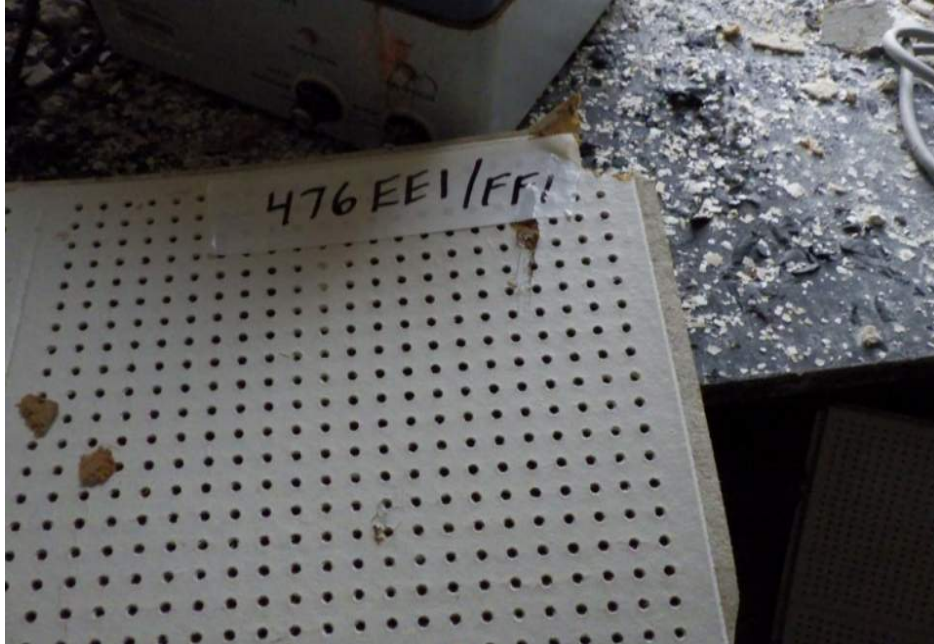
476EE1

**Results:** None Detected

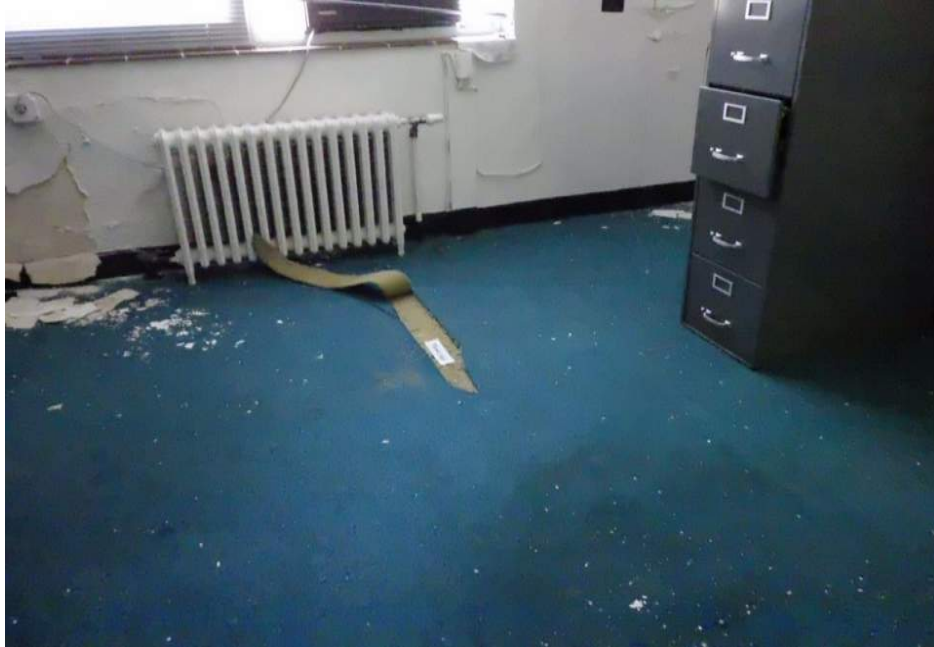
476GG1

**Results:** None Detected

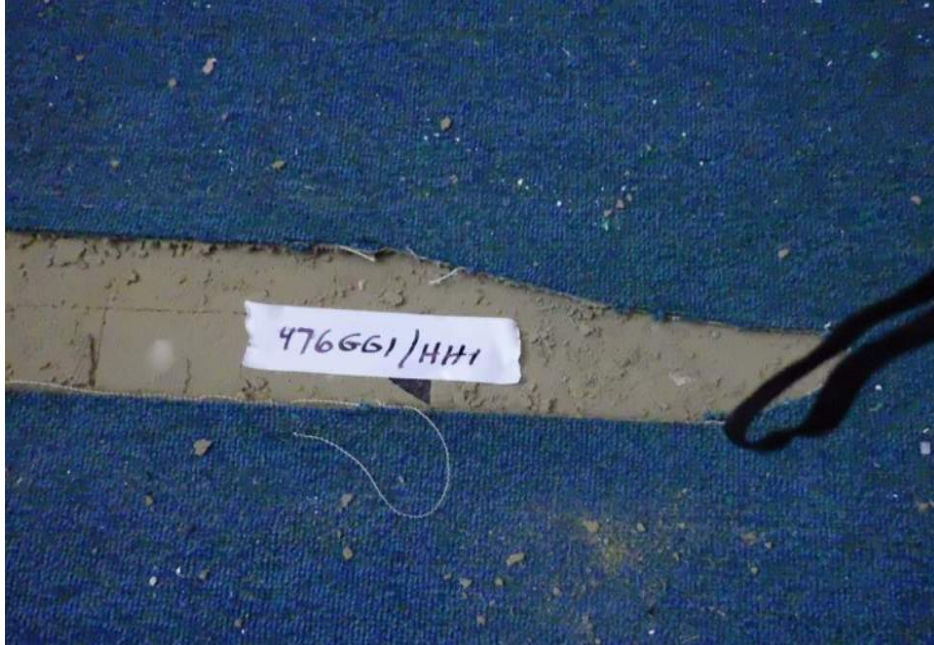
476GG1

**Results:** Chrysotile 5-10%

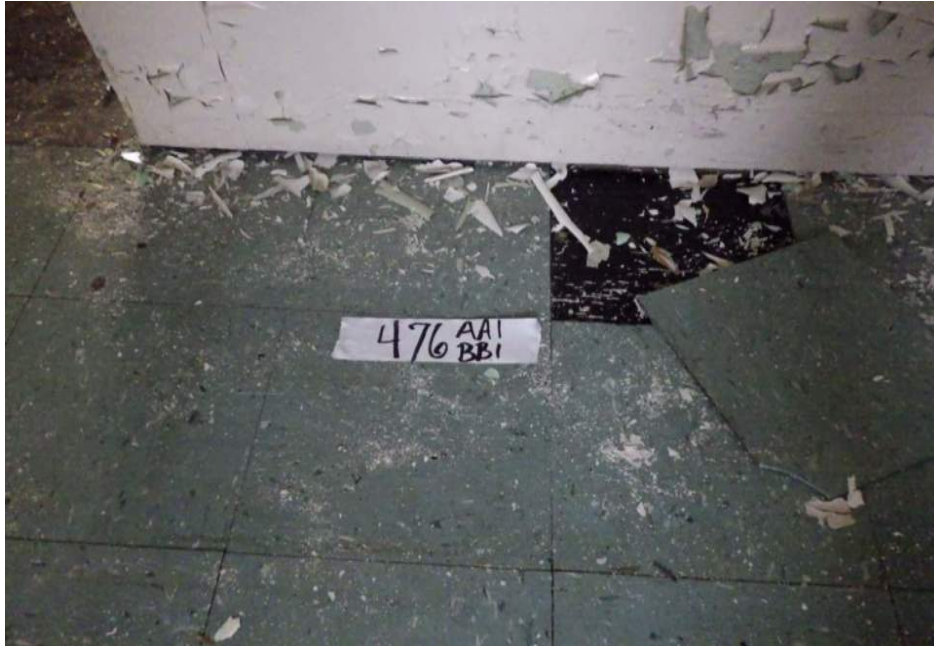
476AA

**Results:** Chrysotile 5-10%

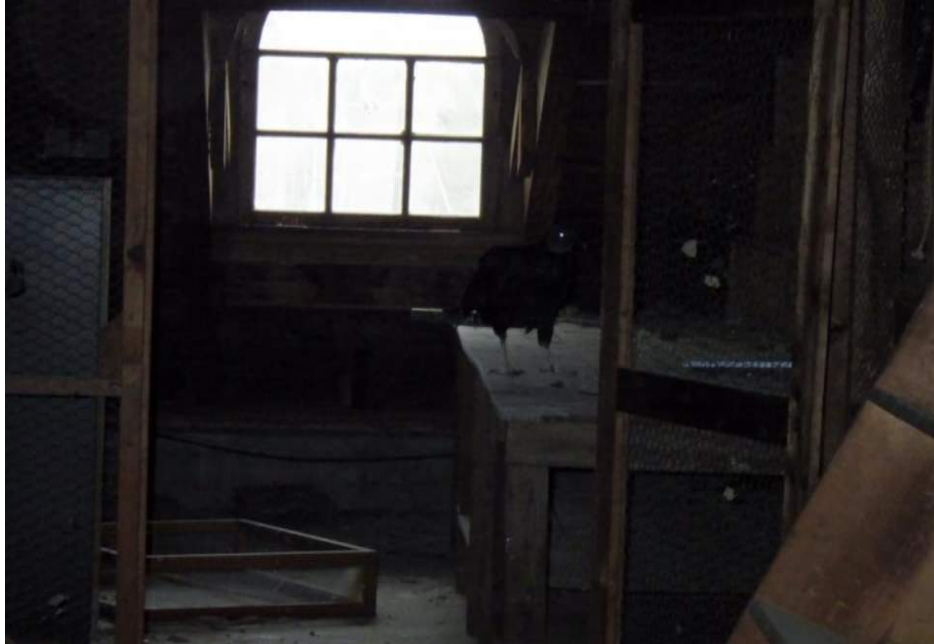
**Description:** vulture in attic

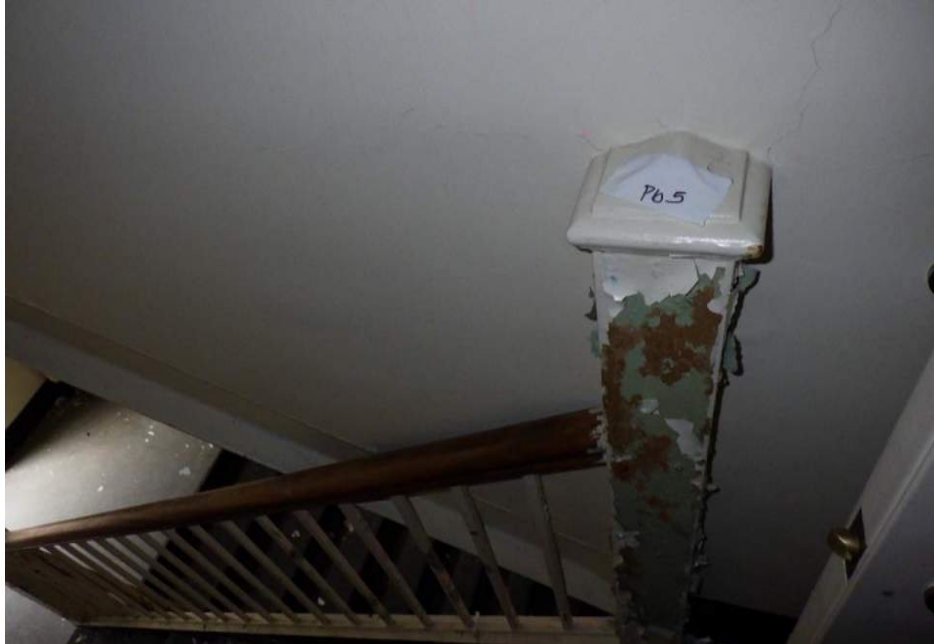
476-Pb5

**Results:**

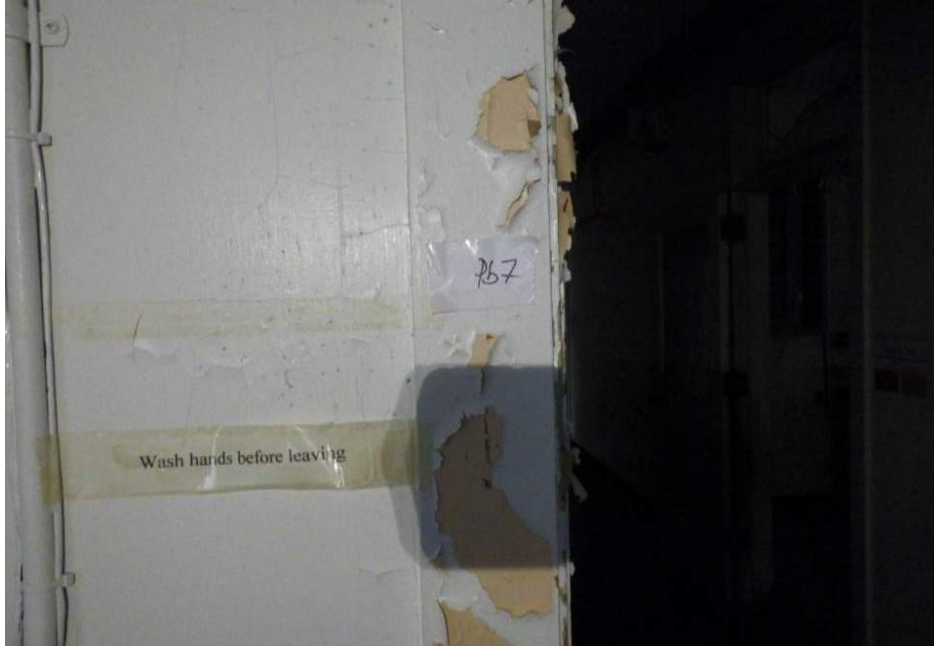
476-Pb7

**Results:** 1100 ppm

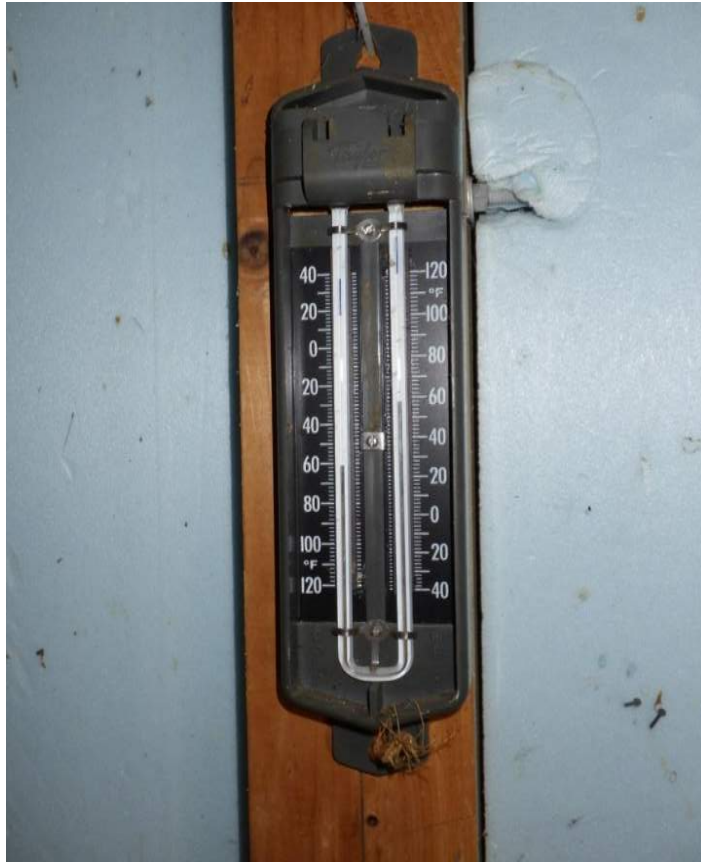
**Description:** mercury thermometer

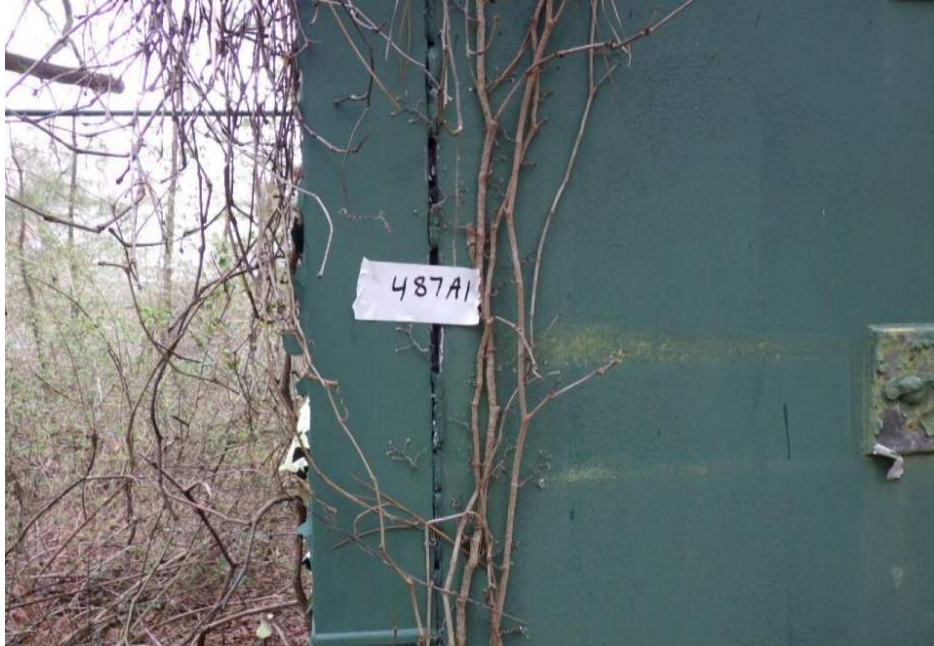
487A1

**Results:**

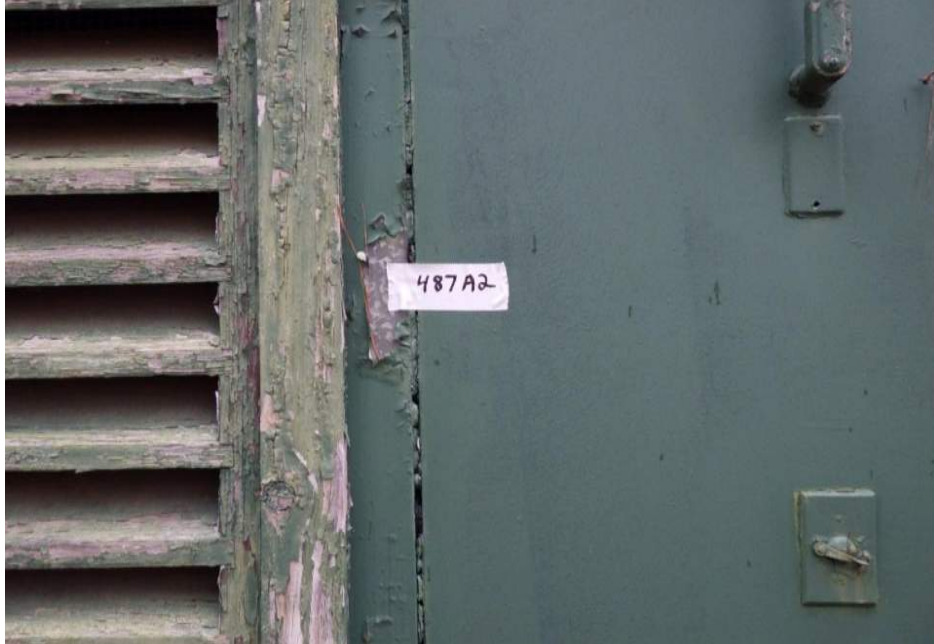
487A2

**Results:** None Detected

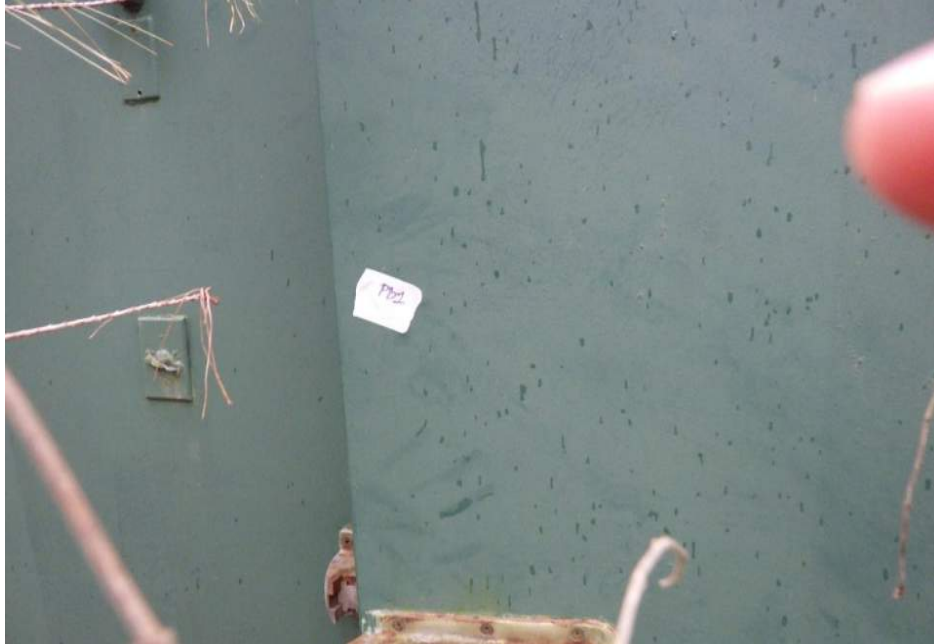
487-Pb2

**Results:** None Detected

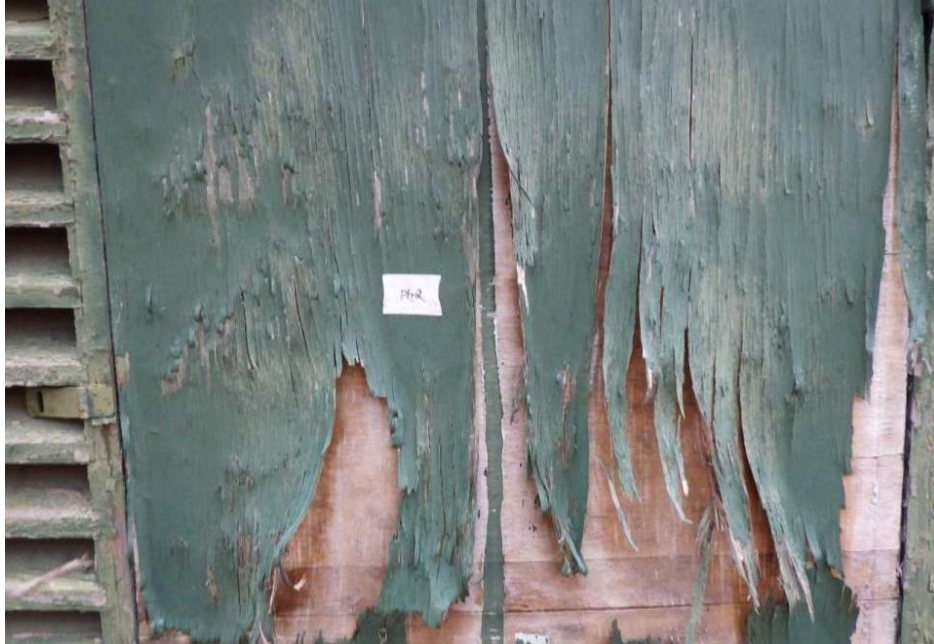
487-Pb1

**Results:** 510 ppm

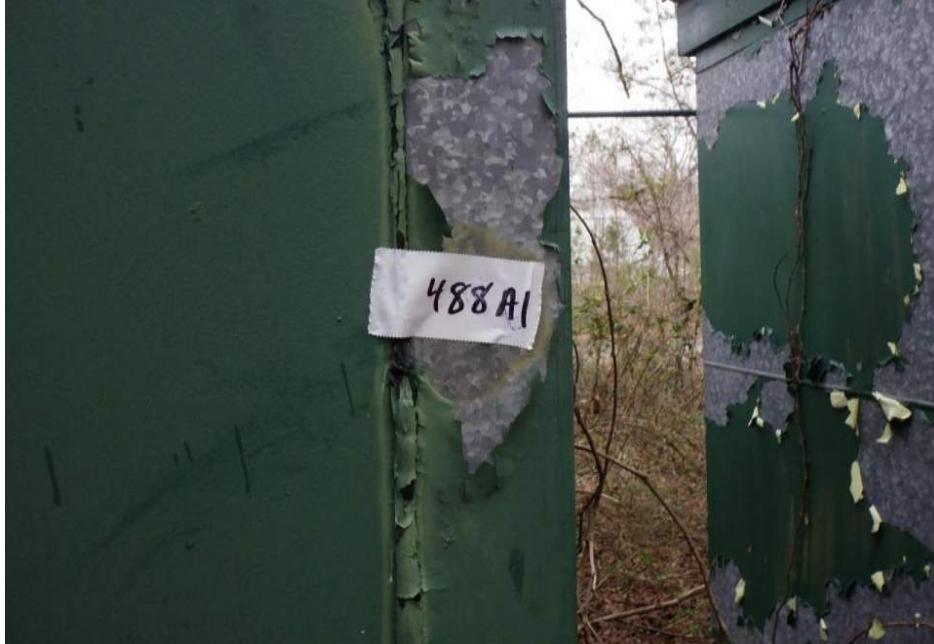
488A1

**Results:**

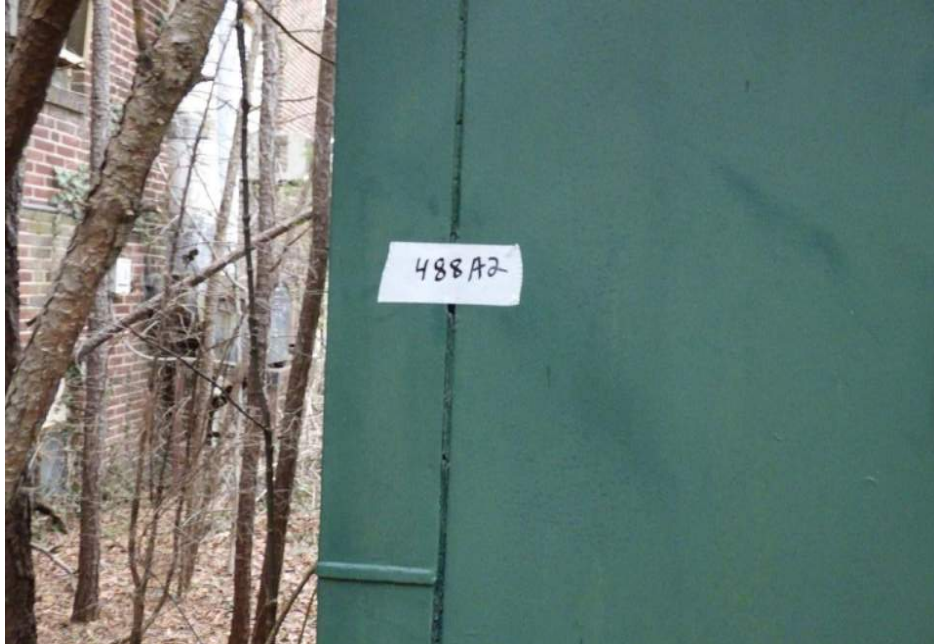
488A2

**Results:** None Detected

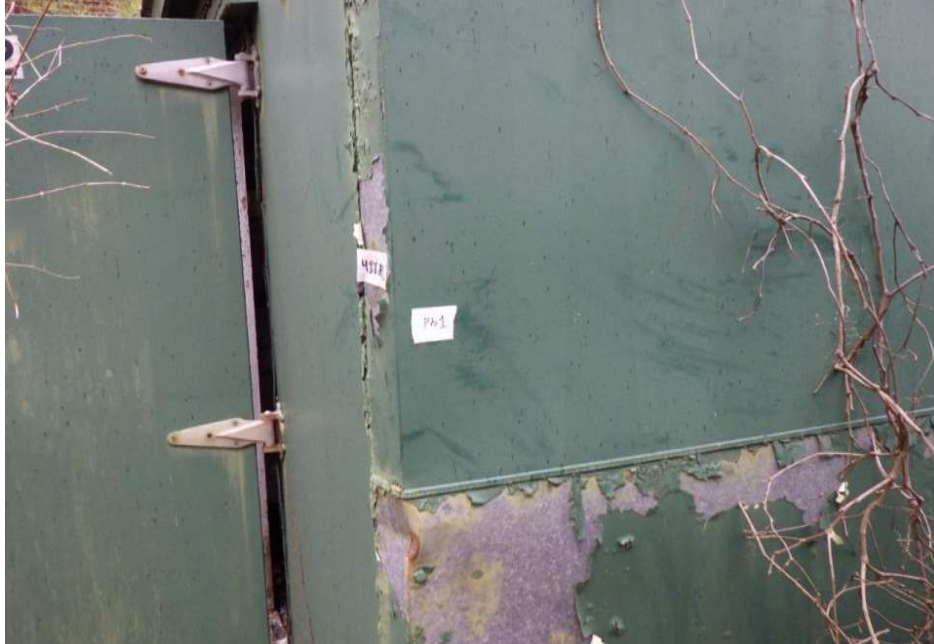
488-Pb2

**Results:** None Detected

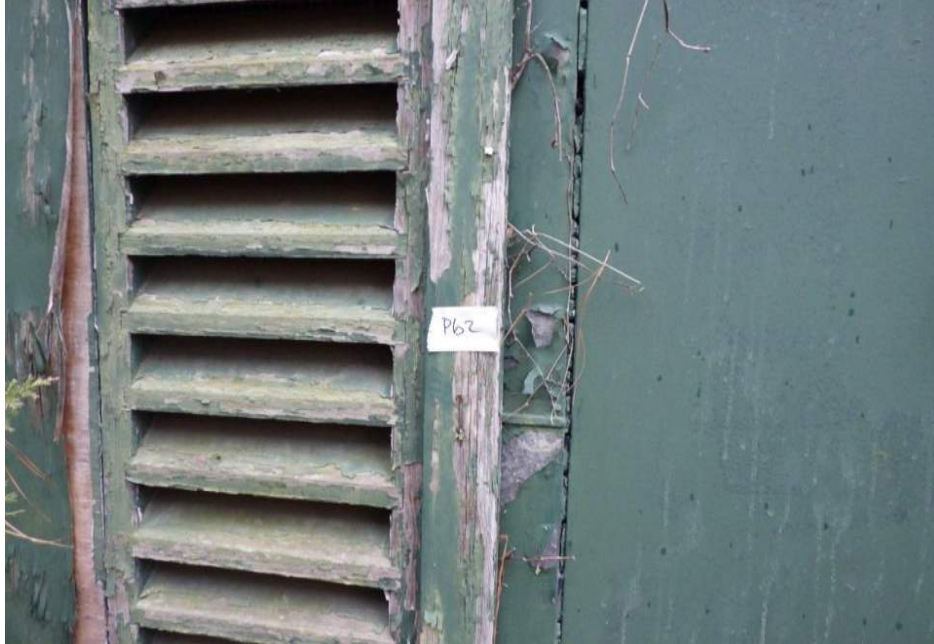
488-Pb1

**Results:** 380 ppm
