# Beltsville Agricultural Research Center Hazardous Materials Assessment Part 2

**Beltsville Agricultural Research Center  
Hazardous Materials Assessment  
Project No. 103144**

**Revision 1  
April 22, 2020**

**Burns & McDonnell Engineering Company, Inc.  
Downers Grove, Illinois**

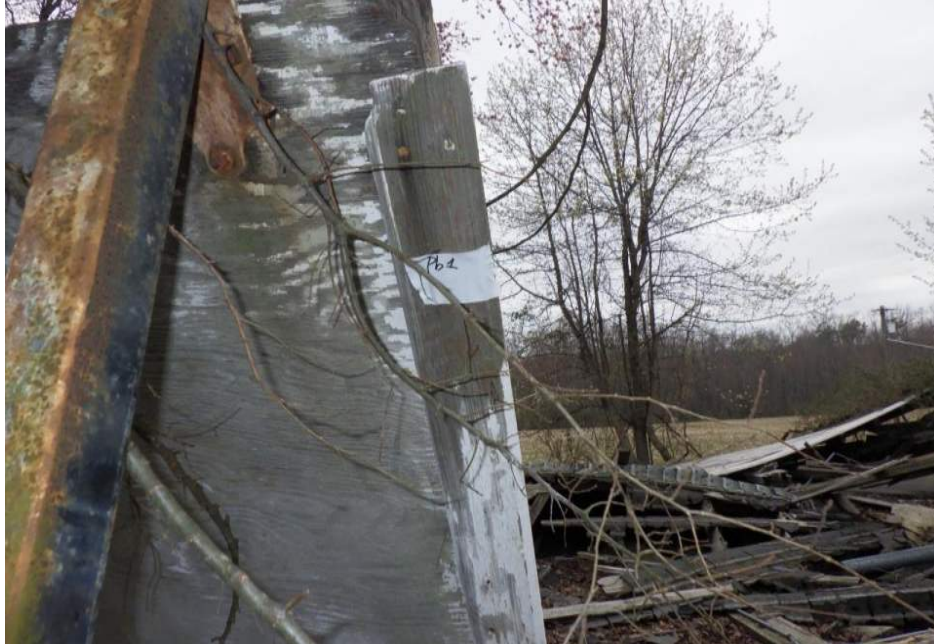
506A-Pb1

**Results:**

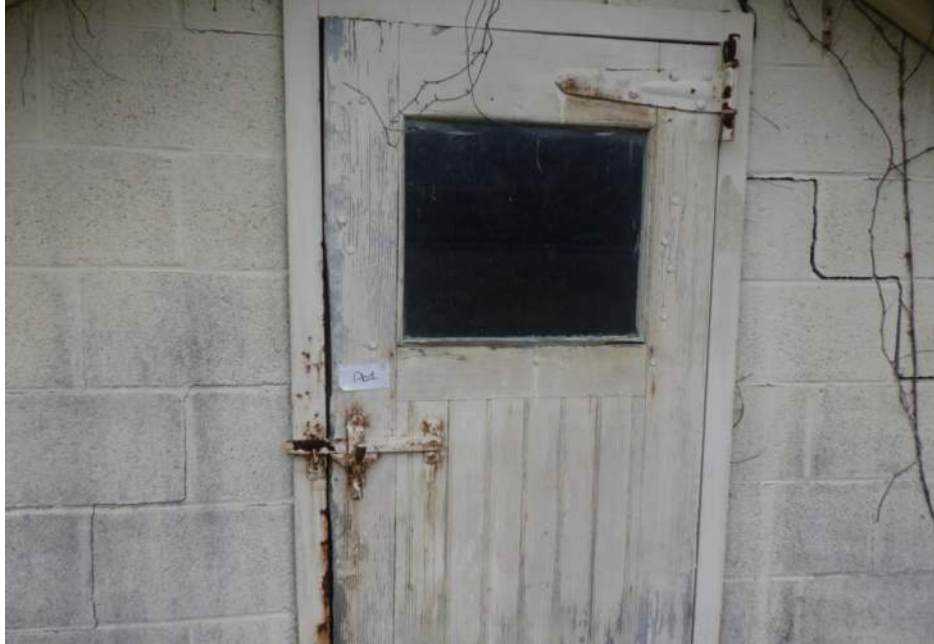
541C-Pb1

**Results:** 370000 ppm

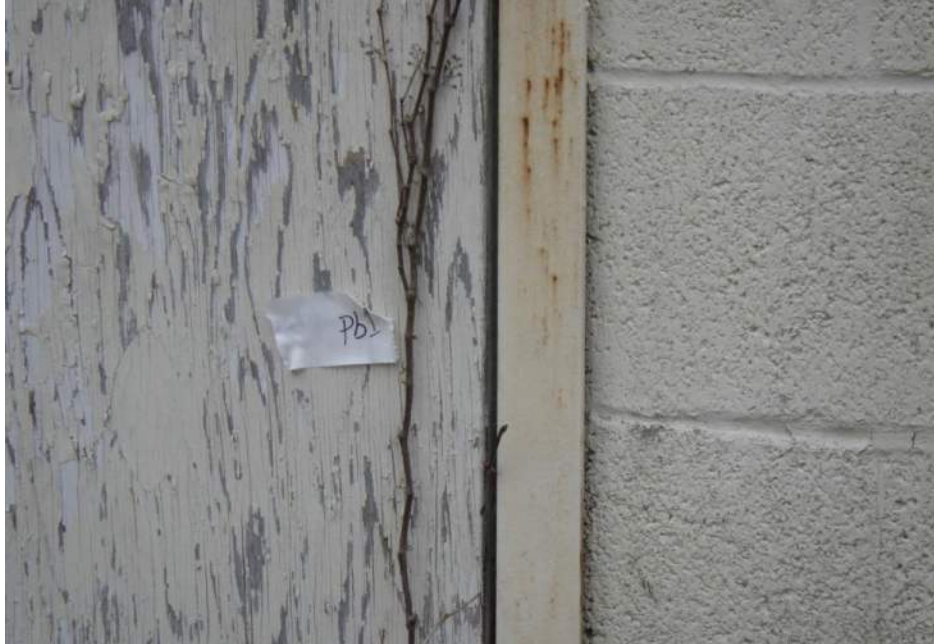
543-Pb1

**Results:** 650 ppm

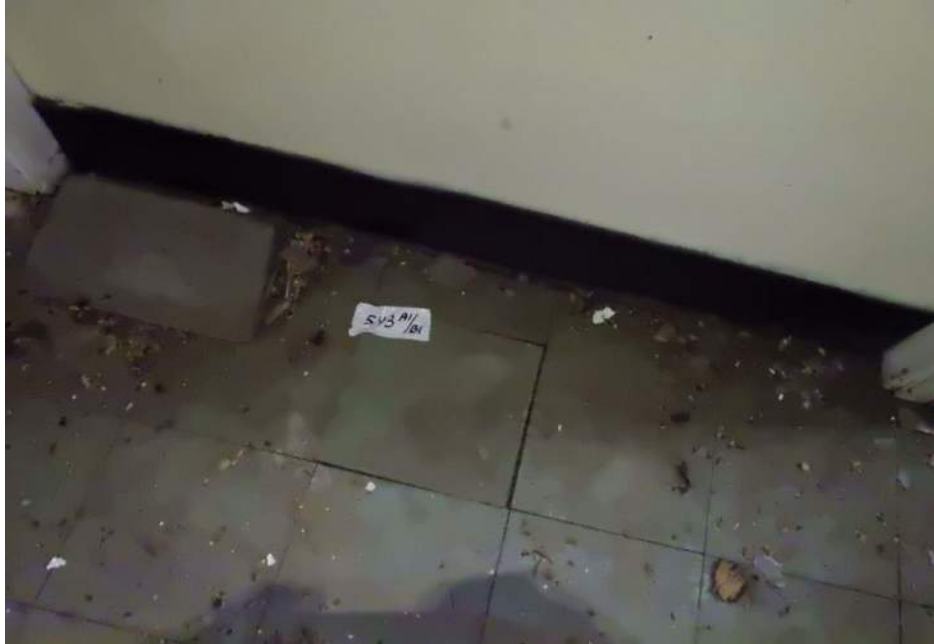
543A1

**Results:** Chrysotile 1-5%

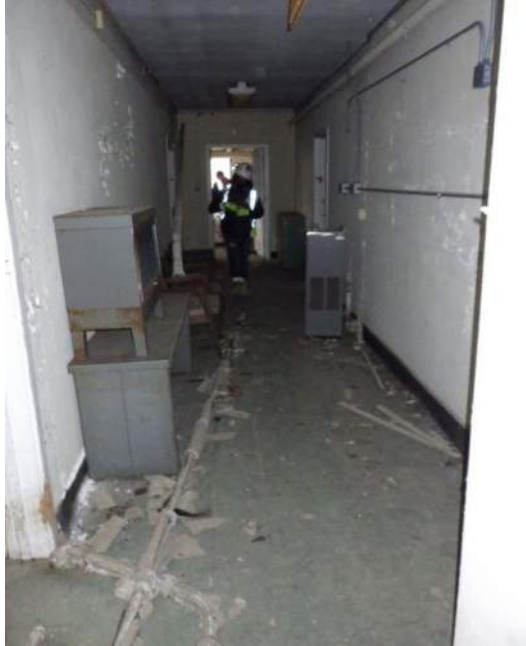
543-Pb2

**Results:** < 84 ppm

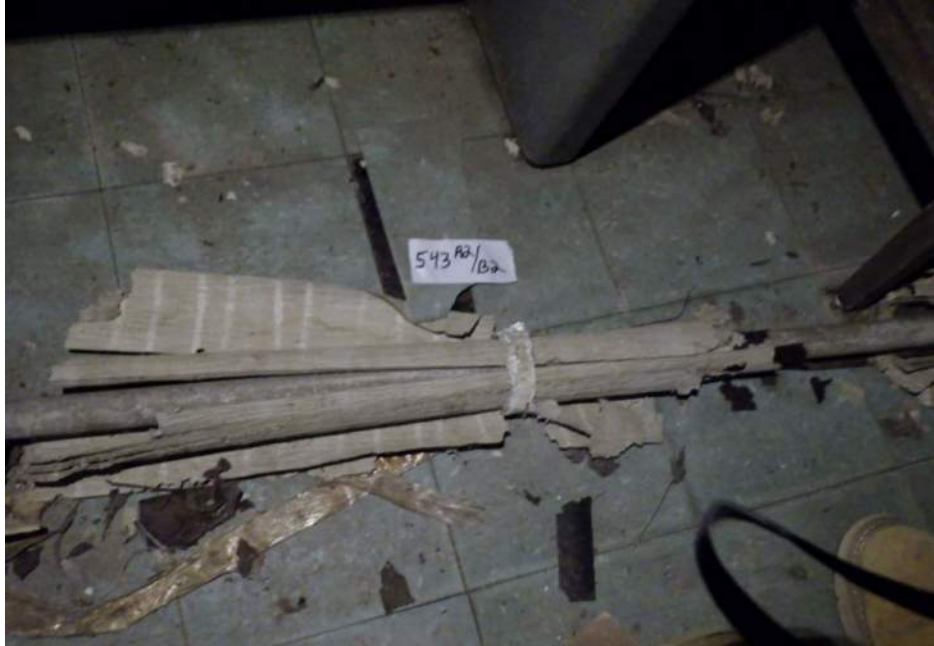
543A2

**Results:** Chrysotile 1-5%

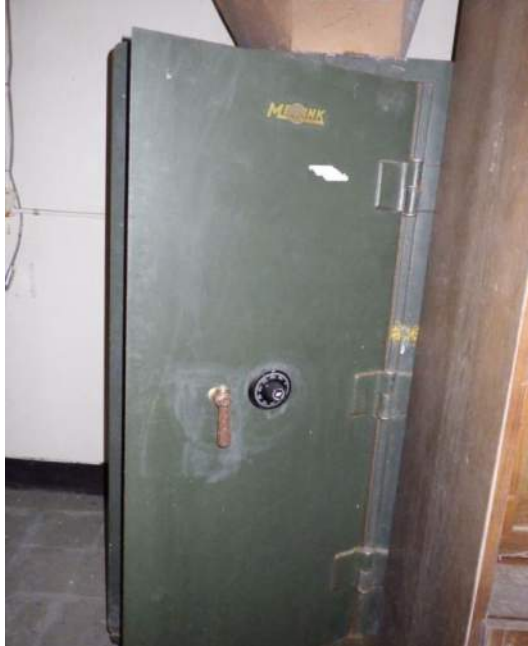
**Description:** fire proof safe, with PACM gaskets, and insulation

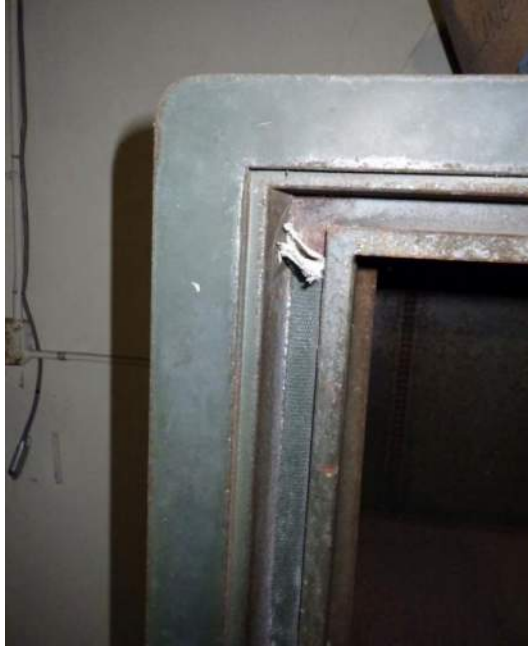
**Description:** fire proof safe gasket

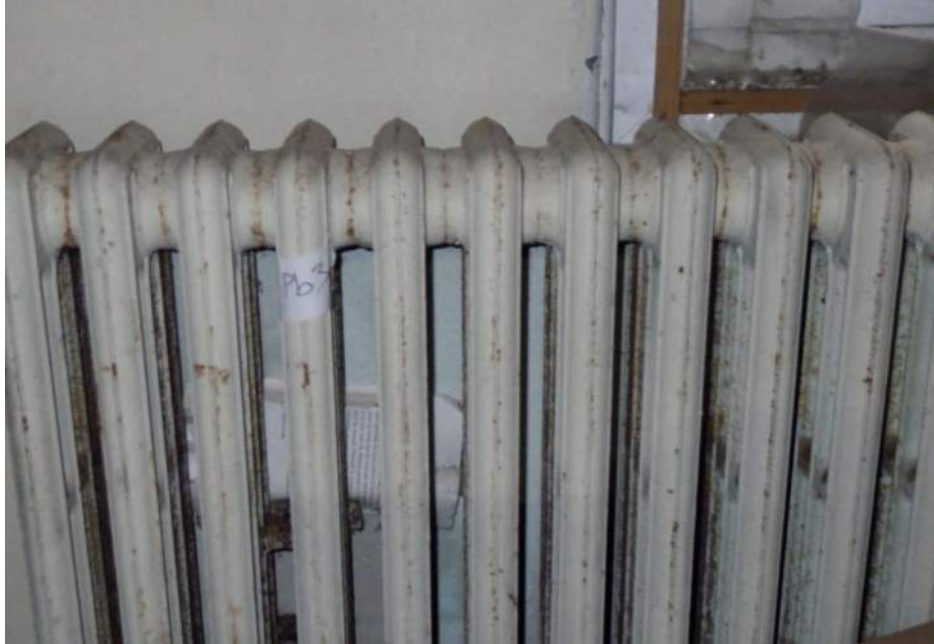
543-Pb3

**Results:** < 88 ppm

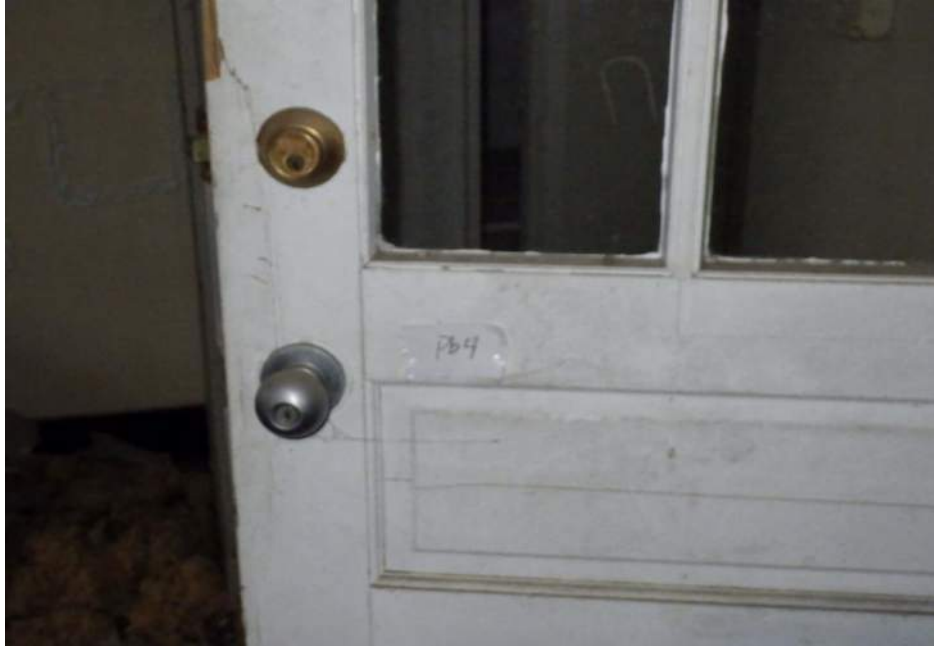
543-Pb4

**Results:** < 84 ppm

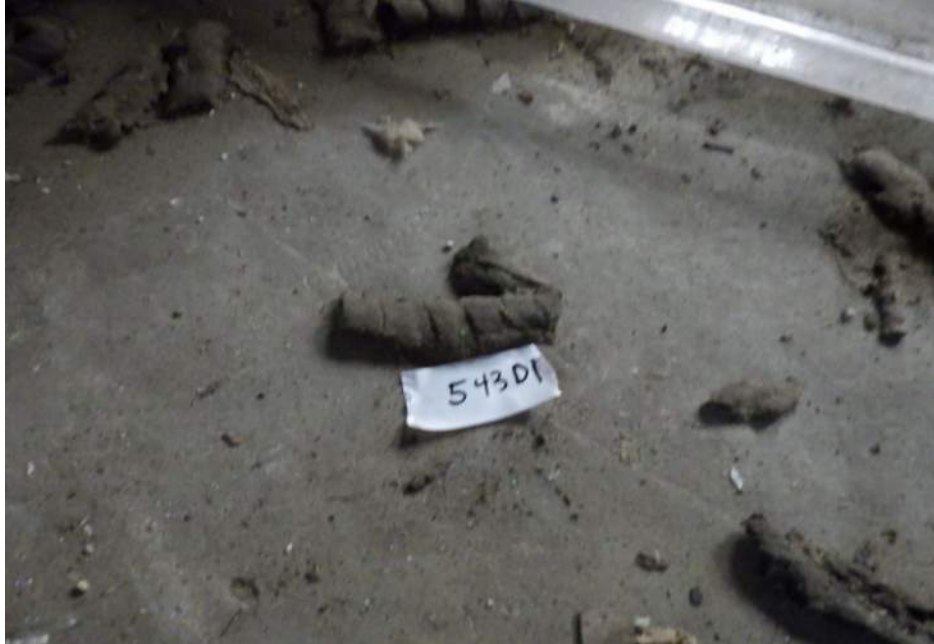
543D1

**Results:** None Detected

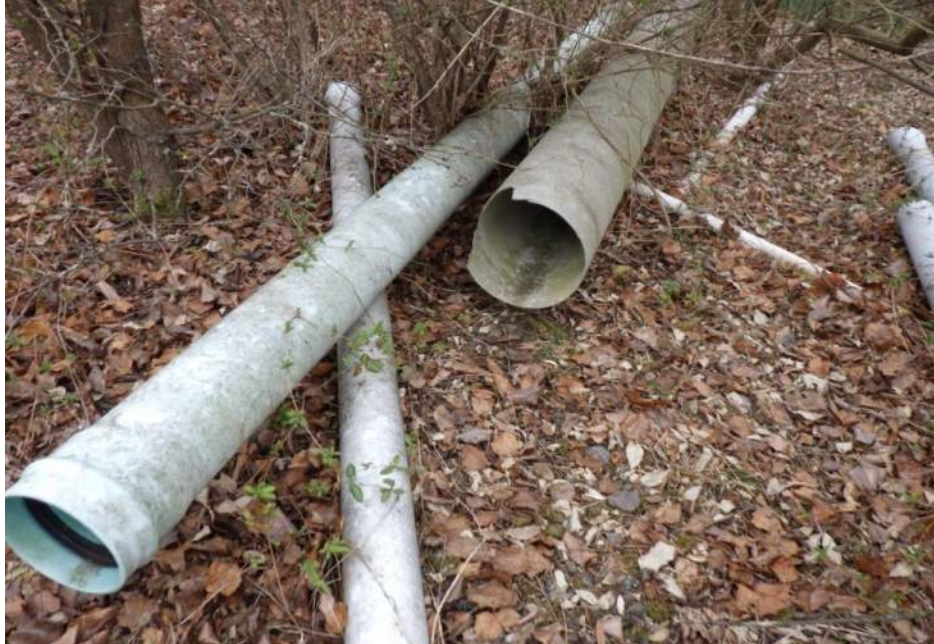
543PACM

**Results:** Not Analyzed

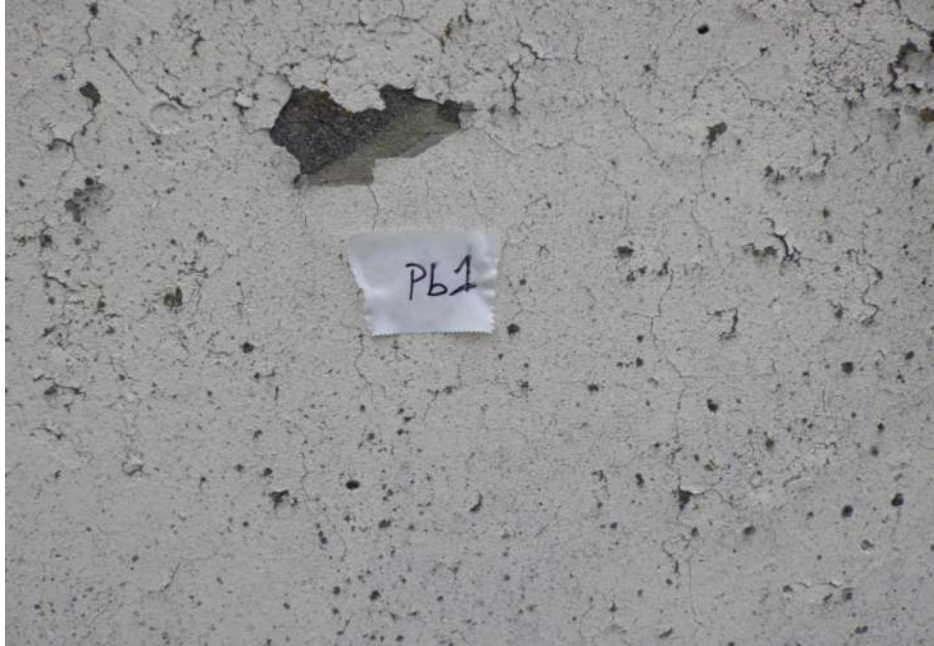
205-Pb1

**Results:** 99 ppm

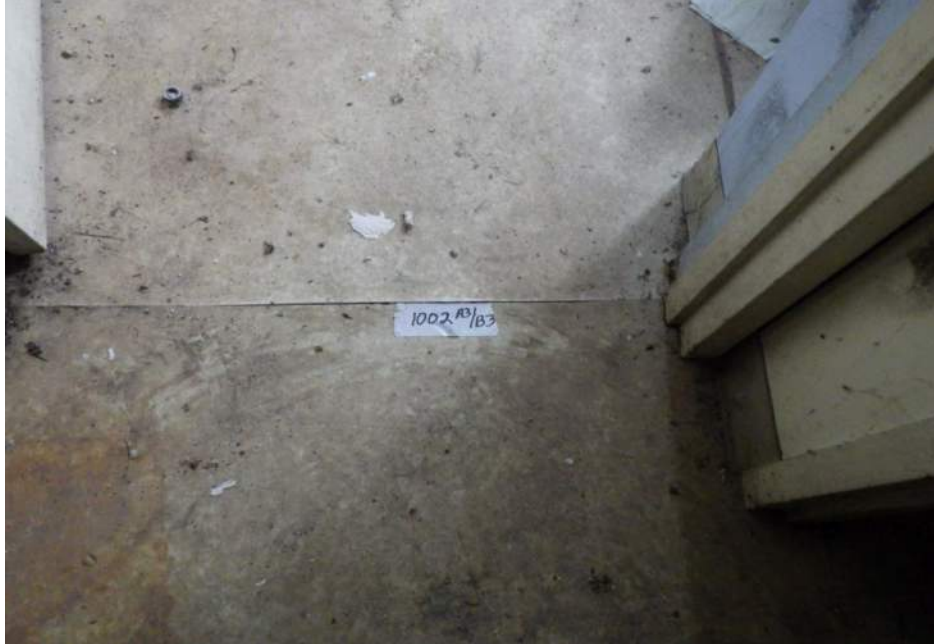
1002A3

**Results:** None Detected

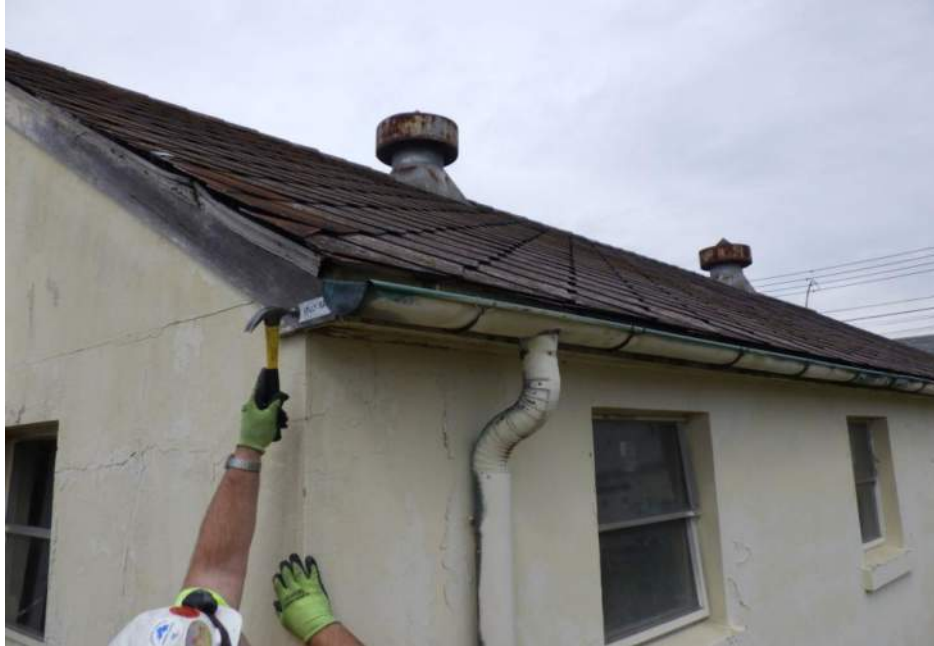
1005A1

**Results:** Chrysotile 20-25%

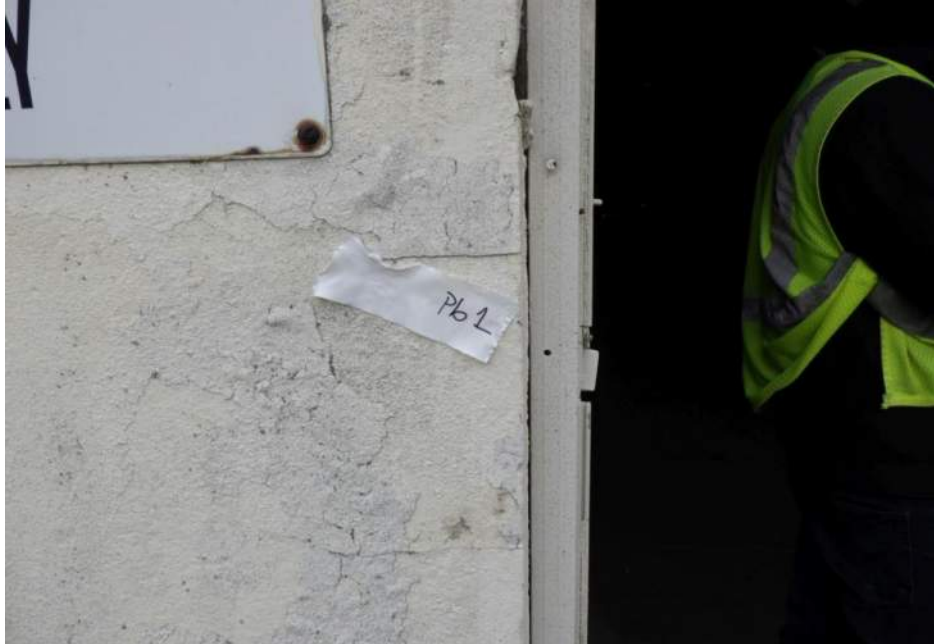
1005-Pb1

**Results:** 320 ppm

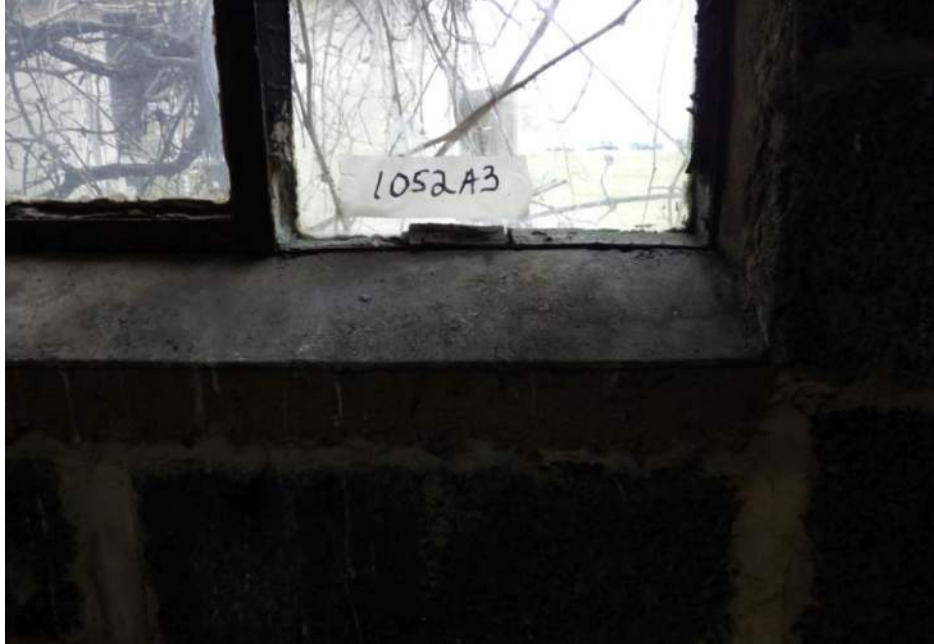
1052A3

**Results:** None Detected

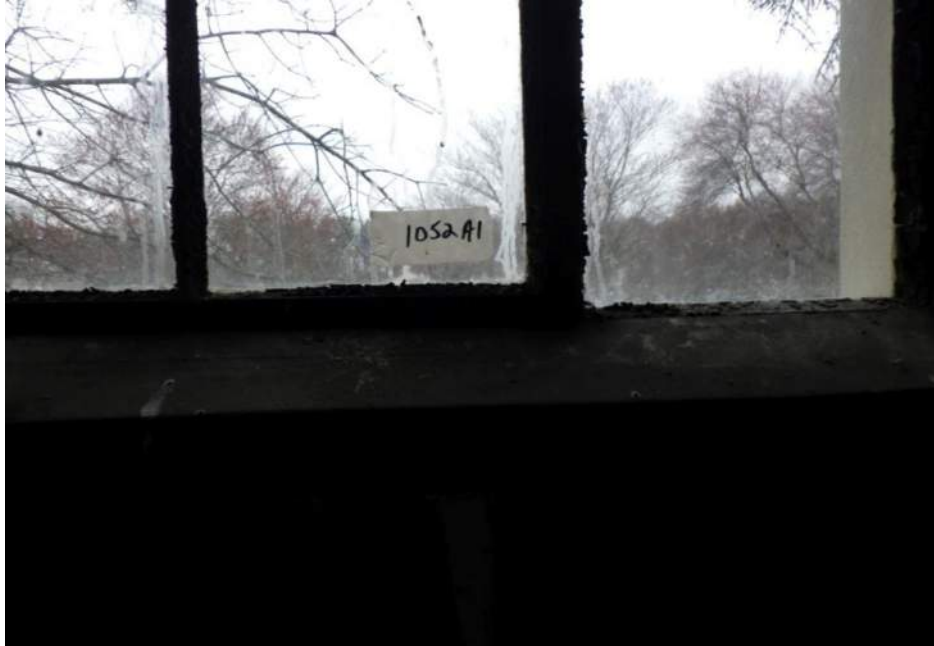
1052A1

**Results:** None Detected

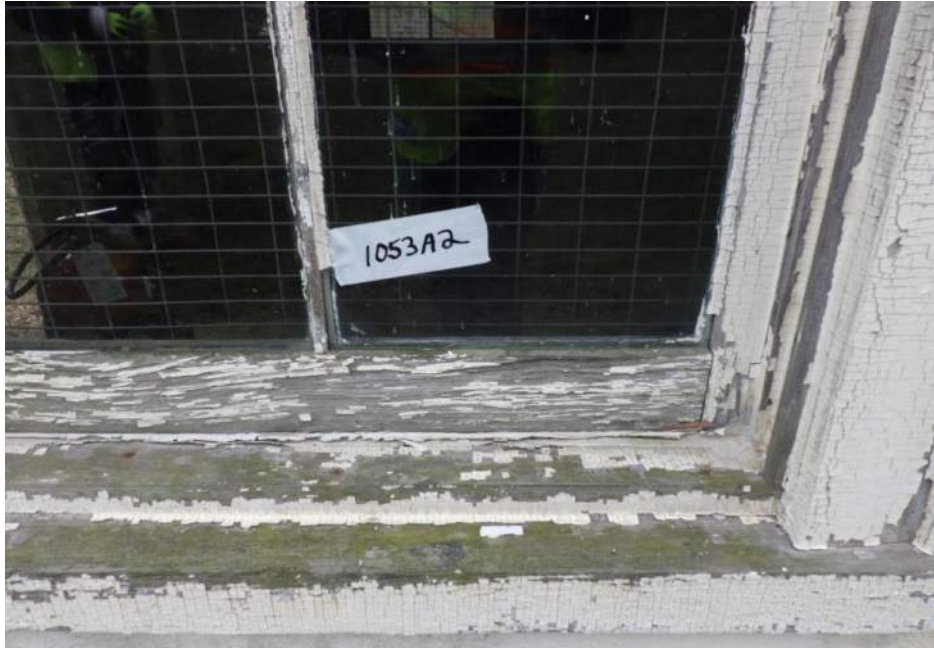
1053A2

**Results:** None Detected

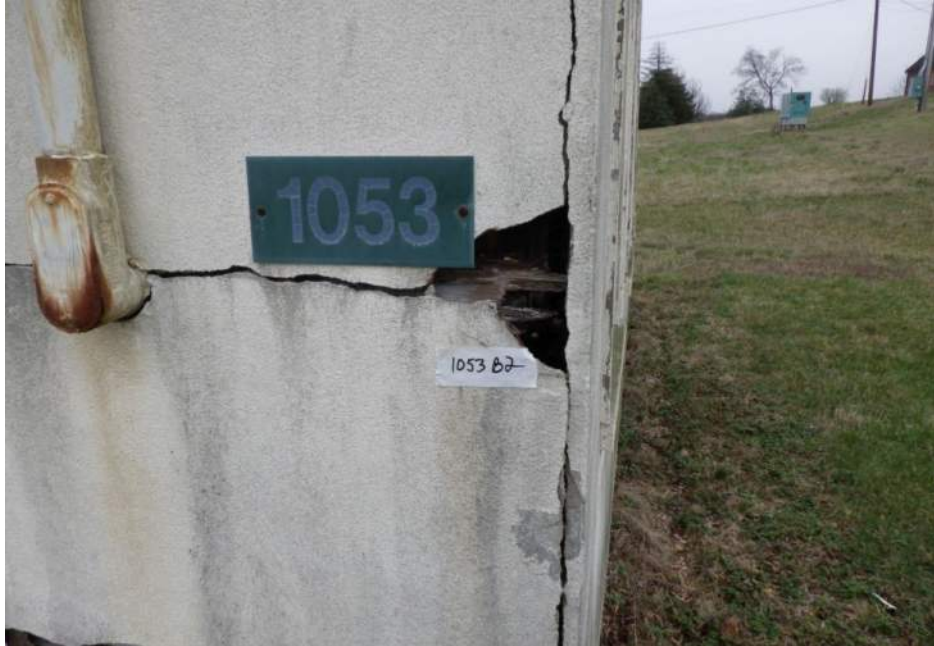
1053B2

**Results:** None Detected

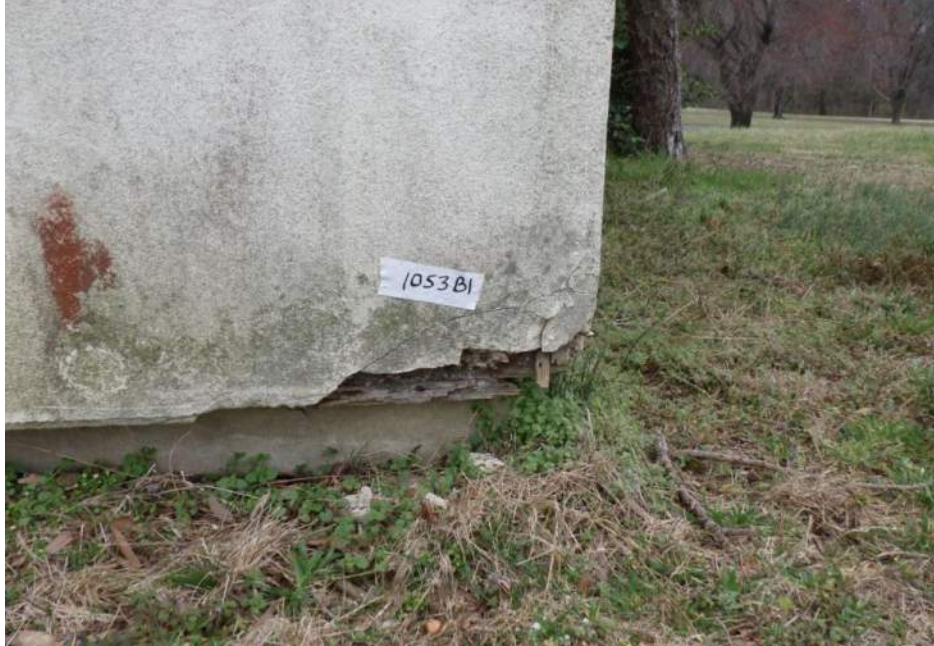
1053B1

**Results:** None Detected

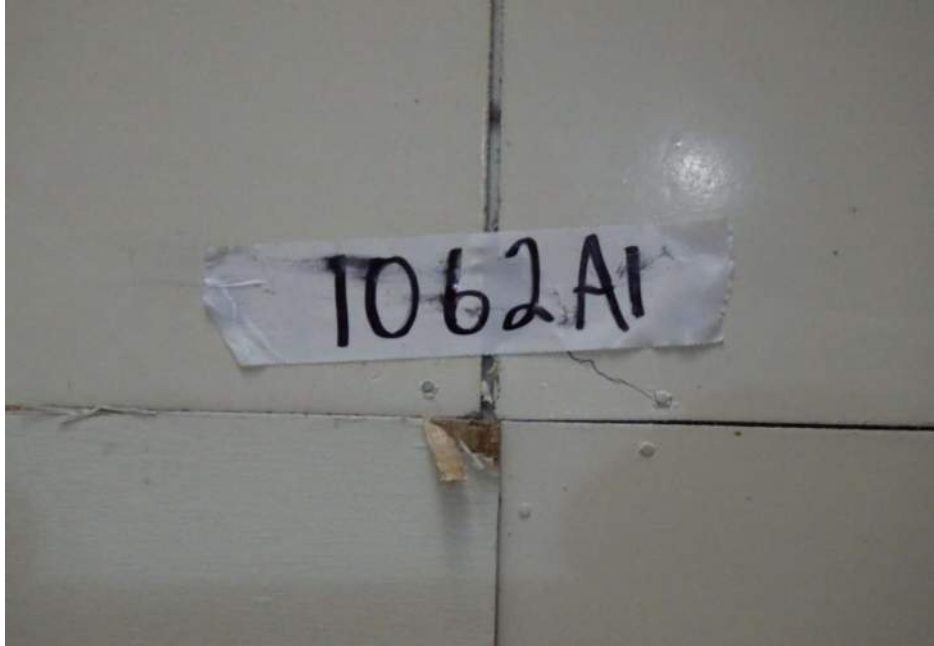
1062A1

**Results:** Chrysotile 20-25%

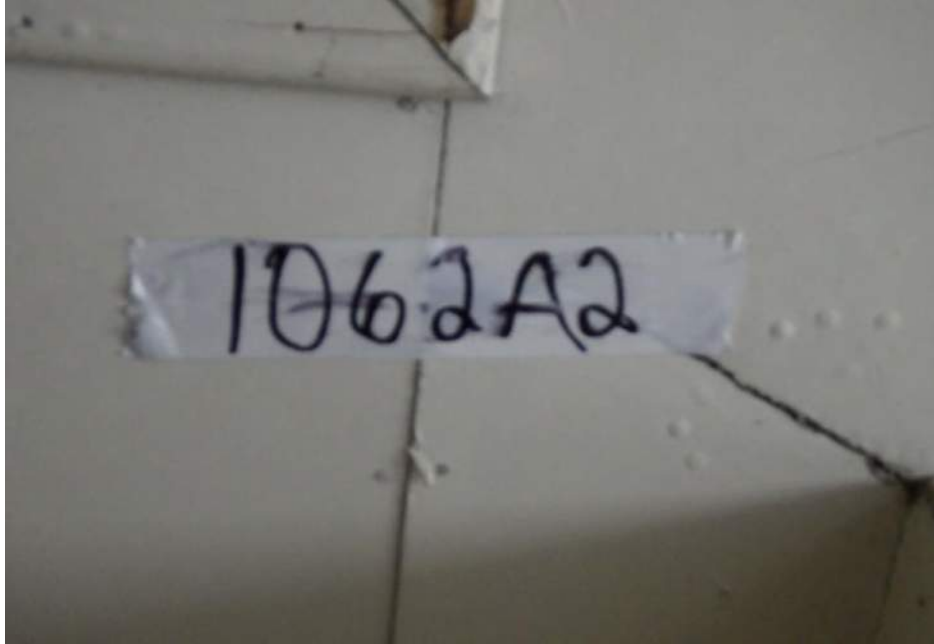
1062A2

**Results:** Chrysotile 20-25%

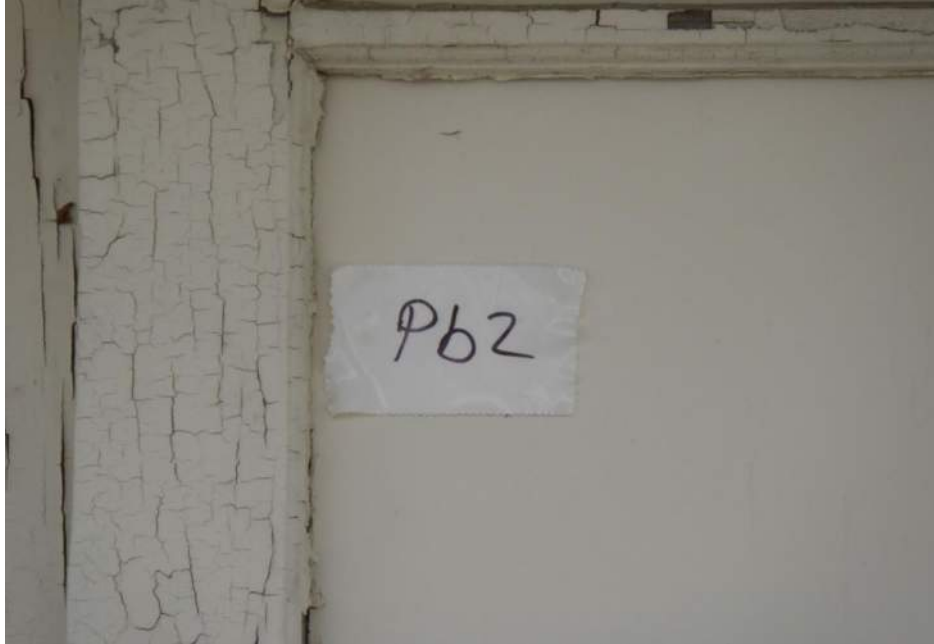
1062-Pb2

**Results:** 8100 ppm

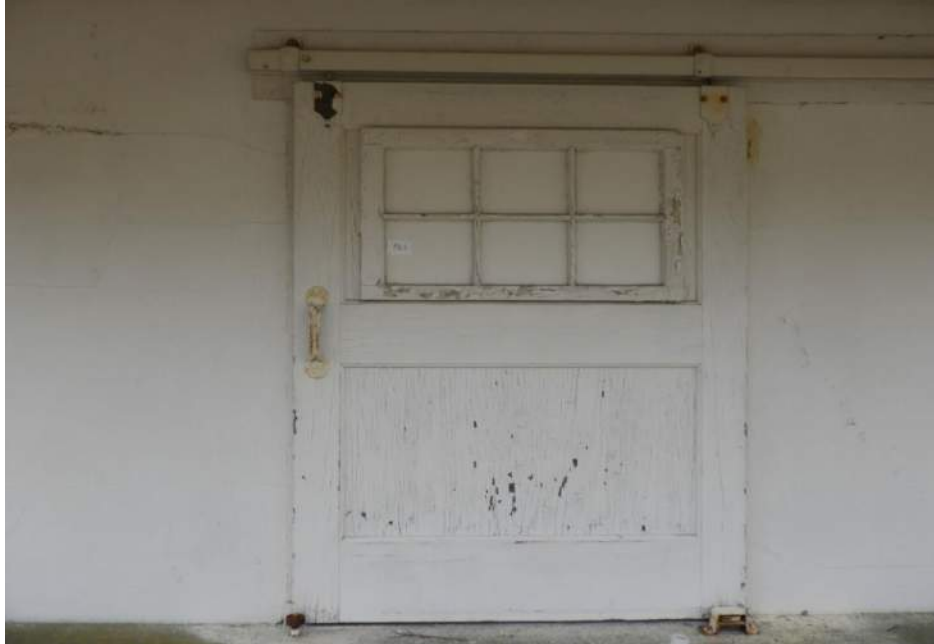
1062-Pb2

**Results:** 8100 ppm

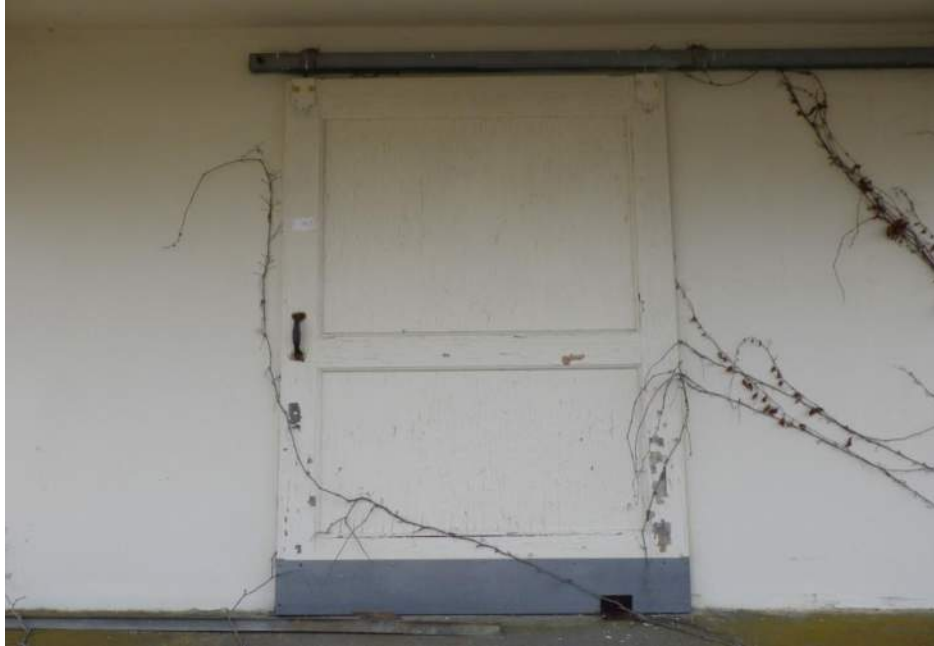
1064-Pb2

**Results:** 240 ppm

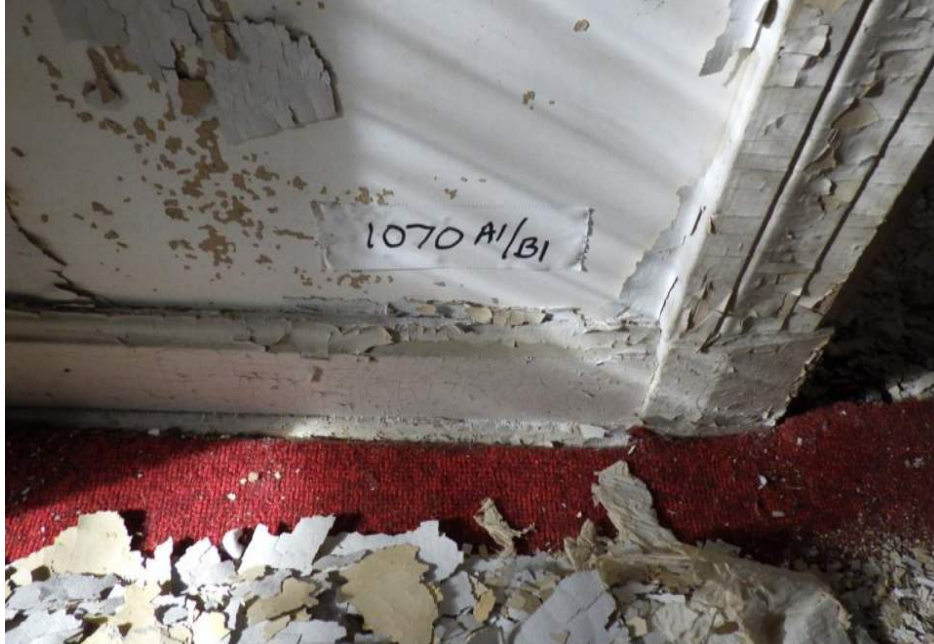
1070A1

**Results:** Chrysotile 5-10%

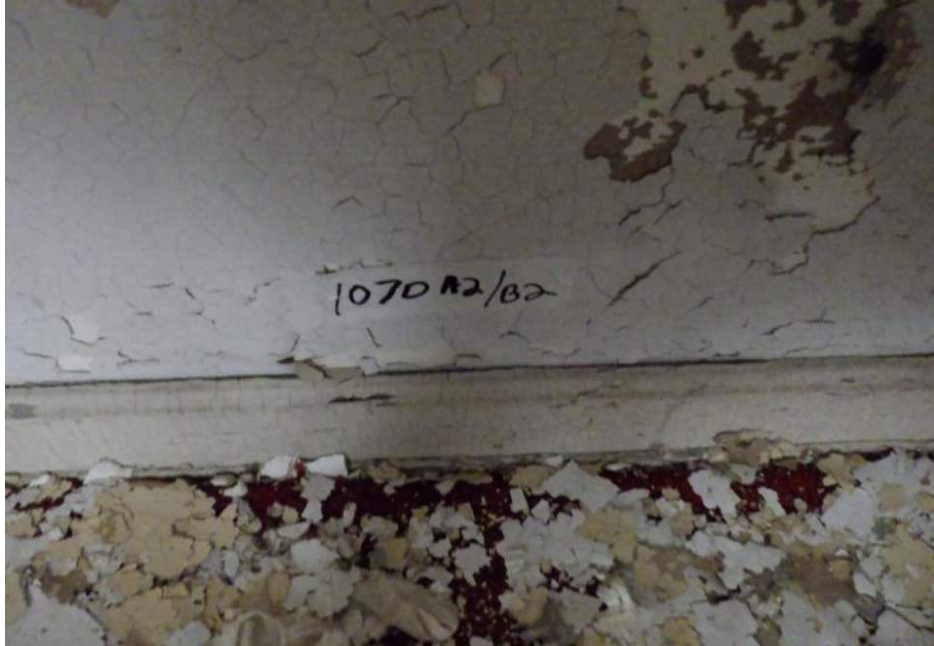
1070A2

**Results:** Chrysotile 5-10%

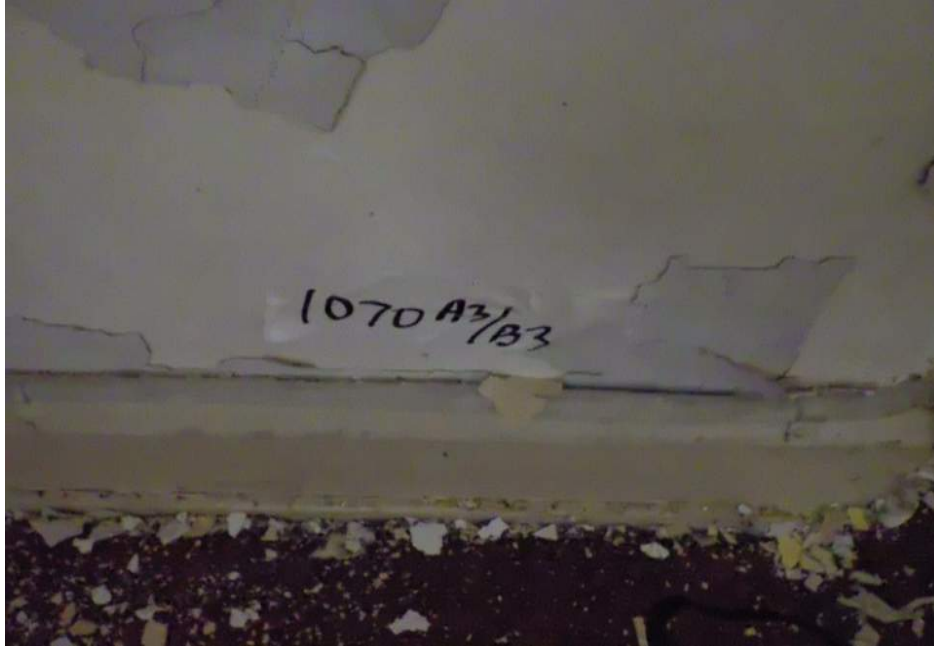
1070A3

**Results:** Chrysotile 5-10%

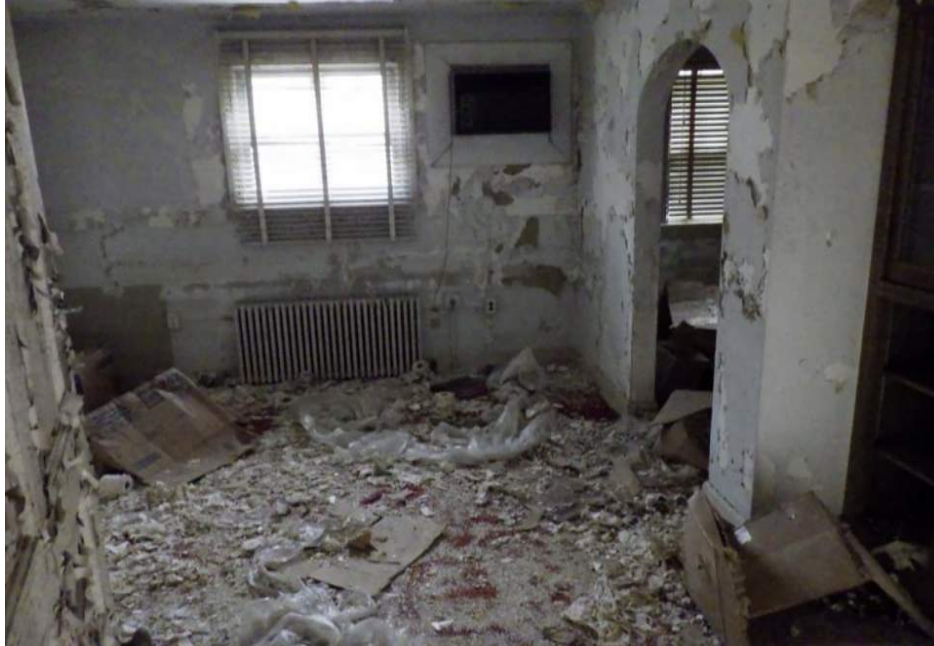
**Building/Unit:** 1070

**Description:** typical interior peeling paint and mold

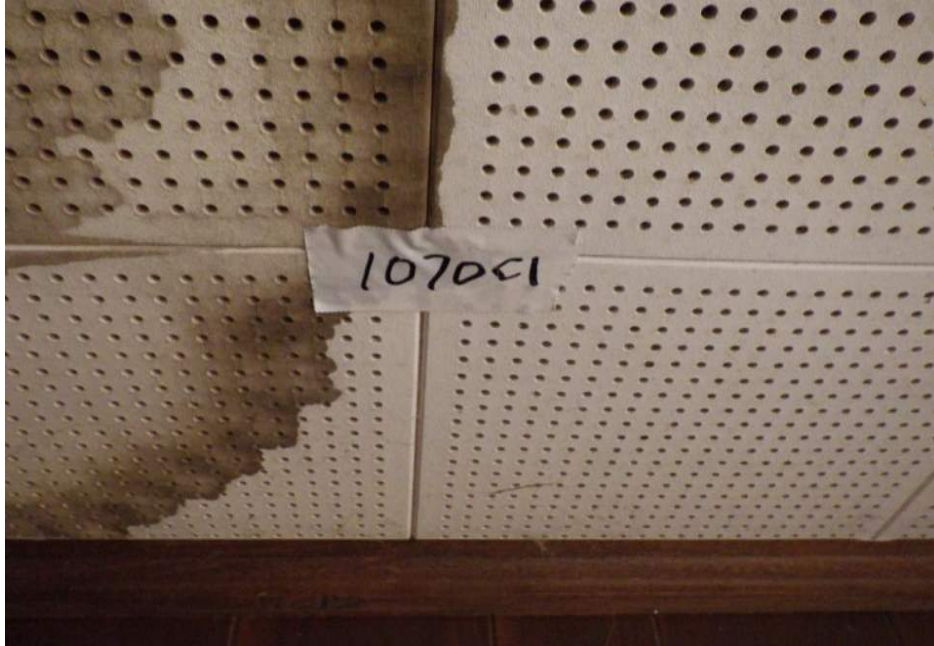
1070C1

**Results:** None Detected

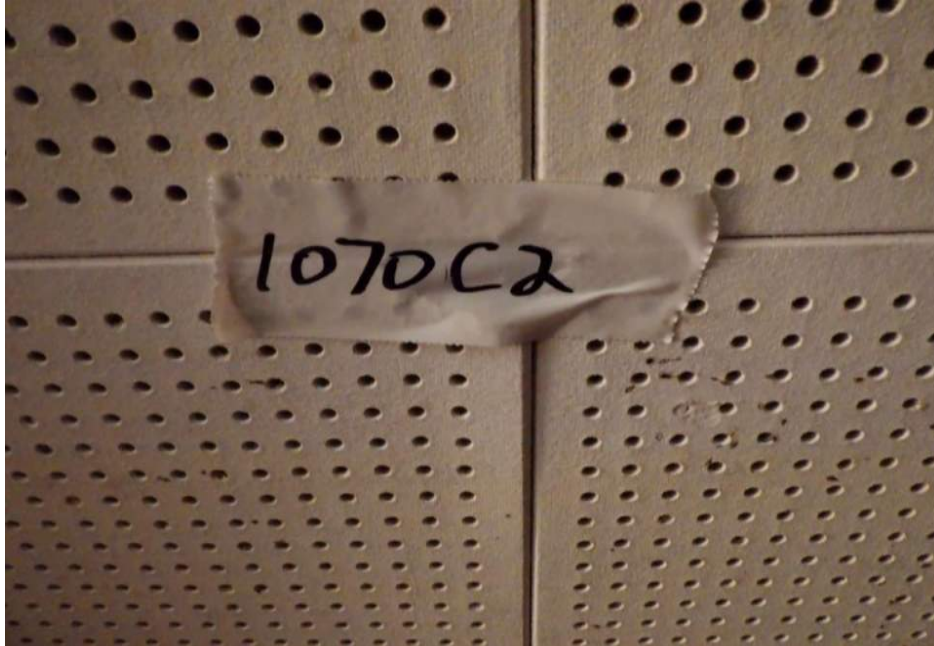
1070C2

**Results:** None Detected

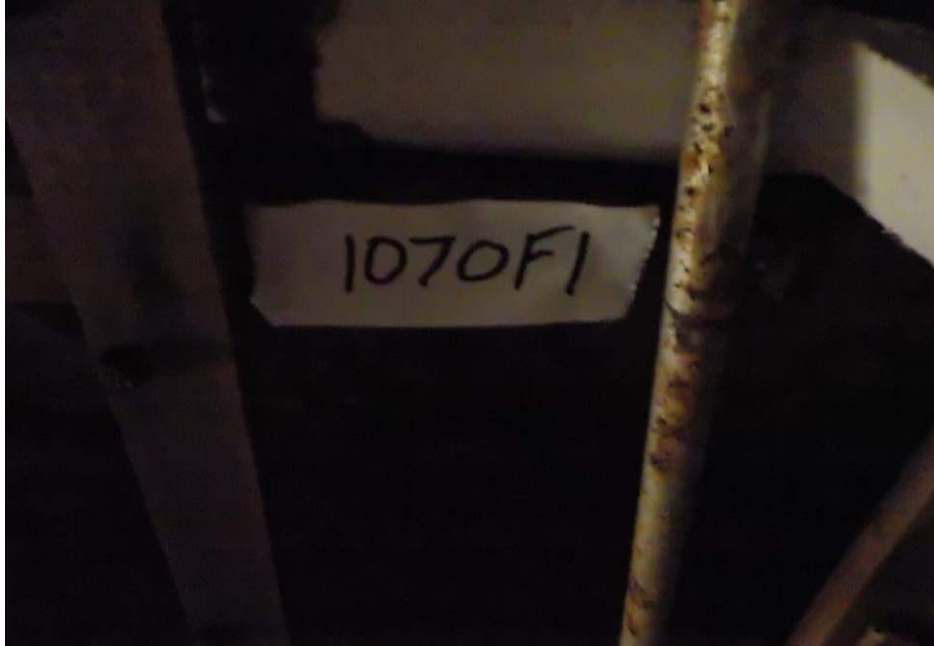
1070F1

**Results:** Chrysotile 5-10%

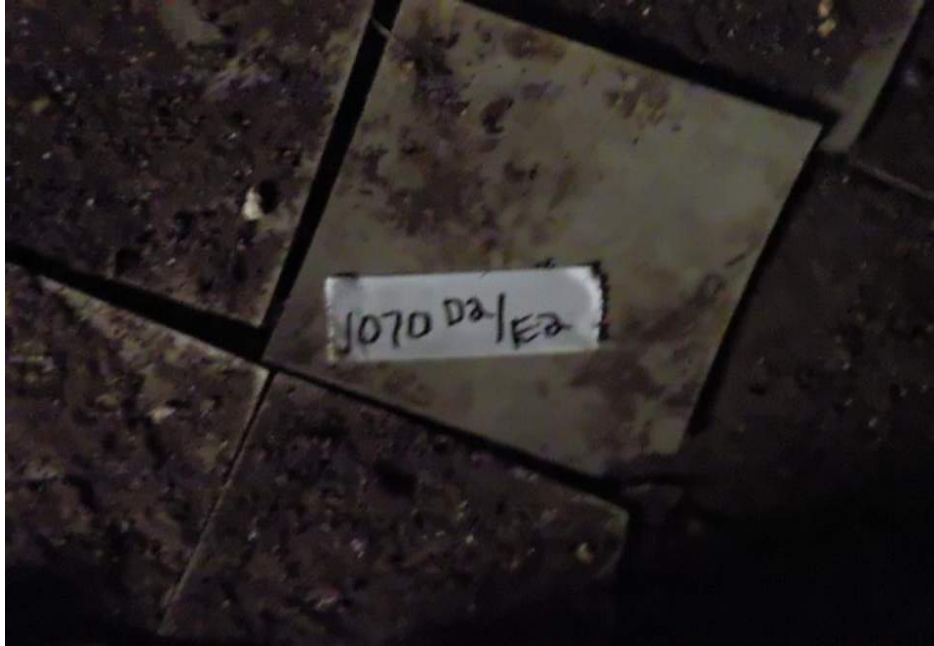
1070D2

**Results:** Chrysotile 5-10%

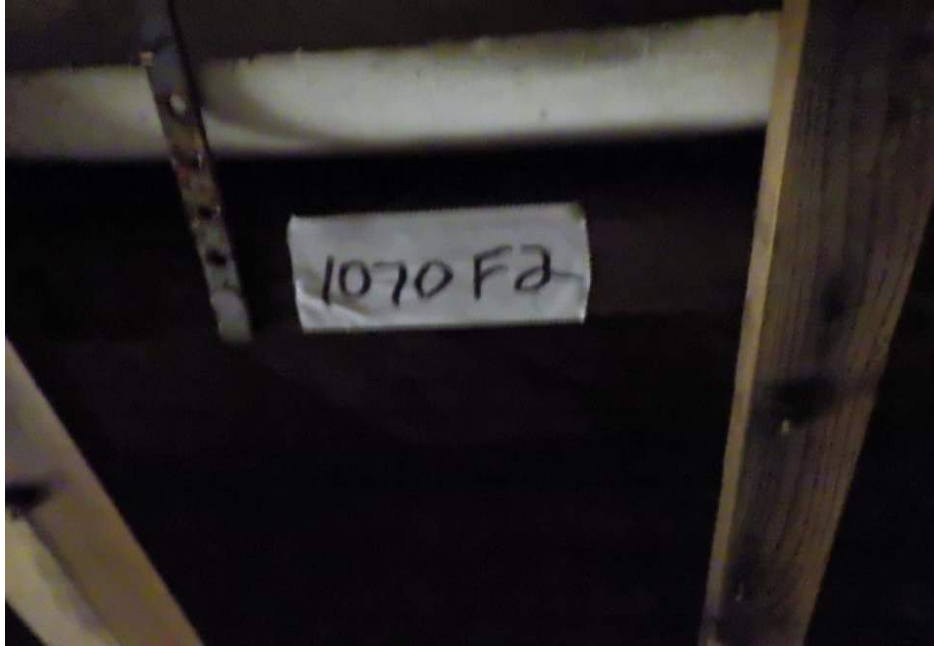
1070F2

**Results:** Chrysotile 1-5%

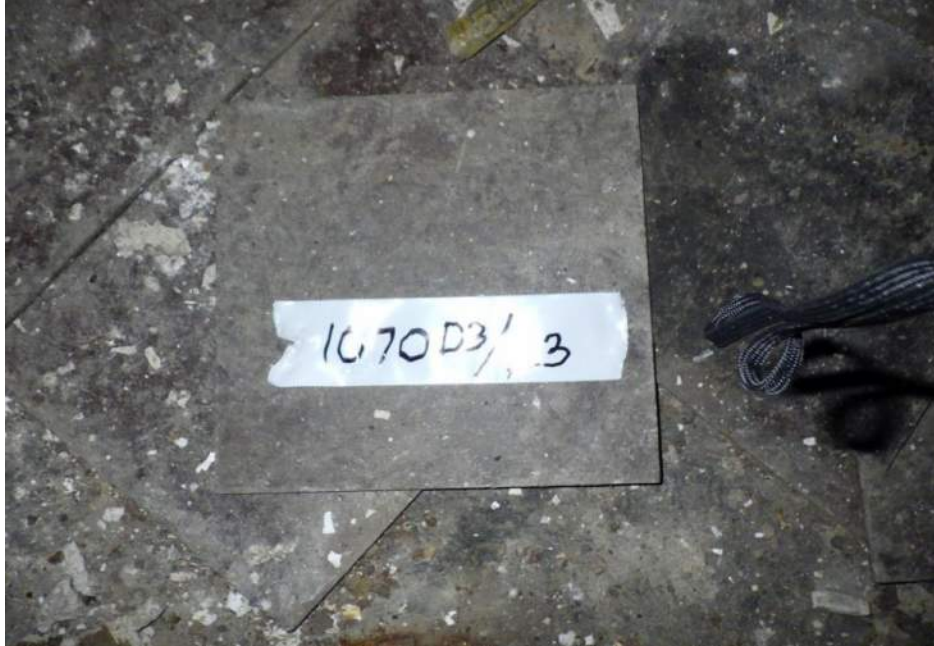
1070D3

**Results:** Chrysotile 5-10%

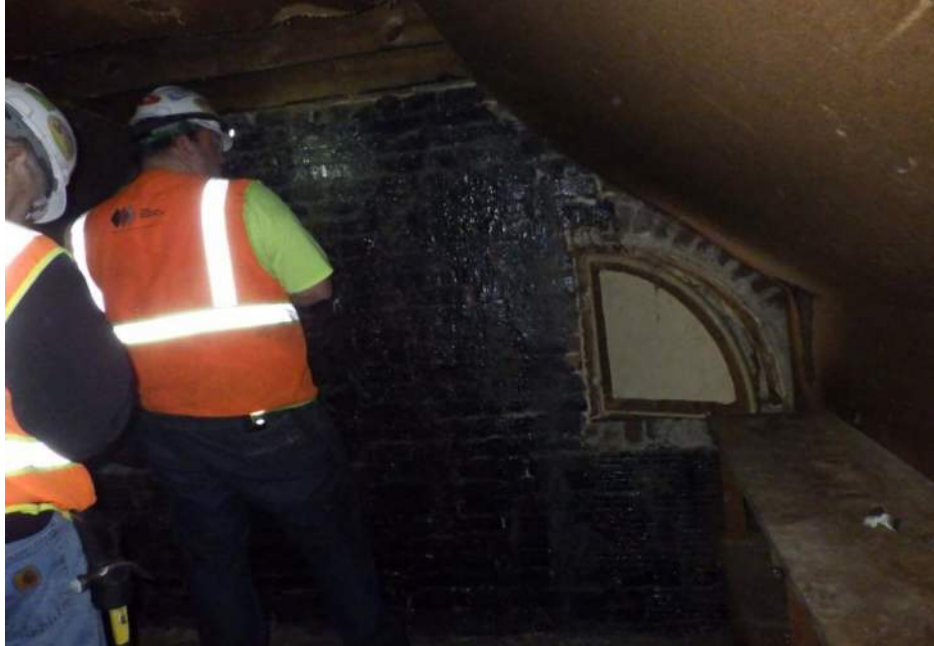
1070G2

**Results:** Chrysotile 1-5%

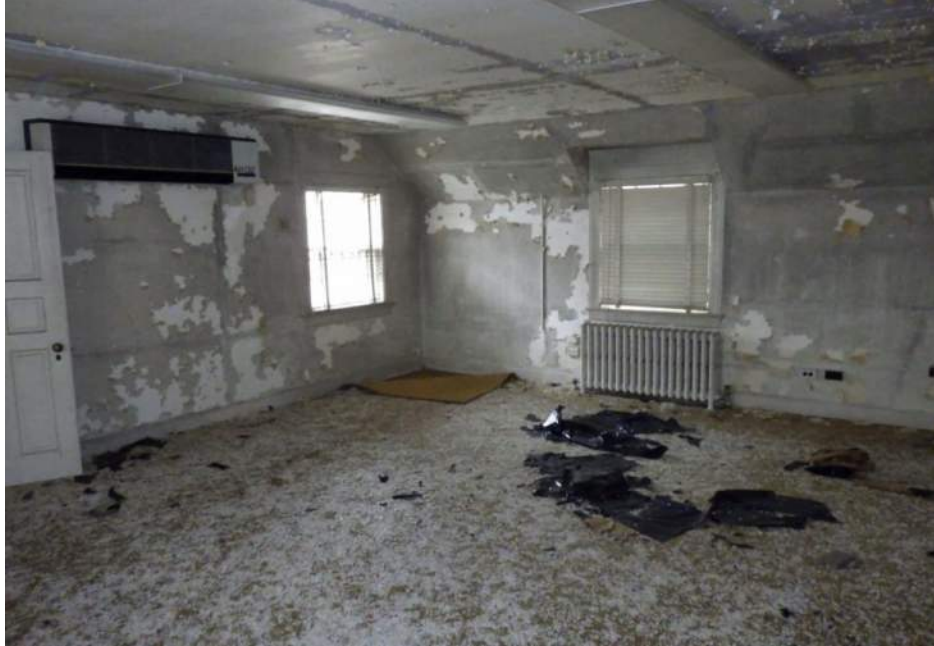
**Description:** interior fluorescent fixtures, mold, flaky paint

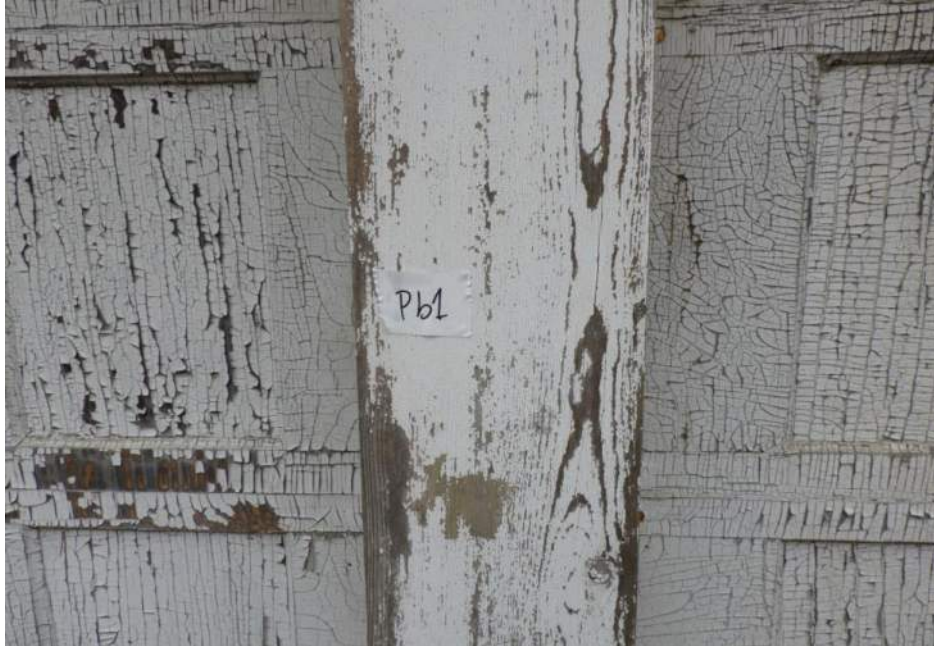
1071-Pb1

**Results:** 380000 ppm
