# Beltsville Agricultural Research Center Hazardous Materials Assessment Part 2

**Beltsville Agricultural Research Center  
Hazardous Materials Assessment  
Project No. 103144**

**Revision 1  
April 22, 2020**

**Burns & McDonnell Engineering Company, Inc.  
Downers Grove, Illinois**

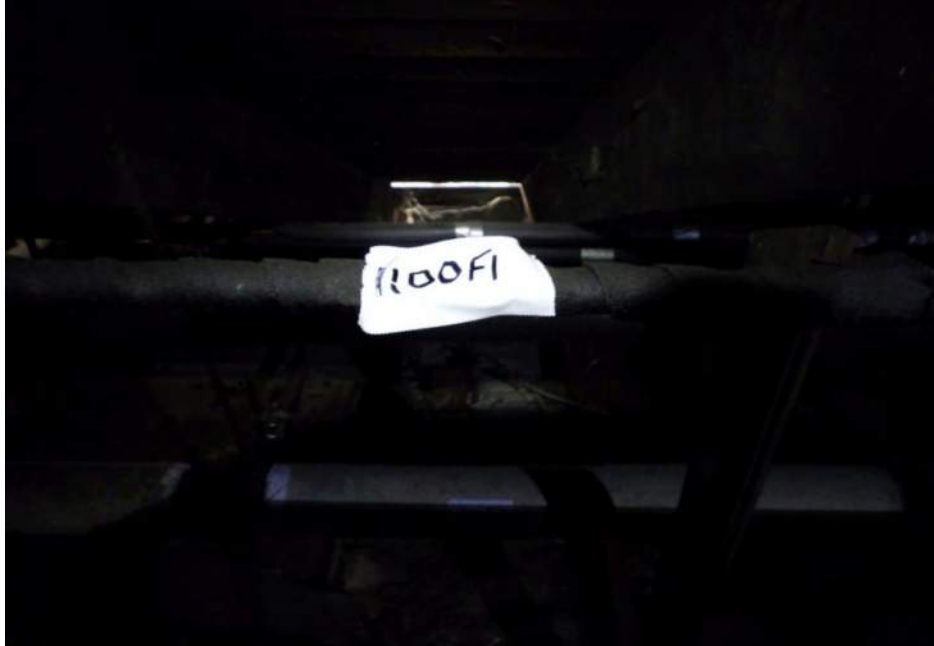
1100F1

**Results:** Chrysotile 1-5%

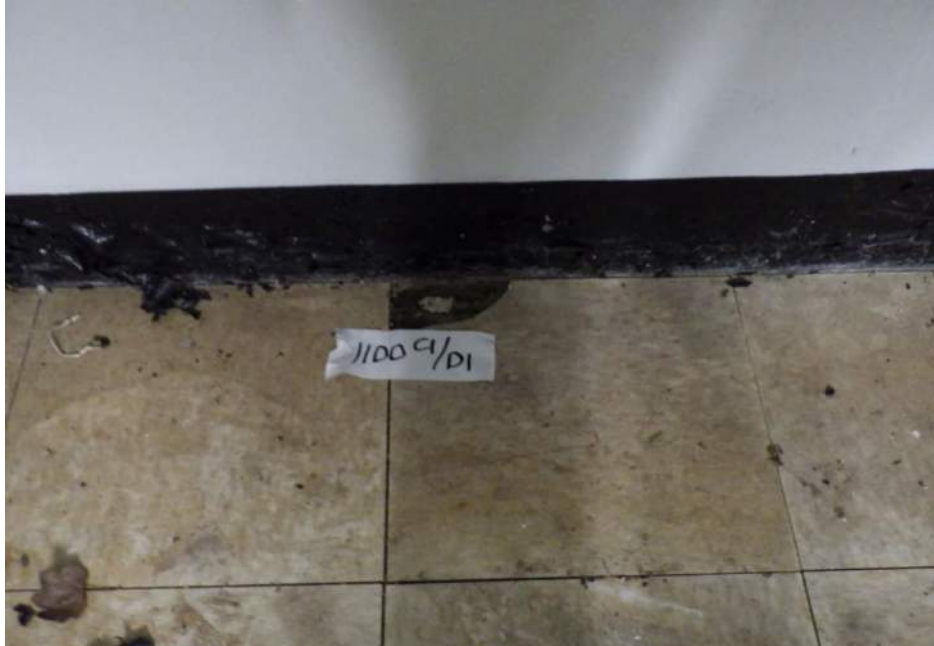
1100C1

**Results:** Chrysotile 5-10% Amosite 5-10%

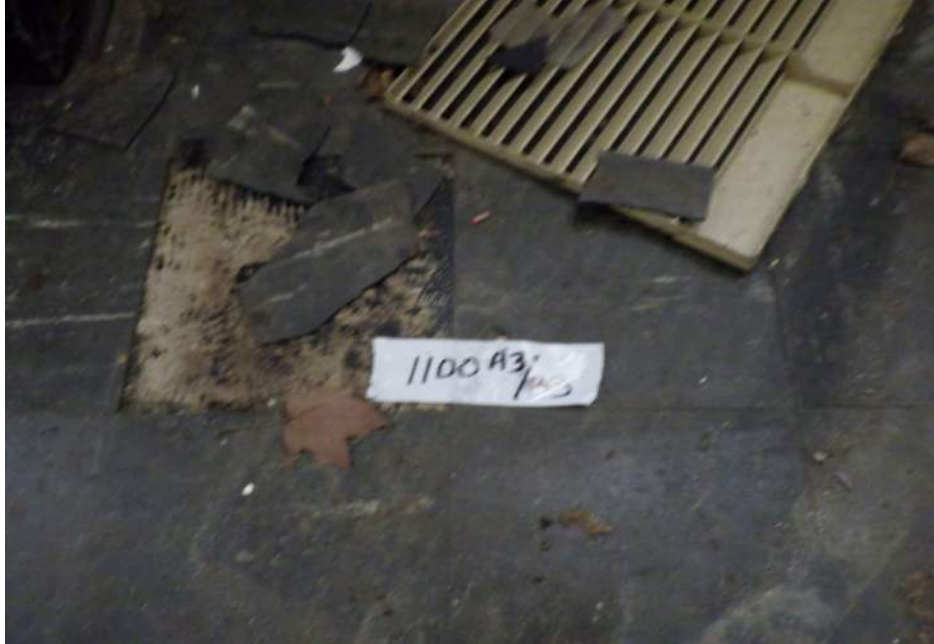
1100A3

**Results:** Chrysotile 1-5%

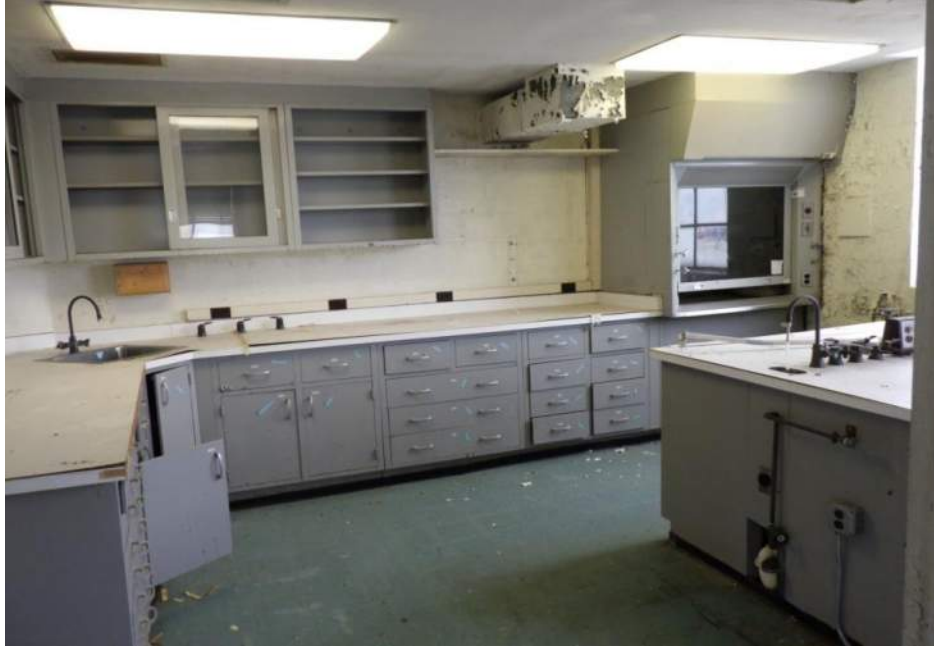
1120A2

**Results:** Chrysotile 1-5%

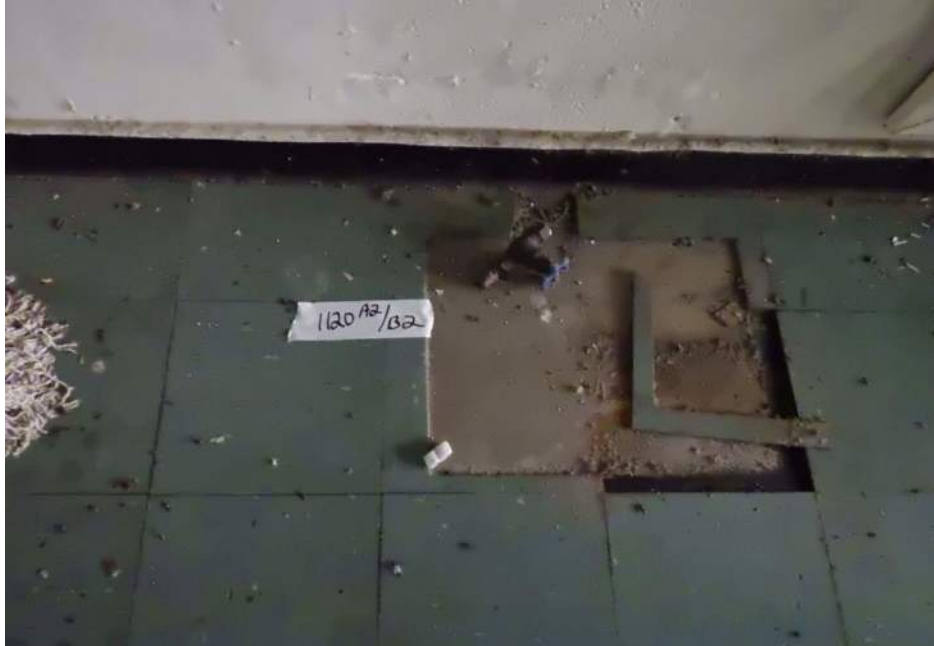
1120A2

**Results:** Chrysotile 1-5%

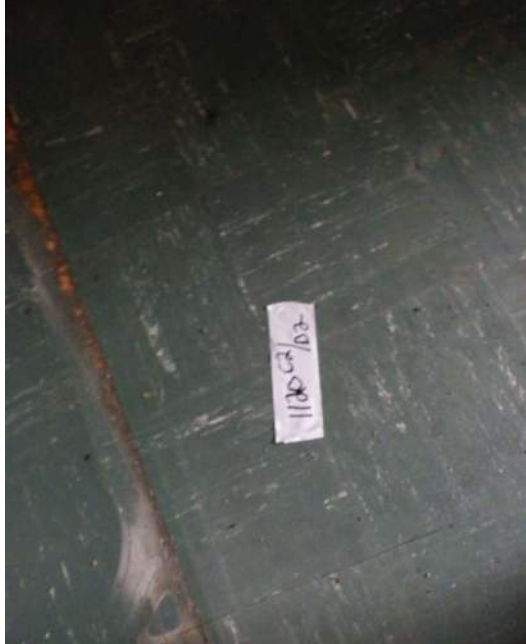
1120C2

**Results:** Chrysotile 5-10%

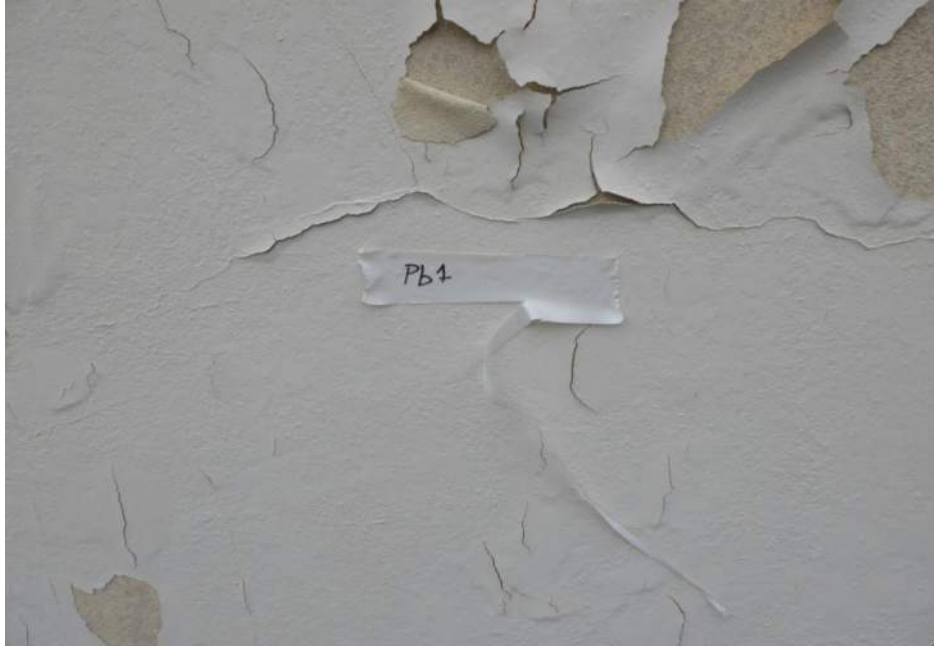
1120-Pb1

**Results:** 130 ppm

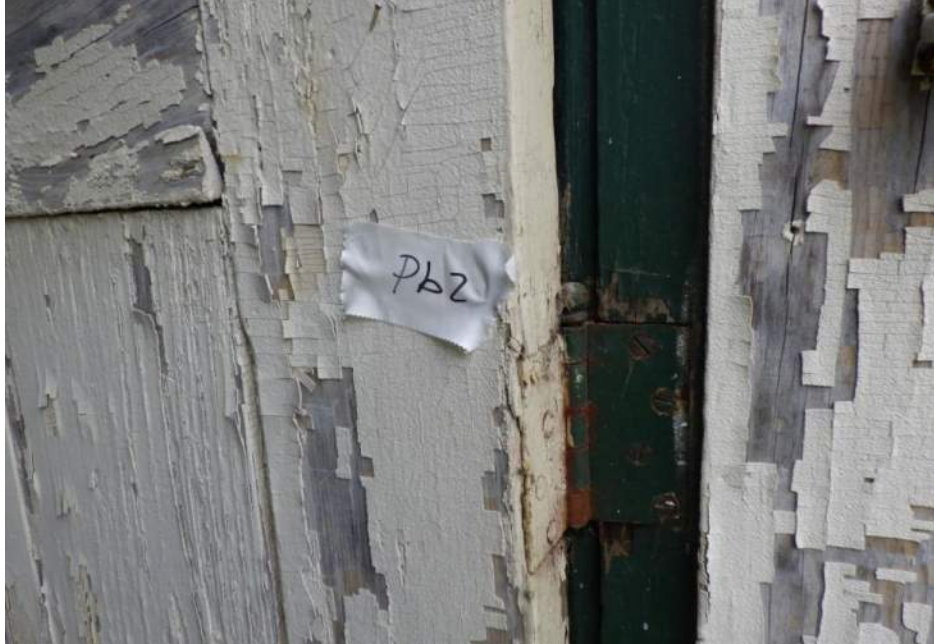
1005-Pb2

**Results:** 230000 ppm

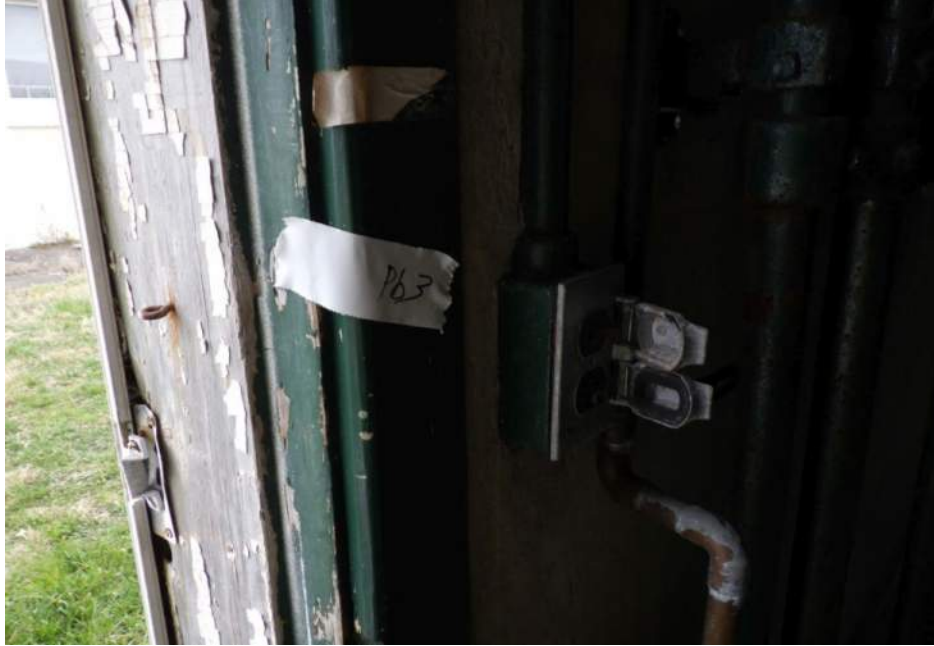
1005-Pb3

**Results:** 440000 ppm

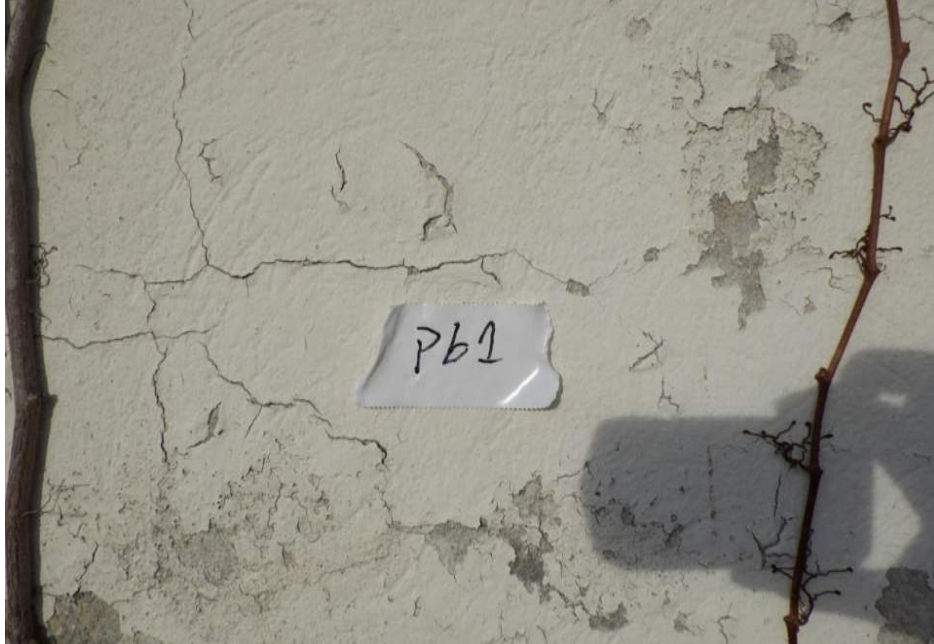
1287-Pb1

**Results:** 300 ppm

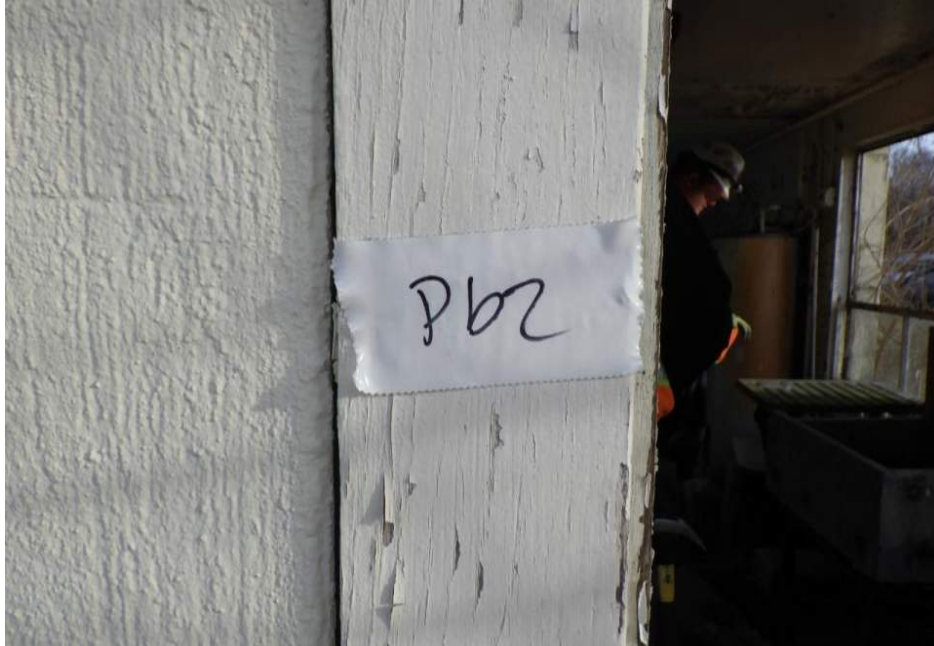
1287-Pb2

**Results:** 17000 ppm

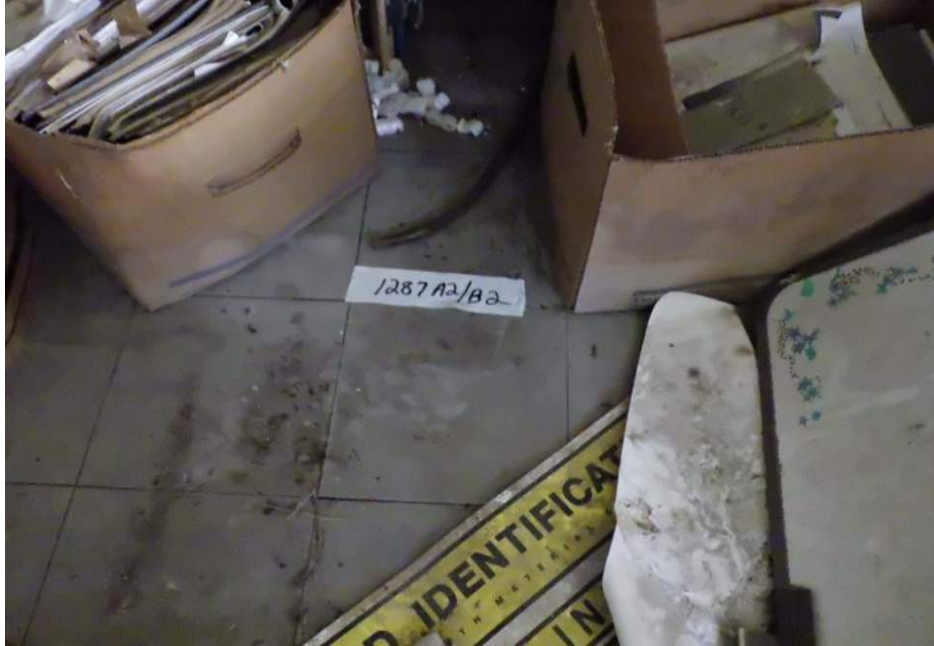
1287A2

**Results:** Chrysotile 5-10%

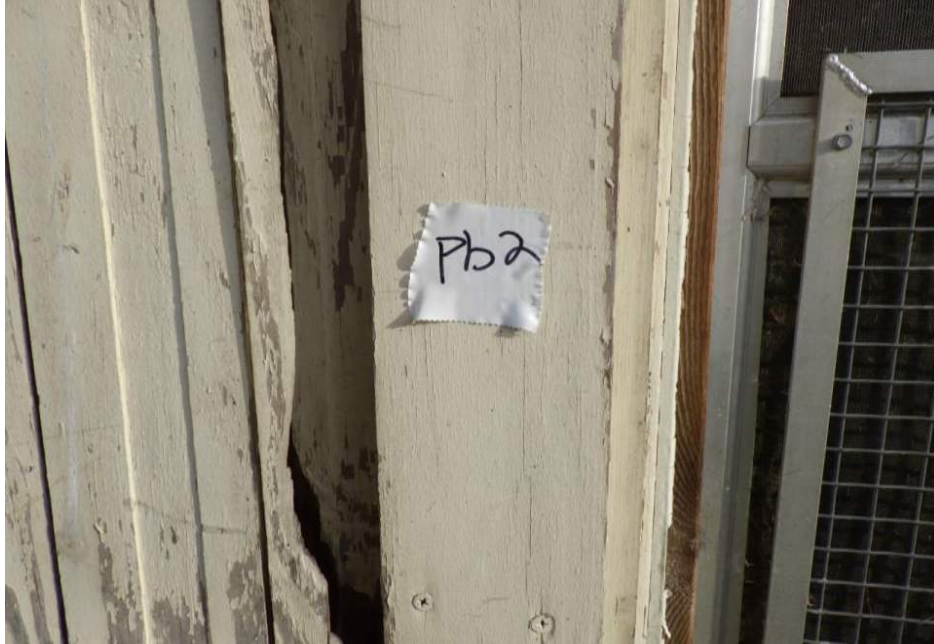
1289-Pb2

**Results:** < 93 ppm

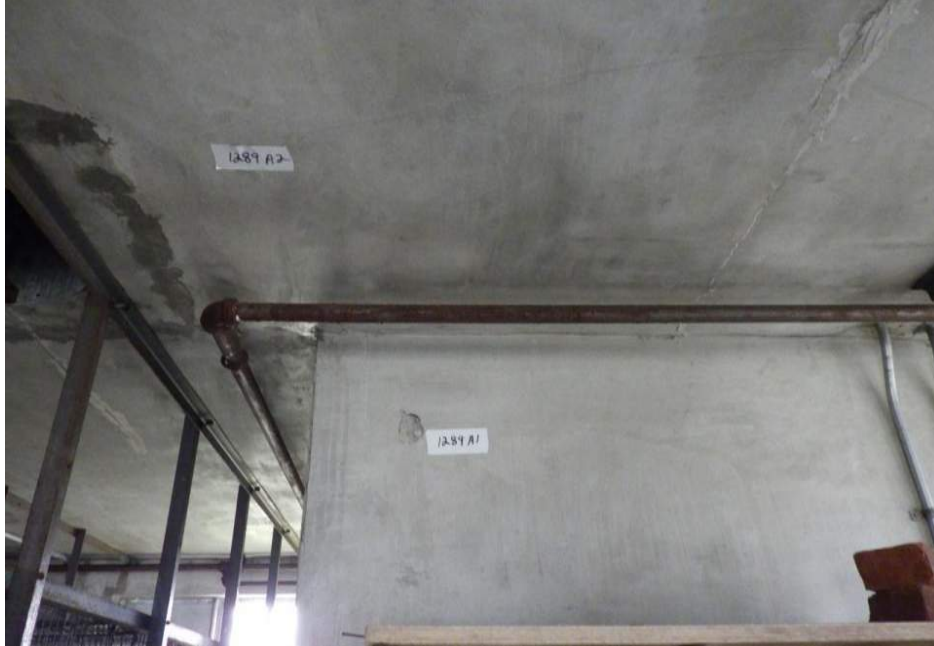
1289A1

**Results:** None Detected

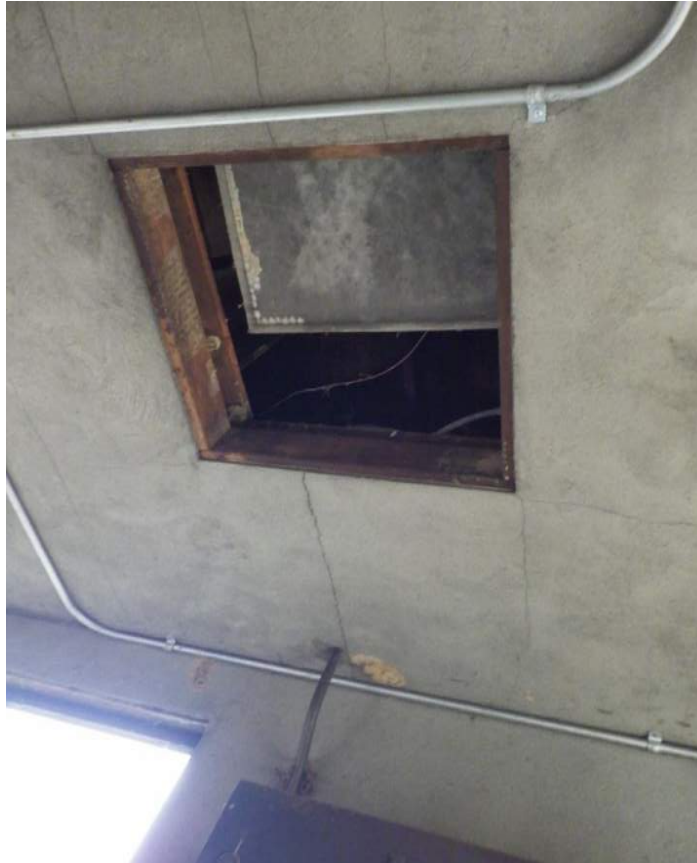
1292PACM

**Results:** Not Analyzed

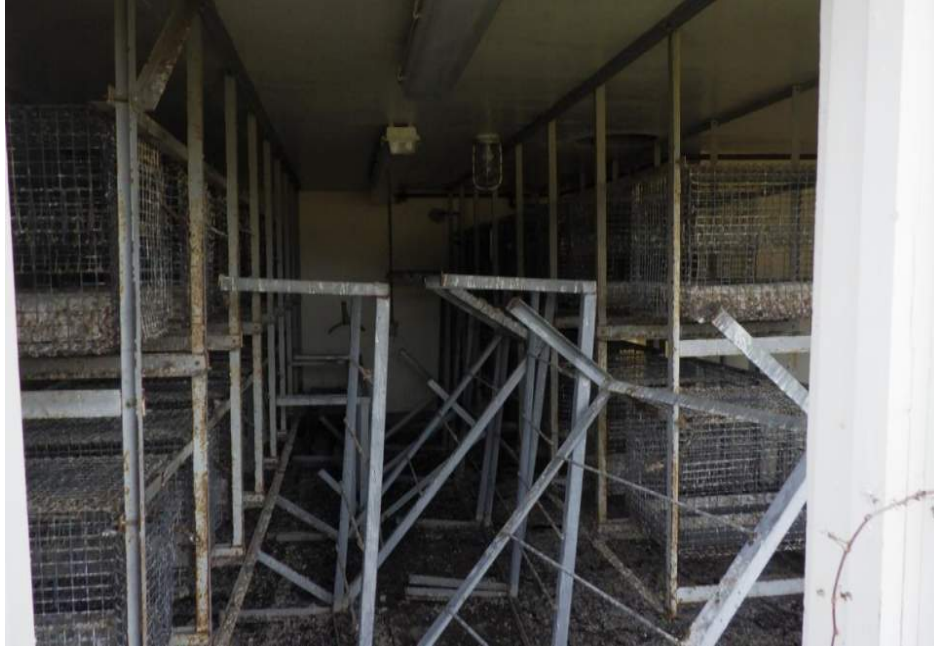
**Description:** building 1292 interior, poultry cages, bird droppings

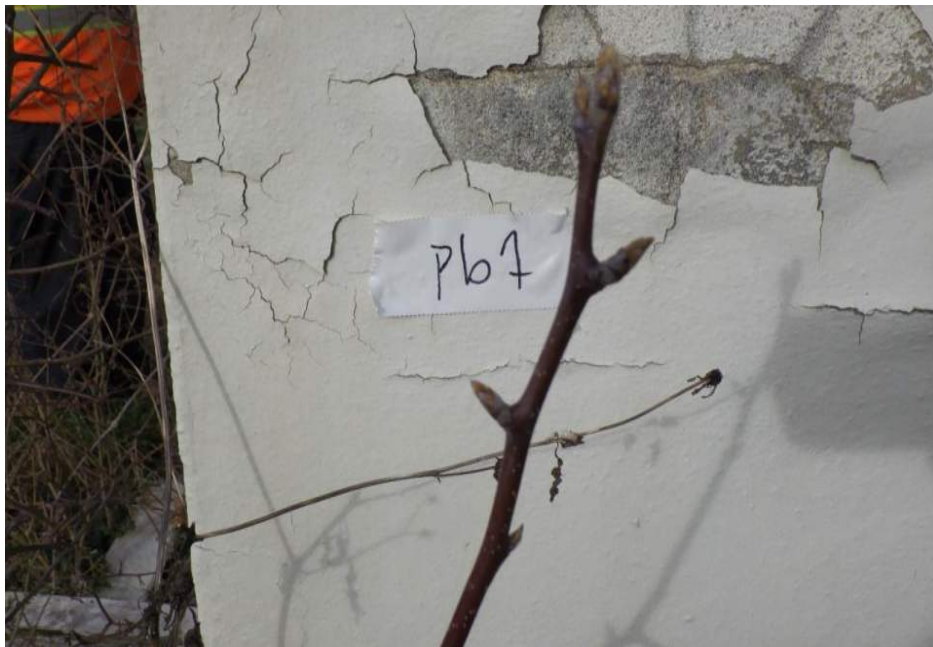
1292-Pb1

**Results:** < 86 ppm

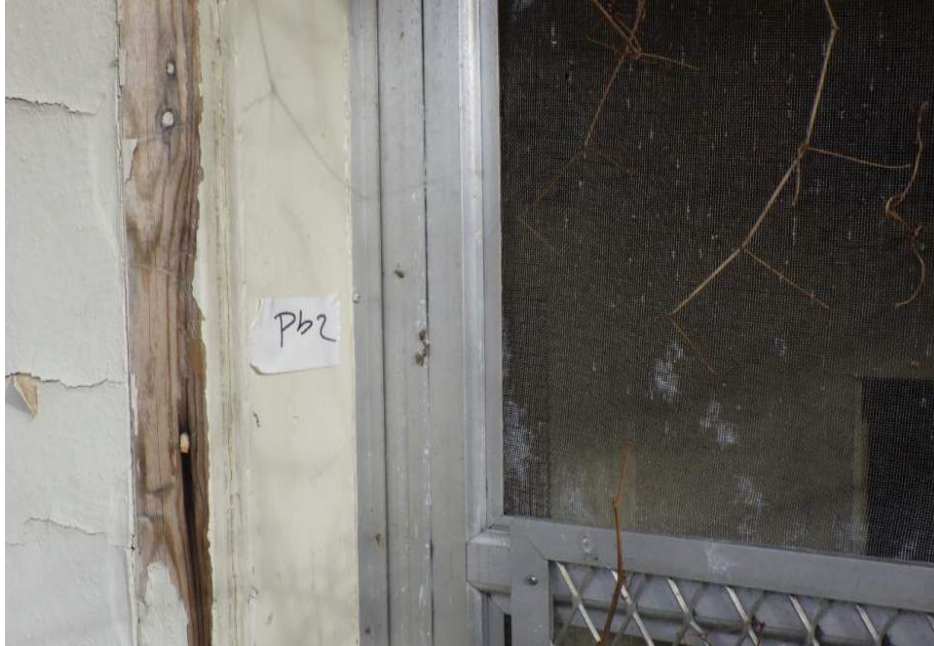
1292-Pb2

**Results:** 1600 ppm

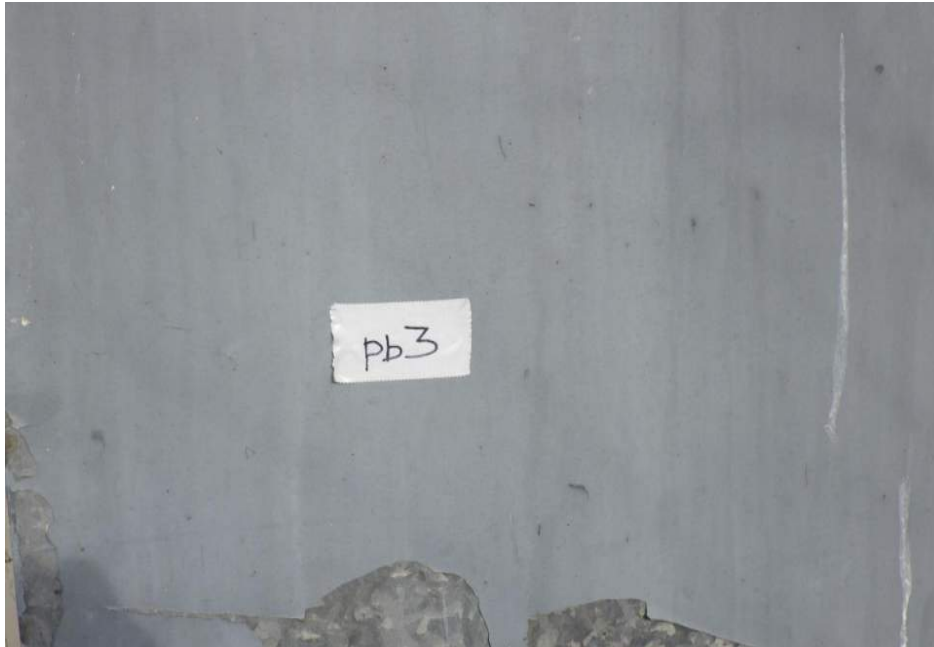
1292-Pb3

**Results:** 190 ppm

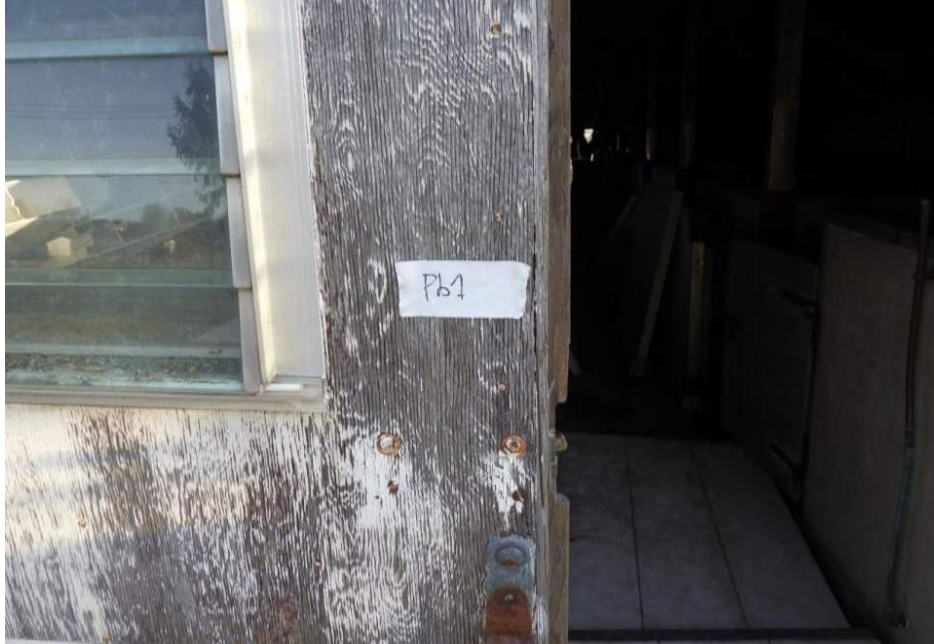
1422-Pb1

**Results:** 200000 ppm

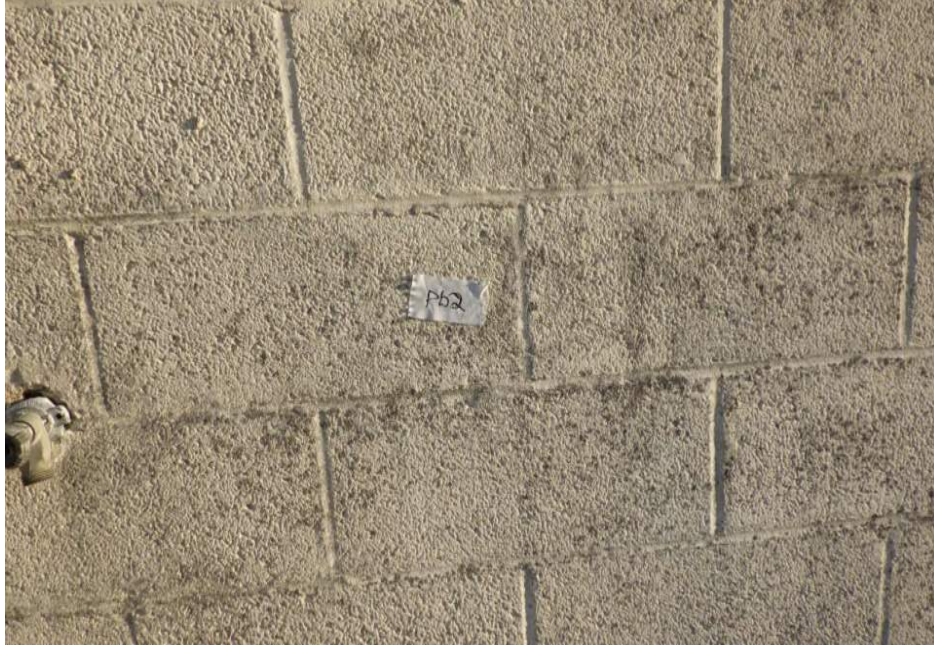
1422-Pb2

**Results:** 2900 ppm

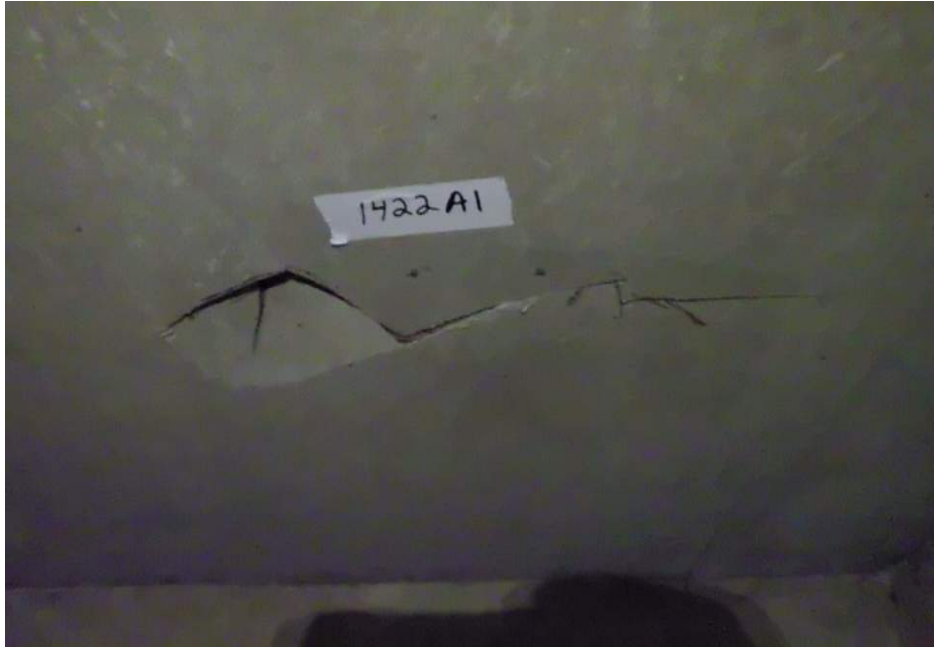
1422A1

**Results:** Chrysotile 20-25%

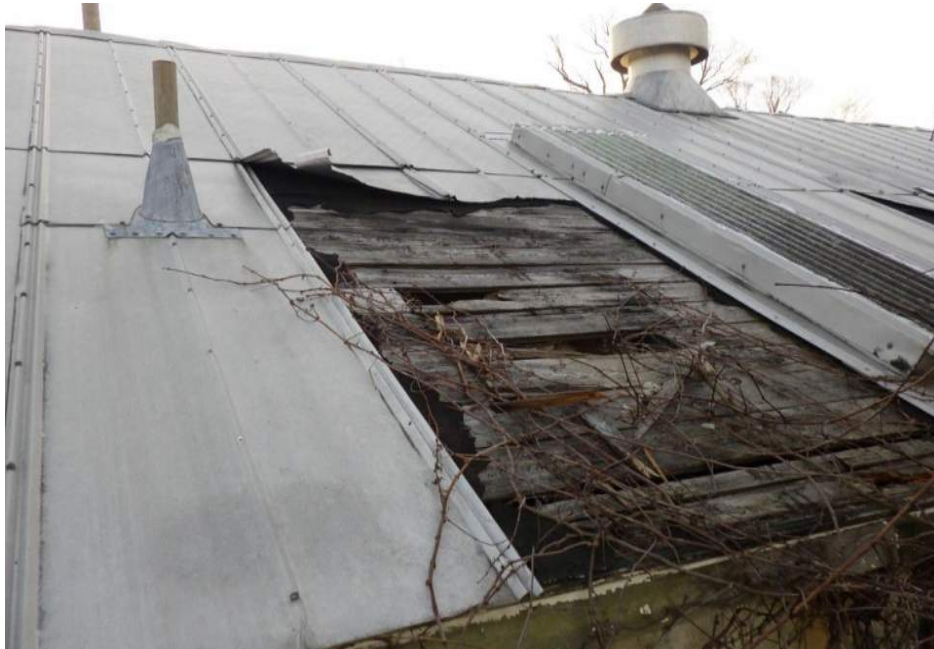
**Description:** building 1425 exterior failing roof

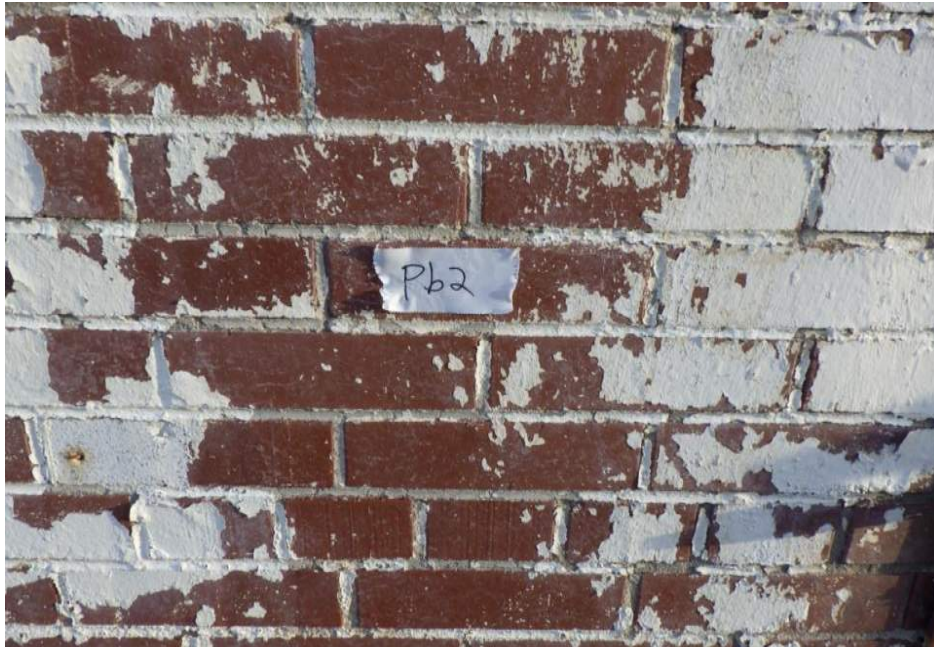
1425-Pb2

**Results:** < 960 ppm

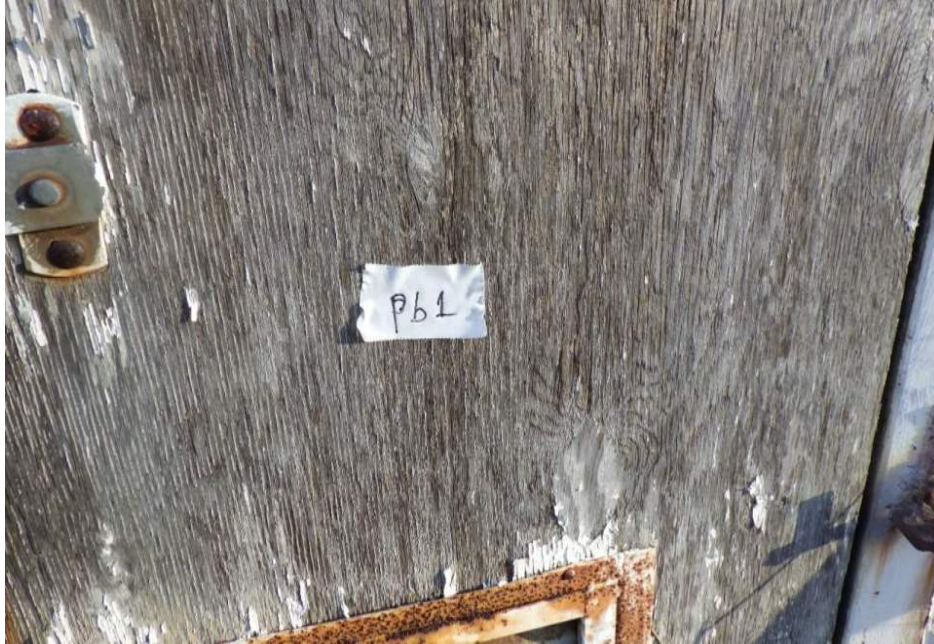
1425-Pb1

**Results:** < 960 ppm

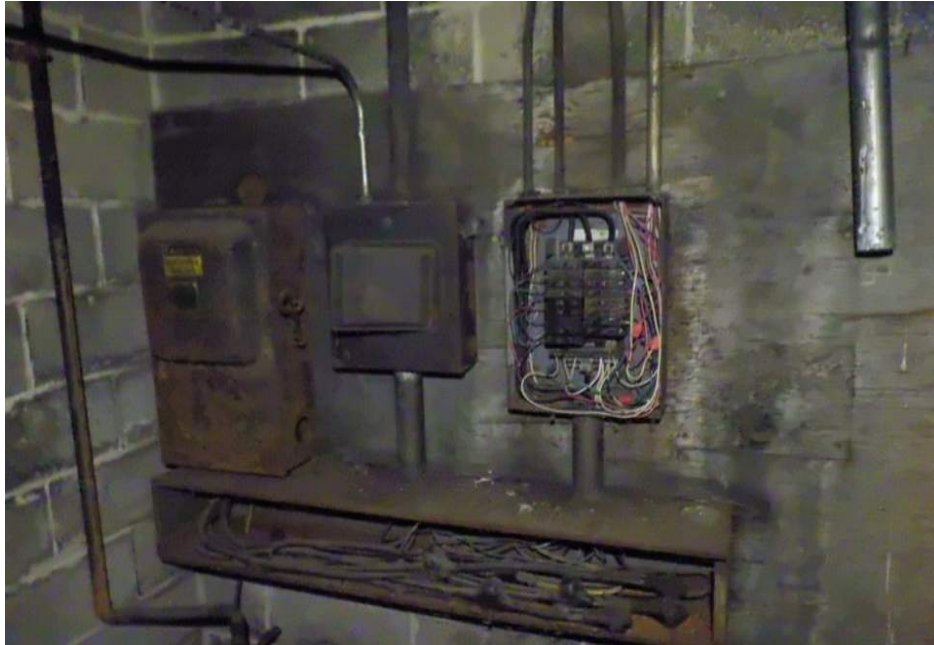
**Description:** electrical circuit breaker equipment

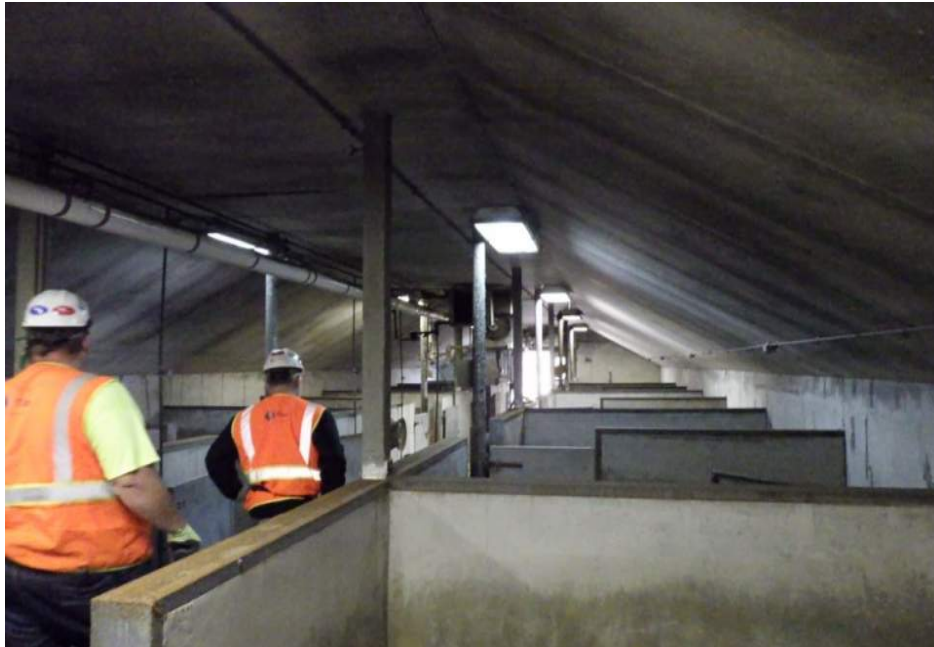
**Description:** building 1425 interior

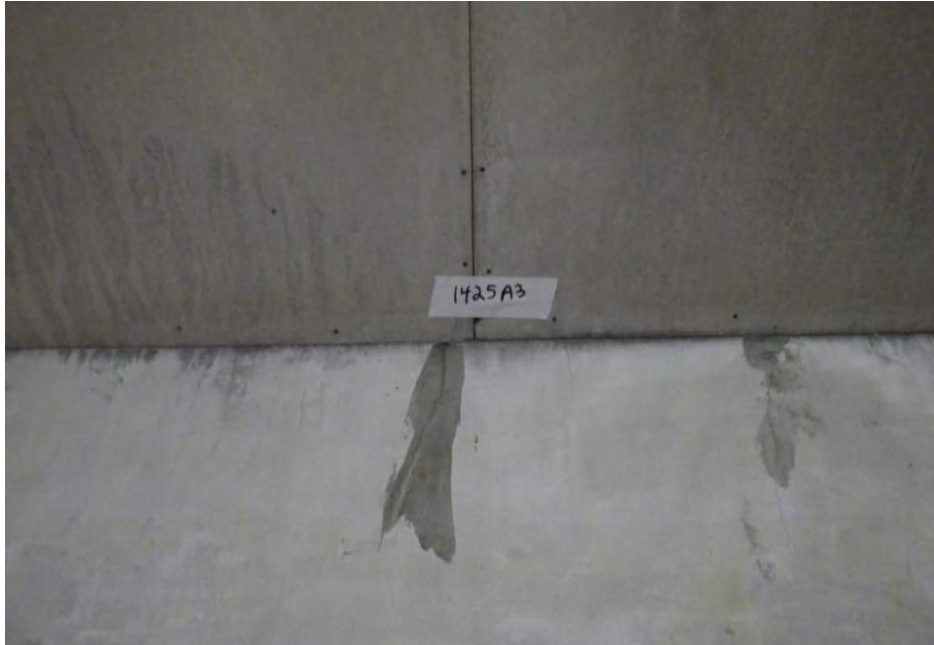
1425A3

**Results:** Chrysotile 20-25%
